**THE DOVECOTE, BREAKSPEAR HOUSE,
BREAKSPEAR ROAD NORTH, HAREFIELD,
HILLINGDON, LONDON, HA6 1BN**

A LEVEL 3-4 HISTORIC BUILDING SURVEY

September 2011

Author: Emma Jeffery

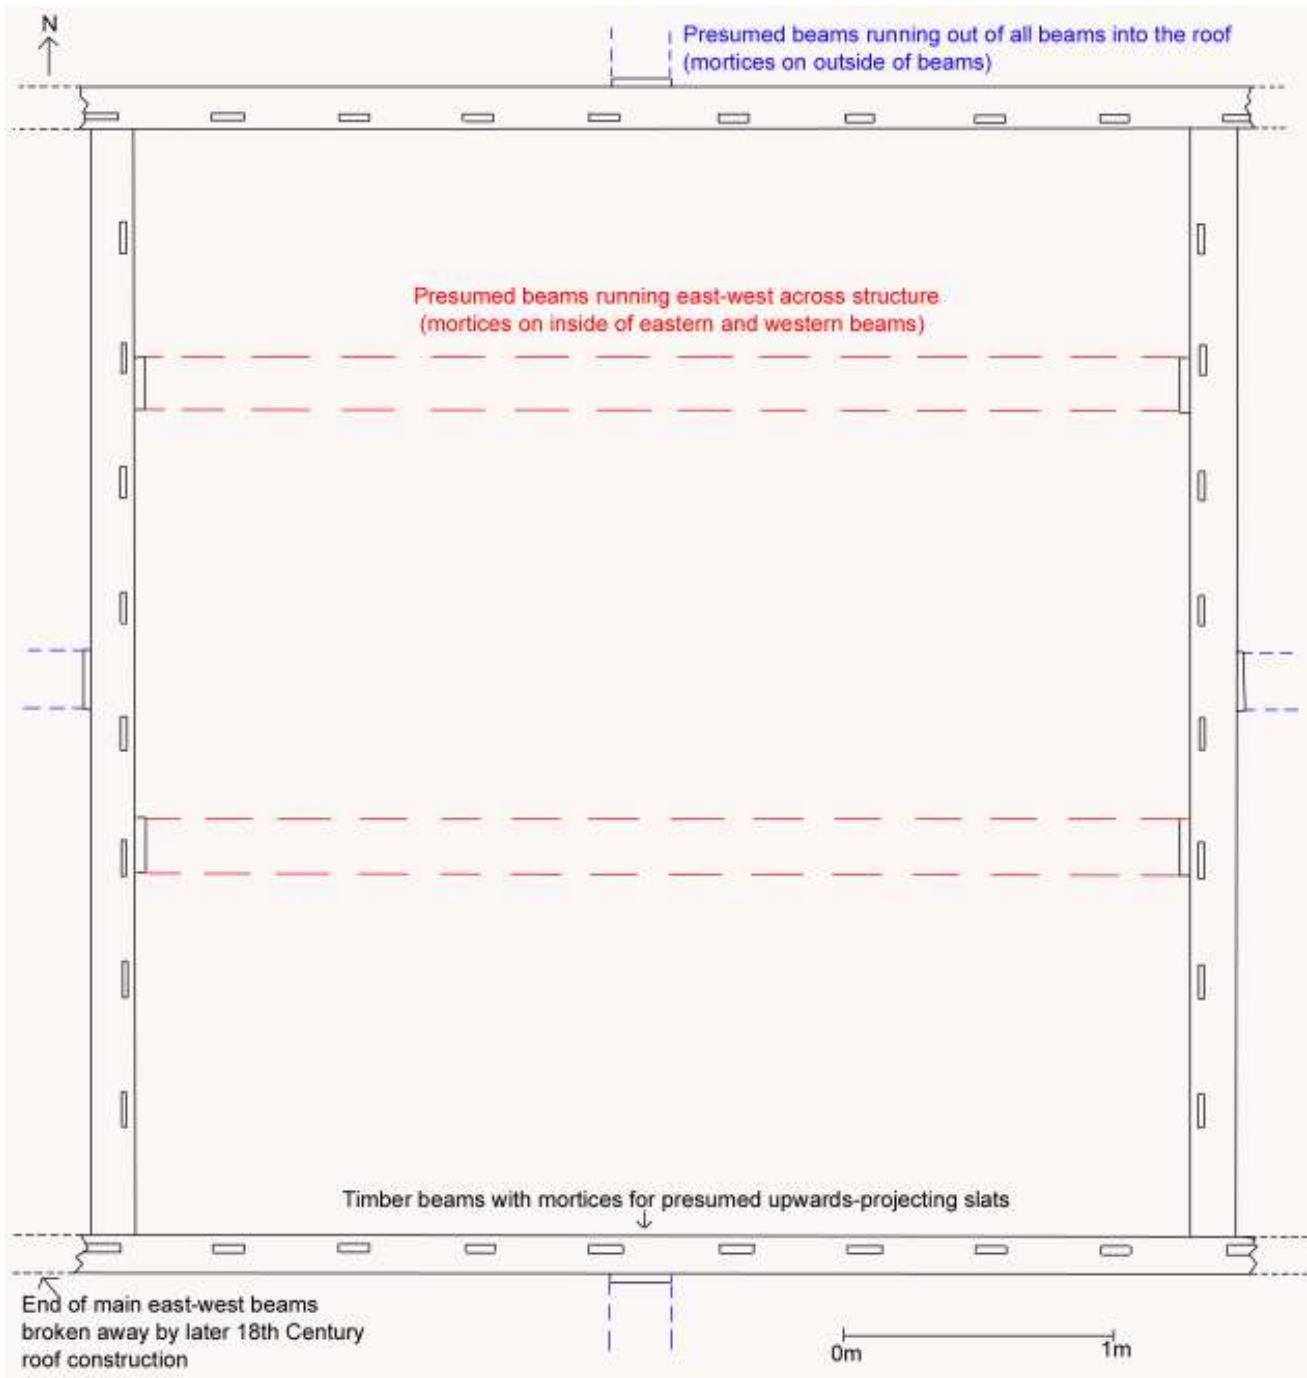
- 9.5.4** Another mortice was observed on the rear (external) face of all four of the timbers. Those on both the eastern and western timbers were located 1.94m south of the northern end (approximately half-way along), and measured *c.*210mm X *c.*35mm X *c.*100mm. Those on the northern and southern timbers were located approximately 2.12m west of the eastern end (approximately half-way along), and measured approximately 210mm X 40mm X 110mm. These mortices presumably held timbers projecting back outwards from the dovecote, presumably to hold other parts of the timber roof construction.

- 9.5.5** Furthermore, the remnants of four more mortices at the far eastern and western ends of the northern and southern timbers (i.e. beyond where the eastern and western timbers join) were observed. These had been partly broken away by the later roof construction, so are no longer complete. Their existence does, however, suggest that this timber roof construction continued further to the east and west, projecting the roof out further to the east and west, supporting the corners of the overlying structure, and thereby providing more room for the doves to enter under the eaves.

Fig. 78: Plan of the roof timbers and mortices at the top of the dovecote. The red hashed lines depict the probable line of east-west running beams. The blue hashed lines depict the probable line of beams running out from the main beams into the roof. It must be noted that although these mortices are depicted projecting outwards (for ease of understanding), they were actually cut into the timber beams.

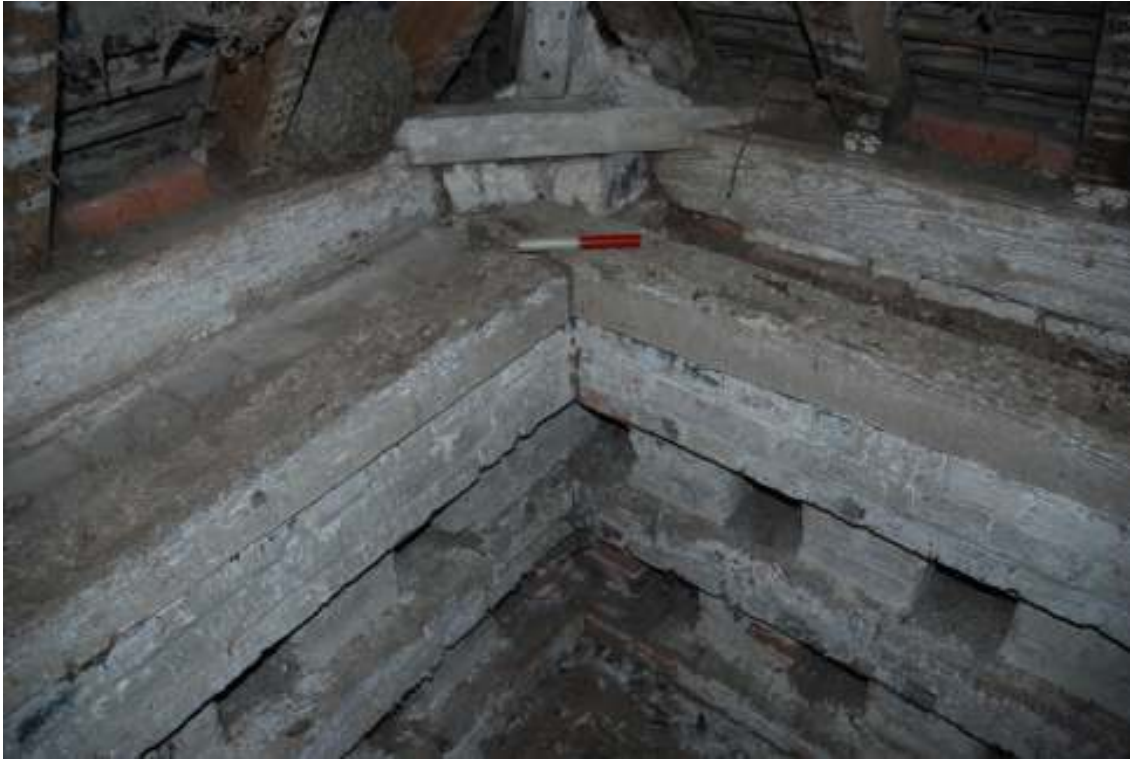
- 9.5** There is also some evidence for the original roof construction, in the form of four large, though heavily decayed, pieces of timber running around the top of the brickwork on the upper floor of the dovecote.

Fig. 79: Photograph of the earlier timber in the foreground along the top of the dovecote wall (south-east corner).

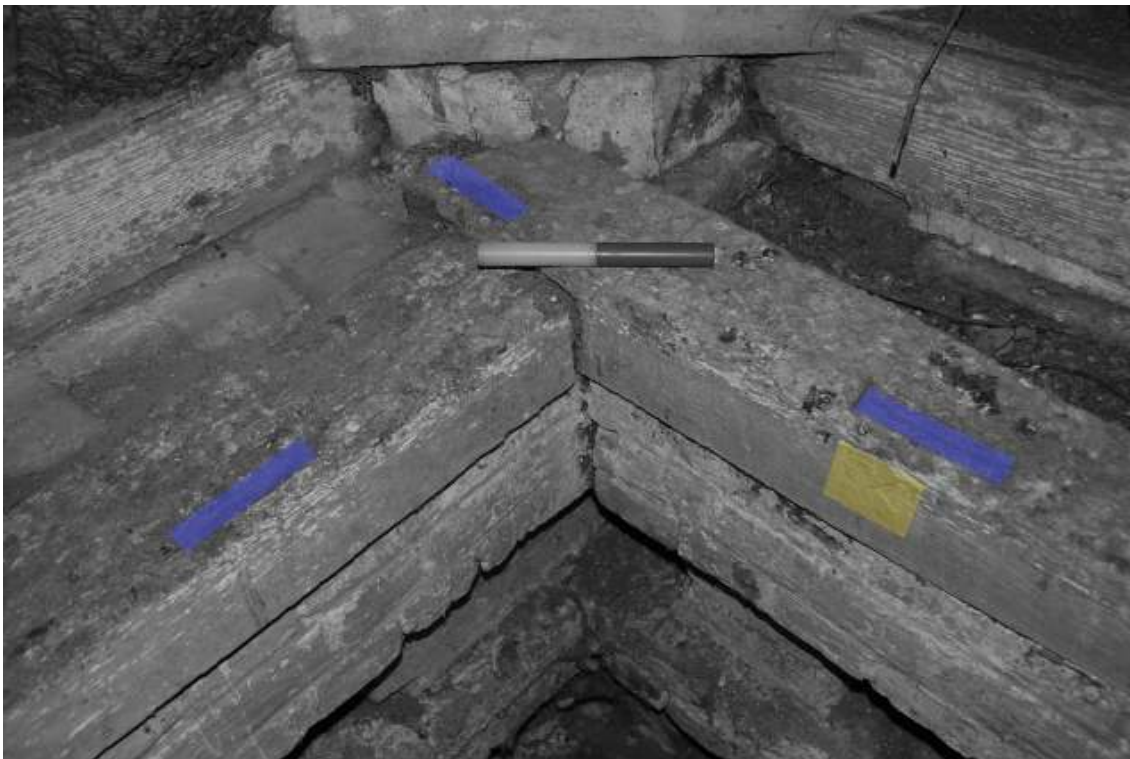
Fig. 80: Annotated photograph of the earlier timber along the top of the wall (south-east corner of the dovecote). Three mortices can clearly be seen (highlighted in blue), two on the right hand piece of timber and cut away behind the scale by the later roof construction. One carpenter's mark ('X') is visible on the right-hand timber (highlighted in yellow).

- 9.5.6** A series of carpenters' marks were also observed on these timbers, such as the mark 'II' below the southern mortice on the eastern timber, and the mark 'IV' by the third mortice from the south on the eastern timber. This is clearly evidence for the method of construction of the timber and roof.

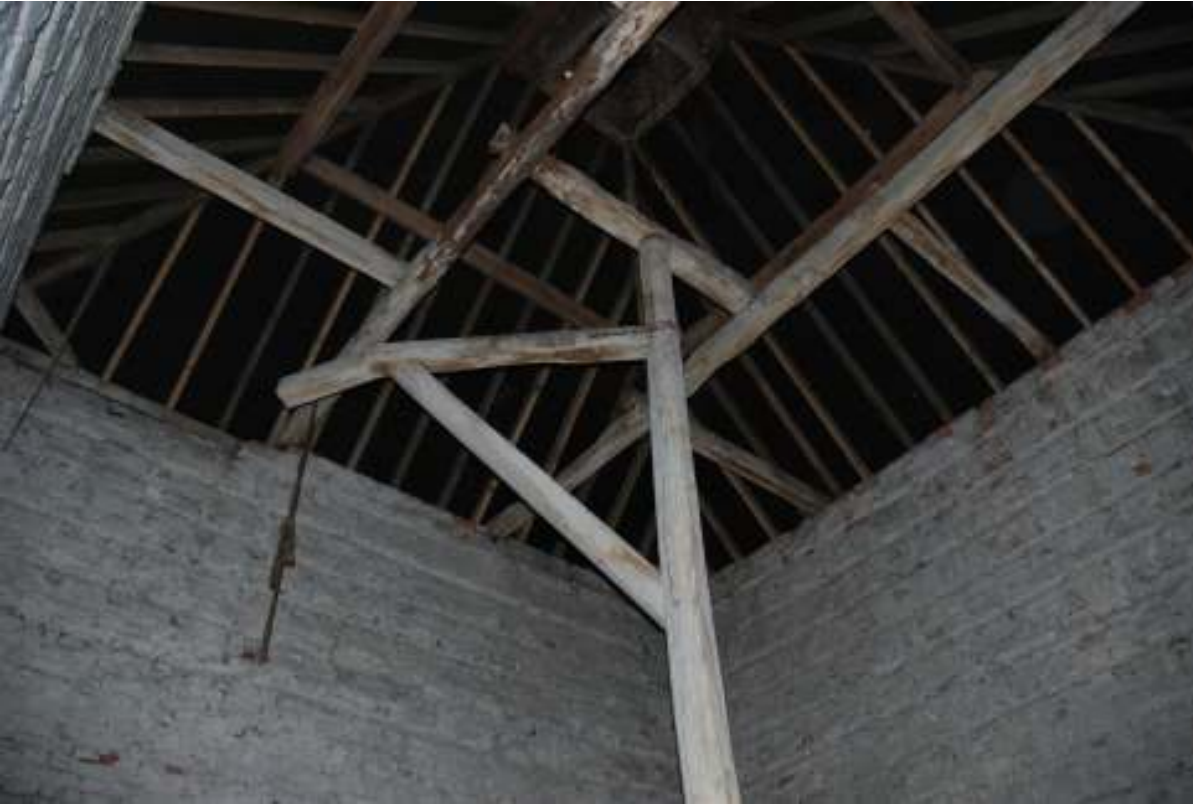
- 9.5.10** Furthermore, the dovecote at Eastcote also had a small timber beam running north-west between the main east-west running beams, off which the octagonal central column of a potence was held. A potence is a structure found mainly in circular dovecotes – essentially a revolving pole with arms onto which ladders could be attached. This enabled the doves' eggs and squabs to be collected, without having to continuously move the ladder round. The potence in the Eastcote dovecote consisted of a central wooden octagonal column, set into a stone base, off which was one main arm (with a slight kink in it at the end), supported by another wooden beam running diagonally up to support the main arm. Other mortices observed in the central column would have supported a further arm, slightly offset and at a lower level. Together, the two arms would presumably have held a ladder, the 'kink' in the horizontal upper arm providing a stable support at the top (i.e. parallel with the lower arm

Fig. 81: Photograph of the interior roof construction and potence in the dovecote at Eastcote.

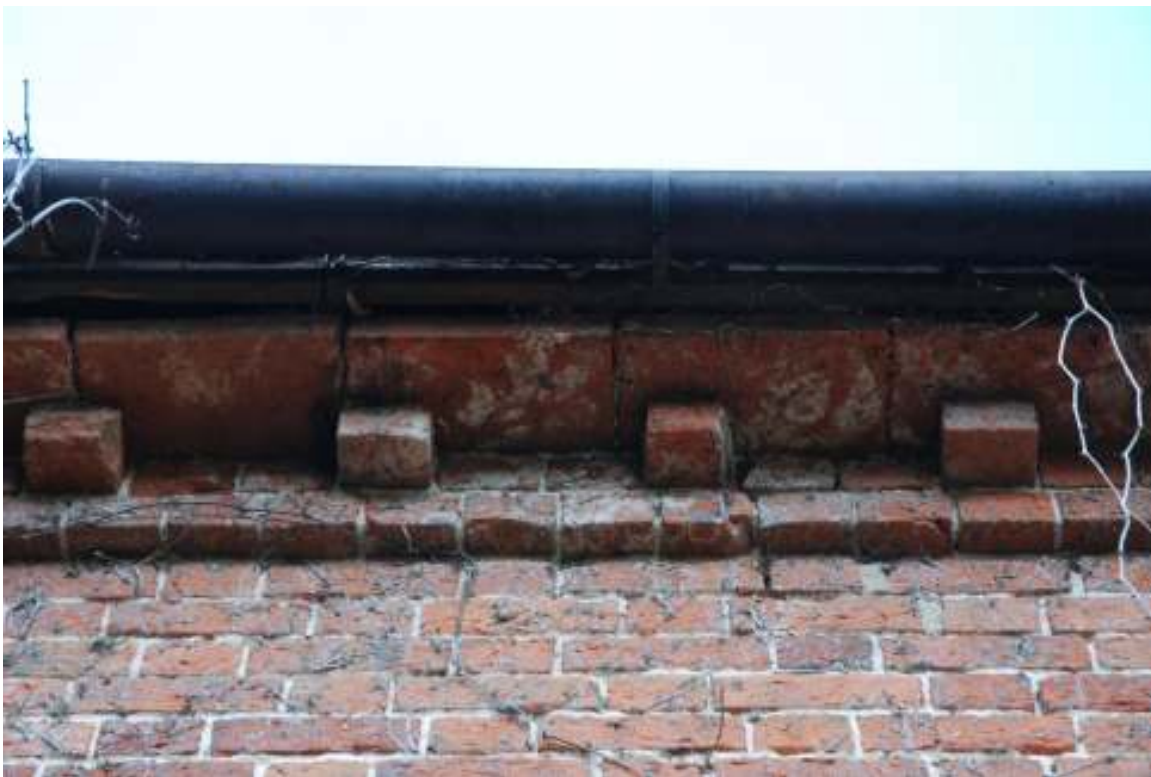
9.5.12 The roof of the Eastcote dovecote is also different from that suspected to have existed in the Breakspear dovecote – in that there is no way for doves to enter the dovecote underneath the eaves at Eastcote. The slats which are suspected to have existed in the earlier Breakspear roof do not exist in the Eastcote roof. Instead, there is a row of bricks sticking out, further corbelled bricks, and a row of tiles laid flat. It is thought that the doves would have entered the Eastcote dovecote through some form of dormer window in the eastern roof (seen on a historic photo), rather than under the eaves, as well as through the cupola.

Fig. 82: Photograph of the exterior top of the dovecote at Eastcote. This shows the outwards-projecting bricks and flat tiles, and no way for doves to enter under the eaves.

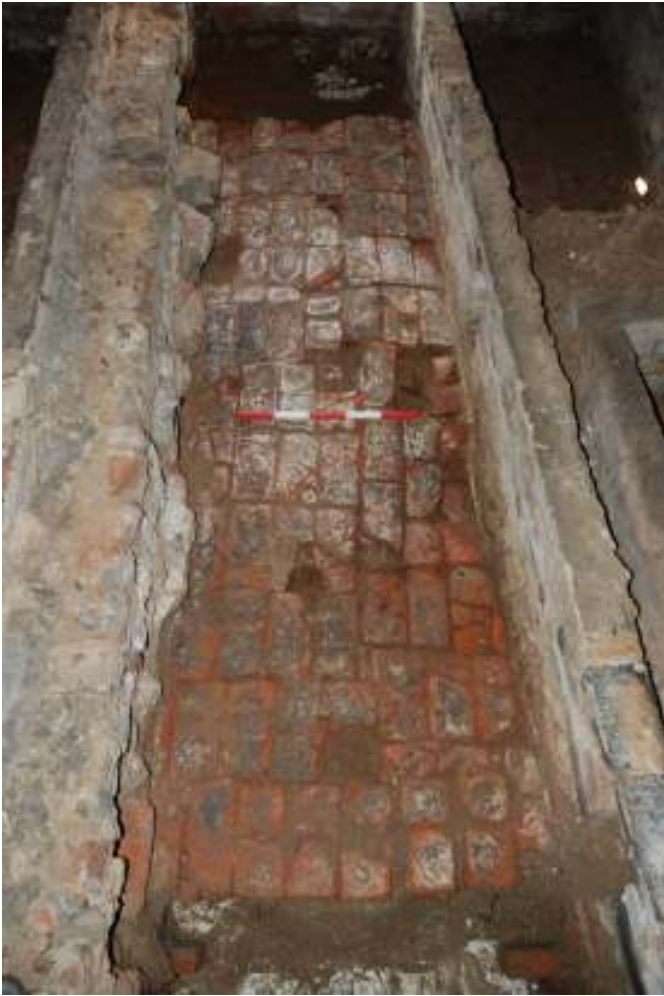
- 10.2** The brick floor consists of red-bricks, many of which were heavily vitrified and heavily worn (unsurprising considering it was a floor). It appears to have been laid dry, with no obvious mortar or mortar-splodging over the brickwork, etc.

Fig. 83: Photograph of the brick floor, overlain by later brick plinths.

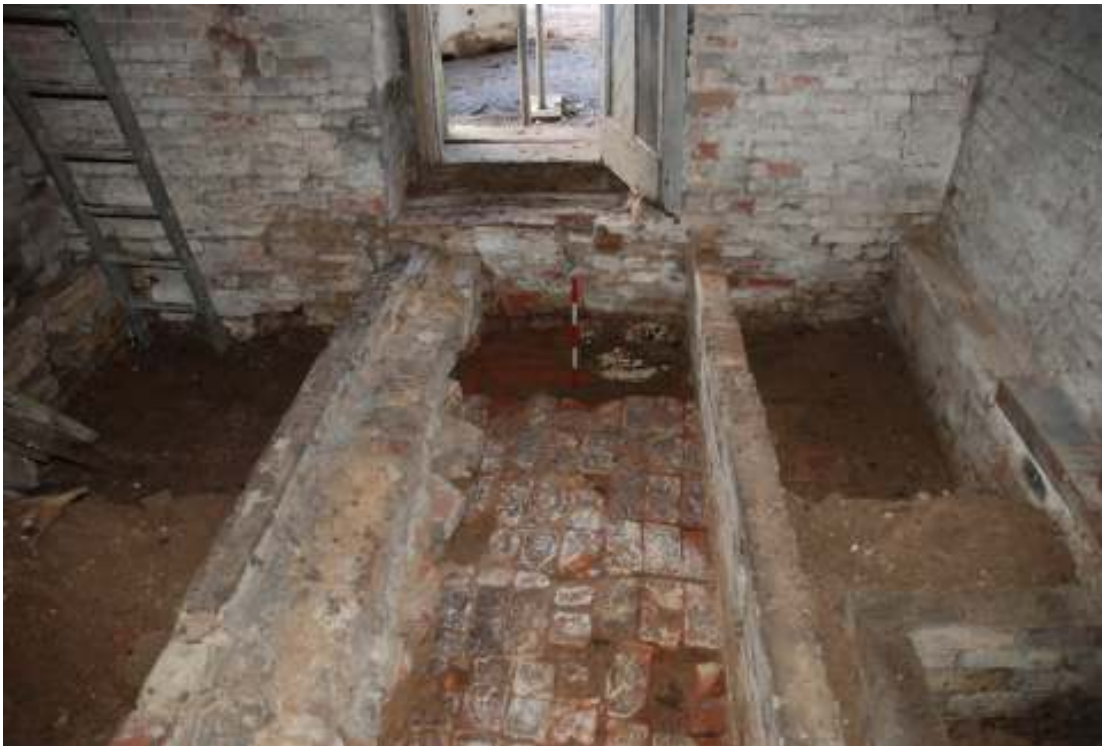
- 10.2.3** The brick floor was found at *c.*81.71mOD (sloping upwards slightly towards the western end where it was *c.*81.73mOD). The floor itself also appeared to slope down slightly away from the centre of the floor. This may have been related to the French drain which ran around the outside of the ground-floor, as a floor which sloped away from the centre would enable water to drain off the floor into the drain.

Fig. 84: Photograph of the brick floor, looking towards the western door.

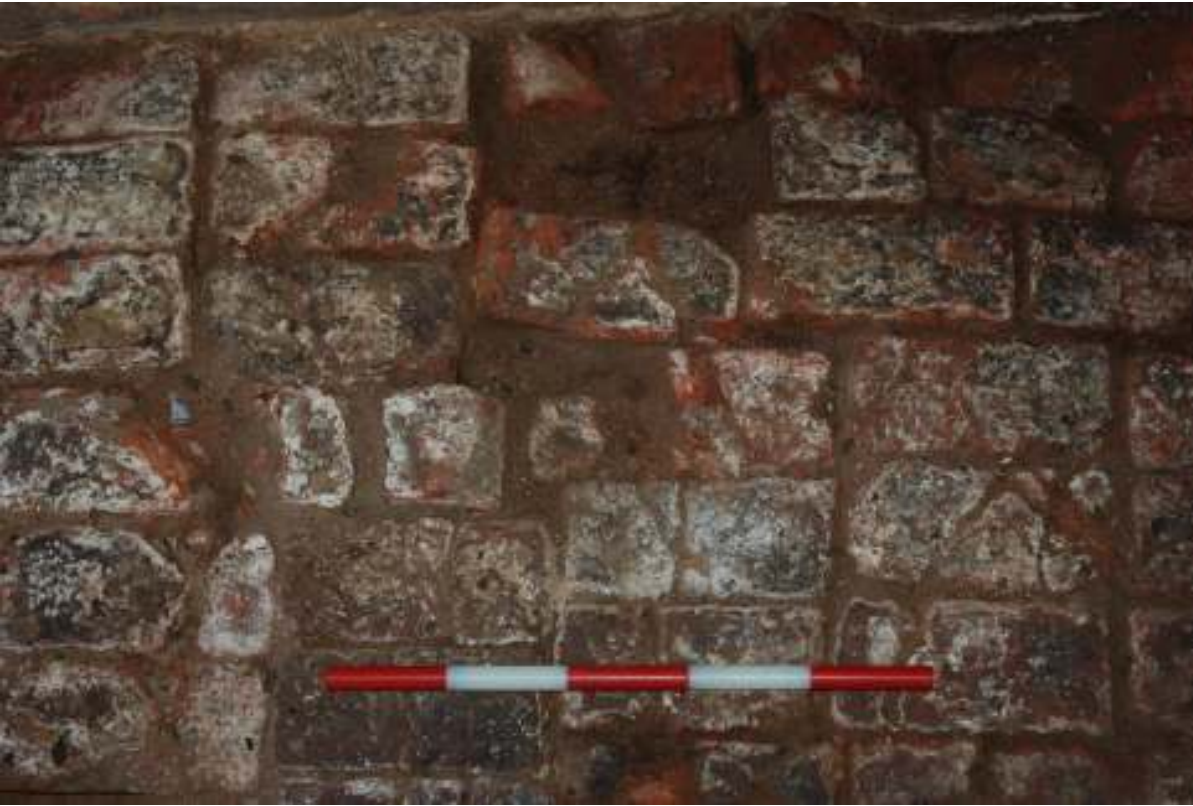
Fig. 85: Close-up photograph of the brick floor.

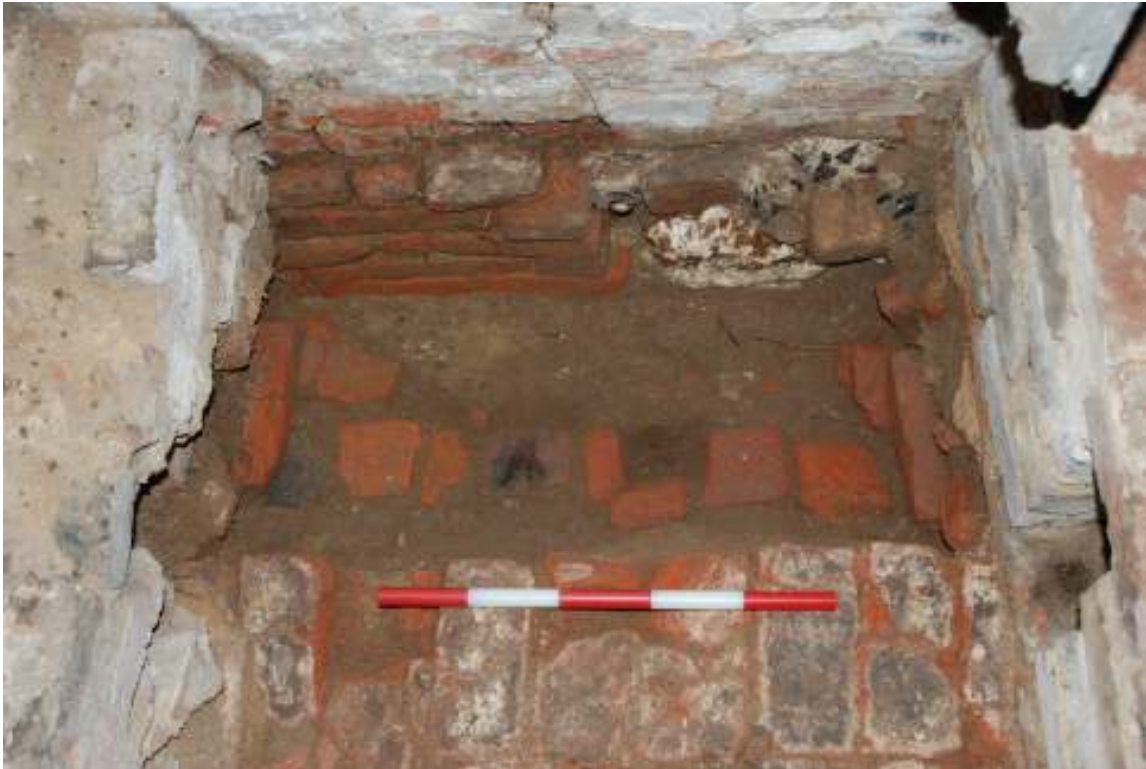
- 10.3.7** The purpose of the French drain within the dovecote itself would have been to facilitate drainage of the interior of the structure. This, in itself, suggests that the structure might have been waterlogged, as it was considered necessary to provide such drainage. This may, furthermore, account for the addition of buttresses to further support the structure, possibly also because of problems of waterlogging etc. This could be related to the fact that in the 18th Century the dovecote stood between two reasonably-sized ponds, and very close to that to the west (see fig. 2).

Fig. 86: Photograph of the French drain, beneath the western doorway. This shows the pieces of bottle and bricks within the drain infill, and the edge of the brick floor.

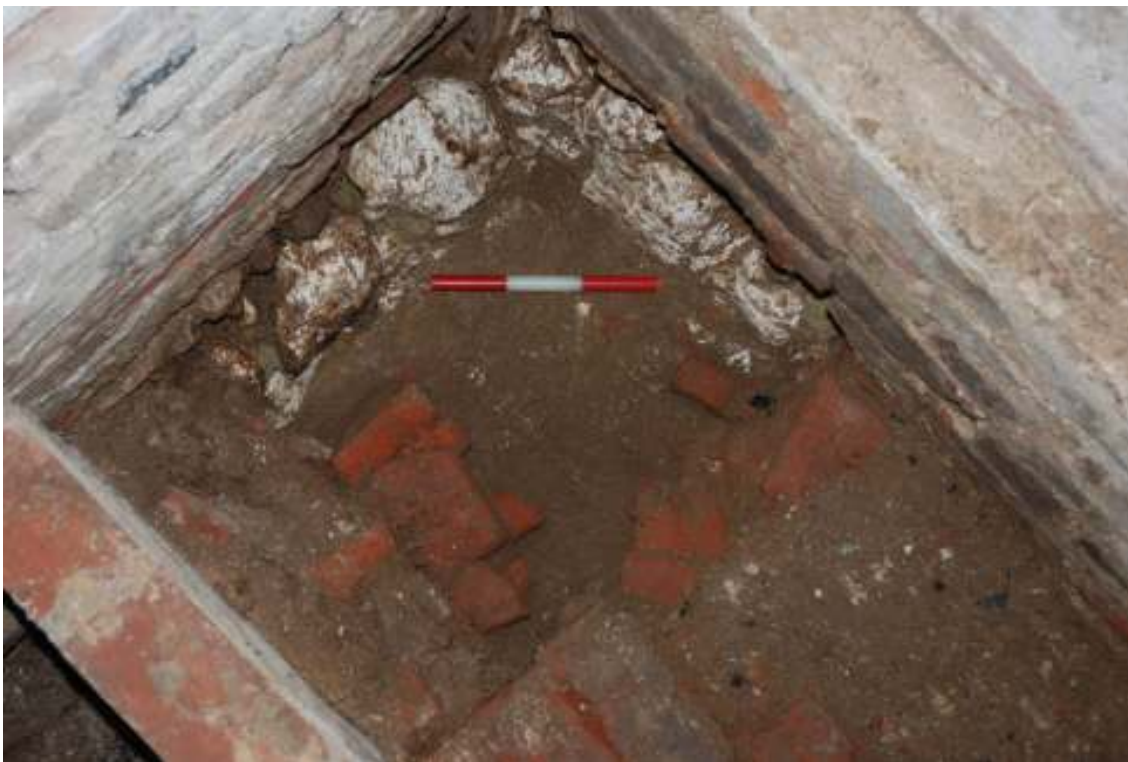
Fig. 87: Photograph of the excavated French drain, in the north-west corner of the dovecote.

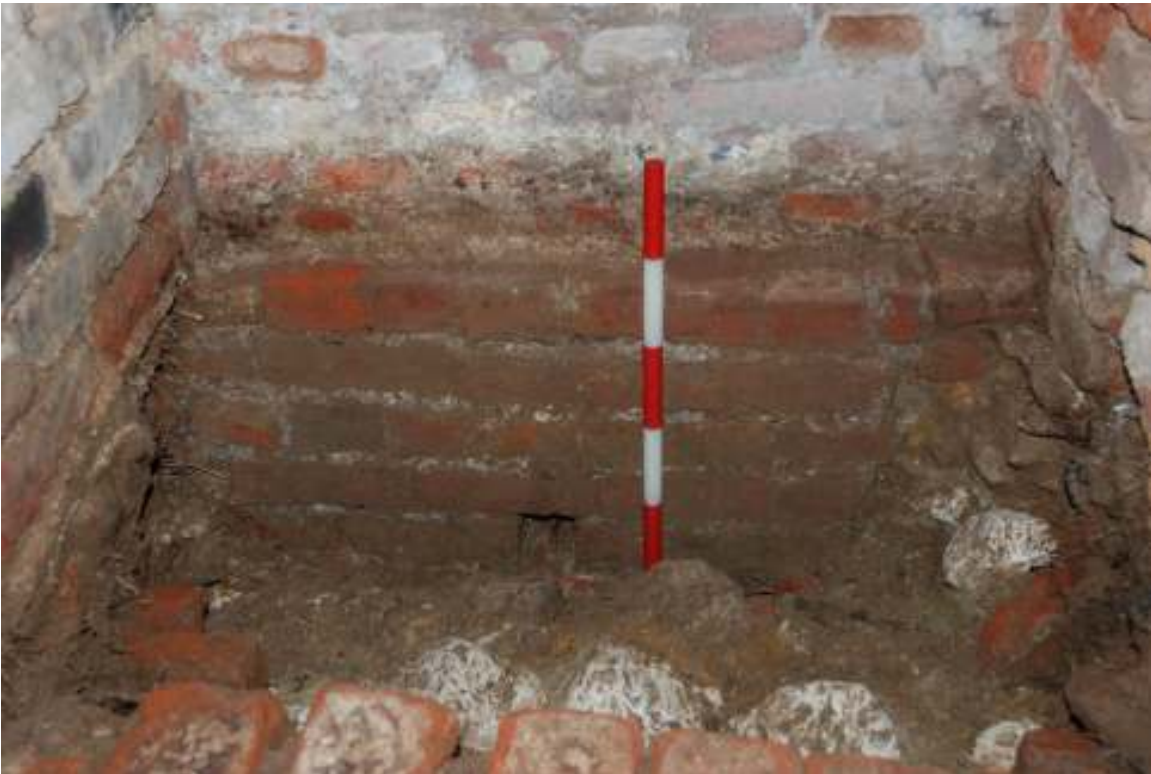
10.4.1 Through this section of blocked-up doorway was a drain hole, observed on both the interior and exterior sides of the dovecote. The base of this was *c.*70mm above the foundations of the structure, at an approximate height of *c.*83.01mOD. This drain hole was square on the interior of the door, and measured *c.*70mm wide, by 90mm high. It was a circular hole (with a drainpipe running through it) on the outside of the doorway, with a diameter of *c.*155mm. The drainpipe observed in this hole was identified as a 2276 type, dated 1650-1850 (see appendix VI).

10.4.2 This drain hole would therefore have acted with the French drain to drain the water out of the dovecote. It is on the correct side for the water to drain out of the dovecote (with the natural slope of the land leading towards this drain hole), and at the same level as the base of the French drain, etc.

Fig. 89: Photograph of the interior of the eastern doorway. This shows the blocking-up of the lower part of the doorway, and the drain hole at the base of this.

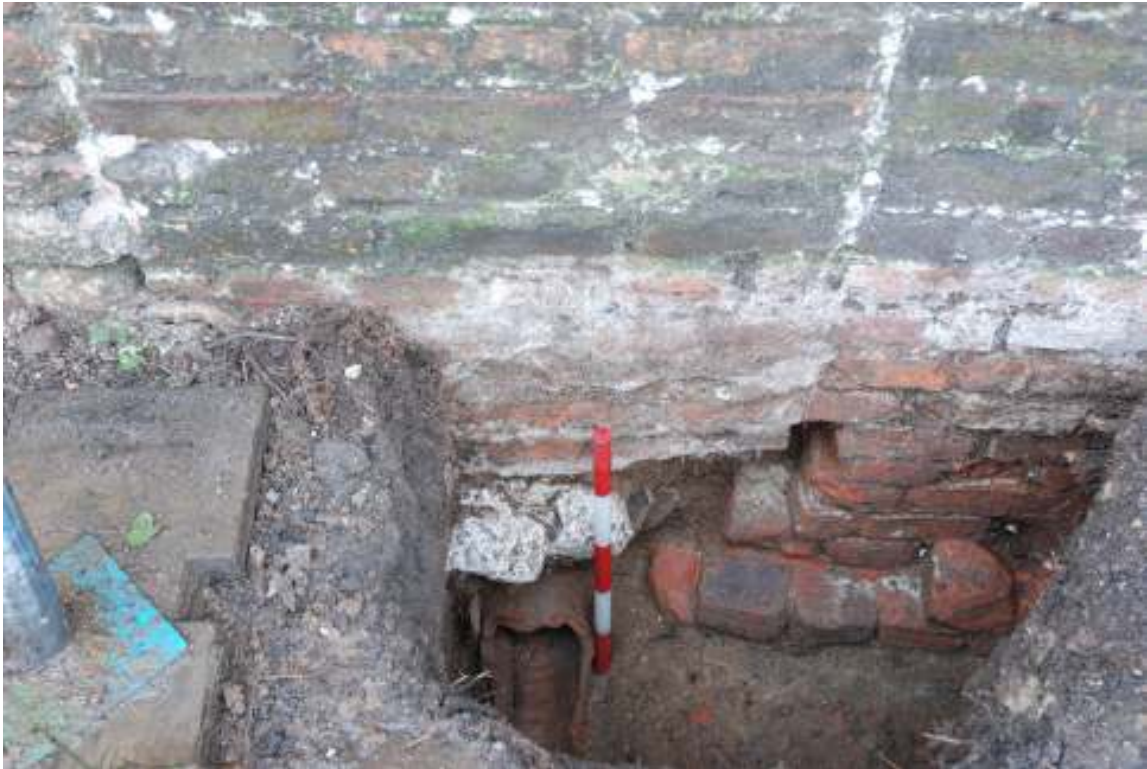
Fig. 90: Photograph of the exterior of the eastern doorway. This shows the drainpipe running through from the inside of the dovecote.

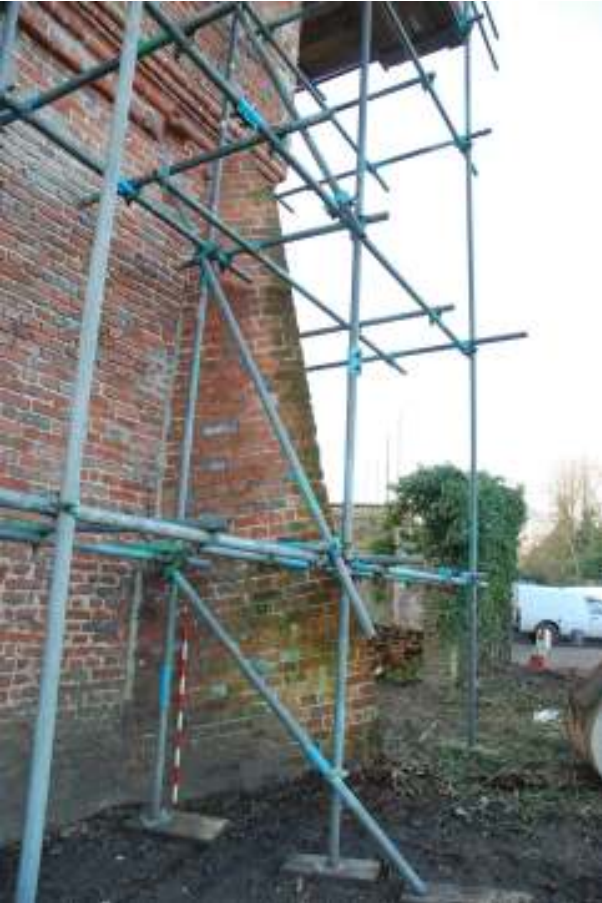
11.2.4 It appears to directly abut the main dovecote structure, i.e. it is slapped directly onto it, with a large amount of grey mortar holding it in place, although this may be later infilling.

Fig. 91: Photograph of the southern side of the north-eastern buttress. This clearly shows the grey mortar that has attached the buttress onto the main dovecote structure.

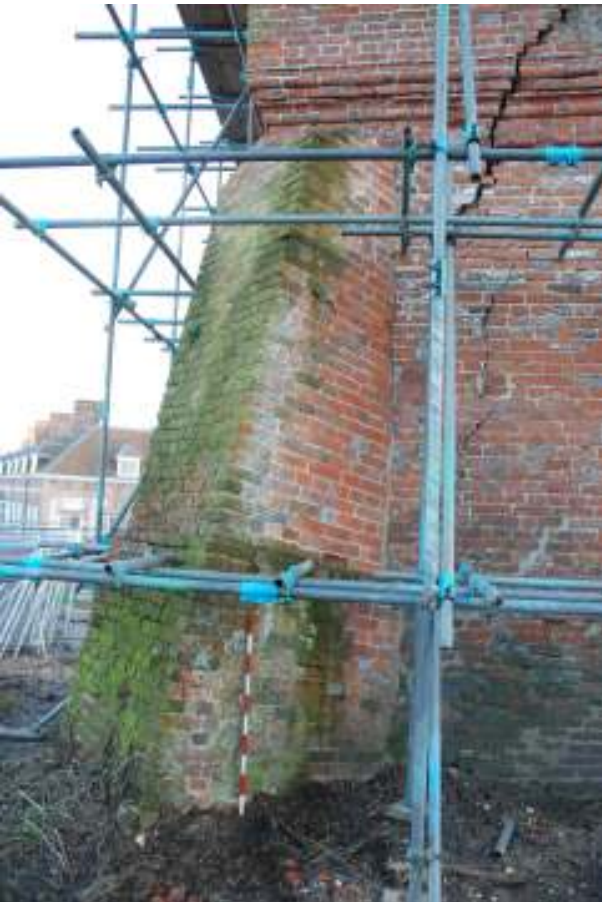
Fig. 92: Photograph of the northern side of the north-eastern buttress. This clearly shows the buttress overlapping the moulded course of brickwork.

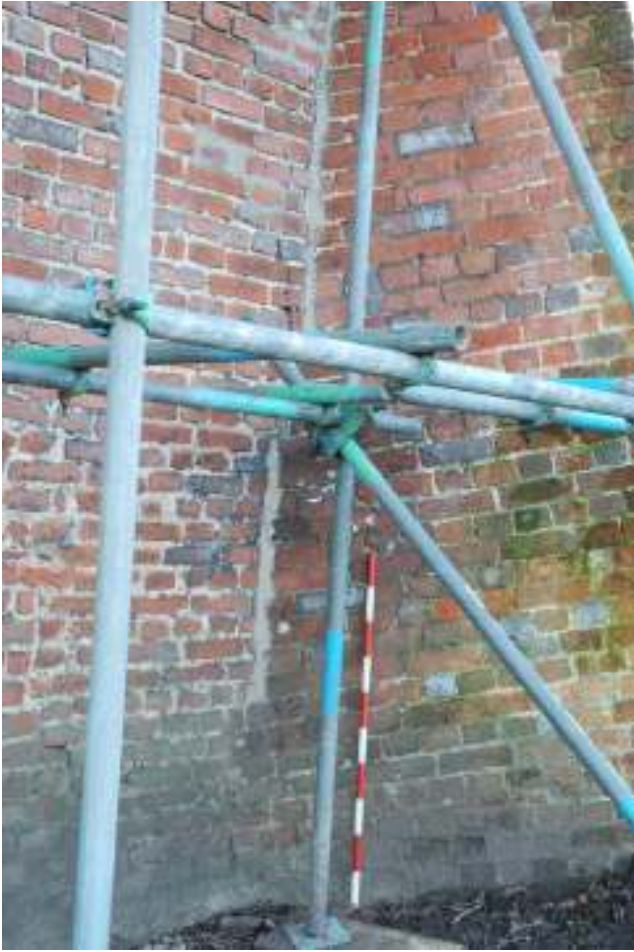
Fig. 93: Photograph of part of the southern side of the north-eastern buttress. This clearly shows the buttress abutting the main dovecote wall, and the grey mortar attaching this.

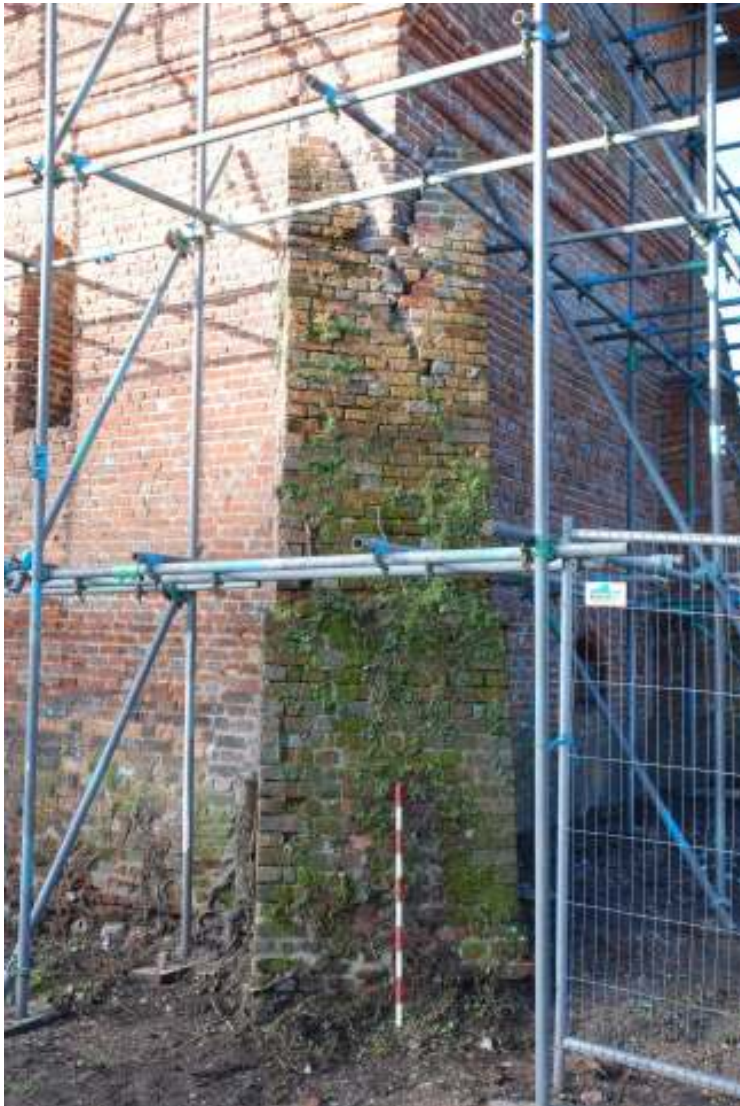
11.3.5 There is also a small 'step' out running around the buttress, out by c.60mm on the front face, approximately 1.74m above the modern ground-surface. The area beneath this appears to have been 're-faced' / patched in some way. It is possible that this is related to the construction (or destruction) of the stable block (mid - late 19th Century), which was abutted onto this buttress (see the 1894 Architect's Plan of Breakspear, fig. 5). This area may, therefore, have been patched following the destruction of these stables, which were attached to the dovecote.

Fig. 94: Photograph of the front of the south-eastern buttress. This clearly shows the buttress being splayed around the dovecote wall. The 'step' out, just beneath the scaffolding, and different patching beneath this can also be seen.

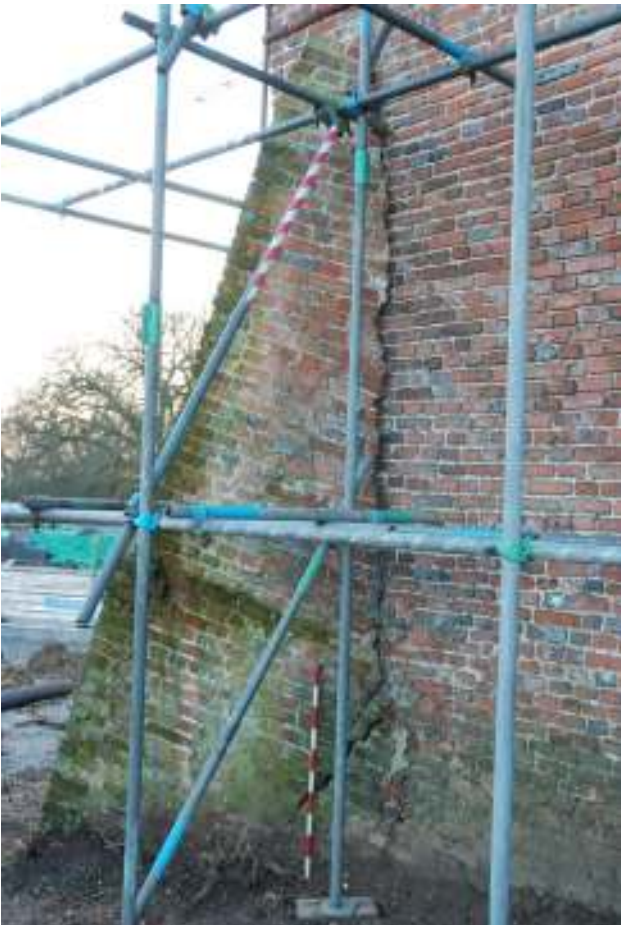
Fig. 96: Photograph of the eastern side of the south-eastern buttress. This clearly shows the rough abutting of the buttress to the main dovecote wall.

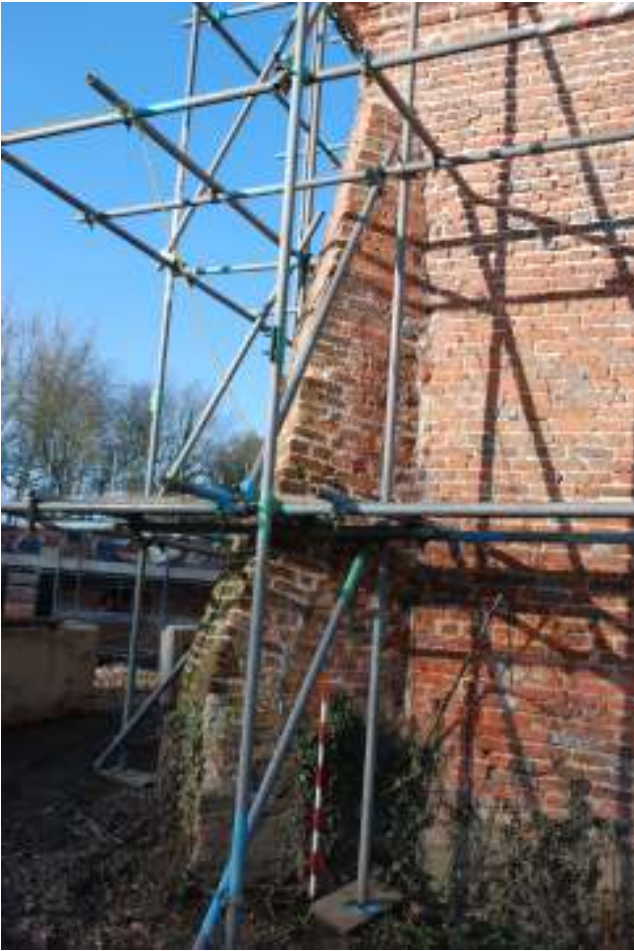
- 11.4.2** This buttress also appears to have been constructed in two phases. This is apparent on the lower part of the eastern face of the buttress, where there is a clear line (visible to the naked eye) of grey mortar cementing in a patch of new brickwork. It is possible that this is related to the apparent stable wall that is depicted on the 1894 Architect's Plan of Breakspear, which appears to abut this buttress. The patching observed on the buttress may therefore have been undertaken following the destruction of this wall, sometime between the mid-1890s and 1914.

Fig. 97: Photograph of the eastern side of the south-western buttress. This clearly shows the later patching of the edge of the buttress.

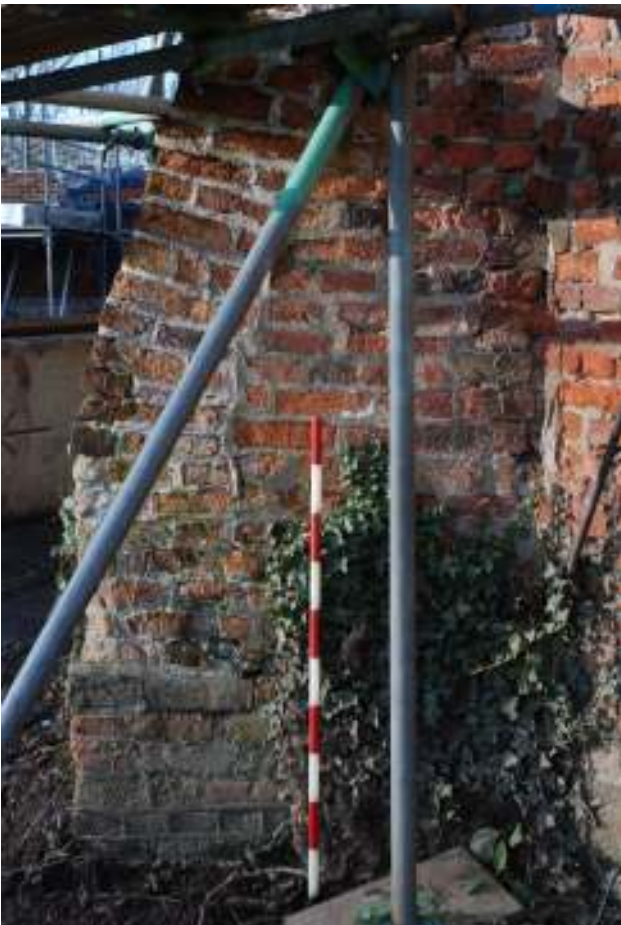
Fig. 98: Close-up photograph of the eastern side of the south-western buttress. This clearly shows the line of the later patching.

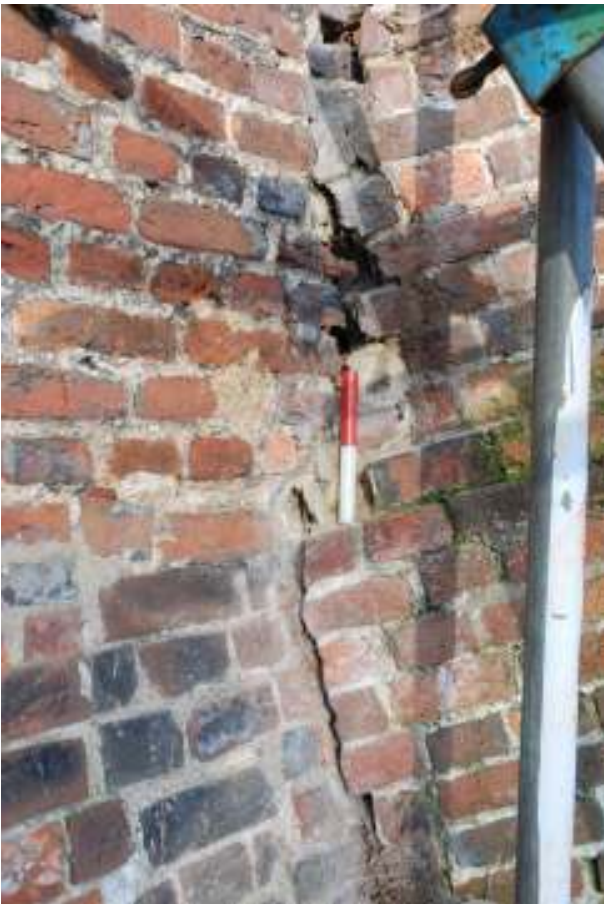
- 11.4.5** In a similar way to the south-eastern buttress, this buttress is built abutting the main dovecote structure in a very rough way. The main wall clearly runs along behind the buttress, with the buttress having been built roughly abutting it (not neatly mortared in like the north-eastern buttress), although this may in part reflect subsequent movement.

Fig. 100: Photograph of the western side of the south-western buttress. This clearly shows how the buttress roughly abuts the main dovecote wall.

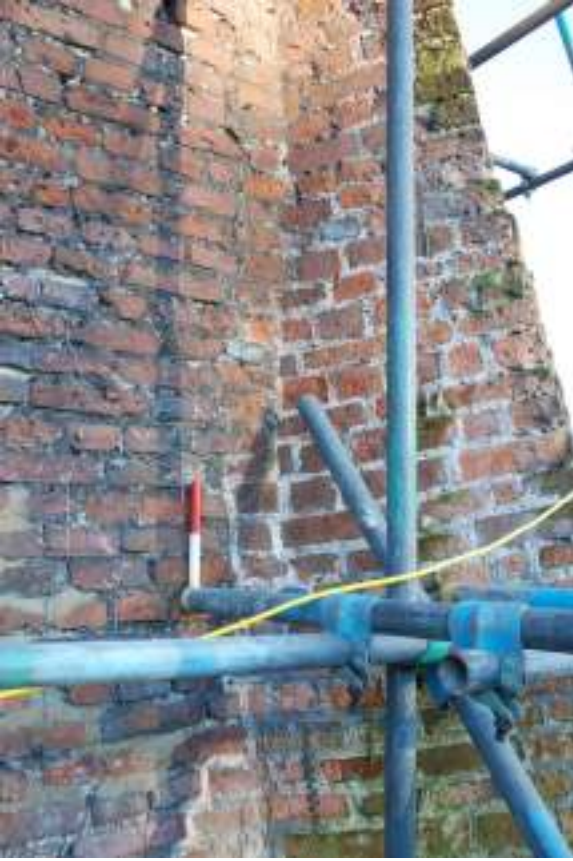
11.5.4 This buttress is notable for the way in which it appears to be 'keyed-in' to the main dovecote structure. This is particularly apparent on the join between the buttress and the northern wall of the dovecote, where some of the bricks in the buttress appear to be built physically into, and mortared into, the main wall. It is not like the other buttresses, which clearly abut the main wall, but, instead, appears to have been 'keyed-in'. This different method of construction of the buttress is further evidence for the suggestion that they were constructed at different times.

Fig. 102: Photograph of the eastern side of the north-western buttress. This clearly shows how the buttress is 'keyed-in' to the main dovecote wall.

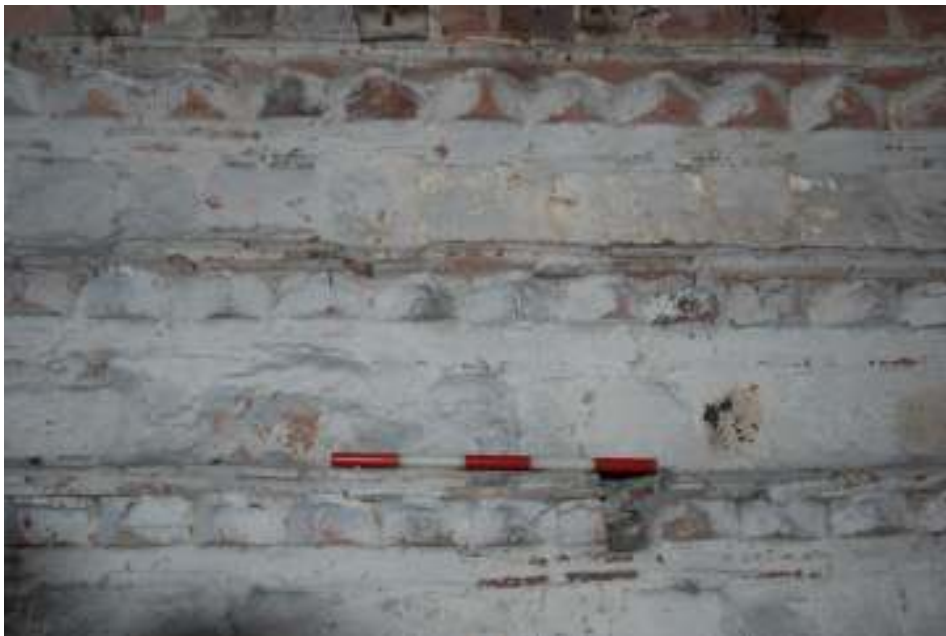
*Fig. 103:
Photograph
showing a
series of
blocked-up
nesting-holes
on the ground
floor. The
nesting-holes
have been
blocked over
by bricks or
tiles placed
horizontally.*

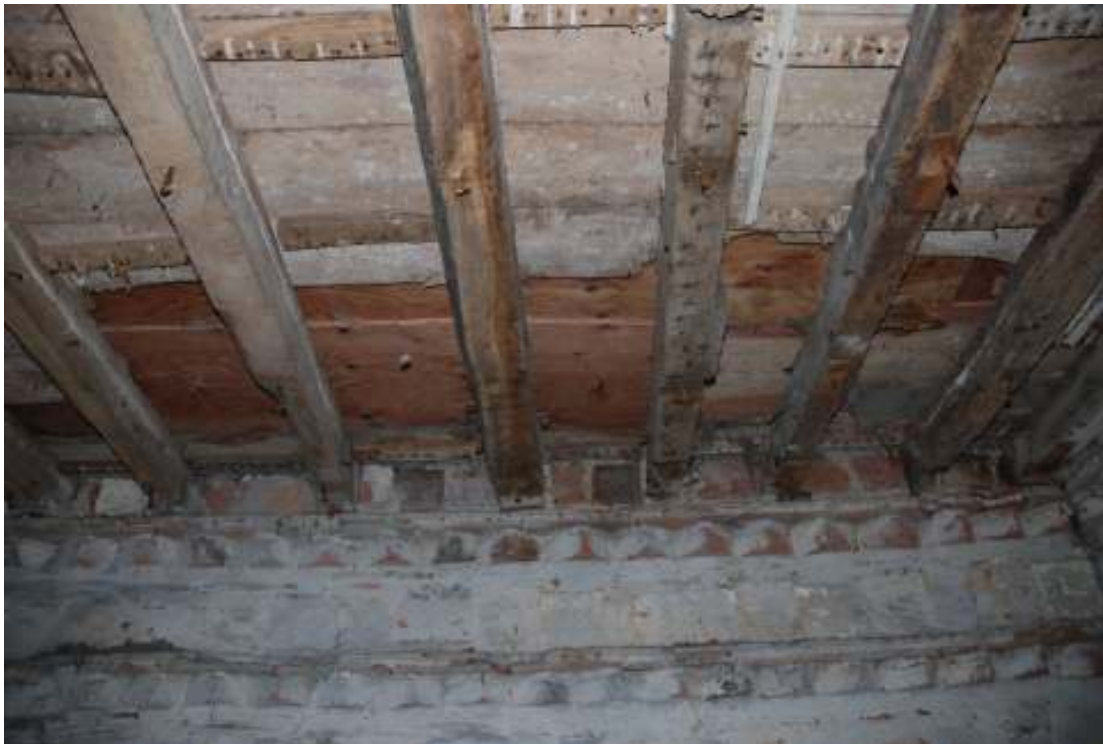
Fig. 104: Photograph of the underside of the first floor taken from the ground floor. This clearly shows how the joists are stuck into the nesting-holes.

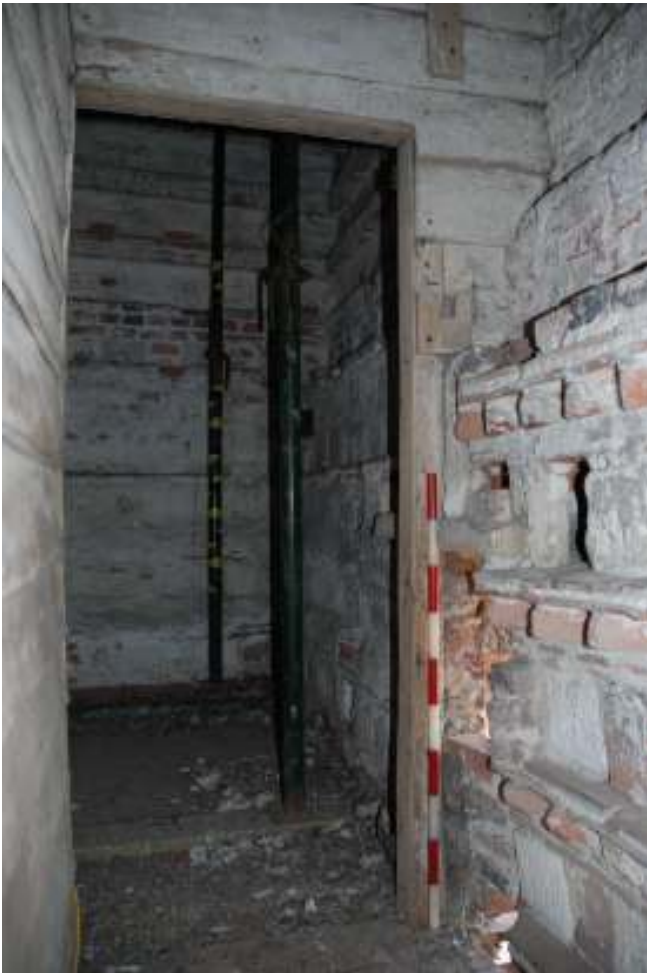
12.4.1 There are two main pieces of evidence for this being inserted at the same time as the floors and blocking of nesting-holes, etc. Firstly, the nesting-holes within the chamber are not as nicely blocked-up, with the line of horizontal tiles blocking the tile and dentil courses (just below the rebuild line) stopping on the exact line as the chamber. This therefore suggests that the holes were blocked-up at the same time as the chamber inserted, and that it was not felt necessary to block up those inside the chamber as well as those in the main room.

Fig. 108: Photograph from inside the wooden chamber, showing how the tile/dentil courses and nesting-holes are not covered over / blocked-up within the chamber; but are in the main first floor room.
