**THE DOVECOTE, BREAKSPEAR HOUSE,
BREAKSPEAR ROAD NORTH, HAREFIELD,
HILLINGDON, LONDON, HA6 1BN**

A LEVEL 3-4 HISTORIC BUILDING SURVEY

September 2011

Author: Emma Jeffery

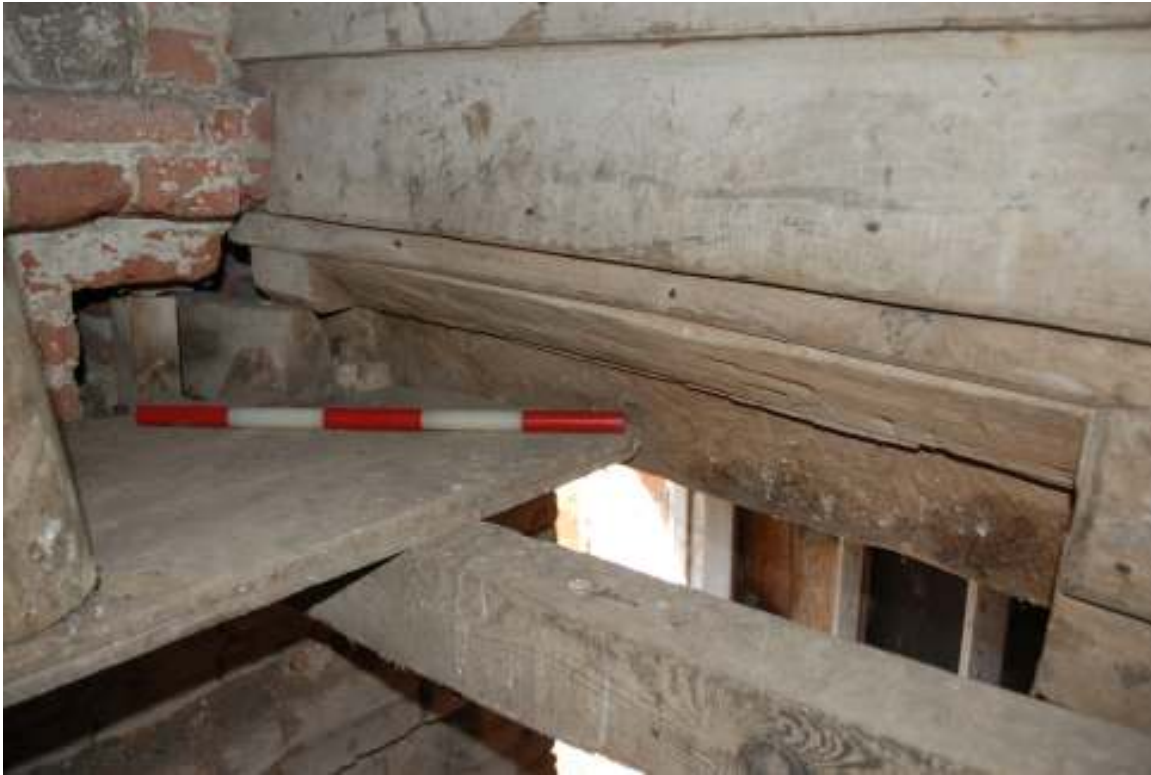
12.4.2 Secondly, there is a ‘cut away’, at an approximately 45° angle, in the adjacent east-west beam running along the base of the northern side of the chamber. This presumably held a ladder or steps, up from the ground floor to the first floor. This would have run up against the western wall. The beam which is ‘cut away’ is within the chamber itself, and therefore suggests that the ladder (which must have been inserted alongside the floors) and the chamber were contemporary in build.

Fig. 109: Photograph showing the 'cut away' beam at the northern base of the chamber, where the earlier ladder up from the ground floor would presumably have stood.

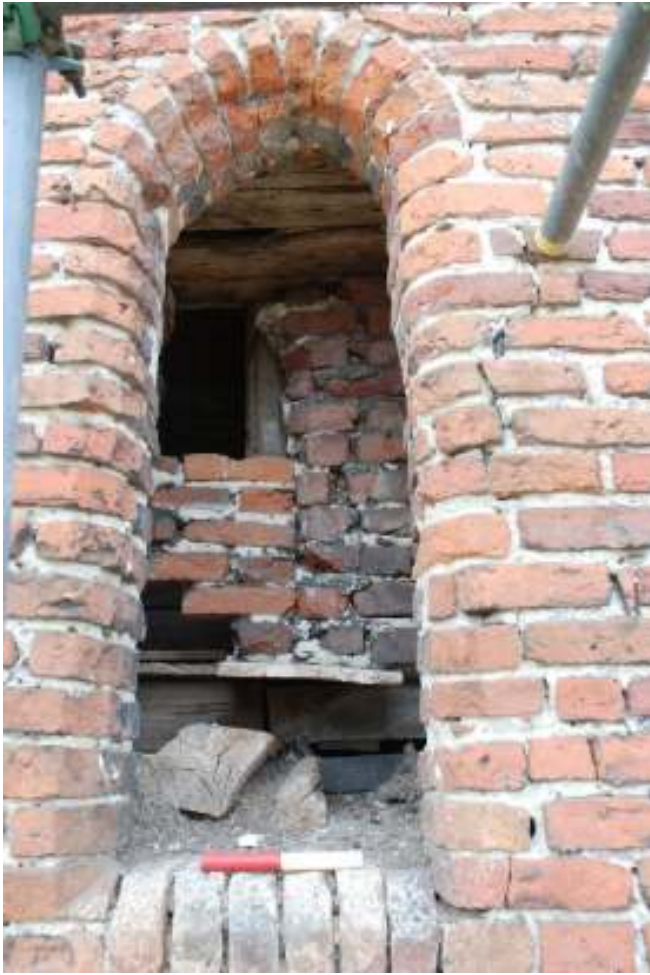
12.4.3 The southern window was also blocked up in two separate phases along the line of this wooden 'chamber'. The fact that the dividing line between the blocking falls exactly along the edge of the chamber suggests that one side of the blocking, possibly that in the main room, was blocked up when the chamber was constructed, with the other side (within the chamber) left open - possibly to allow more light into the chamber and staircase. The blocking of the other side of the window (within the chamber area) might have been undertaken at a later date.

Fig. 110: Photograph of the southern window, clearly showing the two separate phases of blocking (along the line of the internal wooden chamber).

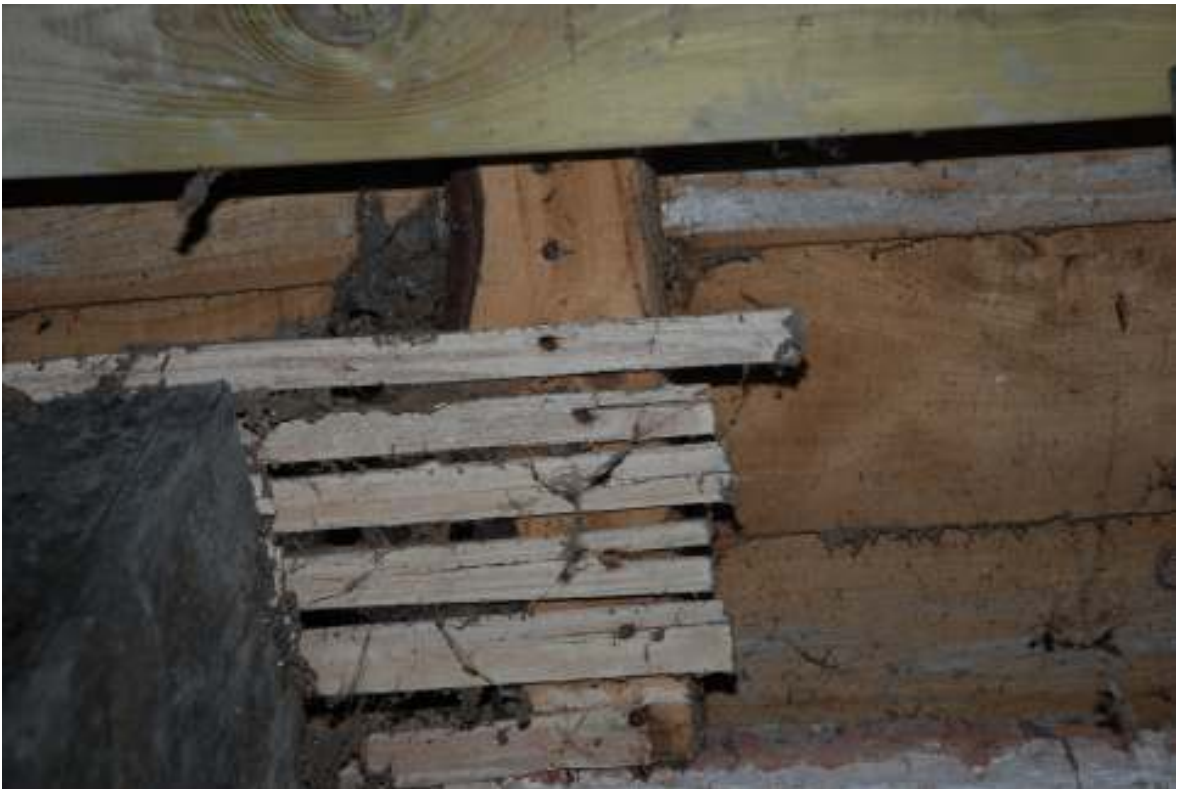
Fig. 112: Photograph showing some remaining patches of lath-and-plaster, on the first floor.

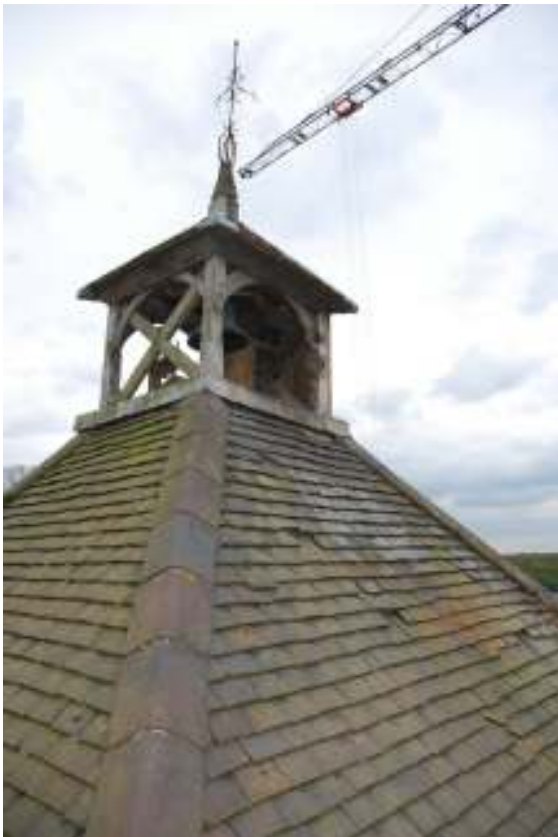
Fig. 114: Photograph of the roof and cupola, from the outside.

12.6.2 The exterior of this roof is made up of overlapping clay tiles. Further support is provided by the four hip rafters running up the four interior edges of the roof, reflected on the exterior by four ‘hips’ covered with tiles.

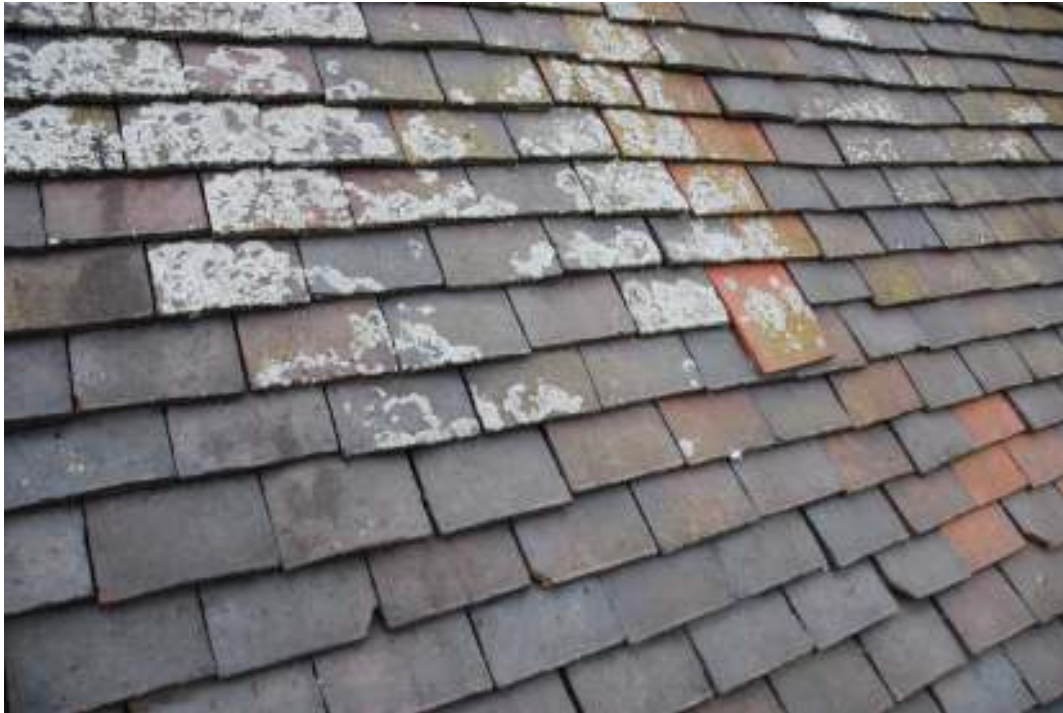
Fig. 115: Photograph of the overlapping tiles on the exterior of the roof.

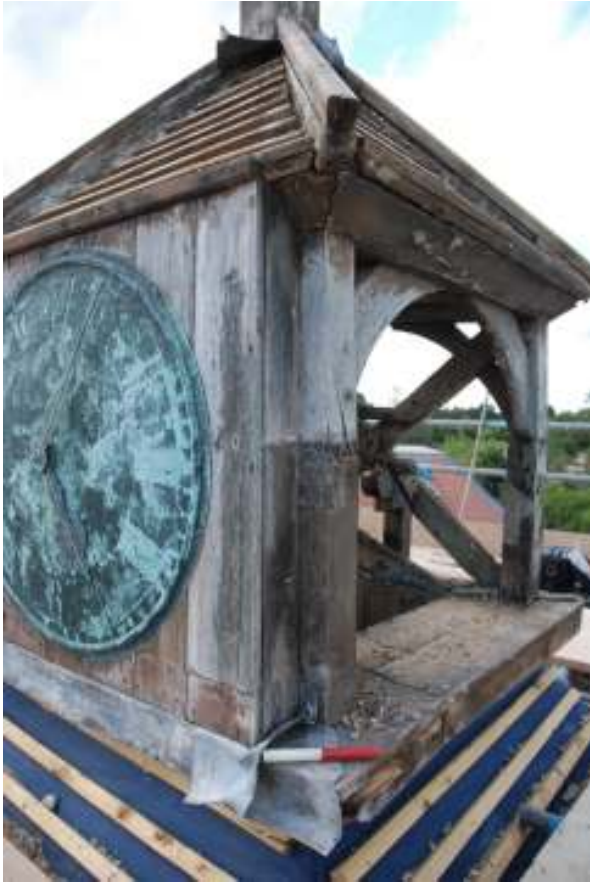
12.6.3 The wooden cupola which still stands on top of the roof was probably constructed at the same time as the roof itself. This measures 1.25m N-S X 1.26m E-W (approximately square), and 0.91m in height. This cupola did not, however, hold a clock until the 1890s (see section 15). The wooden cupola was constructed before the insertion of the clock, and this is clearly visible by the fact that the clock-face is attached to a later wooden backing, clearly constructed and designed purely to hold the clock-face. Instead, the original cupola had diagonal timbers on all four sides. The earlier cupola may have been used partly as a decorative feature, but presumably mainly for dove access. This is particularly because the present roof does not have any openings under the eaves for the doves to get in through, such that the only way for them to enter the structure and reach the upper nesting-holes (which remained open) was through the cupola. Many other dovecotes have a cupola to enable doves to enter the structure, such as at Eastcote.

Fig. 116: Photograph of the wooden cupola at the top of the roof.

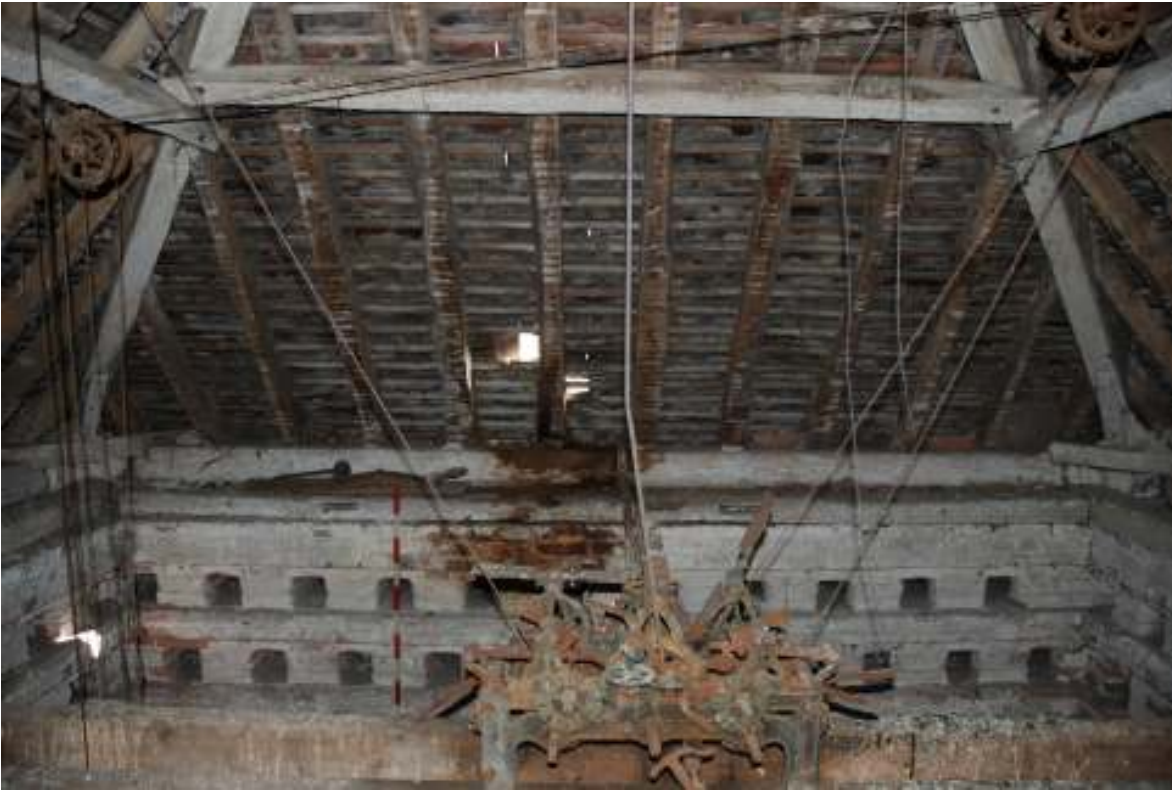
12.6.5 A series of four timber wall plates were observed running around the base of the roof (on the inside). They are located outside of the earlier beam (discussed above), and are braced together at each corner. The northern wall-plate measured 0.22m (wide) X 0.155m (deep); the eastern 0.23m X 0.165m; the southern 0.22m X 0.165m; and the western 0.225m X 0.16m. Interestingly these wall-plates (and the new roof structure) prevented doves from entering the structure through slats underneath the eaves (unlike the earlier roof which apparently had such a facility). Instead, the only entrance for the doves became through the cupola. This could, arguably, have reduced the number of doves being able to enter the structure and therefore be related to the idea that the changes that occurred at this time reduced the number of nesting-holes for the doves (and therefore the number of doves in the structure itself), although it must be noted that in many dovecotes the cupola was the only means of access into the structure.

Fig. 117: Photograph of the interior roof of the dovecote. This clearly shows the wall-plates; hip-rafters; purlins; and rafters.

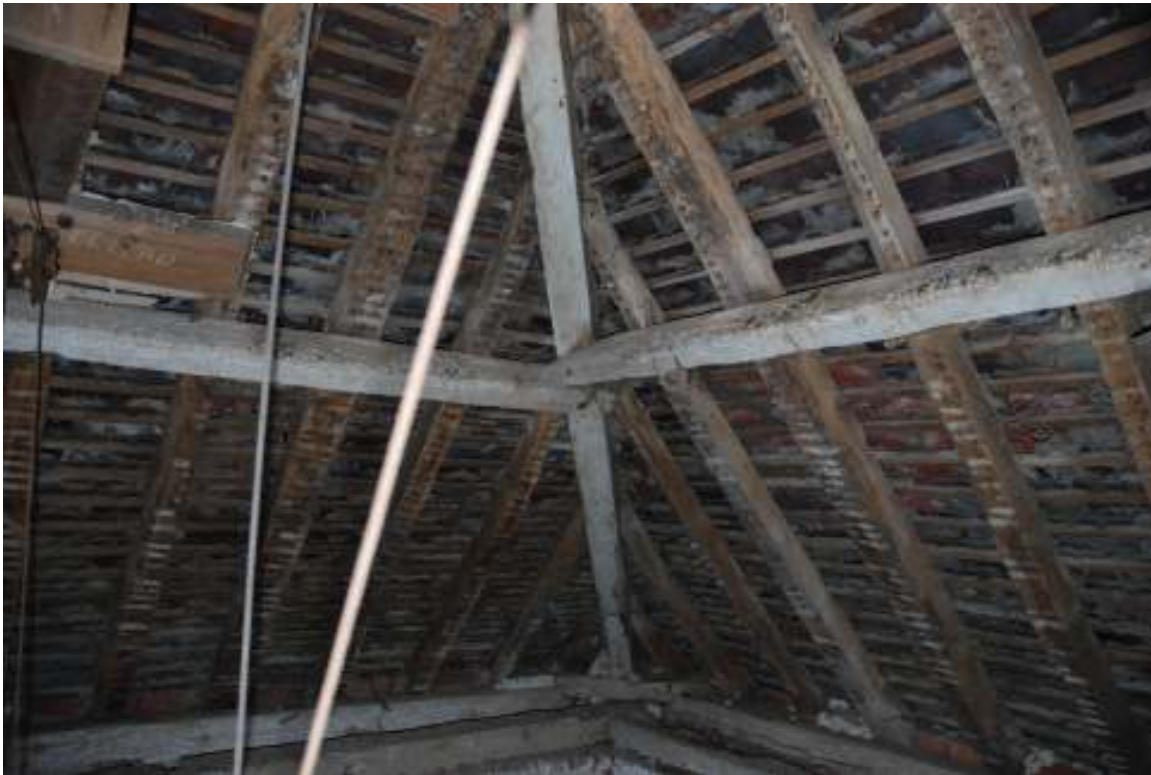
Fig. 118: Photograph of a corner of the interior roof of the dovecote. This clearly shows a hip-rafter; purlins; rafters; and lathes.

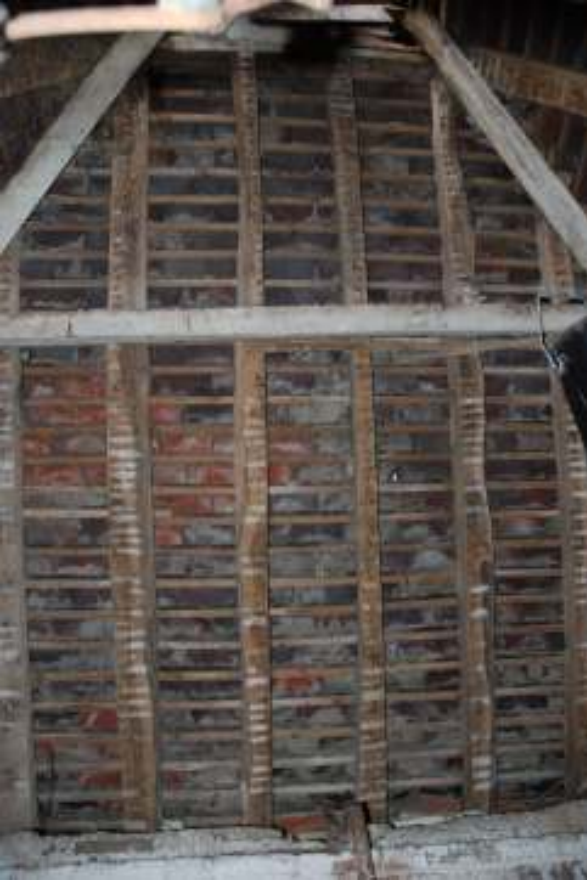
Fig. 119: Photograph of the interior roof of the dovecote. This clearly shows the variation in size of the common rafters, and extremely regular horizontal laths (to hold the tiles).

12.6.6 English Heritage's dendrochronological investigations of the present roof gave the felling date of the timbers as *c.*1769 (see appendix VII). This therefore means that the present roof must have been constructed on or soon after this date. Considering the likelihood that all of the other changes discussed above took place at the same time, they all presumably also took place in the late 18th Century.

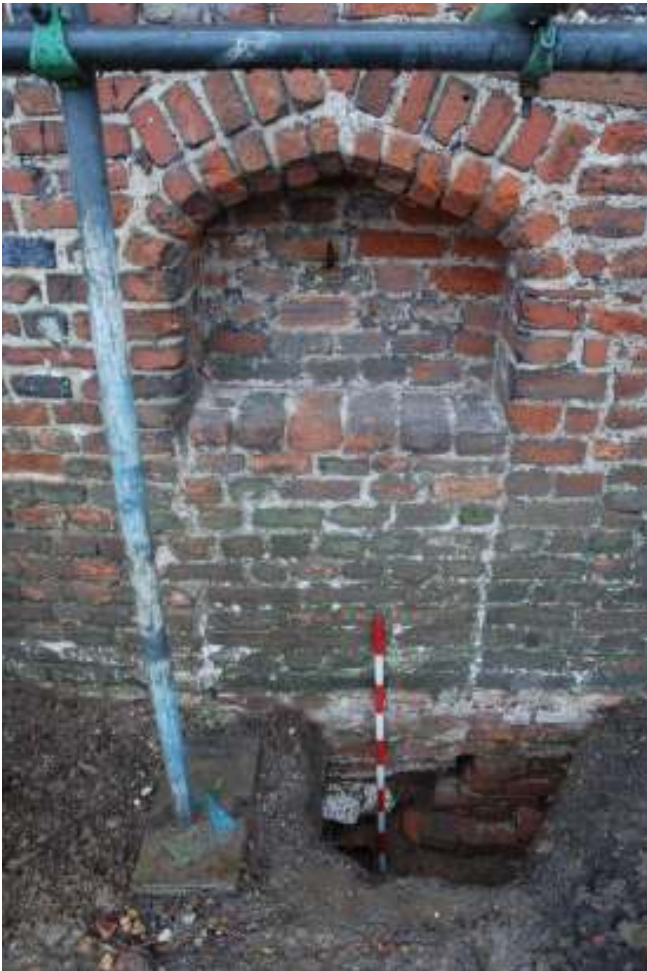
- 13.2 The doorway in the eastern wall was blocked-up using red bricks. This is obvious to the eye externally, with a mortar-line dividing the doorway from the surrounding wall. The lower *c.*0.84m (from the present ground-level) is blocked up on a line with the wall, and the upper *c.*0.49m (maximum, to the point of the arch) is recessed slightly (for *c.*0.2m), but still blocked up, and with a hook in it. A ledge is formed between the upper recessed and lower part of the doorway. This, effectively, creates some form of niche, however it is unclear what this could have been used for or why such a feature was created. The total dimensions of the blocked-up doorway, on the exterior, are 0.67m width (total), by at least 2.13m height. It should also be noted that part of this blocking (on the southern side) appears to have been ‘keyed-in’ to the main dovecote wall.

Fig. 120: Photograph of the exterior of the blocked-up eastern doorway. This clearly shows how it has been infilled.

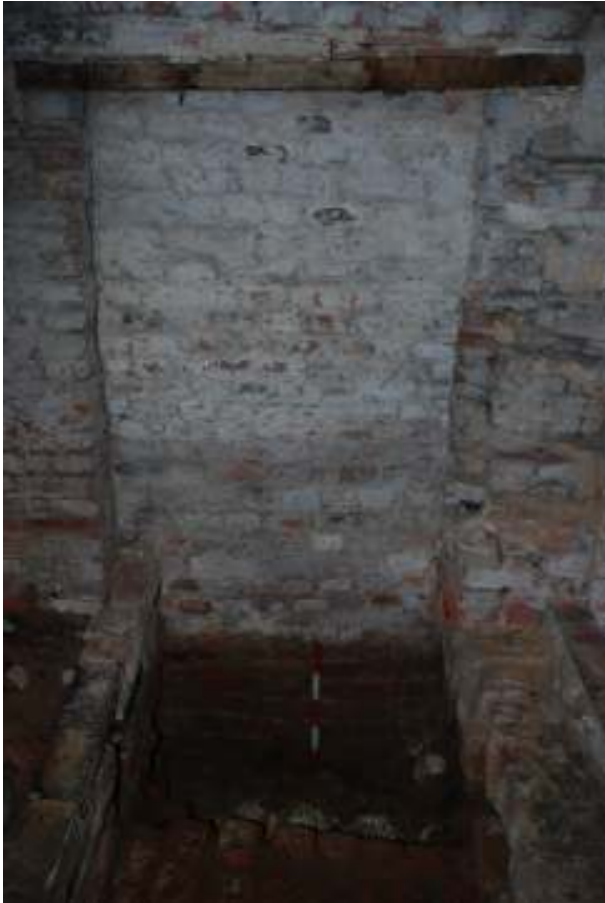
13.2.1 It is also clear from the inside of the dovecote that the door was blocked-up. This was also done with bricks and is recessed slightly (by *c.*0.2m, out towards the exterior of the dovecote). The dimensions of the doorway on the inside are *c.*1m width (total), by at least 1.8m in height (including the timber lintel). This is therefore wider than the exterior doorway, suggesting that the doorway opened up somewhat on entering the dovecote. This blocking has been whitewashed, in a similar way to the rest of the structure. The lower blocking of the doorway has been discussed elsewhere (see section 10).

Fig. 121: Photograph of the interior of the blocked-up eastern doorway. This clearly shows how it has been infilled.

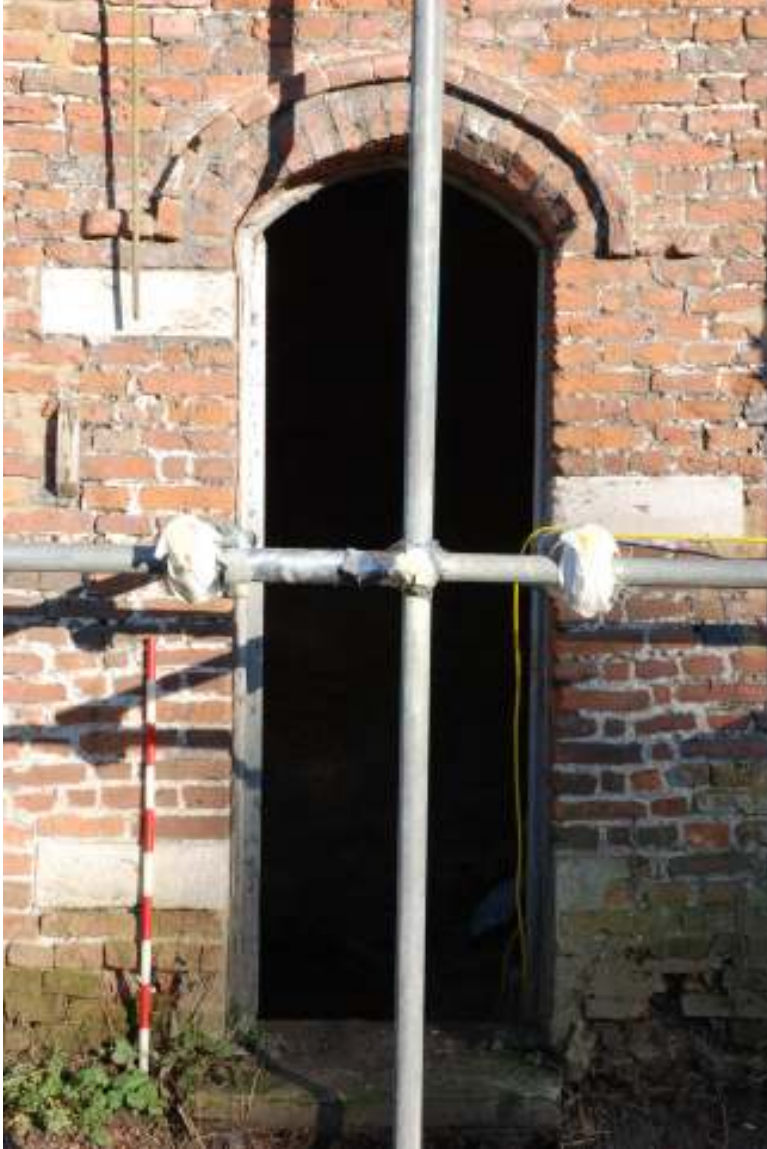
13.3.1 This doorway is *c.*0.765m in width, by *c.*2.2m height (from the exterior step up to the top of the arch). The arch itself is *c.*0.765m wide, and 0.28m high. The external brick decoration surrounding it consists of two rows of brickwork – the inner of which is a chamfered ring of brickwork; with the exterior ring forming a hood by projecting out from the wall by 400mm. The total width of this decoration is *c.*0.175m – the chamfered face is 50mm, the adjacent flat brickwork is 70mm, and the hood is 55mm. The hood also projects north and

south away from the door, by approximately 0.17m. Three slabs of stones are also observed surrounding the exterior of this door, presumably to act as some kind of support or to hold fixtures and fittings, although there was no sign of any hinge or latch fixings.

Fig. 122: Photograph of the exterior of the western doorway.

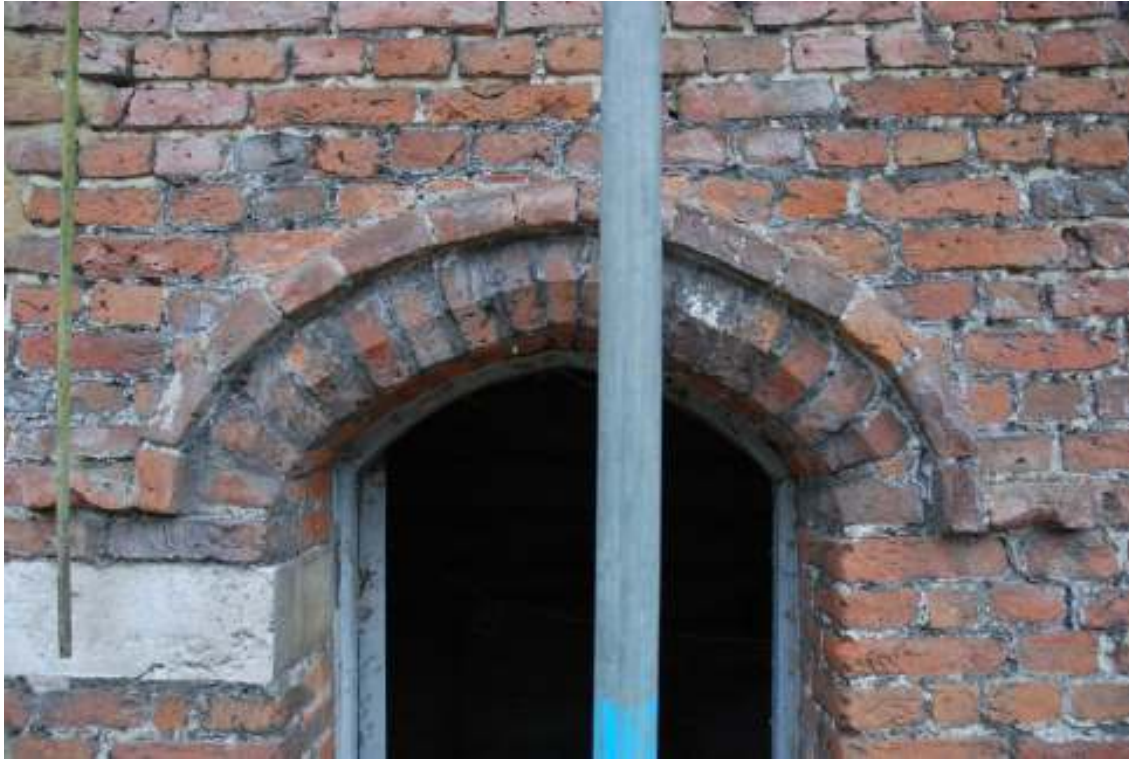
Fig. 123: Photograph of the exterior door-hood of the western doorway.

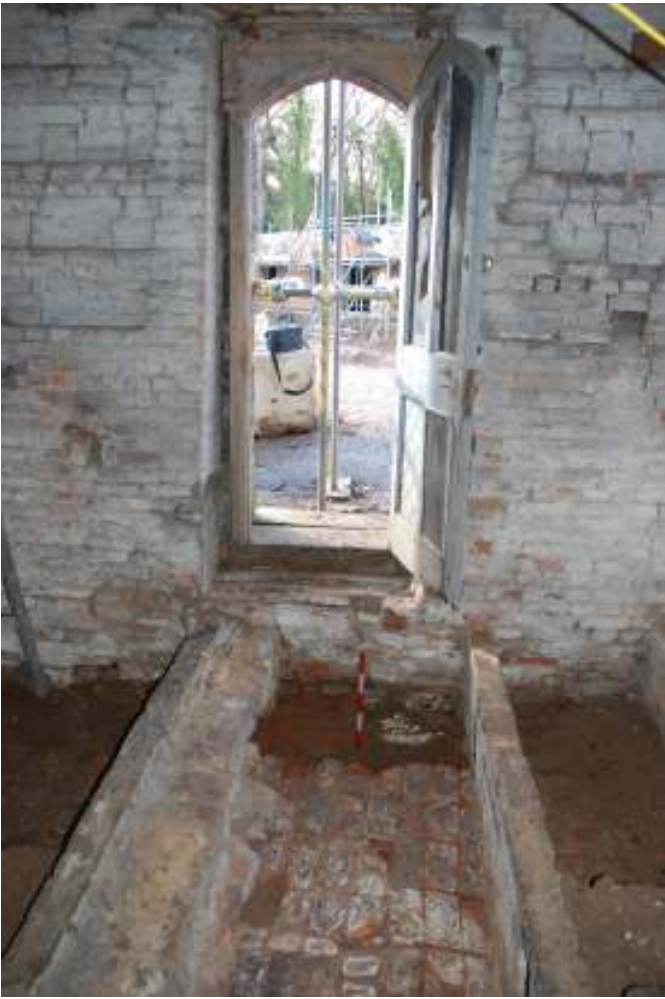
13.3.2 The interior of this door has a timber lintel topping it (c.50mm thick, and running across the exact width of the door). There is also a stone threshold crossing from the outside to the inside of the structure, with a lower brick 'step' on the inside. The present door may be a later addition – possibly later 19th Century.

Fig. 124: Photograph of the interior of the western doorway.

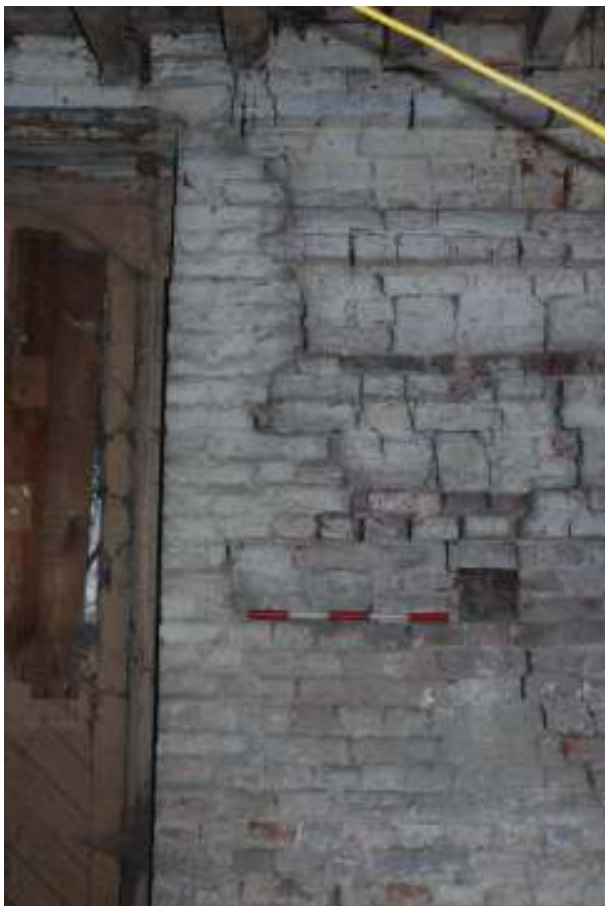
13.3.3 It is clearly visible from the inside that this door was inserted at a later date than the construction of the western wall. A clear line can be observed where the door has been later inserted, the wall surrounding it cut away, and the nesting-holes blocked-up. This area also appears to have been whitewashed more recently, and traces of possible Victorian cement were also observed within this area.

Fig. 126: Photograph of the northern side of the interior of the western doorway. This clearly shows how it was inserted at a later date.

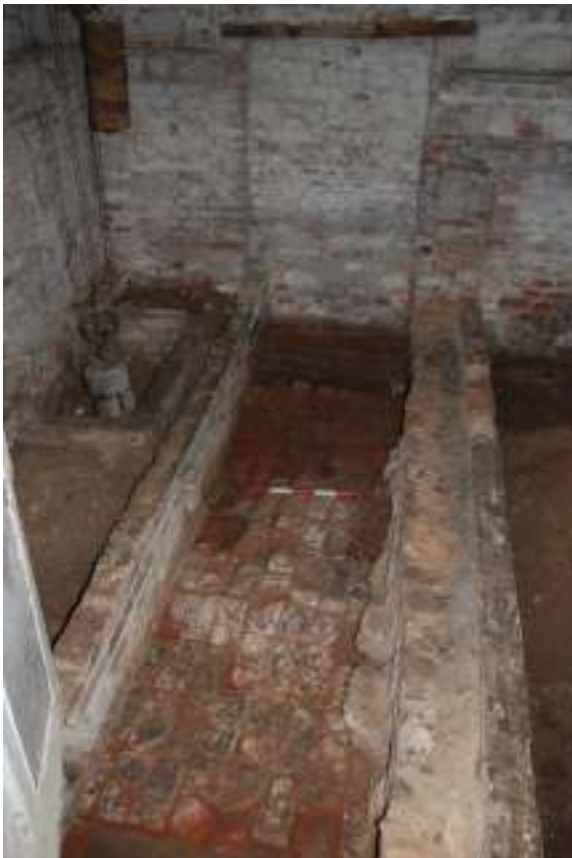
13.4.1 These ground-raising floor plinths are constructed of brick. There were two of these running east-west across the centre of the dovecote, with two more running east-west along either side (north and south) of the dovecote adjacent to the main walls. Each plinth measured *c.*0.11m in width (except the one to the south of the doorway, which was 0.45m thick), and stretched across the whole width (east-west) of the dovecote (*c.*3.6m). They were approximately 0.43 – 0.49m in height, above the brick floor. This, therefore, brought the new floor level to approximately the same level as the threshold through the western doorway. This is far more practical than the 0.49m gap between the threshold and the old brick floor.

13.4.2 Floorboards were placed on top of these ground-raising floor plinths. These are no longer there, however existed until relatively recently.

Fig. 127: Photograph showing the ‘ground-floor raising plinths’, taken from the western doorway into the dovecote.

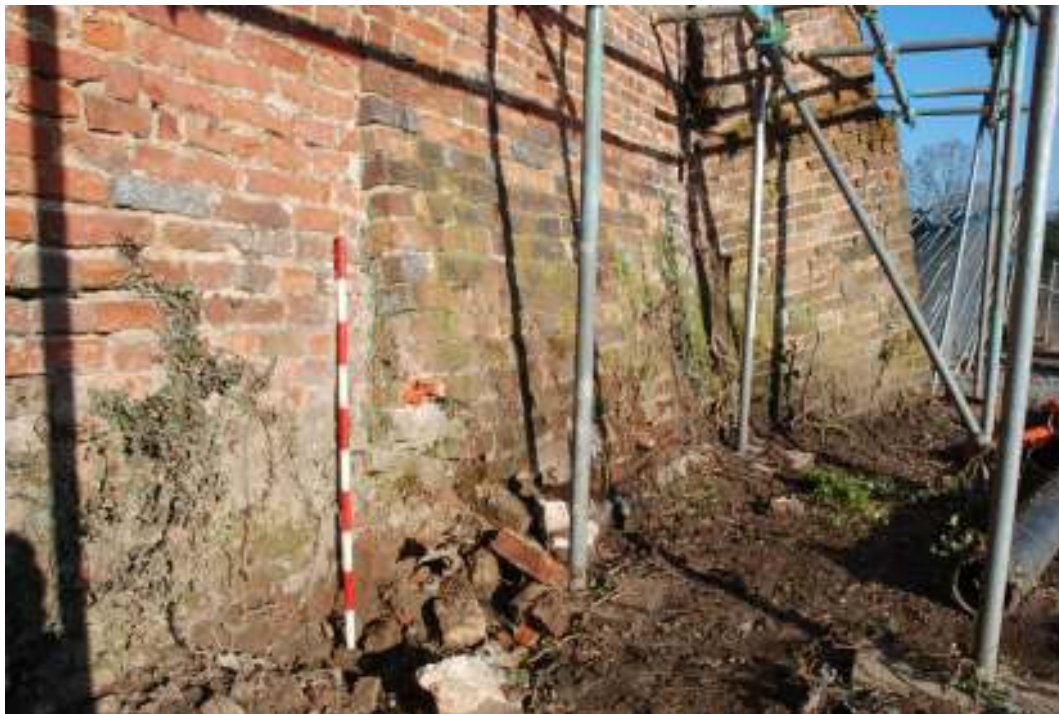
Fig. 128: Photograph of the southern wall of the dovecote, clearly showing the area of ‘patching’ running up to the south-eastern buttress.

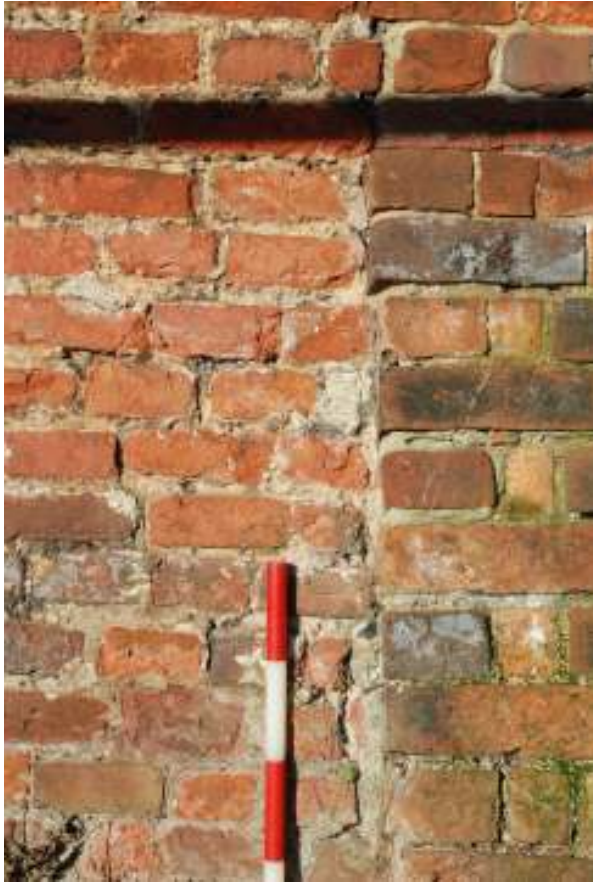
Fig. 129: Close-up photograph of the patching on the southern wall. This clearly shows the difference between the original wall (left side of photo) and the patching (right side of photo).

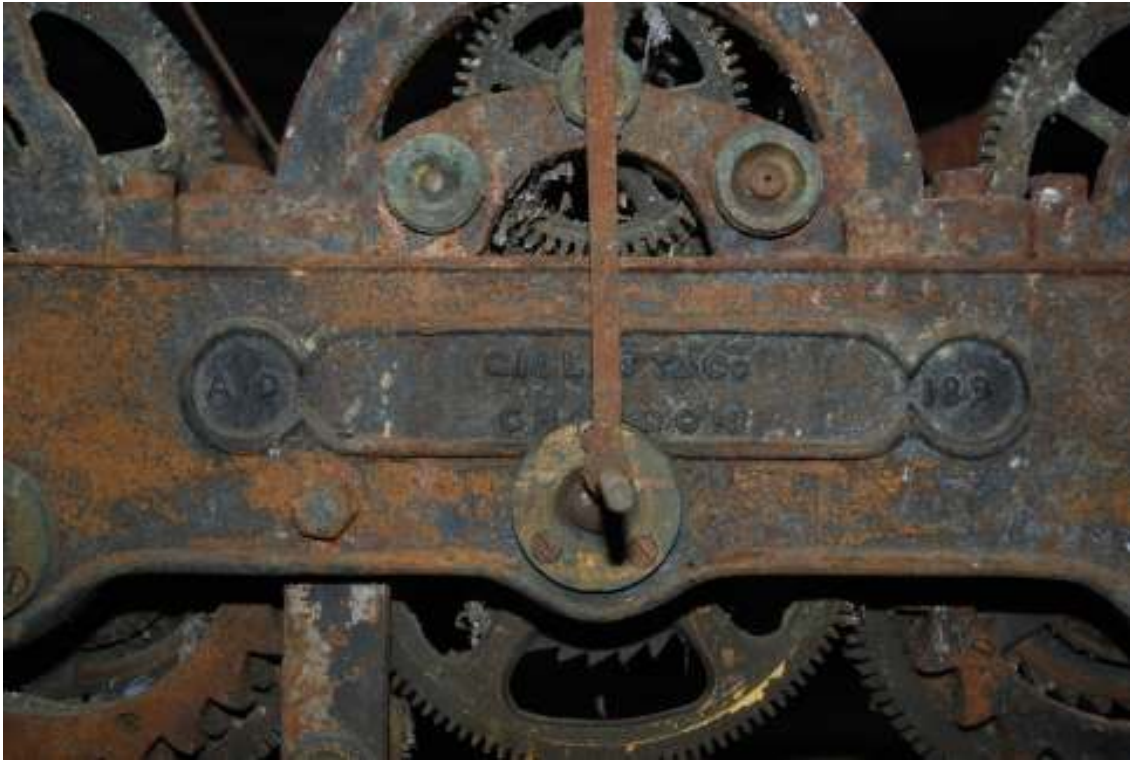
- 15.2.4** Both side-plates on the clock (fixed to the iron frame of the clock) record it as having been constructed by “Gillett and Co” (a clockmakers based in Croydon). It also has the date “AD189” on it, with a space where the final digit would go. This is presumably because such panels were mass-produced, but sadly the final digit was not added before it was sold.

Fig. 131: Photograph of the backplate of the clock (pendulum removed). This says "Gillett & Co, Croydon", flanked by "AD" and "189"

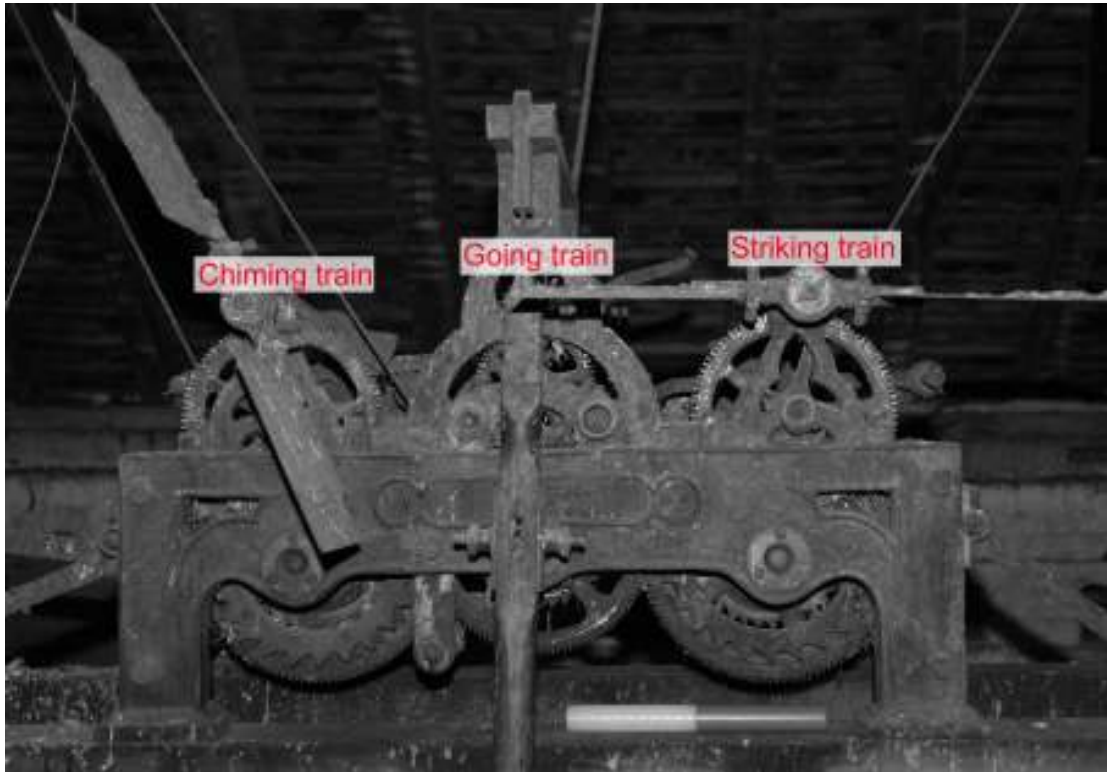
Fig. 132: Annotated diagram showing the three trains of the clock. Two wires can be seen running out of the chiming train (for the chiming of the quarter hours); one wire running out of the striking train (for the chiming of the hours); and the pendulum out of the going train.

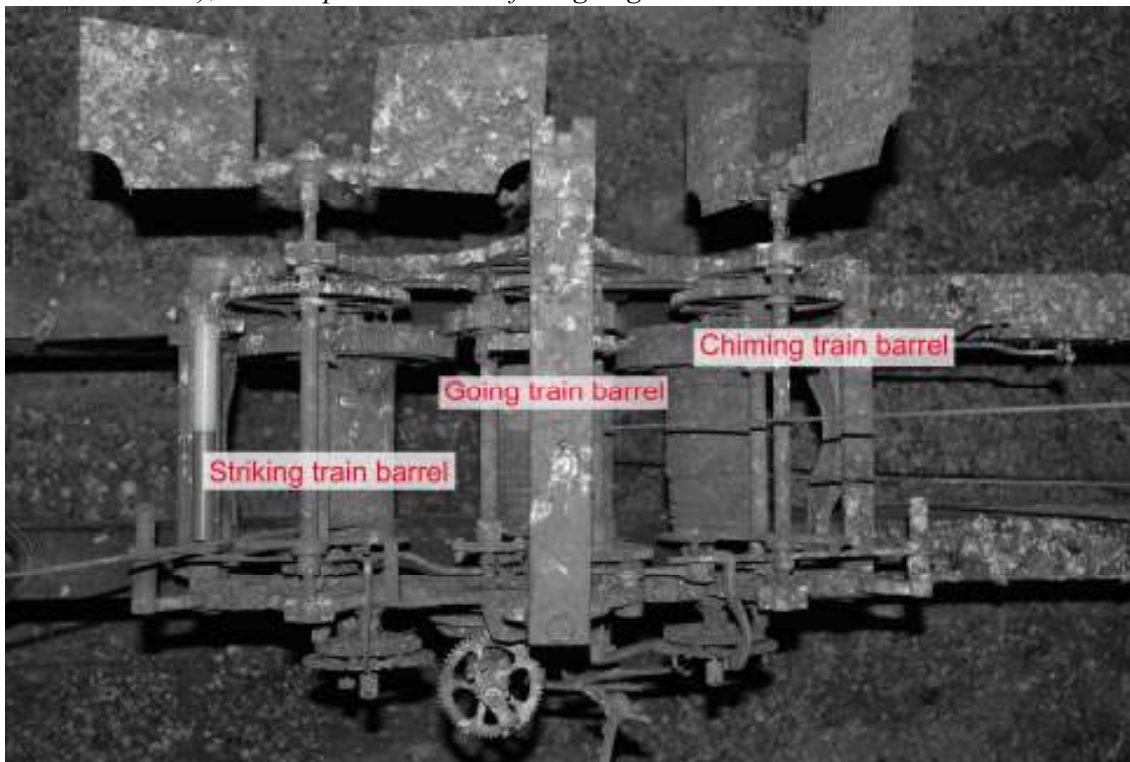
Fig. 133: Annotated diagram showing the three barrels for the three trains of the clock.

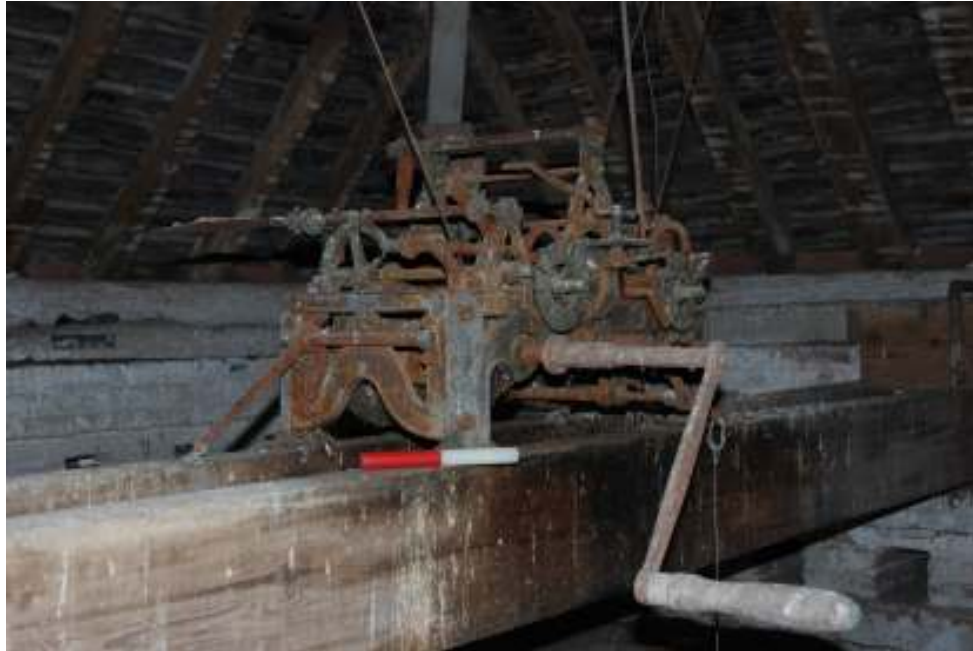
Fig. 134: Photograph of the clock, showing the winding handle attached to the striking train.

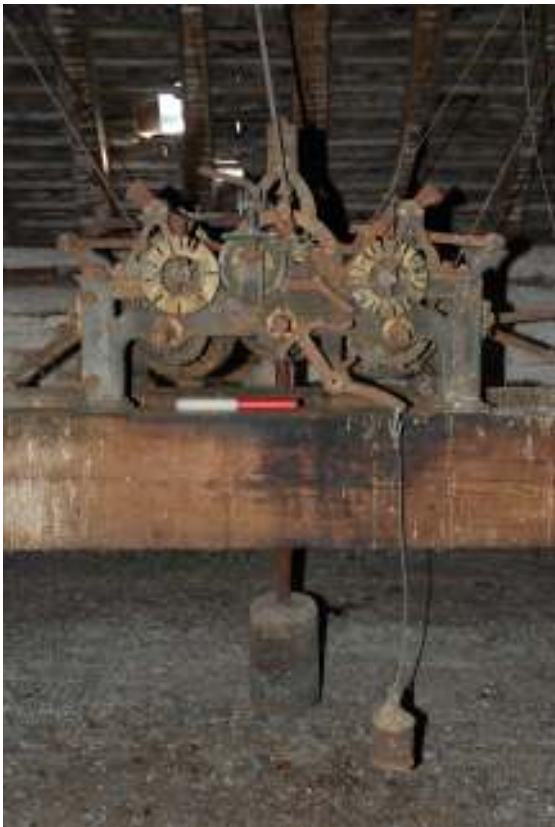
15.2.6 This clock would have needed to be wound up once a week. This would have been a relatively hard task – due to the weight of the clock and winding mechanism, etc. Attached to the “going train” is a maintaining power lever. This would be turned slightly anti-clockwise and pushed inwards to engage with the mechanism and to uncover the winding square, so allowing the clock to continue ticking whilst winding was in progress.

Fig. 135: Photograph of the clock, clearly showing the maintaining power lever with attached weight in the foreground.

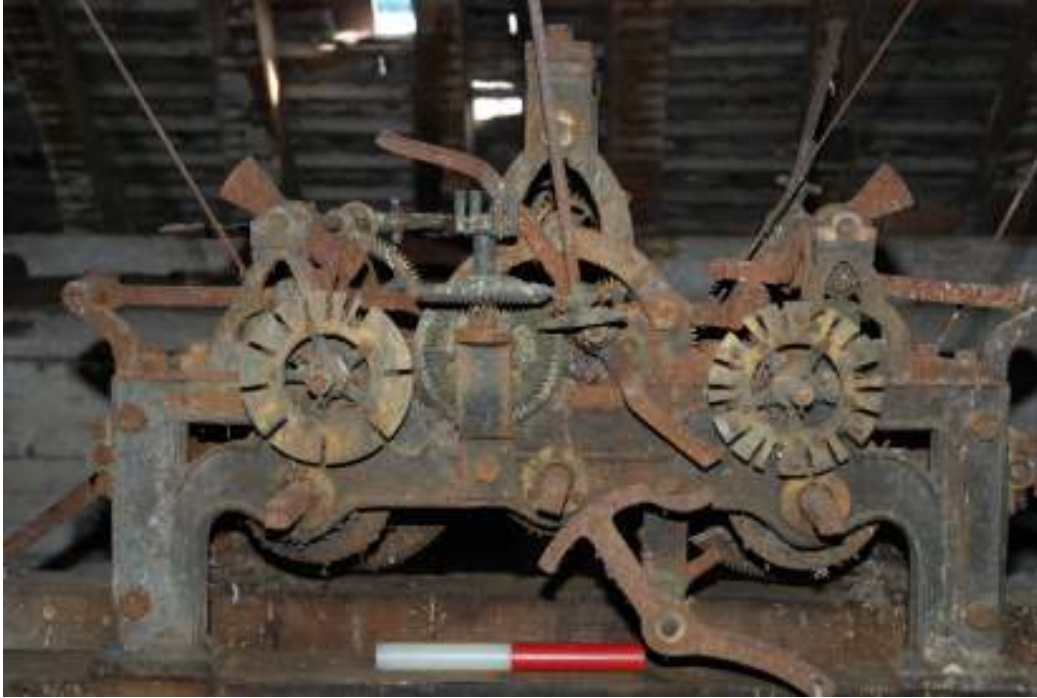
15.2.7 The correct time was set by means of a locking nut and setting dial. When undone the nut (located to the rear just above the central drum) would disconnect the hands from the mechanism. The dial consists of a silvered circular plate at the front of the clock, which is divided into 60 units. Although not easily visible it is also inscribed Gillett & Co, Croydon.

Fig. 136: Photograph of the silvered setting dial, in the centre of the shot.

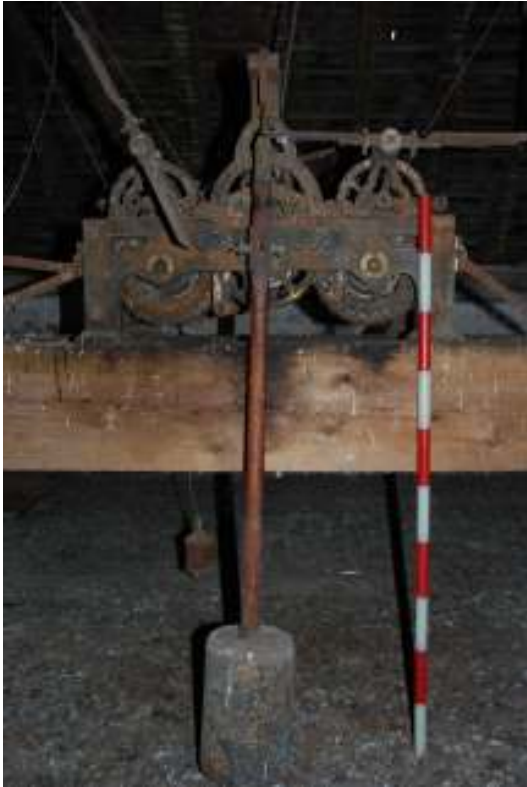
15.2.8 The overall length of the pendulum, from the top to the rating nut below the bob, was just over 1.25m, and the bob *c.*225mm X 150mm in diameter. The main arm of the pendulum (0.843m) was made of wood – apparently mahogany. Unlike metal, this material did not significantly expand or contract with temperature change, so avoiding light changes in the pendulum length which would affect the running of the clock and maintain a regular number of beats per minute.

Fig. 137: Photograph of the pendulum.

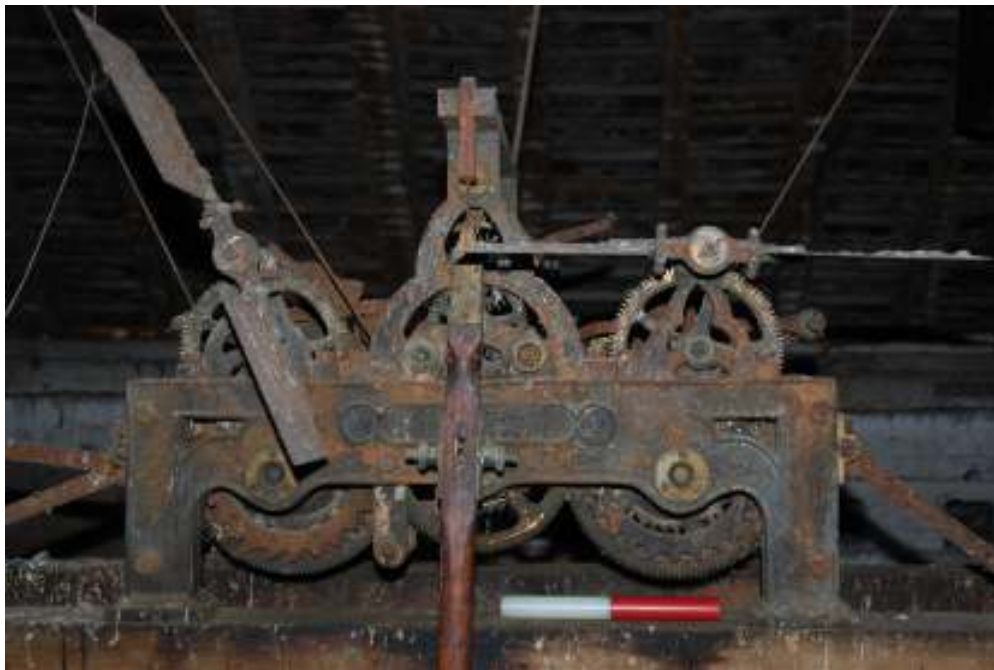
Fig. 138: Photograph of the top of the pendulum, clearly showing the escape wheel.

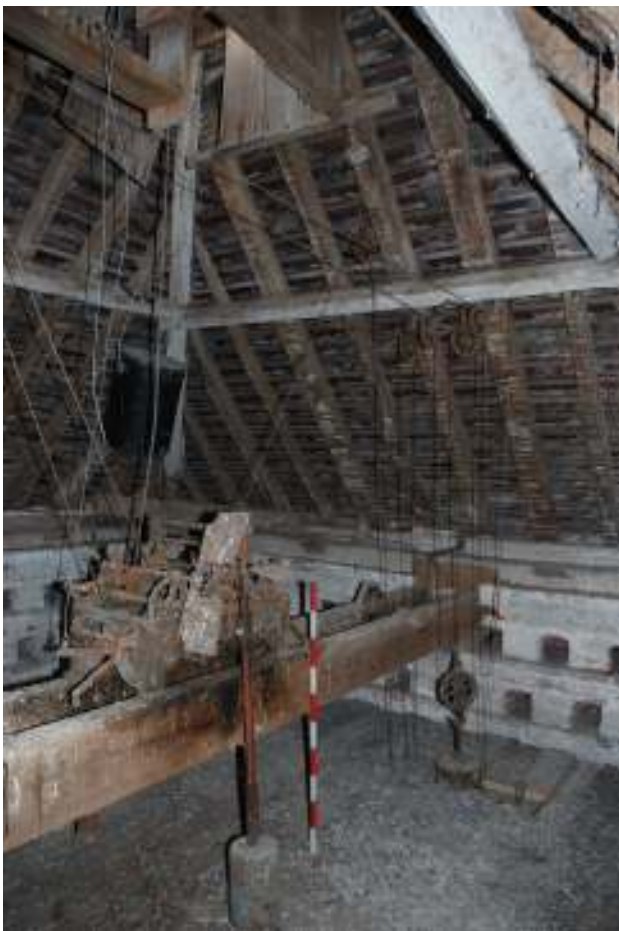
15.2.9 The “striking train” operated the first bell hammer. A lever in this striking train, projecting from the rear left-hand corner of the clock mechanism, was pulled down and released once for each stroke of the bell. This lever pulled a wire, now broken-away, which ran straight up to the belfry, where it lifted a heavy hammer which fell onto the bell. A check spring kept the hammer just off the bell so that it can sound fully.

15.2.10 The “chiming train” operated two levers at the rear right-hand corner of the clock mechanism. One of the connecting wires is now broken, but both would have run up to a pair of bell cranks which are fixed on a projecting timber just below and to the south of the cupola. From there the wires ran more or less horizontally to a second pair of cranks directly below the cupola, and would then have continued upwards to join the hammers, and thereby strike the bells.

Fig. 139: Photograph showing the series of wires, pulleys, etc, connecting the clock mechanism (striking and chiming train) to the cupola.

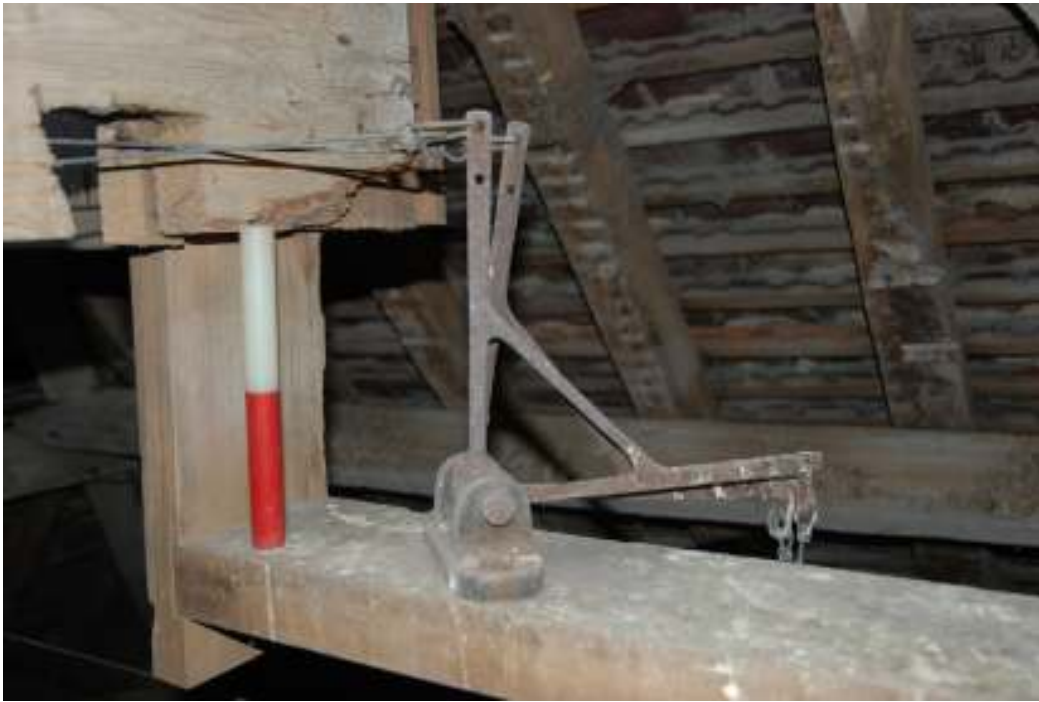
Fig. 140: Photograph of a pair of the bell-cranks.
