**THE DOVECOTE, BREAKSPEAR HOUSE,
BREAKSPEAR ROAD NORTH, HAREFIELD,
HILLINGDON, LONDON, HA6 1BN**

A LEVEL 3-4 HISTORIC BUILDING SURVEY

September 2011

Author: Emma Jeffery

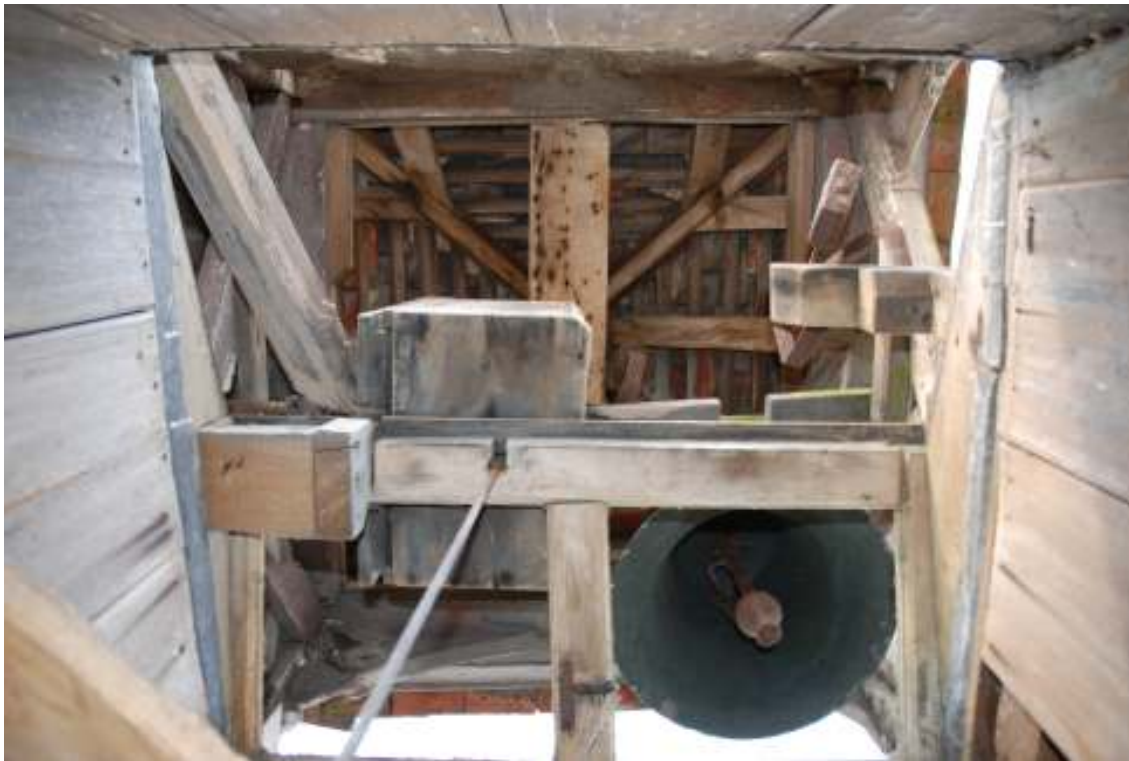
Fig. 141: Photograph up into the cupola. The striking hammer can be seen in the top right of the frame.

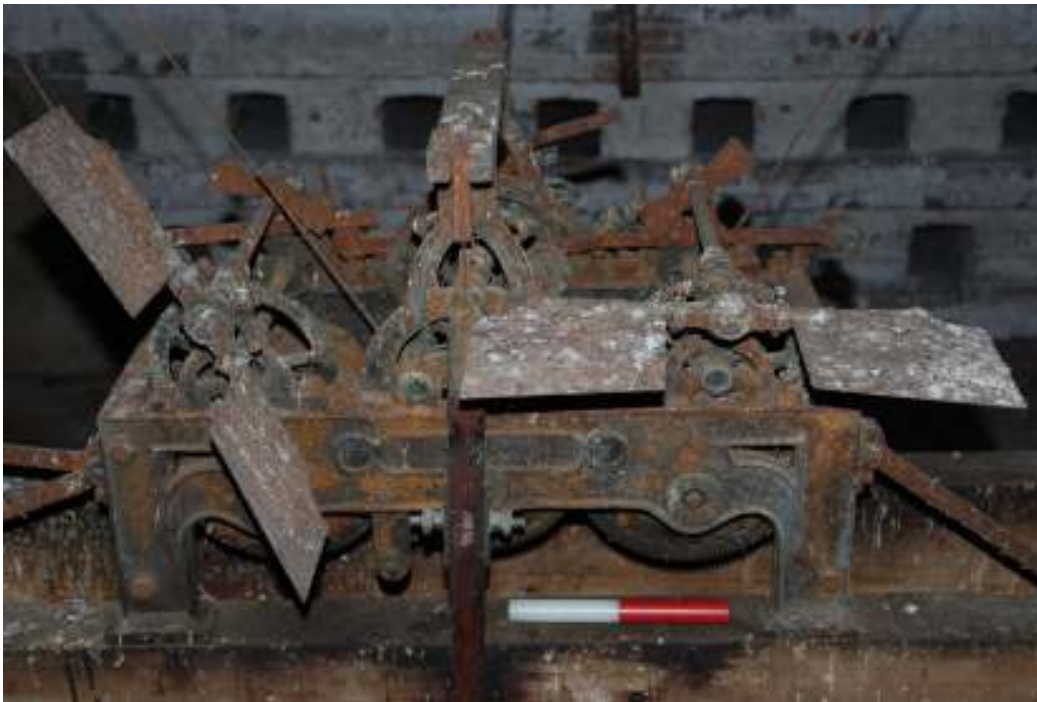
Fig. 142: Photograph showing the pair of two-bladed flies.

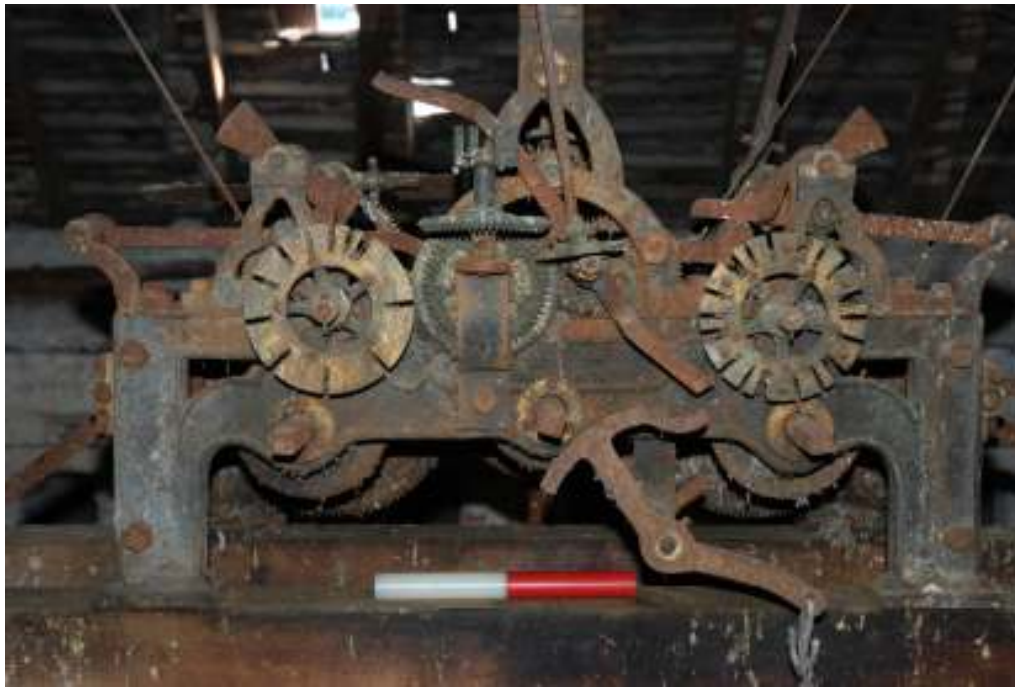
On the left-hand count-wheel (hours) the spaces between slots increase progressively according to the number of strikes, and would rotate fully once every 12 hours. On the right-hand count-wheel (quarter / chiming) the slots area arranged in a total of six groups of three, so presumably the wheel rotated once every 6 hours. On both count-wheels the first and second slots are placed together (as is often the case), hence the striking count-wheel has 11 slots (not 12) and the chiming count-wheel groups of three slots (not 4).

Fig. 143: Photograph showing the count-wheels – one at either end of the clock.

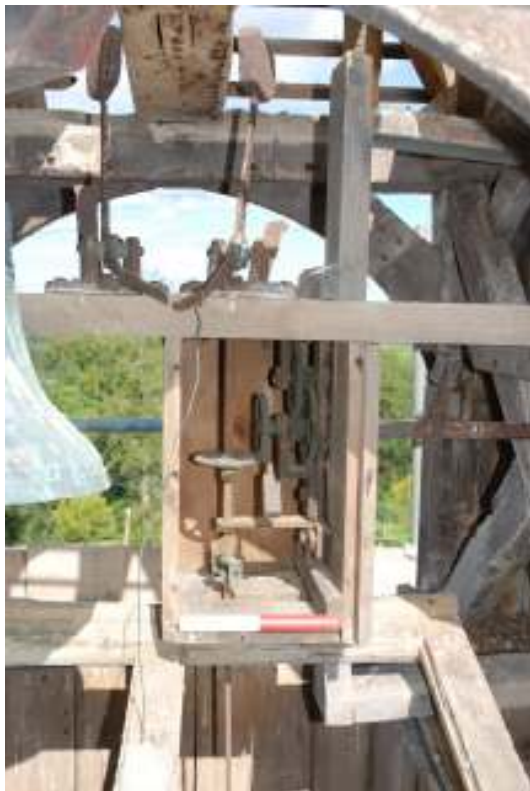
Fig. 144: Photograph of the bell and upper clock mechanism or motion-work, contained in a small wooden casing behind the clock-face.

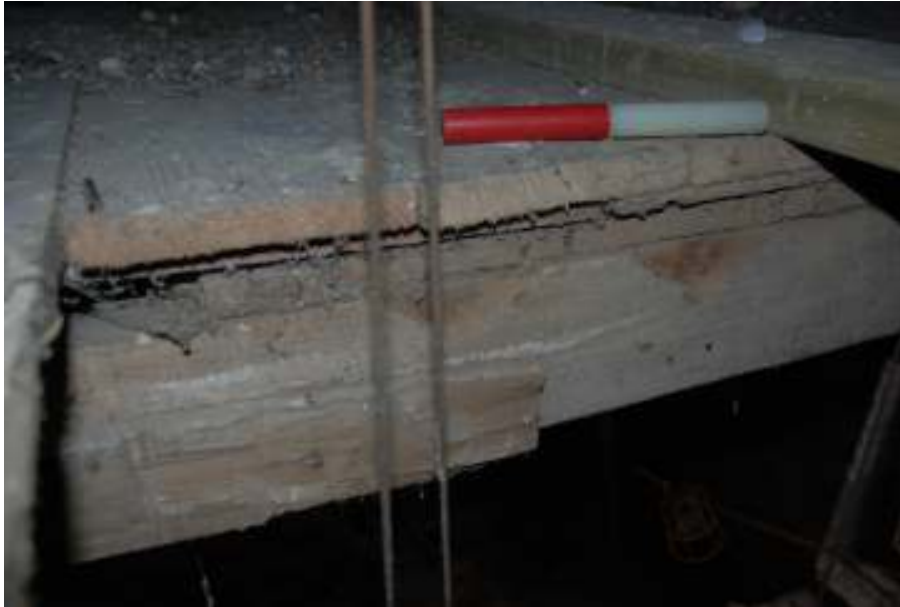
15.2.13 Furthermore, the insertion of the clock depended on the dropping of the clock weights down from the clock to the ground floor. This necessitated the cutting of a slot through the floorboards on the first and second floors, such that the weights could drop down to the ground-floor (into a small brick-lined chamber just below the raised floor level). This is therefore further evidence that the clock was inserted at a later date than the construction of the floors.

*Fig. 145:
Photograph
showing the
cutting-through of
the original first-
floor floorboards
to make way for
the clock weights.
Saw cuts can be
seen not only
across the boards,
but also on the
side of the
underlying joist.*

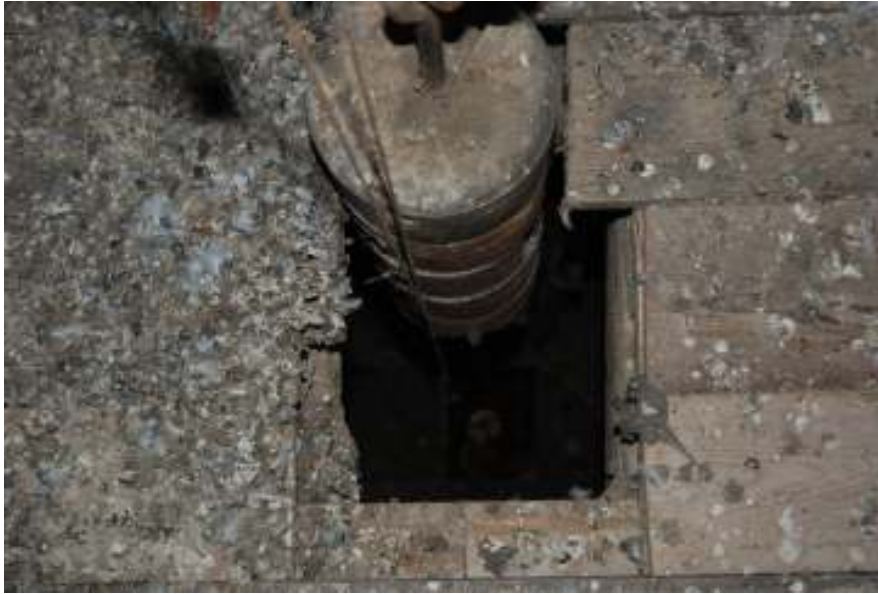
*Fig. 146:
Photograph of the
chiming train
weight, hanging
down through the
first-floor.*

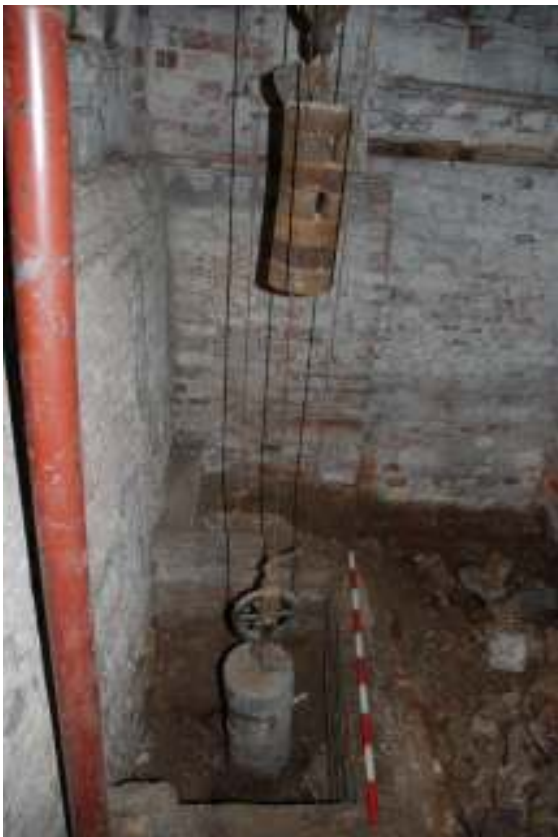
*Fig. 147: Photograph of the going and
striking train weights (going train weight
above striking train weight).*

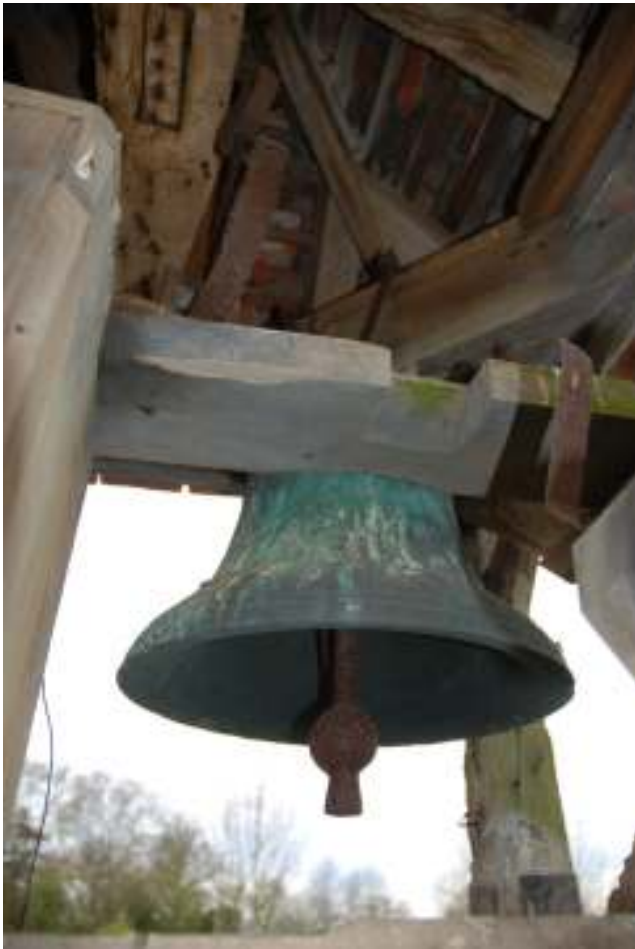
15.3.2 The bell itself is bronze, with a diameter of 0.45m, and is fixed in the north-west corner of the cupola.

Fig. 148: Photograph of the bell, within its cupola.

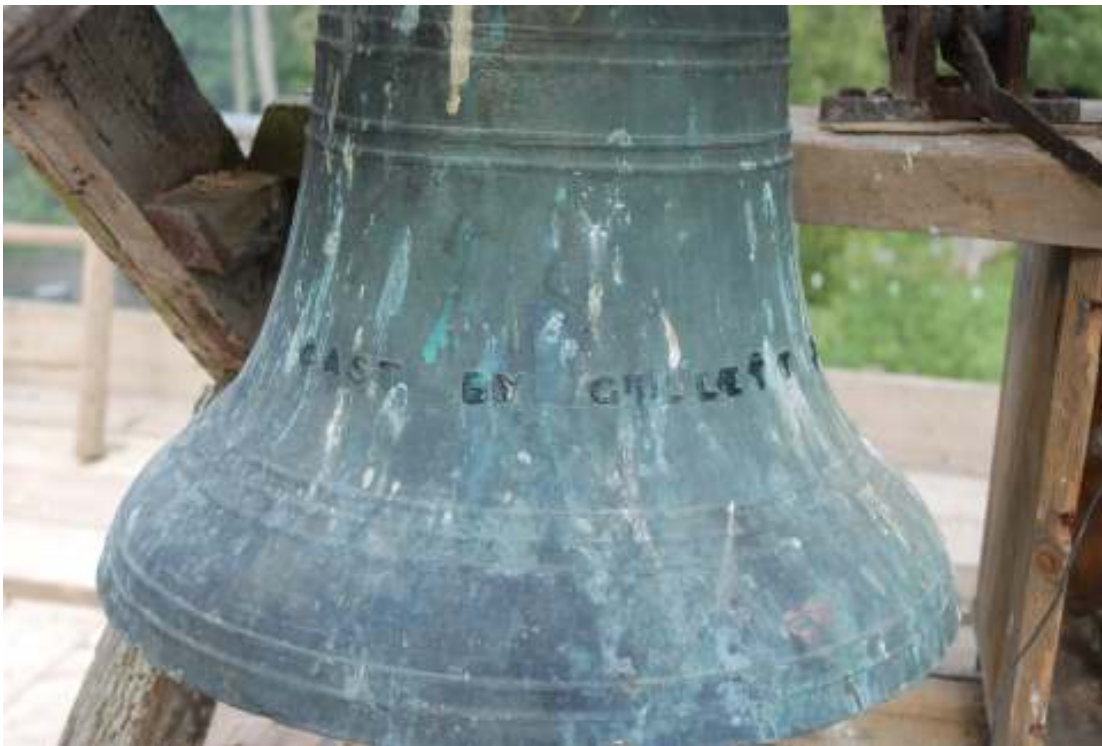
Fig. 149: Close-up photograph of the bell.

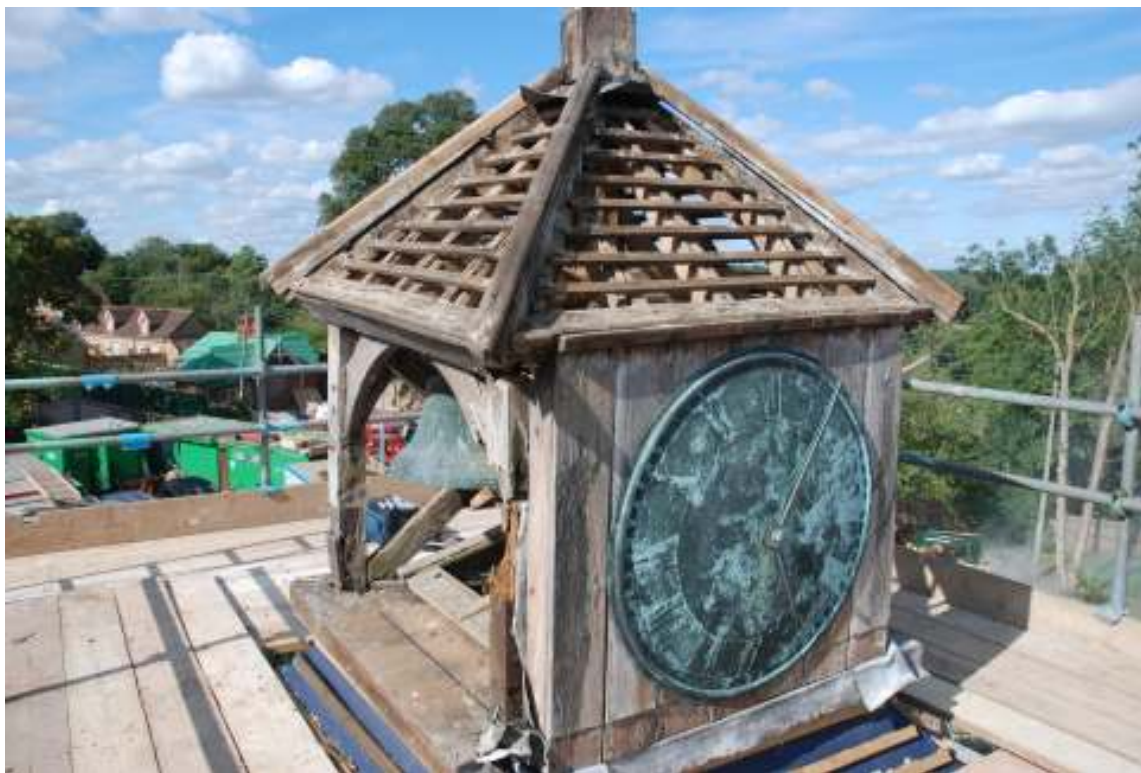
Fig. 150: Photograph of the clock-face and bell.

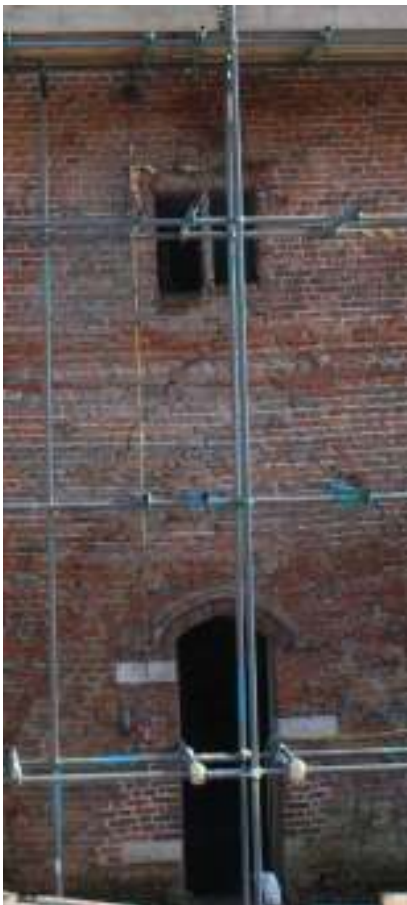
15.4.1 This bell pull was observed on the external left-hand side of the western doorway. This was then connected to an external upwards-running metal bar, running up to eaves-level, which then turned through a 90° angle into the dovecote. This was connected to a contraption in the upper storey of the dovecote (still visible, although disconnected, today), which was then connected to the clapper within the bell itself. Pulling the bell pull at ground-floor level therefore enabled the bell to be rung.

Fig. 151: Photograph showing the bell pull, to the left-hand side of the doorway in the western wall.

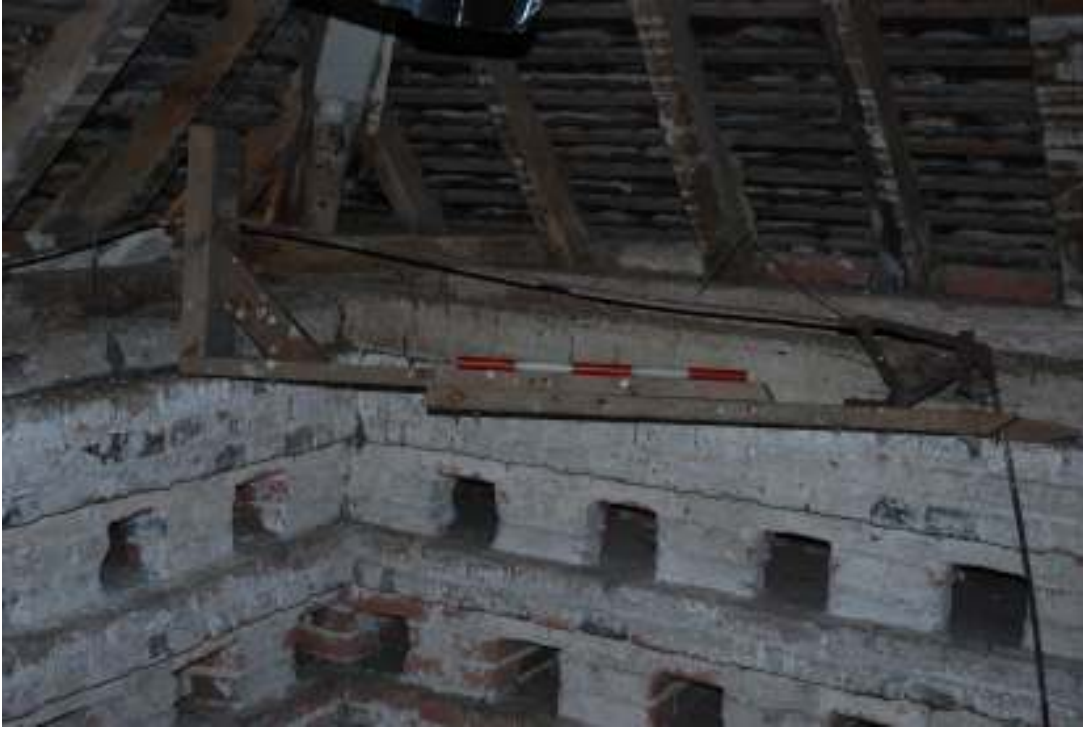
Fig. 152: Photograph showing the wooden contraption in the upper floor of the roof, which connected the bell pull to the bell.

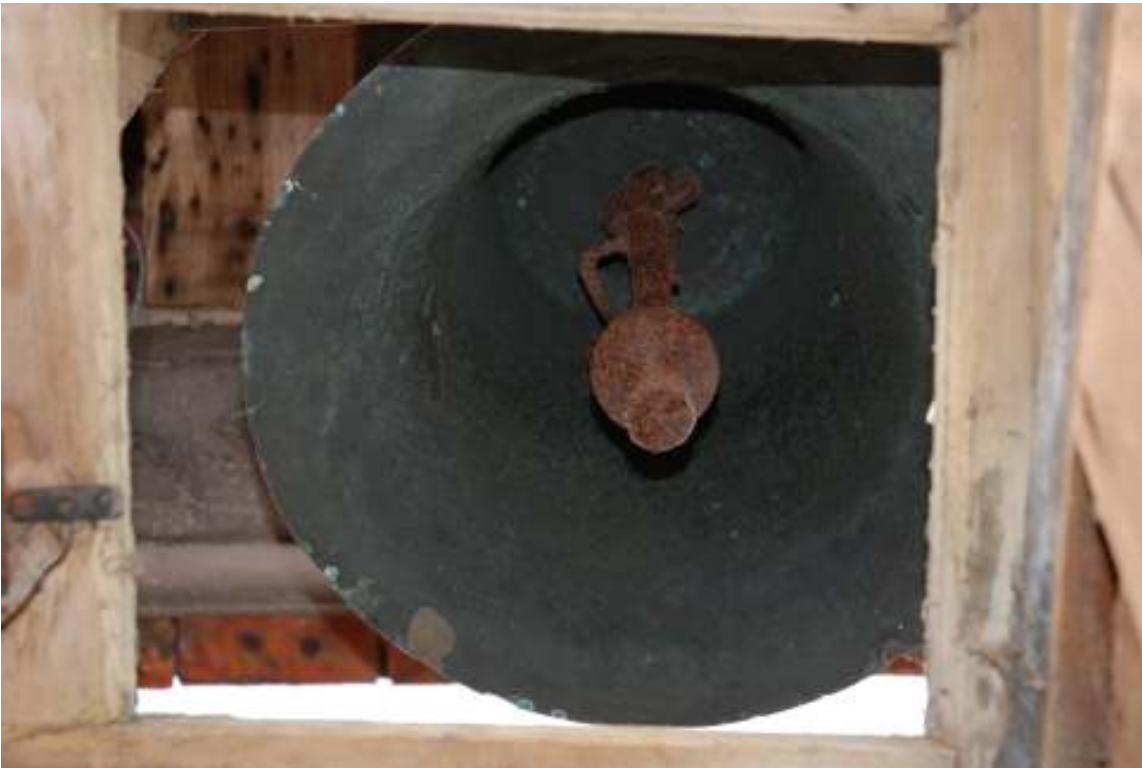
Fig. 153: Photograph of the bell, from below, clearly showing the clapper which was connected to the bell pull.

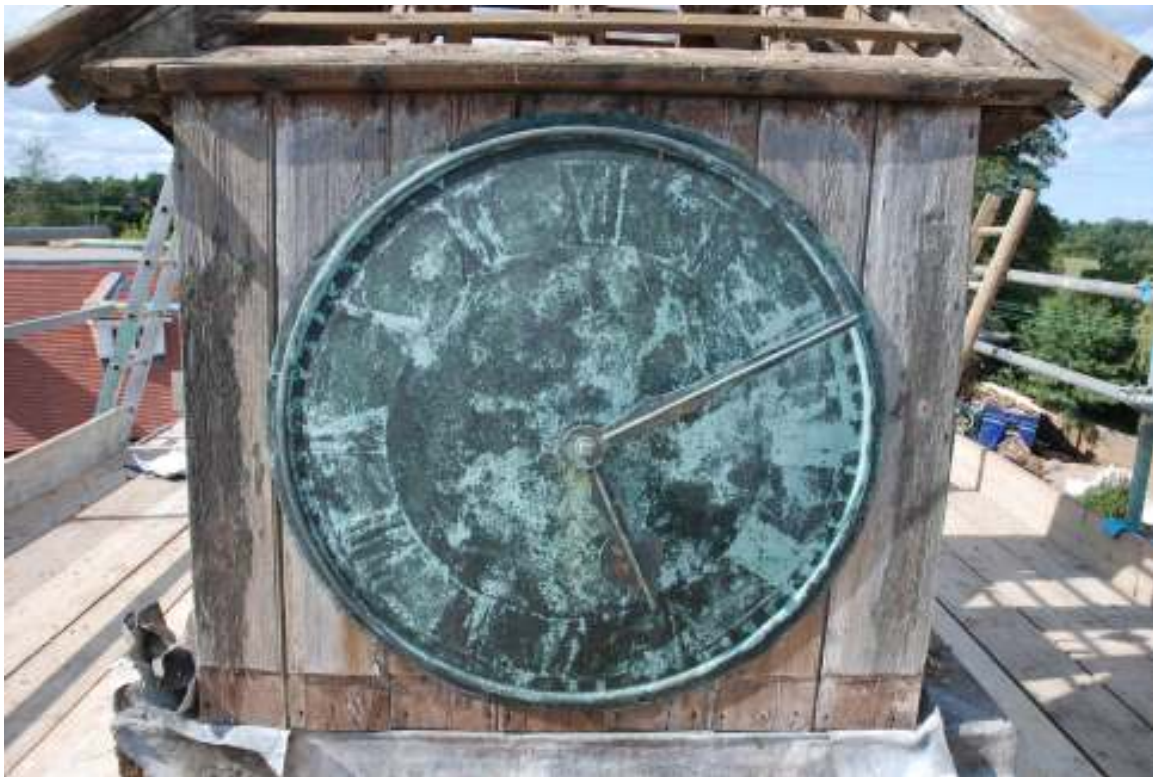
15.5 It also seems likely that the clock-face was inserted at the same time as the bells and clock mechanism. It is a circular copper alloy face, with Roman numerals for numbers, and two hands (a small slightly-broken one for the hours, and large one for the minutes). The Roman numerals have been painted on, and are not in relief. It is positioned on the southern face of the dovecote thereby facing the stable-yard, so it could be seen from the stable-yard. The diameter of the clock-face was *c.*0.92m.

15.5.1 This clock face was clearly inserted on the clock after the construction of the wooden 'bell-tower' itself. The newer wooden facing, on which the clock face was attached, is clearly visible over the older wooden cupola.

Fig. 154: Photograph of the clock-face, straight-on.

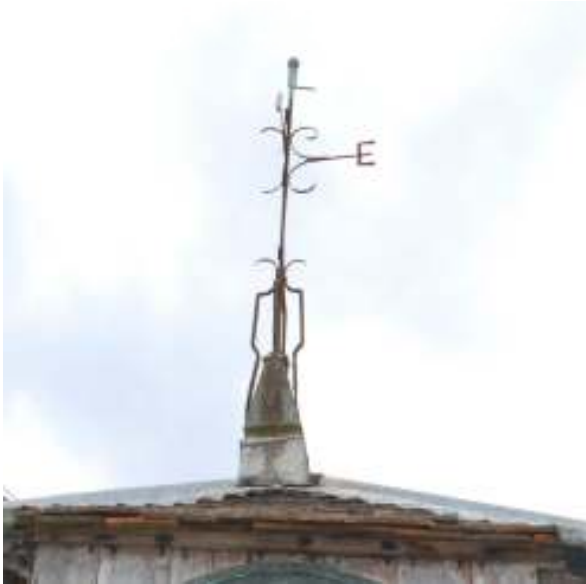
15.6 The weathervane was also probably constructed at this time. It is iron, with a gilt ball on top, a scroll, and the letters (N, E, S, W – although only two of these survive today). It is currently in a poor state, and would have had a far larger arm on it to catch the wind. This is a decorative feature, and was therefore probably constructed alongside the clock after the dovecote fell out of use.

Fig. 155: Photograph of the weather-vane, as it stands today.

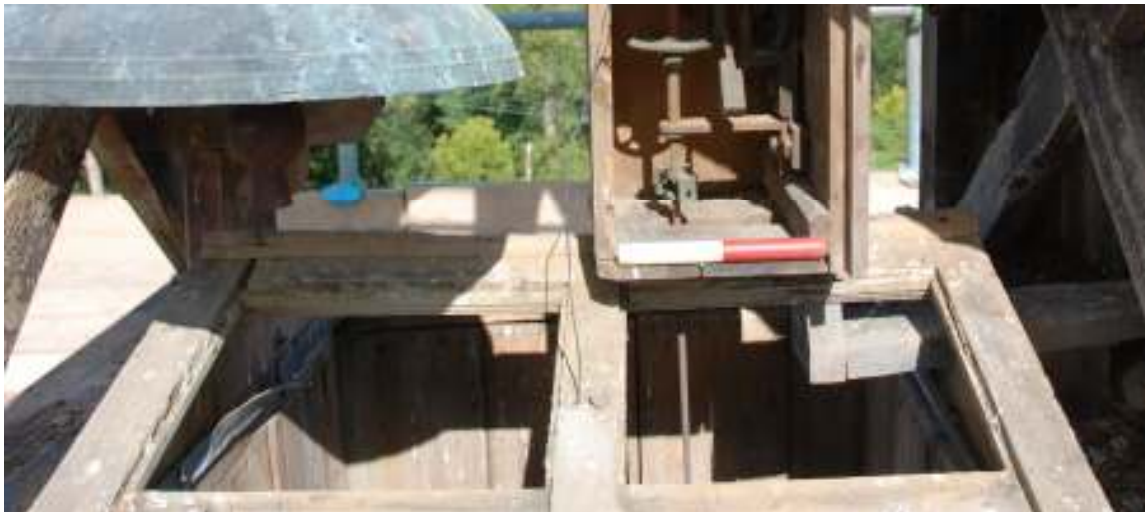
15.7.1 These alterations to the base of the cupola included the insertion of a couple of glazed panels. These are no longer complete, but the wooden frames (which look like window frames) into which the glass would have been set are still visible at the base of the cupola. This would have prevented doves from entering the structure, and thereby ended the life of the upper levels of the dovecote as a 'dove-loft'.

Fig. 156: Photograph of the remaining wooden frames at the base of the cupola, which would have held glass and prevented doves from entering the structure.

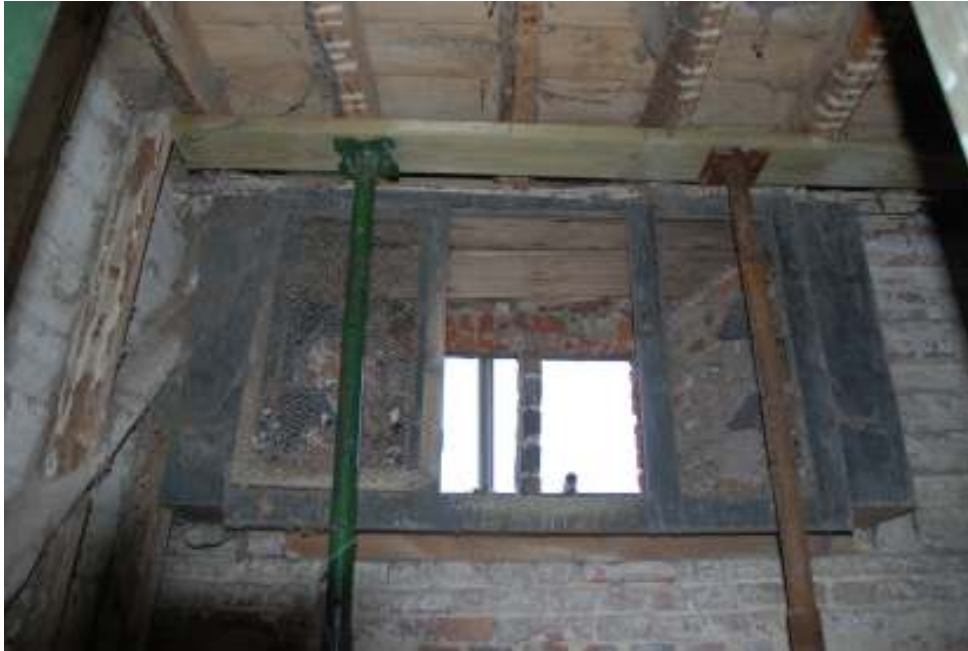
15.8 It is possible that at this time, when the doves were prevented from entering the structure through the cupola, some provision for doves was created in the western first floor window. Six nest-boxes were constructed here (three either side) within a boxed-in area, with mesh on the inner face to prevent the birds from entering the room. This would have offered a very limited provision of dove meat / eggs (room for a maximum of 18 doves). There would have been no reason for this provision whilst the upper floor was still in use as a dovecote, such that it seems likely that this was created once the insertion of the clock and alterations to the cupola had prevented doves from entering the upper storey.

*Fig. 157:
Photograph of
the western
window,
clearly
showing the
iron mesh
between the
nesting-holes
and room.*

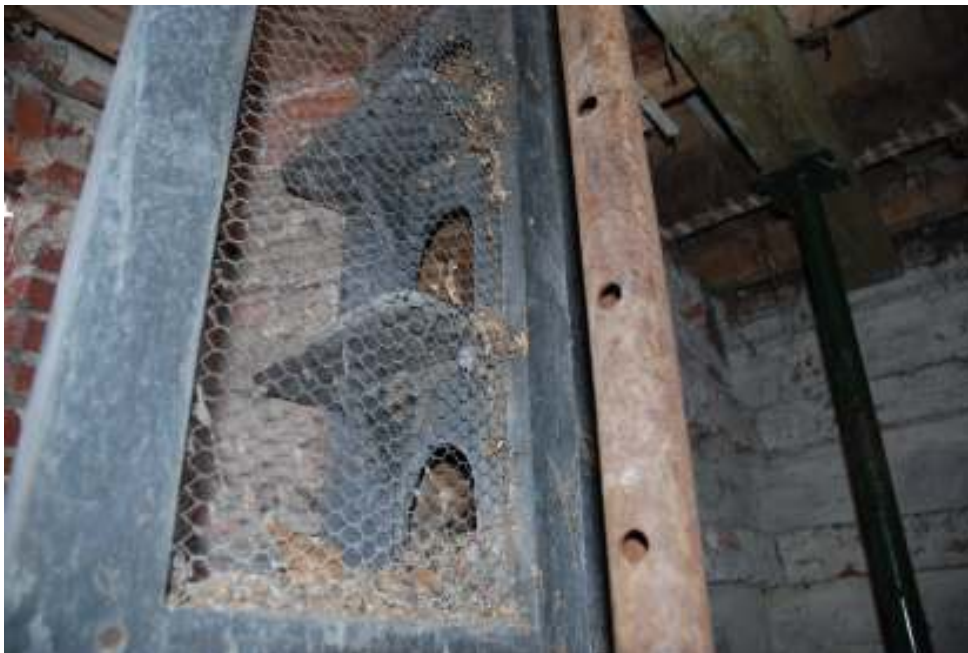
*Fig. 158:
Photograph of
three of the
nesting-holes
in the western
window.*

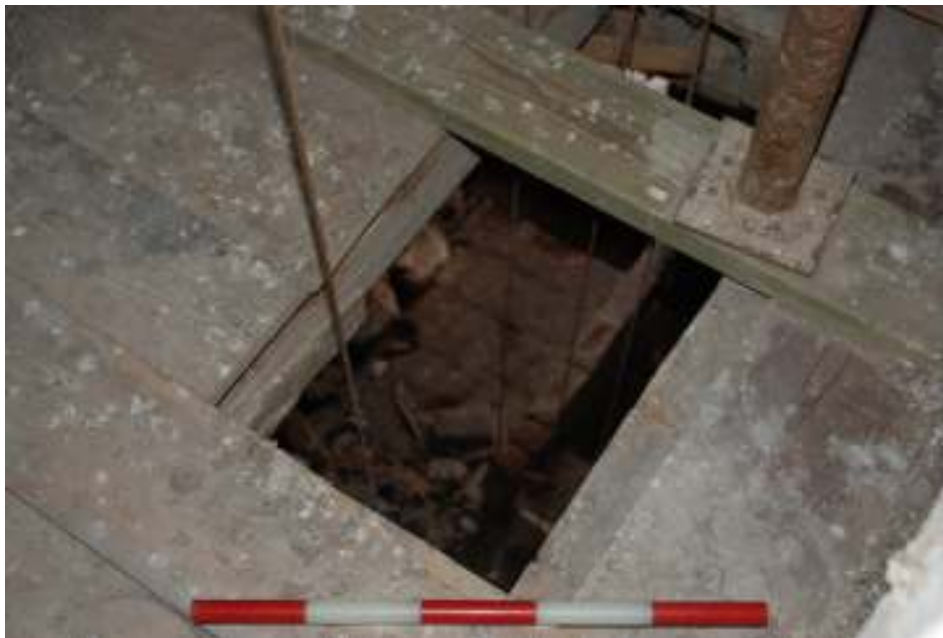
16.3 The current floorboards appear to be replacements of the previous floorboards. These are placed directly over the previous floorboards, with the latest planking on the upper floor overlying intermediate plyboard (also of modern – 20th Century – construction). The exact date when this happened is unknown, however it must have taken place during the 20th Century. The construction of the upper floor prevented the movement of the clock pendulum, which presumably had already gone out of use.

*Fig. 159:
Photograph
of the
modern
floorboards
on the first
floor,
overlying the
earlier
floorboards.*

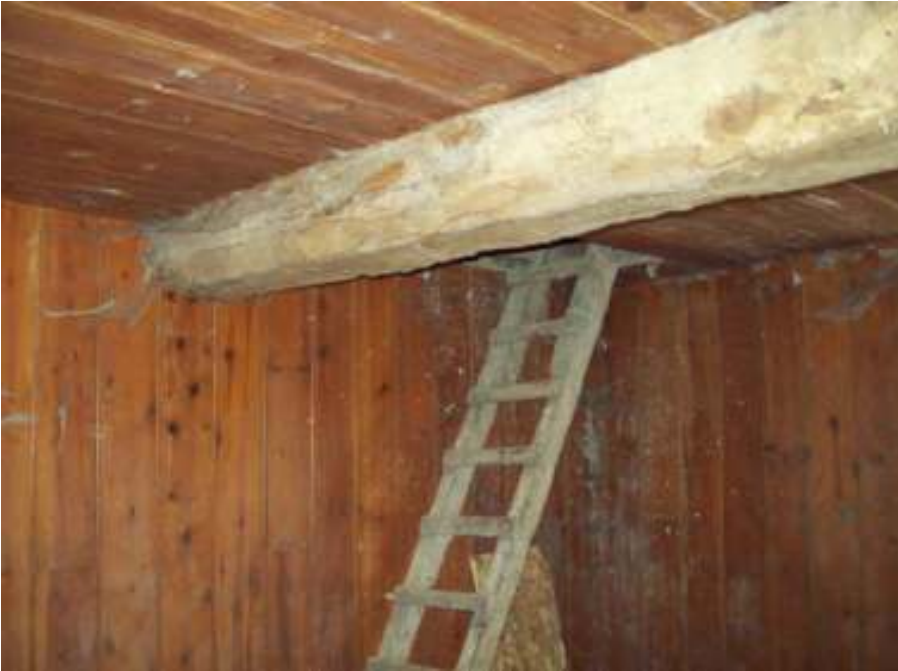
- 12.5.1** The ceiling of the ground floor is slightly more confusing, as although parts of lath-and-plaster were visible, larger nails were also observed projecting out of the western side of this ceiling. These large nails (which stick out 30-60mm) are positioned in a line, and may have had some form of cladding over them. This therefore suggests that part of the ceiling of the ground floor may have been lath-and-plastered, and subsequently had some form of cladding placed over it – possibly the later (20th Century) wooden panelling seen in the photographs supplied by Clancy Docwra (see fig.160)

- 16.4** The interior walls and ceilings of the dovecote were panelled over in wood. This had clearly taken place by 1965, as a 1965 photograph of the ground-floor of the dovecote from the NMR (150858) shows the walls covered by wooden panelling. This had been removed by the time of Compass Archaeology's investigations in 2011, although the below photograph (provided by Clancy Docwra) provides an indication of it.

*Fig. 160:
Photograph
supplied by
Clancy
Docwra
Developments
Ltd which
shows the
wooden
panelling of
the interior of
the dovecote,
ground floor.*
