BREAKSPEARS

THE 19th – 20th CENTURY HOUSE

**BREAKSPEAR ROAD NORTH, HAREFIELD, UB9 6NA
LONDON BOROUGH OF HILLINGDON**

AN INVESTIGATION OF THE HISTORIC BUILDING

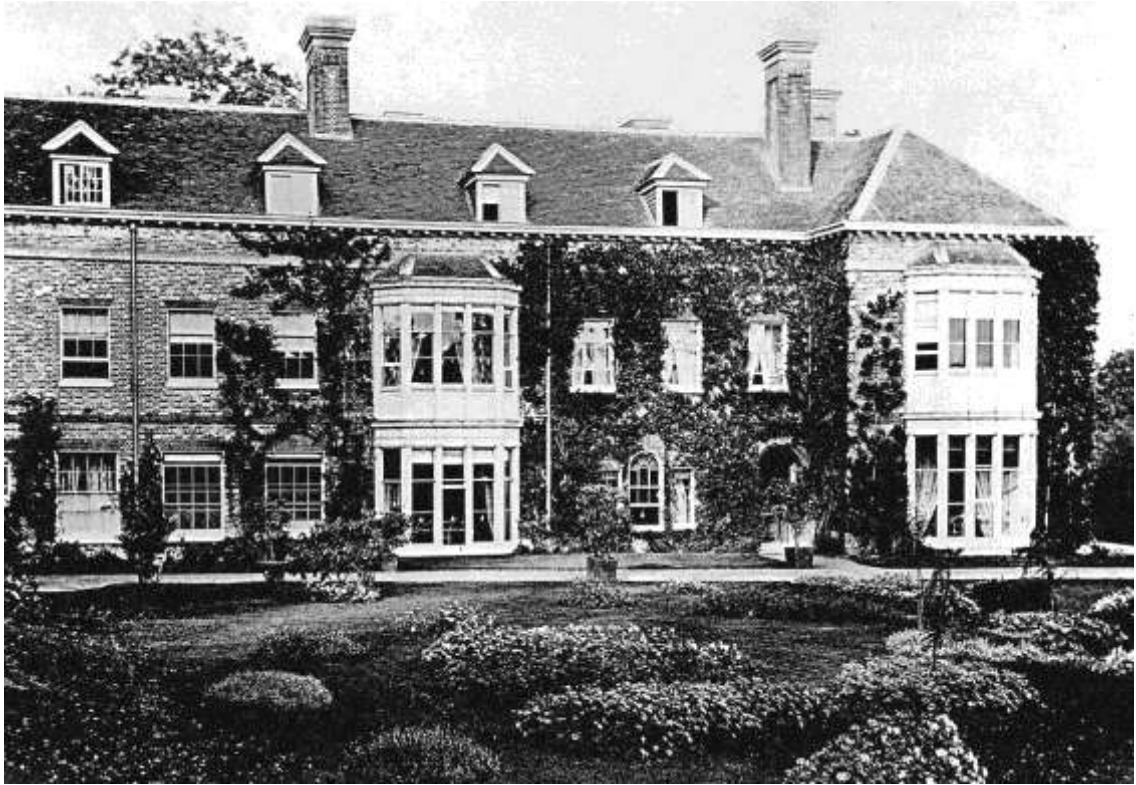
Furthermore, the amount of foliage growing on the southern frontage of the house in a photograph dating to 1860 (fig. 26) suggests that the western extension had taken place several years earlier. This foliage is found across the earlier part of the house (the lower part of the wall around the door) and across the part rebuilt by Joseph Ashby Partridge (particularly the upper part of the house rebuilt above the library, and the area slightly to the west of the library bay window which is entirely new build). This foliage seems to be relatively evenly spread, suggesting that it all began to grow after the house was extended / rebuilt. It would have taken a fair few years, probably at least eight, for such foliage to become established. This therefore acts as further evidence for Joseph Ashby Partridge's phase of rebuilding to be dated to the 1840s / early 1850s.

Fig. 26: 1860 photograph of the southern frontage of Breakspears, with foliage growing evenly over parts of the 'earlier' and 'later' house (NMR. BB75/6800).

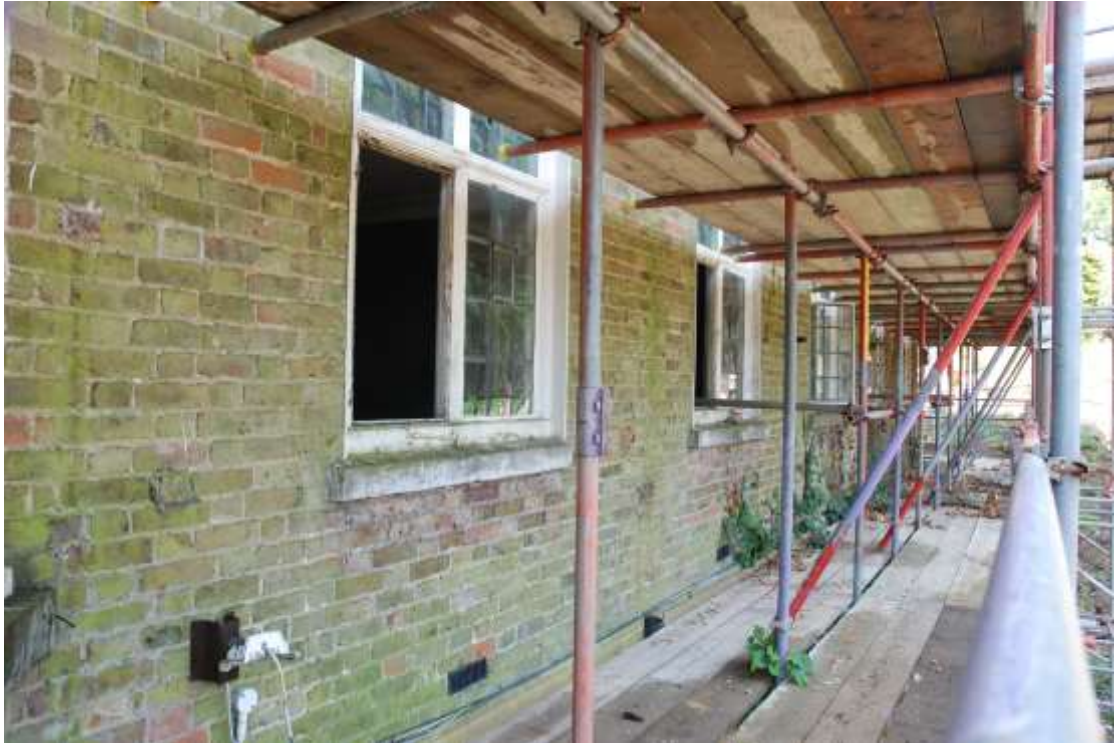
The bricks in the western extension are clearly of a different type, and later in date, than those in the earlier part of the house. They are predominantly purple-red to brownish-yellow bricks, with general dimensions of between 216-218mm in length, 55-62mm in depth, and 90-104mm in width.

This brickwork is set in a regular Flemish bond. This is in contrast to the English bond of the earlier (c.1630s) house, but similar to the Flemish brickwork of the 1690s rebuild – see discussion of this in the early house report.

Fig. 29: Northern frontage, at first floor level, just to the west of room F22 (in the area of Partridge's western extension). The later brickwork, set in a regular Flemish bond, can clearly be seen.

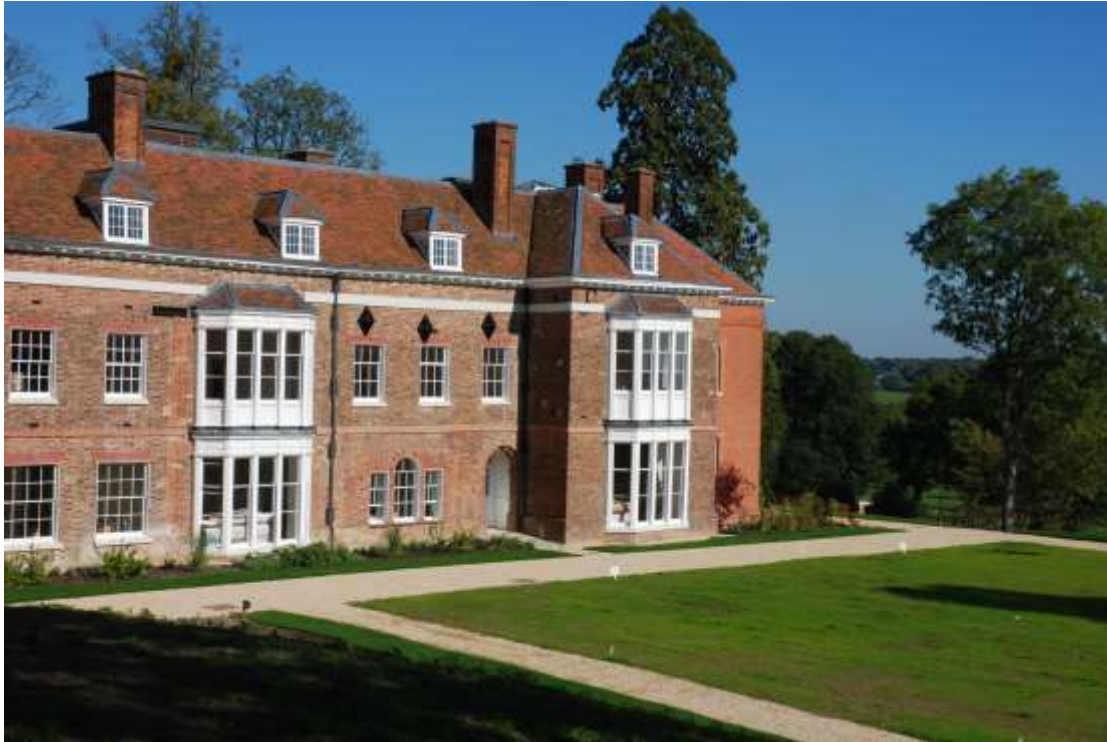
Fig. 30: Southern frontage. The brickwork of the 'earlier' house is visible in the central part of the photo (around the doorway and Venetian window), and that of the 'later' house in the western part (i.e. to the left of the closest bay-window).

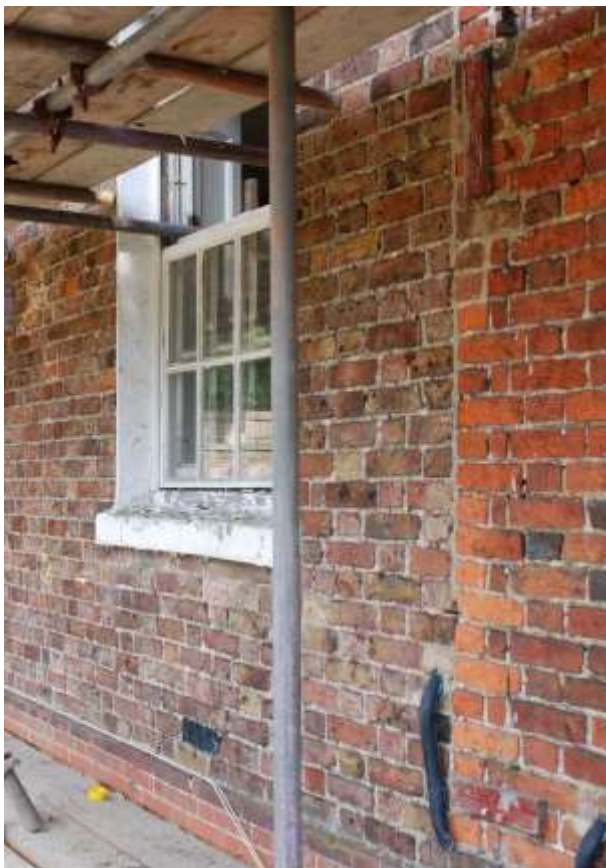
Fig. 31: Close-up view of the line between the red-brick of the 'earlier' house and the grey-brick of Partridge's extension (southern frontage).

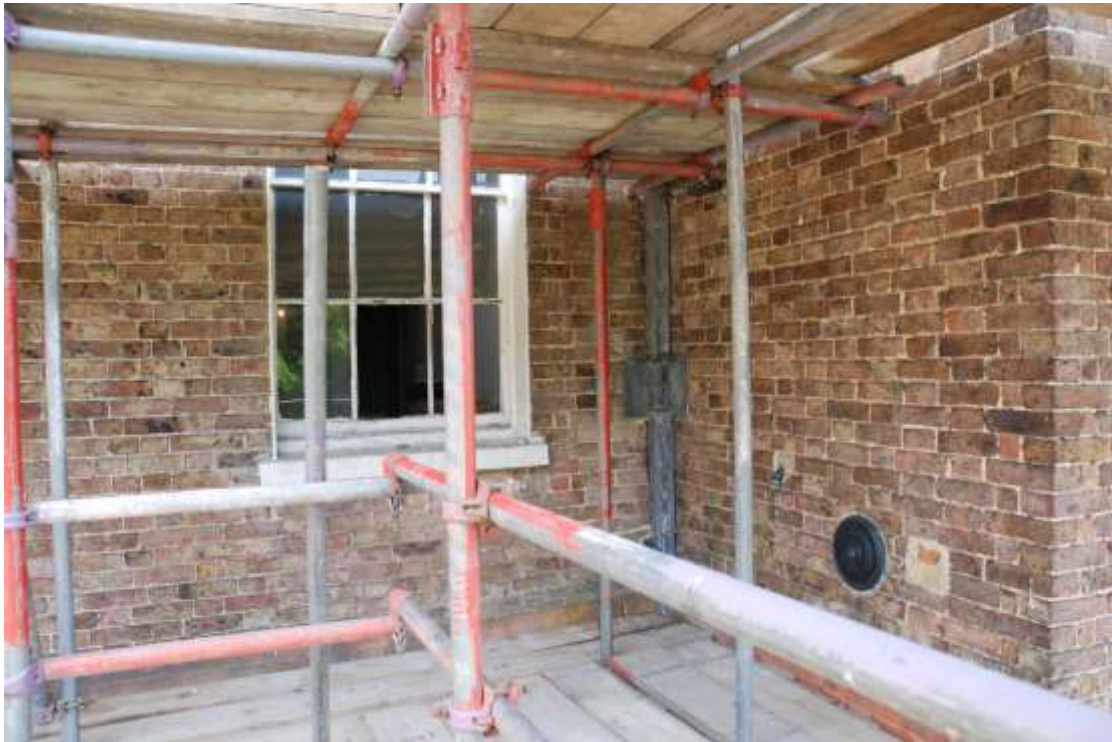
The projecting 2-storey base at the south-eastern end of the house, which previously continued southwards as the service wing, was also rebuilt. This is reflected in the new brick present across all three (south, east, and west) walls here (fig. 32).

Fig. 32: Walls between rooms F5 and F7, at first floor-level, showing the area rebuilt by Partridge with the more modern brickwork.

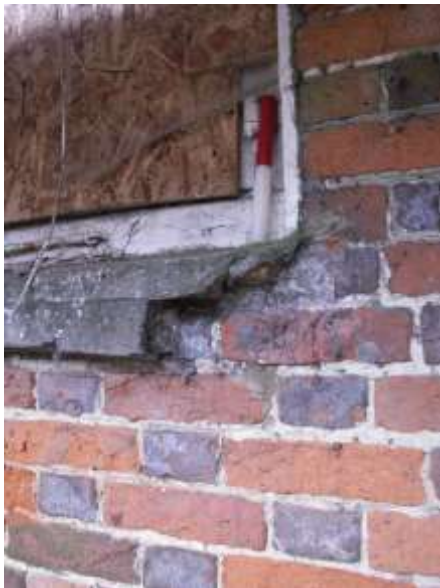
Alongside the insertion of new windows was the replacement of the window sills on the northern frontage of the earlier part of the house. These are concrete, and very similar to those found in the area of the western extension.

Fig. 33: New concrete window-sill.

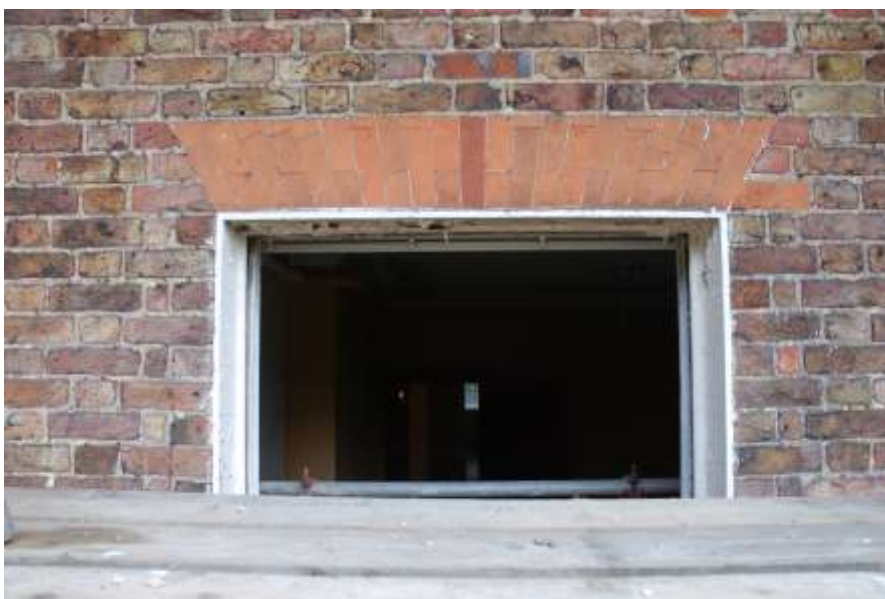
Good quality gauged brickwork was observed in the area of the western extension, above the windows. This is of a similar type to that observed in the lower part of the northern frontage – i.e. the earlier 18th Century façade – and reflects a desire to emulate such early architectural details.

Fig. 34: Gauged brickwork above new windows.

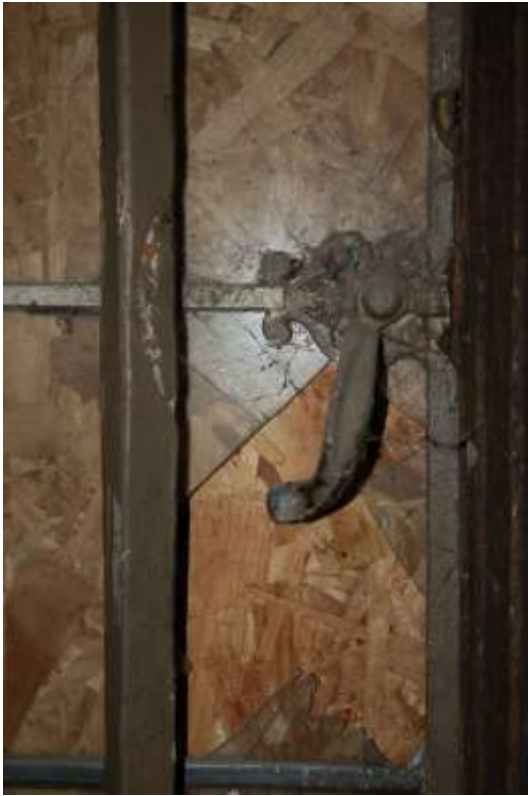
Fig. 35: Window catch on metal frame in the entrance hall (G22) – in the 'early' part of the house but clearly replaced during Partridge's rebuild.

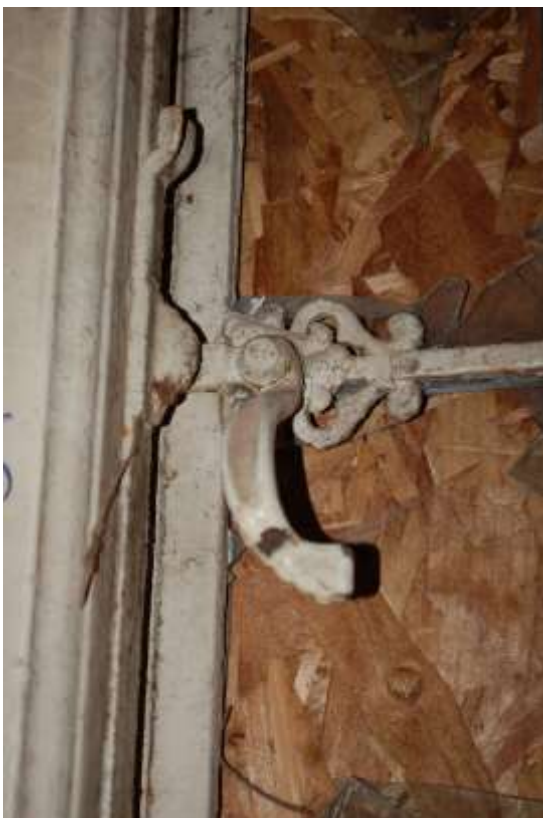
Fig. 36: Window catch in the kitchen (G19) – in the area of Partridge's rebuild.

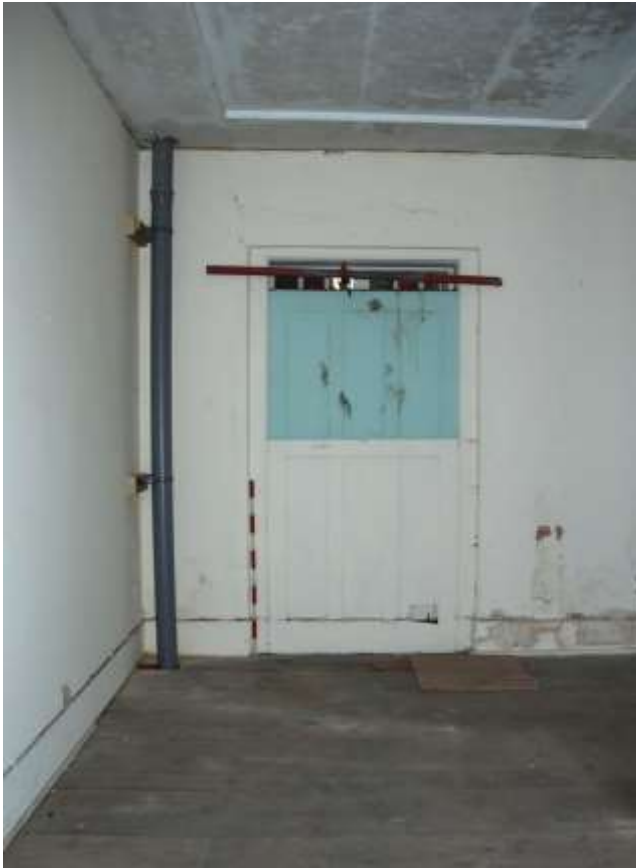
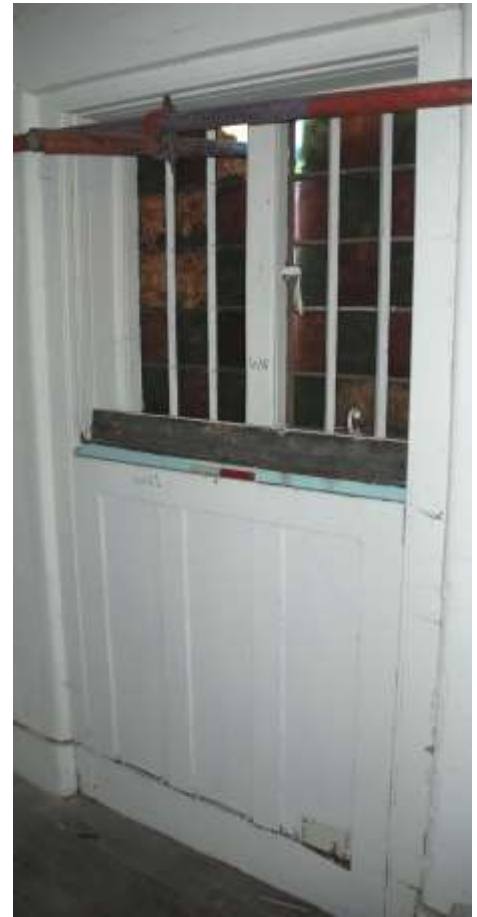
Three other windows with unusual forms were observed at the western end of the house, on the first floor, in rooms F17 and F18. These were small square windows, with the wall rebated in around them, and recessed timber panels below containing separate moving panels which could move up and down as shutters. When the shutter was fully retracted, a narrow hinged board closed to form an internal window sill. These were clearly inserted by Joseph Ashby Partridge as part of his major extension.

Fig. 40: Unusual window in room F18 with shutters which move up and down.

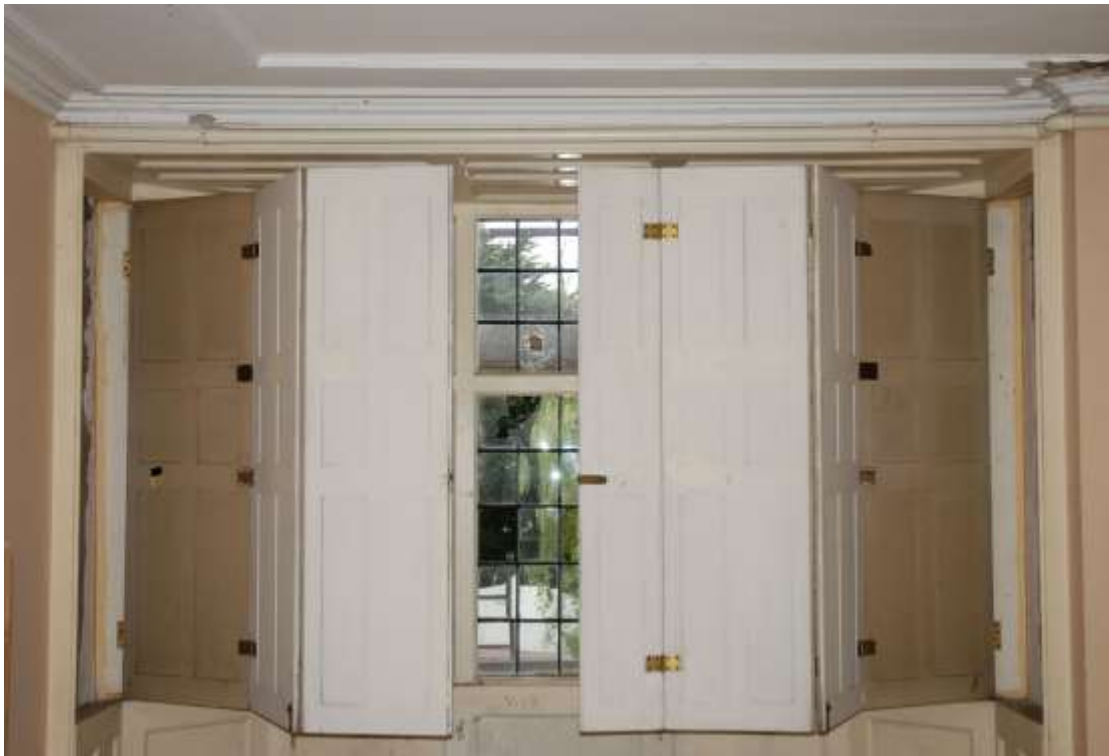
Fig. 41: Horizontal shutters in room F22.

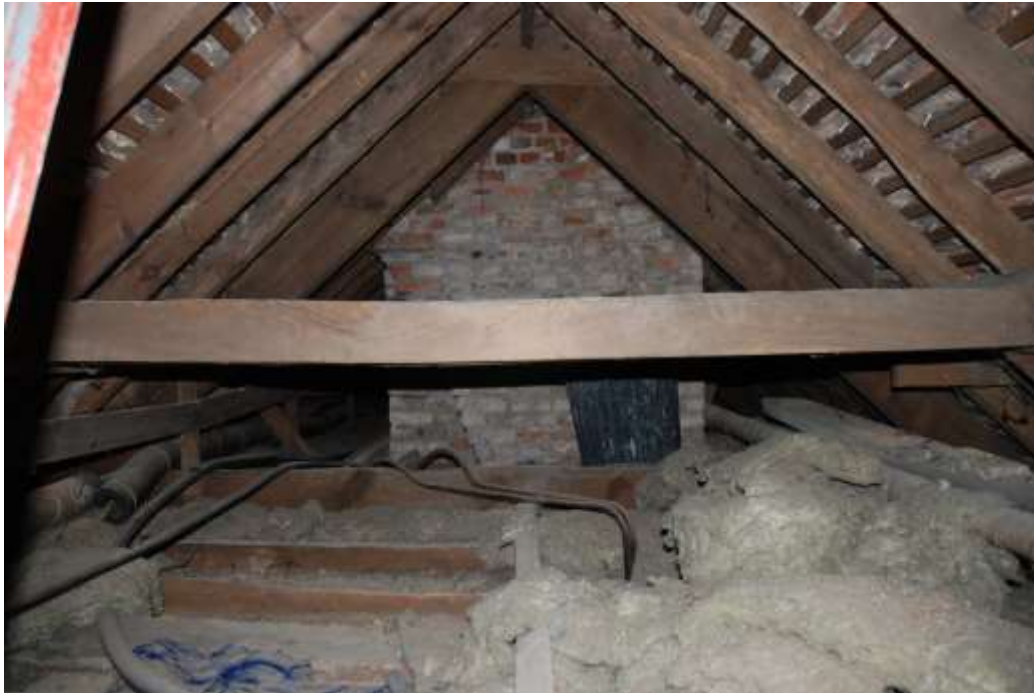
Observation within the roof-space itself provides further evidence for the fact that the roof was completely rebuilt at this date. This is because the type of timbers, plus their general arrangement and form, is similar in both the area of the earlier house, and the area of Joseph Ashby Partridge's western extension. This was observed above room S18 (at the junction between the earlier house and Partridge's extension), and the below photographs (fig. 43 and 44) depict the continuity of the roof-space across this junction.

Fig. 43: Photograph of the roof-space, looking west from above room S18 (into the area of Partridge's extension).

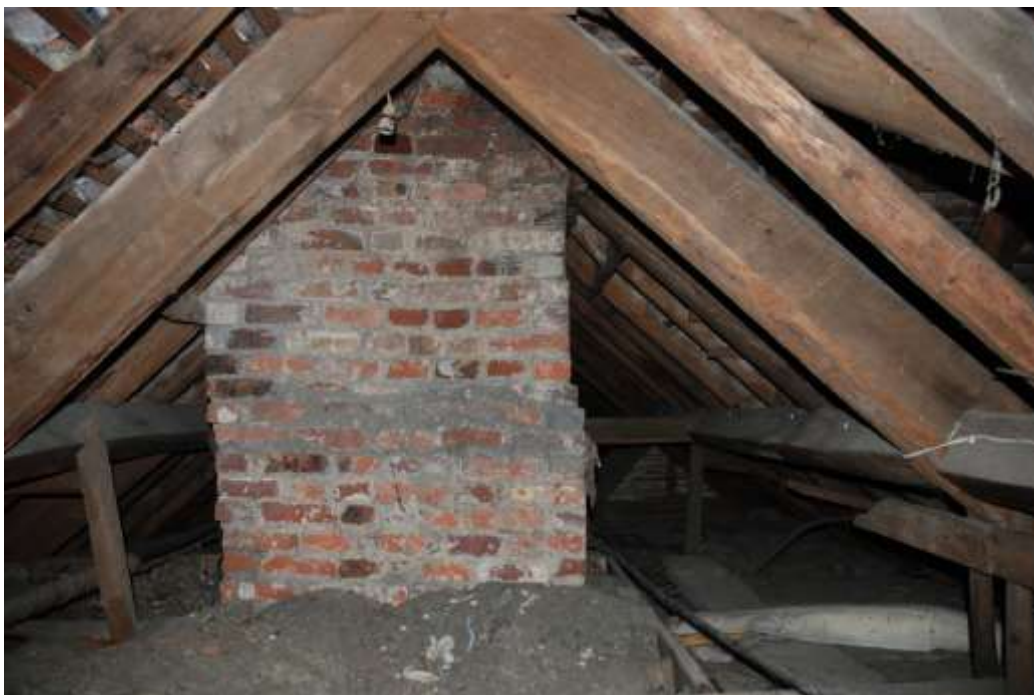
Fig. 44: Photograph of the roof-space, looking east from above room S18 (into the area of the earlier house).

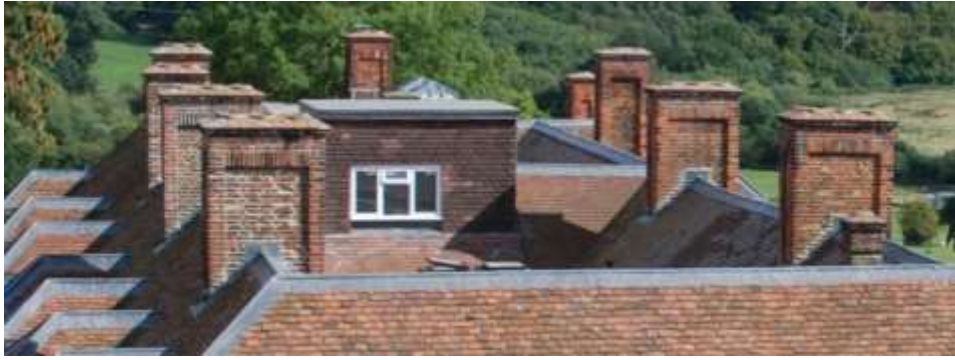
The chimneys, both those in the area of the earlier house, and those in the area of Joseph Ashby Partridge's western extension, seem to have been constructed alongside this phase of development. The chimneys in both the area of the earlier and later house are very similar in form – square or rectangular brick chimney stacks with recessed panels of brickwork and with oversailing caps (no-longer present). The 1860 photograph, in particular, suggests that these may have been constructed of stone rather than brick (fig. 47). Furthermore, the height of the roof in the earlier house was probably substantially lower than the height of the present roof, such that it seems more likely that these chimneys were associated with this roof (as would have been too high to be associated with a lower roof). Moreover, there is no sign (either above roof level or in the roof space) of the chimneys having been extended, such that they were probably constructed at one date (Partridge's extension).

Fig. 46: Photograph of some of the chimneys, looking east.

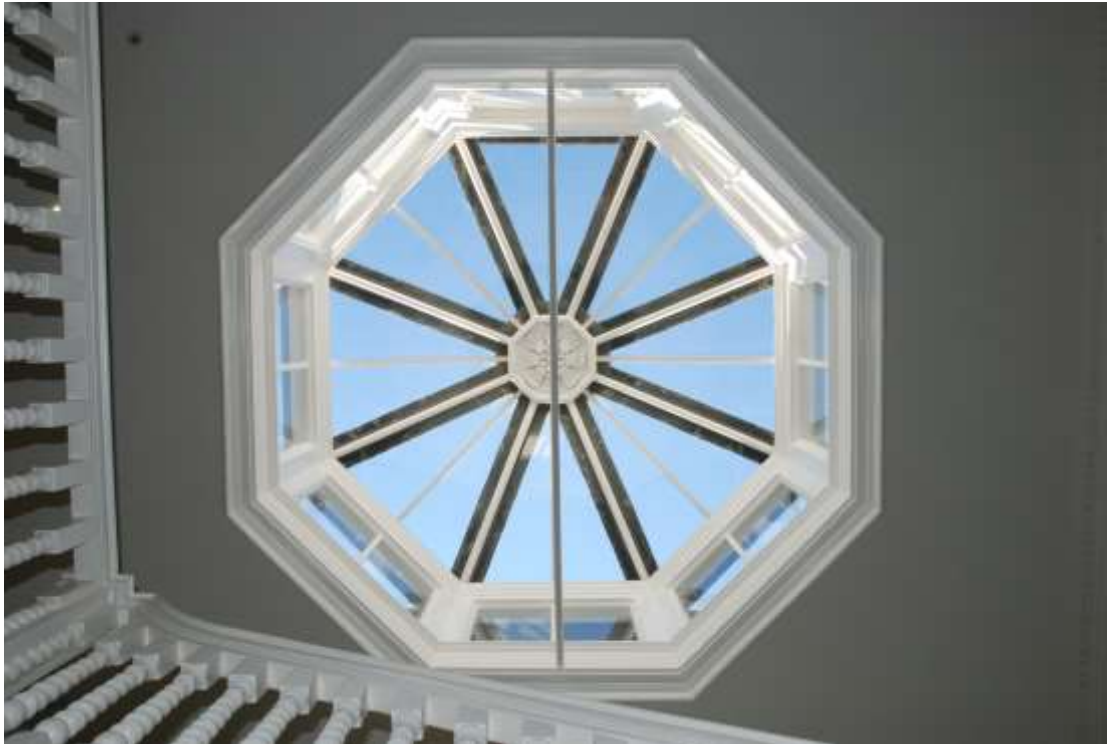
The general stylistic features of this lantern suggest a 19th Century date. This includes the central decorative roundel, from which a chandelier would have hung from the still-extant hook, and the general glazed parts of the lantern.

Fig. 49: Photograph of the lantern, looking directly up at it.

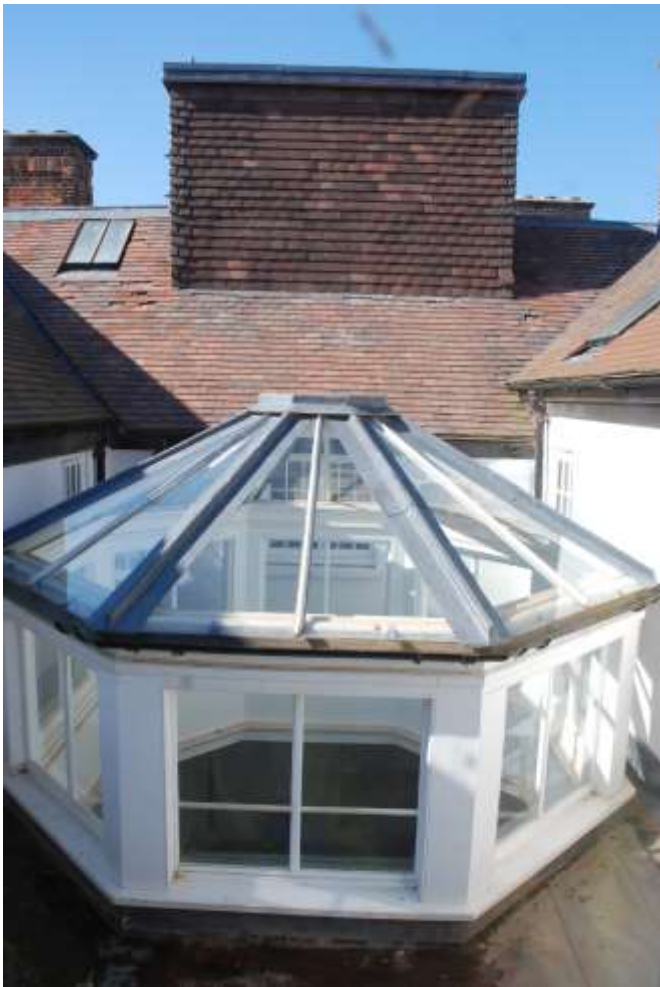
Fig. 50: Photograph of the lantern from the east.

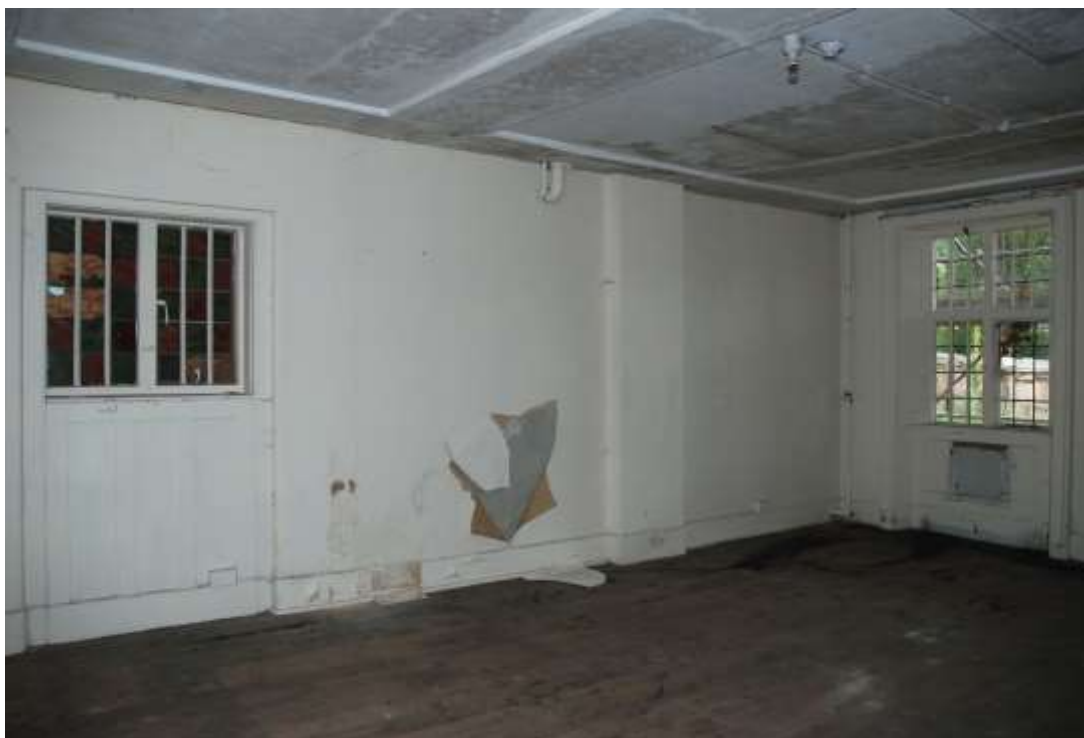
The existence of a chimney breast was noted on the western walls of room F18 and S15 above, and the remains of the chimney itself were also visible on the exterior. This would have been positioned directly above the junction between room G16 and the western subterranean rooms where the oven is located (according to the 1894 Architects Plan), and would, therefore, have been for the oven. The chimney breast was clearly built as an integral feature of the western wall of the main house, and acts as further evidence that the western subterranean rooms are contemporary with Joseph Ashby Partridge's major western extension.

Fig. 53: Chimney-breast on the western wall of room F18.

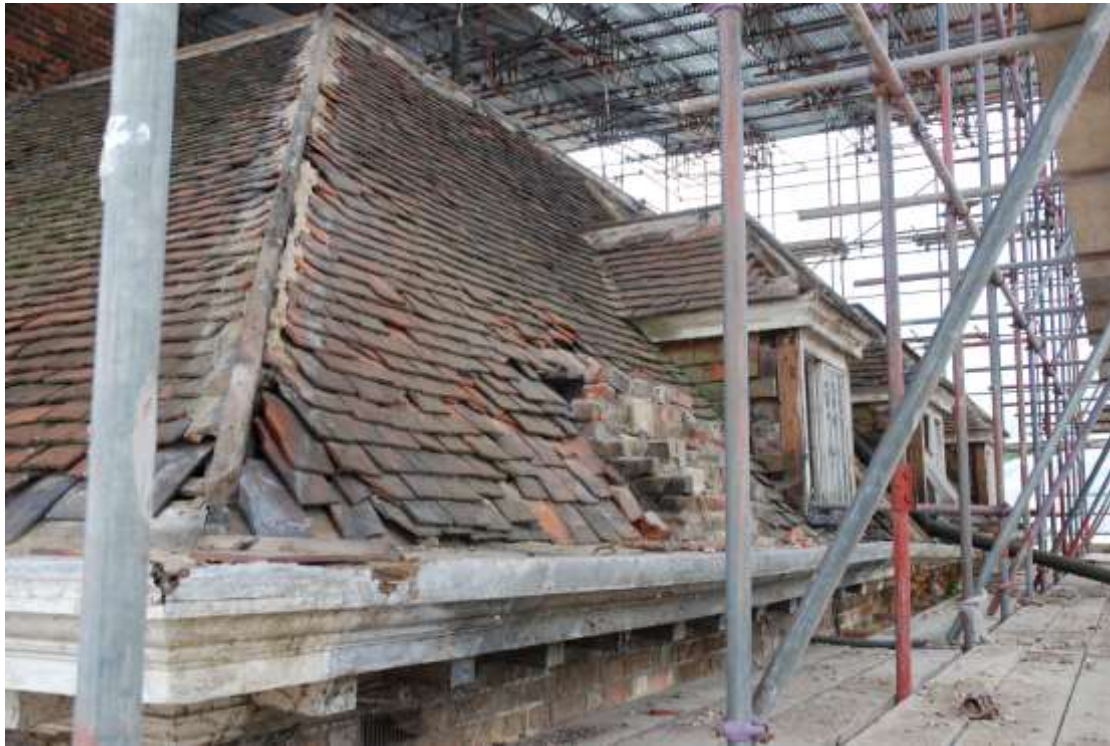
Fig. 54: Remains of the chimney located above the western wall of room S15.

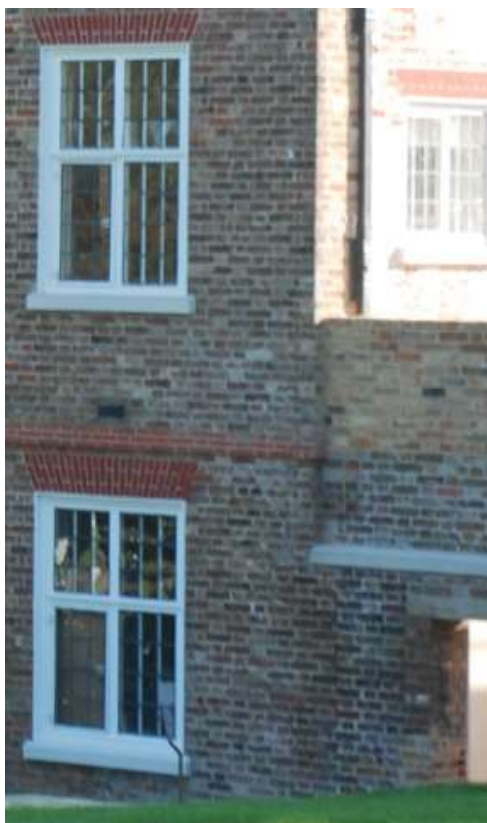
There is little standing structural evidence for the western-most rooms, which were largely demolished before redevelopment. However, the external ground-floor wall, on the northern frontage, continues further to the west than it does at the upper levels, with no apparent break in construction (fig. 55). This is further evidence that the associated rooms at the western end of the house were constructed at the same time as Joseph Ashby Partridge's main western extension.

Fig. 55: Northern frontage, ground-floor wall. This appears to continue further to the west (beyond the western end of the house at the upper levels) with no break in construction, and suggests that the western rooms were constructed at the same time as the main house.
