**THE SPRINGFIELD ICE HOUSE, BURNTWOOD SCHOOL,  
BURNTWOOD LANE, EARLSFIELD, LONDON BOROUGH OF  
WANDSWORTH  
SW17 0AQ**

**AN ON-SITE ARCHAEOLOGICAL INVESTIGATION**

Grade II listed building  
Historic England List Entry Number: 1065554

Site code: ICE 15  
NGR: TQ26717 72466

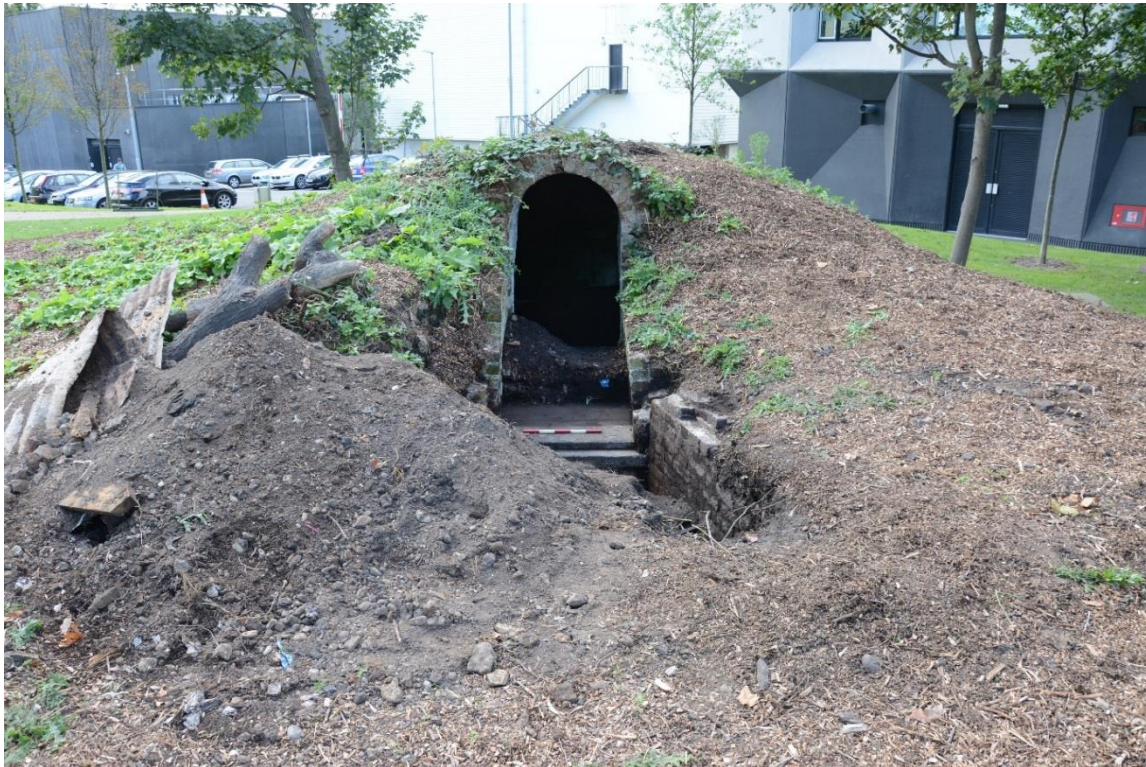
*Fig.1: The Springfield ice house- a present day view*

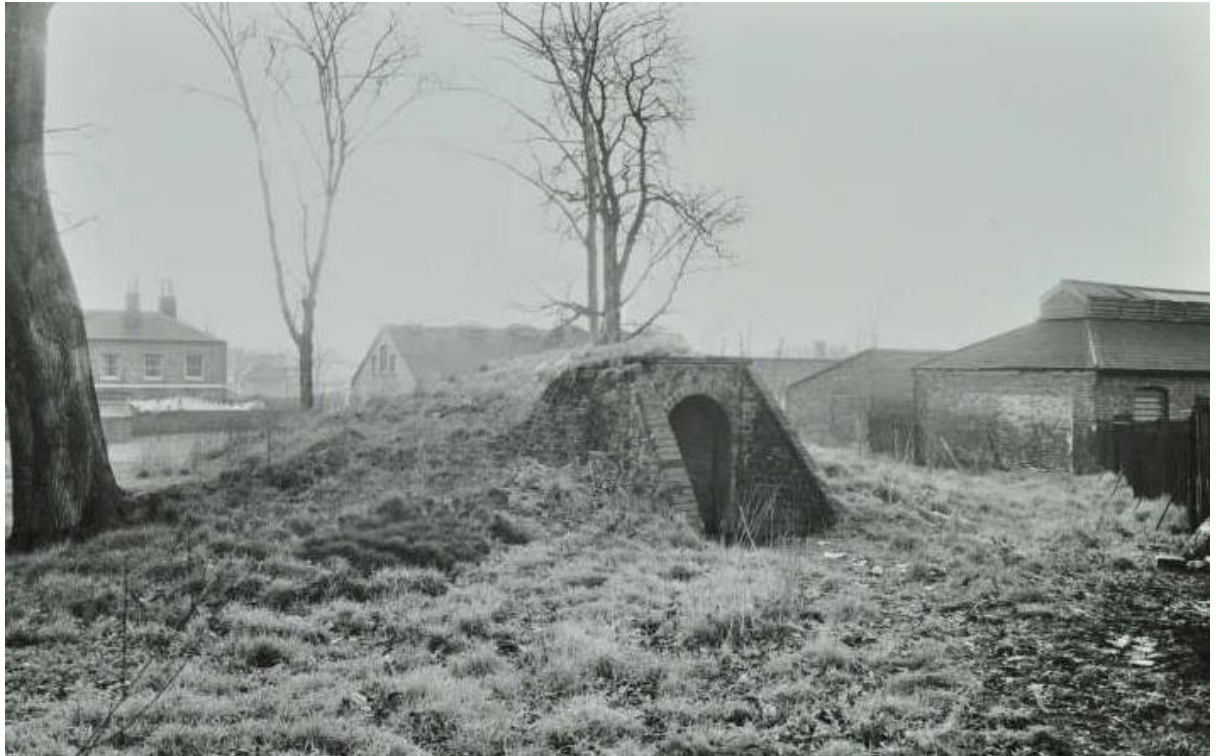
The earliest known photograph, (fig.6), however shows the ice house in a more complete (and presumably more or less original) form, with what is clearly an arched outer entrance and adjoining tunnel, in front of which are splayed, sloping walls. The brickwork is nicely finished and the entrance tunnel has a flat, squared-off, roof. Just within the tunnel entrance, where it meets the splayed walls, there is a thin gap in the brickwork suggesting a former setting for a door frame at the entrance to the tunnel. This in effect would have created an entrance tunnel sealed at both ends to better insulate the structure. At this time the ice house appears to still be surrounded by the farm buildings of Springfield Farm.

*Fig.6: View of the ice house, 1952*

The point where the splayed walls originally ended has been reached which is indicated by the transverse course of bricks (headers) exposed at the end of these walls (figs.19-21). The transverse course of bricks at the end of the walls also confirms that the walls were sloping, and not vertical (see 1952 photograph- fig.6).

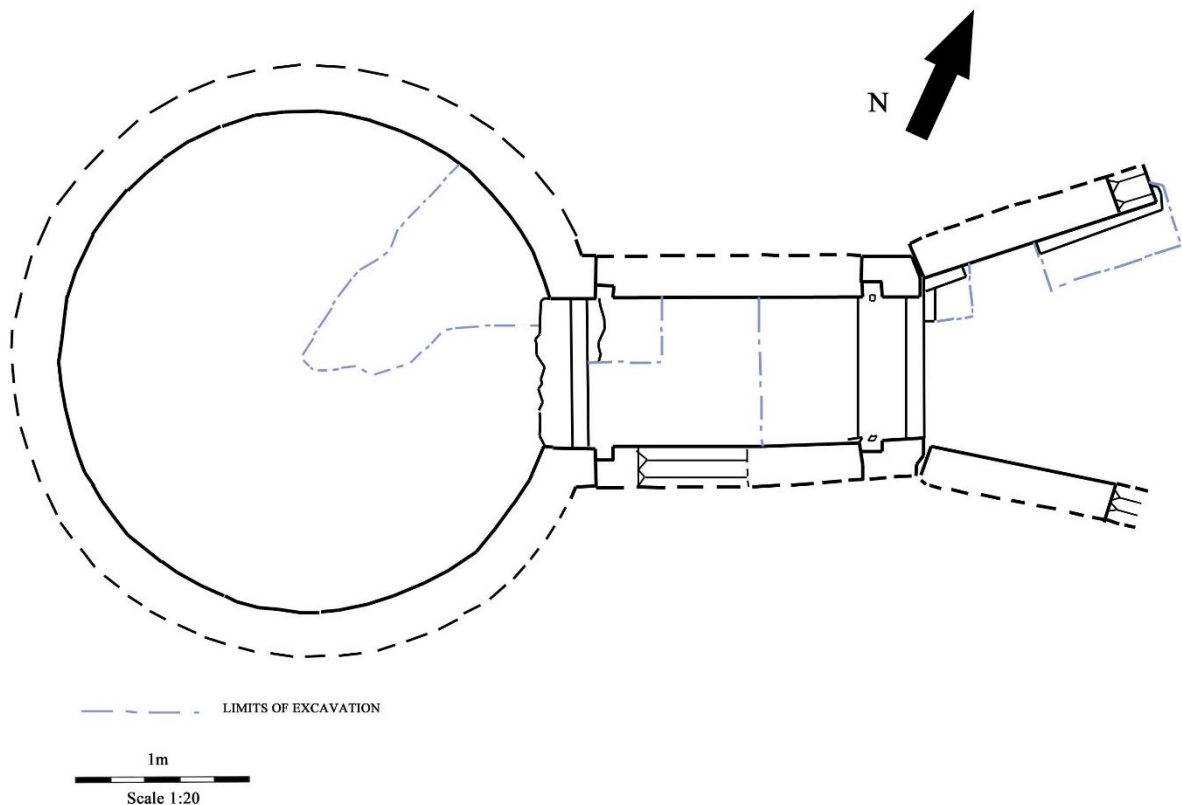
**5.2.2** The fieldwork included the hand excavation of test pits in both internal and external areas of the building (fig.7). Inside the ice house a rectangular trial pit was dug against the inside face of perimeter wall and abutted the existing vaulted-arch entrance to the building. The pit was extended towards the centre of the building and measured 1.43m in length and 1m in width (at the wall's face). Its depth from the original threshold was 2.08m. A part of the trial pit that was closer to the centre was dug 0.62m deeper, to the depth of 2.70m from the original threshold. The diameter of the ice house's domed interior (checked at the level of the widest point just above the entrance threshold) measured 3.01m

**5.2.3** Outside the ice house the existing remains of the walls and parts of the pathway leading to the domed space were cleared of accumulated debris and exposed. The wall on the northern side was investigated in greater detail, with two trial holes dug up to its base. The trial holes measured approximately 0.30m x 0.40m (next to the stone threshold), and 0.90m x 0.45m (at the end of the wall). The depth of the pit next to the stone threshold was approximately 0.50m and the depth of the pit at the end of the wall was approximately 0.35m. At the depth of 0.35m the base of the northern splayed wall was reached.

*Fig. 7: The general plan of the ice house with investigated areas outlined in grey*

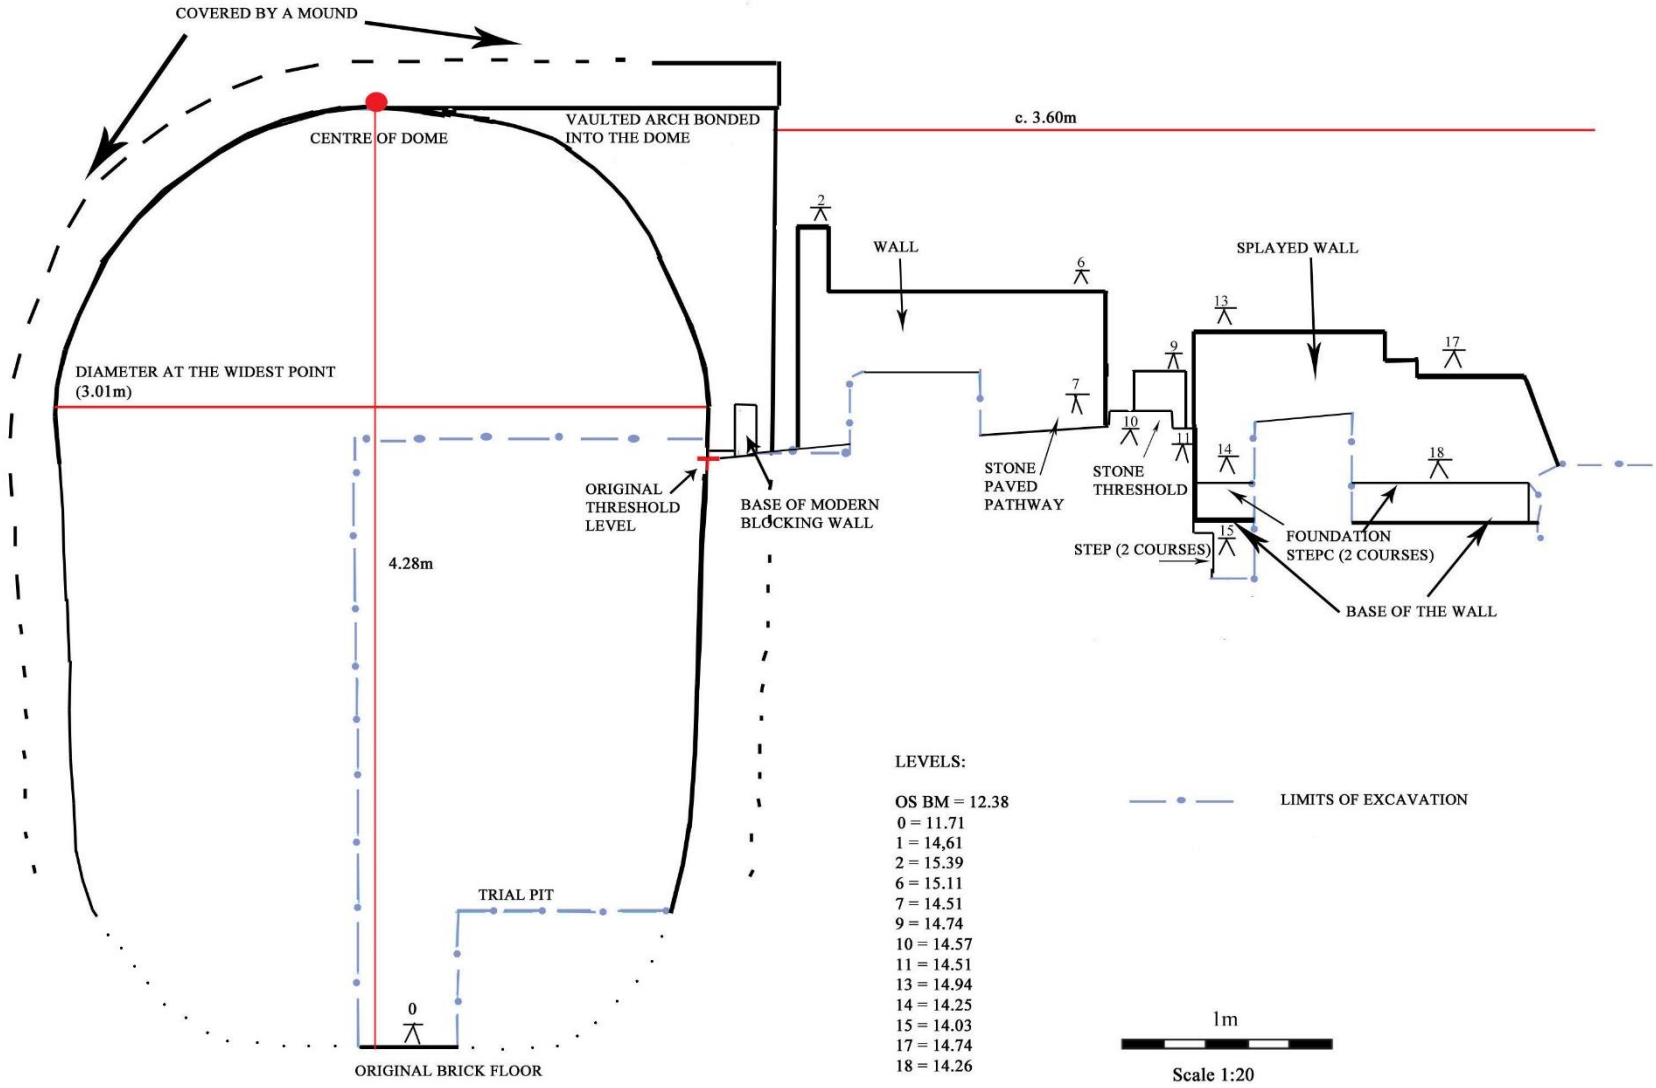
Fig.9: Ice house in section

6.2 The single room constituting the main part of the ice house is domed and brick lined. Inside the ice house domed interior the trial pit was dug against the inside face of perimeter wall and abutted the existing vaulted-arch entrance to the building. The pit was of a roughly rectangular shape and extended towards the centre of the building (figs.9-11). The pit measured 1.43m in length and approximately 1m in width. Its depth from the original threshold was 2.08m. The diameter of the ice house's domed interior measured 3.01m (at the widest level). The interior turned out to be a regular circle.

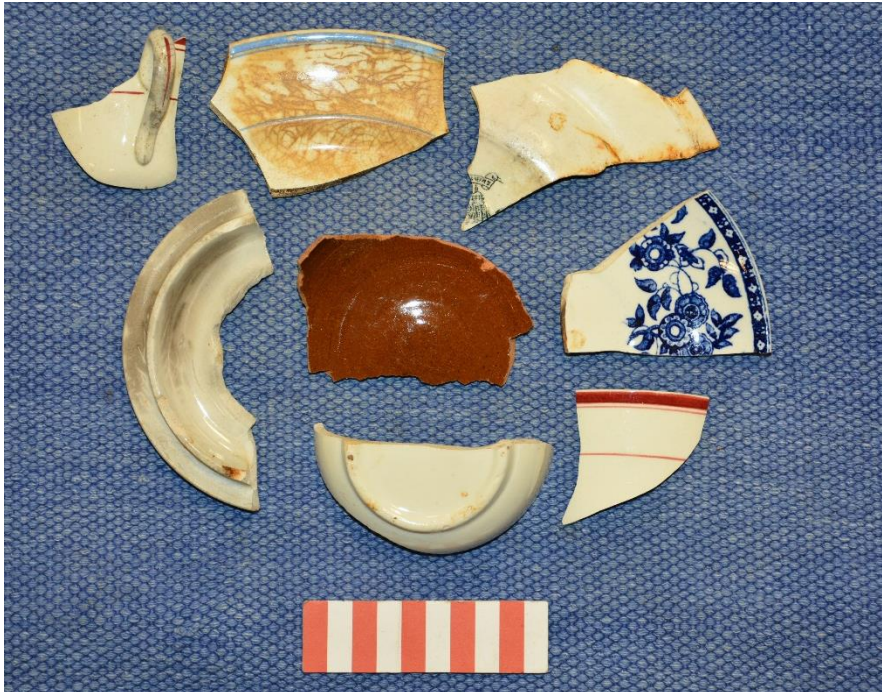
Finds were retrieved from the fill of the trial pit inside the ice house (context 1). All finds date to early 20<sup>th</sup> century. Find include: two pieces of broken glass, a few pieces of broken pottery of various type (fig.27) including a James Green & Nephew printed piece (fig.28), numerous fused burnt pieces of pottery, and four slag type fragments of burnt pottery fused with burnt brick and wood/coal pieces.

*Fig.27: Various types of late 19<sup>th</sup>-early 20<sup>th</sup> century pottery- fragments (0.1m scale)*

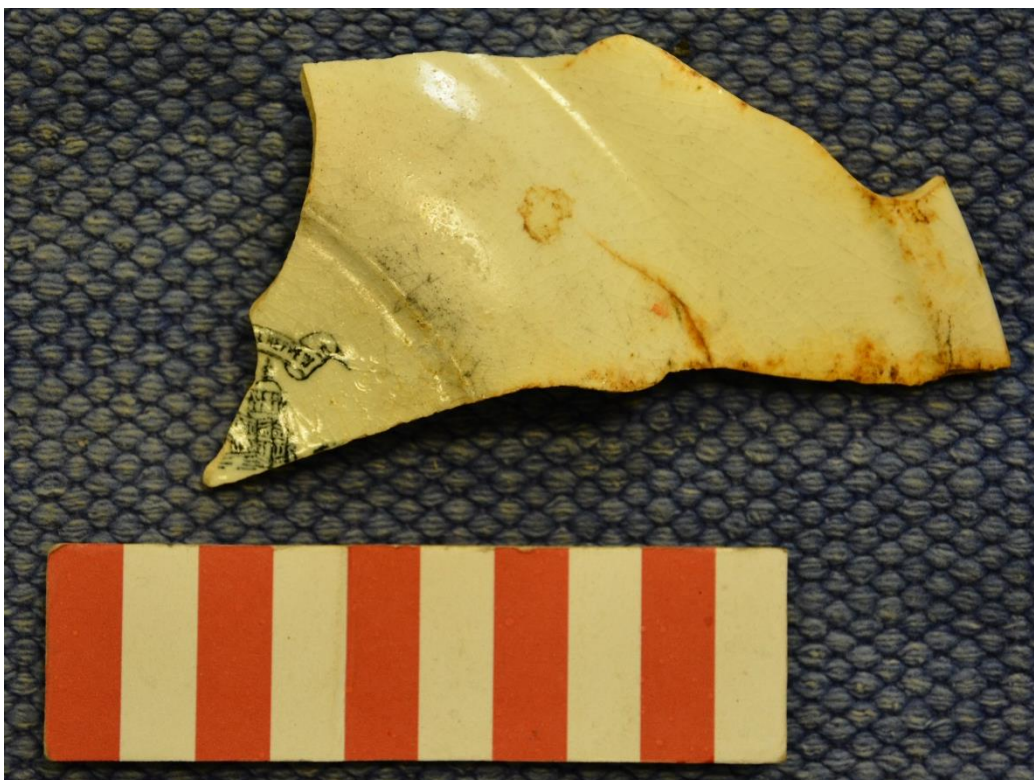
*Fig.28: James Green & Nephew printed pottery piece (0.1m scale)*
