WHITEHALL, 1 MALDEN ROAD, CHEAM

LONDON BOROUGH OF SUTTON, SM3 8QD

**AN ARCHAEOLOGICAL WATCHING BRIEF AND
HISTORIC BUILDING RECORDING**

September 2018

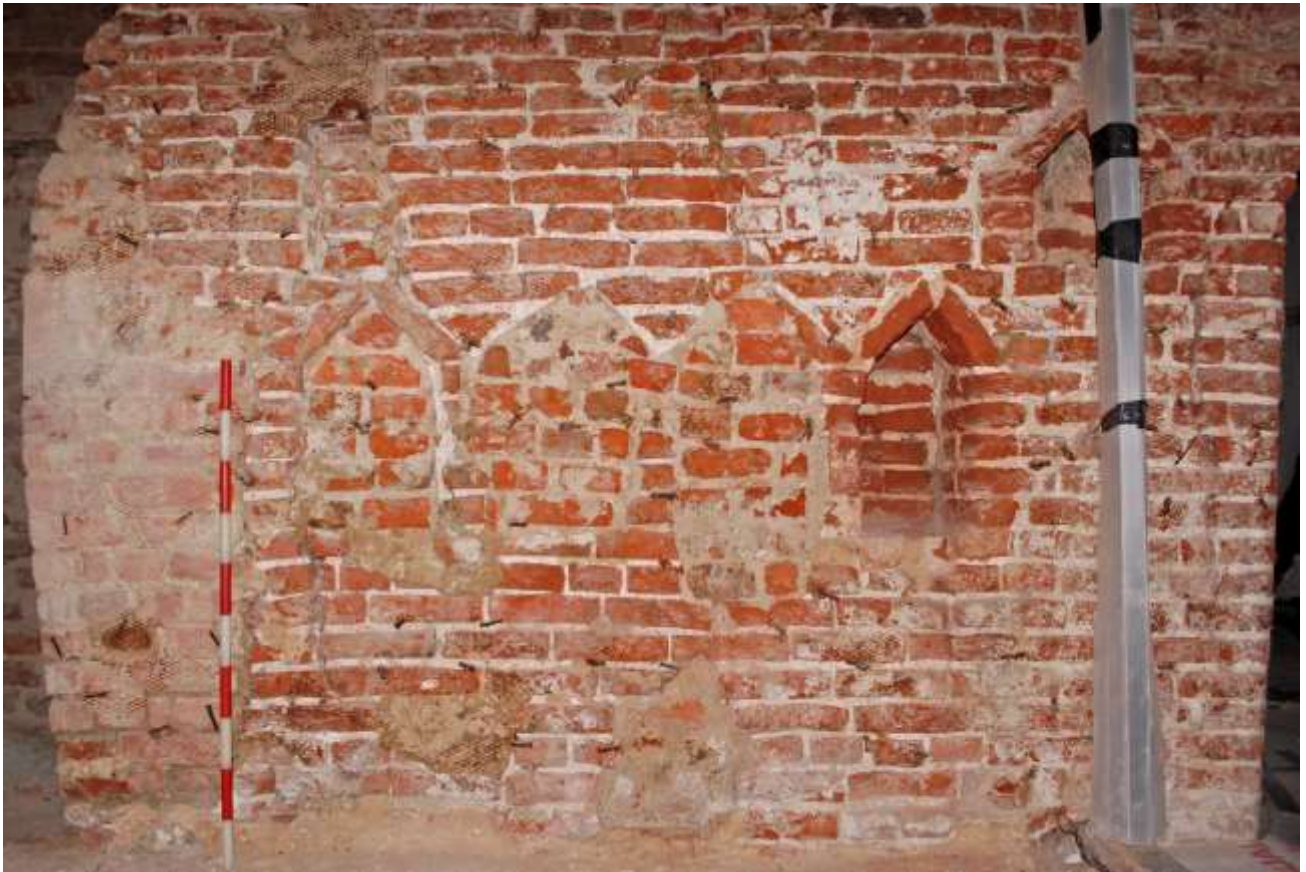
The plaster stripping revealed three further blocked niches within the brickwork, in a line to the east of the lower niche that was already visible (Figs.19-21). These were all of similar height – *c* 460mm – although those now exposed were slightly wider than the first (approx. 275mm as against 225mm). For reference the upper (westernmost) open niche is also about 275mm wide, but only *c* 325mm high.

Fig.20: The northern side of the chimneystack, showing existing and blocked niches (1.0m scale)

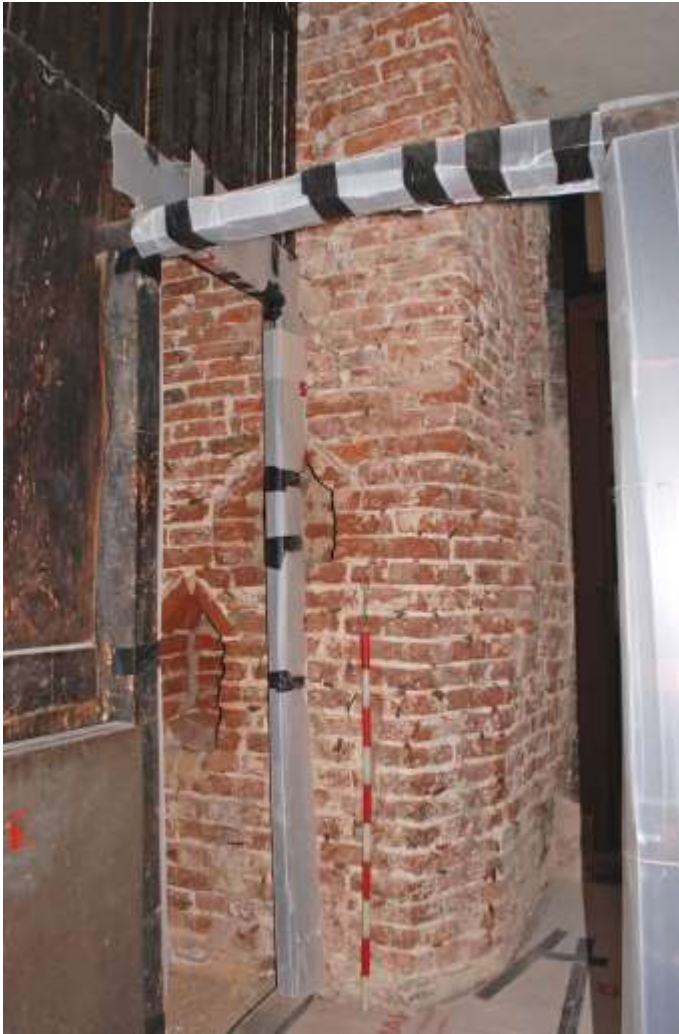
Fig.22: *The western end of the stack viewed from the top of the cellar steps, and showing the two previously open niches*

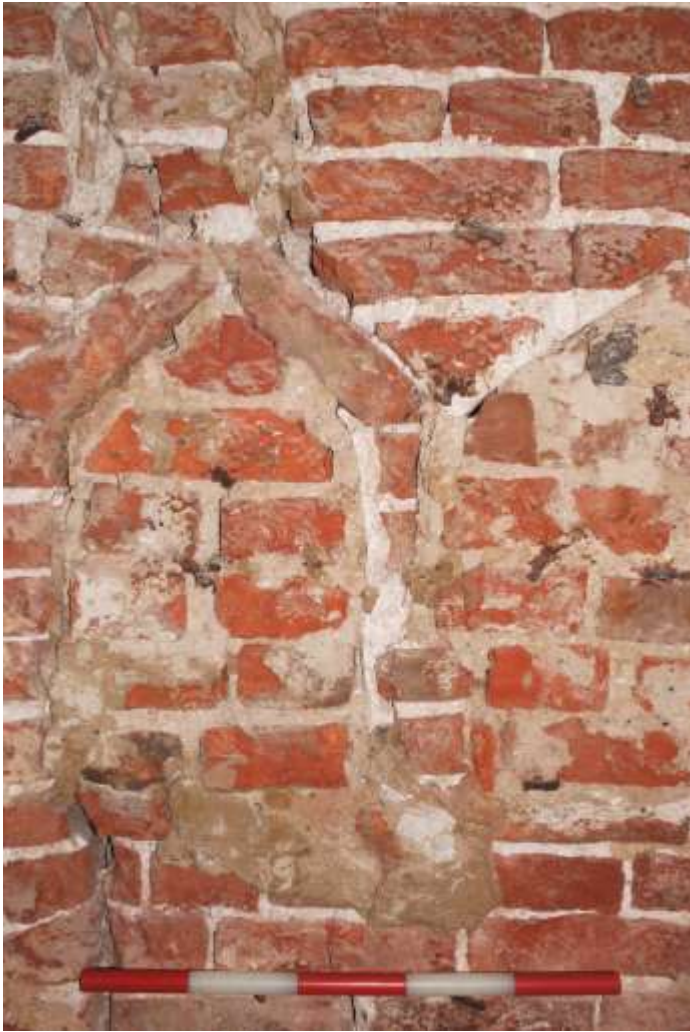
A number of interpretations for the niches have been previously been offered, including oven openings, aumbries and lamp receptacles. There is no compelling evidence for any of these, although the new findings do at least suggest that the interior faces may originally have been rendered (*cf.* Fig.25). Possibly the niches were used for storing certain foodstuffs/ additives in reliably dry conditions: for example spices, or as salt boxes (Nail *nd.*) – which would also fit with the suggested original use as noted above.

Fig.25: *Detail of first & second blocked niches from the east. The surviving light-coloured plaster on the right hand side of the first suggests that the interiors may originally have been rendered (0.5m scale)*

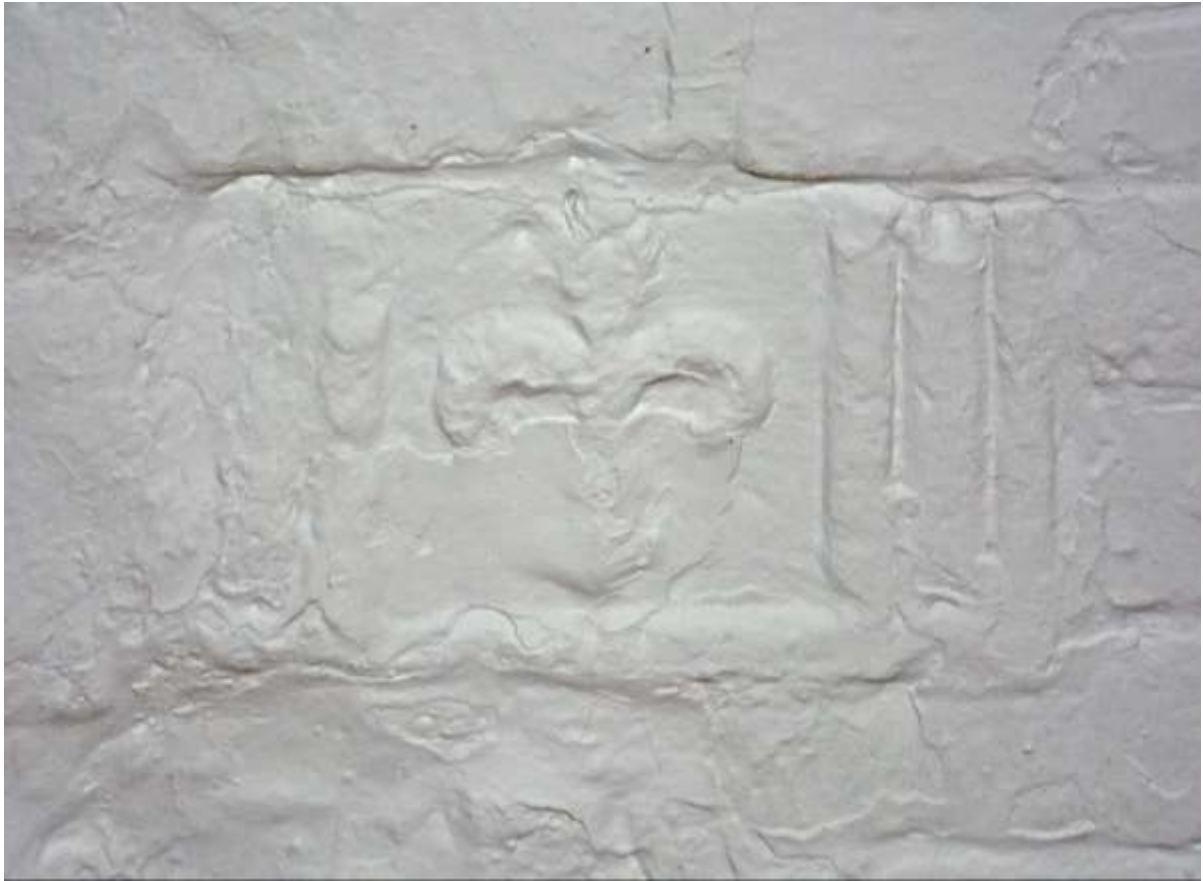
The two blocks are essentially the same, each measuring approximately 160mm by 300mm, although there appear to be slight variations that indicate that they are of stone (as previously suggested) rather than ceramic (& therefore formed in a mould). It is also likely that they are reused – the presence of raised bars either side of and below the central design but nothing above hinting at an originally more extensive design. It is tempting to associate this with the demise of Nonsuch Palace, although being early 1680s somewhat later than the suggested construction date here.

Fig.32: *Decorative block with fleur-de-lys design built into the external southern wall. Located at 'A' on Fig.31*

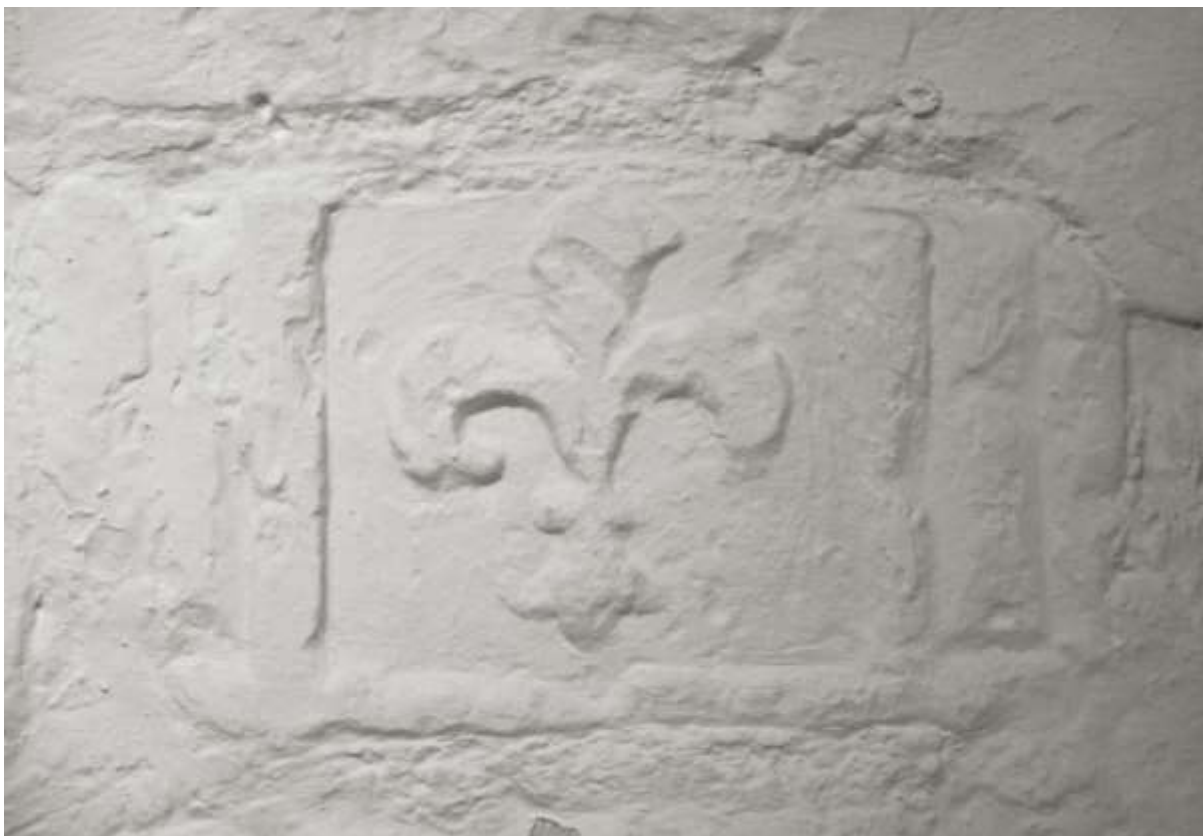
Fig.33: *The second example as above: located at 'B' on Fig.31*

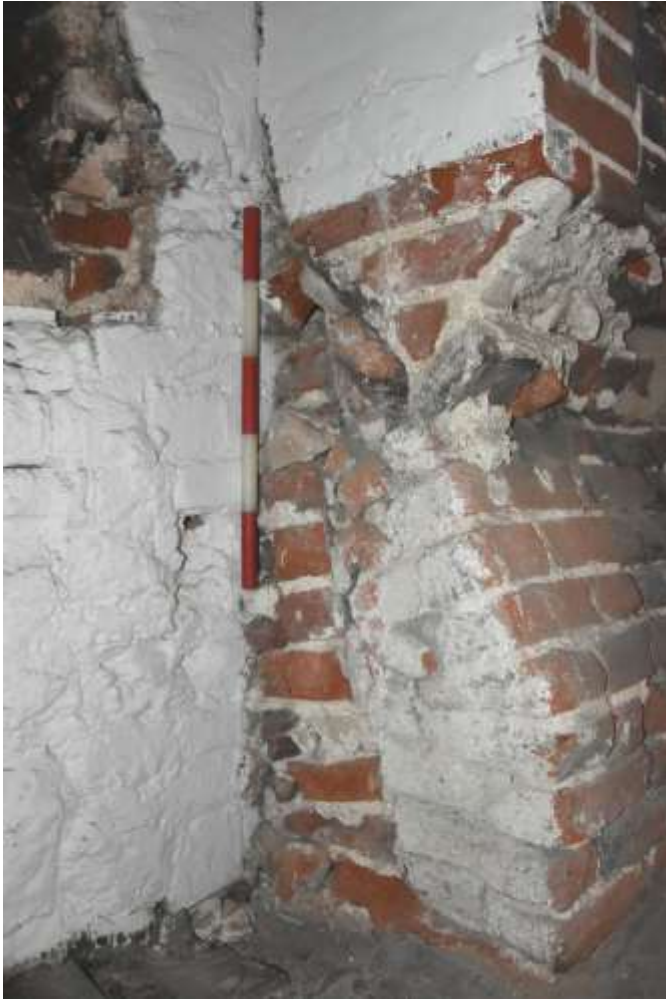
Fig.35: *The eastern side of the central brick pier within the fireplace. This appears to incorporate several phases of construction, all subsequent to the original structure (0.5m scale)*

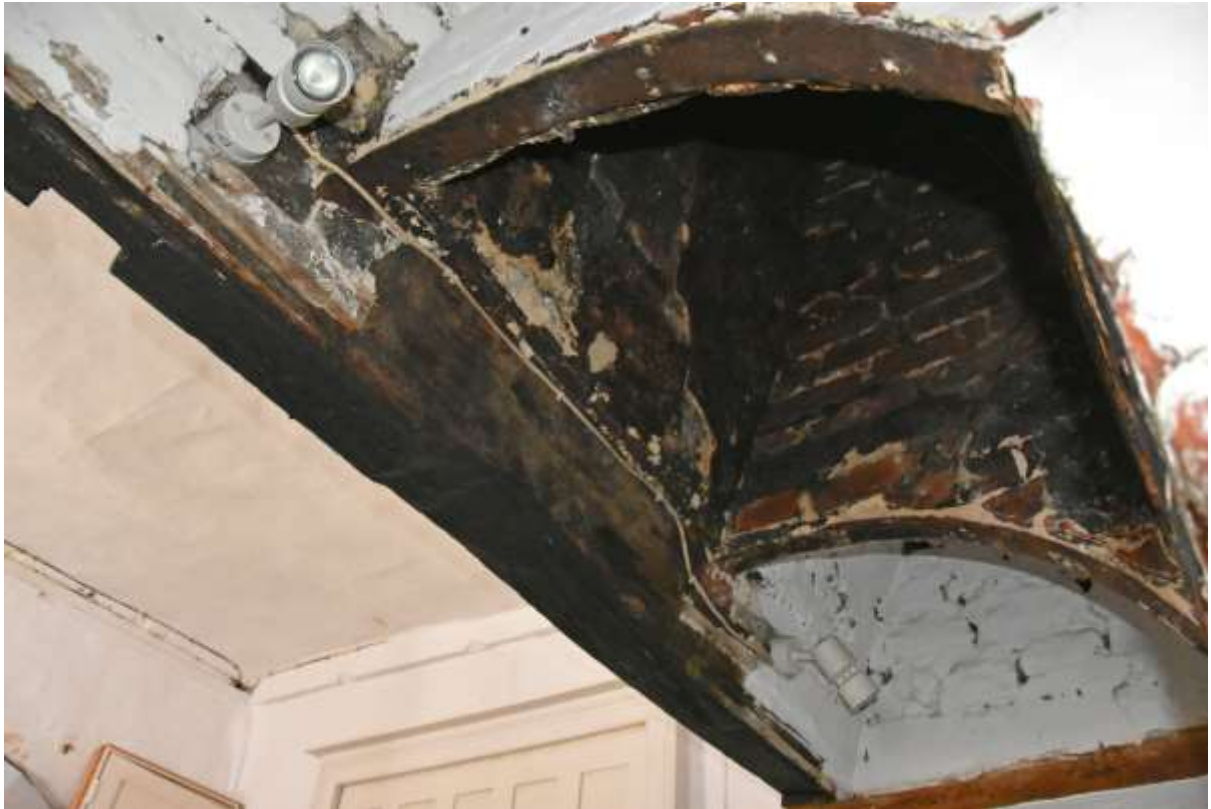
Fig.37: The central flue, with brickwork supported on iron bands that span the area from the central pier to the lintel. The bands themselves are punctuated by a series of bolt or nail holes, and presumably reused

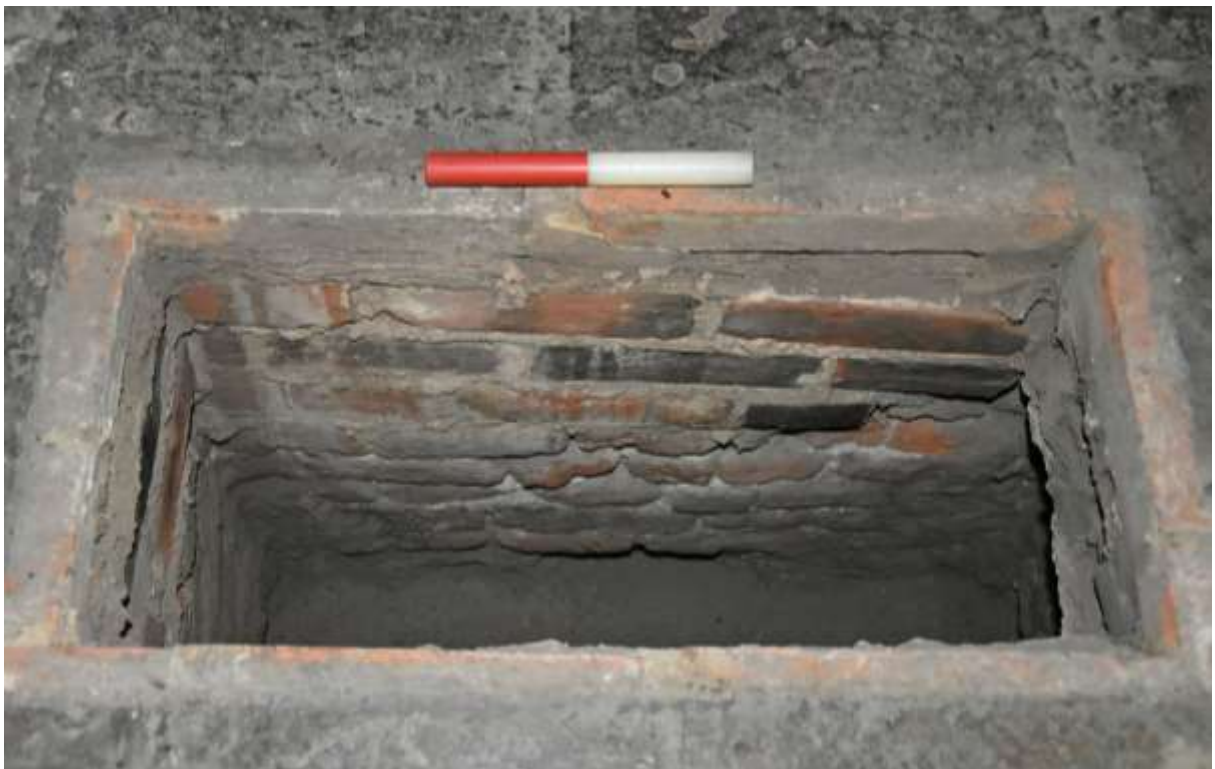
- A rectangular brick-lined pit near the front of the hearth, presumably to accommodate a lift-out ash box. The feature measures 170mm by 590mm in plan at the top and is *c* 670mm deep, coming down onto apparently natural sand. It also has two phases of construction – apparently original and a modern rebuild: the latter is stepped in at one end and may be part of the 1970s refurbishment.

Fig.38: The brick-lined ash pit near the front of the hearth (0.2m scale). The upper 2-3 courses of brick & cement are quite modern, but below this are 5-6 courses of older mortared brick that are also stepped back some 130mm further to the west (right of photo)

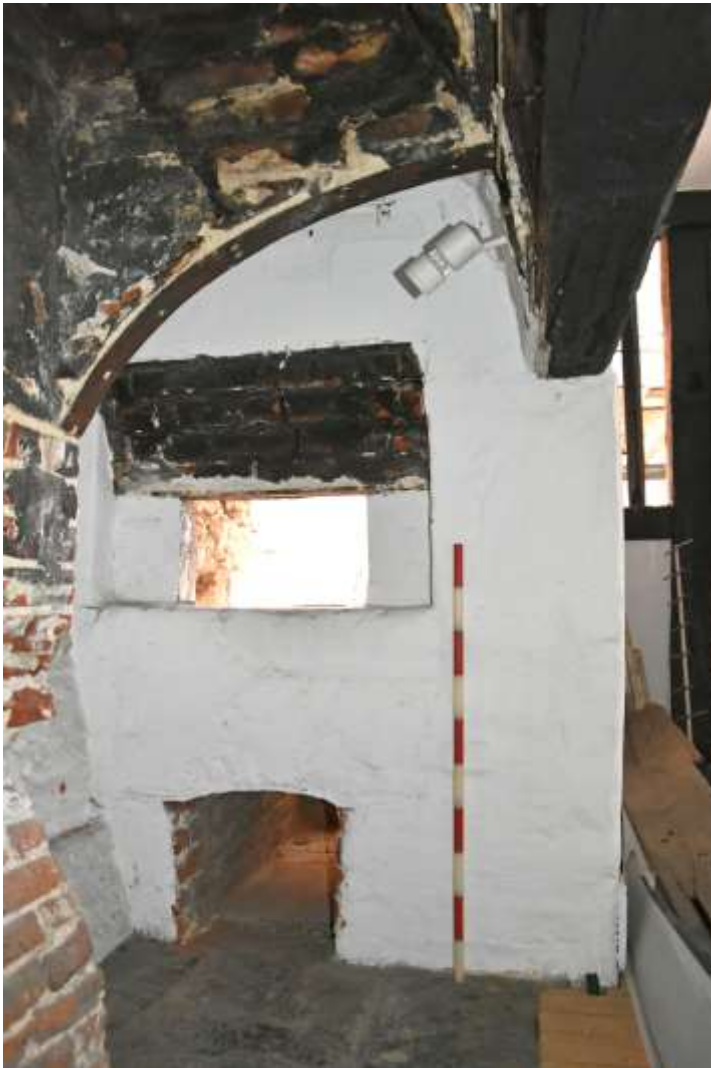
- Two openings in the flank wall to the right of the fireplace, assumed to be for a former bread oven.

Fig.39: *View of the west side of the fireplace showing openings for a presumed bread oven – the upper to the oven itself, and the lower probably for fuel such as fast-burning timber (1m scale)*

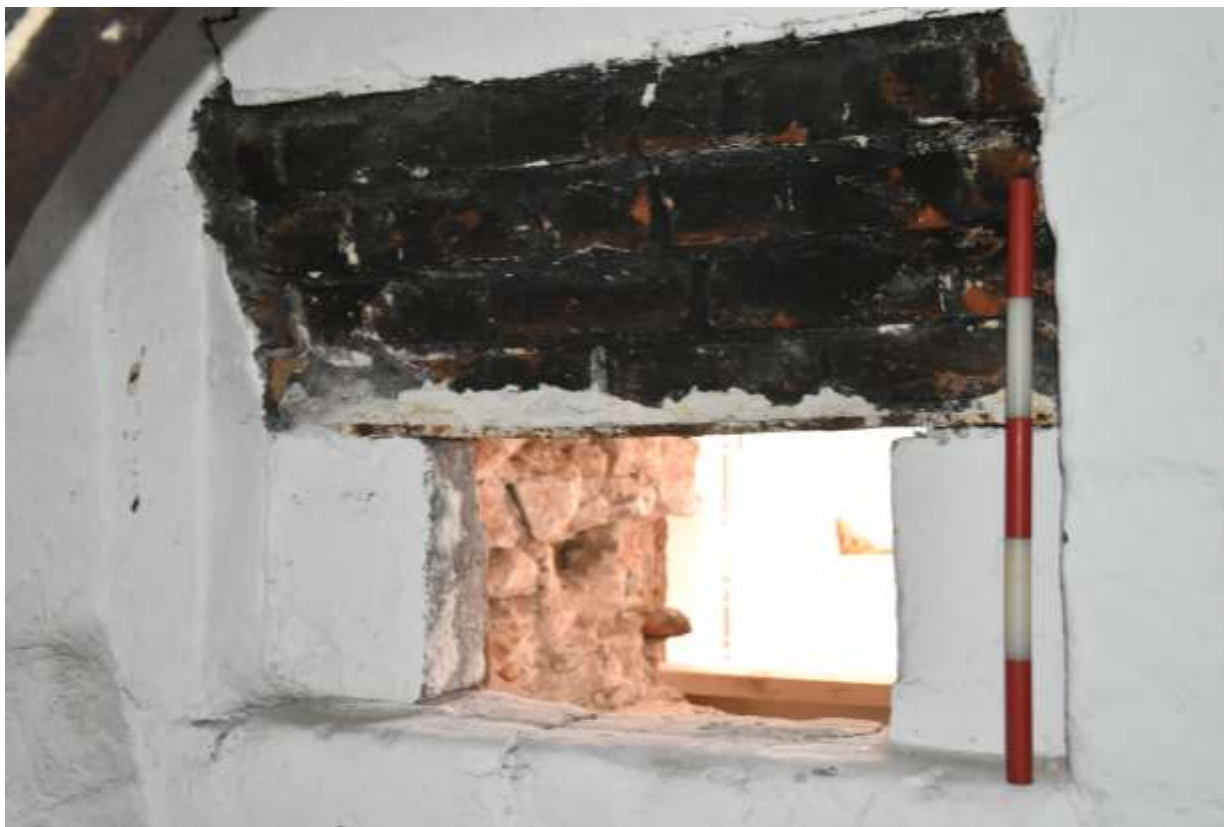
Fig.41: Detail of the mouth of the oven, with stone lining and overlying brickwork supported on an iron lintel (0.5m scale)

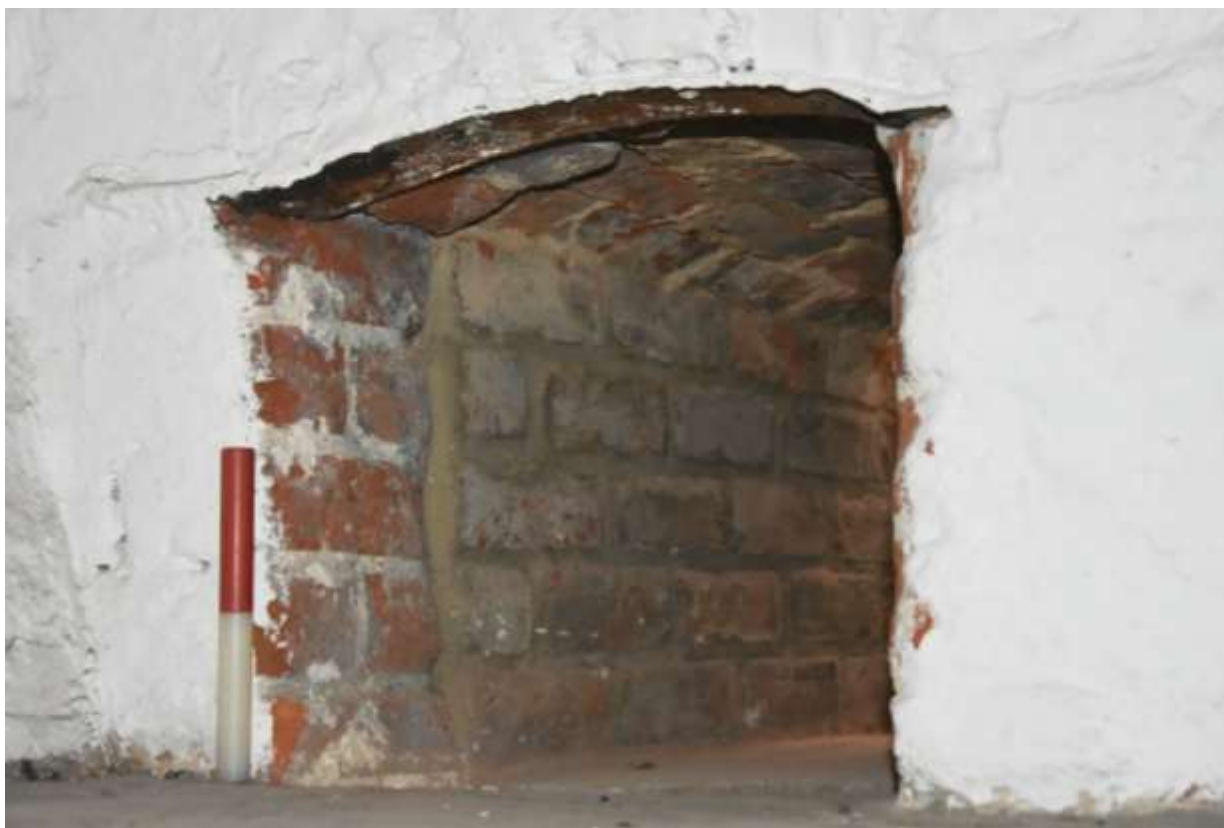
Fig.42: Opening to the lower (storage?) chamber, here with a slightly concave iron lintel over. Note also the contrast in brickwork, with a modern reconstruction to the rear (0.2m scale)

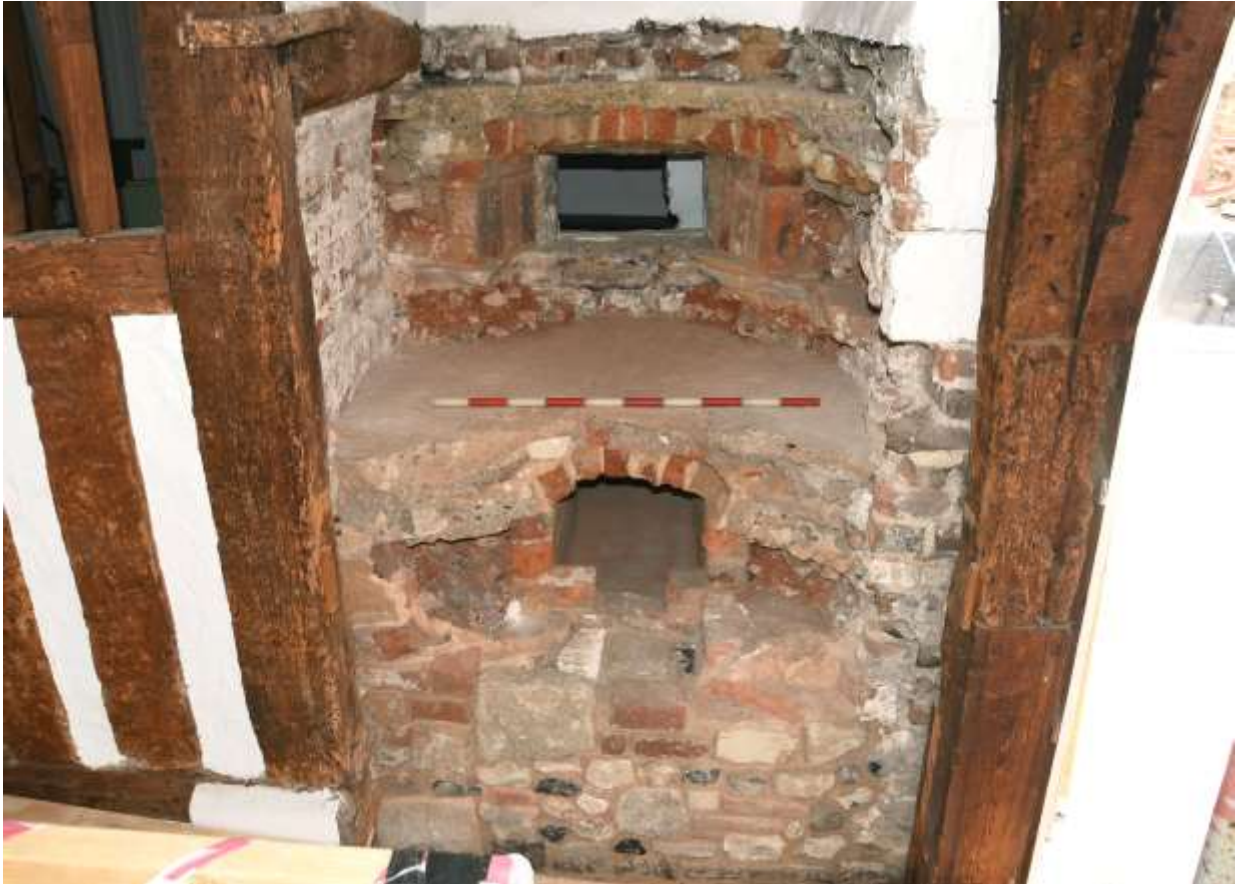
Fig.43: A view of the extant structure of the oven from the adjacent Room G-04 (1.0m scale)

The surviving oven structure as seen in the above picture is however almost entirely a modern reconstruction, tied in with the surviving evidence in the western wall of the fireplace and presumably dating to the refurbishment of the mid-1970s. The subsequent history is unclear, but it appears that what was reconstructed (probably essentially correctly) as a beehive oven has since been partially demolished. Almost all of the stone floor, walls and dome of the oven have disappeared, at the rear breaking through the concrete sub-base into the lower chamber.

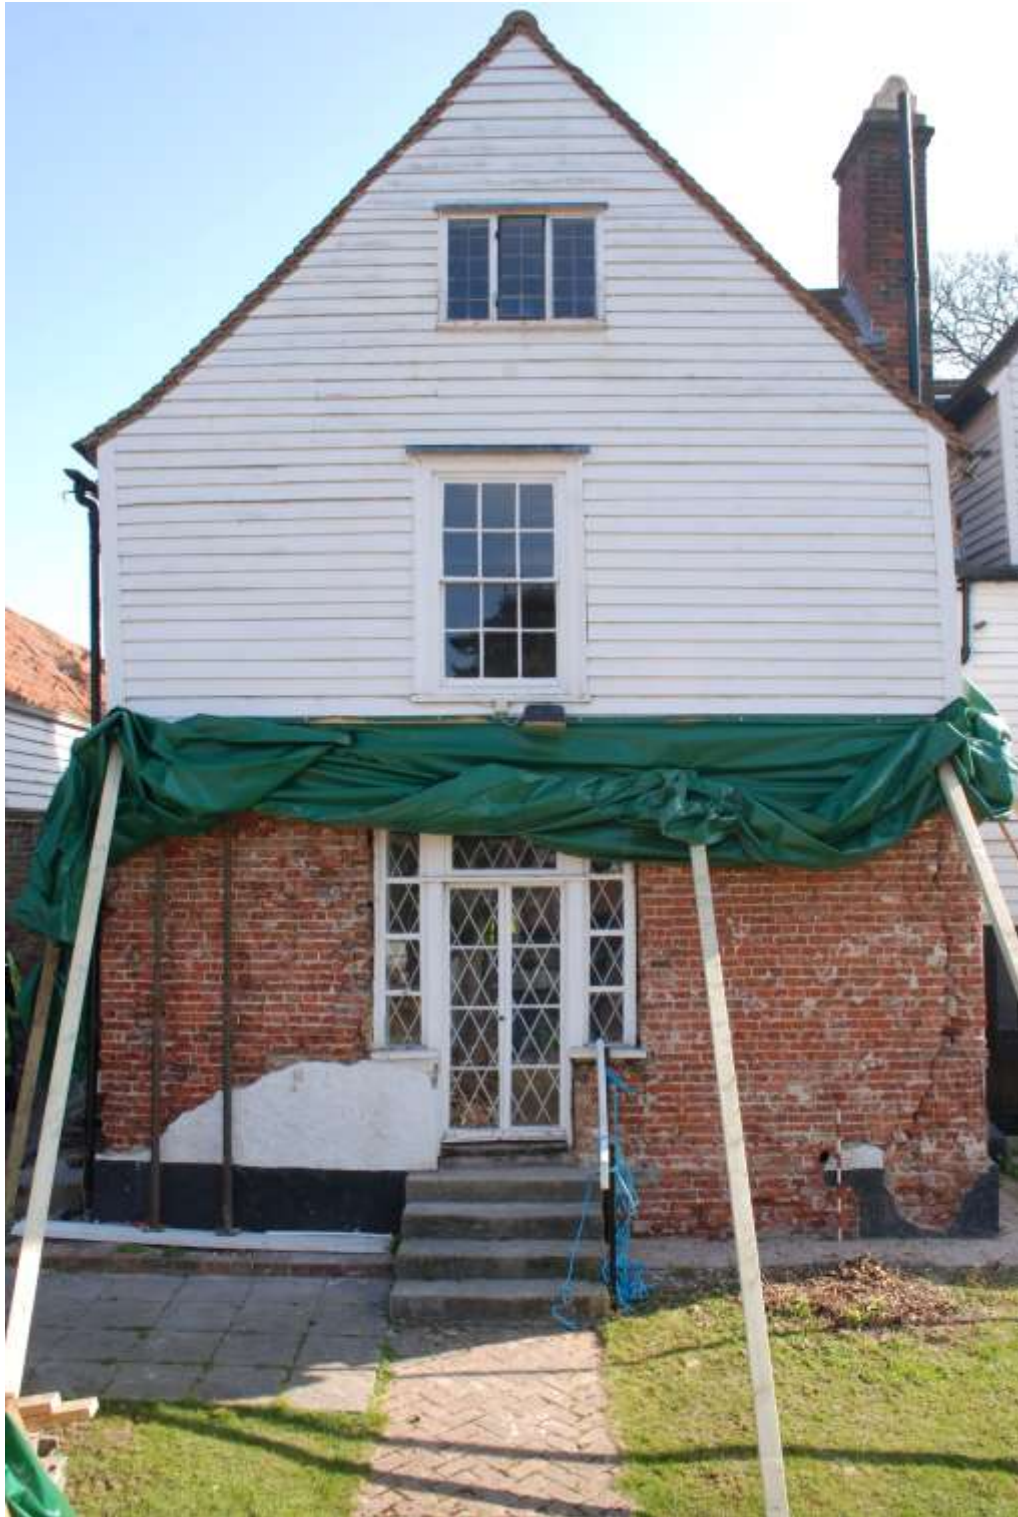
Fig.48: The western face of the extension that includes Room G-12, after stripping of most of the ground floor external render

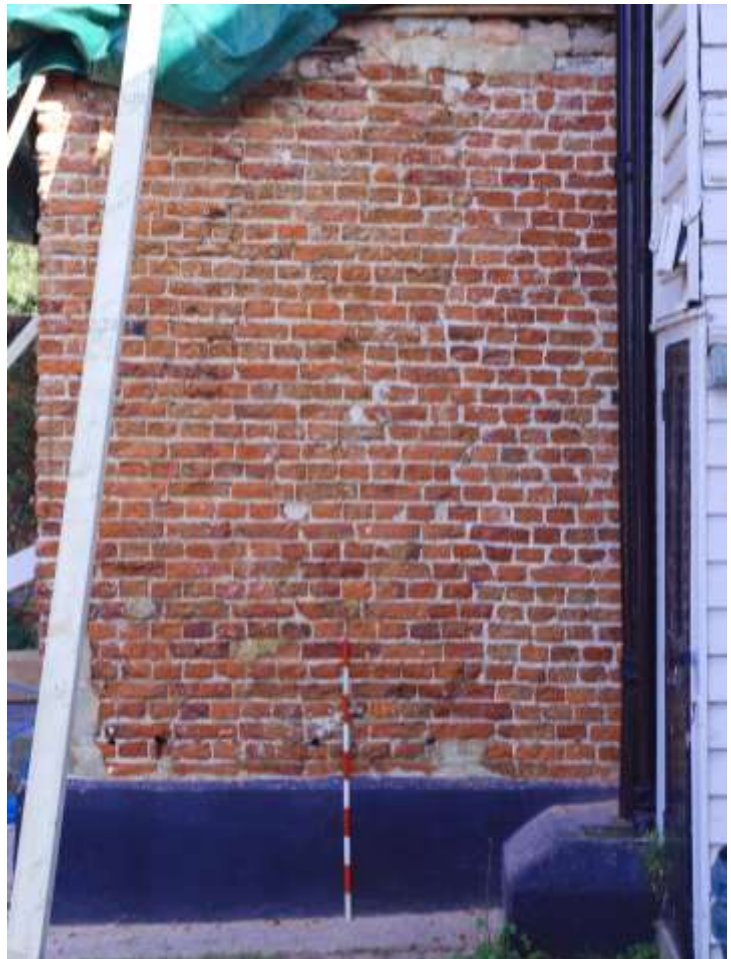
The one obvious exception to this dating of the walls was found on the southern side, where stripping revealed a roughly vertical change in the brickwork, between the main wall and that just to the west of the projecting chimney (Figs.56-58). To the west the wall was built in a more or less regular English bond, the bricks having an orange-red hue set in a buff-coloured mortar. To the east of this line the exposed brickwork was almost entirely composed of headers, whilst the bricks themselves had a slightly brighter red colour in an off-white mortar. Close inspection also indicates that – although there are part-bricks on both sides of the dividing line – it is those to the west (& particularly in the stretcher courses) that have been broken *in situ*. That is to say, it appears that the western part of the wall is earlier, and that it has been cut back (or partially collapsed) before construction of the brickwork to the east.

This break in the brickwork is clearly related to the construction (or rebuild?) of the chimneystack within Room G-12, which also appears to have taken place in the 18th century. It is recorded elsewhere that the chimney had been relocated from a position on the western wall (Nail nd.), but no evidence was found for this during the present works (*cf.* Section 9.5.2). It is possible that the chimney was simply rebuilt in its present location.

Fig.57: The southern wall of Room G-12, showing a change in brick construction to the right of the 1m scale that is clearly related to the adjacent chimney (1m scale)

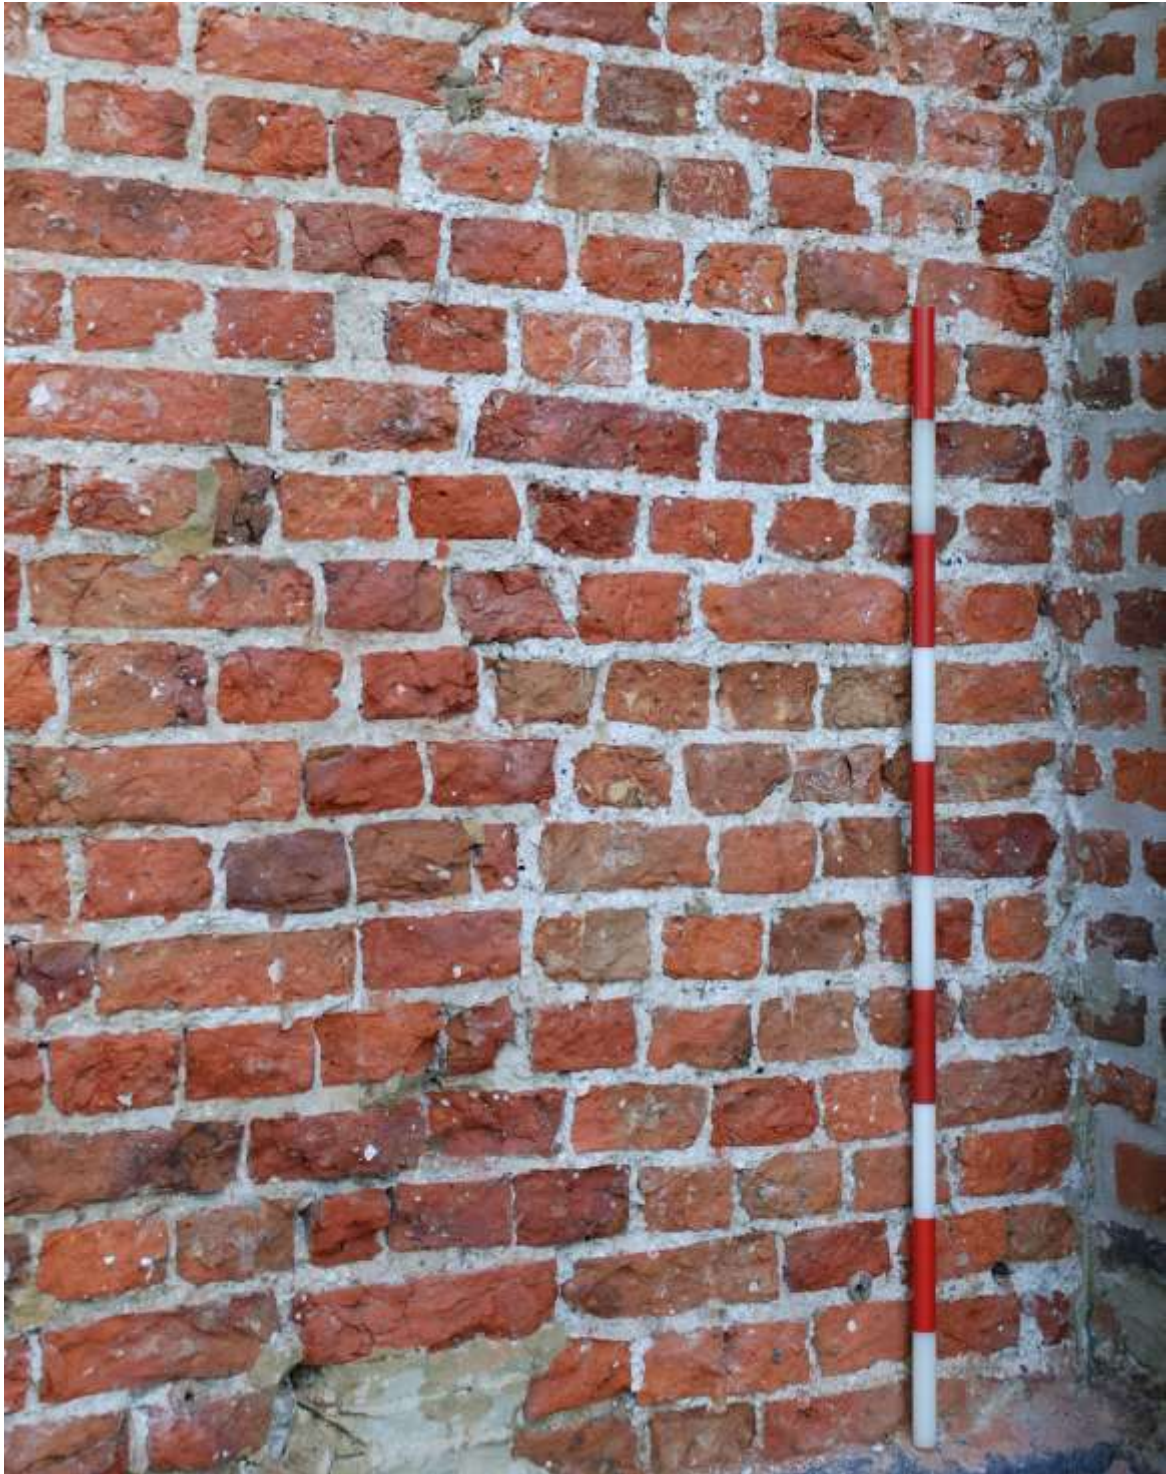
Fig.58: Close-up view of brickwork in the lower left-hand corner of Fig.57, showing the change in brickwork associated with the chimney that is just visible on the right-hand side of the frame (1m scale)

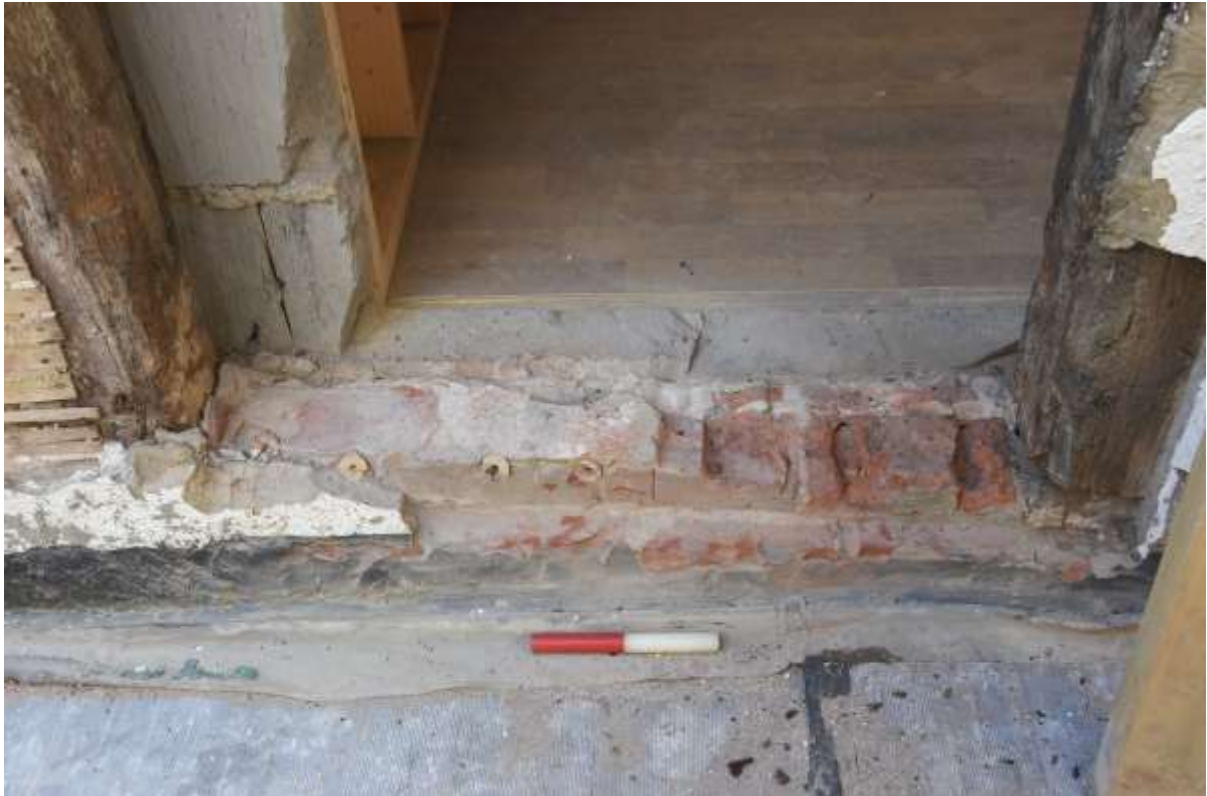
Fig.70: *Surviving brickwork of the door threshold, with a chamfered lower course but the upper course almost entirely lost (0.2m scale)*

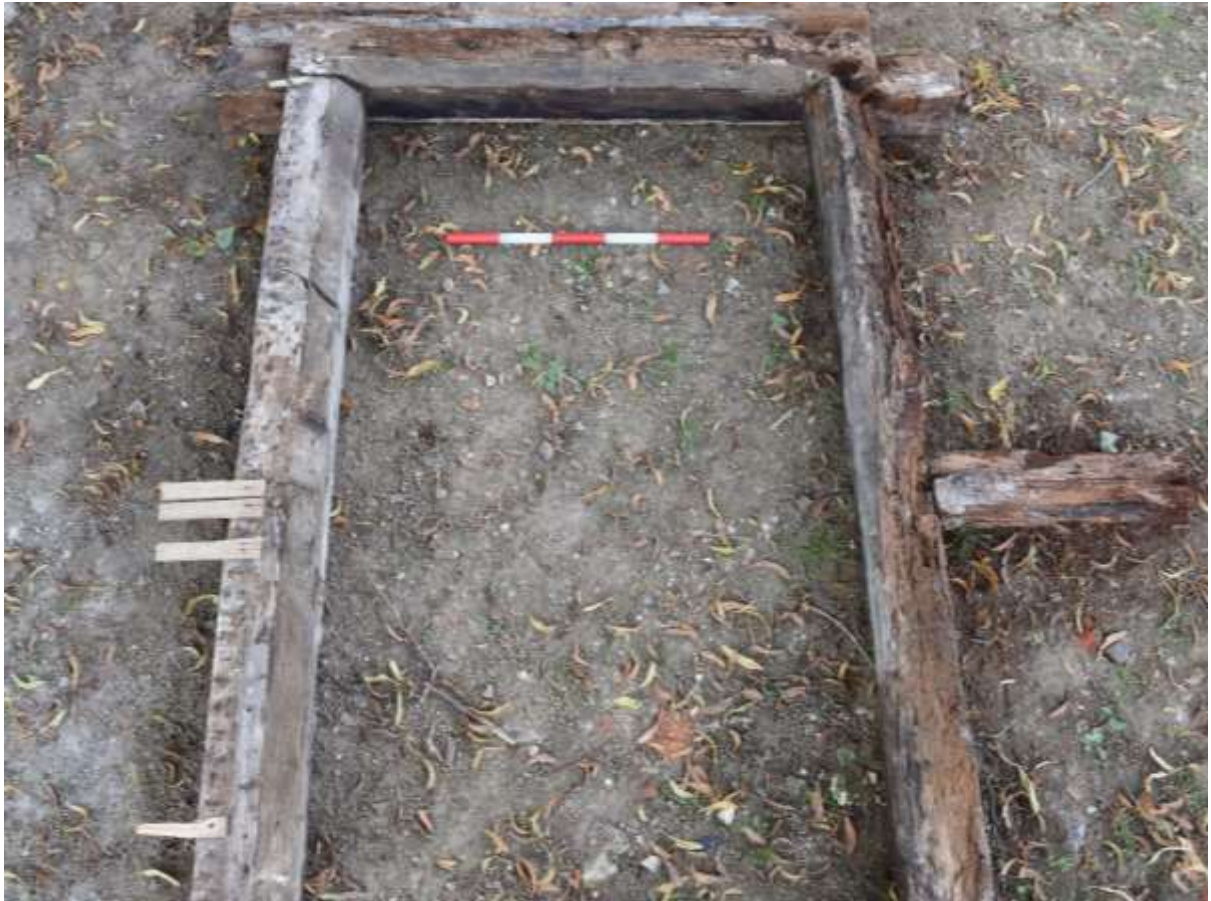
Together the above points indicate that the doorframe was reused – its design was clearly intended for insertion within a continuous brick wall, and the fact that the eastern ‘spur’ has been sawn off emphasises the point that it was probably not original to this location.

Fig.72: The oak doorframe from the north wall, exterior face. Note the 'spur' located midway up the right hand and previously set into adjacent brickwork (0.5m scale)

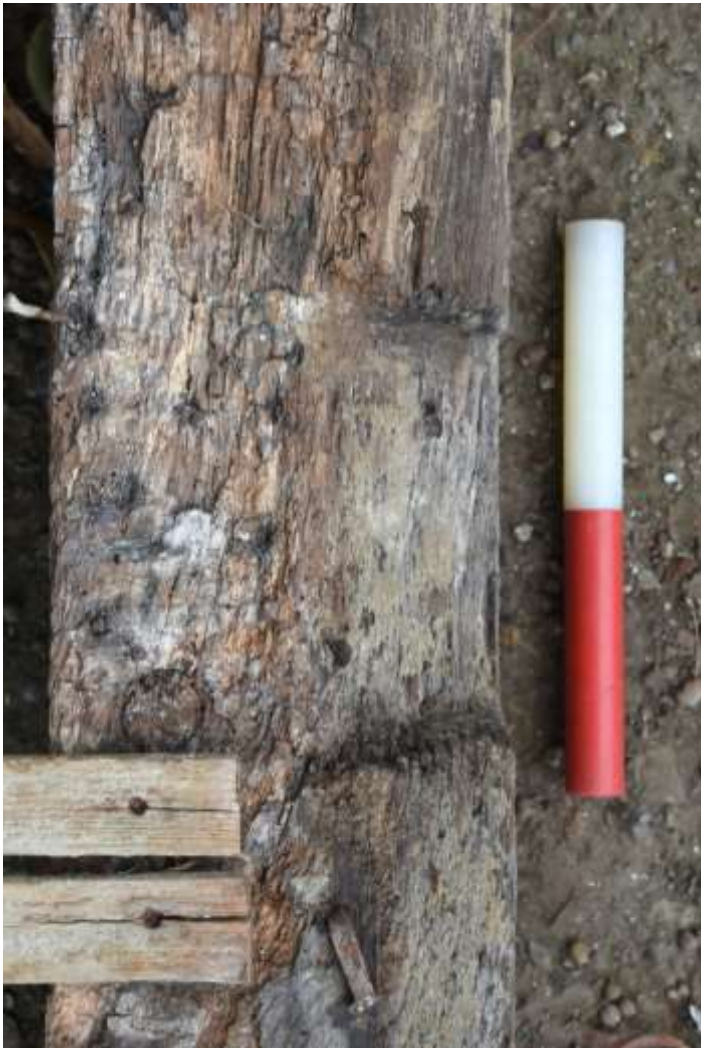
Fig.76: *Detail of the shallow slot cut into the chamfered face of the eastern jamb, which may relate to some kind of latch (0.2m scale)*

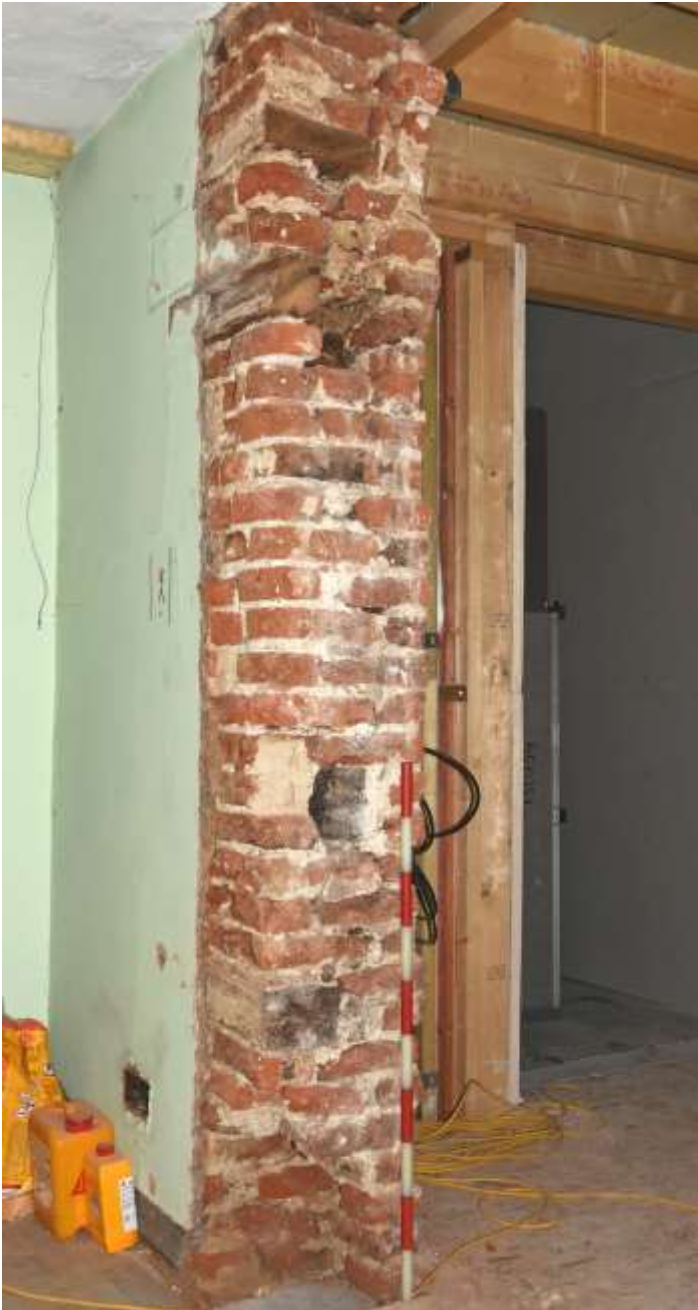
Fig.80: *The brick wall to the west after removal of the doorframe. There are two holes where timbers have been removed, at the upper level the end of the doorhead and below this the projecting 'spur' from the western jamb (by the top of the 1m scale)*

The photo also shows two bond timbers built into the wall, set three courses below the top & seven above the base – a traditional feature to tie or reinforce the structure (respectively 220mm x approx. 65mm and 160mm by 110mm)

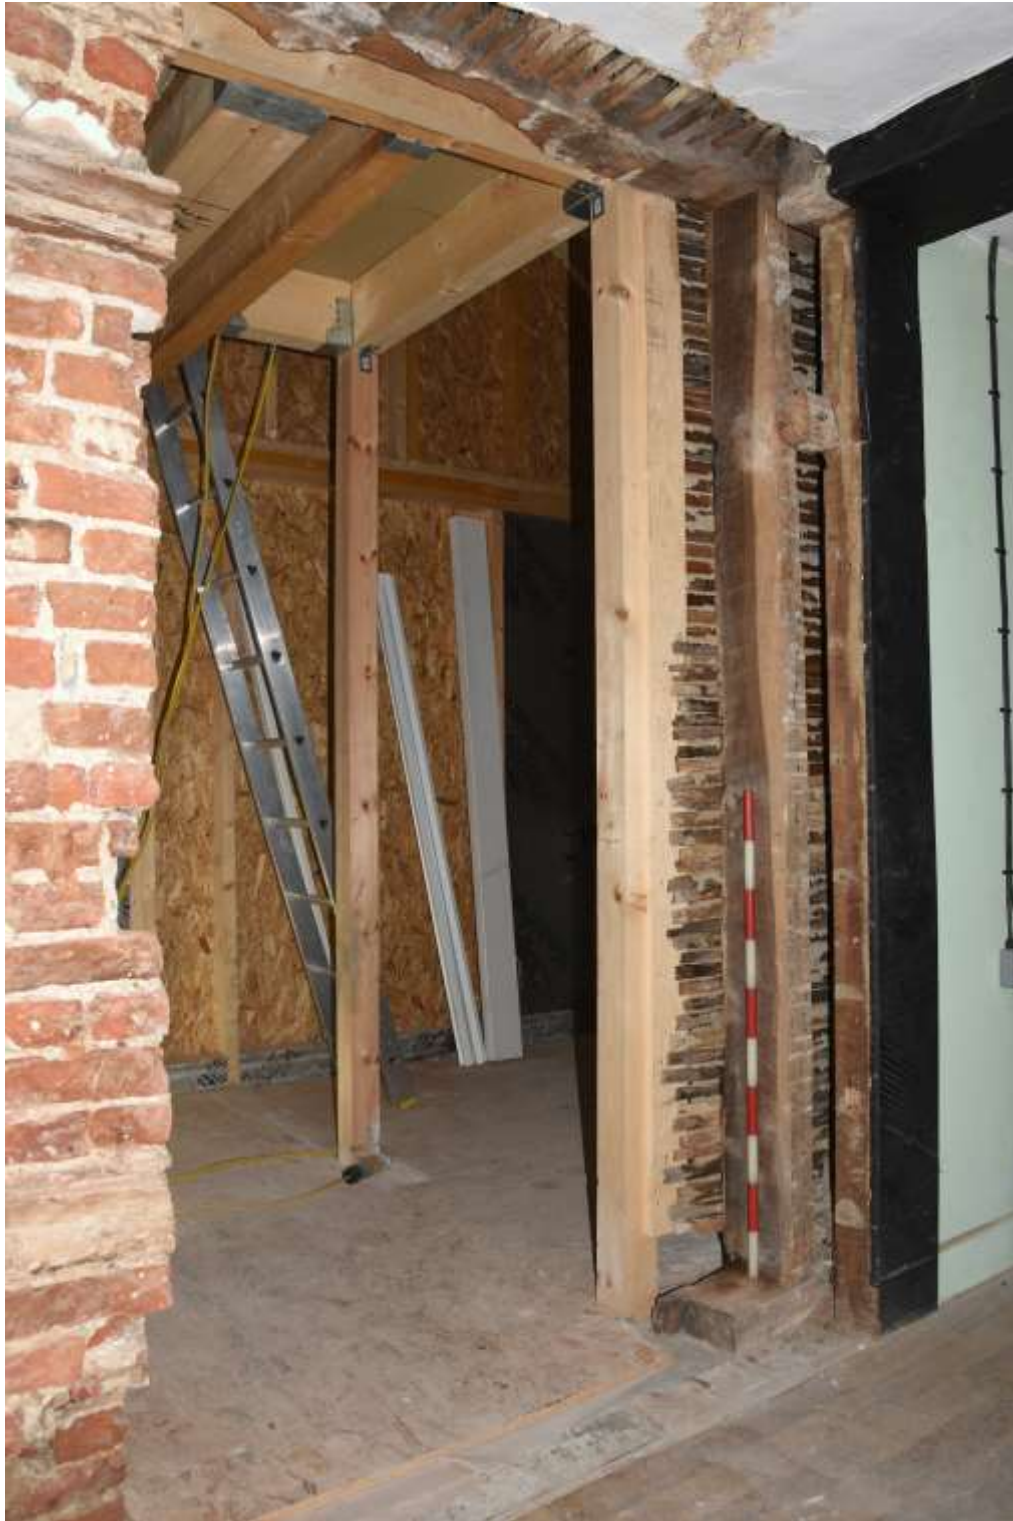
Fig.82: A further view of the area after the removal of the doorframe, showing timber framing to the east

As described previously the brick wall was carried over the doorframe, but did not go any further than the adjacent stud – seen in the above photo immediately behind the 1.0m scale. This area was only partially exposed (and internally not at all beyond

- The stud noted above and seen in Fig.82 had evidence for lath and plastering down the full length of its internal face – including fragments of *in situ* lath near the top. The same thing was also observed towards the top of the next stud, some 315mm further to the east.
