WHITEHALL, 1 MALDEN ROAD, CHEAM

LONDON BOROUGH OF SUTTON, SM3 8QD

**AN ARCHAEOLOGICAL WATCHING BRIEF AND
HISTORIC BUILDING RECORDING**

September 2018

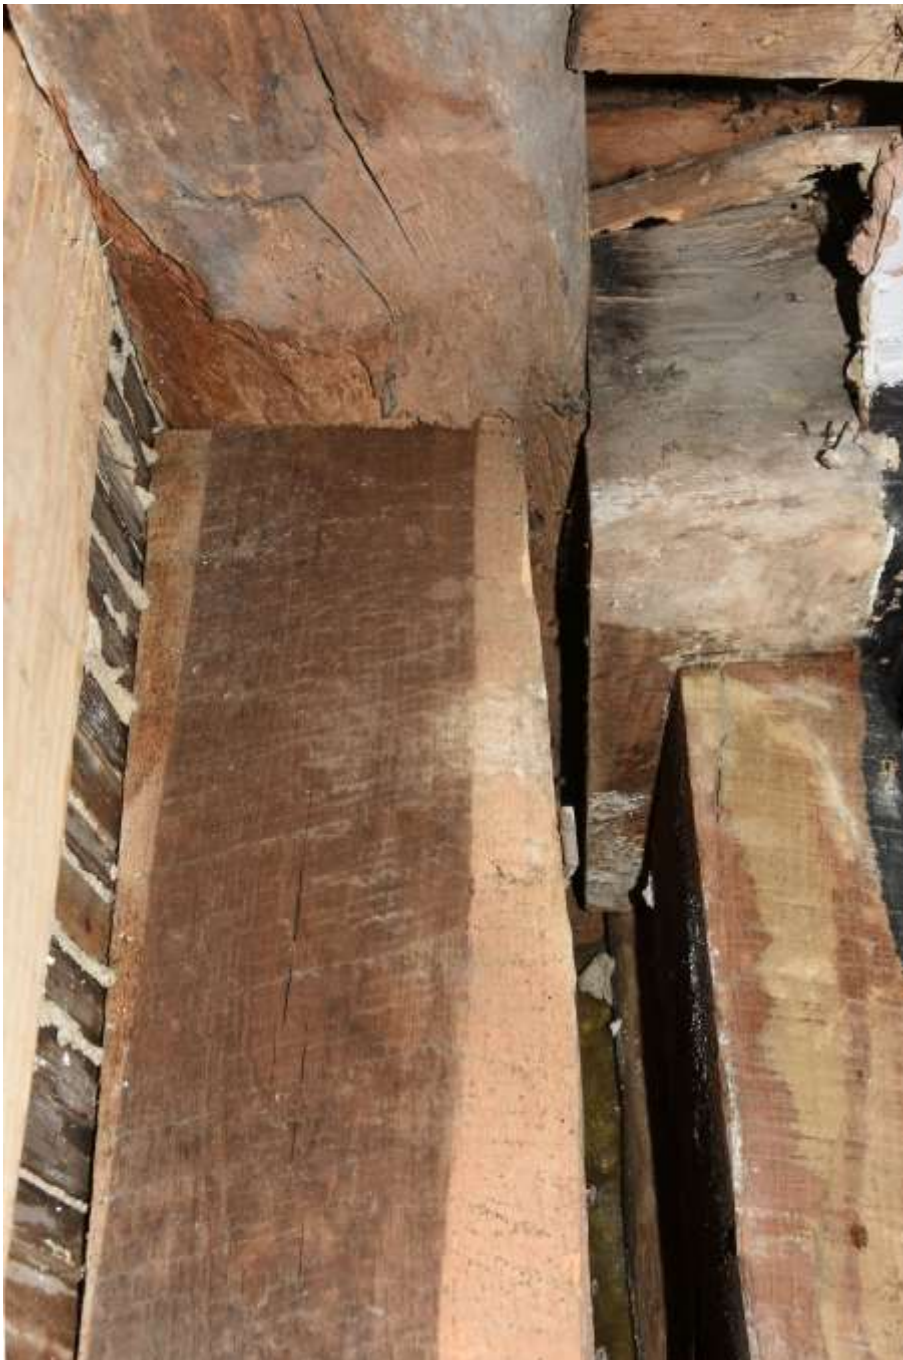
Fig.83: *Detail of timbers at the top right hand corner of Fig.82. Two separate elements are represented: on the left an original stud and overlying beam, and to the right the northern end of the secondary ceiling beam and supporting post*

- Some 50-60mm in front of the stud and presumed original wall face was a further post, with a cross-section *c* 105mm north-south by 205mm east west (shown in Fig. 82 with black-painted front & adjoining the modern green-painted wall to the east). This supports the very substantial (*c* 263mm high x 340mm wide) beam that spans the north-south centre line of Room G-12, and forms part of a wall face *c* 140mm south of the original.

These latter beams must represent an addition to the room, presumably introduced to give extra support to the overlying ceiling and first floor level. This may also be associated with the structural failure and repairs seen on the first floor, in particular the replacement of the girding beam at the base of the western wall (*cf.* Section 9.5.2).

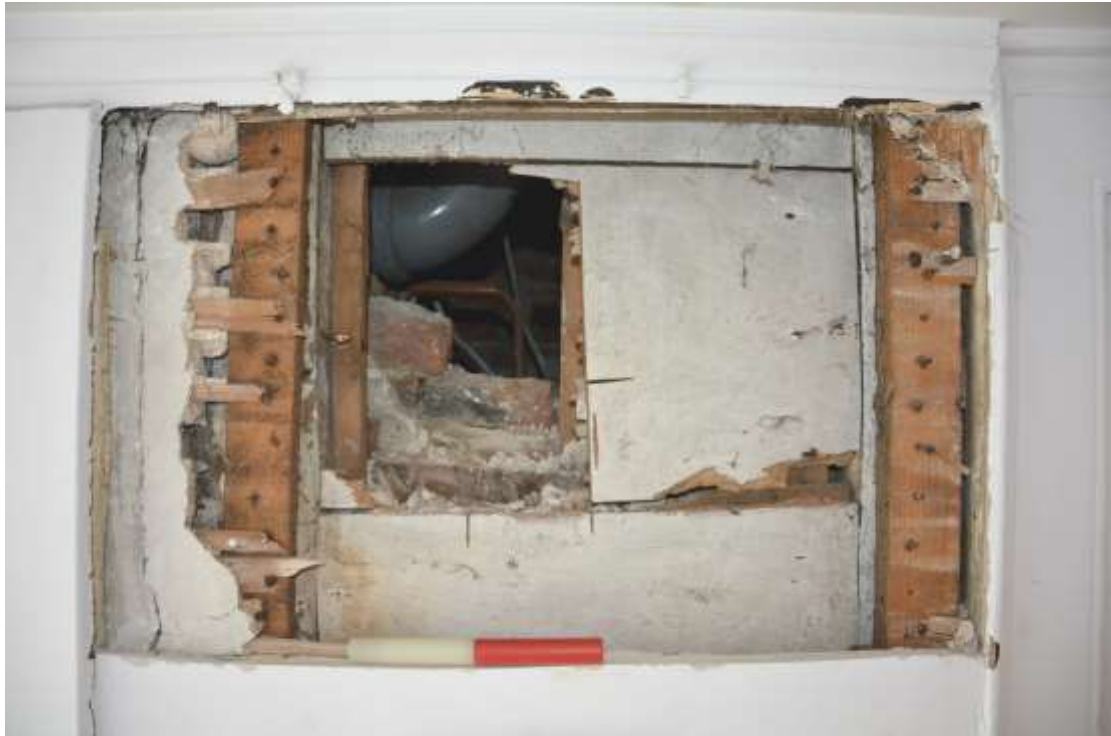
In 2016 a small test hole (c 700mm x 450mm) was cut into the upper part of the wall (Figs.85-86). This revealed several phases of wall covering – the modern plasterboard overlying lath & plaster, and this in turn over several pieces of painted board which appeared to have been fitted between two pre-existing studs c 430mm apart.

Behind this was further lath and plaster and then brickwork, then opening into a void between brickwork at the rear of area G-14 and the western wall of G-11 (possibly timber panelling). The space was not further opened up or investigated, although it is at least established that it is not the solid wall nearly 0.5m thick depicted on Fig.84.

Fig.85: *Exploratory hole cut in the northern wall of the corridor G-09 (0.2m scale)*

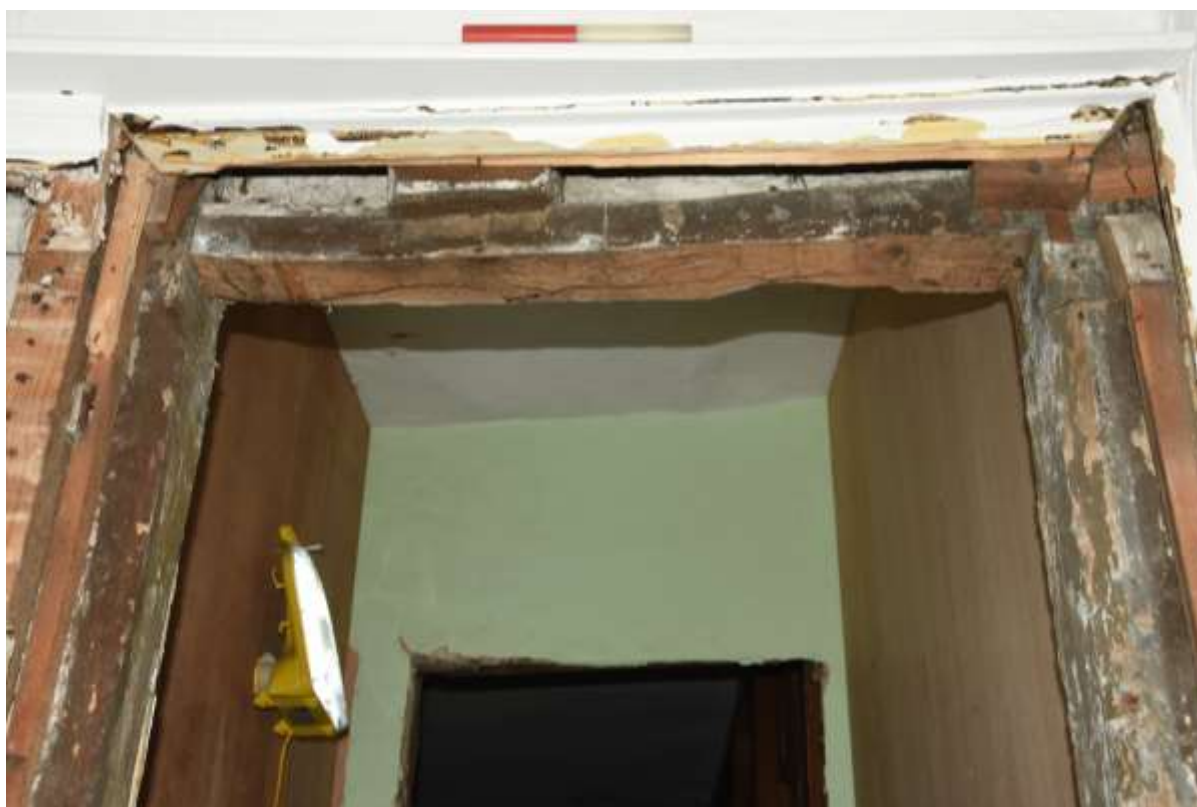
Both frames had been cut back to increase the size of the opening – in the case of the southern doorway only the doorhead, but in the case of the northern doorframe both the head and the jambs. Approximately 40mm to 70mm was removed in each area, leaving a crudely worked and unpainted surface.

Fig.87: *The upper part of the southern doorframe, viewed from the main corridor and showing the bare and roughly finished lower surface of the doorhead (0.2m scale)*

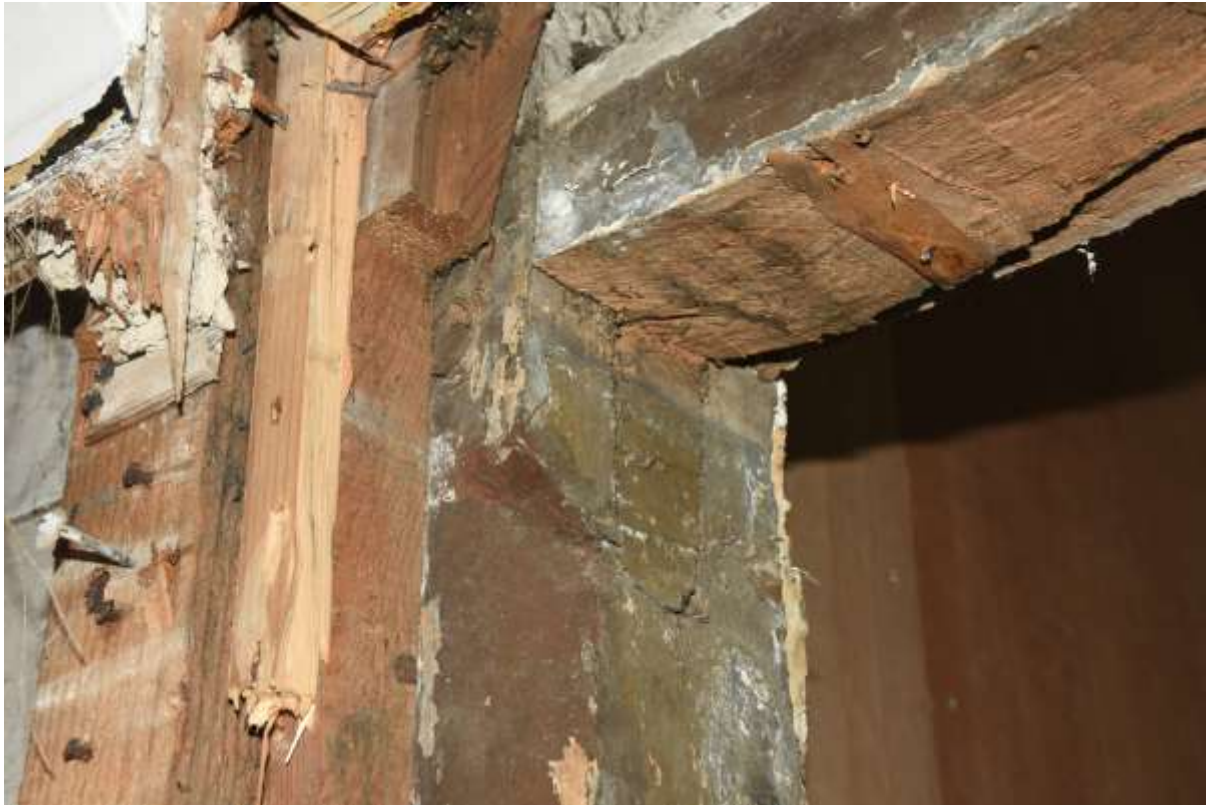
Fig.88: Detail of the western corner of the southern doorframe. About half the thickness of the doorhead has been removed, as indicated by the 90° turn on the chamfered jamb and by the truncated tenon just behind this

Given that the reduced surfaces were left unfinished it is assumed that the purpose was not really to enlarge the doorways, but rather to facilitate a remodelling of the frame without decreasing the overall size – perhaps to replace what seems to have been a fairly plain oak surface with more decorative moulded timber.

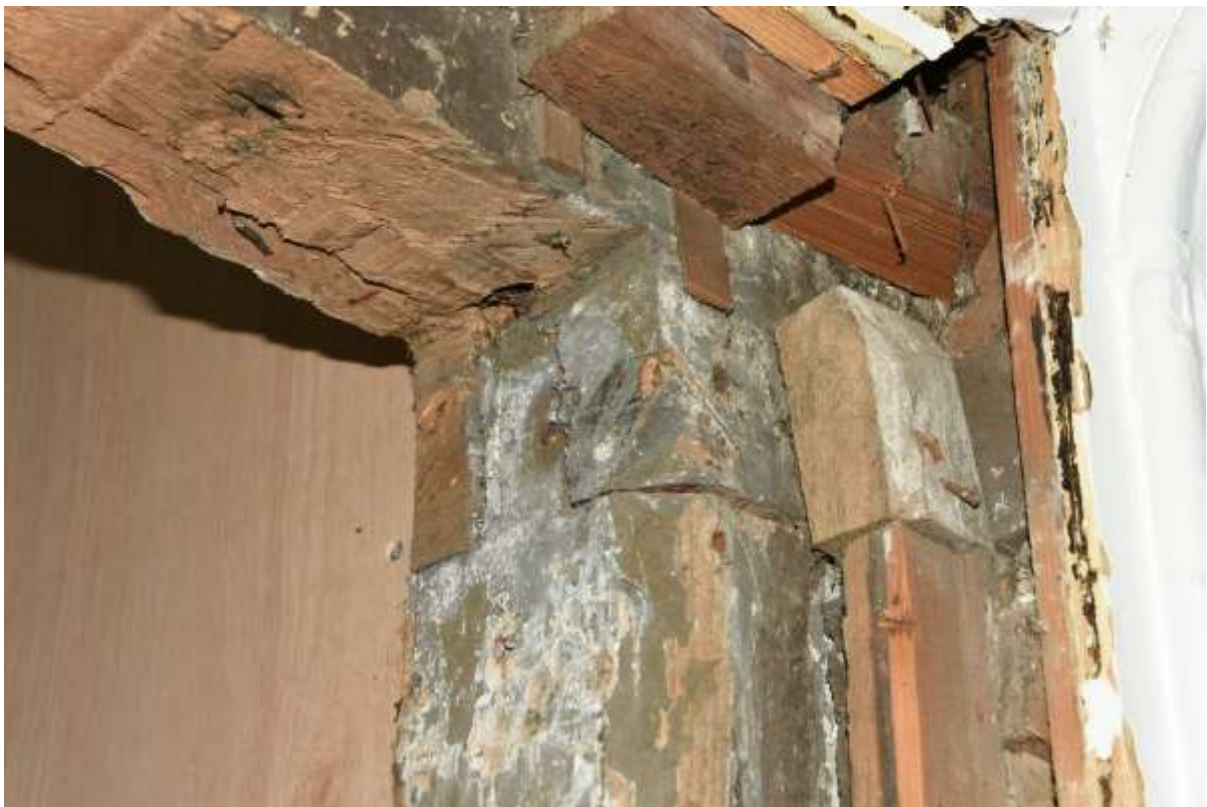
Fig.89: The top eastern corner of the southern doorframe. A similar view to the above, except that here the jamb is tenoned into the doorhead

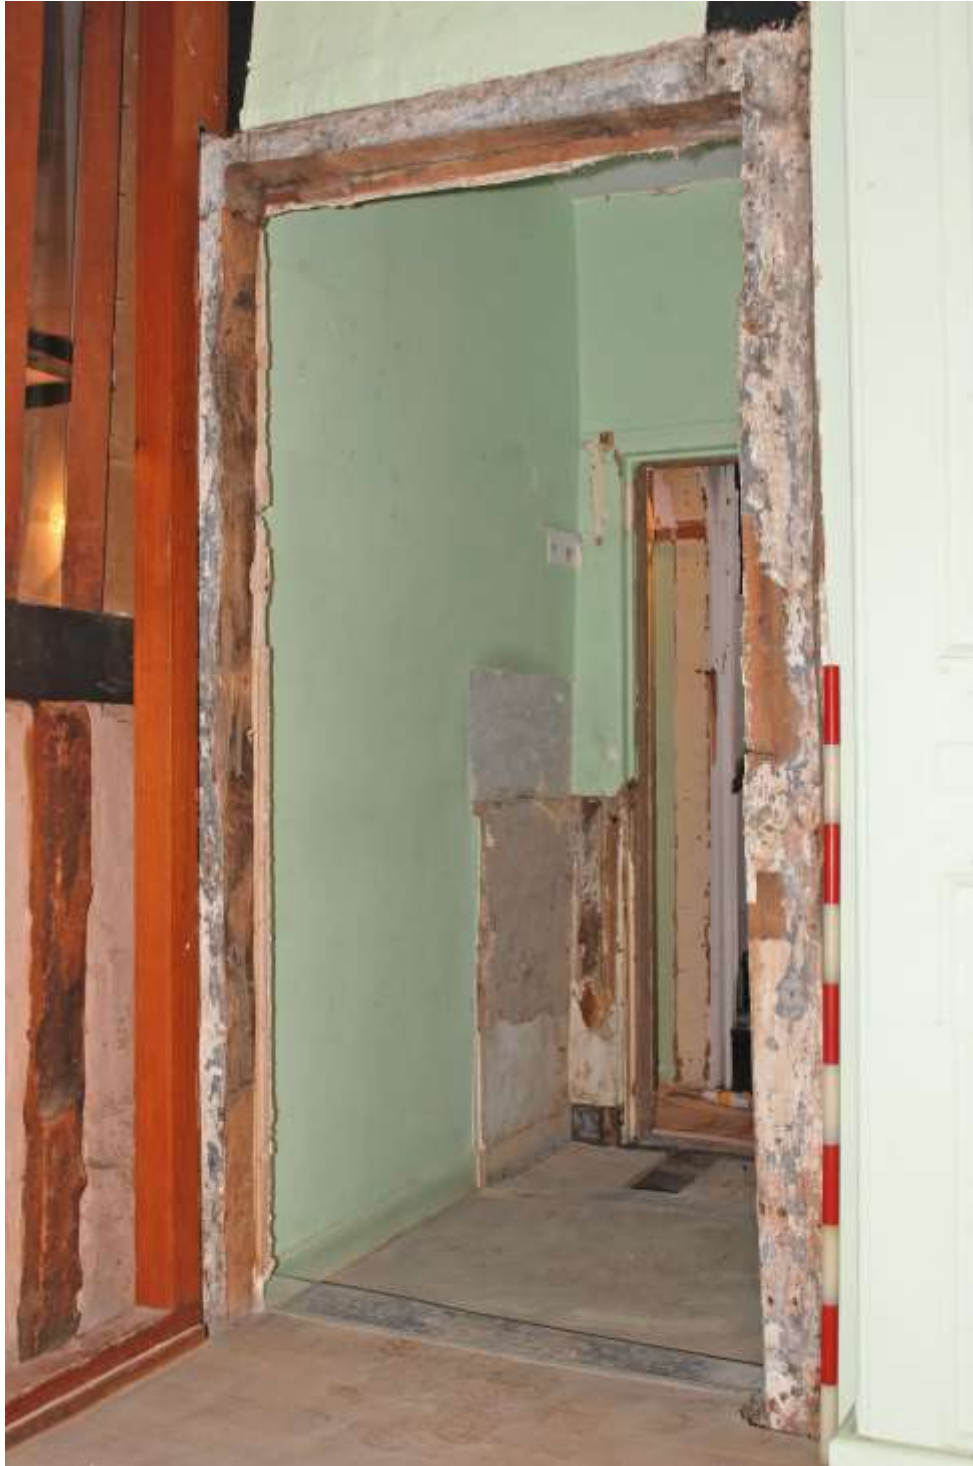
Fig.90: *The exposed northern doorframe viewed from Room G-12 (1.0m scale)*

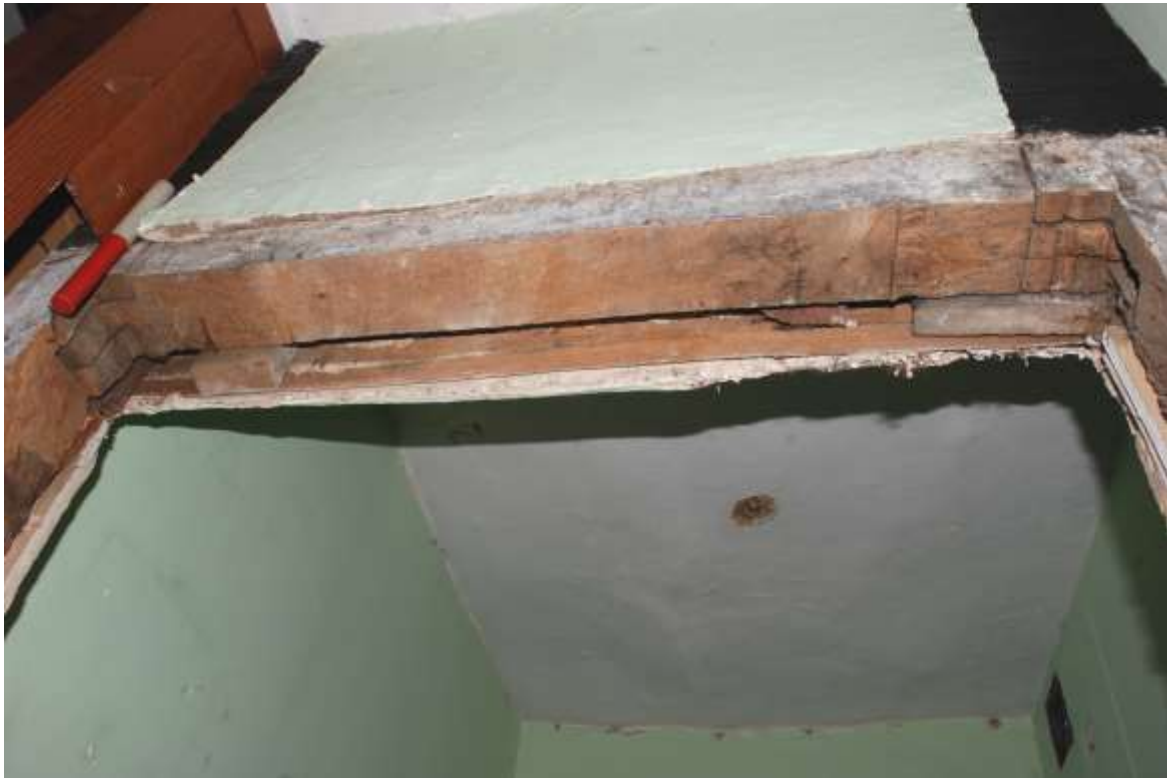
Fig.91: *The upper part of the northern doorframe, viewed from the adjacent room*

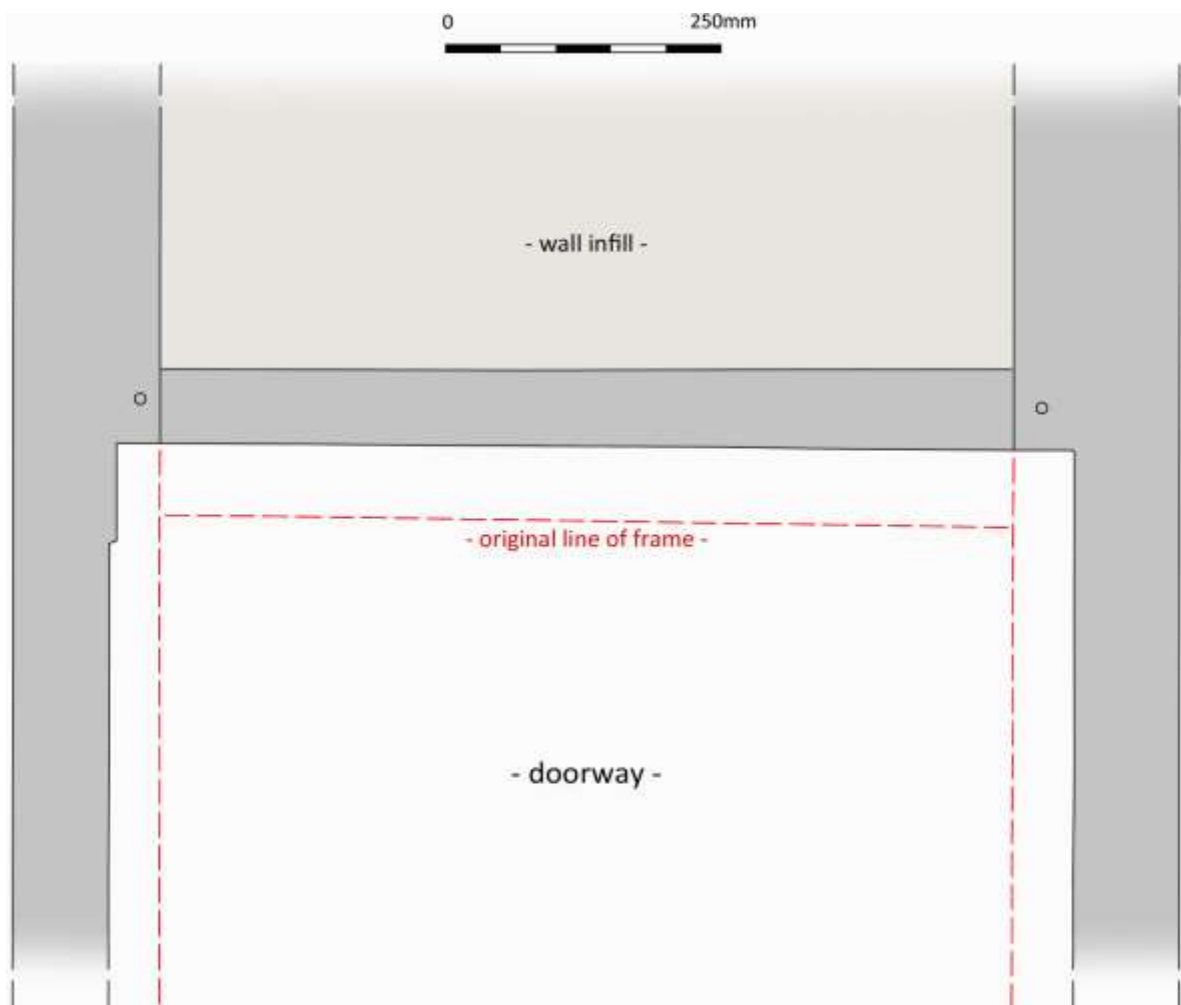
Fig.92: *Elevation of the upper part of the doorframe, including a projection of the original line*

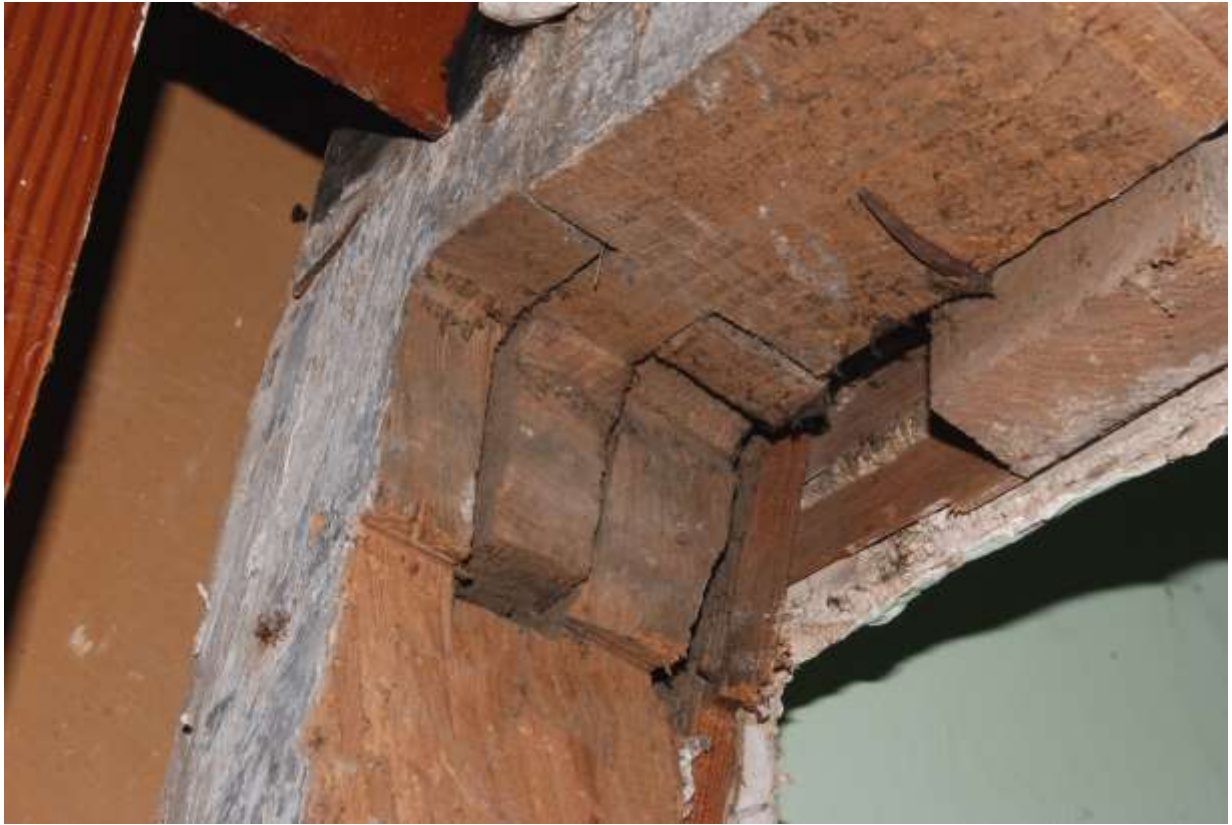
Fig.93: *Detail of the top eastern corner of the northern doorframe*

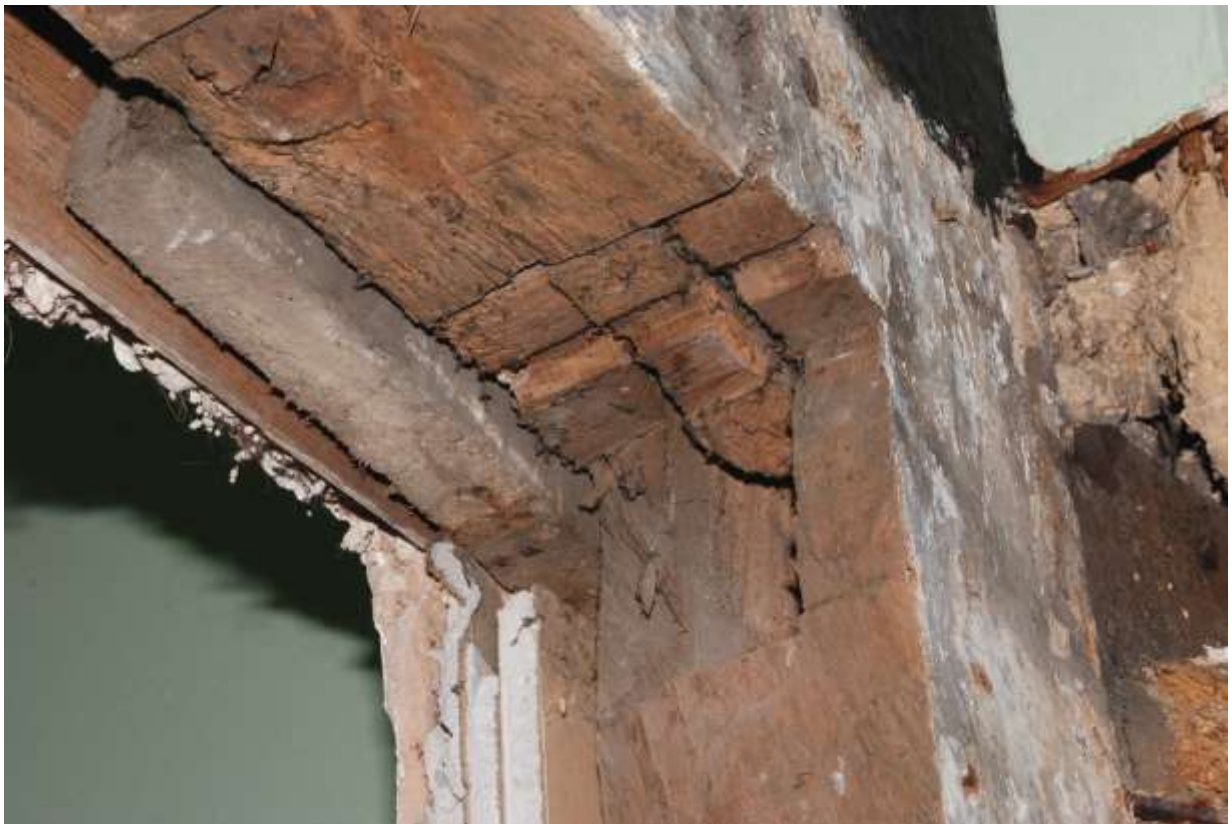
Fig.94: *Detail of the top western corner – unlike the southern frame the doorhead here is tenoned into the jambs at both ends, as the latter continue to ceiling level*

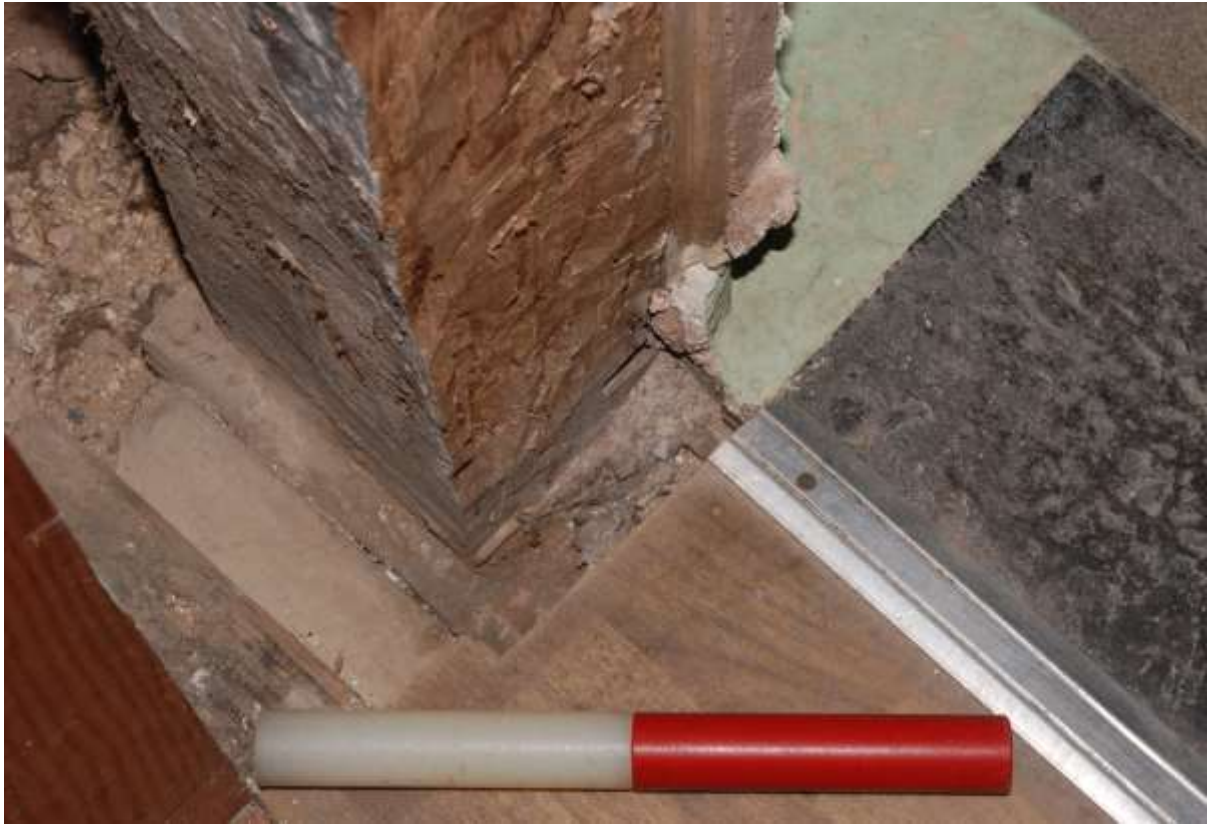
Fig.95: *The northern doorframe – base of the eastern jamb (0.2m scale)*

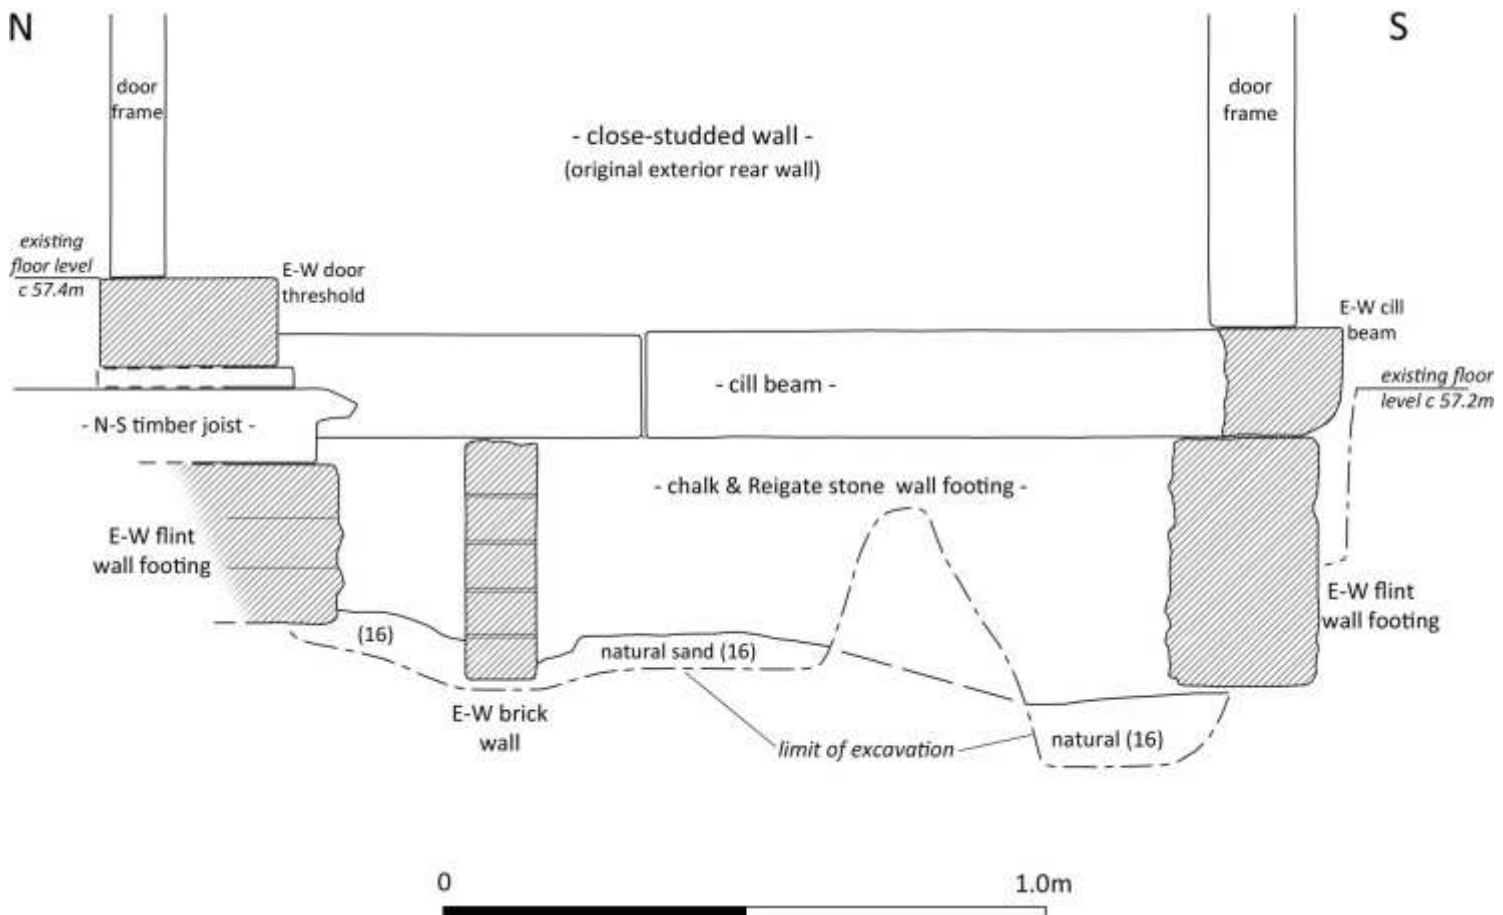
Fig.96: Combined section and elevation, showing the various elements of Corridor G-09 and to the rear the original external western wall plinth and cill beams

The depth of the main wall plinth was between *c* 320mm 460mm, and it appeared to come down onto quite soft natural ground. Abutting it at right angles at either end of this area were further stone bases, primarily if not wholly constructed of flint. That to

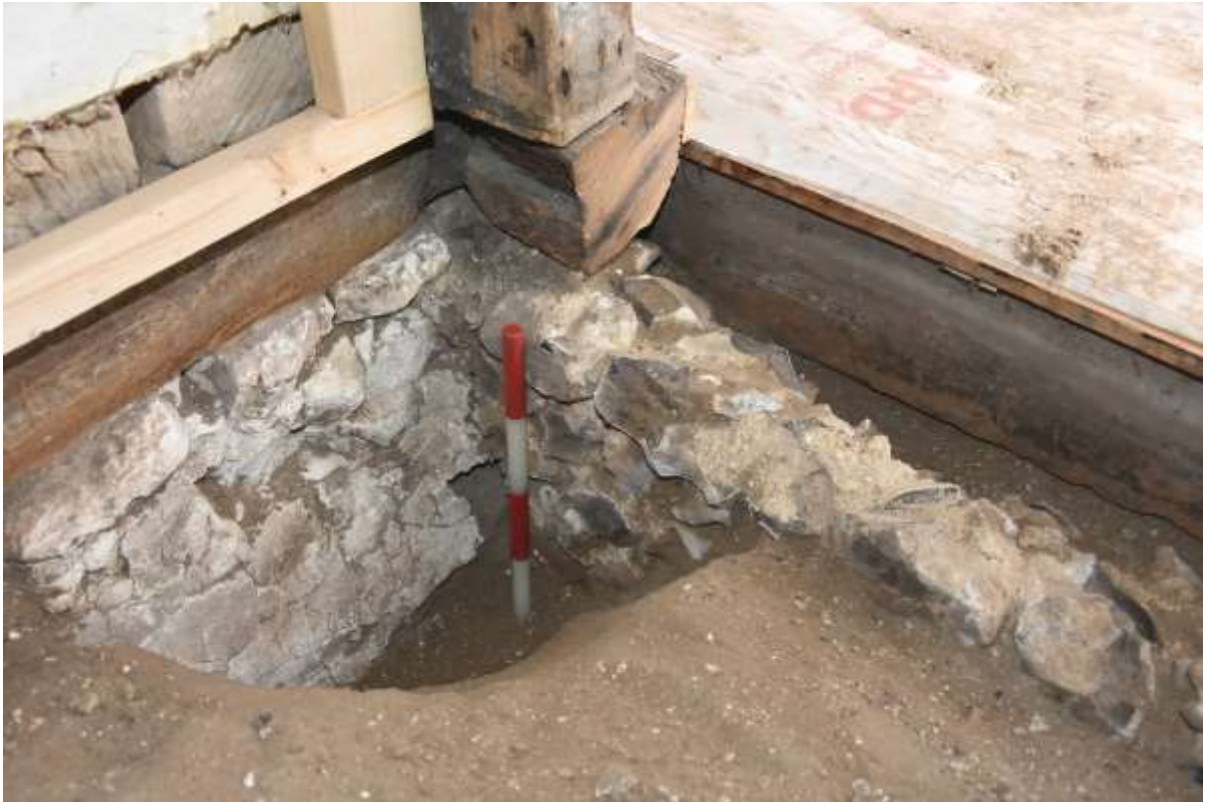
the south (Figs.97 & 98) is presumably part of the staircase turret extension, and is believed to date to the later 16th century: the stonework was about 220mm to 240mm wide, and 410mm deep. It too was overlain by an oak cill beam (partially removed).

Fig.97: The southeast corner of area G-11, with the original wall plinth and cill beam to the left of the 0.4m scale. The mortared flint base to the right & timber immediately above the scale presumably form part of the staircase turret addition

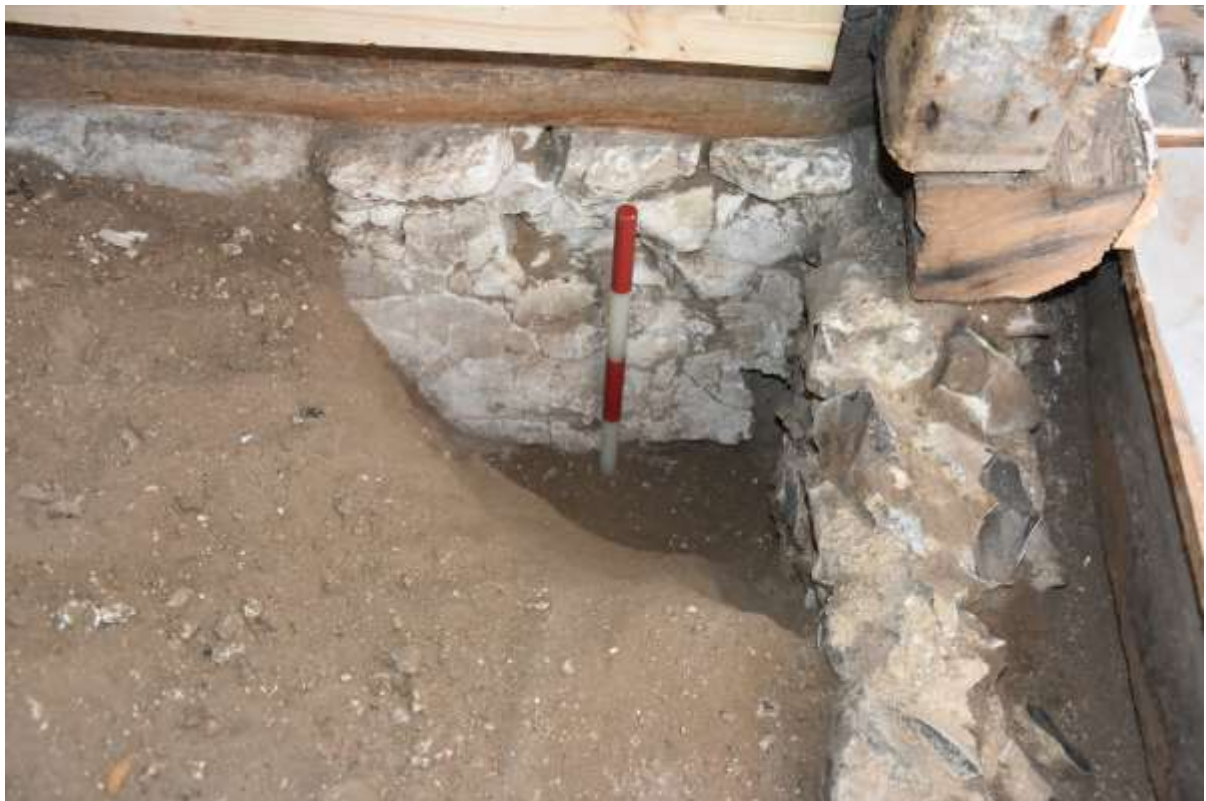
Fig.98: As above, looking directly at the original external wall plinth & cill beam

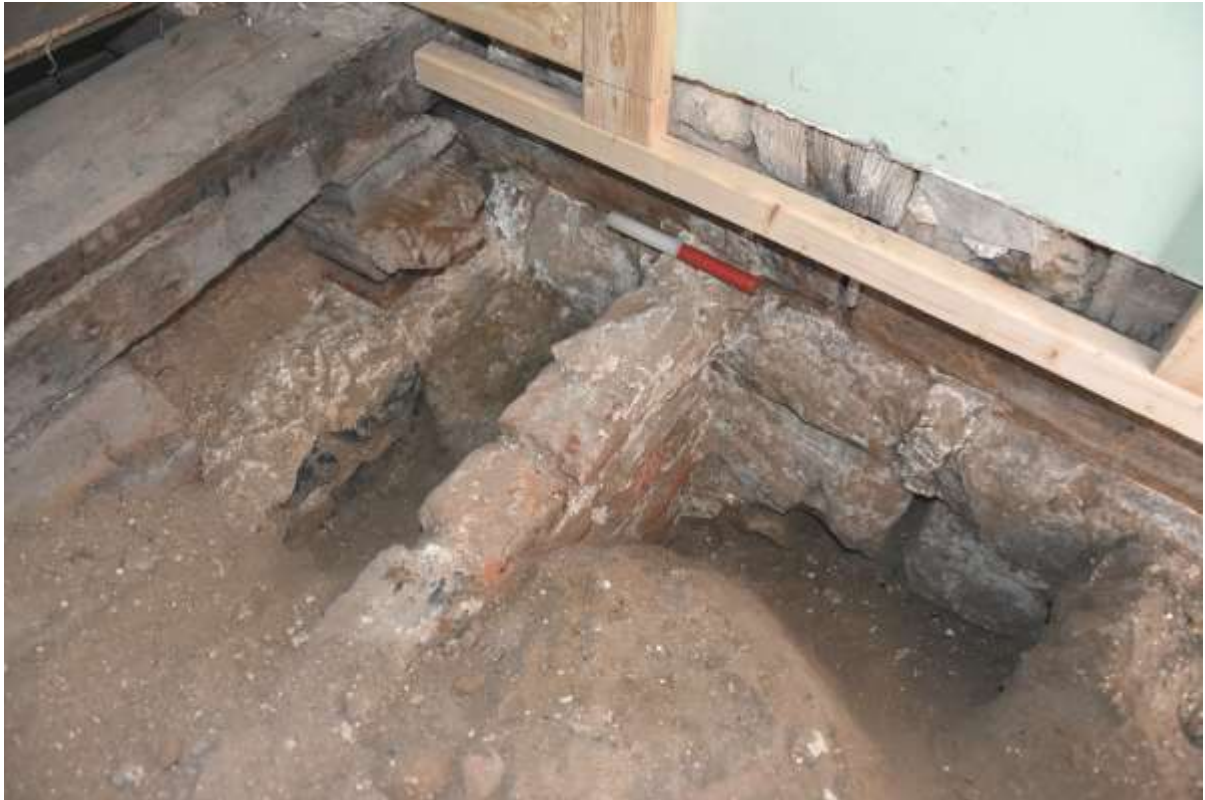
Fig.99: The northeast corner of G-11, with the original wall plinth and cill beam to the right of the frame: two studs are also just visible above the new timber. In the top left-hand corner is the timber door threshold to Room G-12, with two joists below resting on a flint base

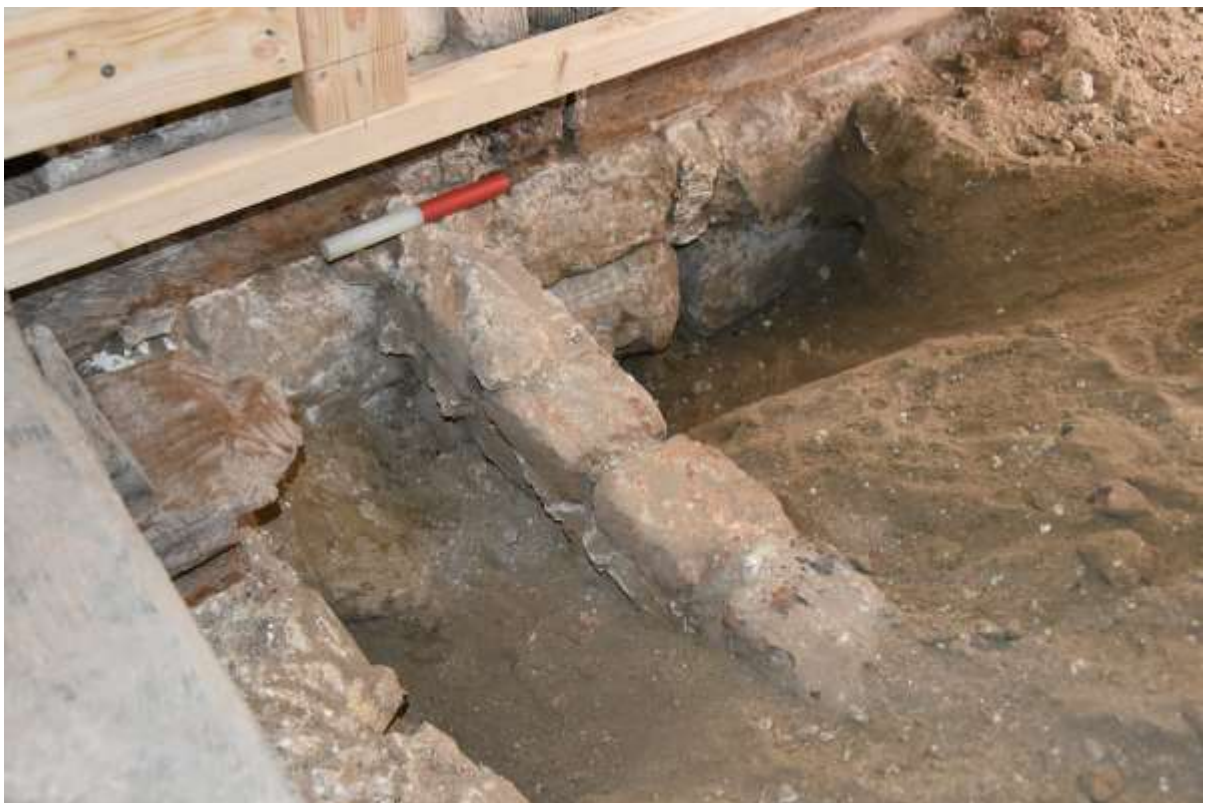
Also abutting the original rear wall plinth towards the northern end of the corridor was a single-header thickness mortared brick wall. The depth of this from the extant top was about 380mm (five courses), and the wall continued across the corridor to abut further brickwork at the base of the western wall – a distance of c 1.41m to 1.45m. The function of this is unknown: if it was more centrally located, or if there were corresponding structures to the south one would assume a floor support, but this does not fit the specific evidence.

Fig.100: As above, viewed from the northern doorway. The 0.2m scale is resting on the narrow brick wall that spans the corridor

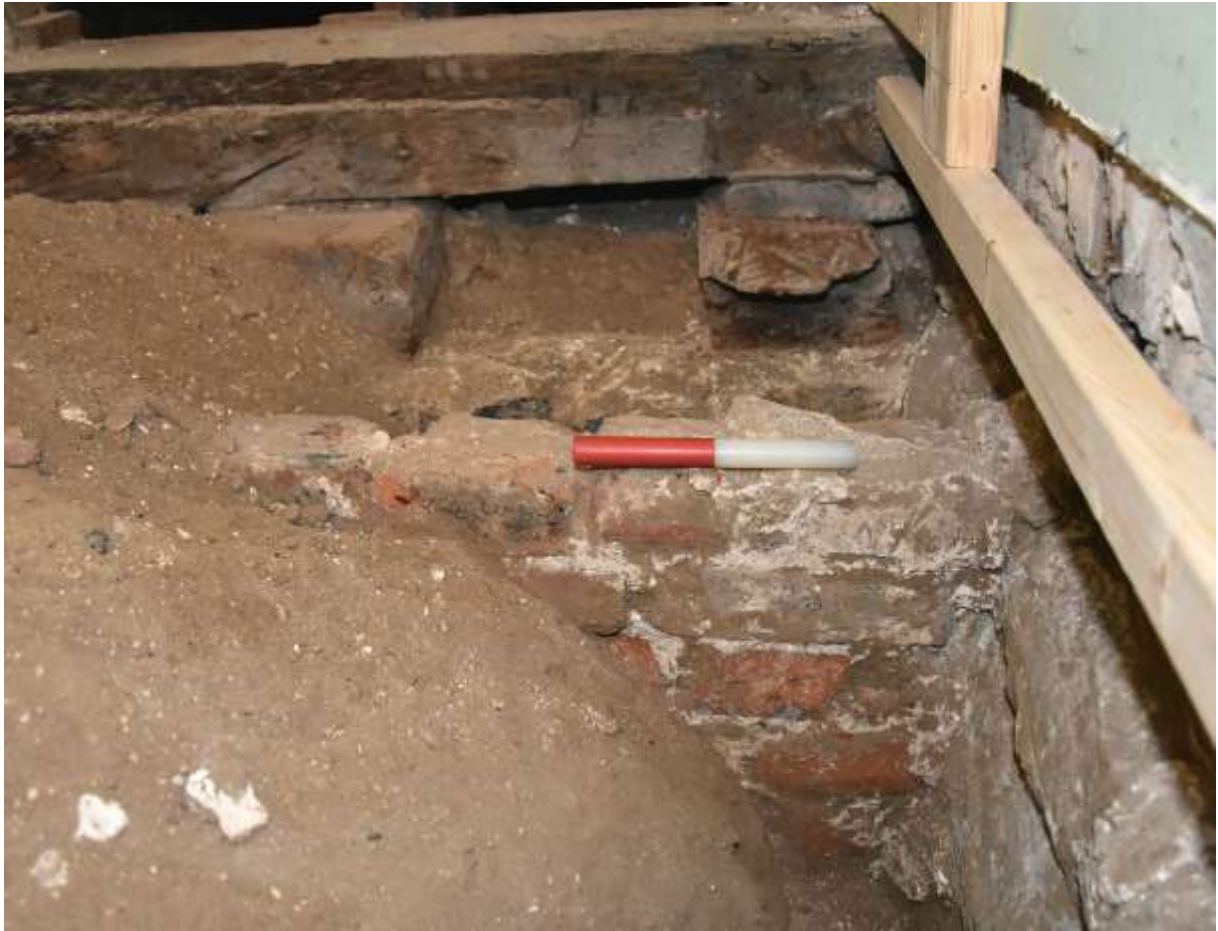
Fig.101: View looking north with the brick wall in the foreground, the threshold and joists of Room G-12 to the rear, and the original external stone wall plinth at lower right

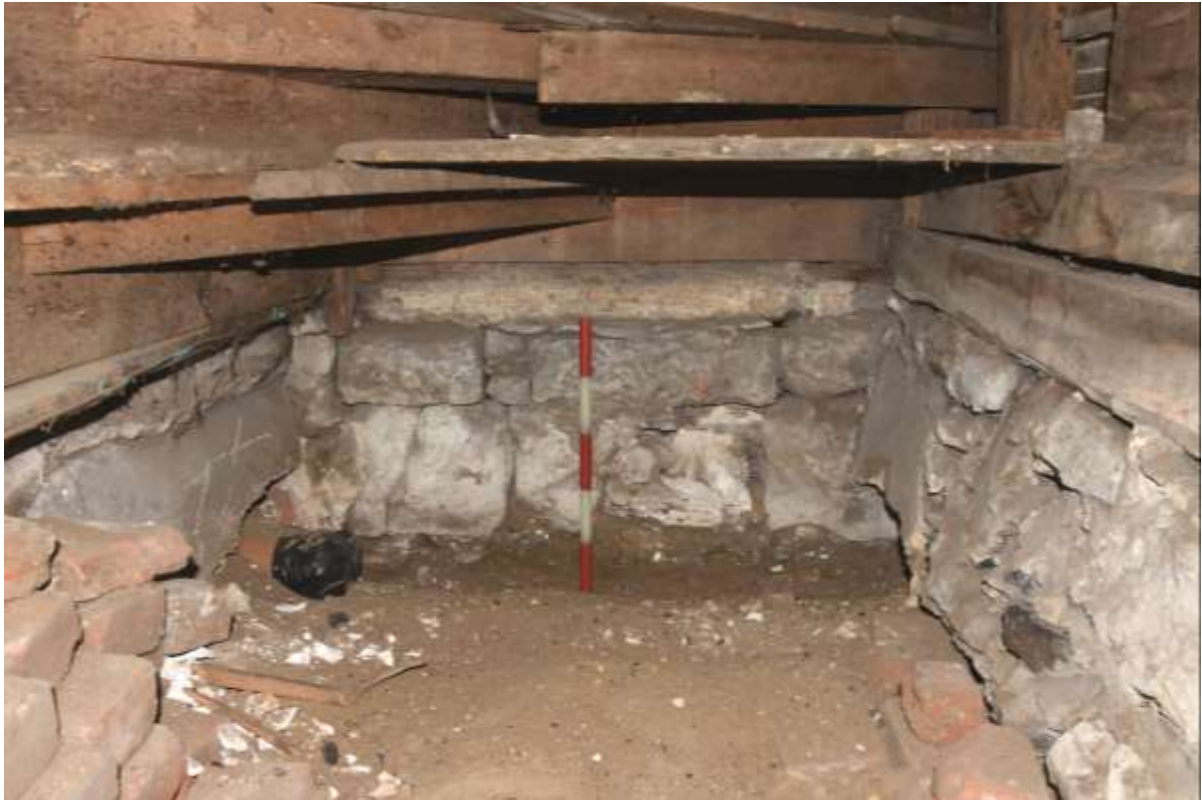
The ground level within this area has evidently been reduced – as the figures overleaf show it is actually about 100mm below the base of the original wall plinth. Cleaning up of the surface (context 17) for photography produced a complete miniature tin-glazed ware “ointment pot of 17th century date (cf. Appendix III).

Fig.102: View below the staircase, with the 0.5m scale standing against the stone plinth of the original west (external) wall. To the right is the stone and flint plinth for the stair turret

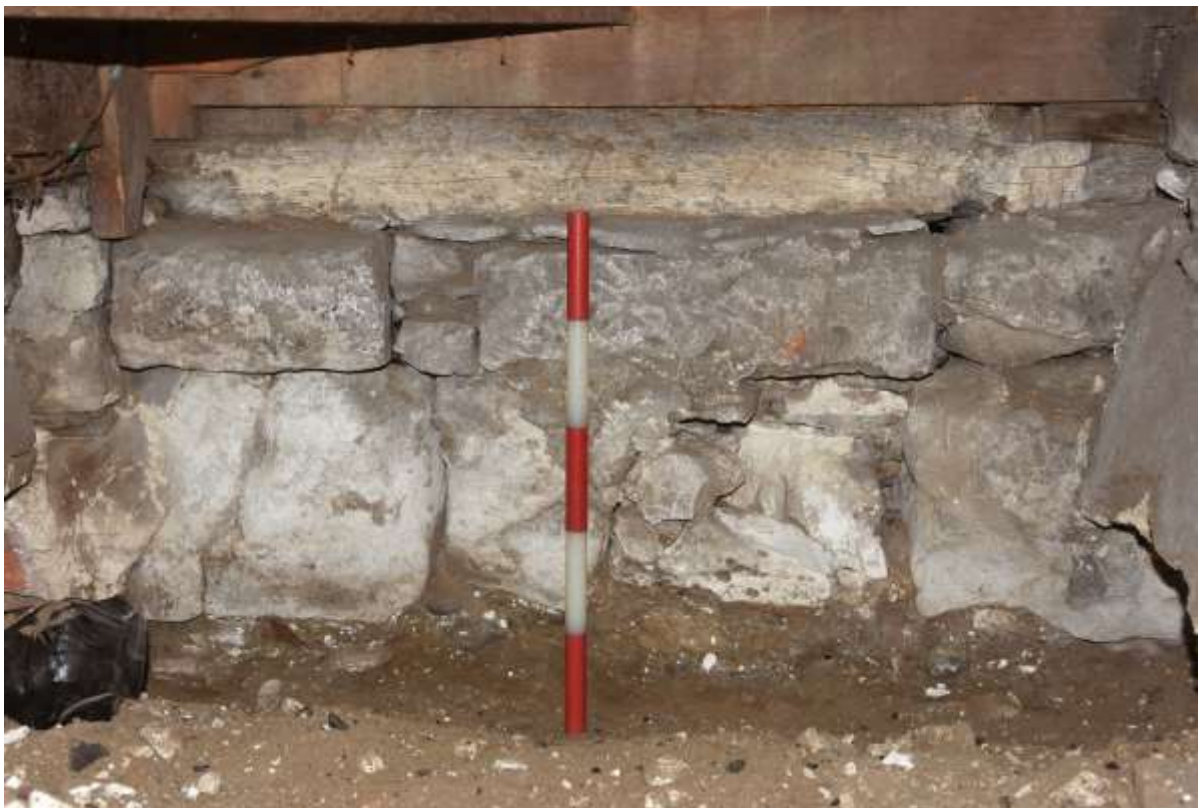
Fig.103: Detail of the above, showing the original stone plinth and overlying cill beam
