WHITEHALL, 1 MALDEN ROAD, CHEAM

LONDON BOROUGH OF SUTTON, SM3 8QD

**AN ARCHAEOLOGICAL WATCHING BRIEF AND
HISTORIC BUILDING RECORDING**

September 2018

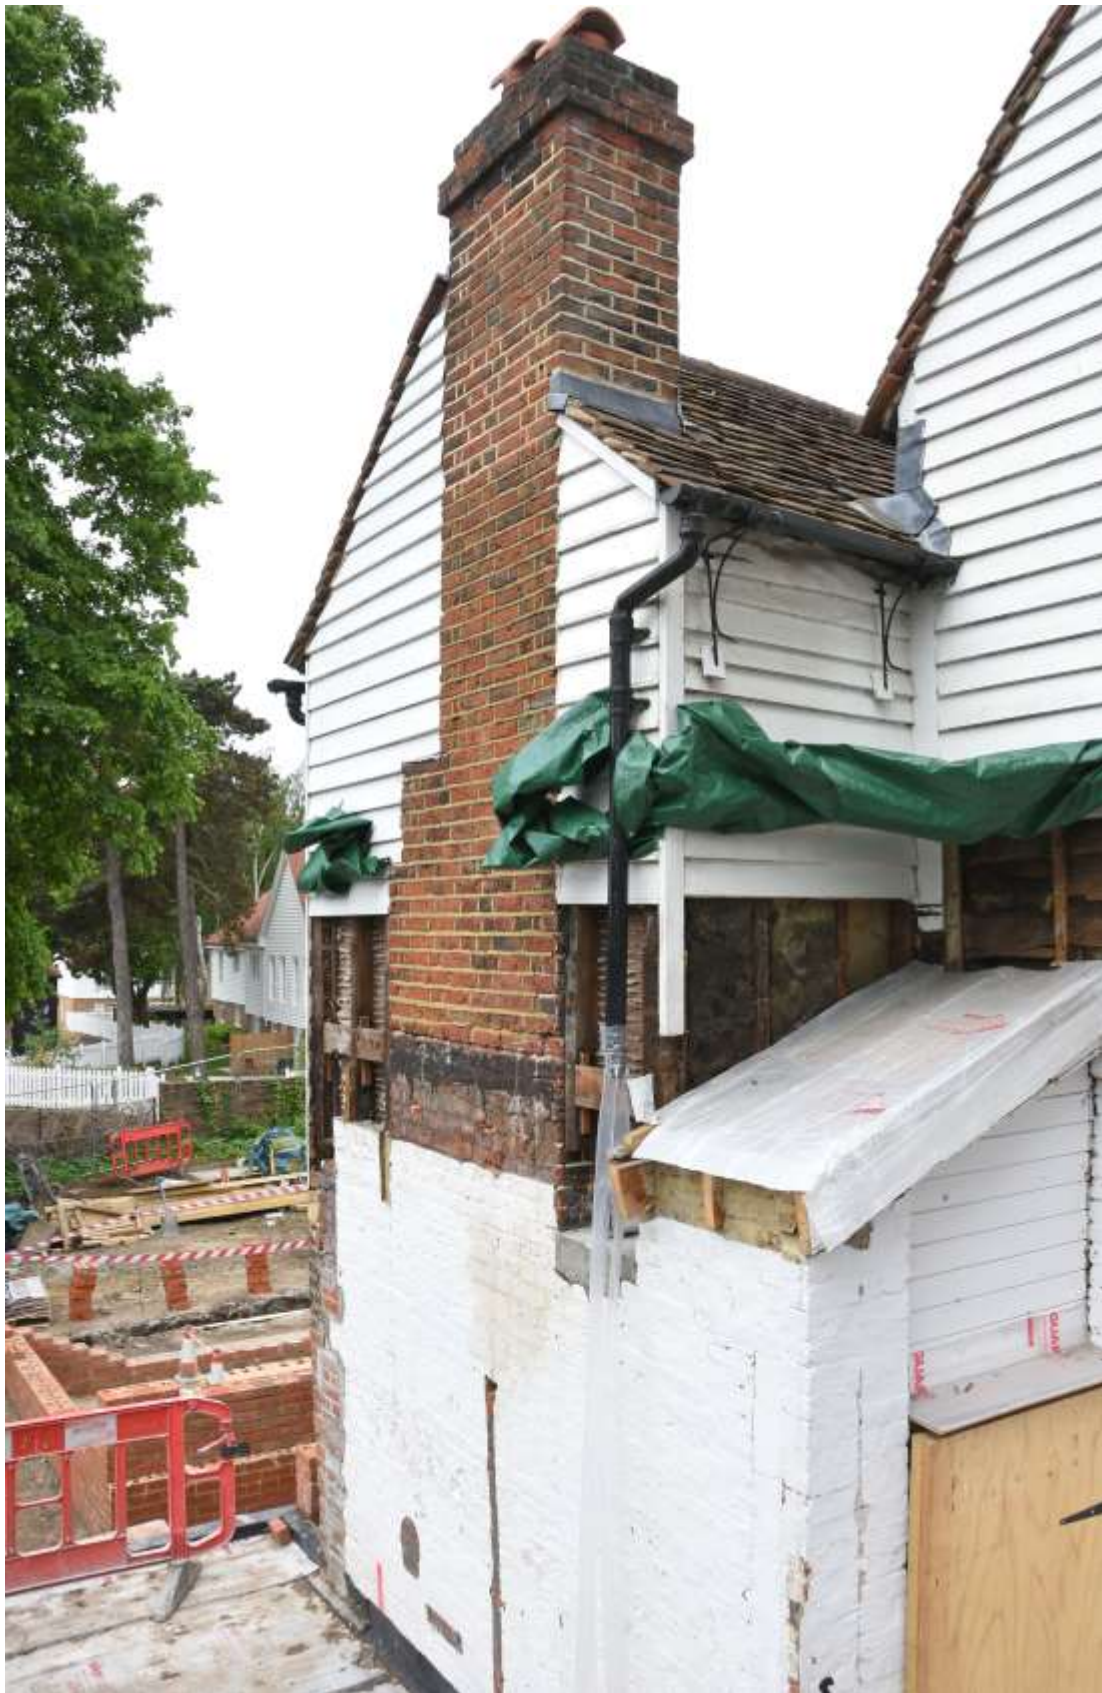
At ground floor level the southern wall is constructed of brick on both sides of the chimneystack (Fig.105). However, at the southwest corner the brickwork steps down to the level of the window sill on the west face; just to the north of the window it then appears to step down again, to a simple plinth that continues to adjoin the earlier stair turret below the timber weatherboarding. Some details of the western wall and foundation were observed during external excavations (*cf.* Section 11.3): however, the more general reasons for this apparently stepped construction are unclear.

Fig.105: General view of the southern end of Room G-04 plus overlying structure (Room F-05 & roof), looking towards the rear

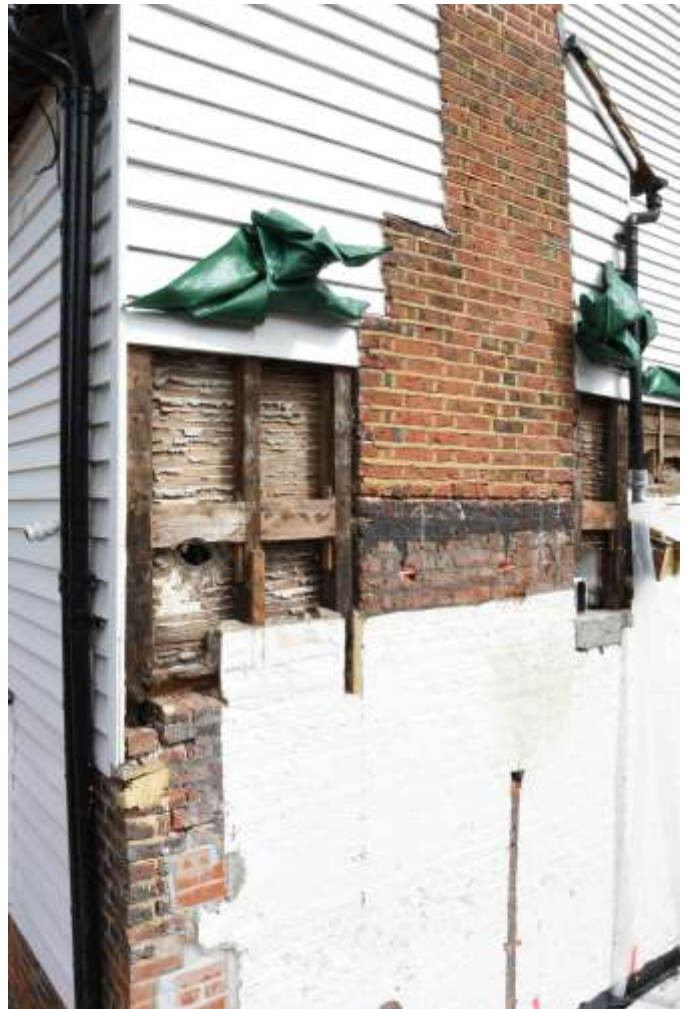
Fig.106: *The southern end of Room G-04, looking approximately north*

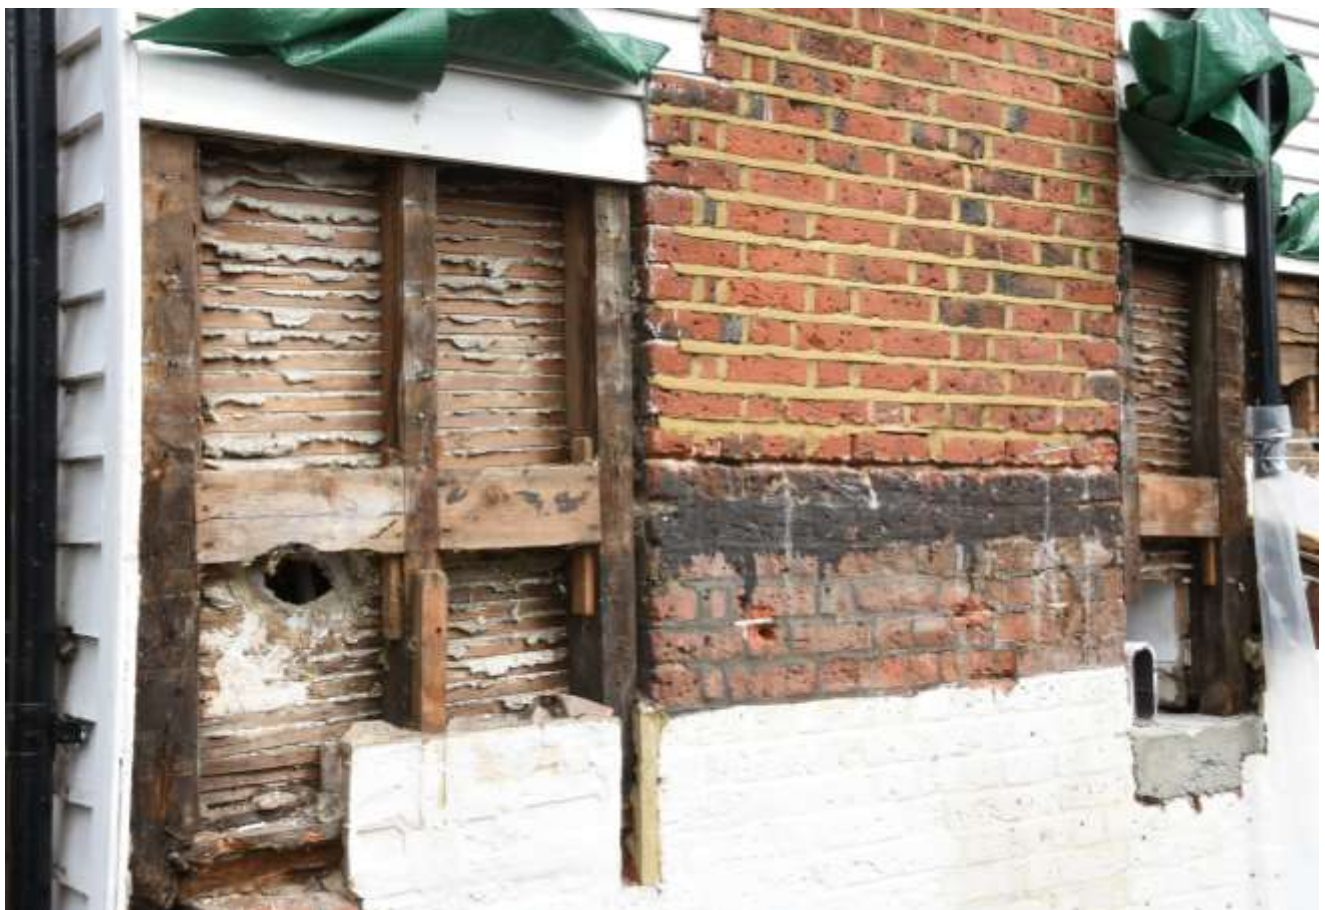
Fig.107 (below): *Detail of the above, showing timber framing and repointed chimney*

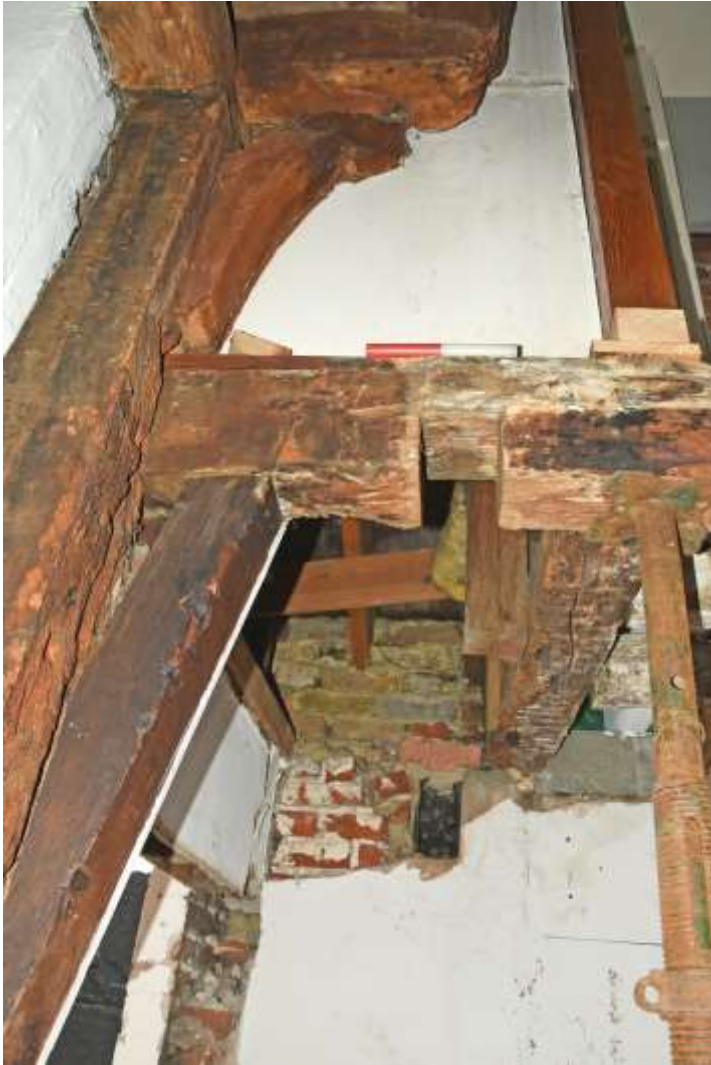
Fig.108: *The southeast corner of the room, with the original southwest building corner and jetty at top right*

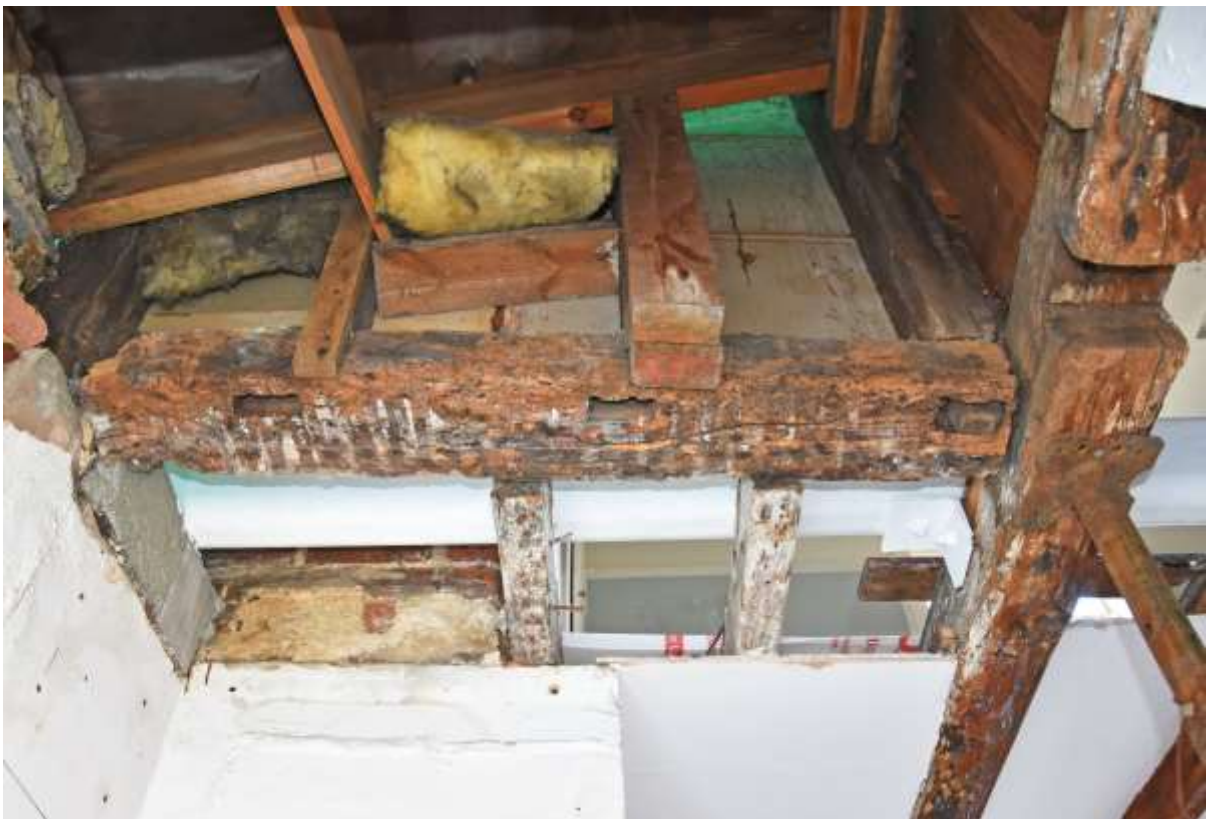
Fig.109: *Detail of roof construction and reused timbers at the southeast corner, looking west towards the chimneystack*

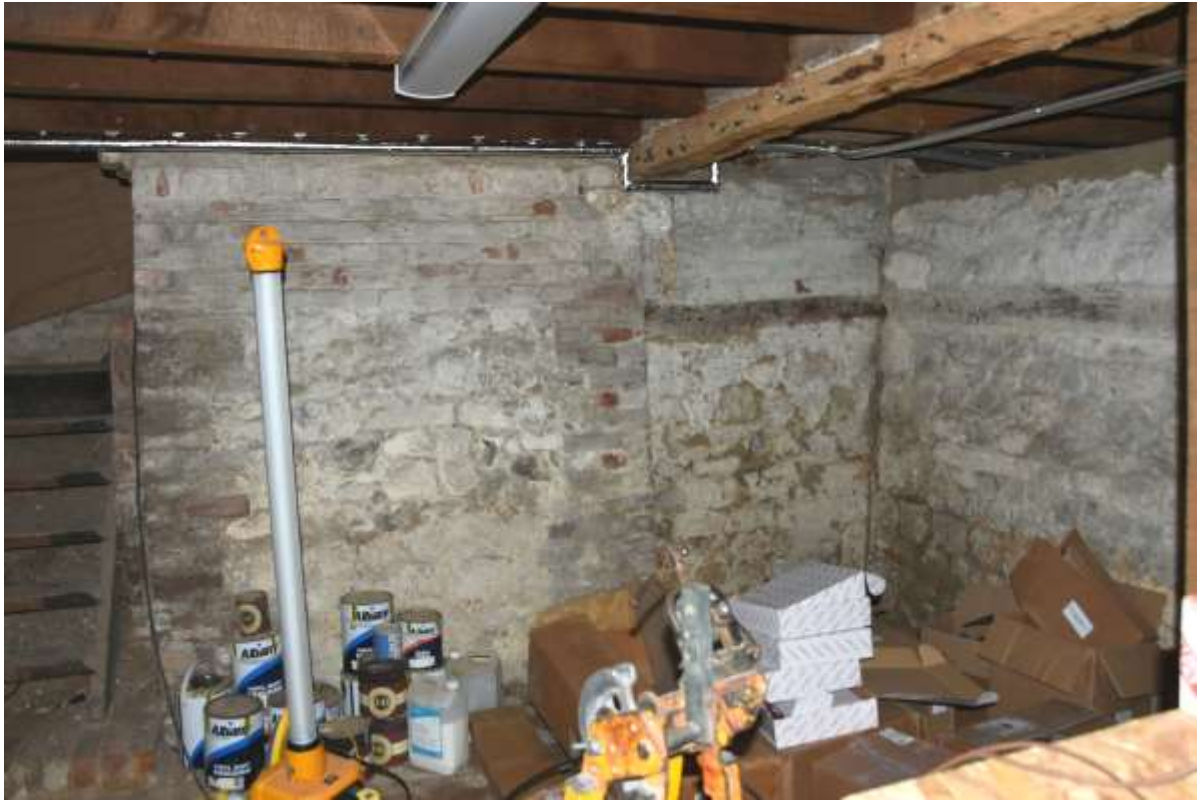
Fig.111: *General view of the cellar, looking approximately south. Internal steps on left*

Both the above figures show the varied construction of the cellar in both brick and stone, and though not investigated further certainly indicate more than one phase of development: it has been suggested (for example) that the structure originally extended further to the south, below Room G-12 (Archaeology South-East 2012, 17).

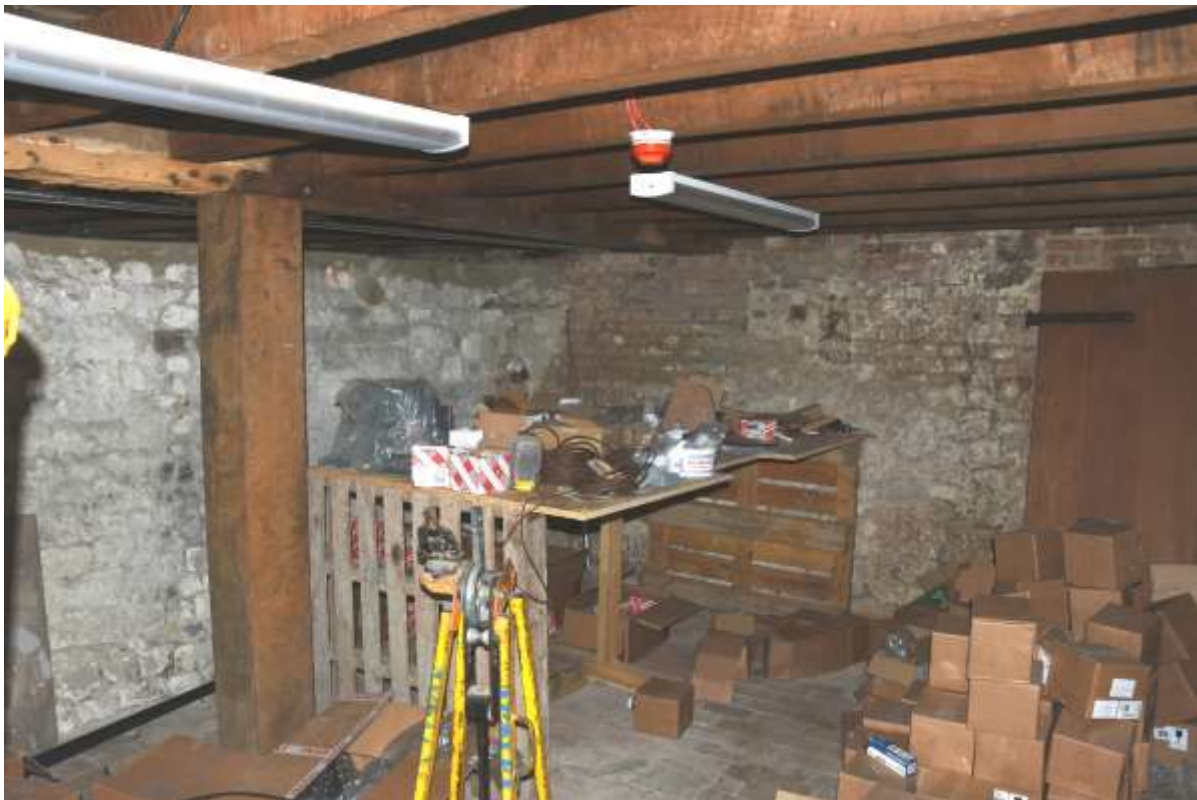
Fig.112: *General view looking approximately south*

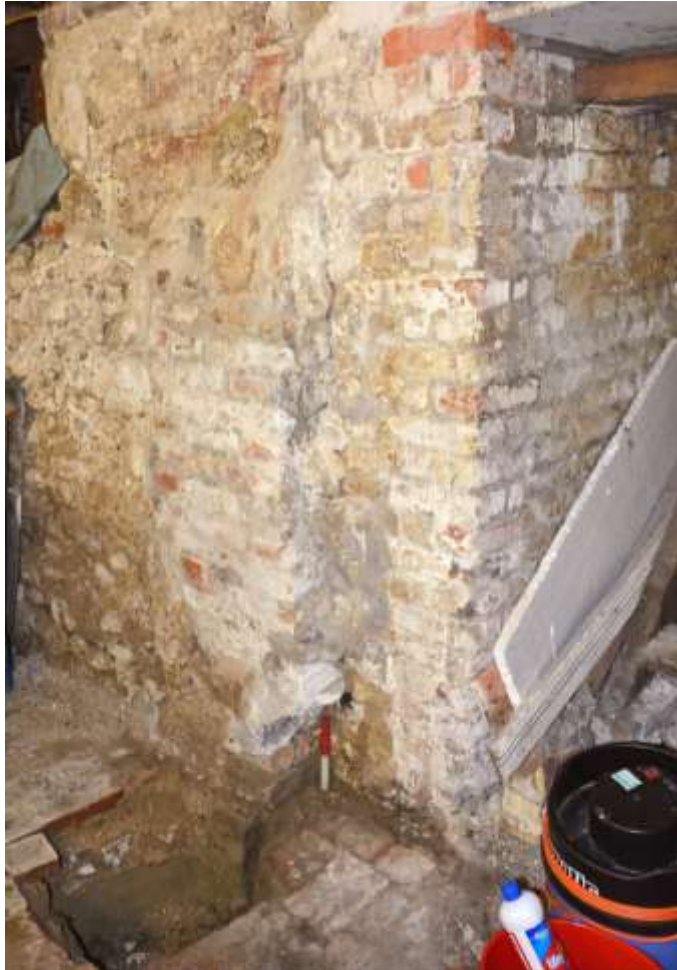
A single preliminary test pit some 350mm deep was excavated through the dry-laid brick floor, close to the western side of the external entrance (Figs.113 & 114).

Fig.113: *General view of the test pit*
(bottom left; 0.2m scale)

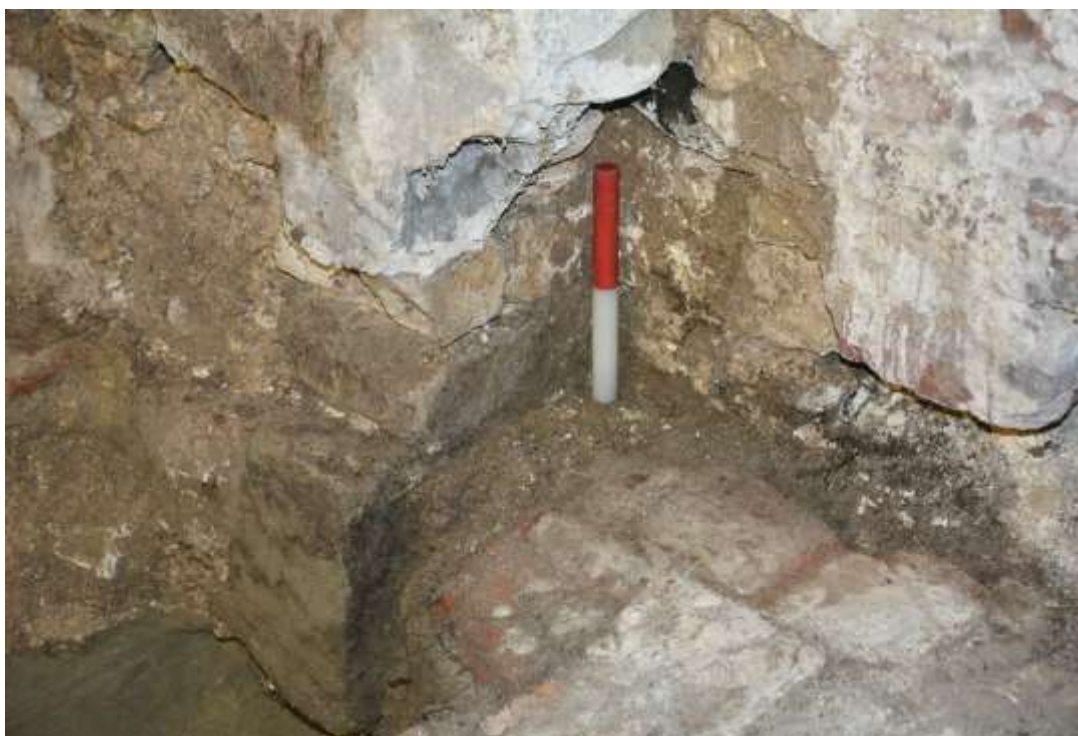
Fig.114 (below): *Detailed view showing*
Reigate stone block immediately to the
left of & below the 0.2m scale

The cellar wall immediately above the test pit stepped back some 350mm before the corner to the entrance, and the pit revealed a squared-off Reigate stone block roughly on this same line. It is possible that this represents one side of an original entrance, subsequently rebuilt and perhaps narrowed. Elsewhere removal of the brick floor exposed *c* 150mm of mixed sandy/chalky bedding, and thence truncated natural sand.

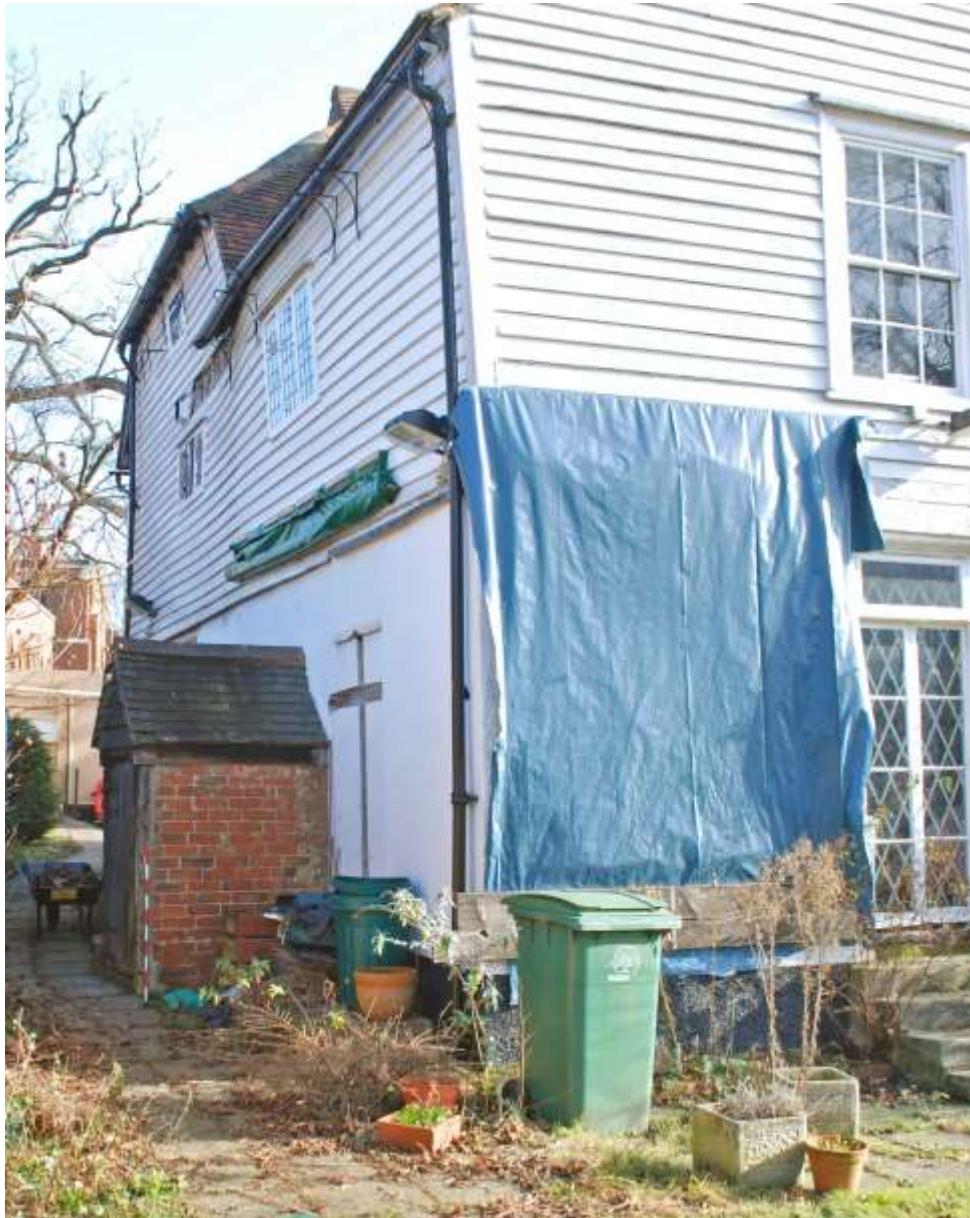
Fig.115: General view of the northern end and northwest corner of Whitehall in February 2017, showing the brick-built canopy over the external cellar access

This picture also shows investigation of the wall just to the west of the cellar entrance (the cruciform area of stripped render). This corresponds to a blocked doorway, briefly referred to in Figs.123-24 and described in detail elsewhere (Section 7.3.1.2). Also just visible above this is a slight vertical step back in the wall itself: this was later shown to coincide with a change in construction from brick to lath & plaster.

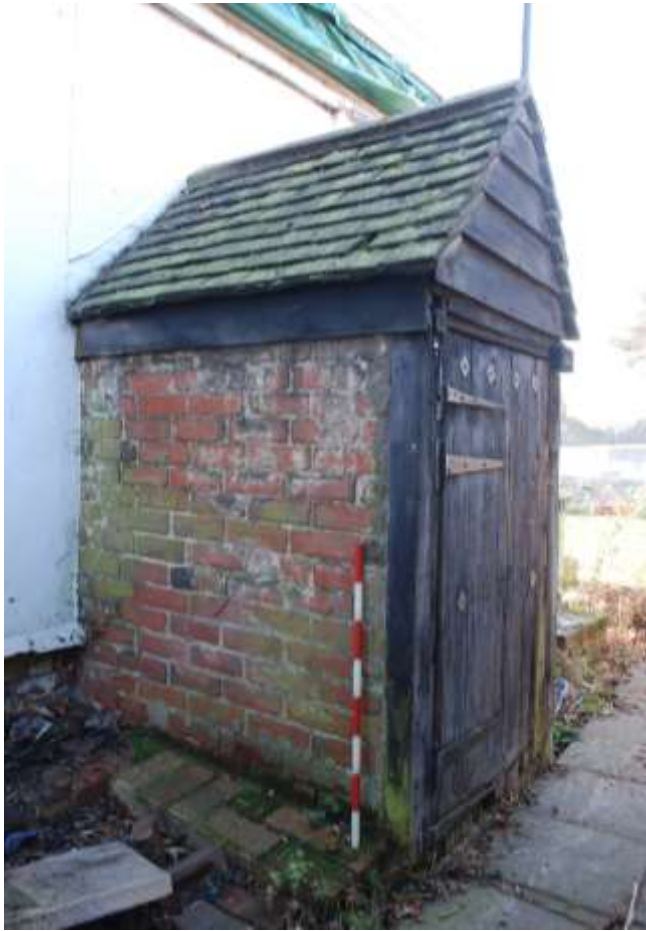
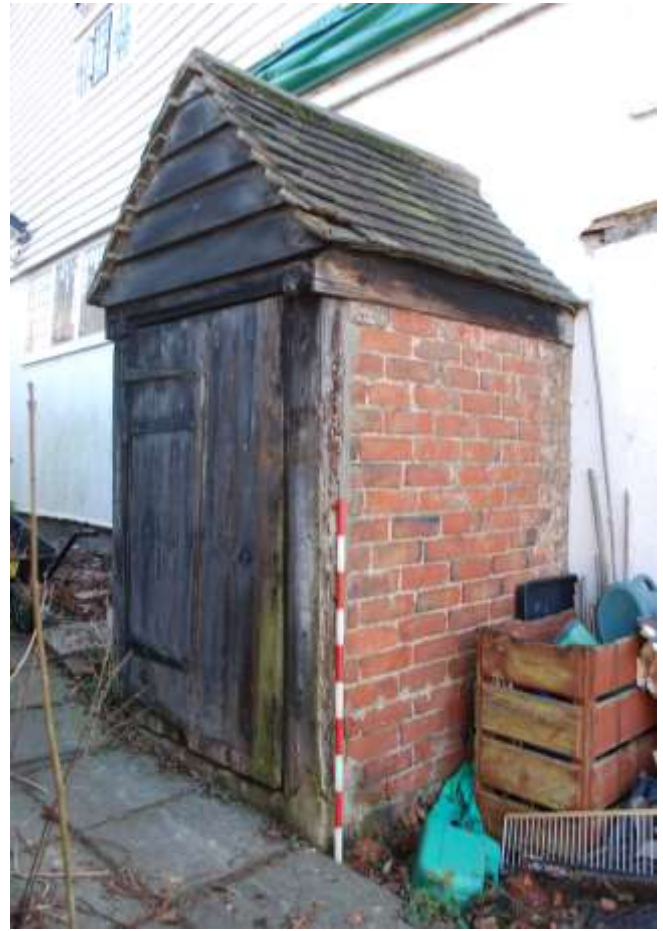
Figs.116 & 117 (above): *Views of the cellar entrance canopy, looking southwest and east*

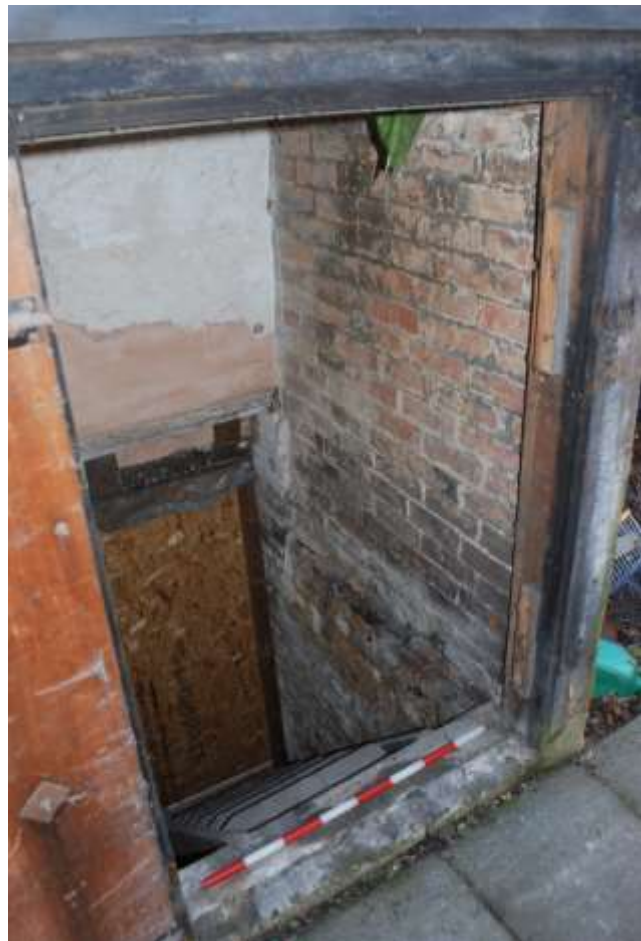
Fig.118 (opposite): *Oblique view looking down the steps into the cellar entrance (1m scale)*

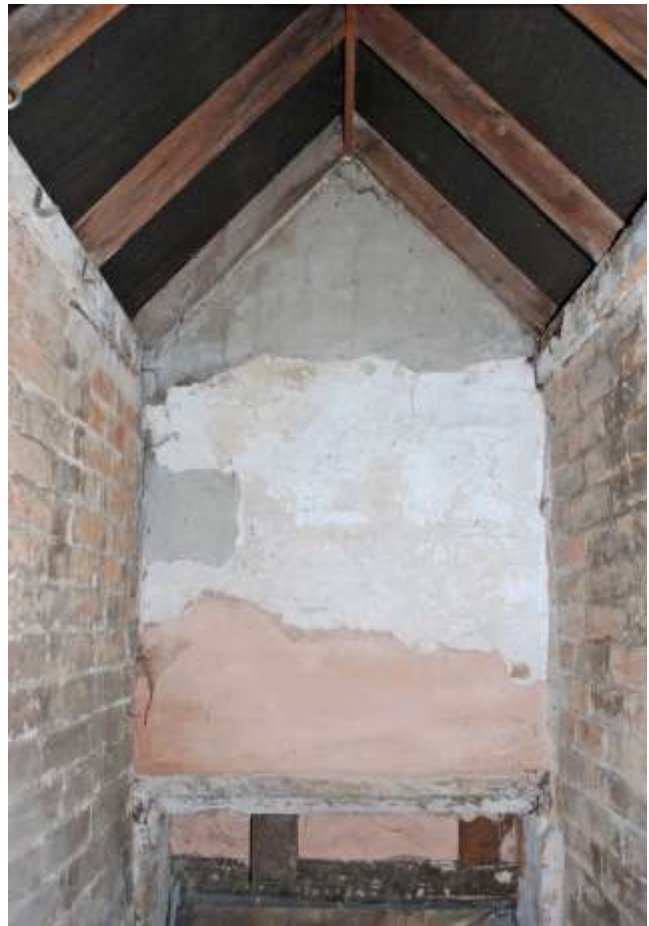
Fig.119: *Upper section of the enclosed cellar entrance*

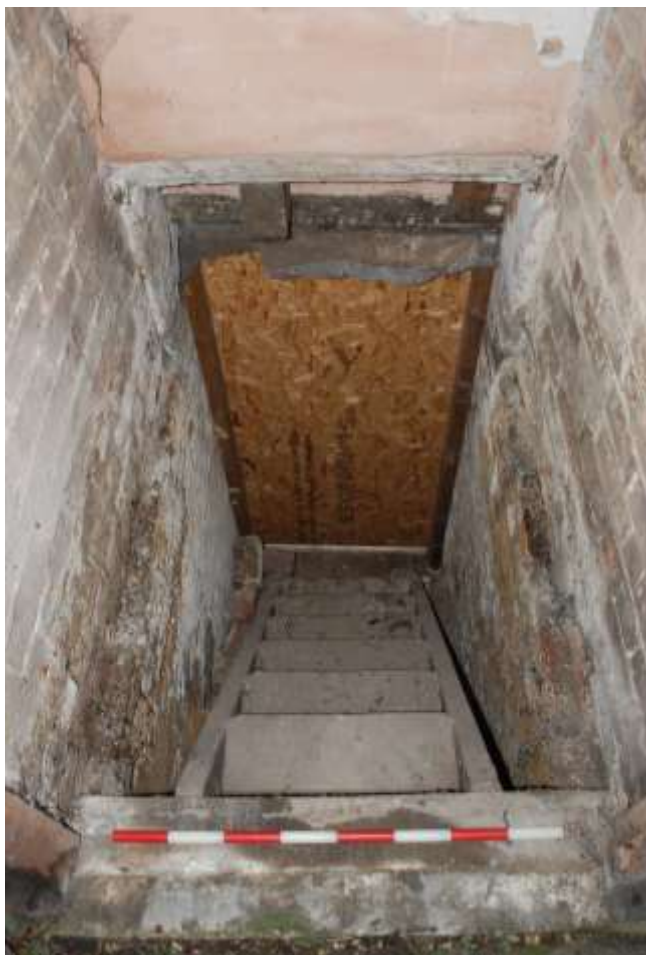
Fig.120: *Lower section of the entrance and wooden steps*

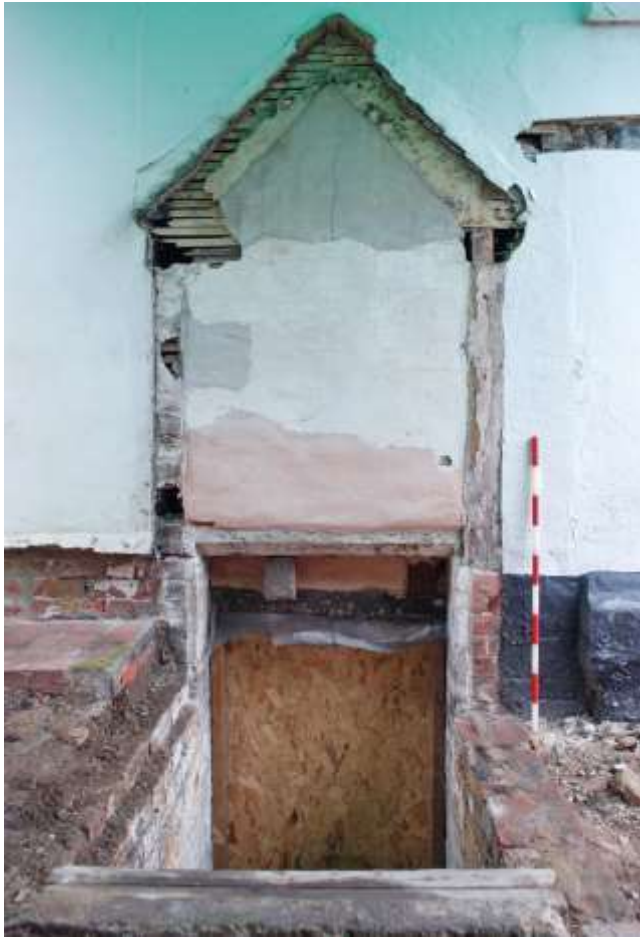
Fig.121: *The north wall and cellar entrance after removal of the entrance canopy*

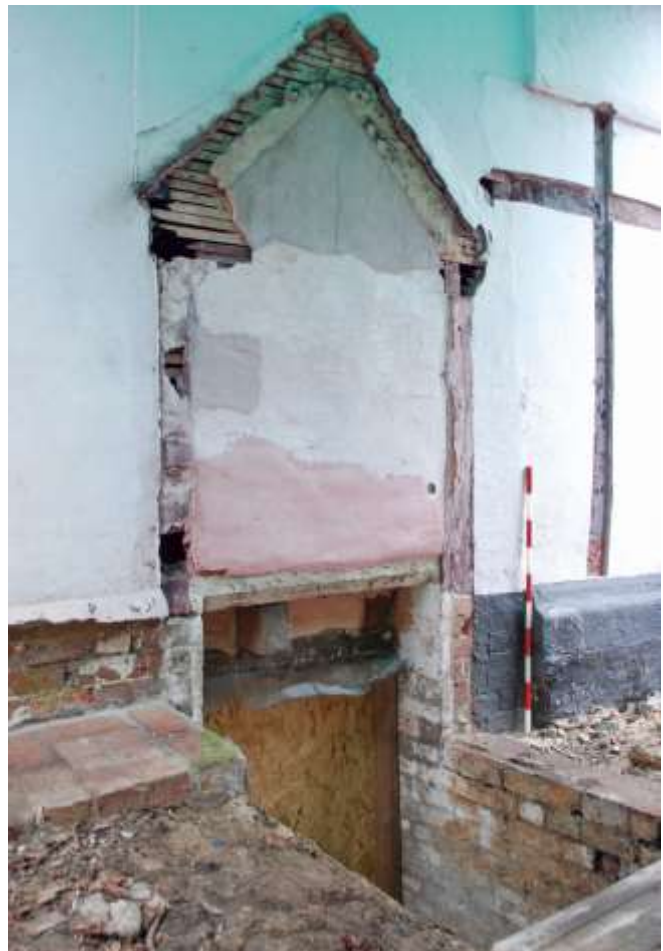
Fig.122: *Oblique view of the above, looking approx. south (1m scale)*

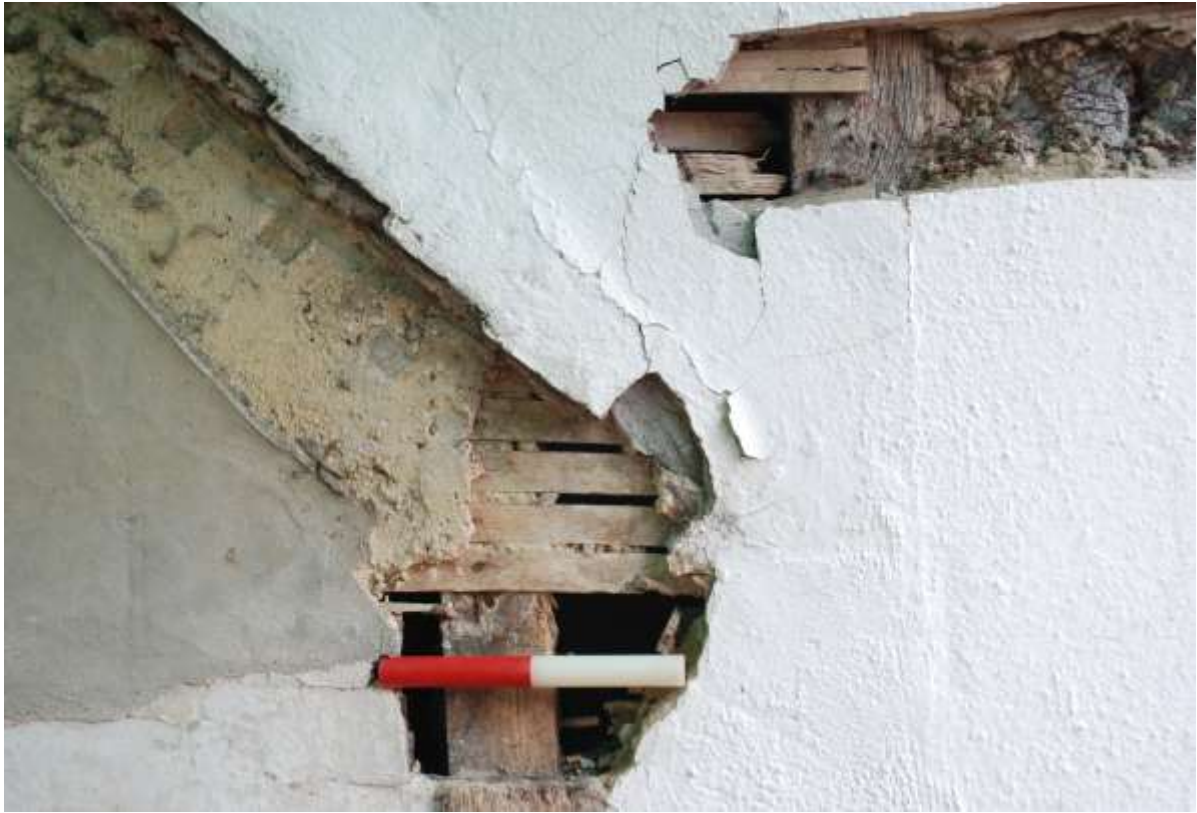
Fig.123: *Detail of the north wall after removal of the canopy, showing lath & plaster construction, a supporting stud and at top right the edge of a blocked doorway (0.2m scale)*

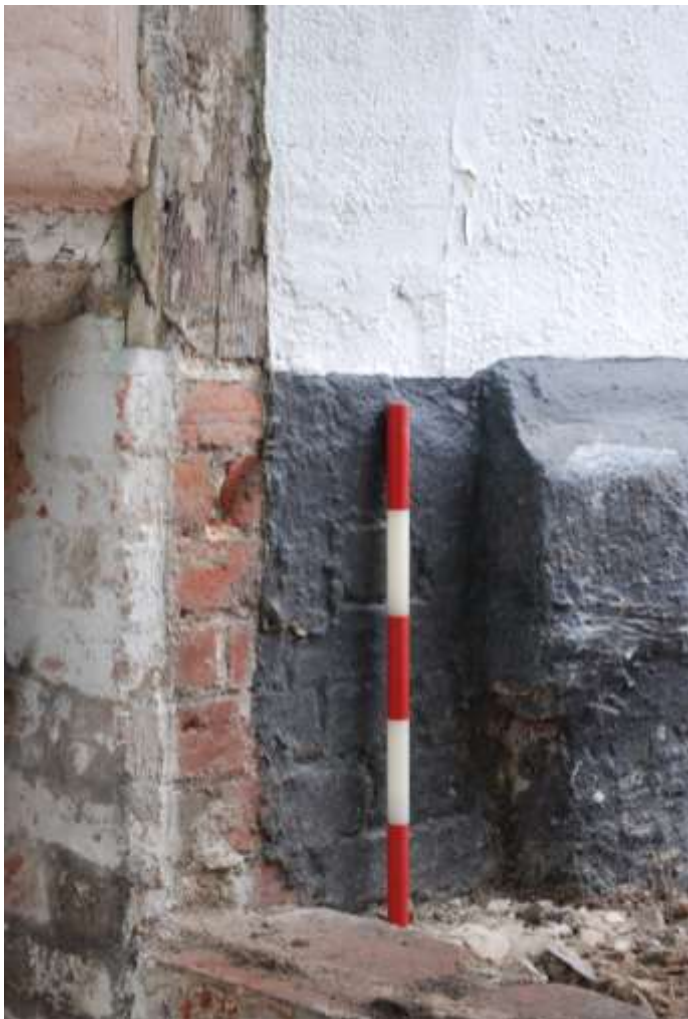
Fig.124: *Detail of brickwork adjacent to the cellar entrance. The projecting section to the right of the 0.5m scale is a remnant of steps below the blocked doorway*

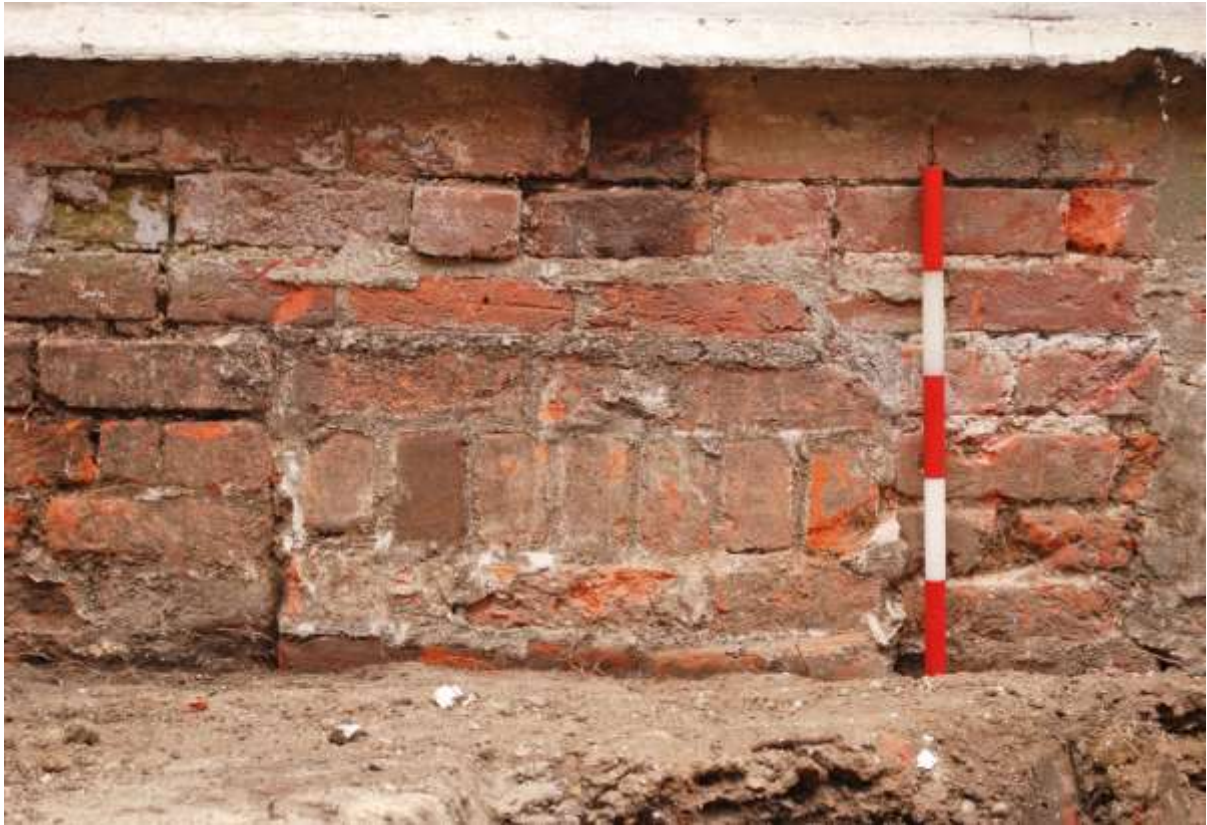
Fig.127: *The upper part of a previously blocked cellar window, to the east of the entrance (0.5m scale)*

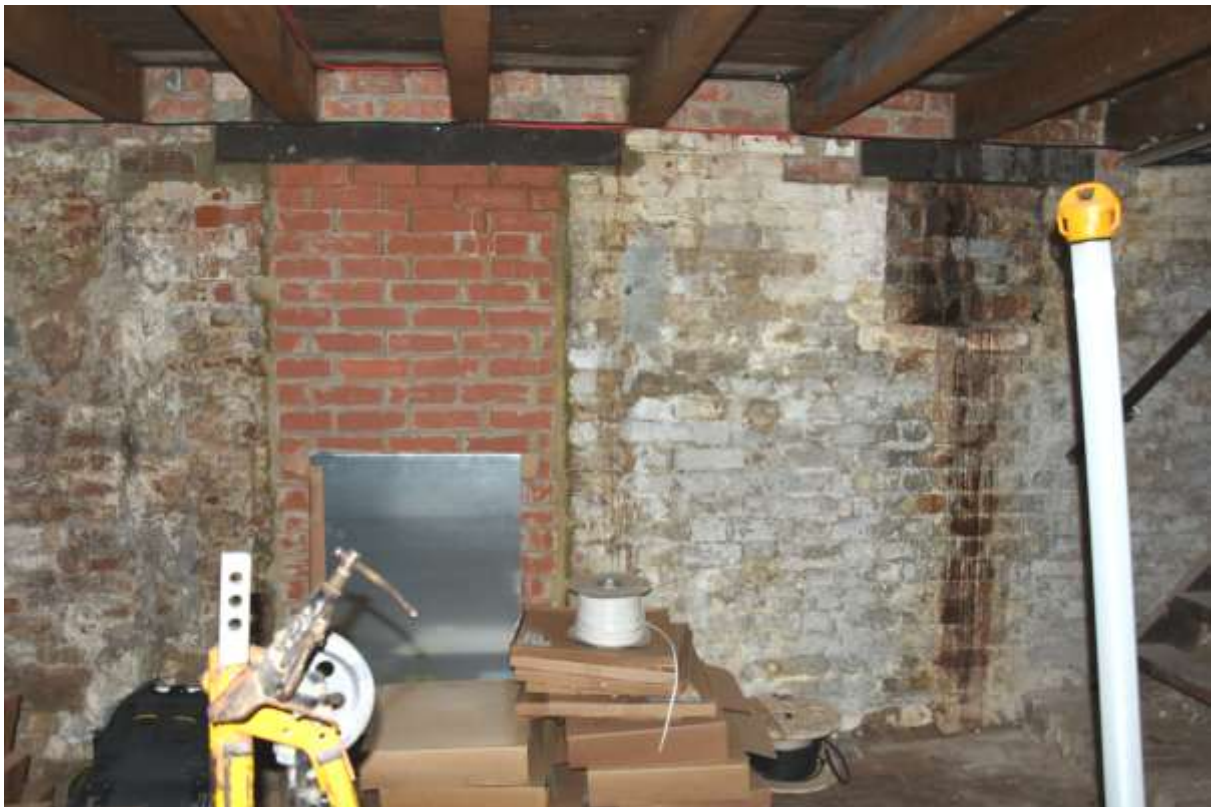
Fig.128: *The completed works from within the cellar, showing the bricked-up external entrance. The previously blocked window (Fig.127) is visible to the right*
