9. THE FIRST FLOOR

The impact of works on the first floor was variable, with significant evidence being recorded in the central corridor (F-02) and the Porch Chamber (F-03), both internally and on the external wall of Room F-04, and most extensively within the rear extension Room F-07.

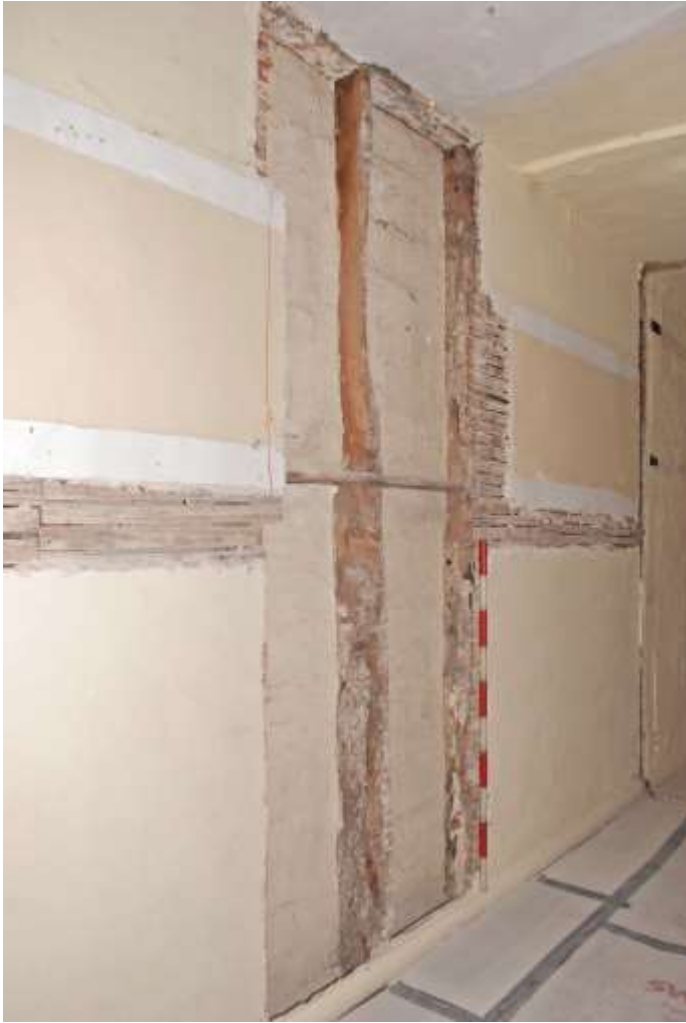
However, removal of the lath and plaster wall covering on the corridor side of the new doorway (and also a strip of plastering on either side of this) revealed that there was an earlier finished surface between the studs – essentially matching that on the other side of the corridor (Figs.132-33). Thus it is assumed that originally this was intended to be seen, and only subsequently covered over. Why one side of the corridor should have been treated in this way but not the other is unknown.

Fig.132: *The outline of the new doorway looking approx. southwest, after removal of the outer lath and plaster covering and showing the earlier finished surface behind (1m scale)*

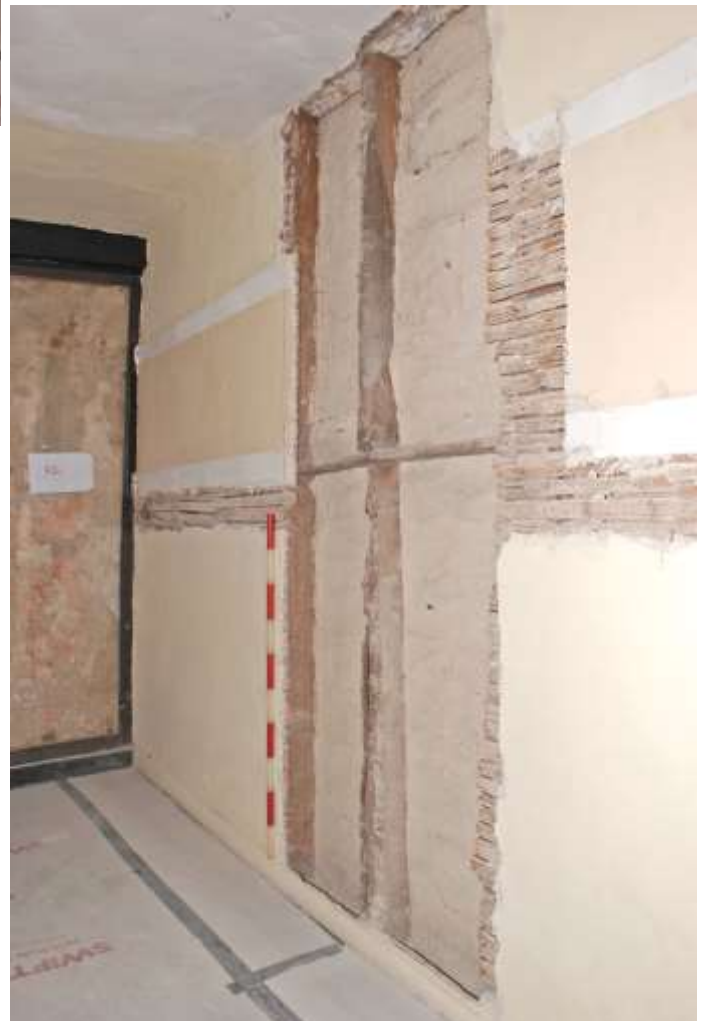
Fig.133: *As above, looking approximately east*

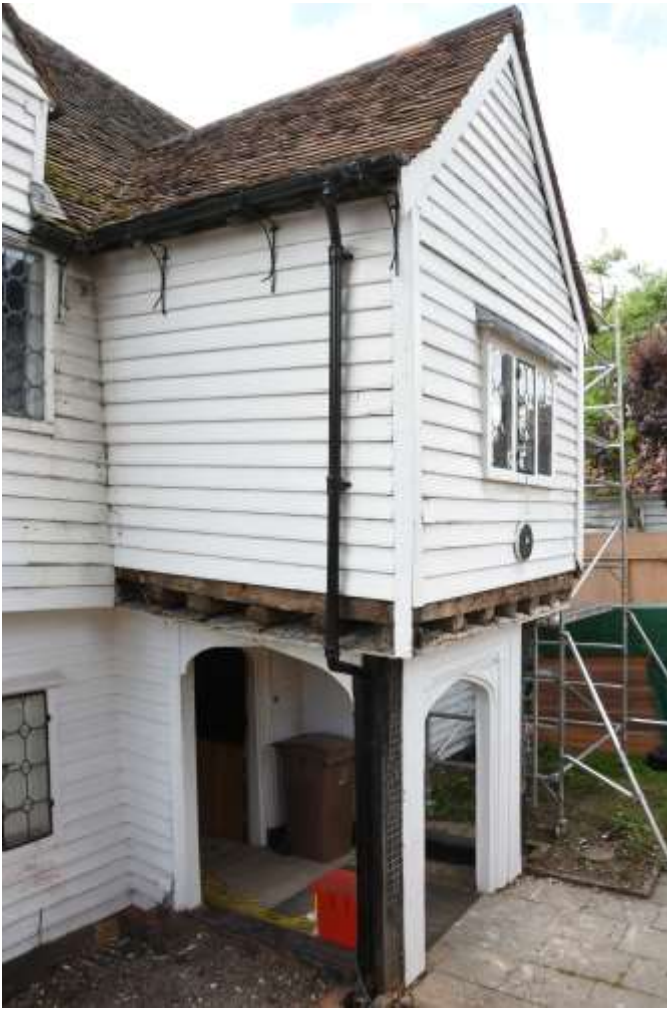
Fig.137: *General view of the porch and overlying room, looking northwest. The lines of weatherboarding have been removed to expose the projecting joists and overlying jetty bressumer*

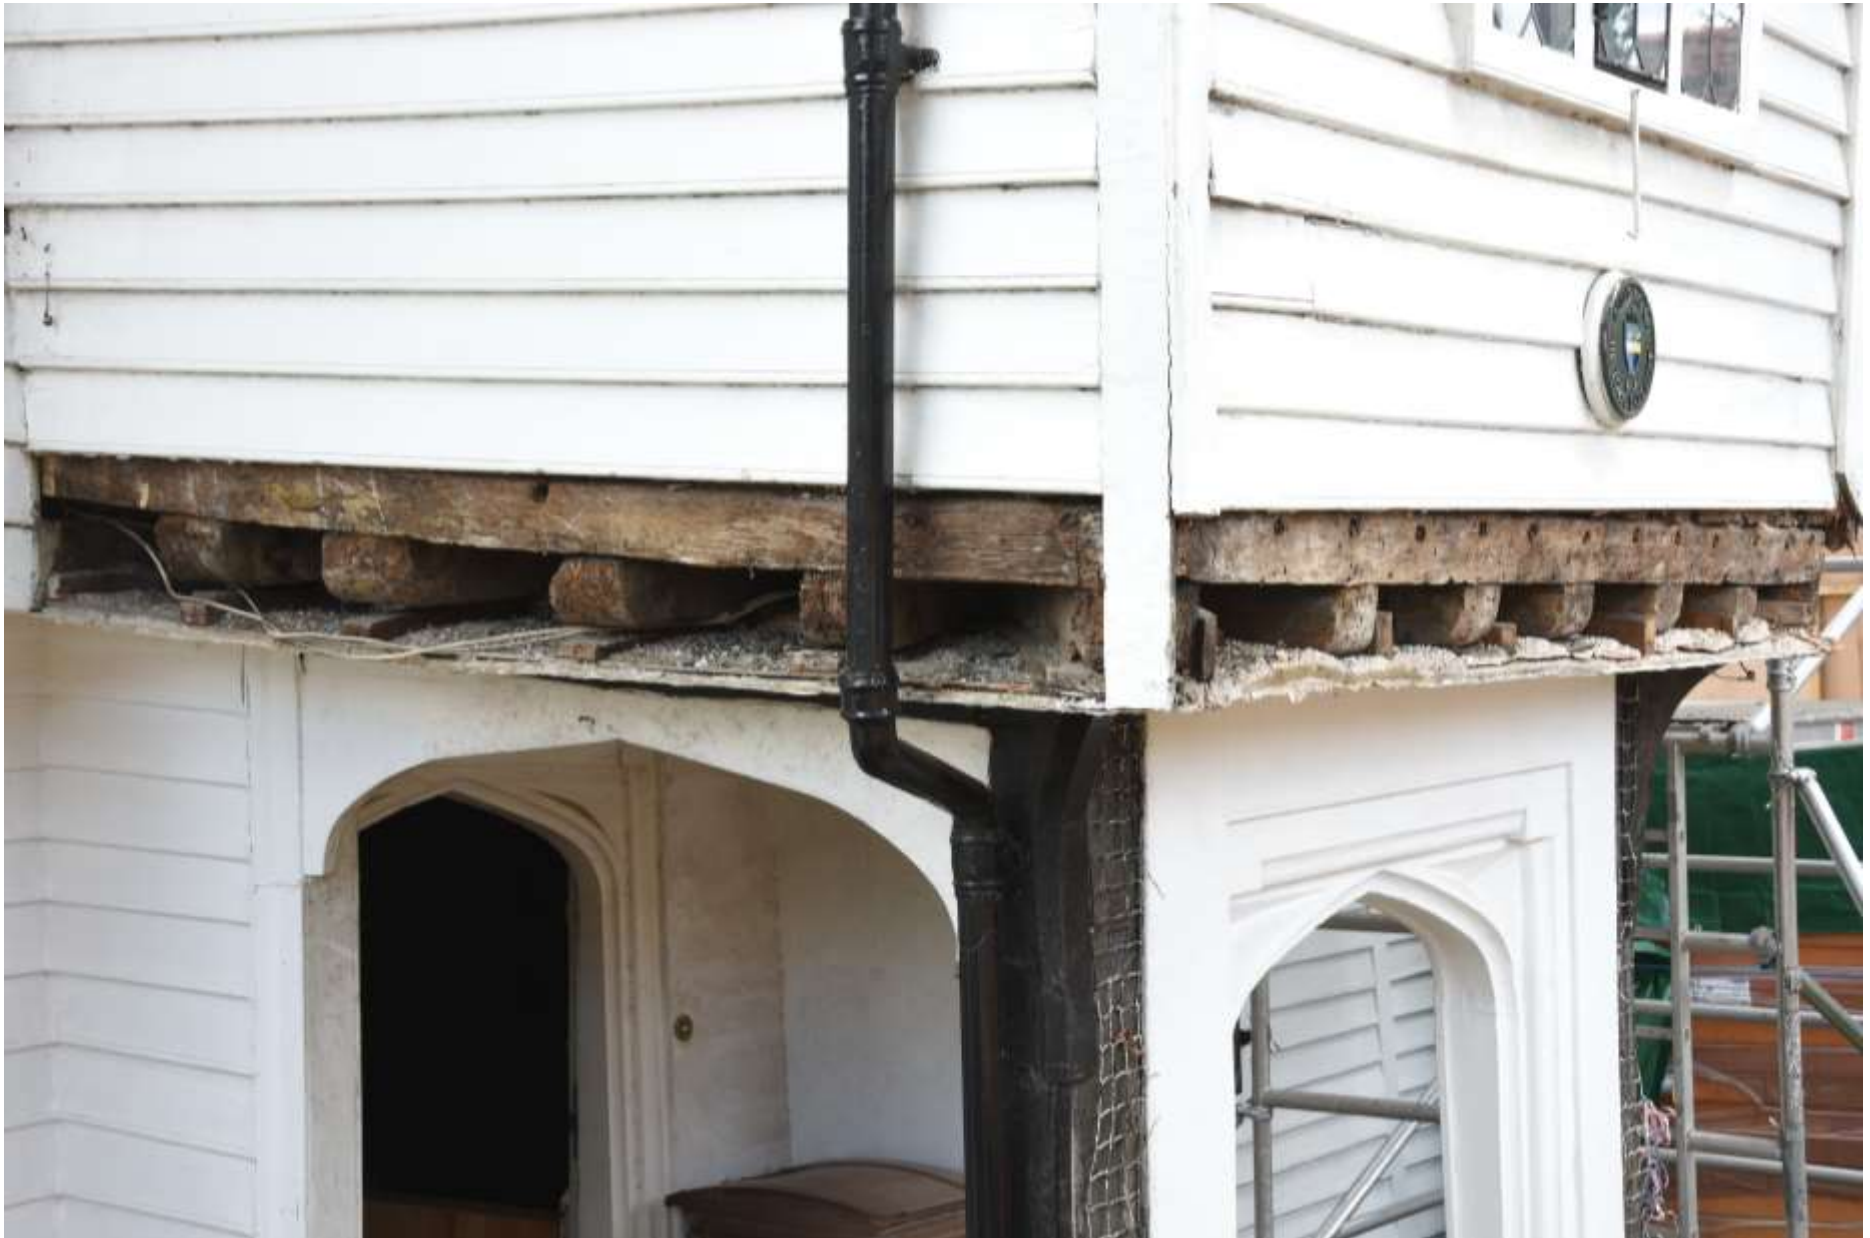
Fig.139: Detailed view of the jettied section of the porch. On the front (east) face the dowels securing the close-studded wall are also clearly visible

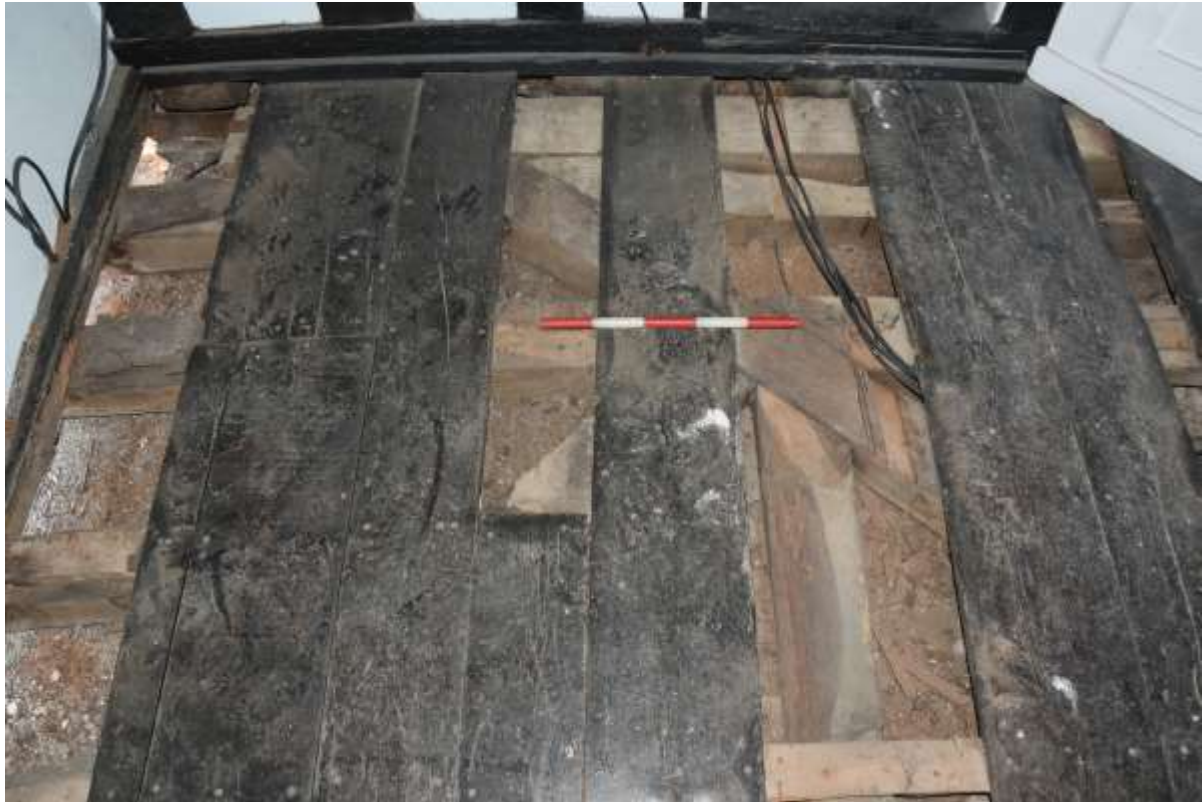
Fig.147: *Exposed floor timbers, looking from the outer side of the porch chamber back to the main frontage (0.5m scale)*

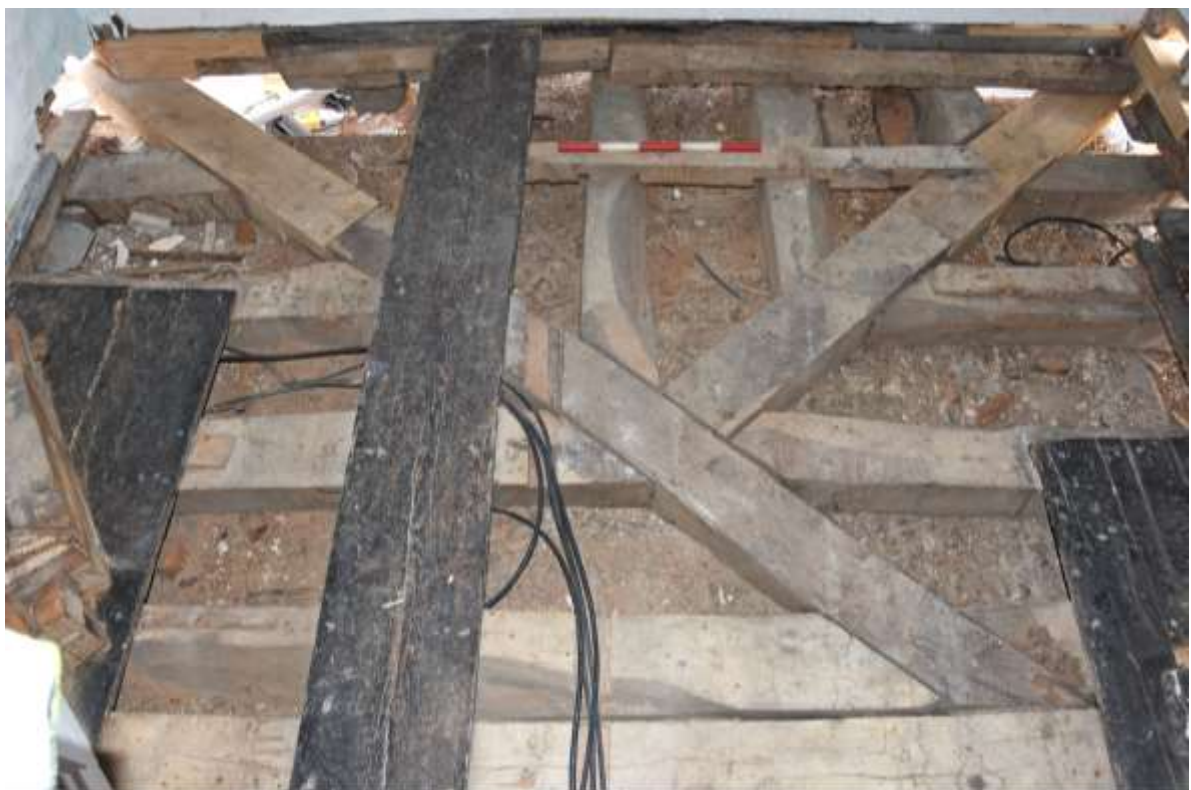
Fig.148: *A view looking in the opposite direction to the above, and after removal of further boards and some repair work to the underlying beams*

In the course of works several timbers (or at least parts at the outer corners of the porch) found to be decayed and in need of replacement. This process was also recorded, and sections of removed timber salvaged for further off-site examination and potential dendrochronological dating.

The timbers removed included parts of the diagonal oak beams, which – as well as the arrangements illustrated here – were also morticed into the underlying jetty brackets at the corners of the porch. Sections of the overlying jetty bressumer at each corner were also replaced (*cf.* Figs.151 & 153).

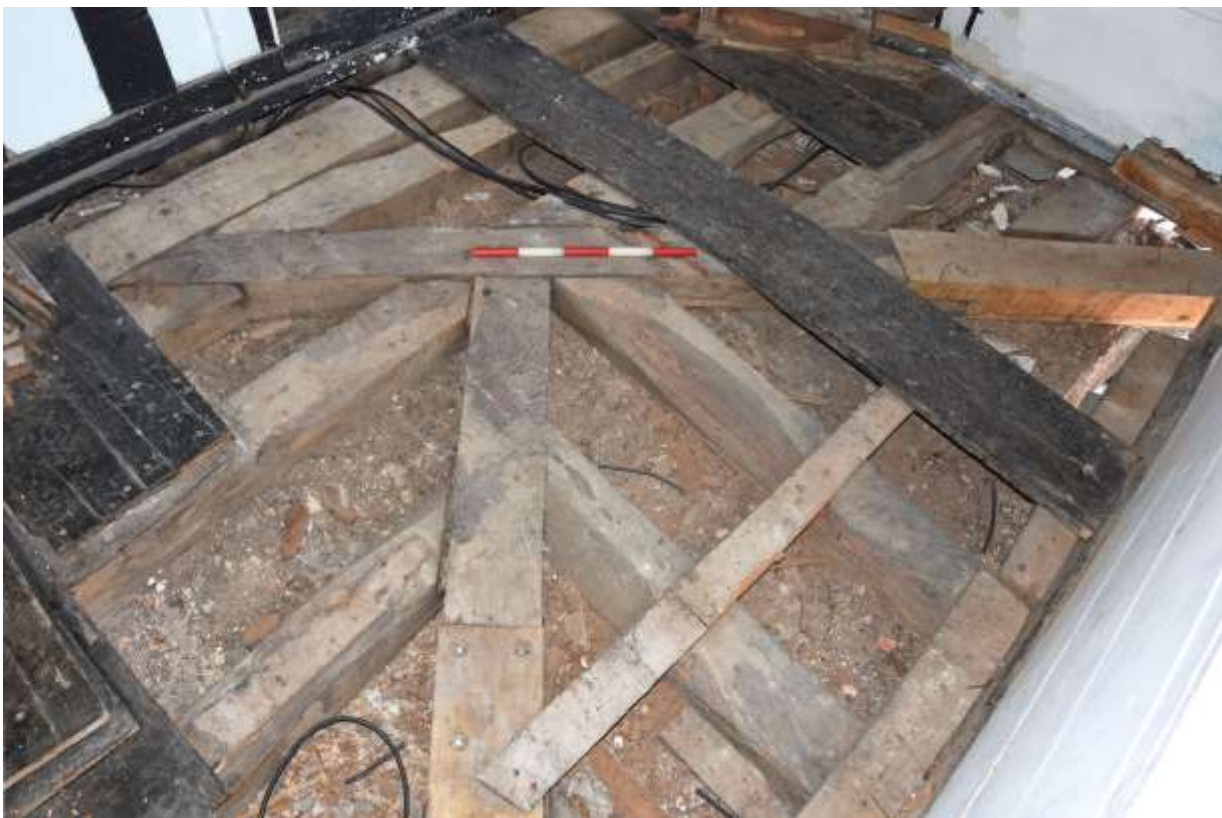
Fig.152 (below): A general view of the floor after replacement of the outer sections of the diagonal beams

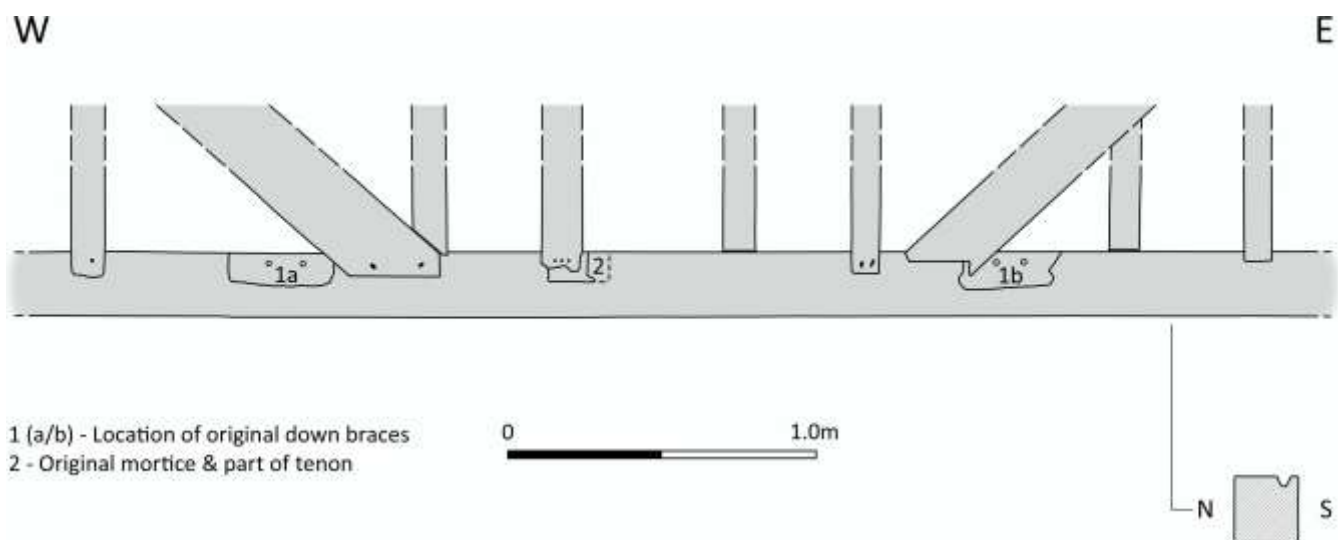
The overall length of the girding beam was *c* 5.74m, and cross-sectional dimensions approximately 200mm by 215mm (width x height): the height also reduced slightly towards the western end, to *c* 195mm. The beam had an apparently continuous V-

shaped groove cut into the upper face: where surviving intact this was some 40mm wide and a similar depth, and set back some 25mm from the front face (see Fig.163 inset).

Fig.163: *Elevation of the central part of the girding beam and associated timbers*

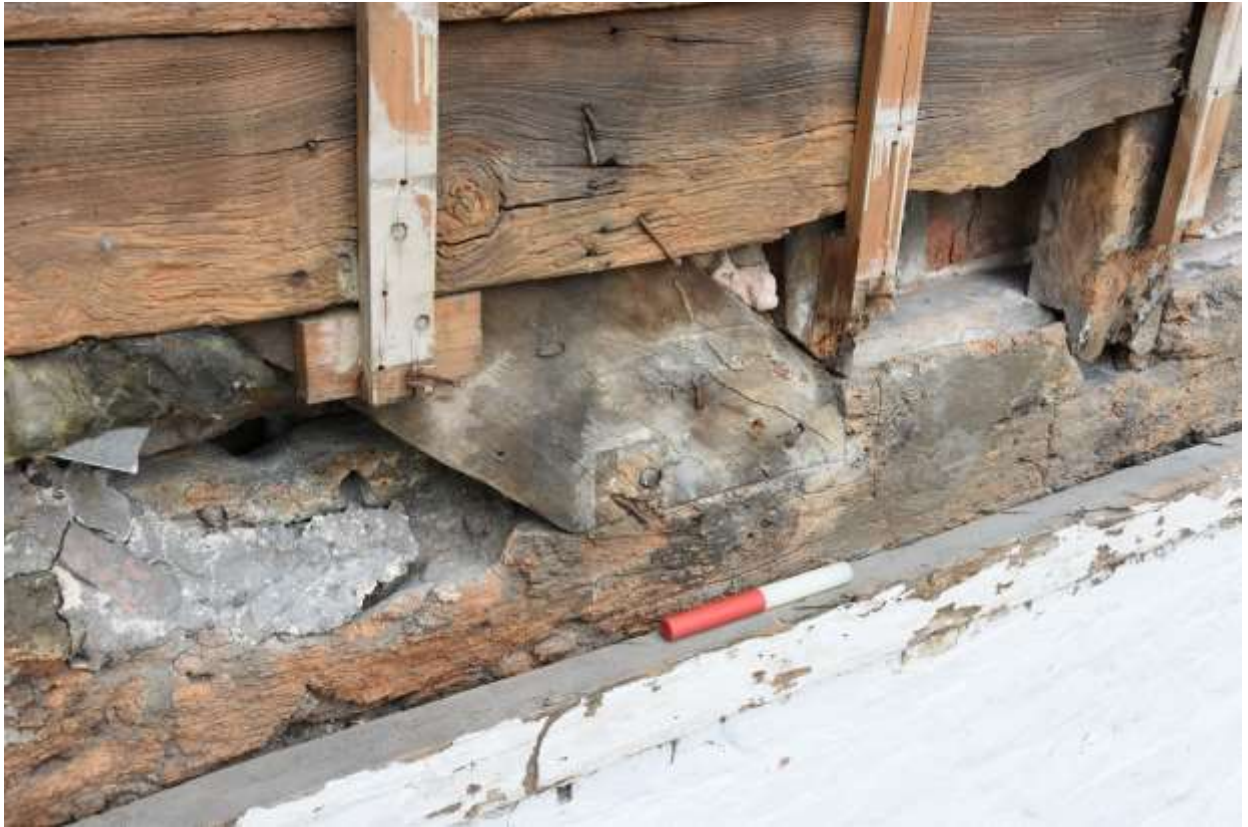
All the timberwork above this level was secondary, although some of the individual timbers may be reused. The construction itself was not of a comparable standard to the original, with the down braces quite roughly set near the top of the beam and nailed rather than pegged into substantial lap joints (Fig.166). Similarly the studs were variously placed on or stepped over the front beam, or utilised existing mortices or slots (*eg.* Figs.165, 169 & 174).

Fig.167: *Oblique view of the western down brace, with the earlier cut-out in the foreground*

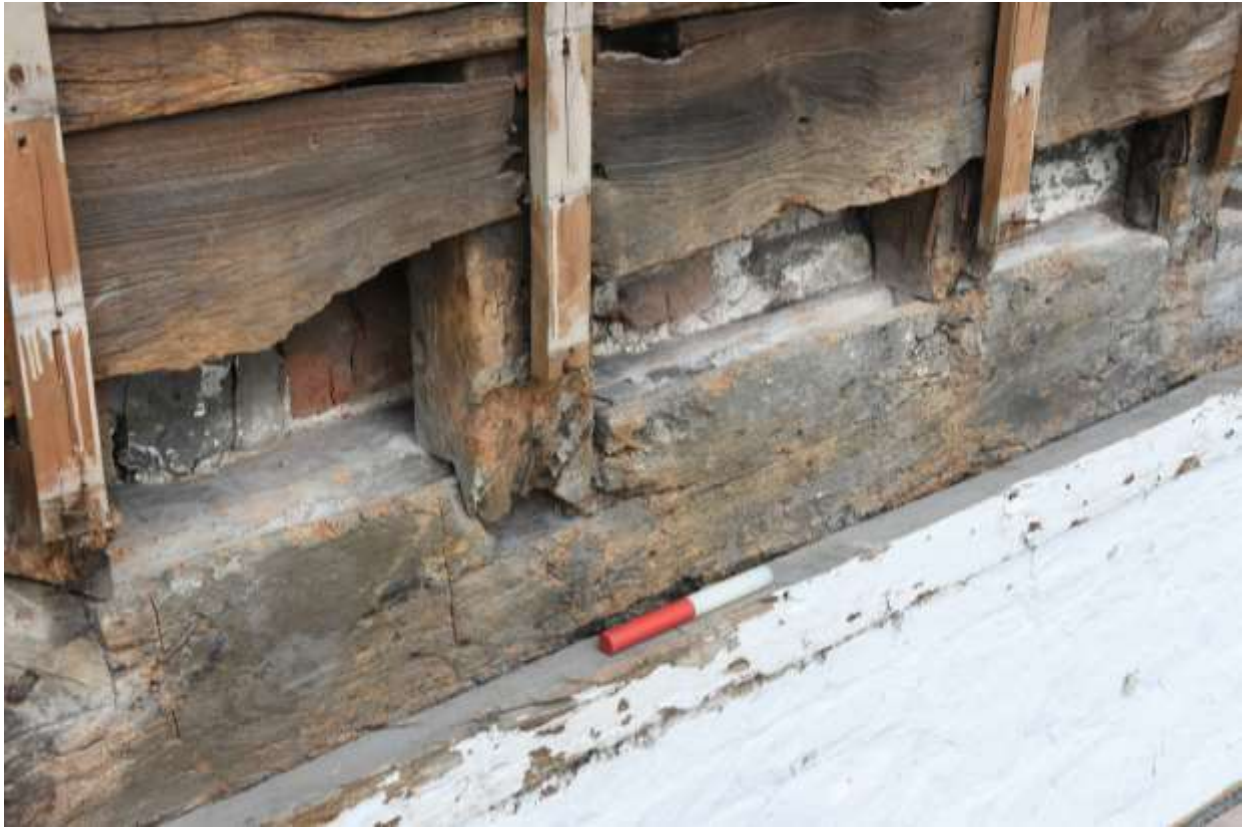
Fig.169: View of the studs and girding beam between the two down braces, looking north (0.2m scale)

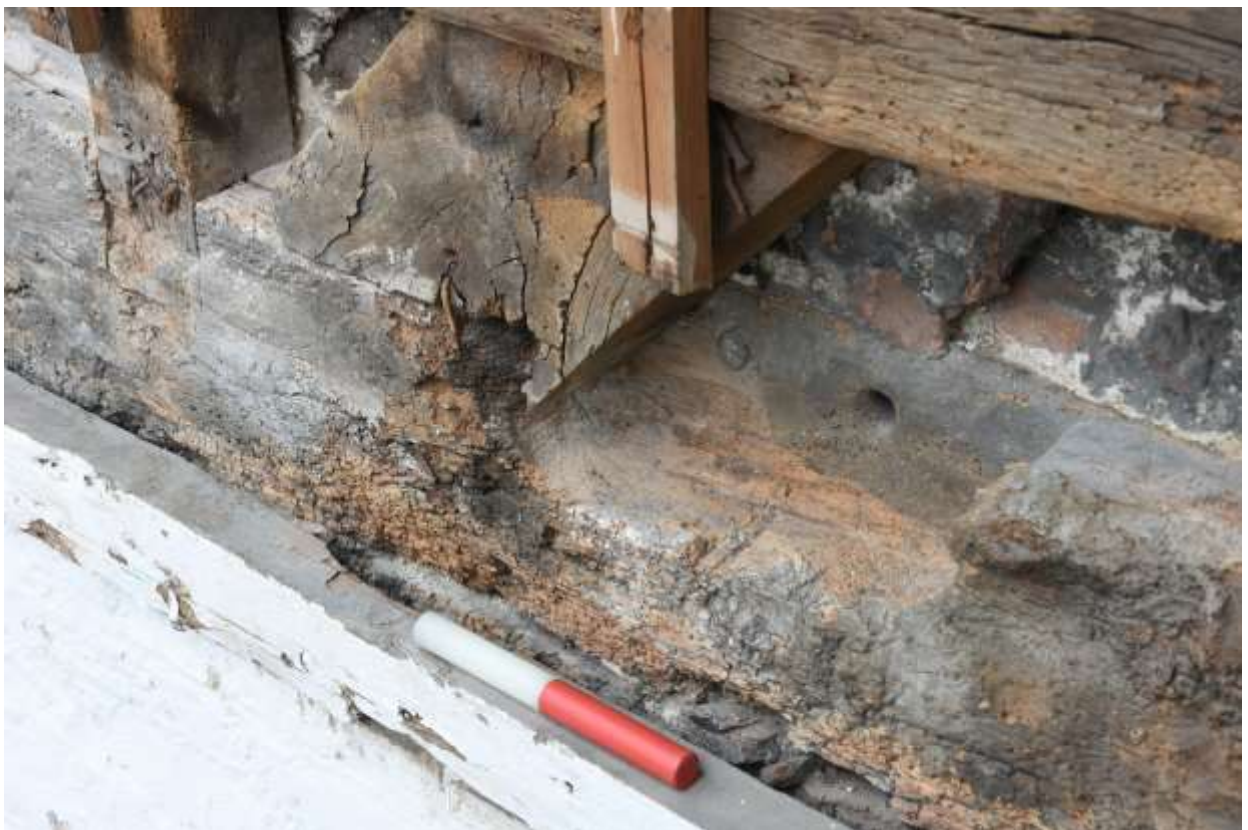
Fig.172: As above, oblique view with the earlier cut-out in the foreground

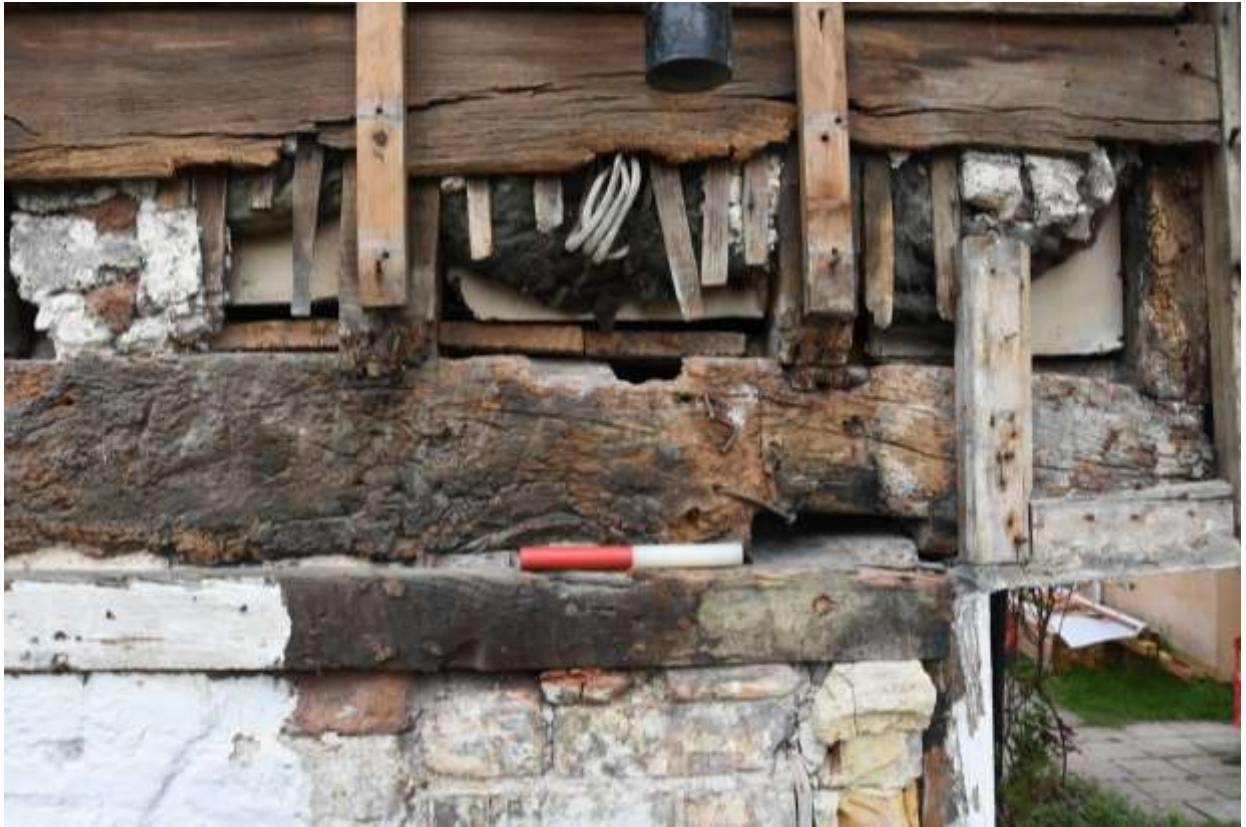
Fig.173: The eastern end of the girder beam, extending over the jetty to the right. Immediately to the right of the 0.2m scale the base is cut away to form a lap joint with the adjacent N-S beam

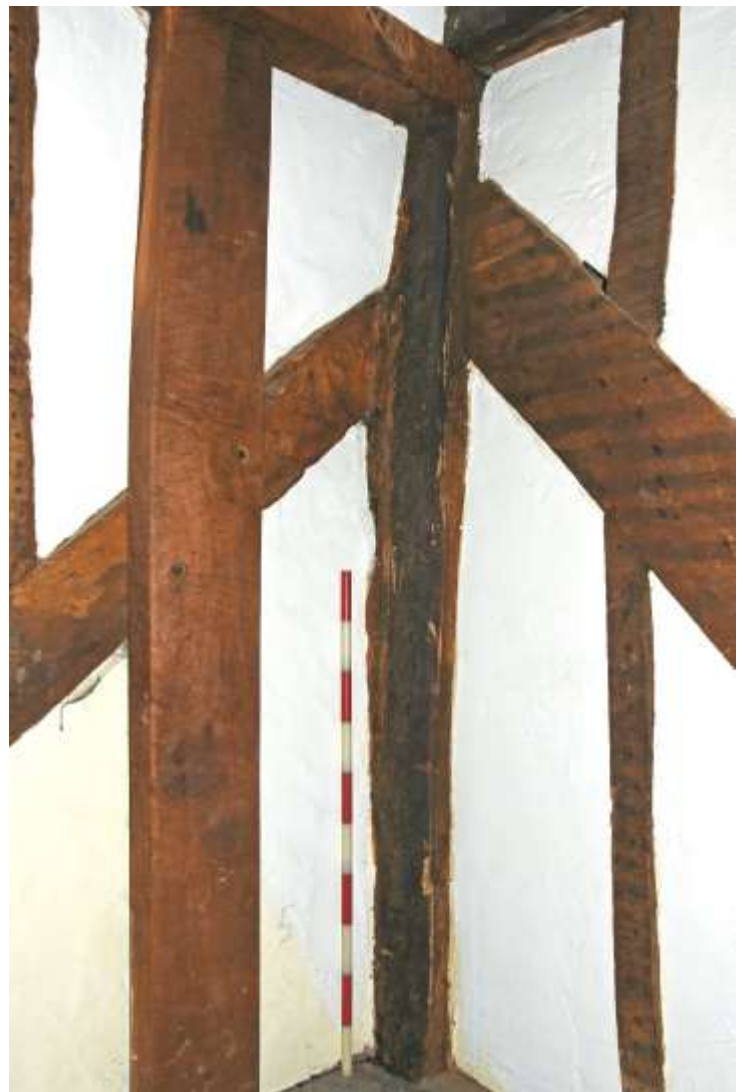
Fig.177: *The southwestern corner of the room, the principal post also containing several redundant mortices or lap joints – in the east face roughly level with the top of the 1m scale, and two above & below this in the north face (c 100mm to 200mm in length)*

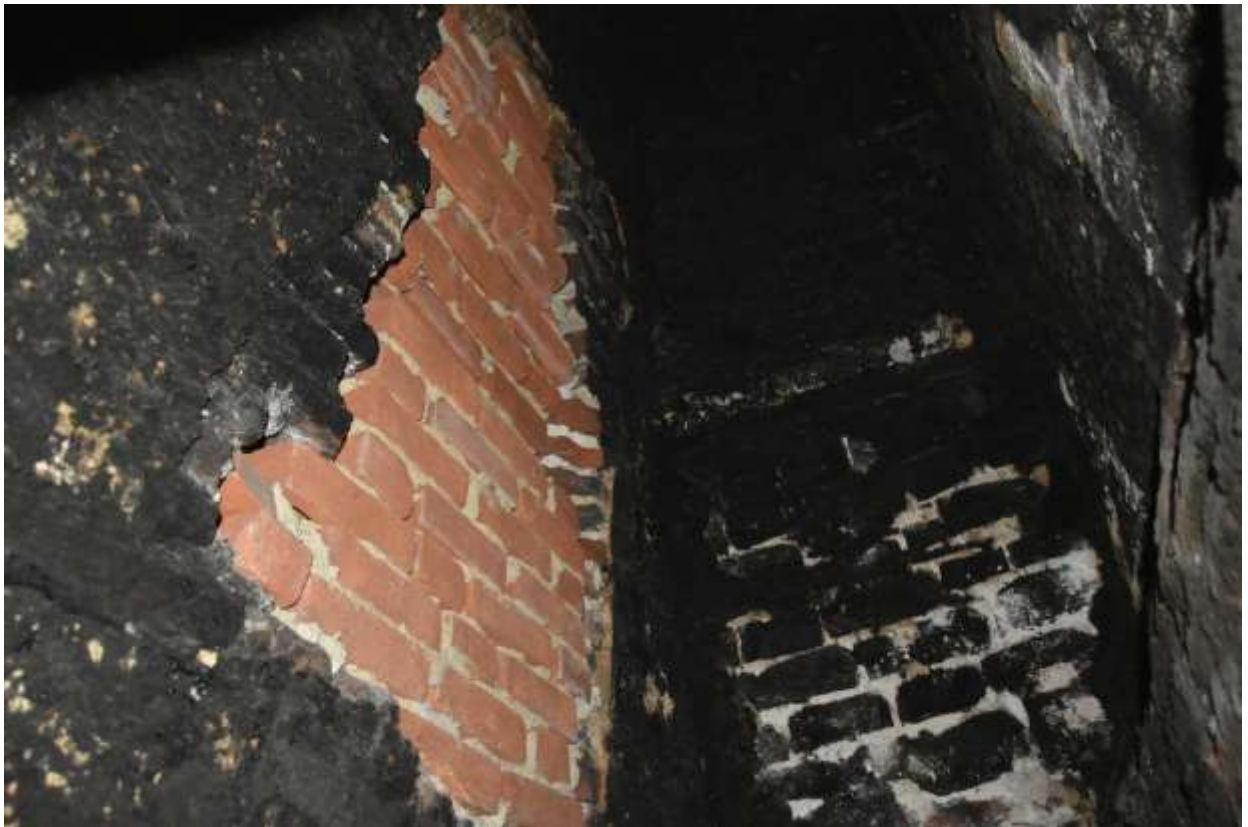
There was some indication on the internal face of the southern wall for the rebuild observed outside and described in the preceding Section. Evidence was also obtained for fairly recent (probably mid 1970s) blocking within the chimneystack, to the rear of the fireplace (*cf.* Figs.178-79).

Fig.179: Another view of the above, looking approximately northeast

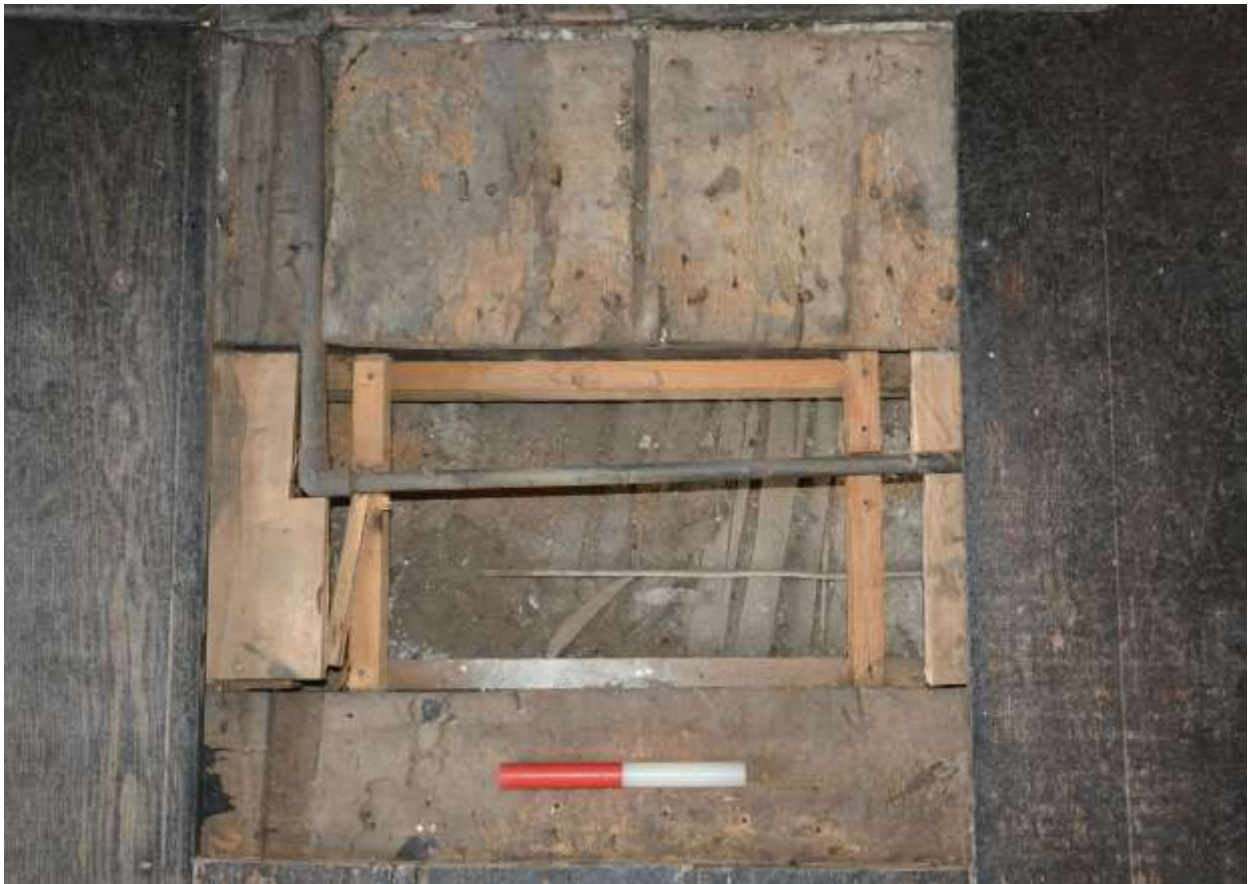
The preliminary (2016) investigations in this area included removal of a small section of flooring on the south side of the room. This revealed earlier boards immediately under the present covering, as illustrated below. However, subsequent works to east and west did not expose any further evidence, so the actual extent of these is probably quite limited.

Fig.180: *Earlier floorboards immediately in front of the hearth (at top of frame), exposed during preliminary investigations in March 2016*

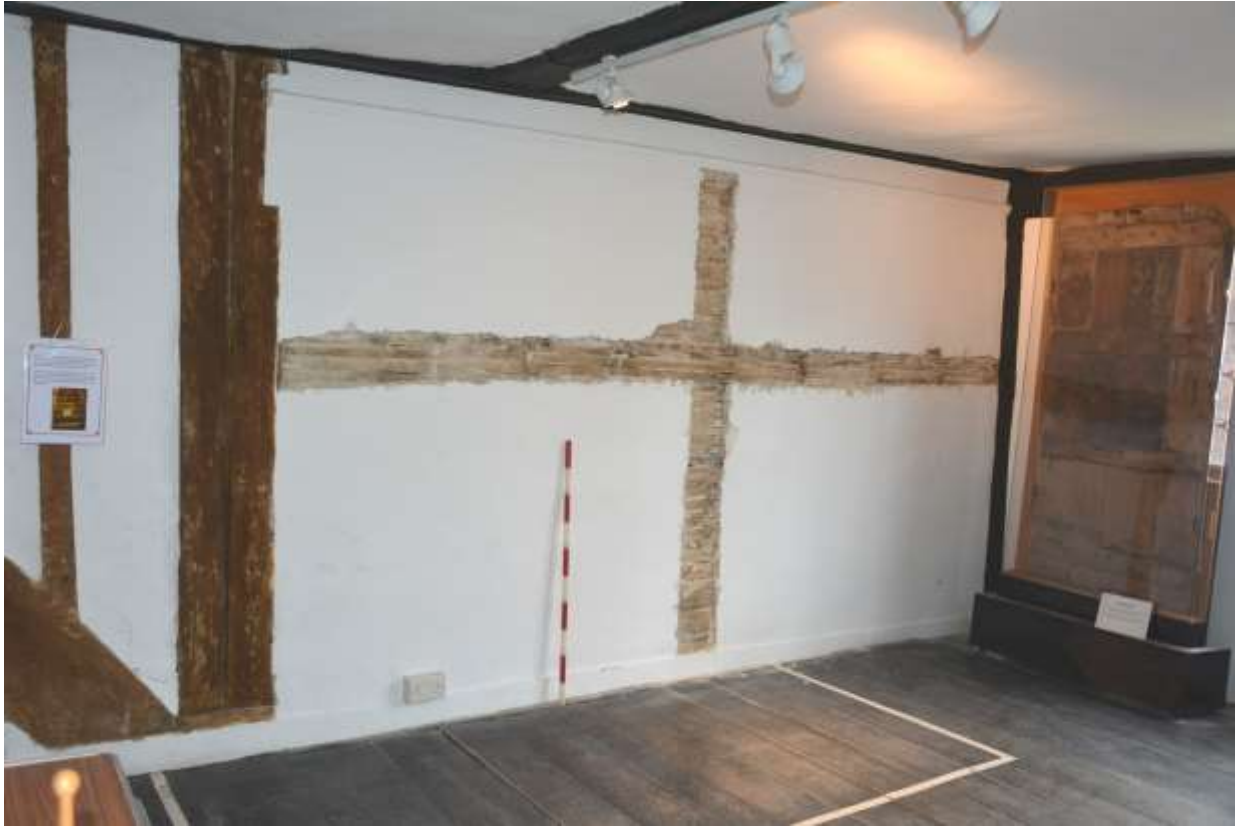
Fig.181: A picture taken during the preliminary investigations in Room F-04, which also shows part of the outline of the original stair opening marked out on the floor against the north wall

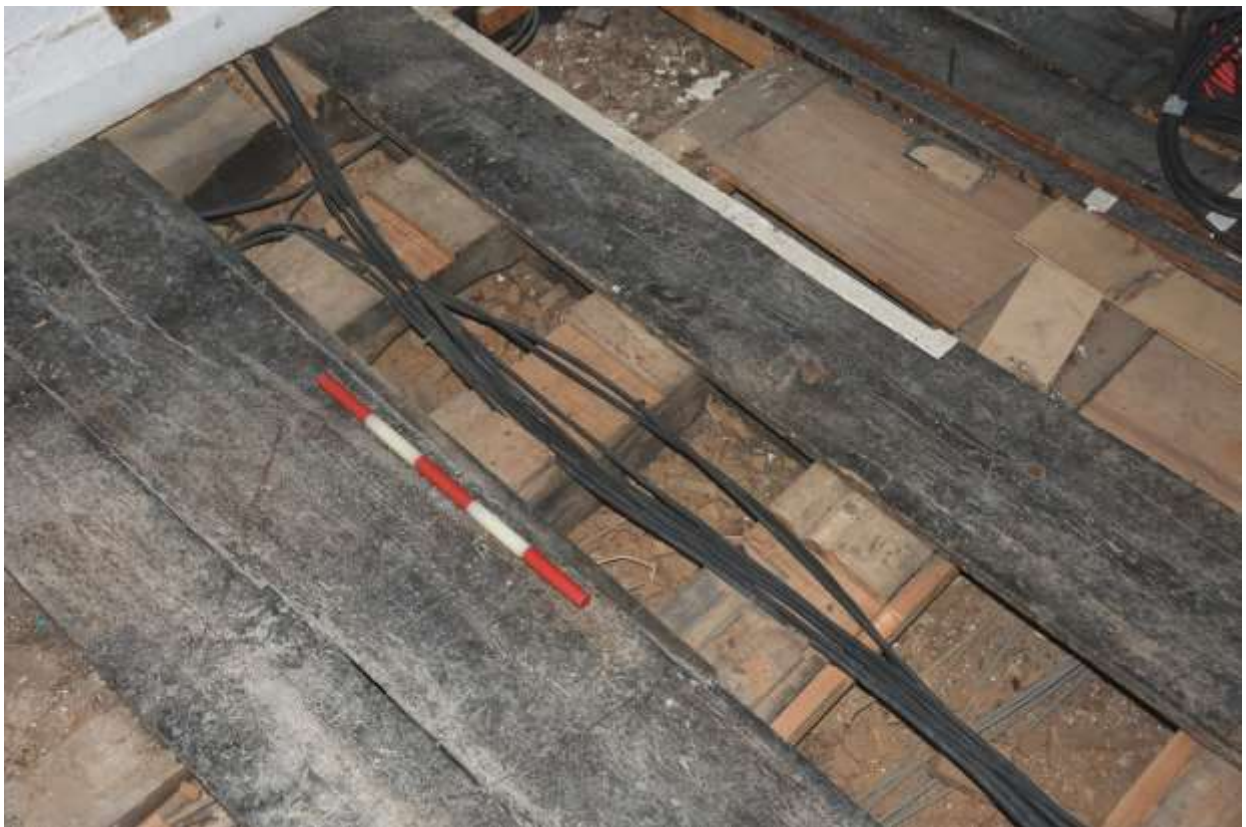
Fig.186: As above, but an oblique view looking towards the northern wall. In the centre foreground is a grooved joist, which to the east forms one side of the staircase opening

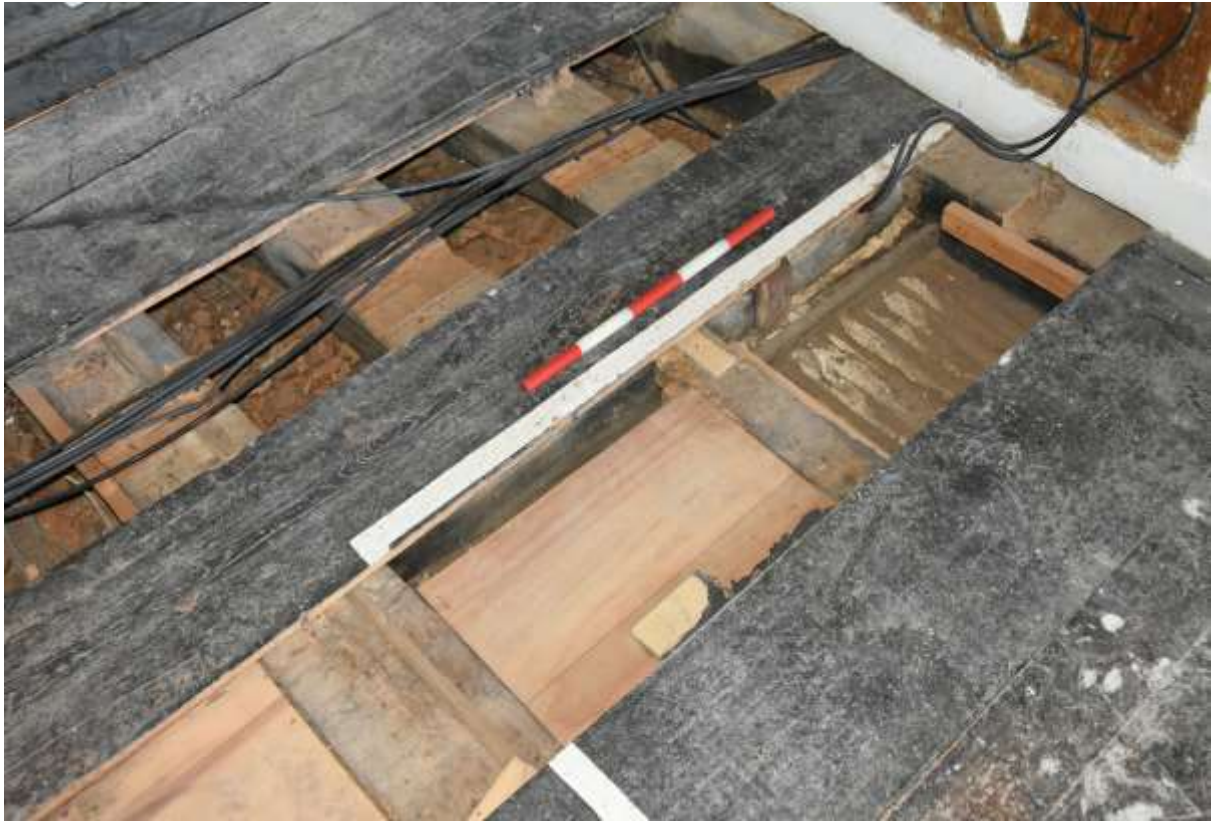
Fig.187: View from the centre of the room with the western end / southwest corner of the staircase opening in the foreground, including the grooved joist on its southern side

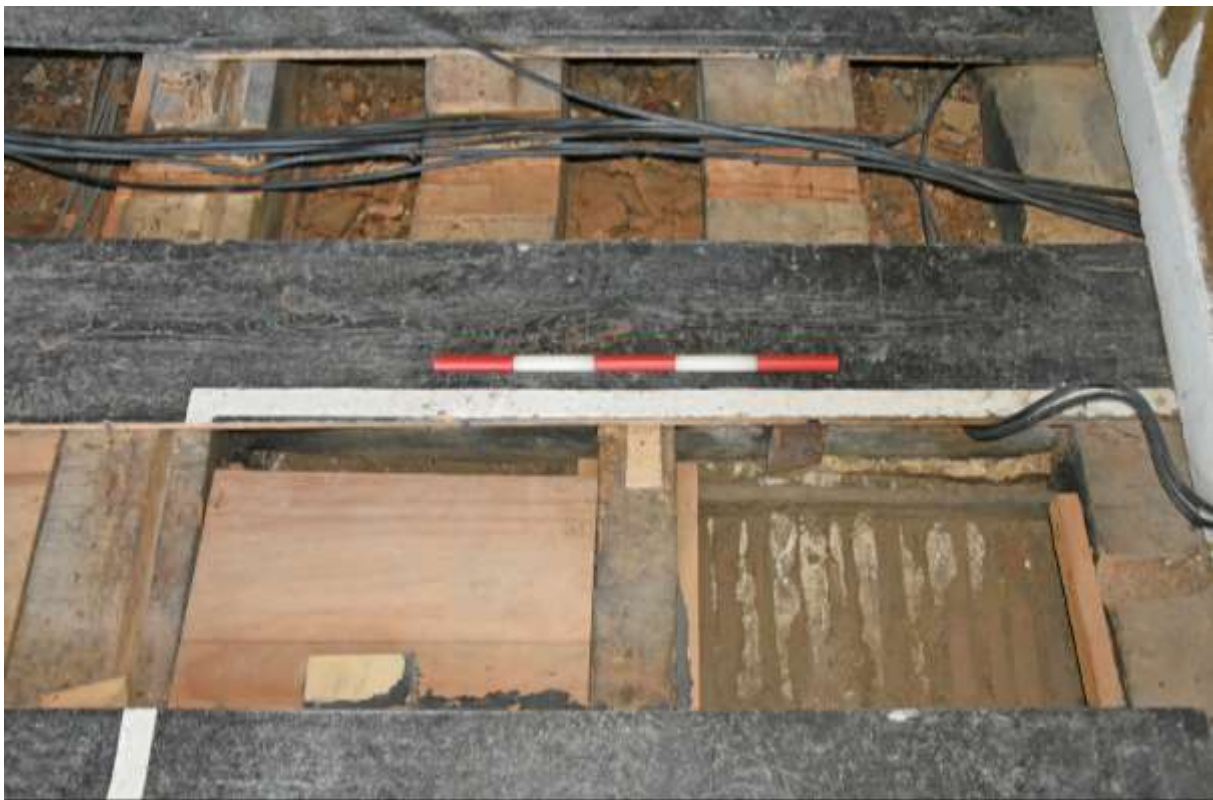
Fig.188: View of the former staircase opening looking west, the grooved joist to the left and the trimming piece forming its western end below the 0.5m scale & in situ floorboard. Also on the right-hand side and just below the wiring that runs under the floorboard is a short length (c 300mm) of plastered face, which presumably also relates to the original opening

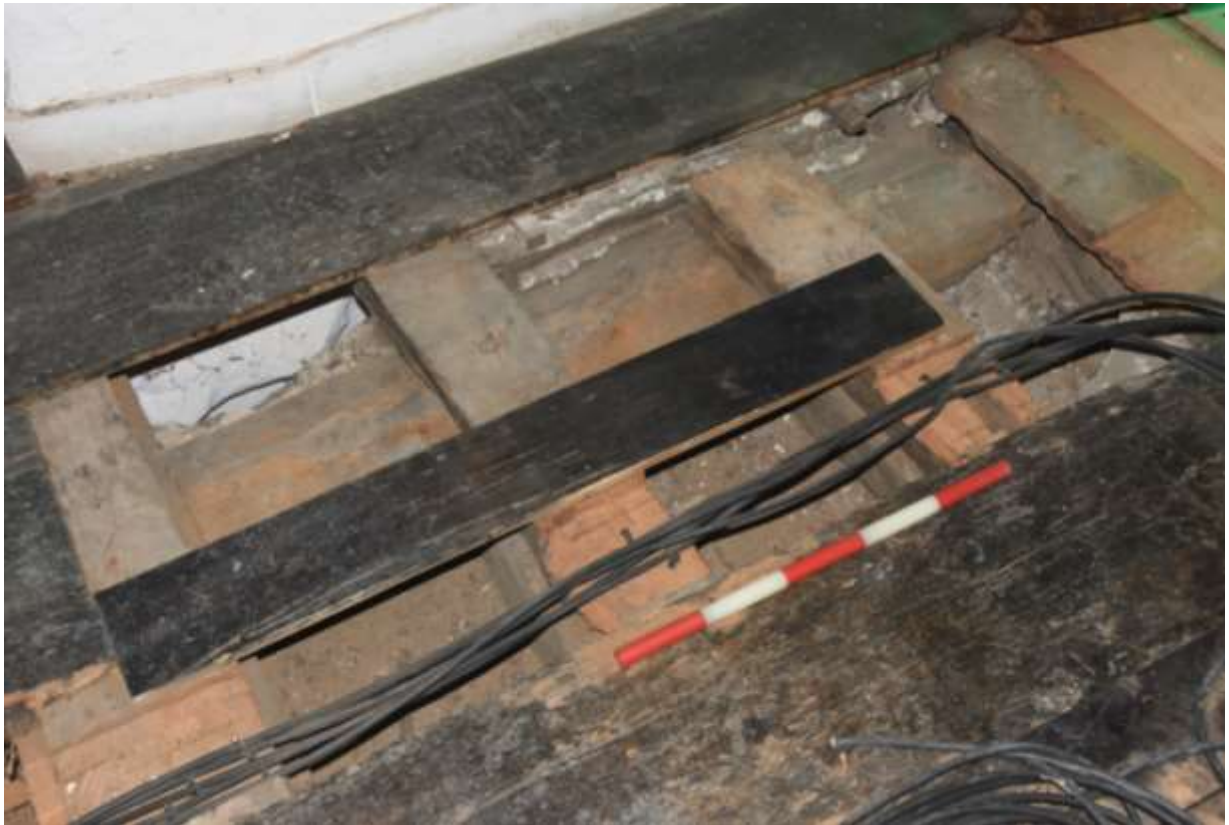
Fig.189: A view of the joists and trimming piece on the western side of the chimneystack – although in this area both overlain by later and narrower beams on which the floorboards rest

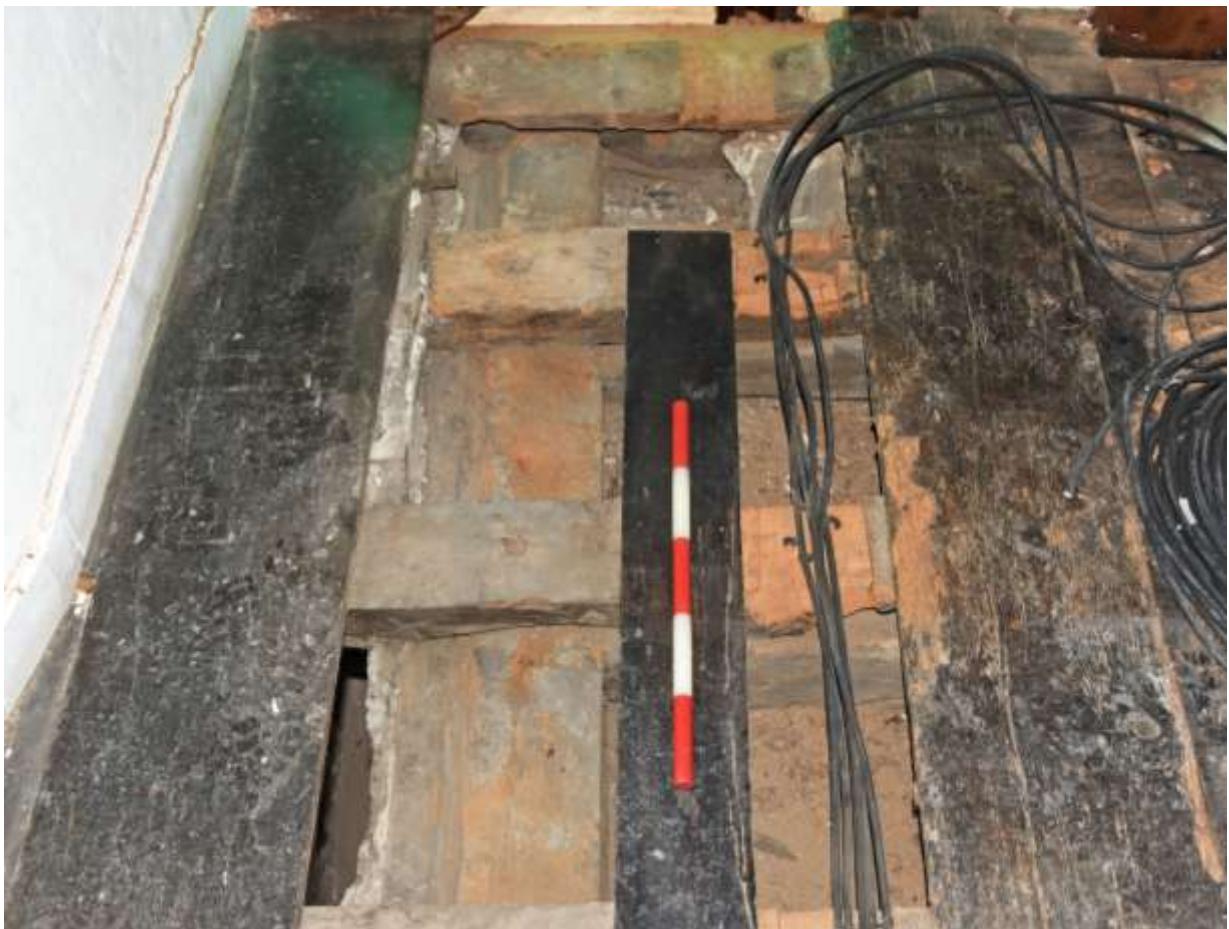
Fig.190: A further view of the above, looking south and with the chimneystack to the left
