9. THE FIRST FLOOR

The impact of works on the first floor was variable, with significant evidence being recorded in the central corridor (F-02) and the Porch Chamber (F-03), both internally and on the external wall of Room F-04, and most extensively within the rear extension Room F-07.

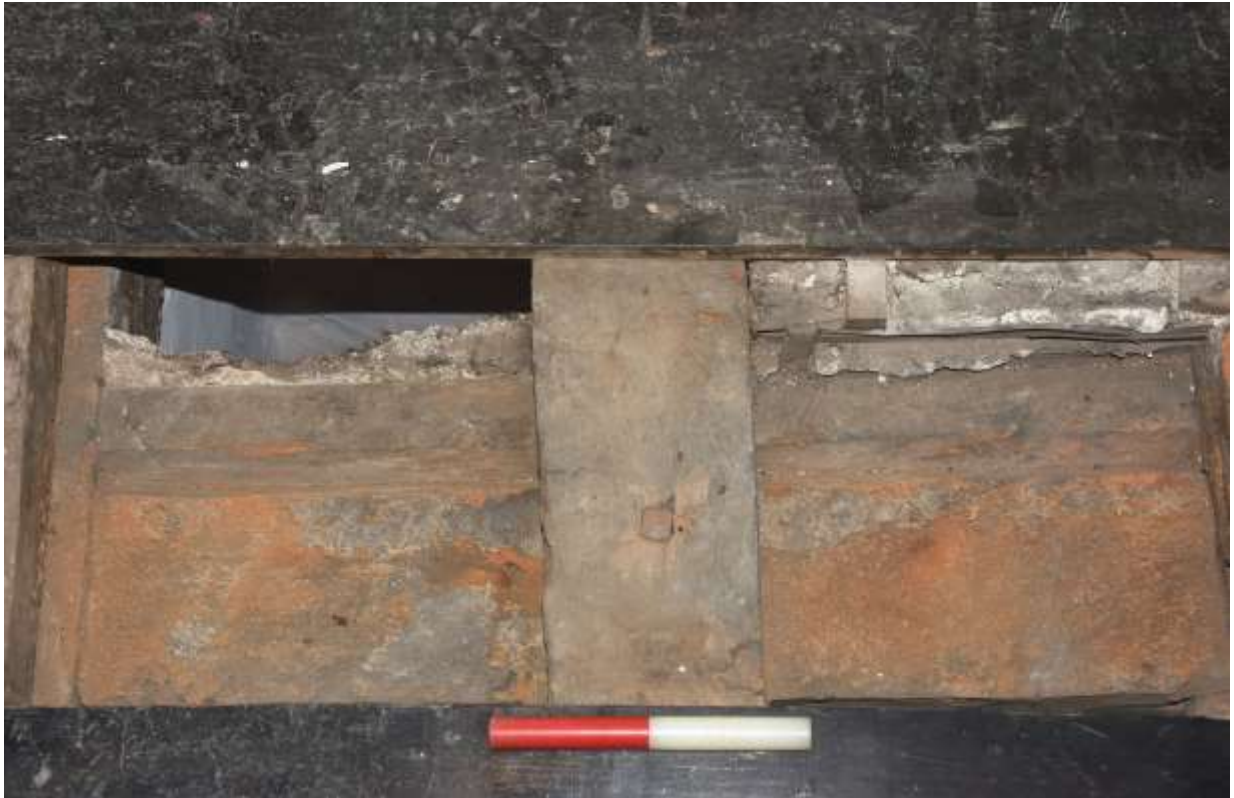
Fig.191: *Detailed view of the grooved trimming piece to the west of the chimneystack, adjoining a continuous beam at the left-hand (northern) edge of the frame – both overlain by later joists supporting the present floor*

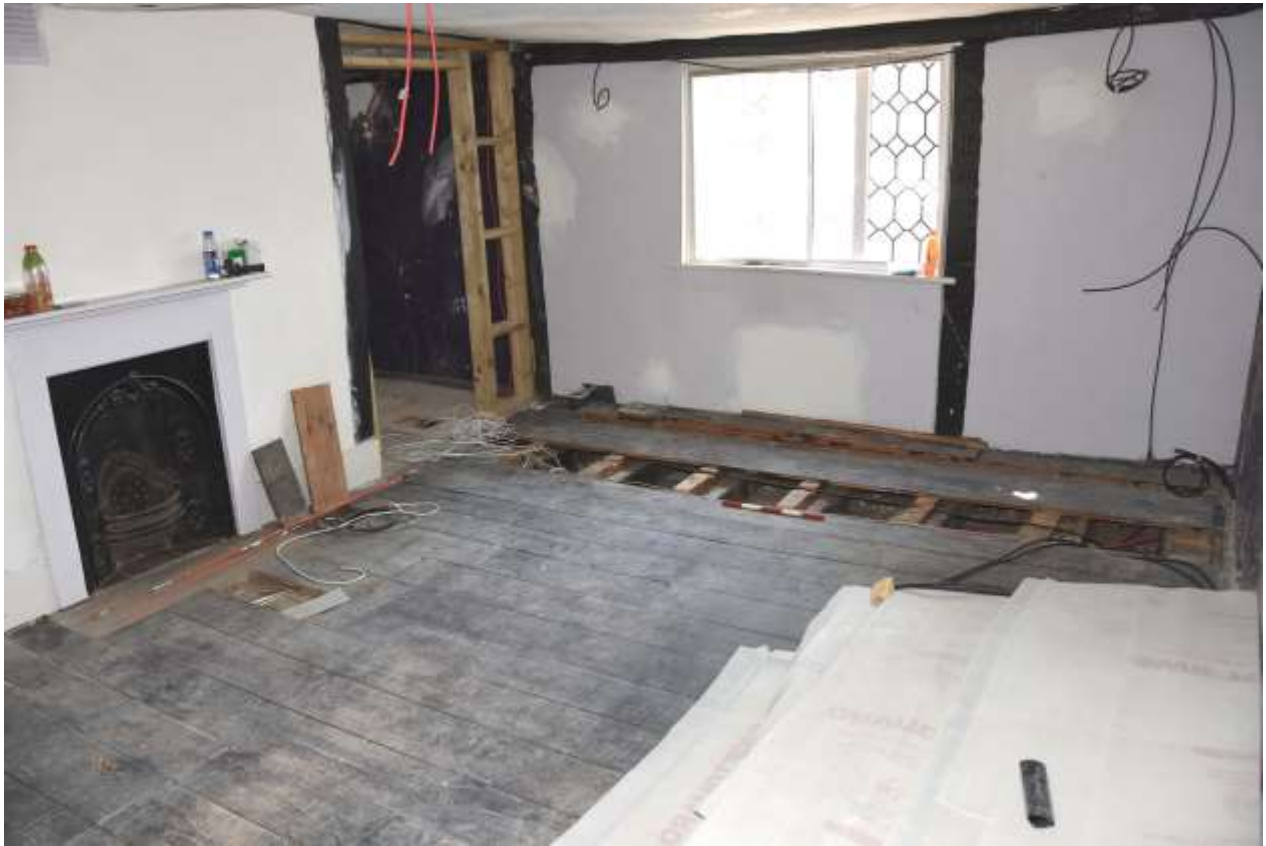
A modern partition across the southern part of the room (not shown on plan) was removed in the early stages of works. Apart from that changes were limited: a shorter partition between the chimneystack and the front (east) wall was replaced and the doorway relocated, as shown in progress below (Fig.193). This partition was also

Fig.193: *General view of works in Room F-10*

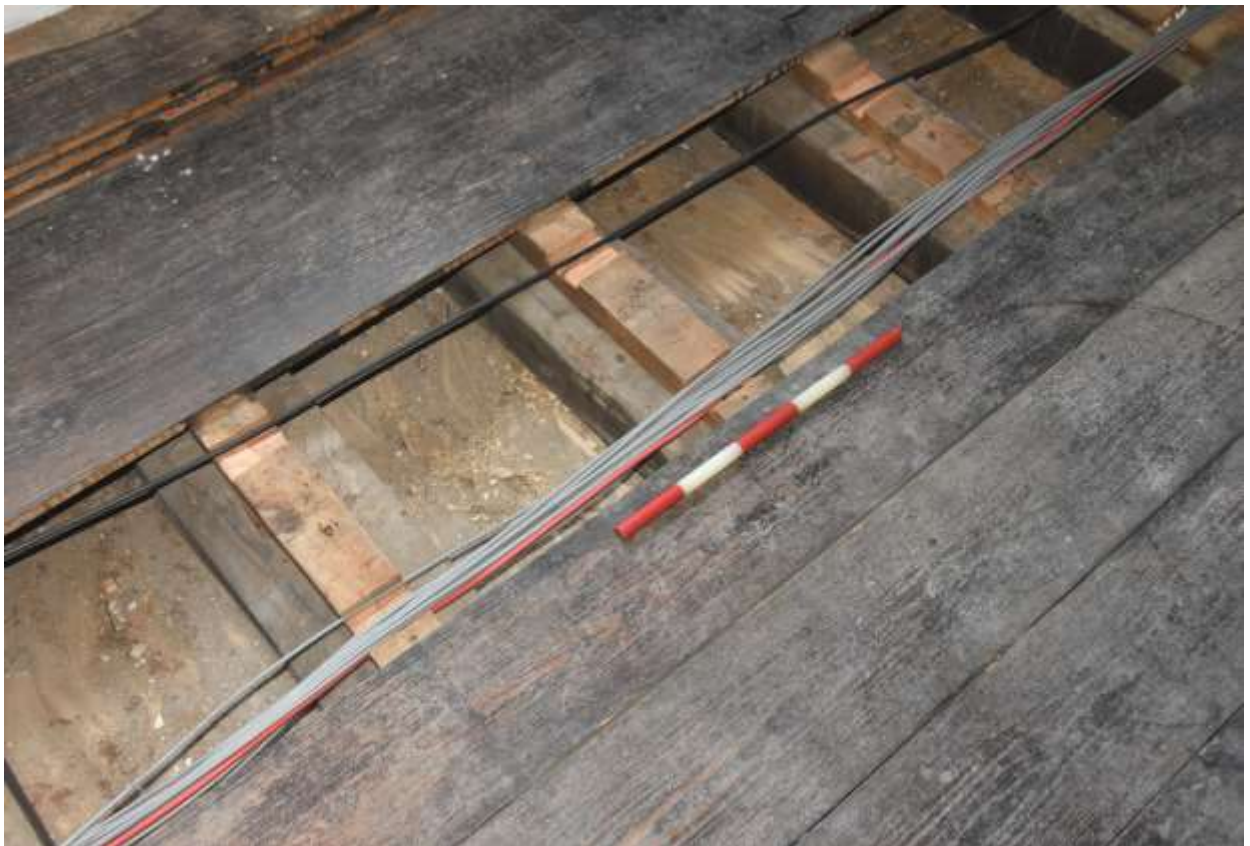
Below the window several floorboards were lifted in order to locate new services (Figs.194-95). As elsewhere this revealed that the present floor was a fairly recent reconstruction: the previous floor had been removed and narrow secondary timbers laid over the original joists.

The seven east-west joists that were examined had a quite uniform cross-section, 222mm to 240mm wide by 140mm to 148mm high: the spacing between was also fairly constant, at 312mm to 350mm. The narrow overlying timbers ranged in depth from 33mm to 71mm, increasing towards the centre of the floor and presumably laid in this fashion to correct a previous downward bow. The floorboards themselves also appeared to be fairly recent, softwood timbers *c* 217mm to 230mm wide by 20mm to 21mm thick.

Fig.195: *As above, oblique view looking approximately east*

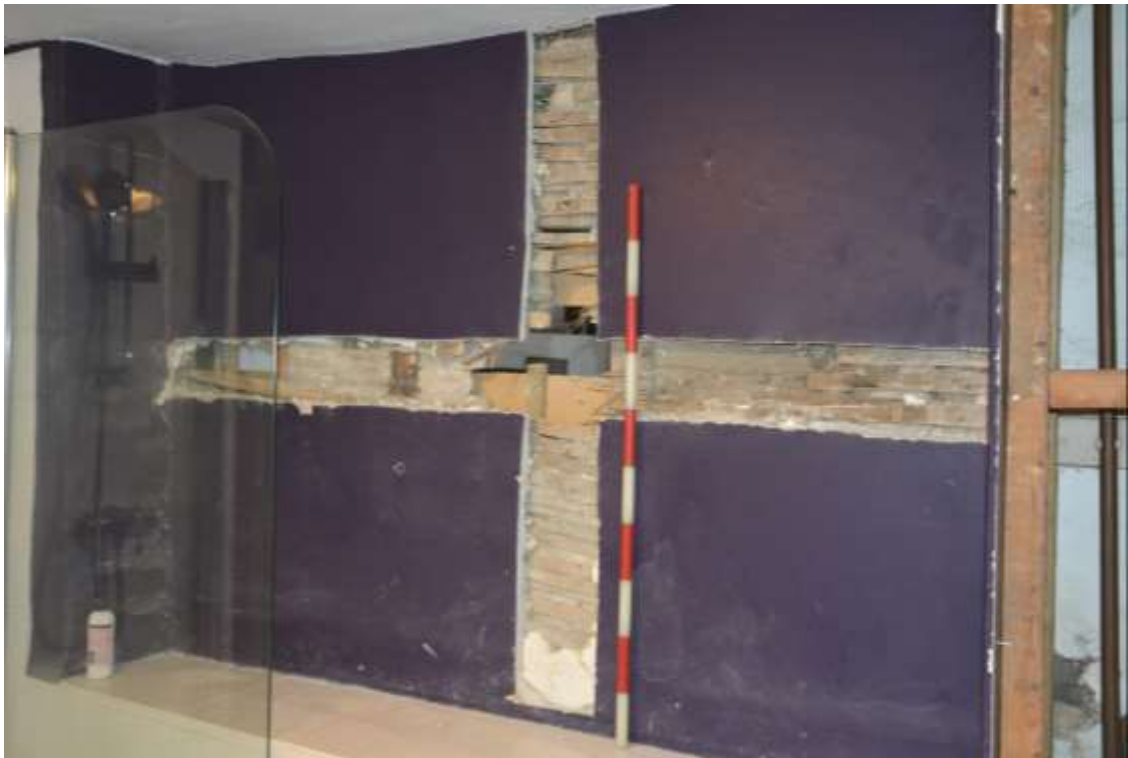
Fig.196: *Lath & plaster in Room F-12, exposed by preliminary works in March 2016*

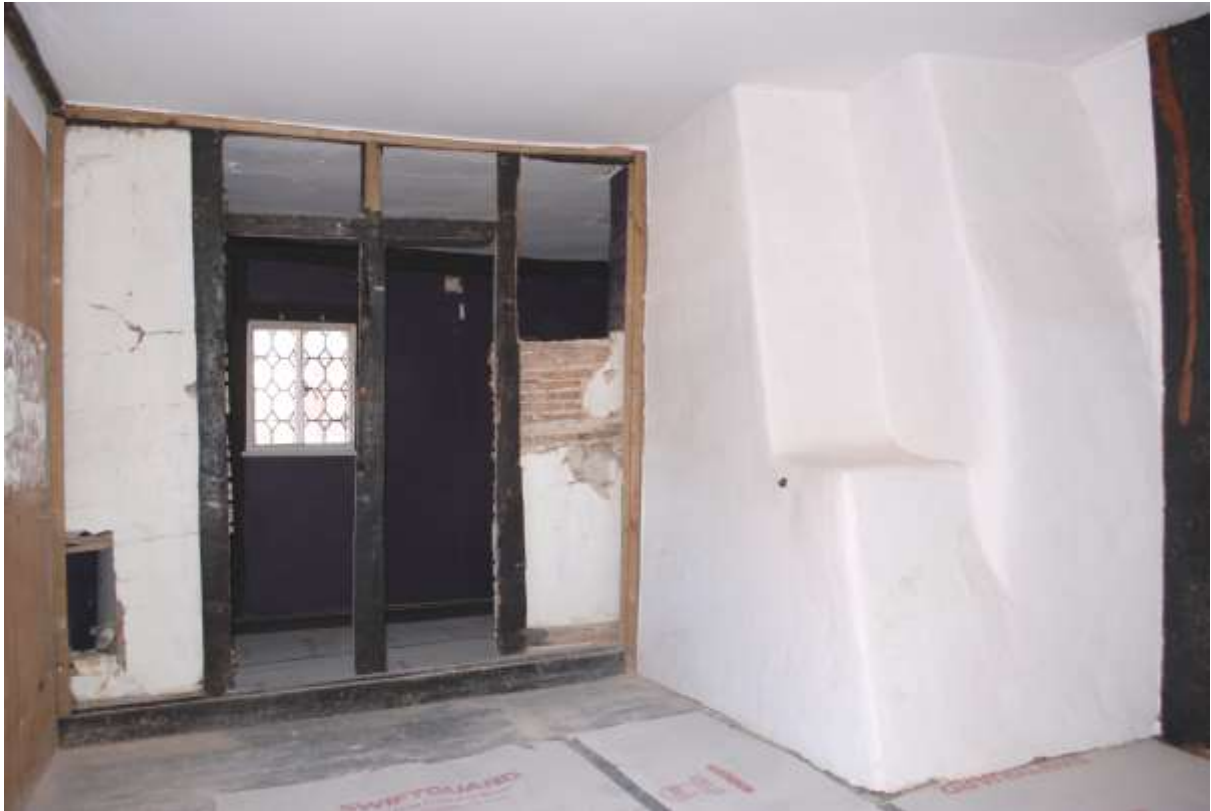
The wall is evidently later than the adjacent building, and probably formed the subdivision of an originally single room. The construction was quite rough, with several specific observations to support this conclusion:

Fig.197: *The area after removal of lath and plaster wall coverings, looking from Room F-11 towards the front of the building with the chimney stack on the right*

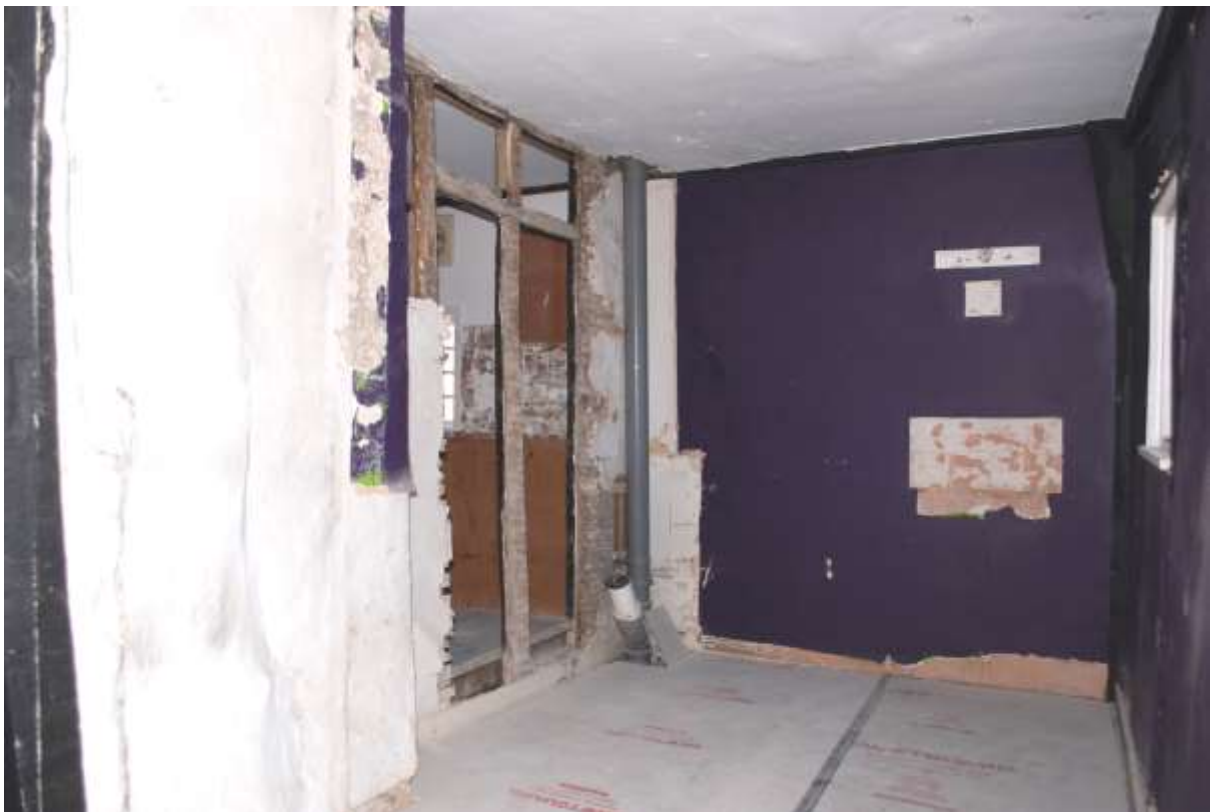
Fig.198: *As above, looking from Room F-10 towards the northern end wall*

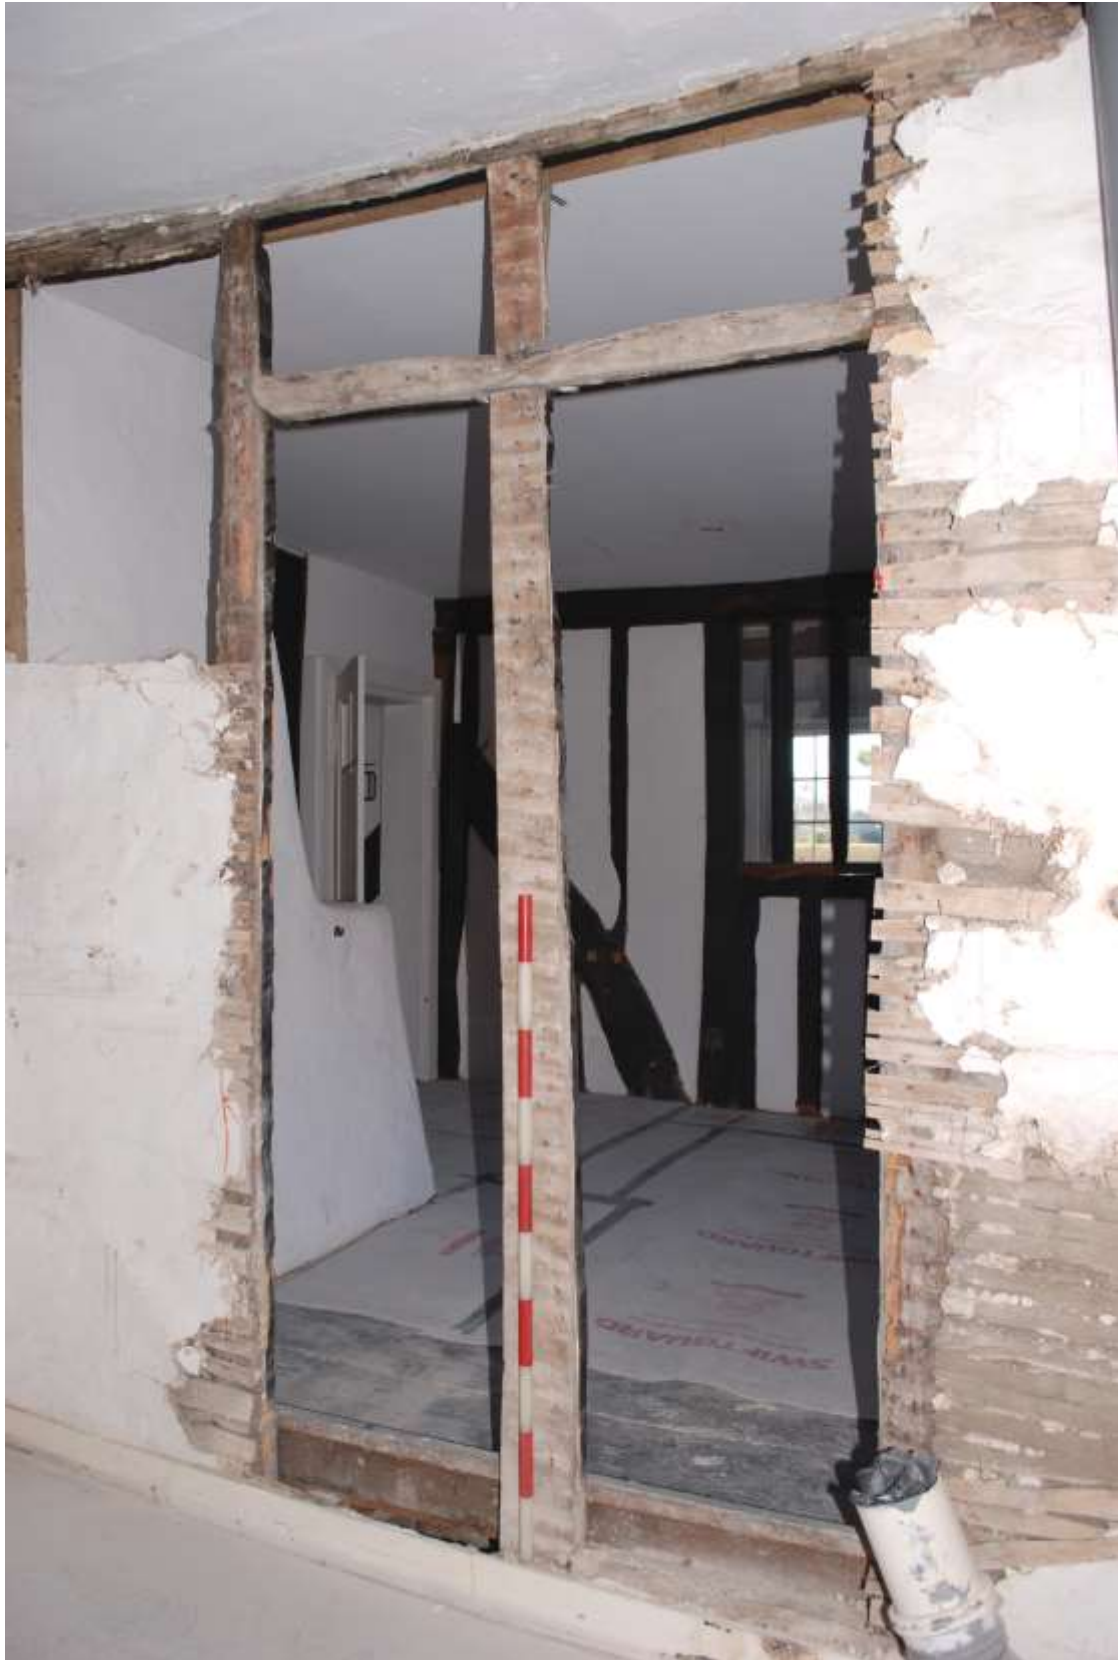
Fig.199: View from the northeast corner of the building, with timber framing of the original rear wall in the background – the same perspective as the earlier Fig.196 (1.0m scale)

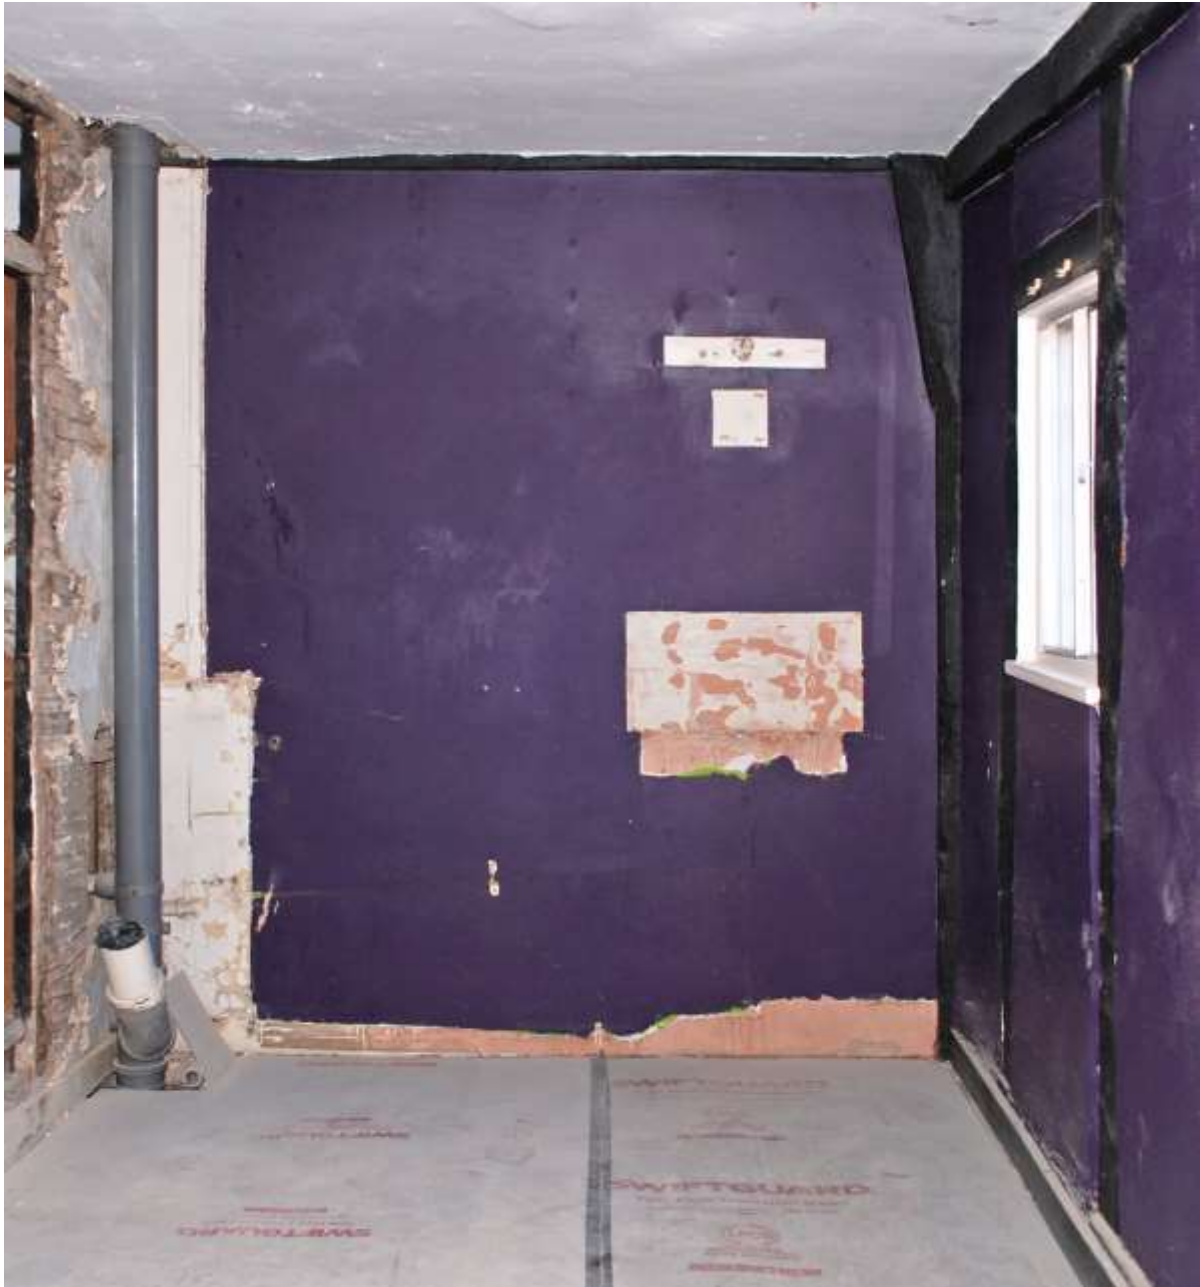
Fig.202: A further view of Room F-12 to highlight the jowled corner post (or root-stock) at top right – a widening of the vertical timber to accommodate jointing with the tie beam (to left) and wall plate

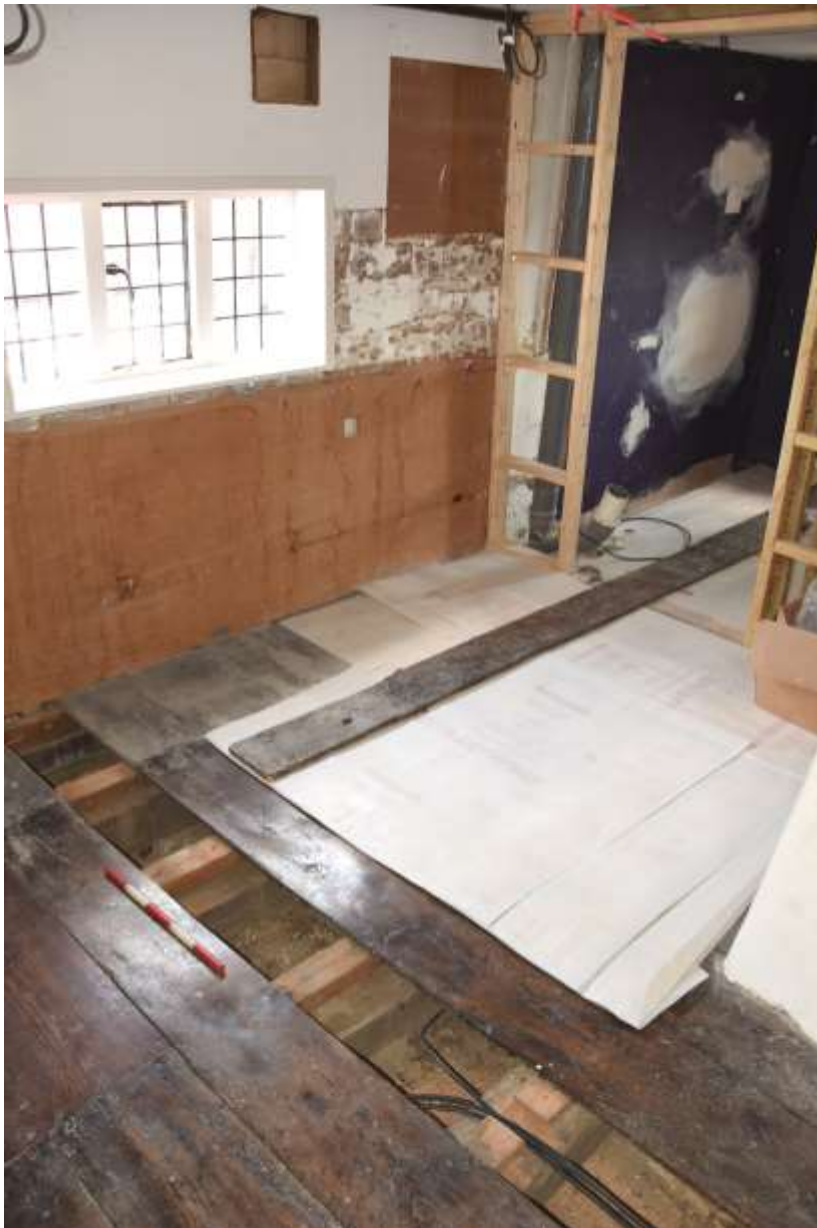
Fig.203: *General view of Room F-11, looking towards the northern wall*

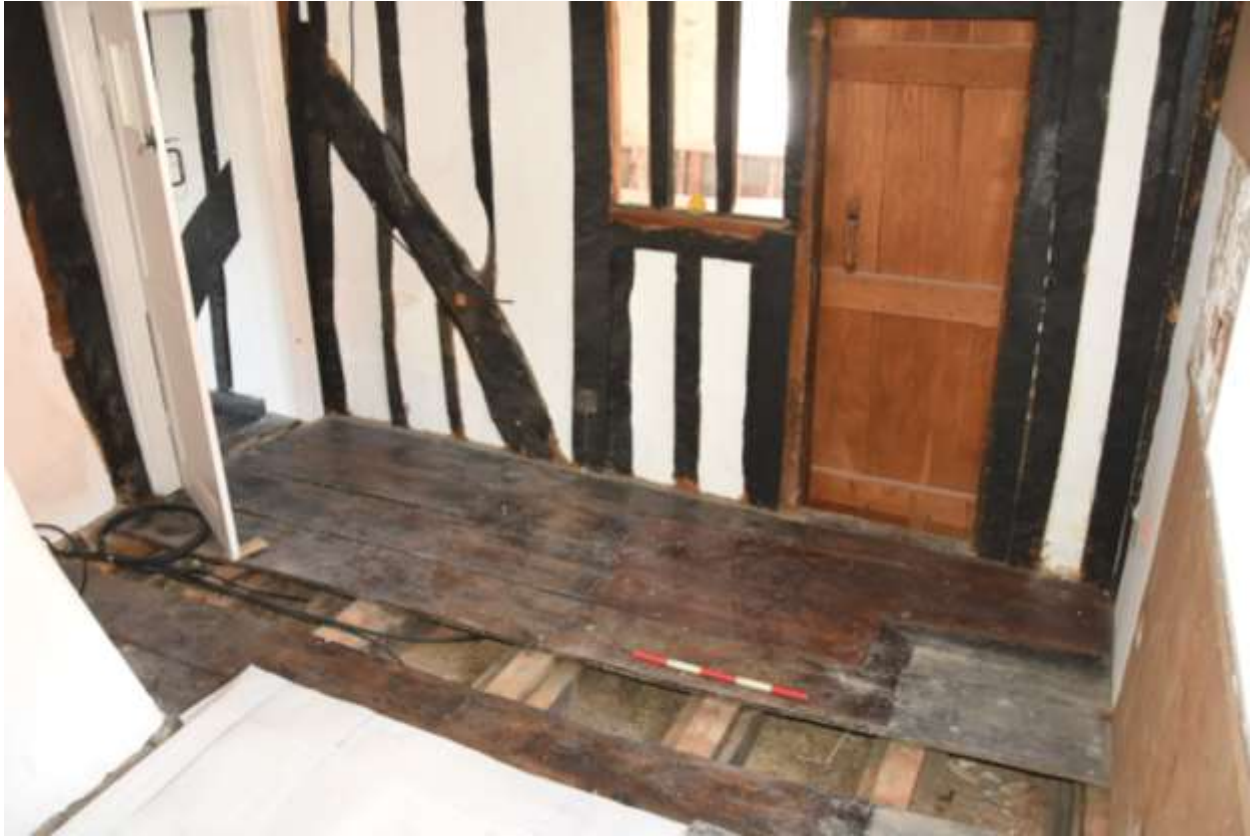
A single floorboard was lifted across the western part of Room F-11. This revealed a similar reconstruction to that in F-10 (& quite possibly contemporary), with the boards set on narrow secondary timbers that had been laid over the original joists (see Figs.204 & 205 below).

Fig.204: Room F-11, looking towards the rear (western) wall

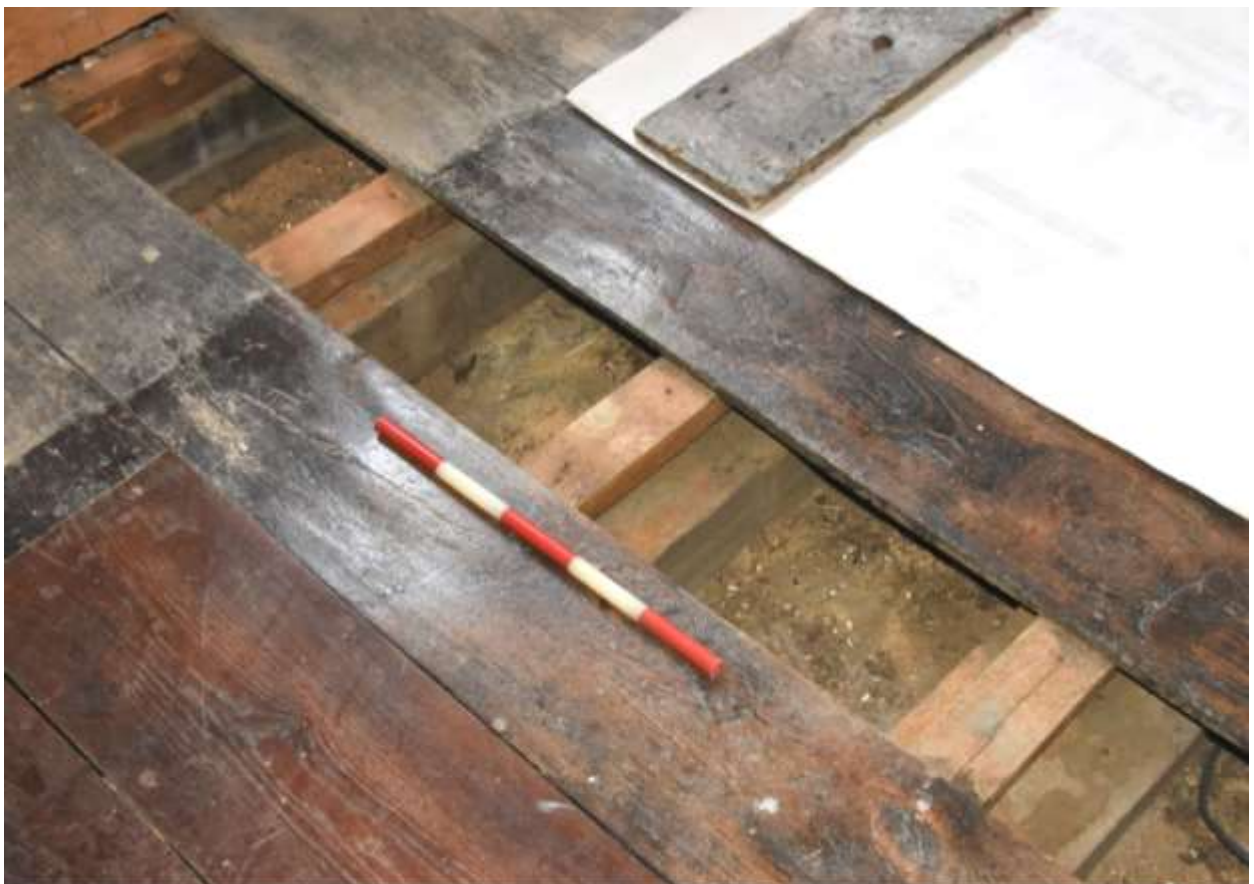
The joists that were examined were however more variable in cross-section than those of F-11, with widths ranging from 190mm to 260mm and heights of 142mm to 176mm. By contrast the spacing between joists was quite constant (& similar to F-11), at 312mm to 350mm. The overlying timbers ranged in depth from c 30mm to 100mm, increasing towards the northern external wall. The floorboards themselves also ranged quite widely in width, from c 215mm to 310mm; where visible the thickness was 19mm to 21mm thick.

Fig.205: Detail of joists and overlying floor build-up, looking approx. northeast (0.5m scale)
