9.5 Room F-07

Room F-07 forms part of the northwestern extension otherwise represented by Rooms G-12, S-05 and the cellar (Sections 7.3, 10.4, *etc.*), and is of probable mid to later 17th century date. The principal development here comprised the creation of a new access doorway from the northern staircase/ lift extension, located towards the western end of the north wall (*cf.* Figs.207-209).

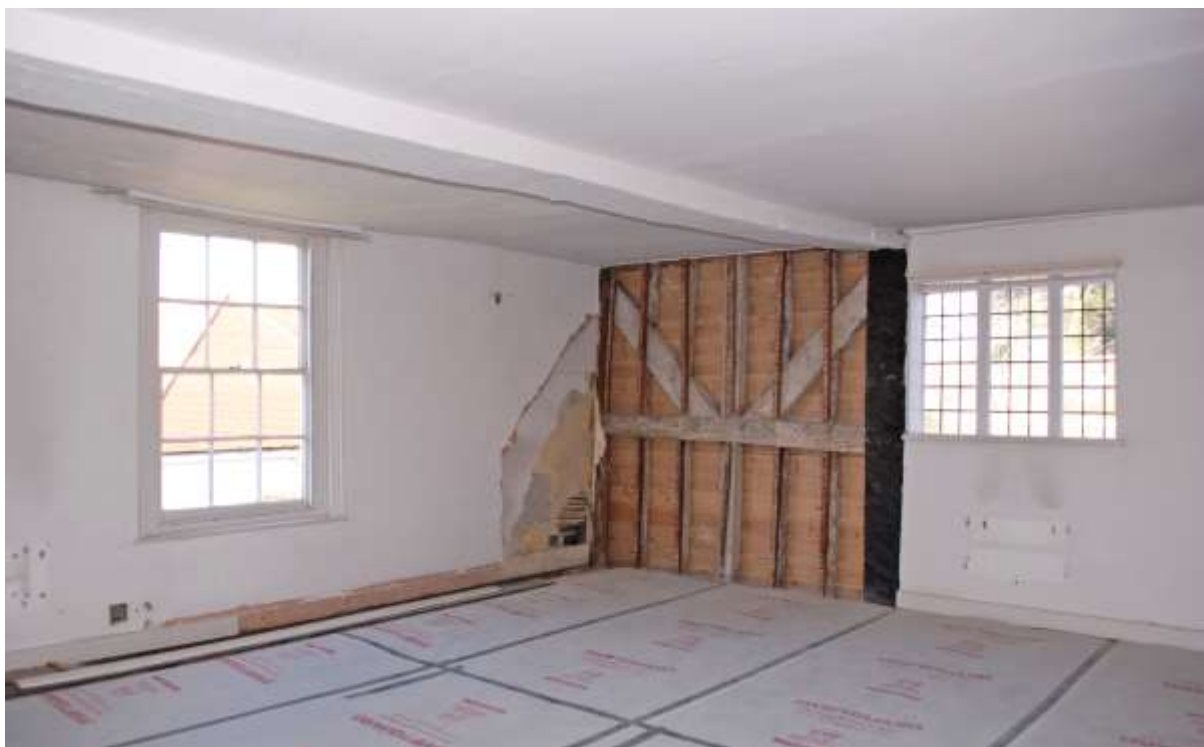
Fig.209: General view of the northwestern part of the room and proposed new access area after stripping of the lath and plaster wall covering

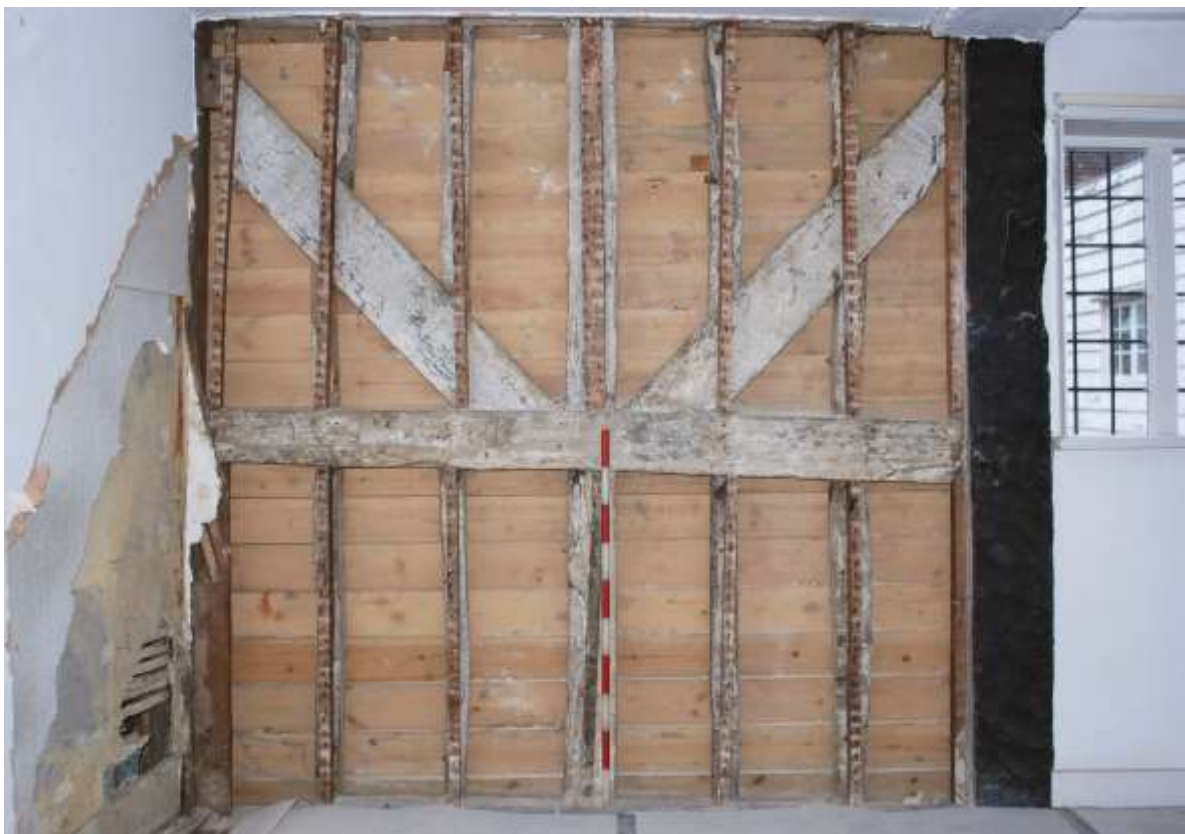
Fig.211: *As above, direct elevation view (1m scale)*

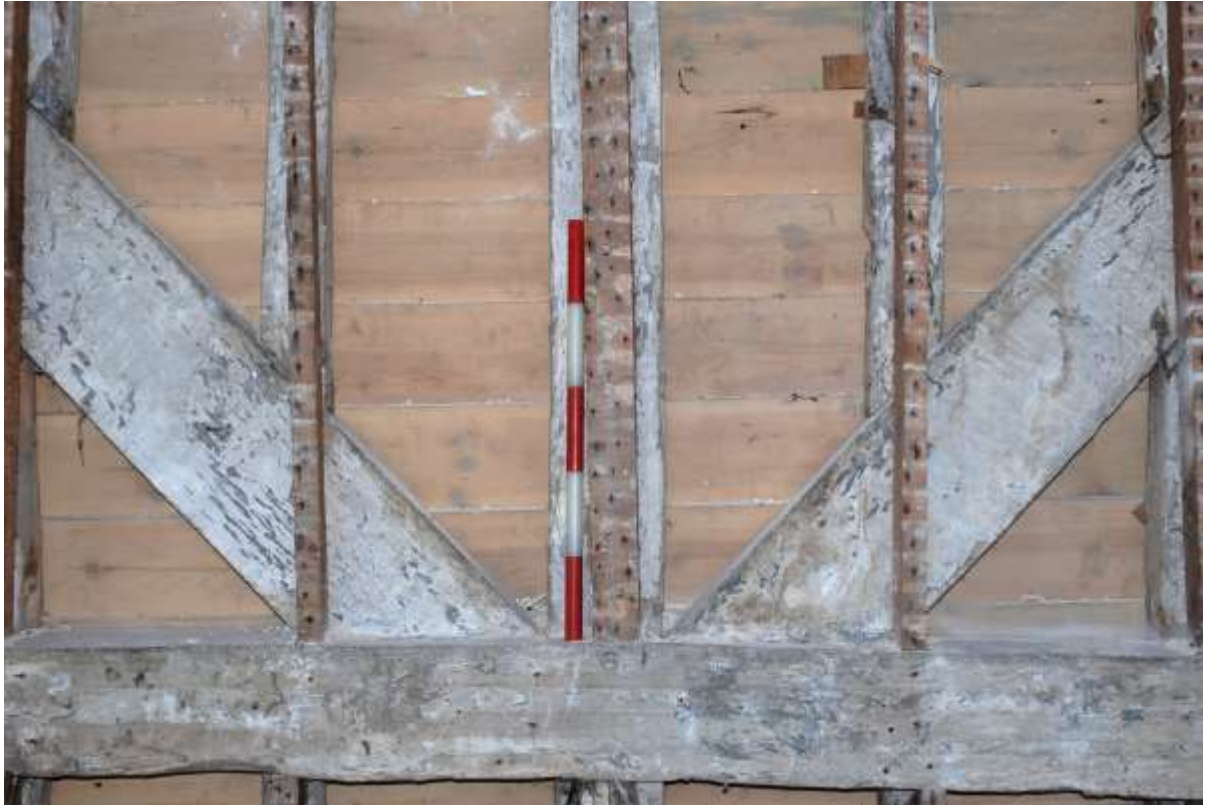
Fig.212: *Detail of the timber framing on the northern wall, the limewash covering also clearly visible (0.5m scale)*

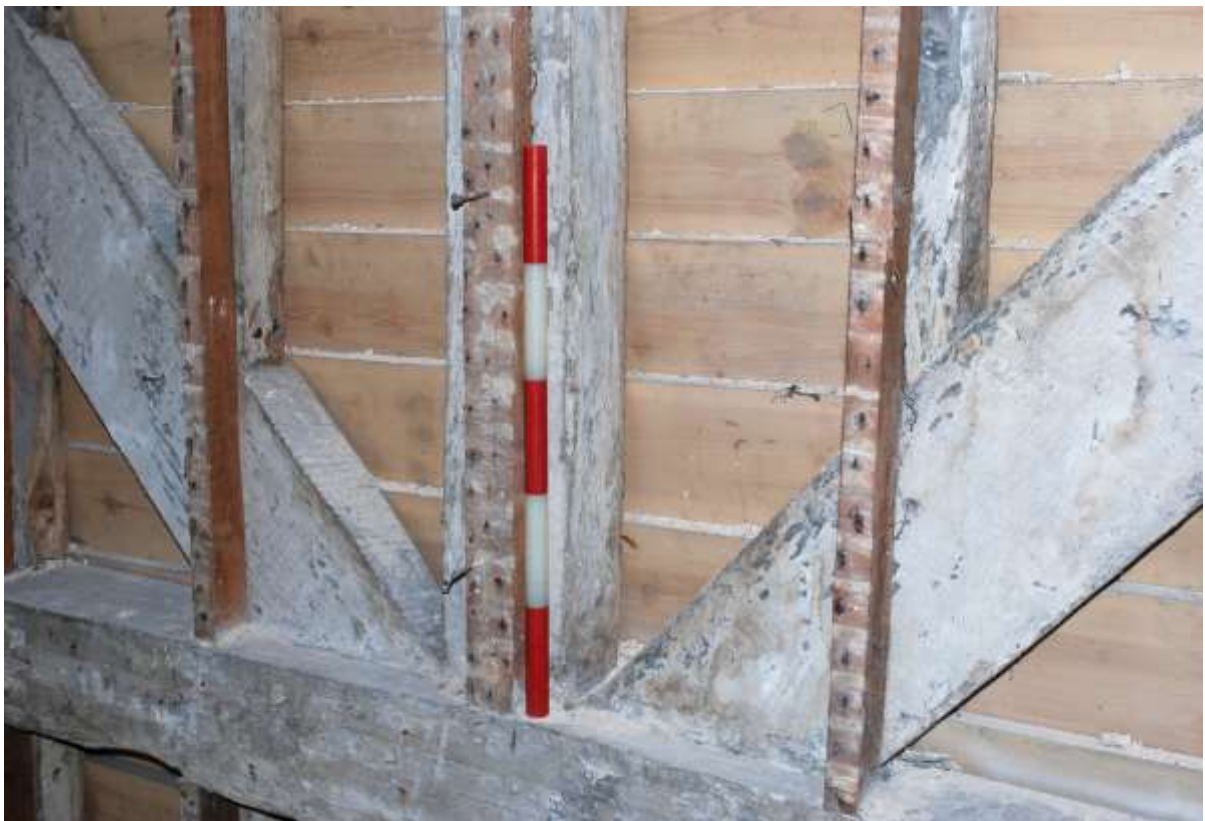
Fig.213: *As above, oblique view looking towards the northwest corner*

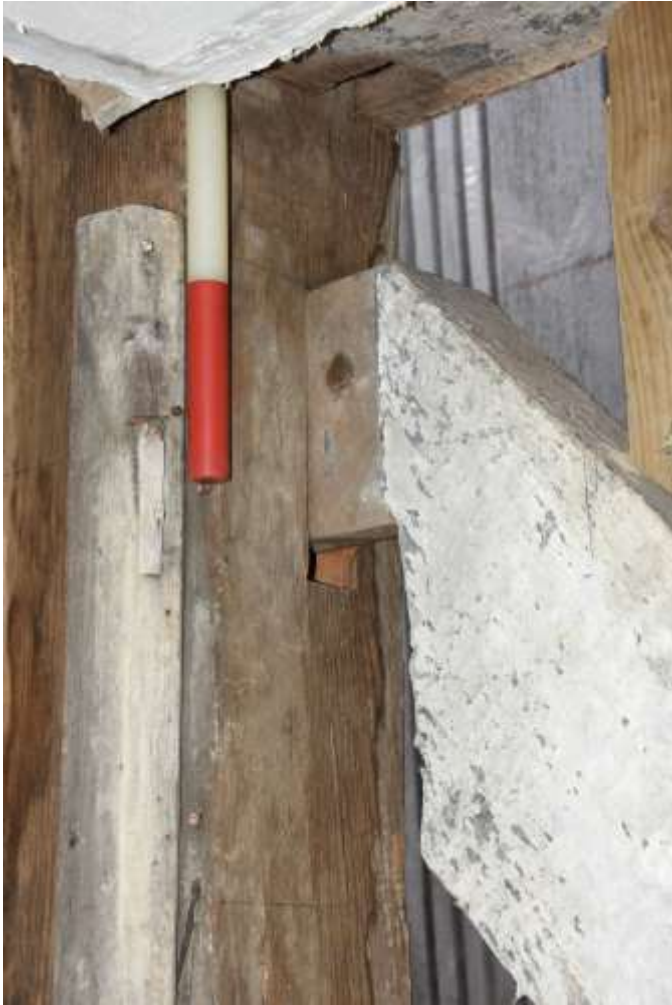
Fig.216: *Mortice & tenon joint between the corner post and down brace at the western end of the north wall. The post is not original, & lacks a peghole to correspond with that in the tenon (0.2m scale)*

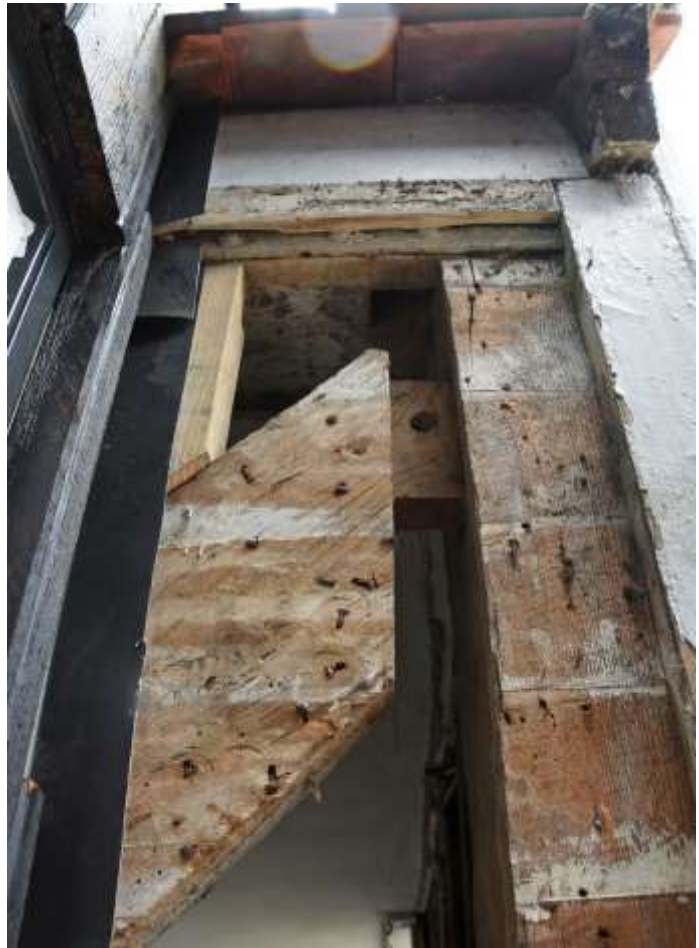
Fig.217: *External view of the above joint. A horizontal iron strap is also visible near the top of the frame, partly covered by weatherboarding*

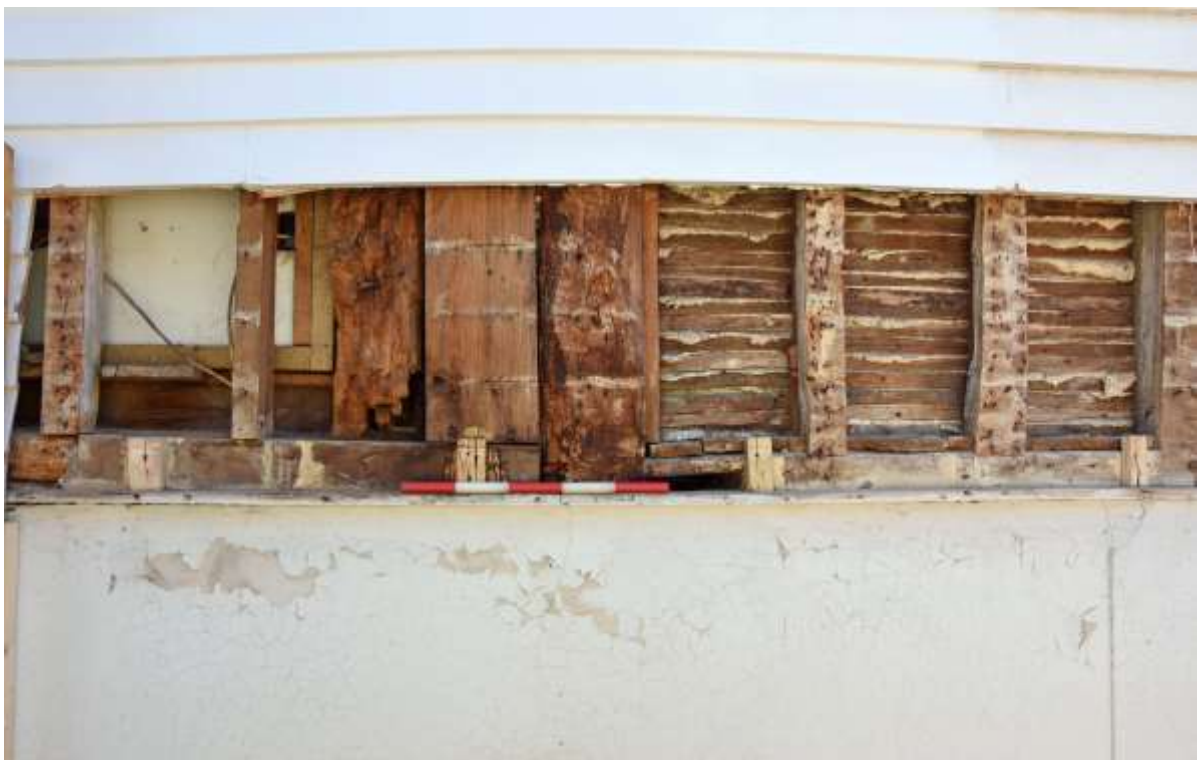
Fig.221: Detail of the above, with the junction between the original building (to the left) and northwestern extension immediately above the centre of the 0.5m scale

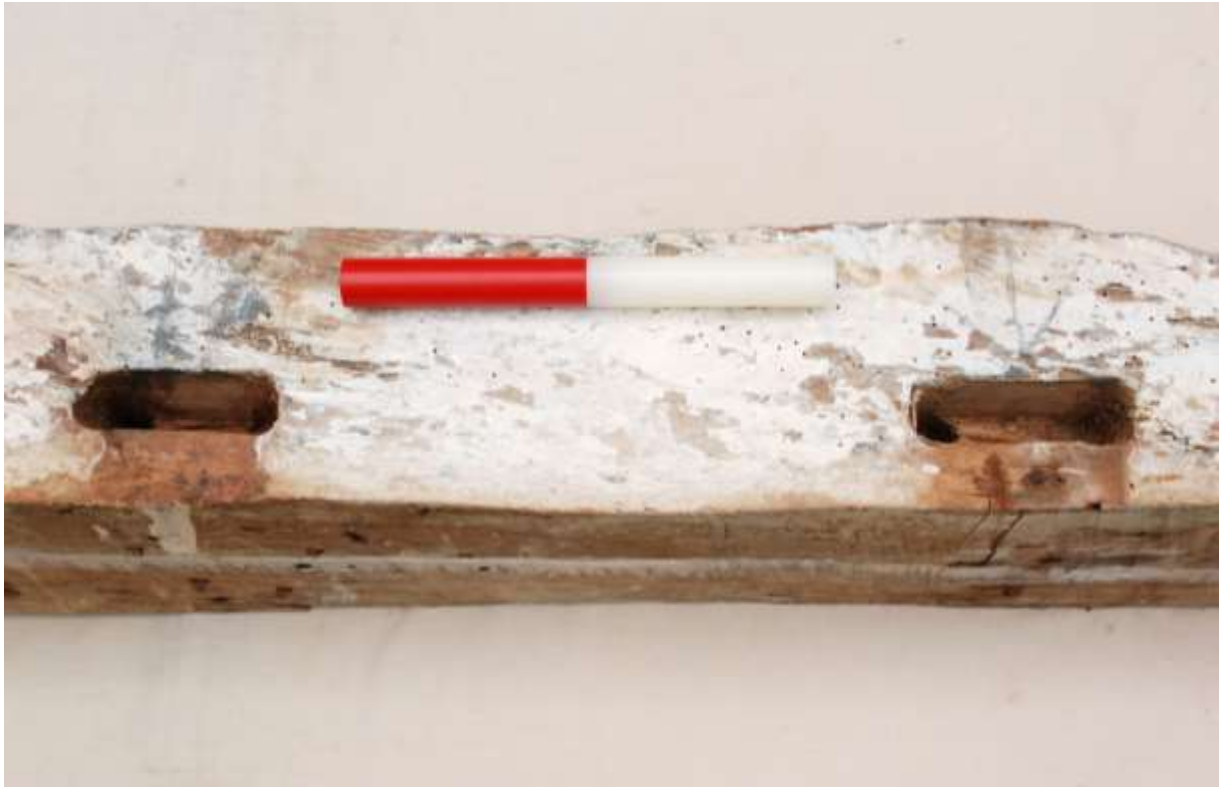
Fig.224: Mortices for studs in the underside of the midrail, dimensions c 84mm x 25mm by 40mm to 50mm deep (0.2m scale)

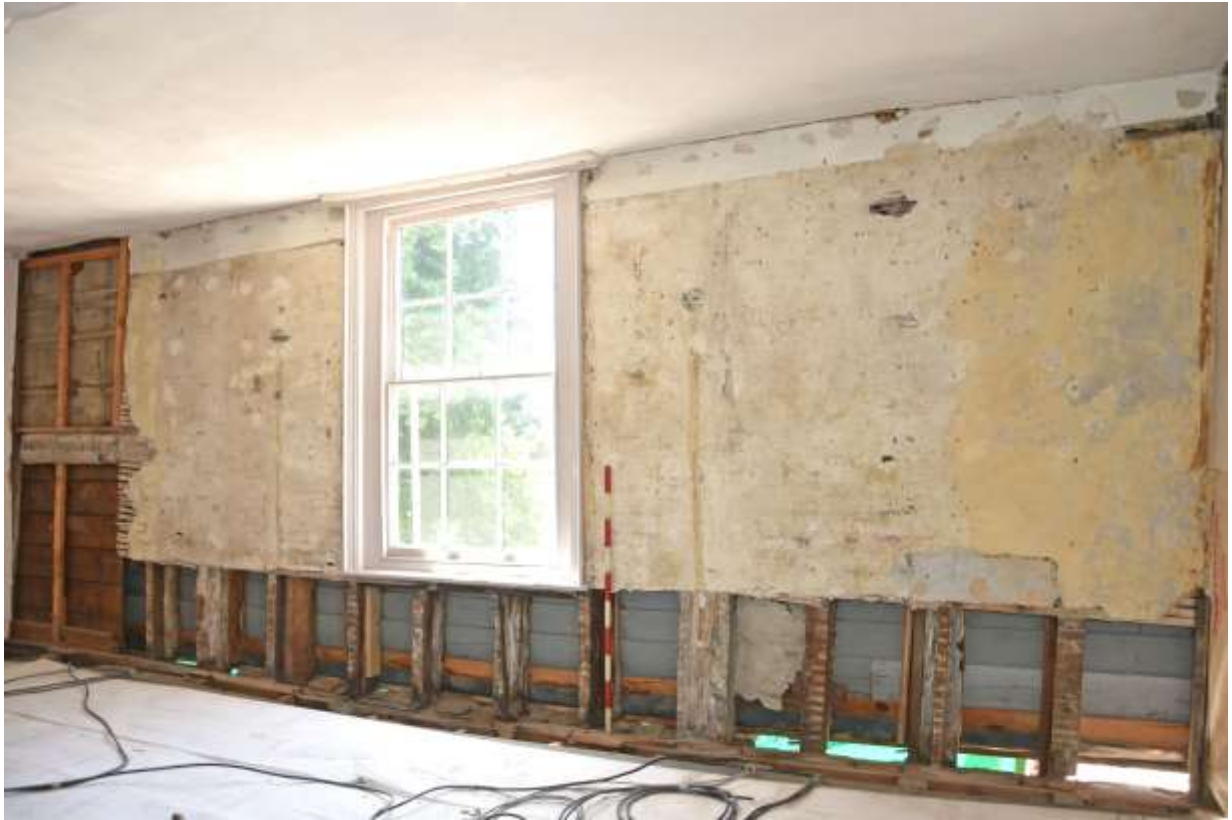
Fig.228: *Oblique view from the northern side of the room (1.0m scale)*

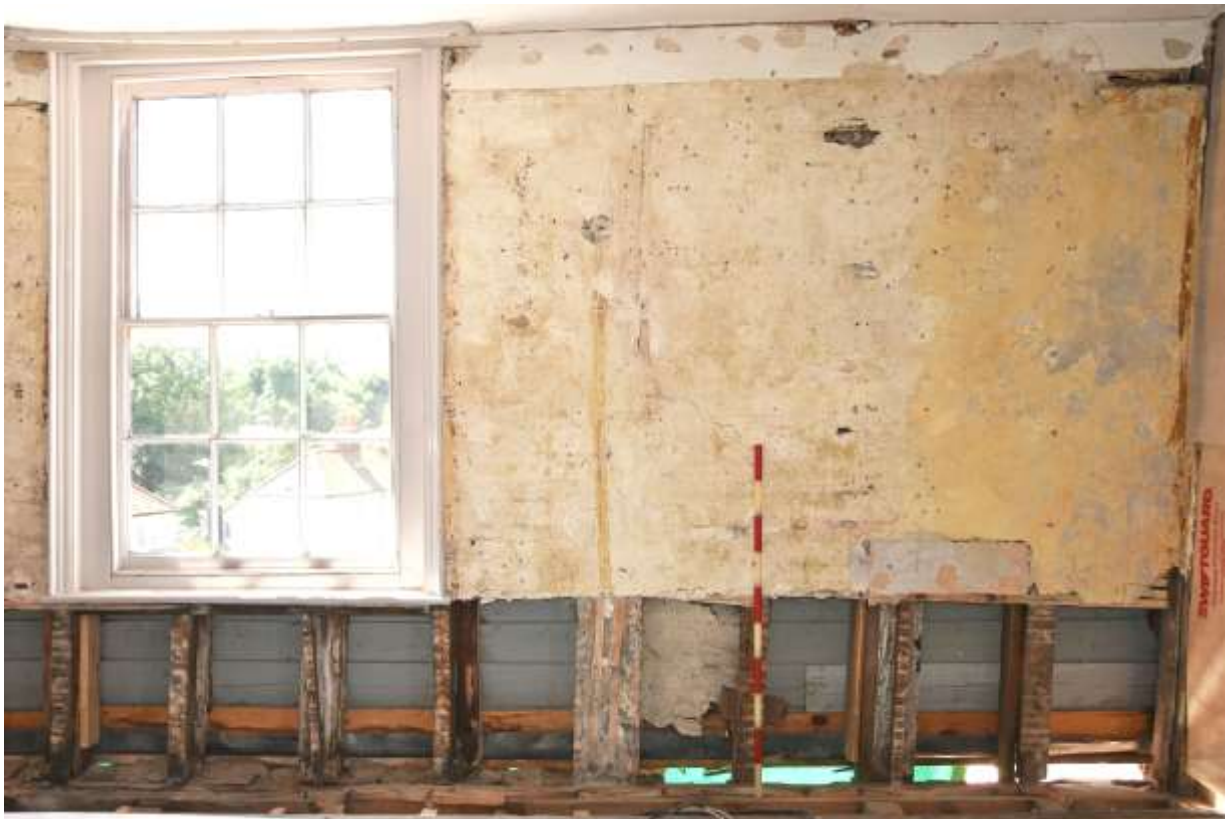
Fig.229: *The northern part of the wall and window*

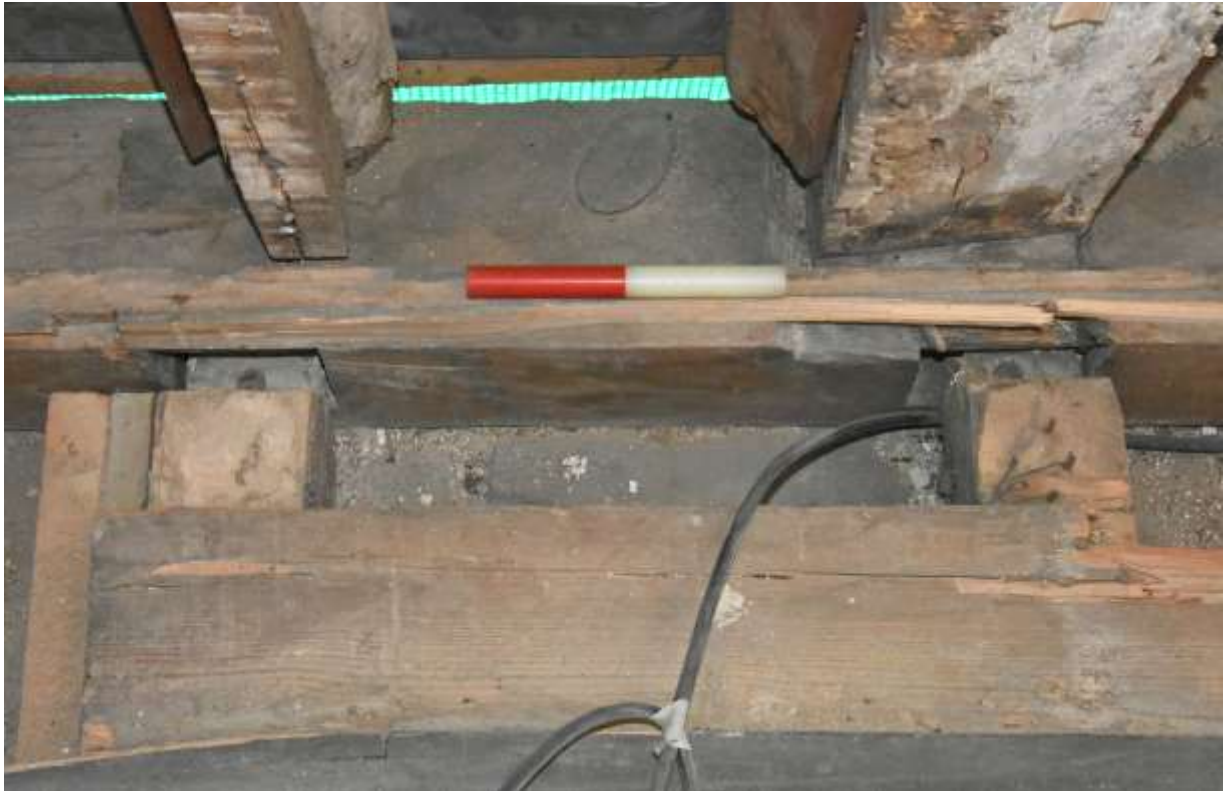
- Mortices had been cut in the replacement girding beam to receive the existing joists with their tusk tenons (Figs.230-31; 271-72, *etc.*), and on the east side of the northern corner post to fit the tenons of the northern wall down brace and midrail (Figs.216-17.). Almost all of these tenons had pegholes – and were presumably thus secured in the original construction. However, there was no evidence for any corresponding holes in the replacement timber – and consequently the whole structure had moved apart by several centimetres, as noted above.

Fig.230: Detail near the southern end of the girding beam. The tenons in both joists have been revealed by the outward movement of the beam, including the unused pegholes (0.2m scale)

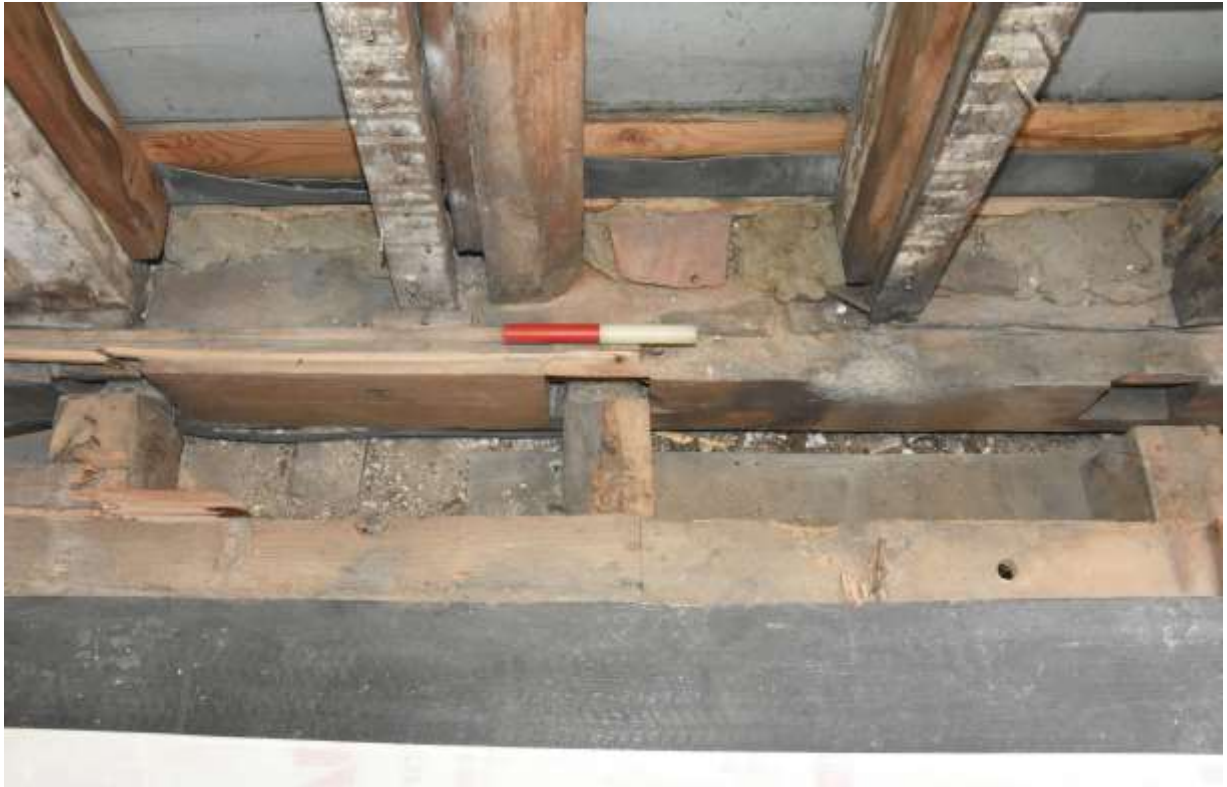
Fig.232: *The girder beam and adjacent timbers immediately to the south of the window*

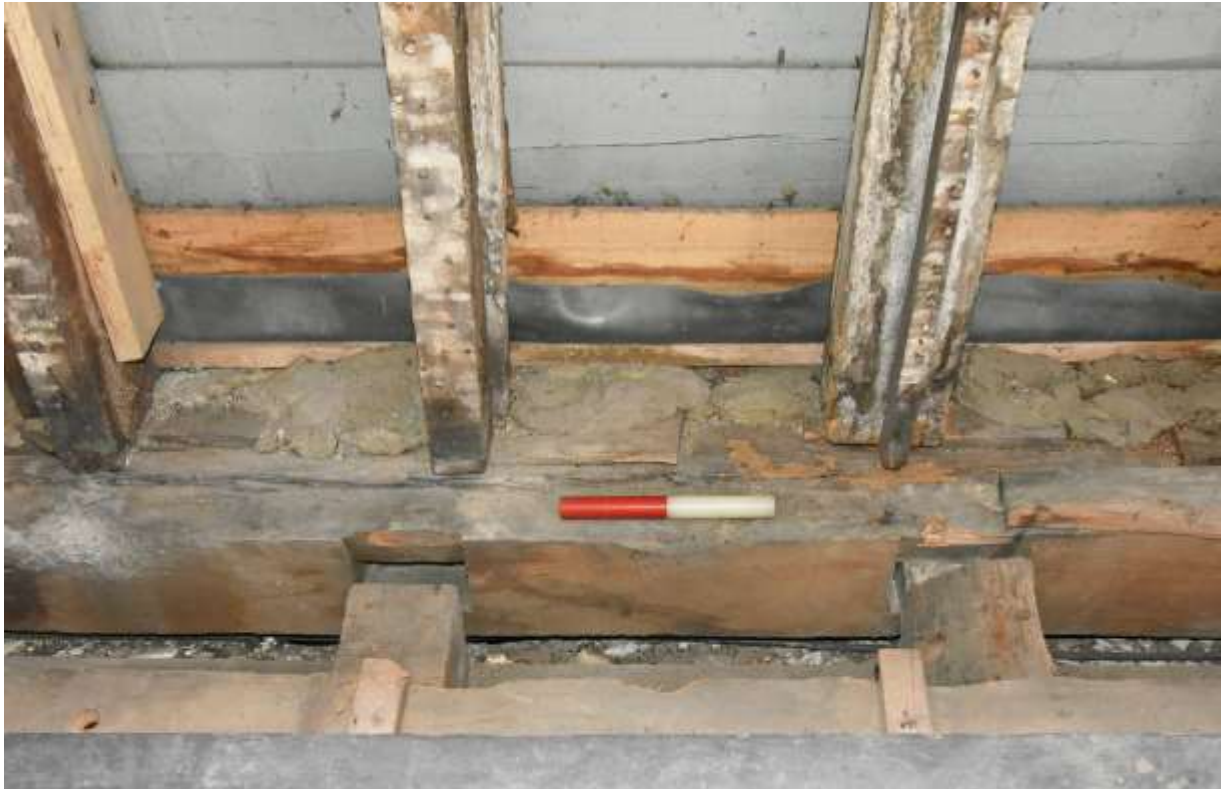
Fig.234: *The girder beam and adjacent timbers in the area below the window (0.2m scale)*

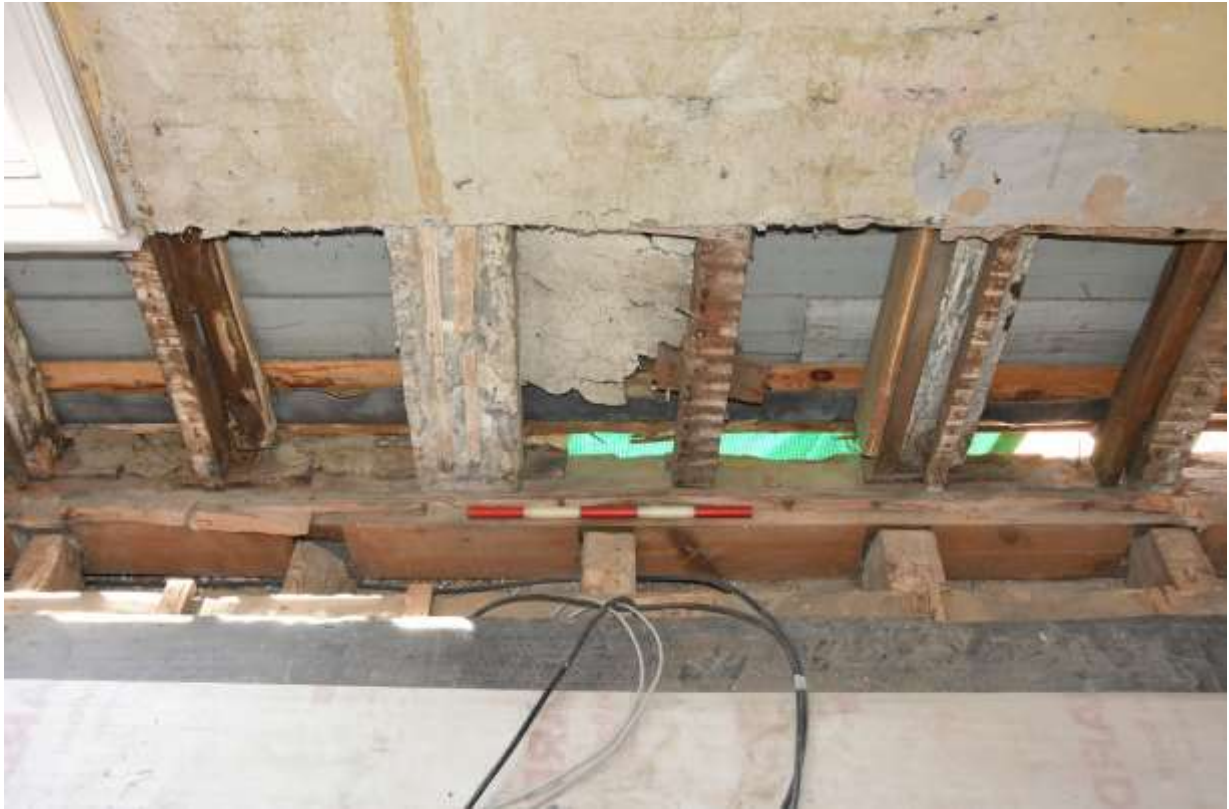
Fig.236: *The area to the north of the window, with the second principal stud at the left hand end of the 0.5m scale and original in situ lath and plaster above*

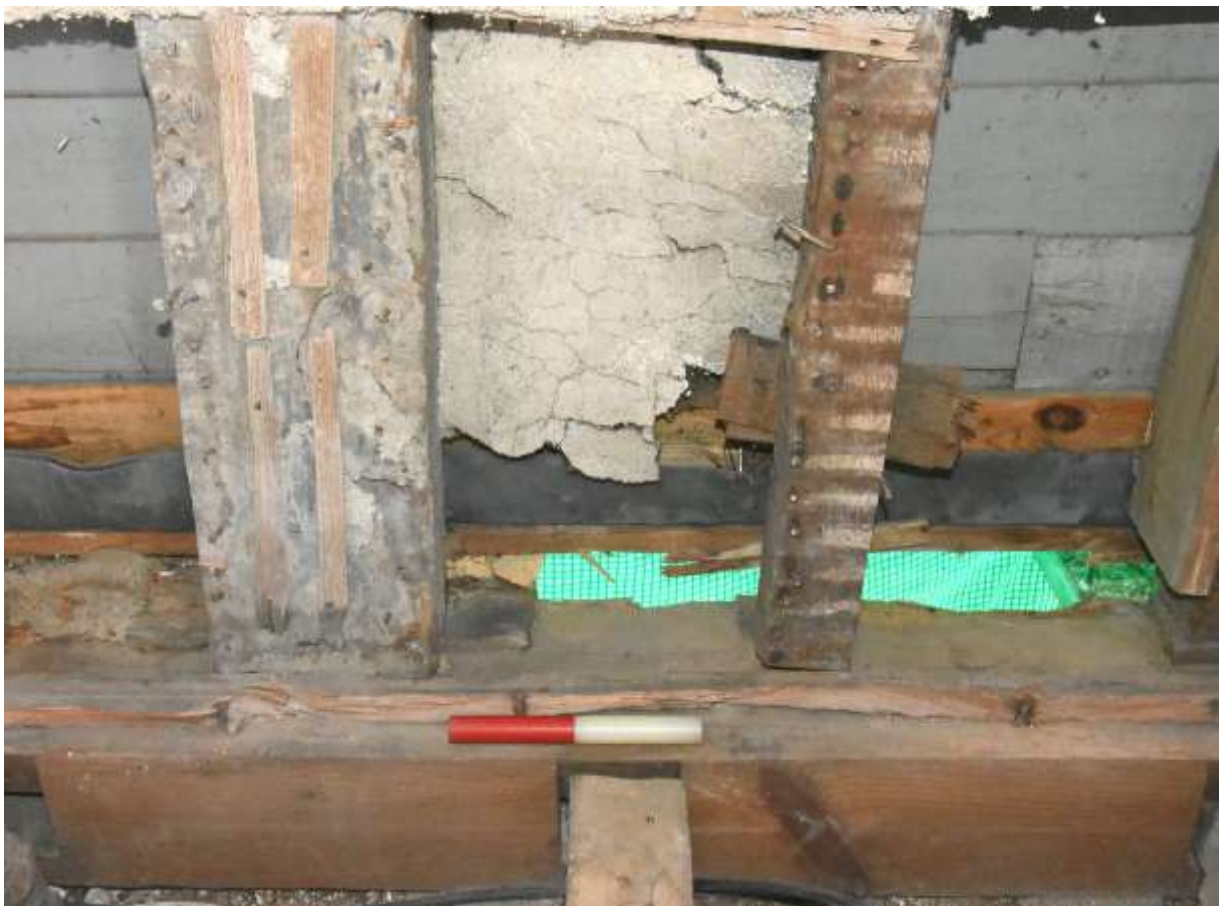
As in the northern wall, the original timbers here had been limewashed/ painted. There was also one surviving area of *in situ* lath and plaster set between two studs, just to the north of and below the level of the window (*cf.* Fig.237). In a number of places the plaster line could also still be made out towards the back of the timbers.

Fig.237: *Detail of the surviving in situ lath and plaster, to the north of the second principal stud*

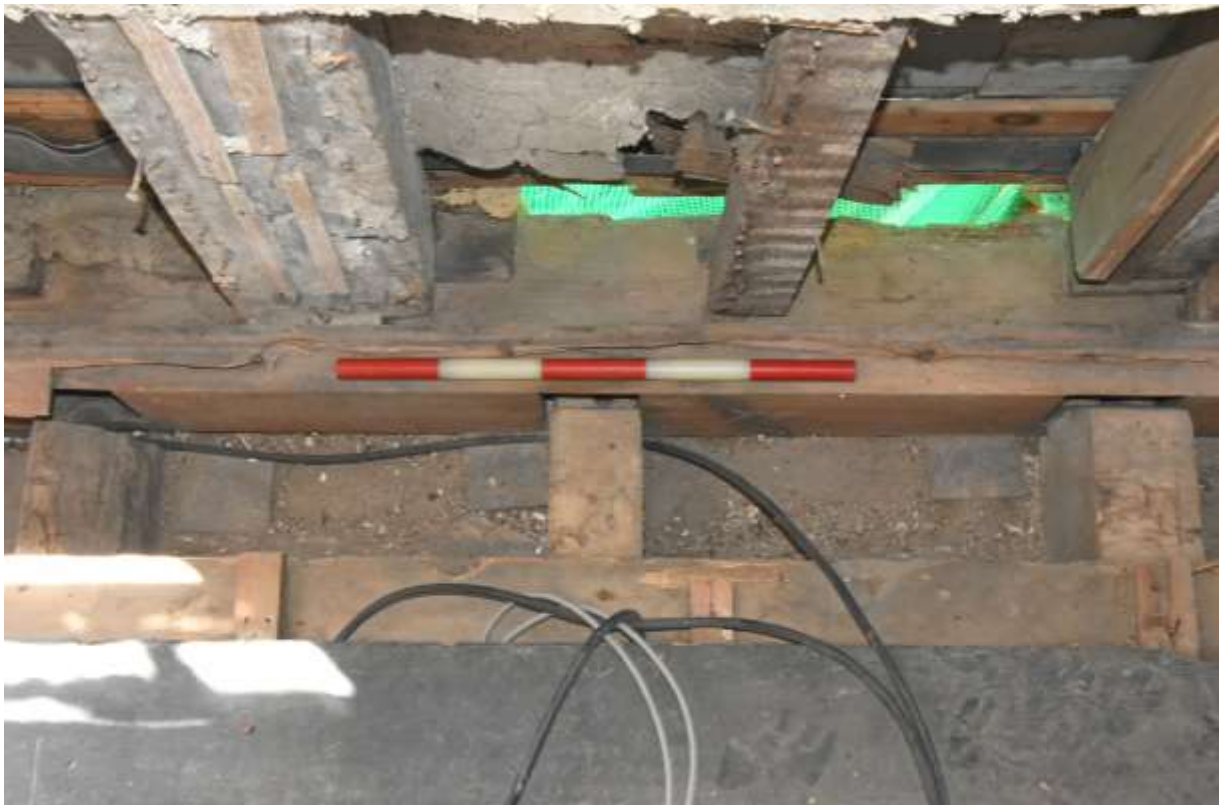
Fig.238: Approximately the same area as Fig.237, viewed from above. On the joists to centre and right the tenons & pegholes are just visible, but that to the left has apparently been sawn off leaving a c 30mm gap (0.5m scale)

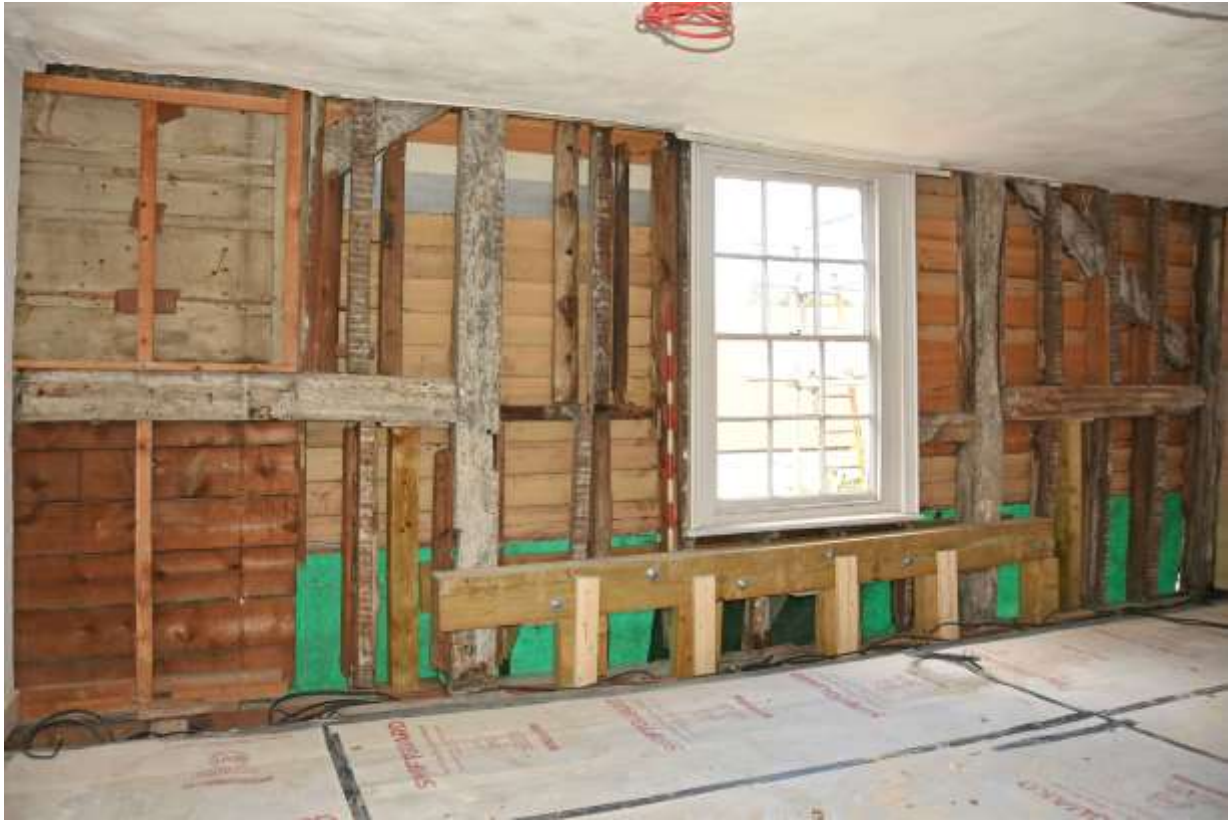
Fig.243: An oblique view of the western wall interior from the southern end (1m scale)

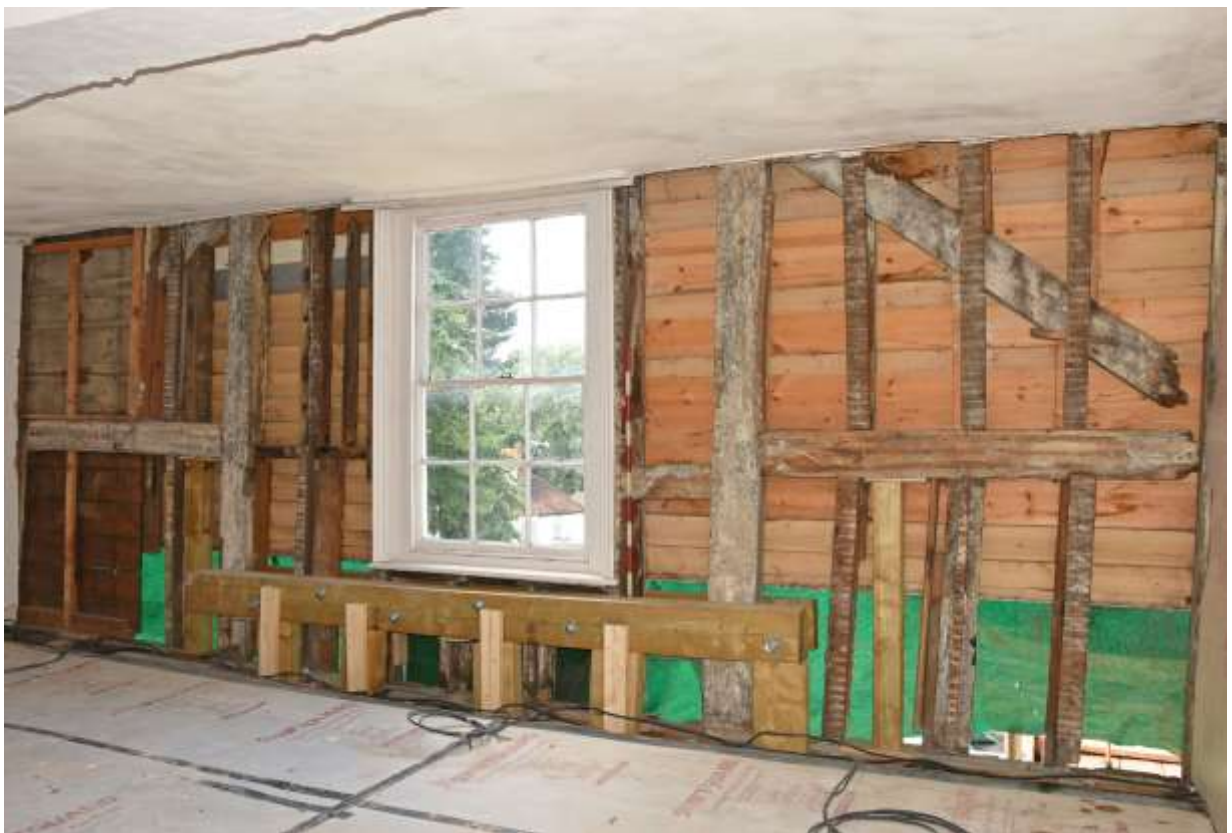
Fig.244: As above, viewed from the northern end

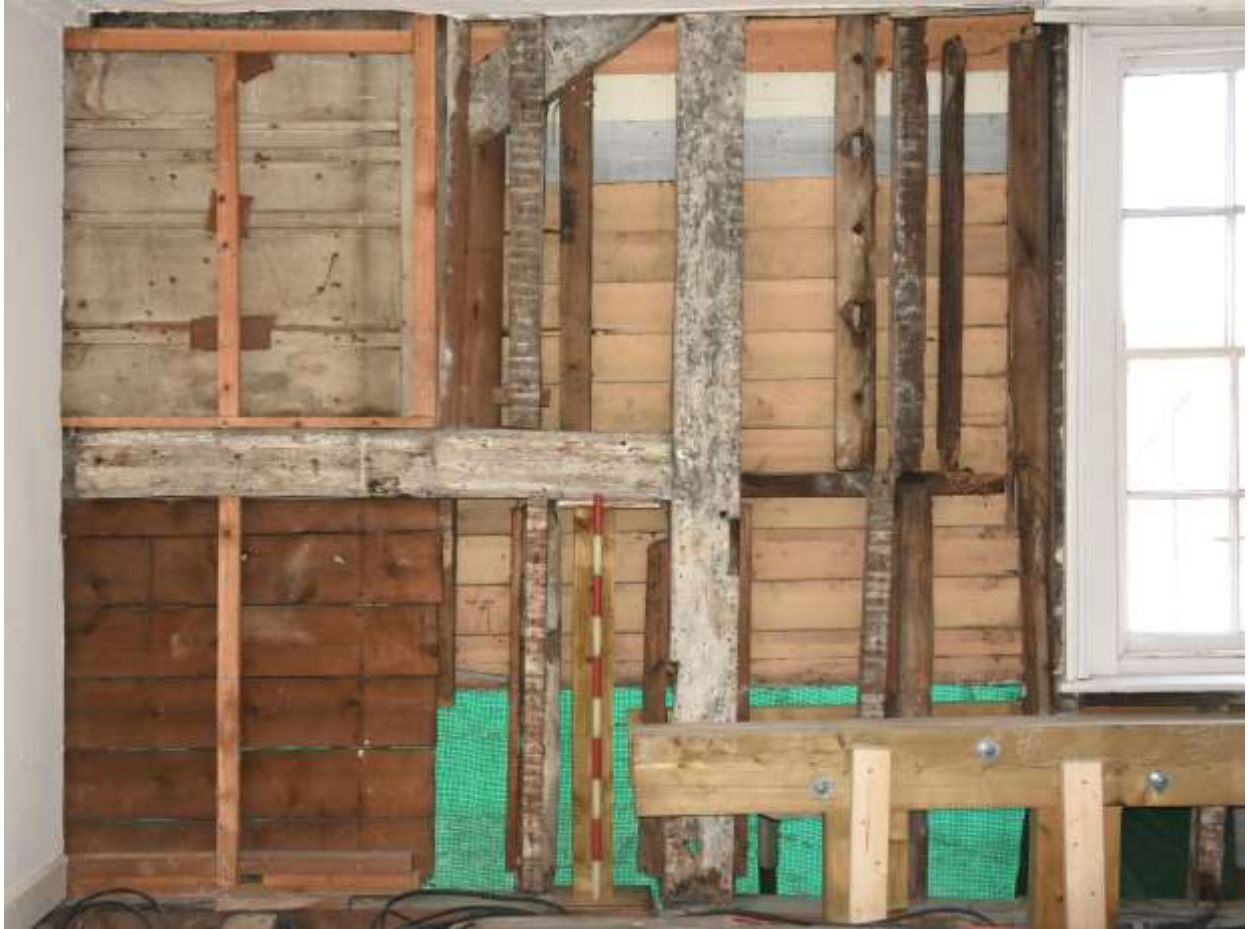
Fig.245 (above): *The southern end of the wall. As previously noted, the boarding adjacent to the corner formed the backing to a 19th century corner cupboard (Gravett 1966, Fig 1)*

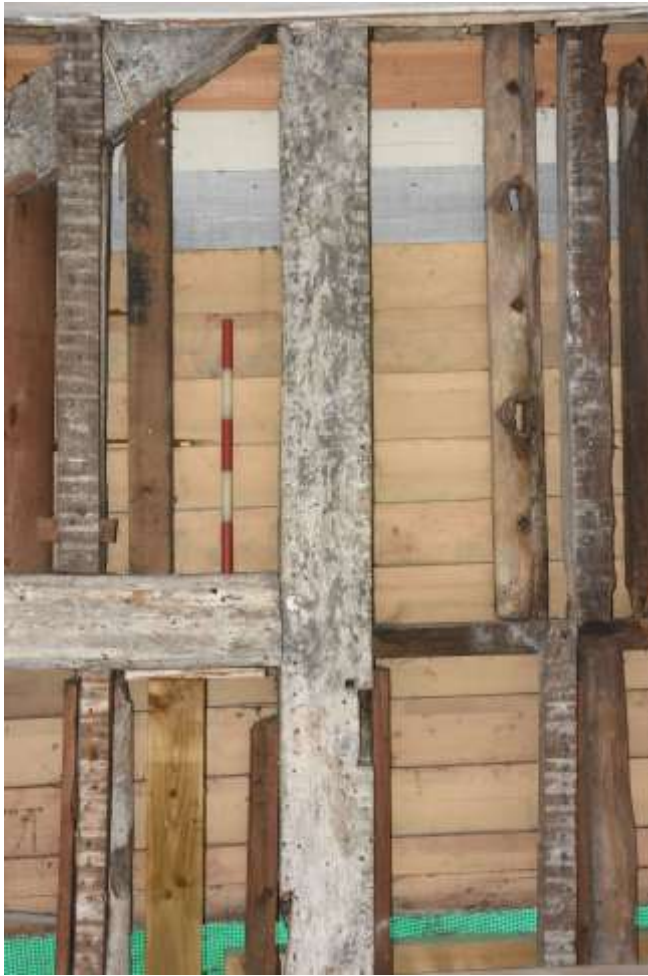
Fig.247: *The timber framing immediately to the south of the window, including the original principal stud and midrail plus various reused and secondary studs (0.5m scale)*

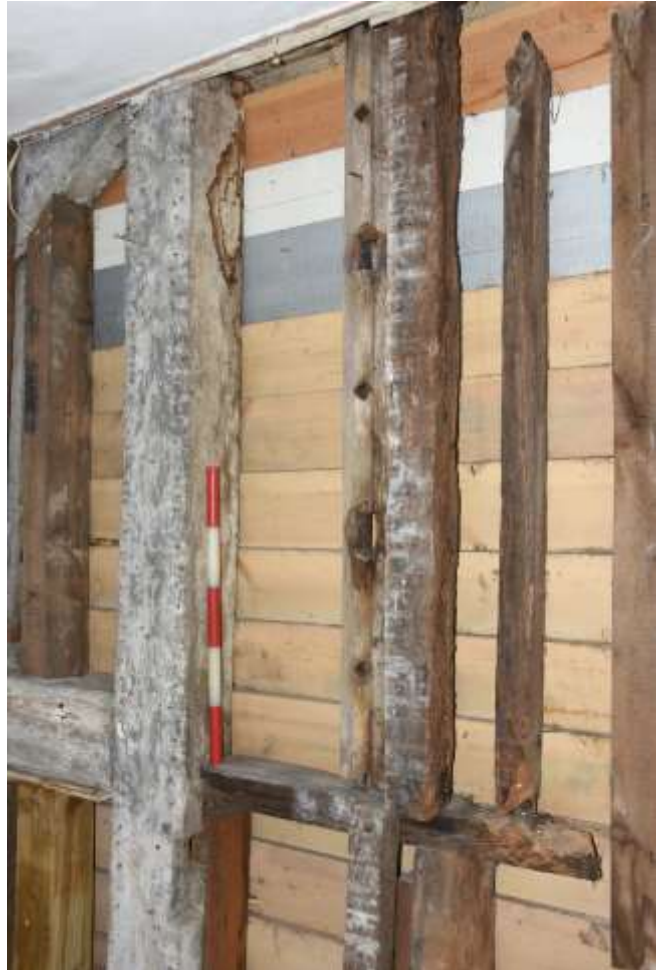
Fig.248: *As above, oblique view looking south*

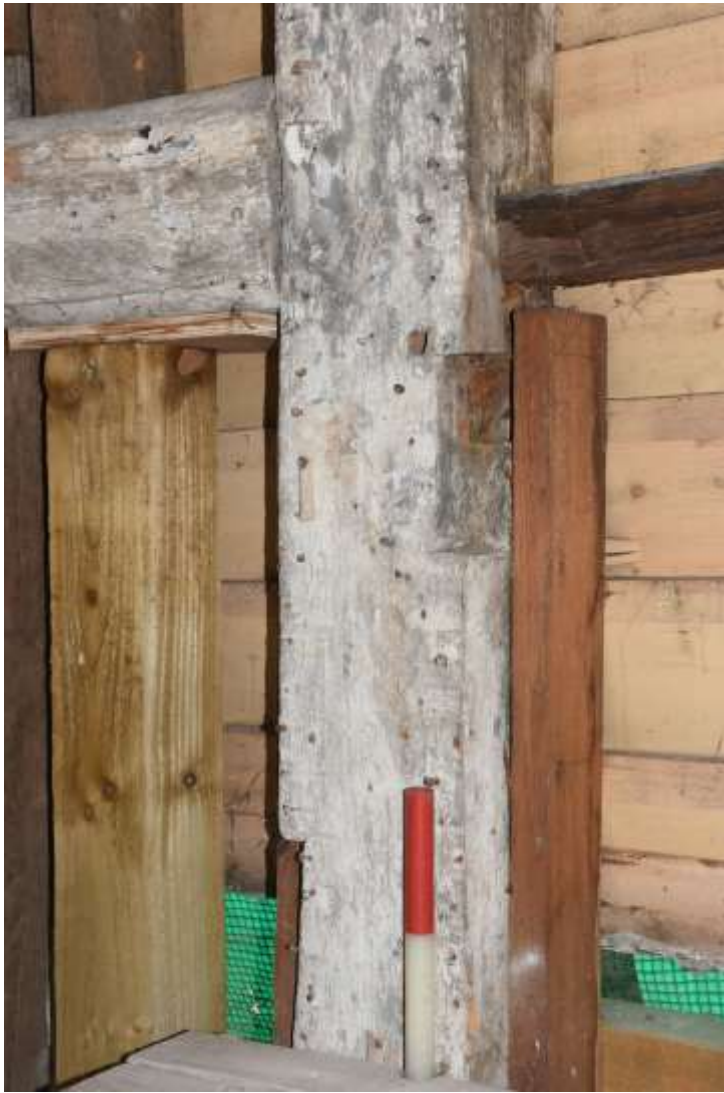
Fig.249: *The principal stud and adjacent midrail in the southern part of the wall, looking south. Obscured by the later and unpainted timber in the foreground is a mortice that would have held the central midrail, at a slightly lower level (see Fig.242)*

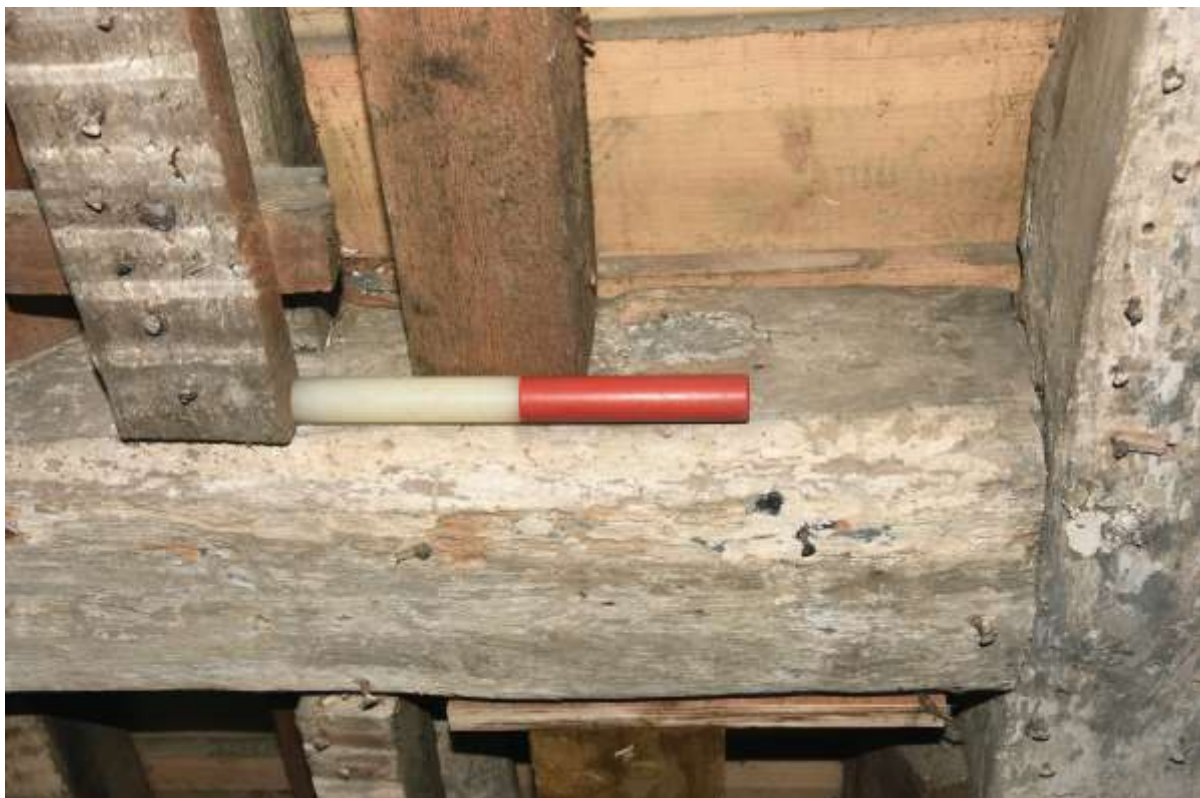
Fig.250 (below): *Detail of the junction between the principal stud and the southern midrail. There is a blocked mortice just behind the red end of the 0.2m scale*
