9.5 Room F-07

Room F-07 forms part of the northwestern extension otherwise represented by Rooms G-12, S-05 and the cellar (Sections 7.3, 10.4, *etc.*), and is of probable mid to later 17th century date. The principal development here comprised the creation of a new access doorway from the northern staircase/ lift extension, located towards the western end of the north wall (*cf.* Figs.207-209).

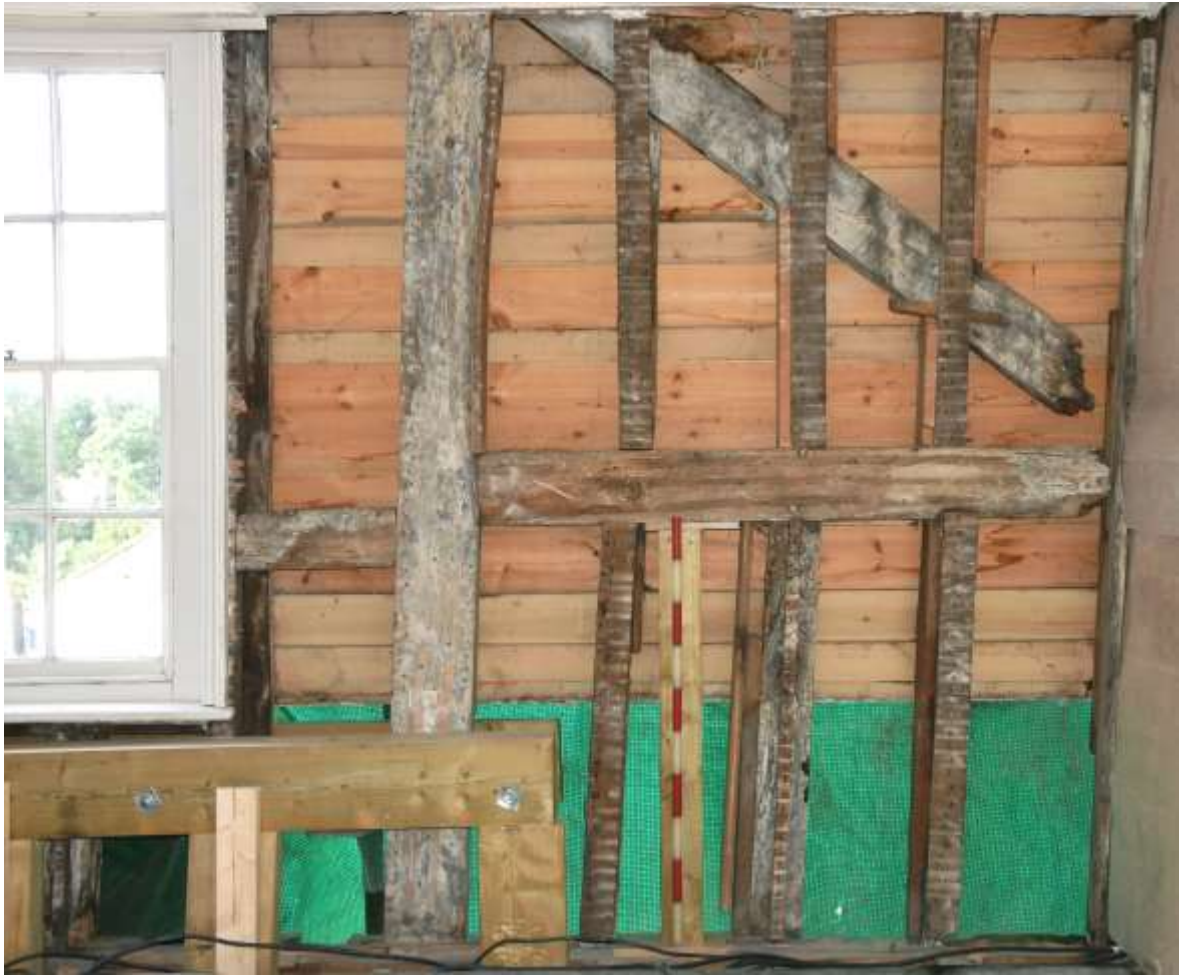
Fig.251: *The northern end of the wall, with the principal stud close to the window (1.0m scale)*

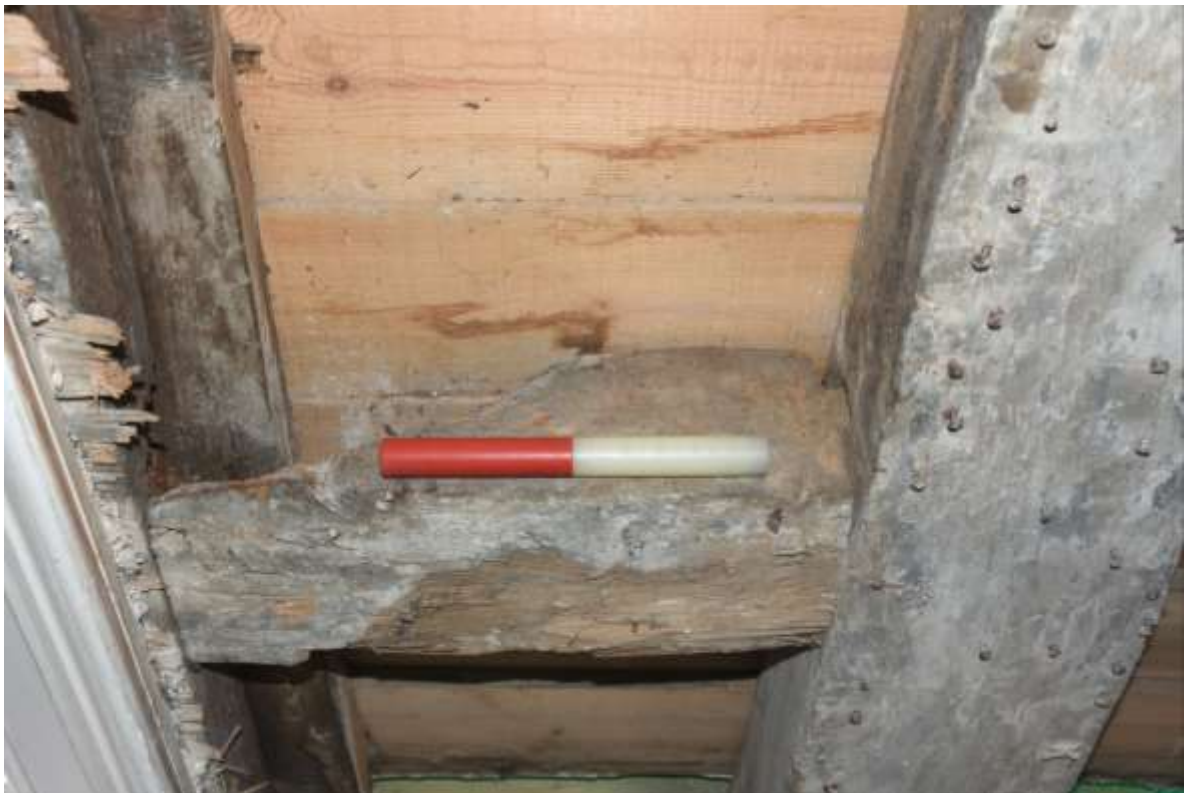
Fig.252: *Detail of the junction between the northern principal stud and the surviving northern end of the central midrail (0.2m scale)*

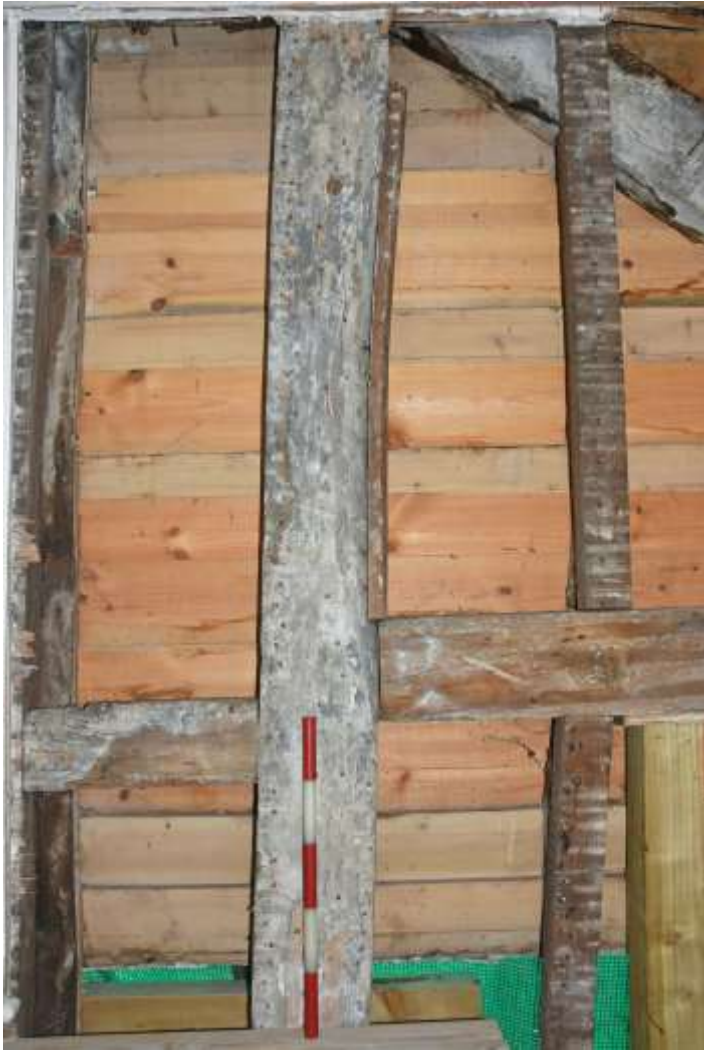
Fig.253: *The principal northern stud and adjacent timbers (0.5m scale)*

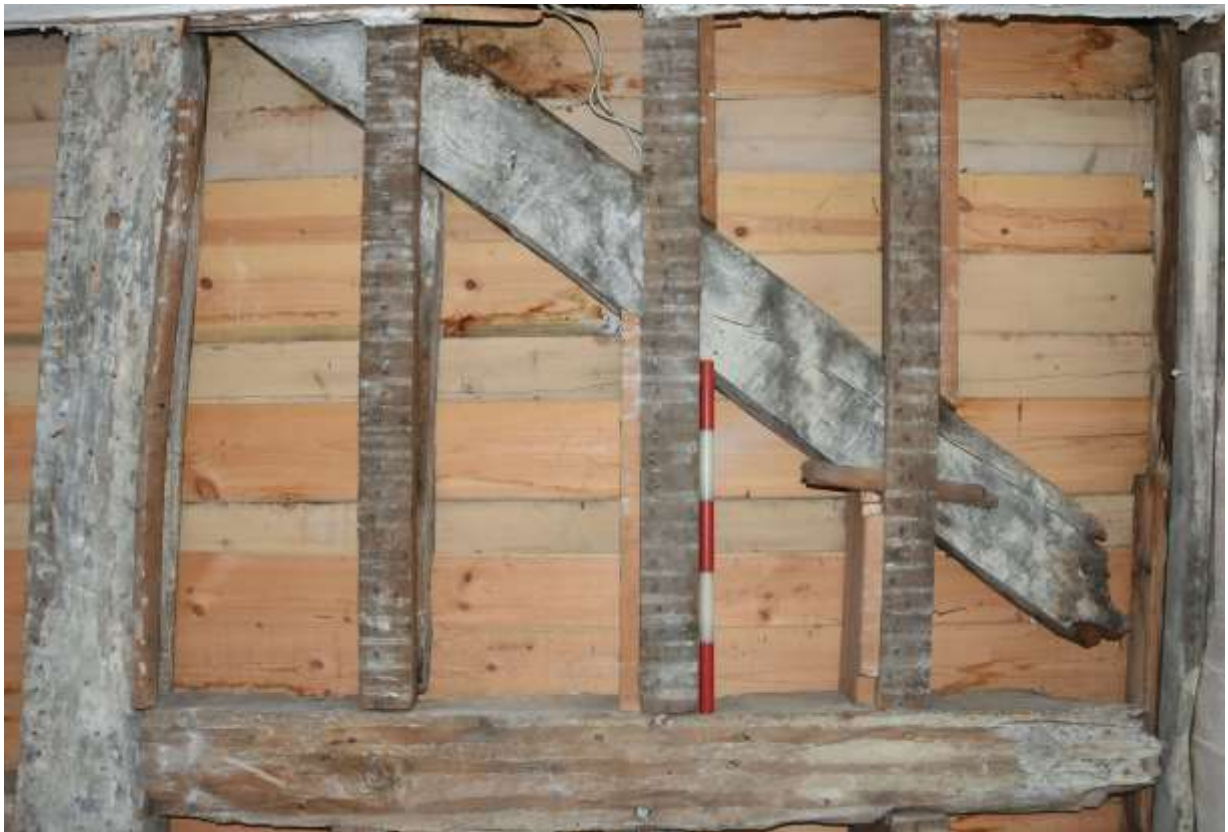
Fig.254 (below): *The original northern midrail and head (or upward) brace, neither of which now connect with the replacement corner post to the right*

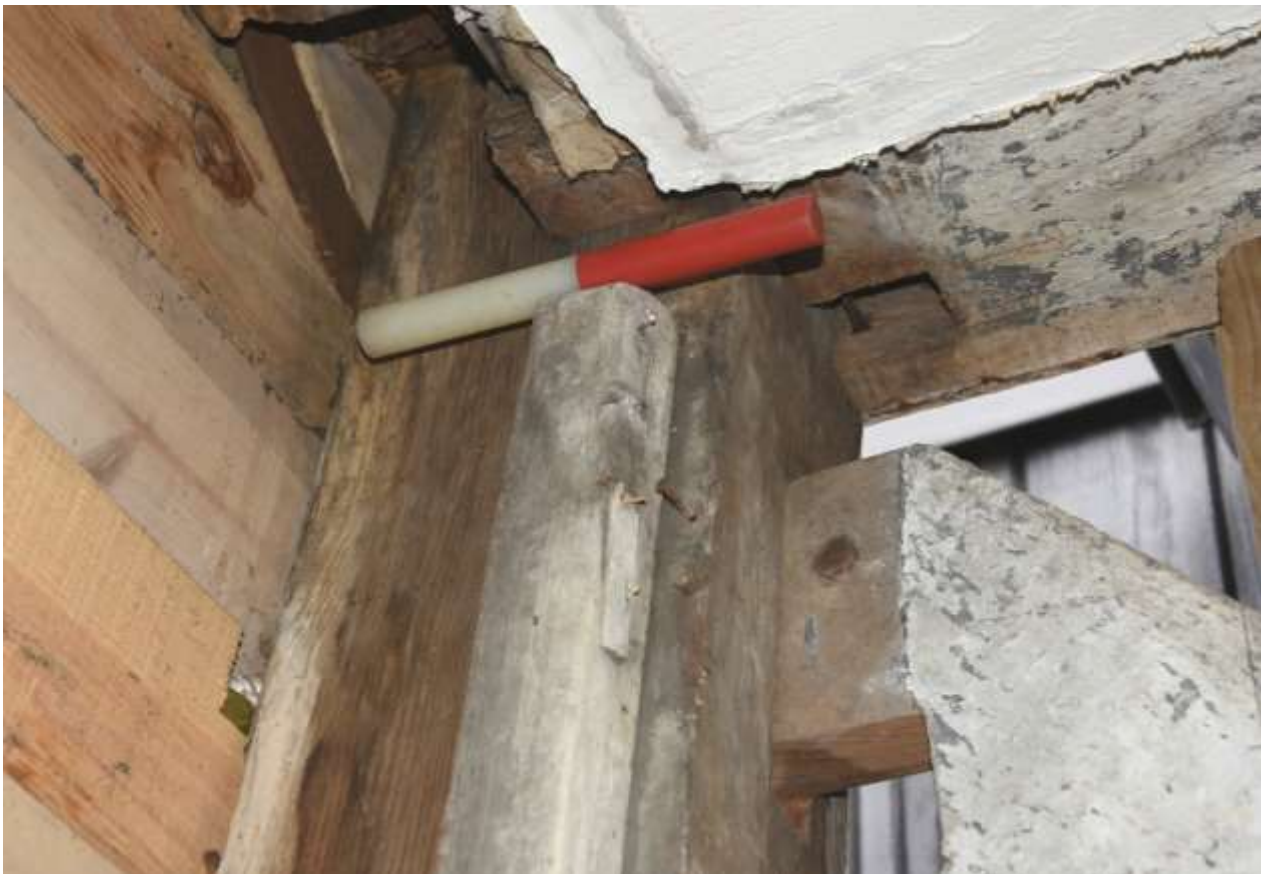
Fig.256 (below): *The top of the replacement post at the NW corner of the room. An iron strap is visible to the left of the 0.2m scale, between this & the western wall plate. There is also a second strap at higher level – the lower edge of just visible at the base of the northern wall plate*

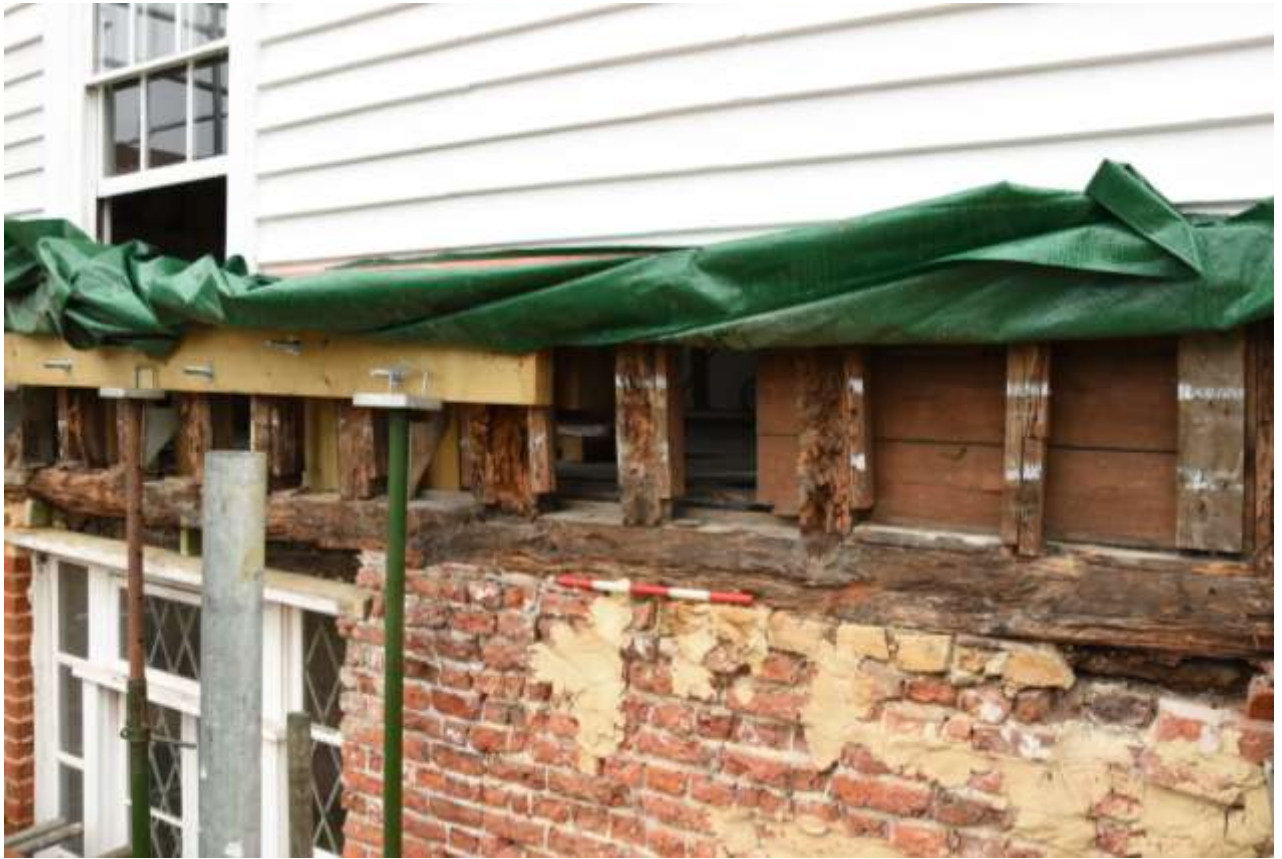
Fig.257: *Exposed timber of the west-facing wall at first floor level, looking approx. north (0.5m scale)*

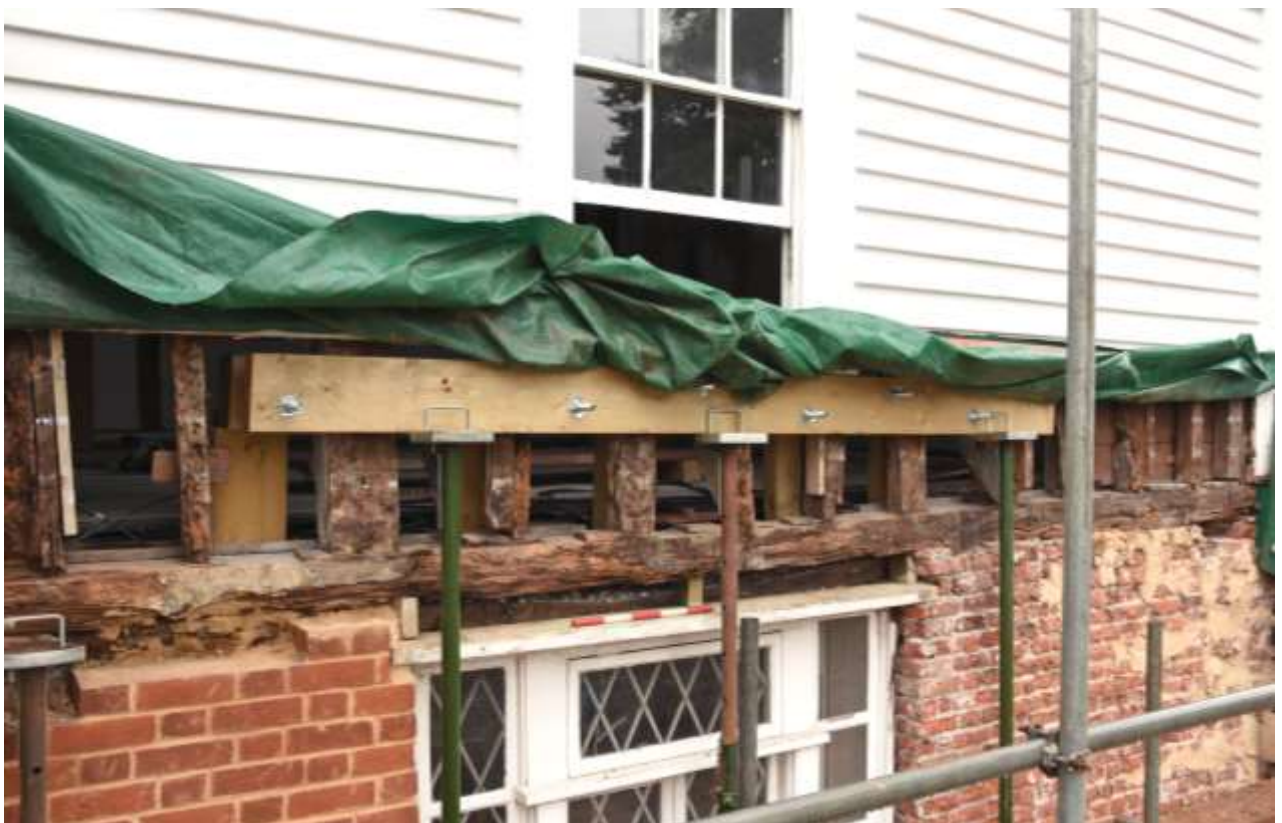
Fig.258: *As above, looking southeast. Note that brickwork in foreground has been replaced*

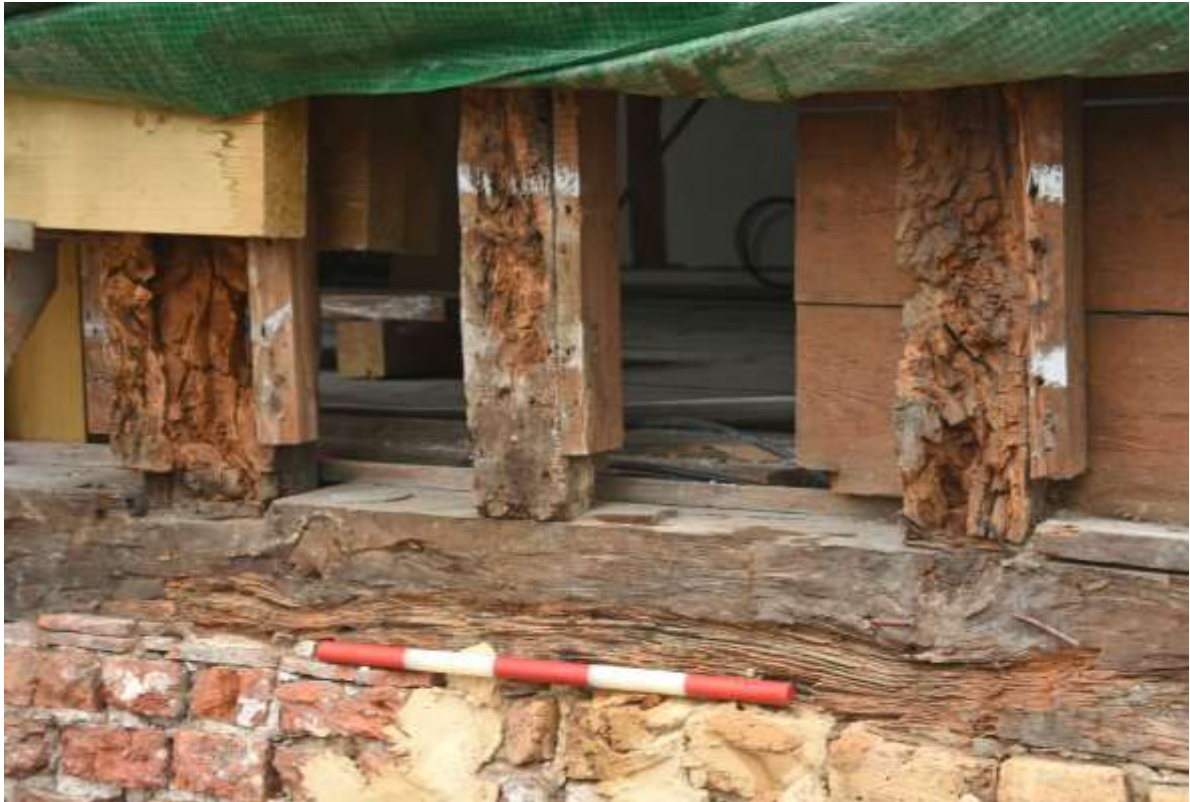
Fig.259: *External view of studs near the southern end of the wall, the original principal stud in a shallow cut-out to the left (0.5m scale)*

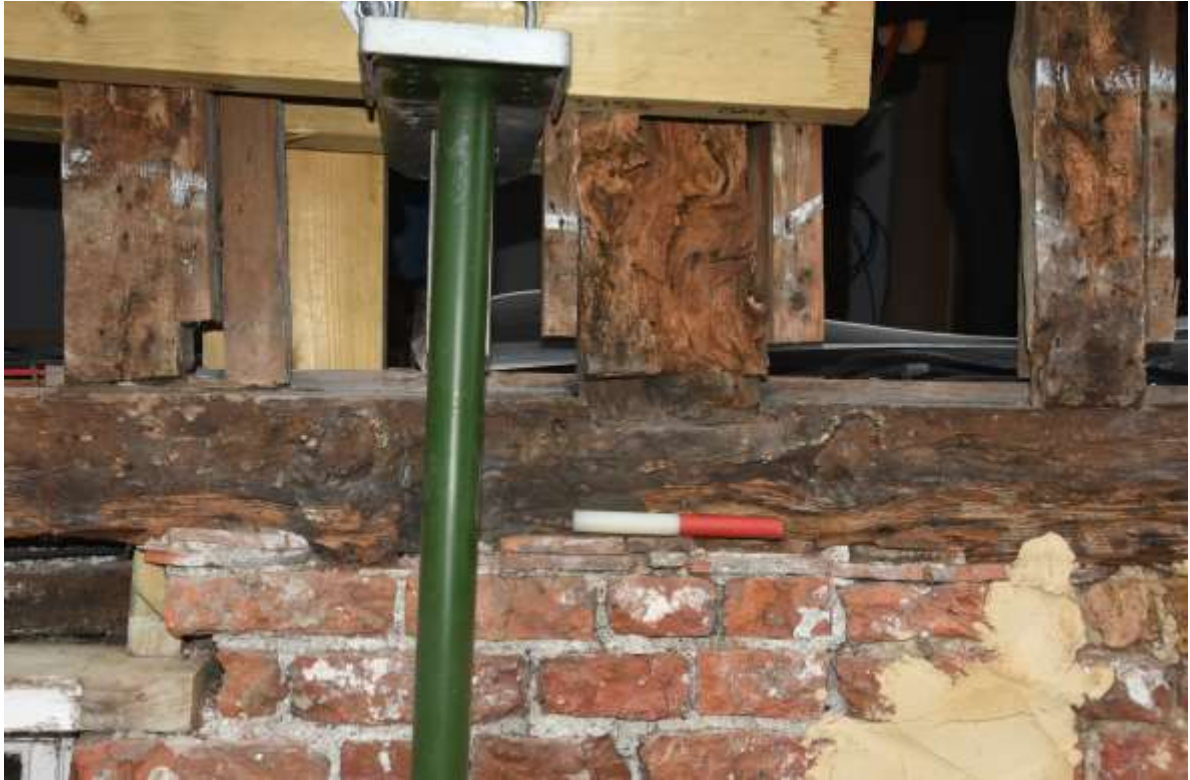
Fig.261: Another view of the principal southern stud (above the scale) and adjacent timbers, plus the uppermost course of brickwork and tile packing in front of the lower beam

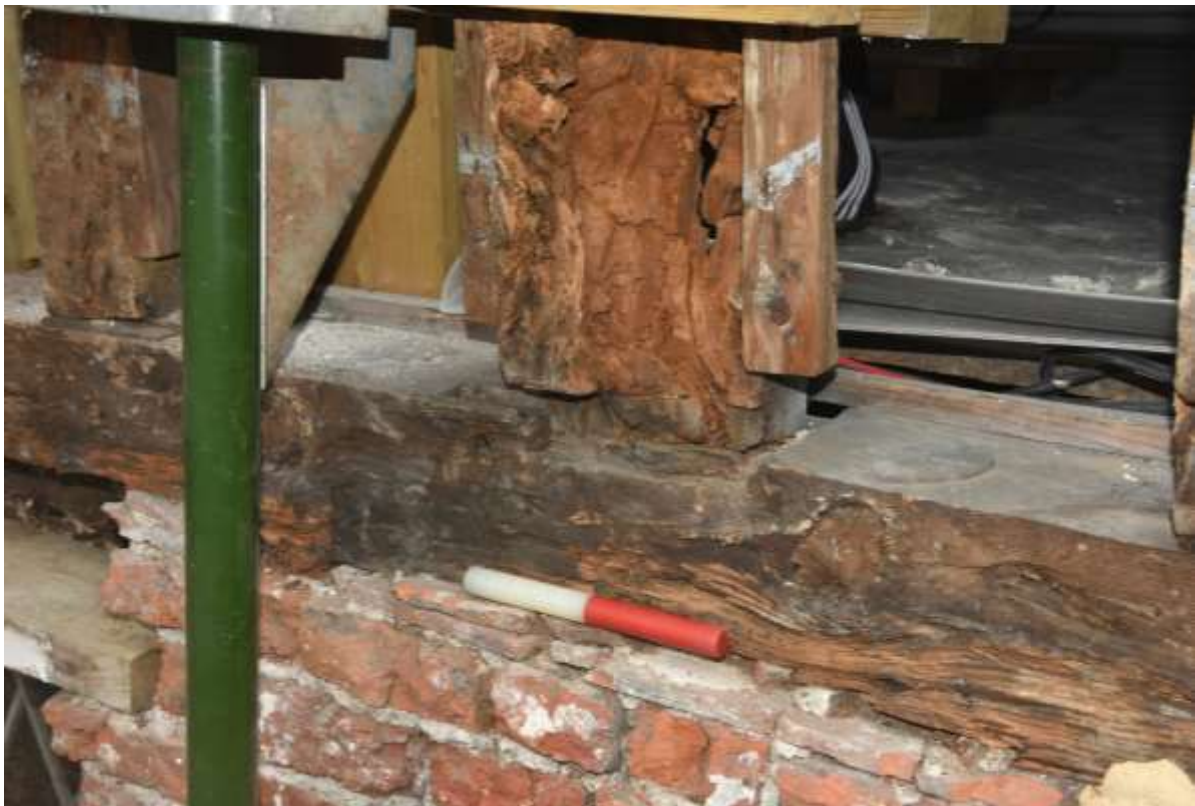
Fig.262: As above, detailed oblique view showing the slight (c 20mm) inset of the principal stud into the girder beam, plus an empty mortise immediately to the left

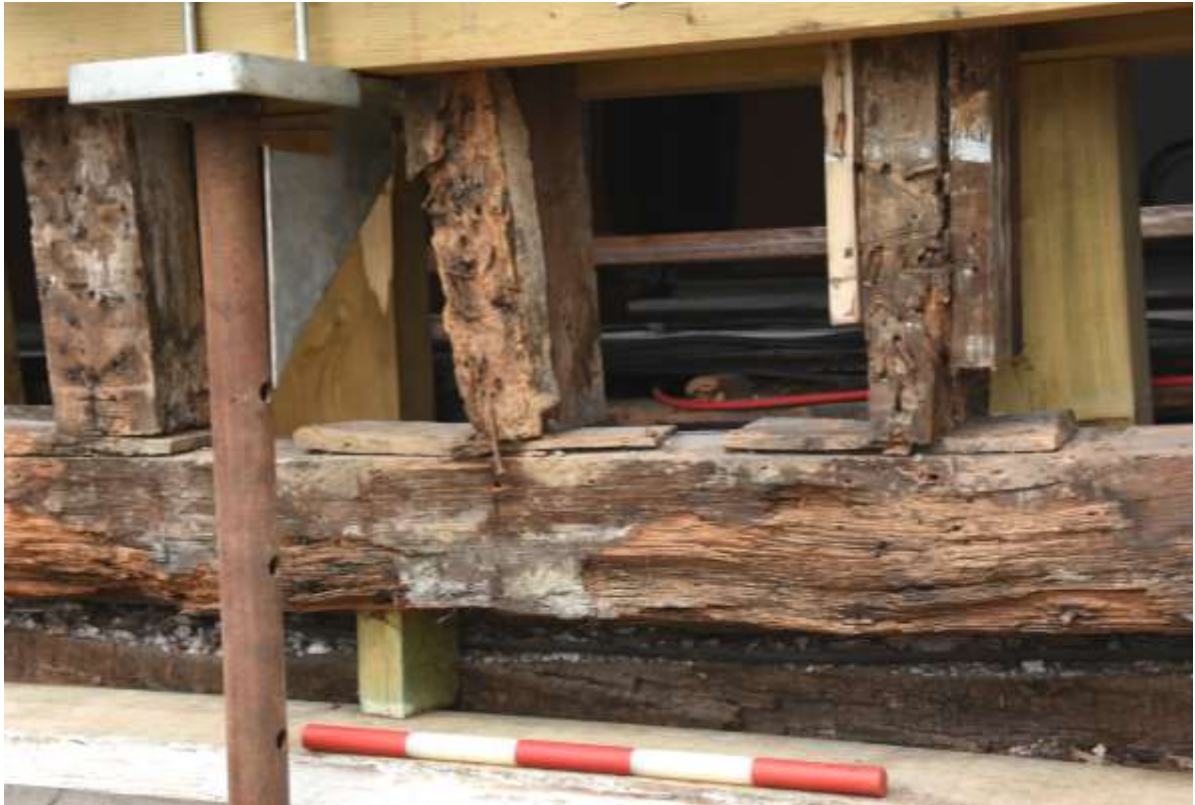
- Between the studs of the western wall and underlying girding beam there were a series of small wedges and fillets *c* 5mm to 25mm in thickness (see Figs.231, 239, 260, 263, *etc.*). None of the timbers had been properly secured into the beam.

Fig.263: *Detail of studs above the French doors, all with thin wedges or fillets (<25mm) inserted between their bases and the underlying girthing beam (0.5m scale)*

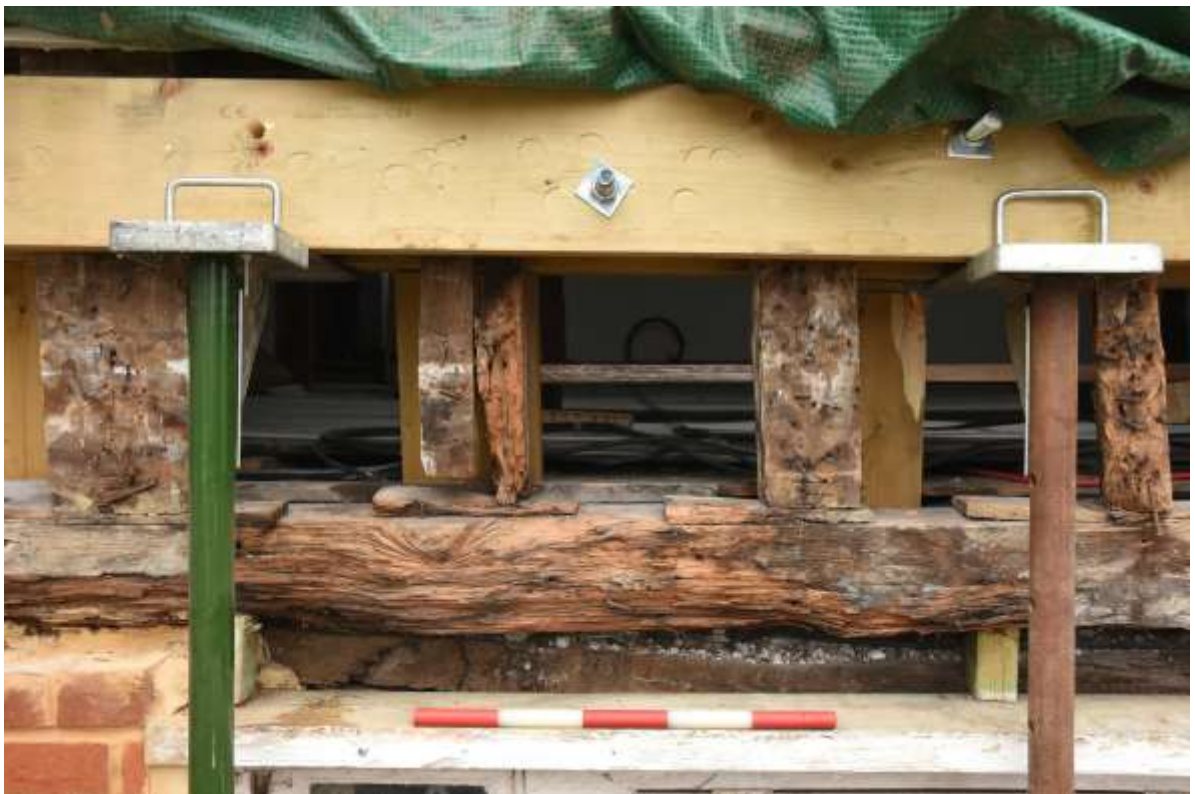
Fig.264: *As above. Note also the secondary timber below the main girthing beam, which continues either side of the doors behind the recent and original brick wall facing*

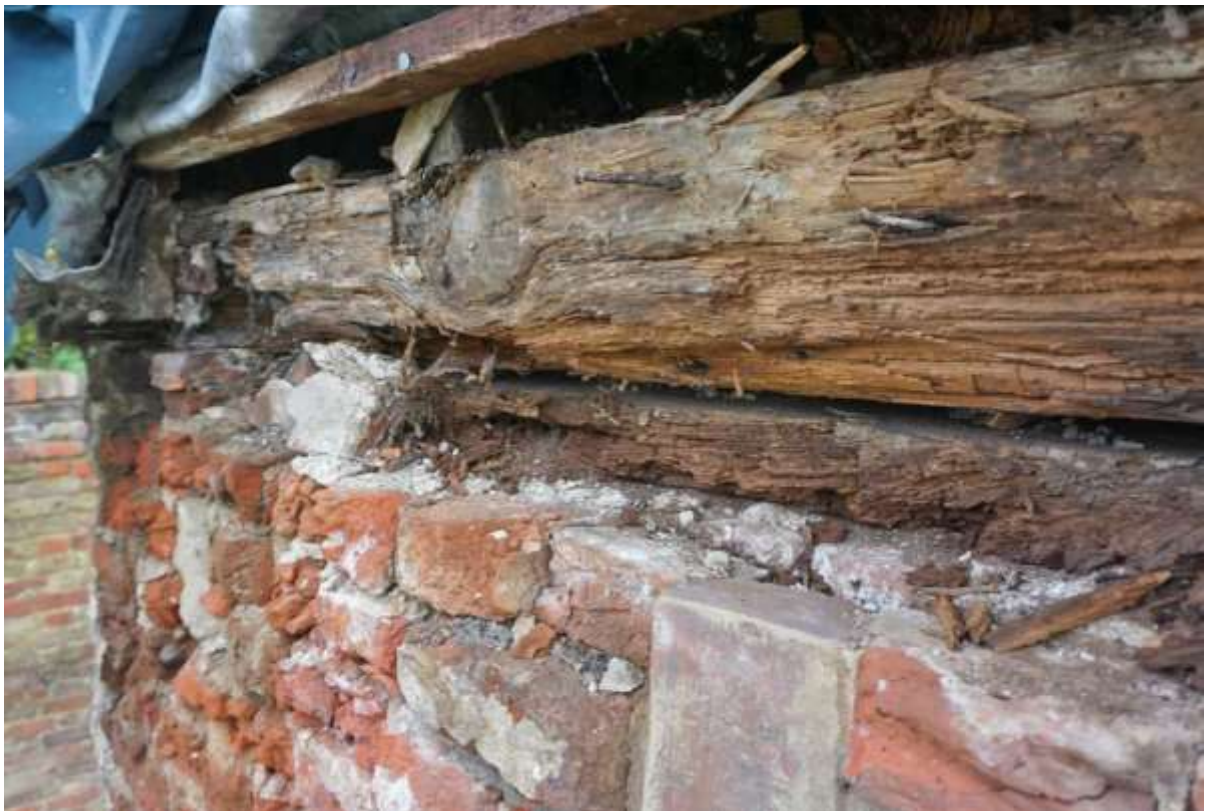
Fig.268: Oblique view of the above looking north, and also showing the smaller secondary timber below the girding beam (still partly hidden to the left by brick facing).

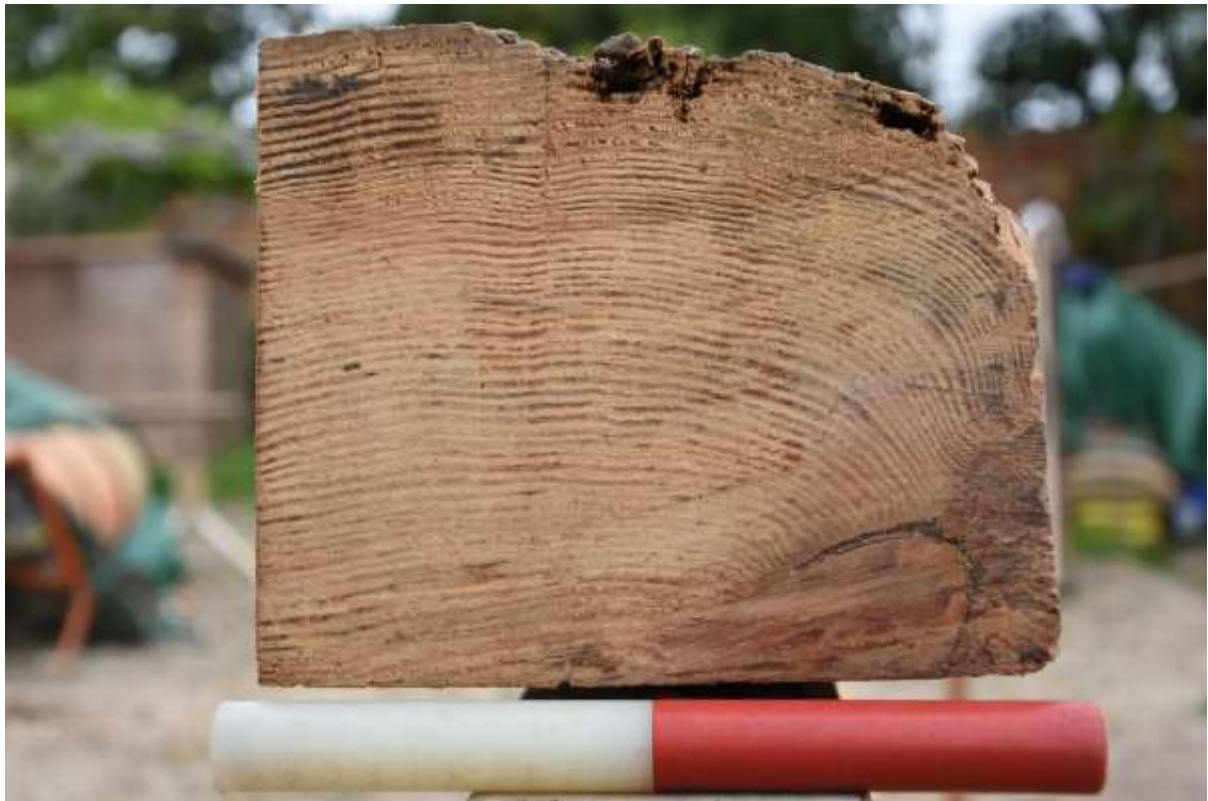
The most obvious evidence for repair was the replacement of the girding beam that ran across the full width of the room – some 6m – although this too was now in poor condition and required replacement. The lower sections of the corner posts at both ends also had to be replaced – the southern post an original element of the framing, the northern post already replaced once.

Fig.269: A section through the removed girding beam from the western wall. The timber is softwood, rather than the oak of the original construction

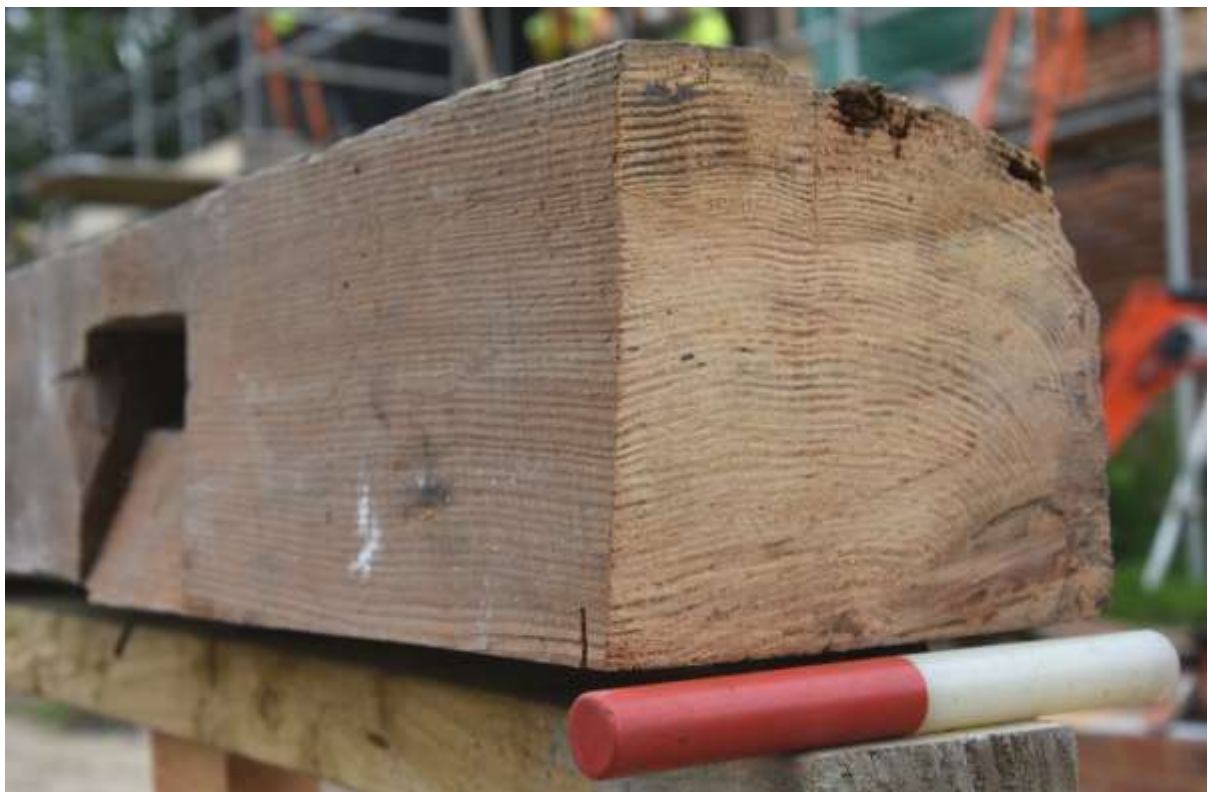
Fig.270: As above, with one of the joist mortices to the left. Note: beam is upside down in both these views

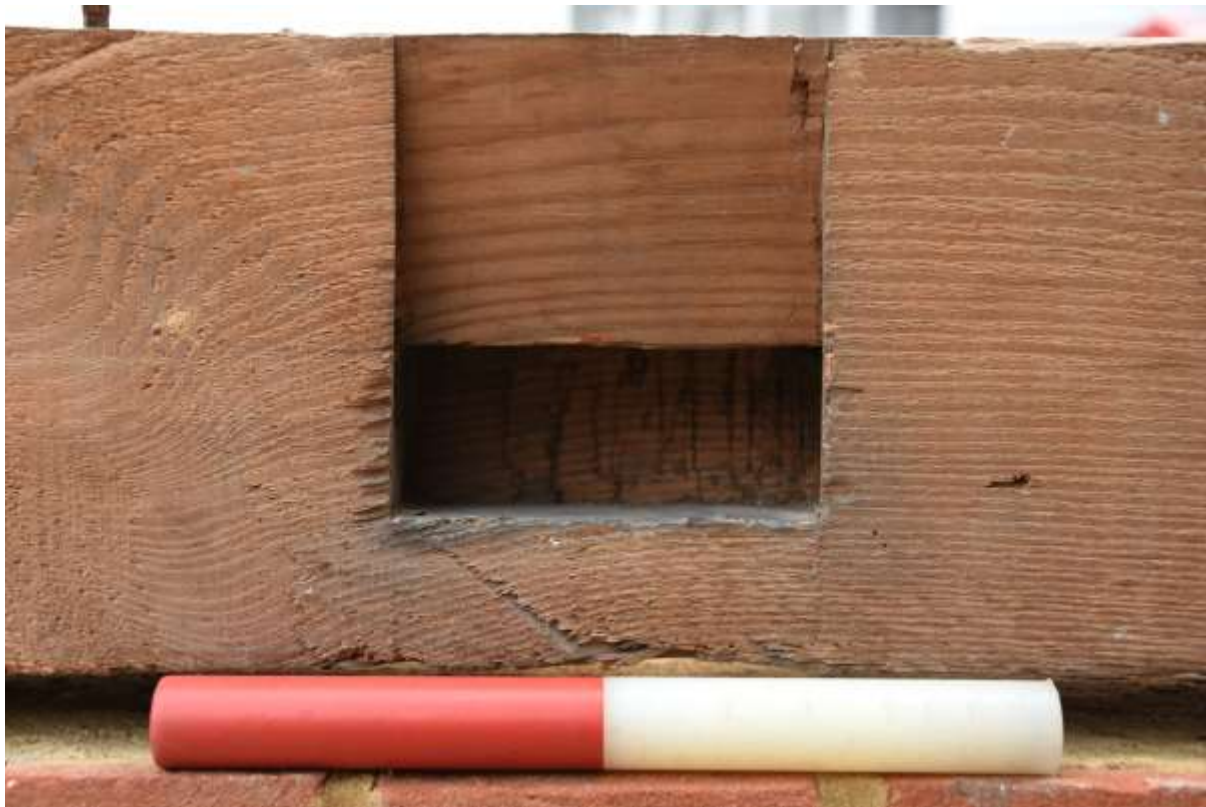
- Mortices had been cut in the replacement girding beam to receive the existing joists with their tusk tenons (Figs.230-31; 271-72, *etc.*), and on the east side of the northern corner post to fit the tenons of the northern wall down brace and midrail (Figs.216-17.). Almost all of these tenons had pegholes – and were presumably thus secured in the original construction. However, there was no evidence for any corresponding holes in the replacement timber – and consequently the whole structure had moved apart by several centimetres, as noted above.

Fig.271: Detail of a joist mortice on the eastern face of the girding beam (0.2m scale)

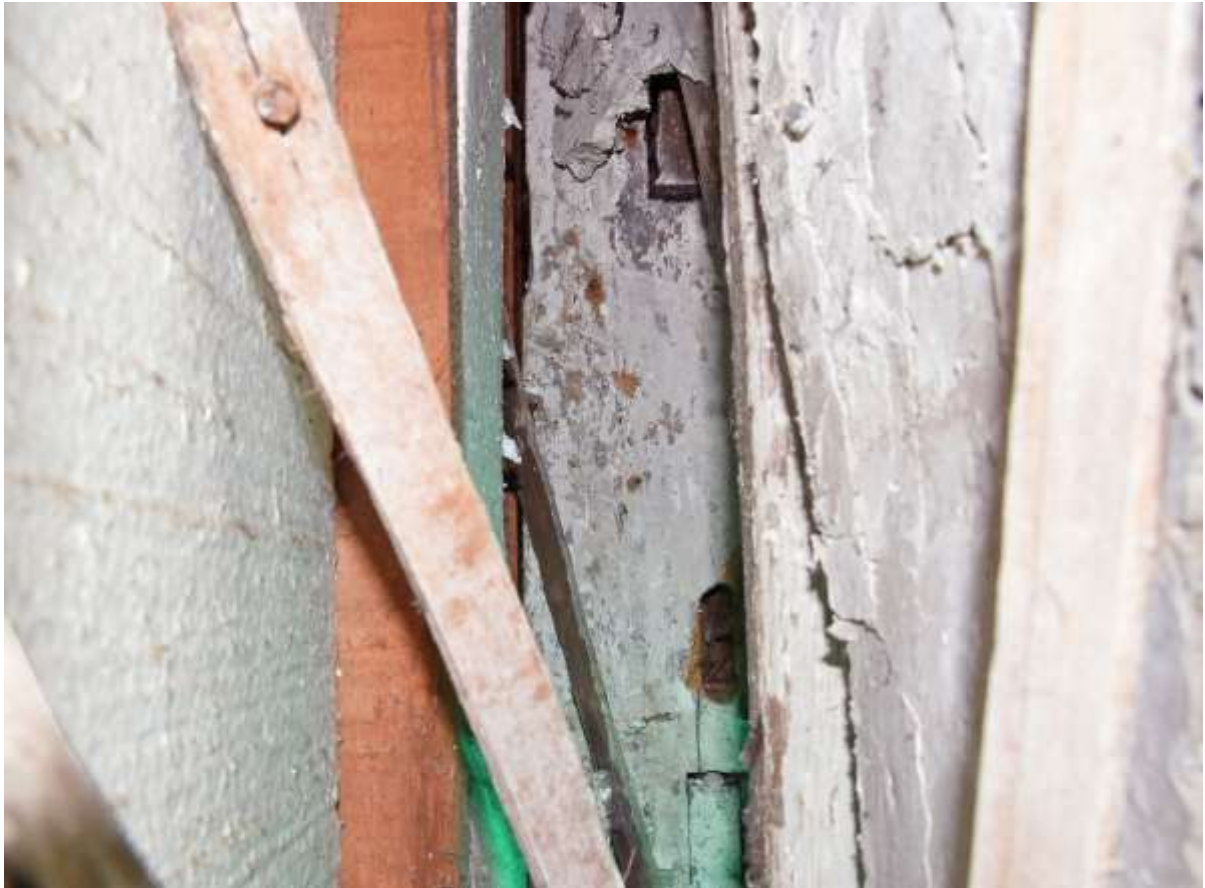
Fig.273: The southern wall of Room F-07 looking eastward from the southwest corner. This view is taken in the cavity between recent timbers and wall covering (centre/left of frame), and remnants of the original lath & plaster facing set back between studs to the right

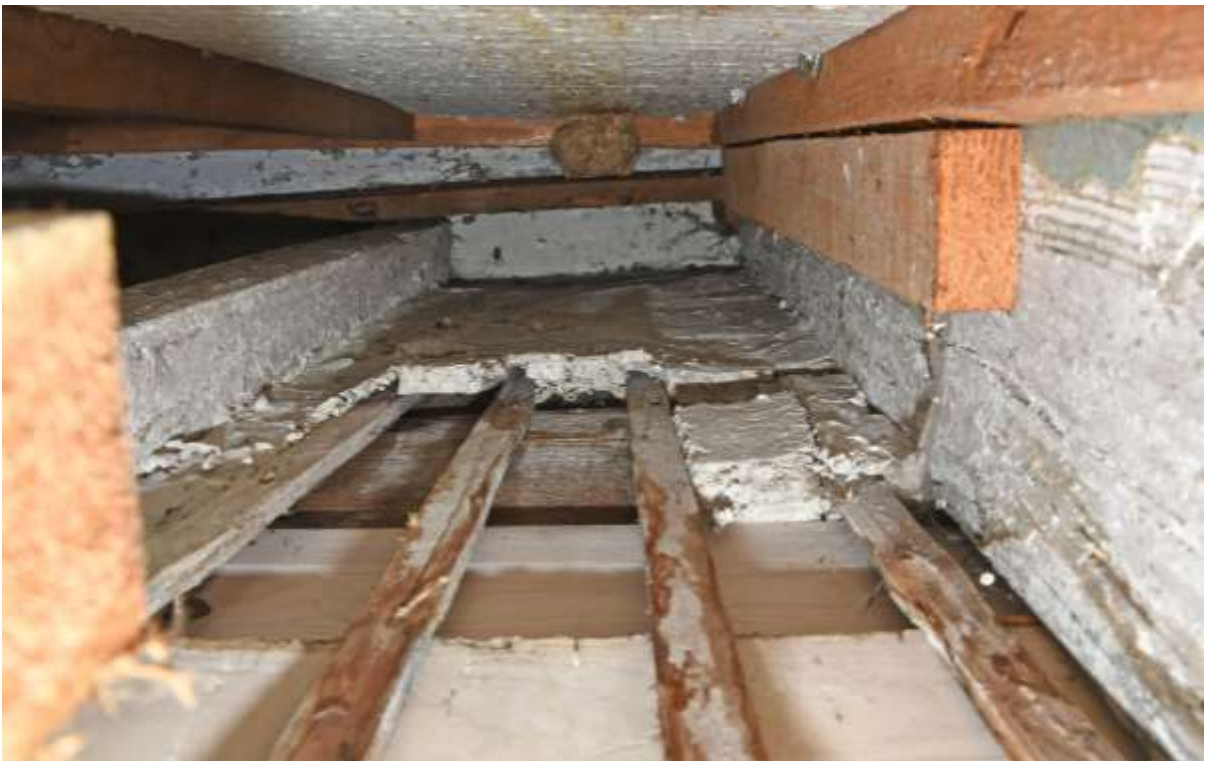
Fig.274: As above: looking upwards within the cavity between the modern wall covering (at the top) and original vertical laths, plastering & limewashed studs in middle/lower part of the frame

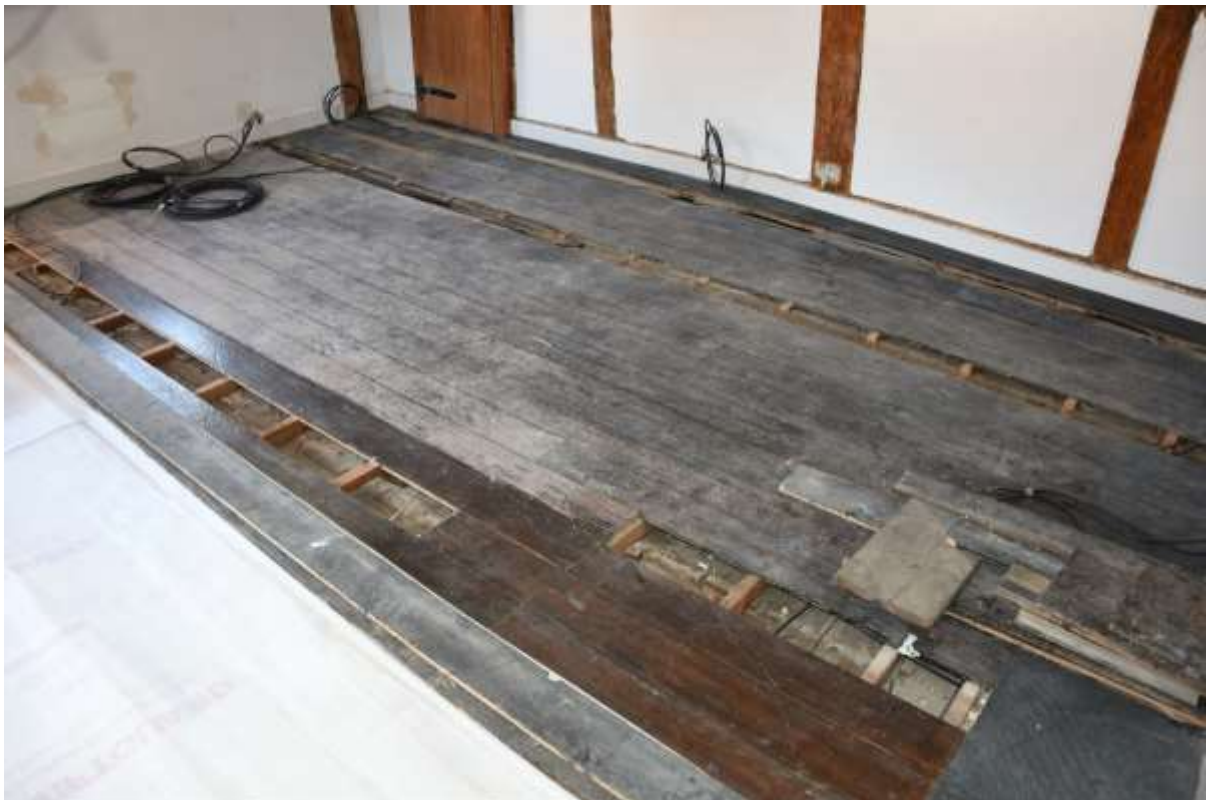
Fig.275: General view of the floor area looking approximately southeast, and showing the series of blocks put over the earlier floor to level its replacement. In general the thickness of these increased from north to south, from c 20mm up to about 100mmn

Fig.276: As above, looking northeast

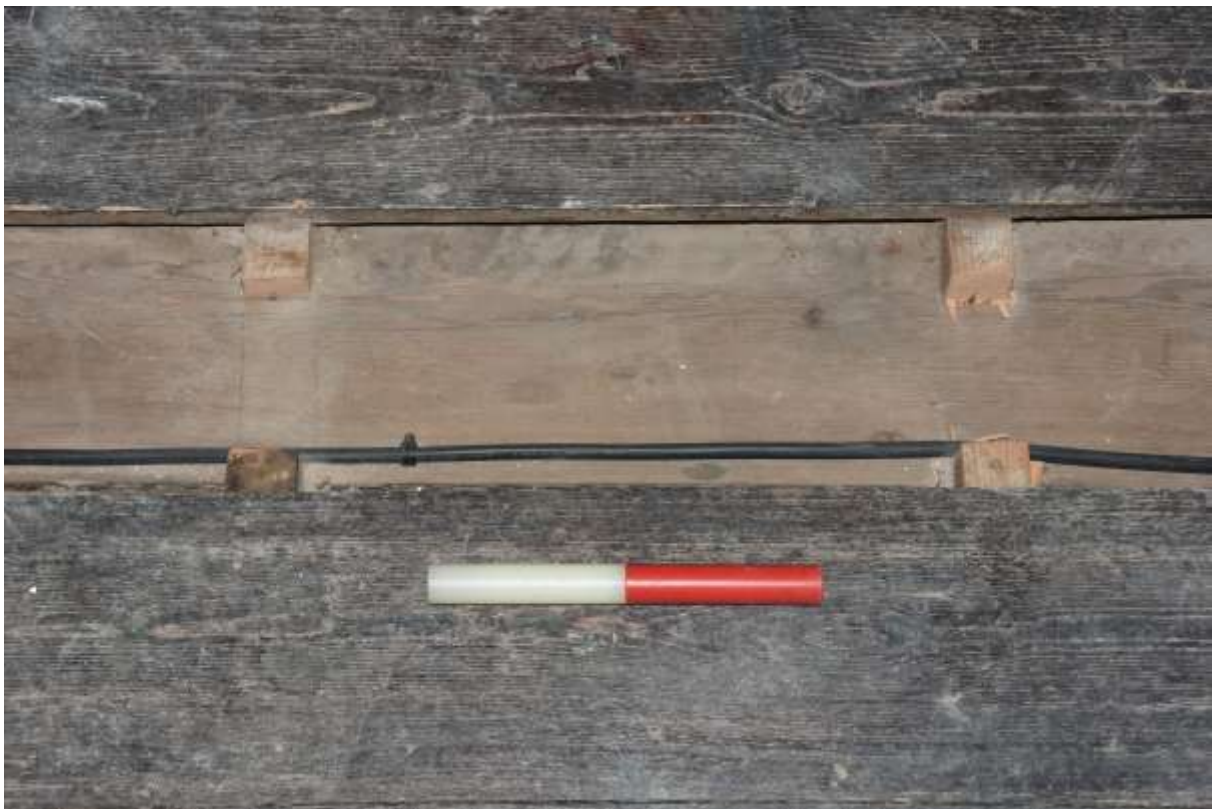
Fig.278: *As above, but the area towards the rear of Figs. 275-76*

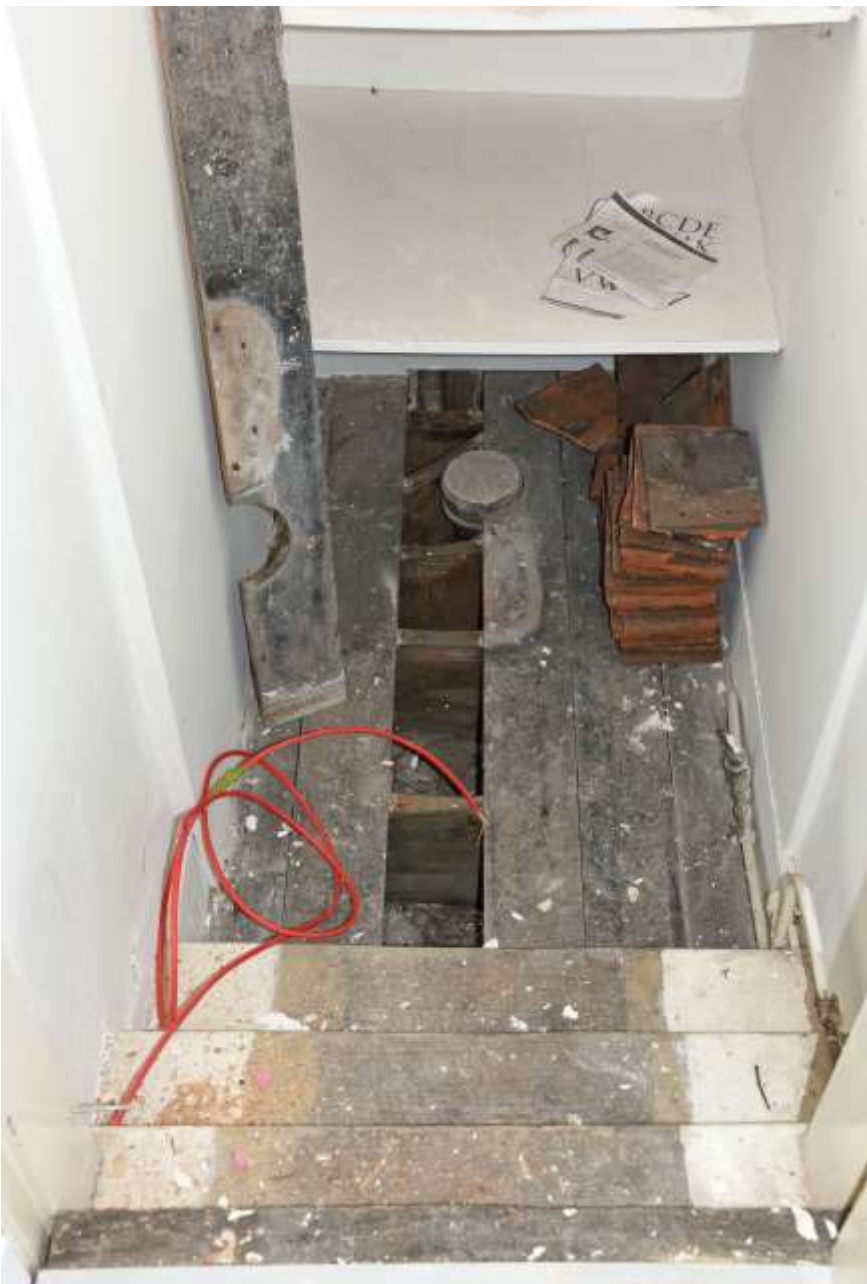
Works in the area of F-09 were limited to the lifting of floorboards to expose the underlying cavity and joists: the latter were narrow but deep (c 37mm by 275mm).

Fig.279: A view looking into the storage area (& former w.c) F-09, showing exposed joists and three steps down from the main floor

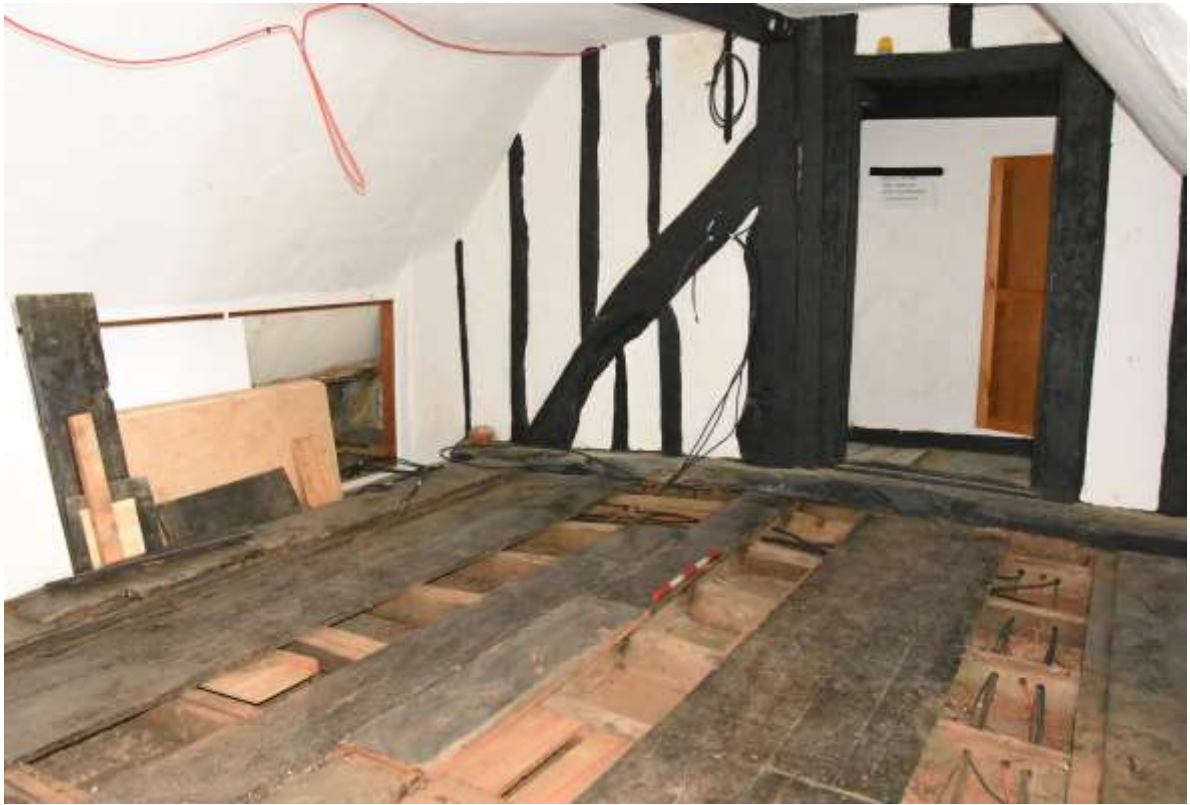
The junction between joists and the axial beam was formed by a simple unpegged mortice and tenon joint. Some past outward movement had occurred here, exposing the detail of the joint (*cf.* Fig.284). The degree of movement also seems to been greater at the top rather the base (c 30mm to 45mm), thus in effect rotational as well as outward and producing the slightly convex east-west profile exhibited by the present floor – clearly visible in Fig. 282 overleaf.

Fig.282: *General view of Room S-03 and exposed joists looking northwest*
