9.5 Room F-07

Room F-07 forms part of the northwestern extension otherwise represented by Rooms G-12, S-05 and the cellar (Sections 7.3, 10.4, *etc.*), and is of probable mid to later 17th century date. The principal development here comprised the creation of a new access doorway from the northern staircase/ lift extension, located towards the western end of the north wall (*cf.* Figs.207-209).

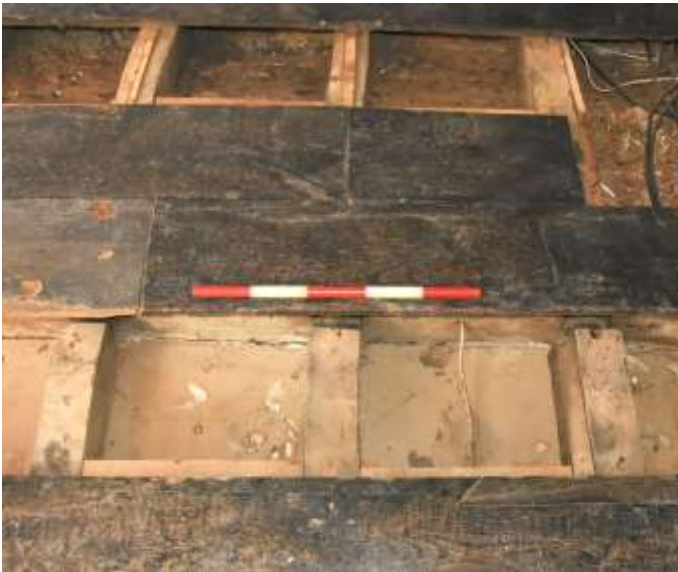
The junction between joists and the axial beam was formed by a simple unpegged mortice and tenon joint. Some past outward movement had occurred here, exposing the detail of the joint (*cf.* Fig.284). The degree of movement also seems to been greater at the top rather the base (c 30mm to 45mm), thus in effect rotational as well as outward and producing the slightly convex east-west profile exhibited by the present floor – clearly visible in Fig. 282 overleaf.

Fig.283: *Detailed view to show outward movement of joists from the axial beam (0.5m scale)*

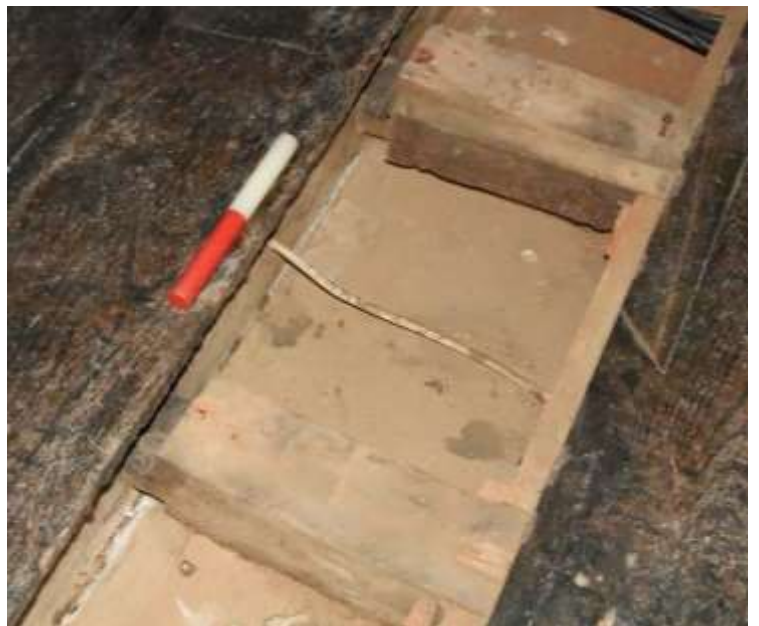
Fig.284: *An oblique view of the same area (0.2m scale)*

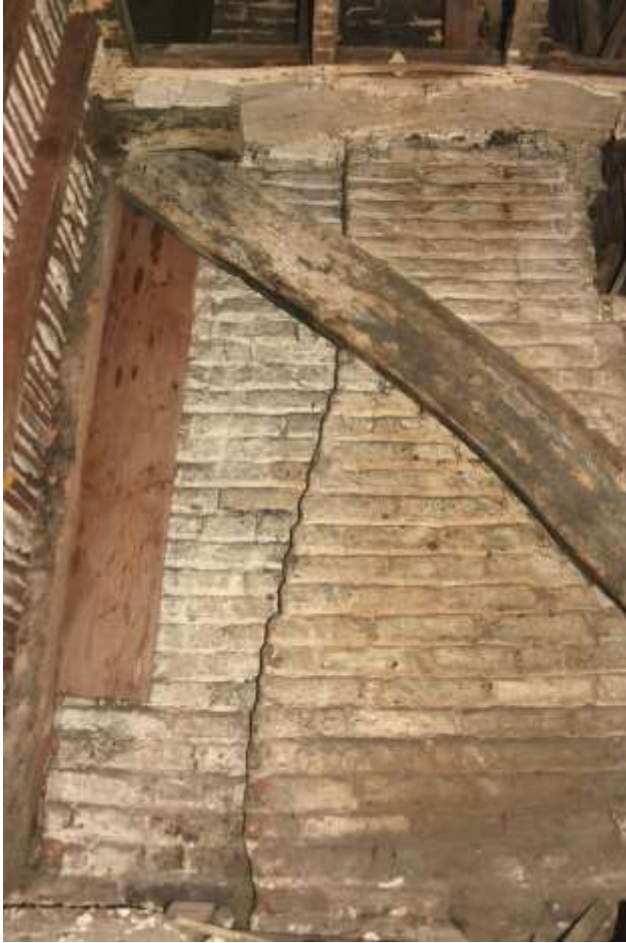
Although now in poor condition the internal surfaces (including a remnant of ceiling) were at one time well finished, plastered and limewashed. The only exception to this was the dividing wall to the present room, where the unfinished rear of the lath and plaster construction was exposed (Fig.285). It would appear therefore that this space was originally integral to the room itself, with no intervening partition.

Fig.285: *The western side of the chimneybreast, with the rear (lath & plaster) face of the internal wall to the left. The brickwork is limewashed but now within an enclosed and disused space*

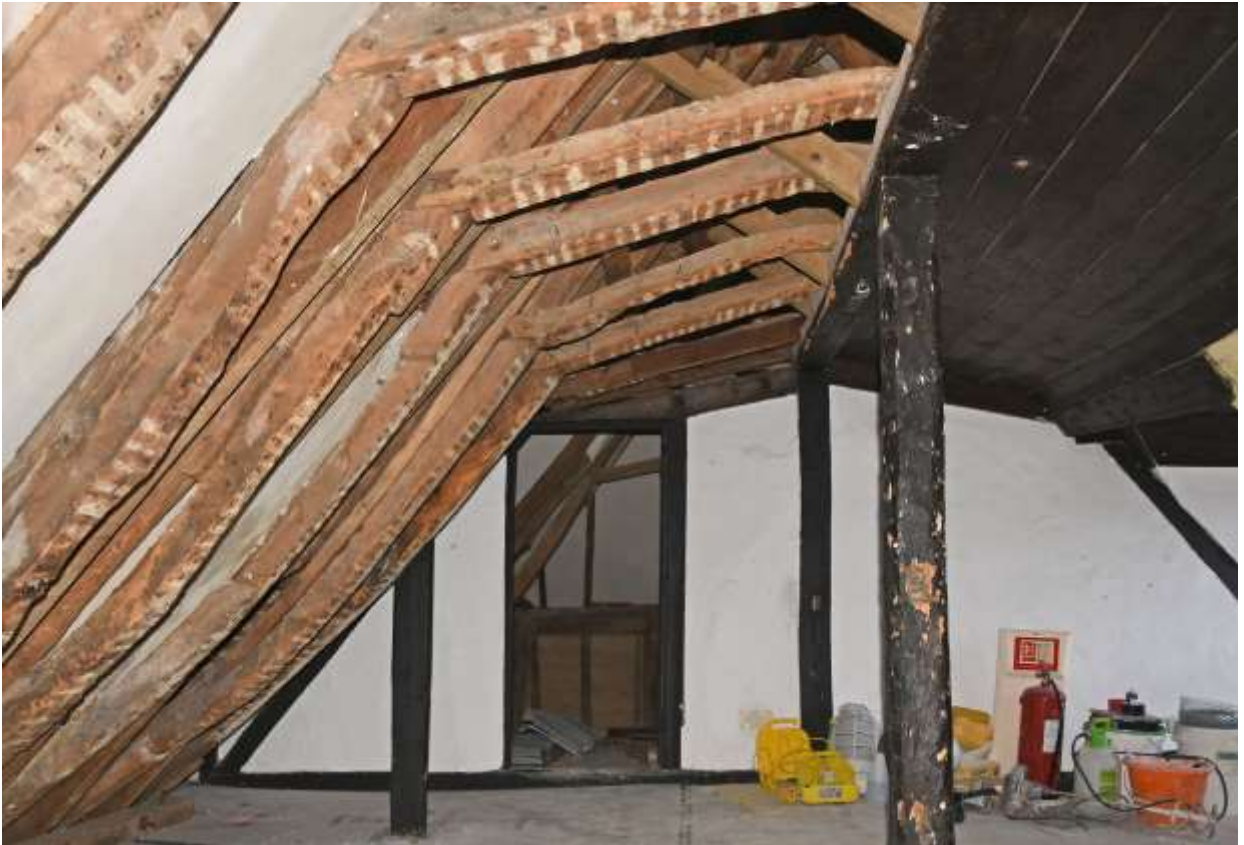
As seen overleaf, this area had mostly lost its previous lath and plaster covering (except at the north and south ends). Part of the ceiling had subsequently been boarded over (probably relatively recently, a development that presumably includes the central post and a series of diagonal struts running from the western edge of the boarding up to a clasped purlin.

Fig.290 (above): *Exposed roof timbers within Room S-04, looking northwest*

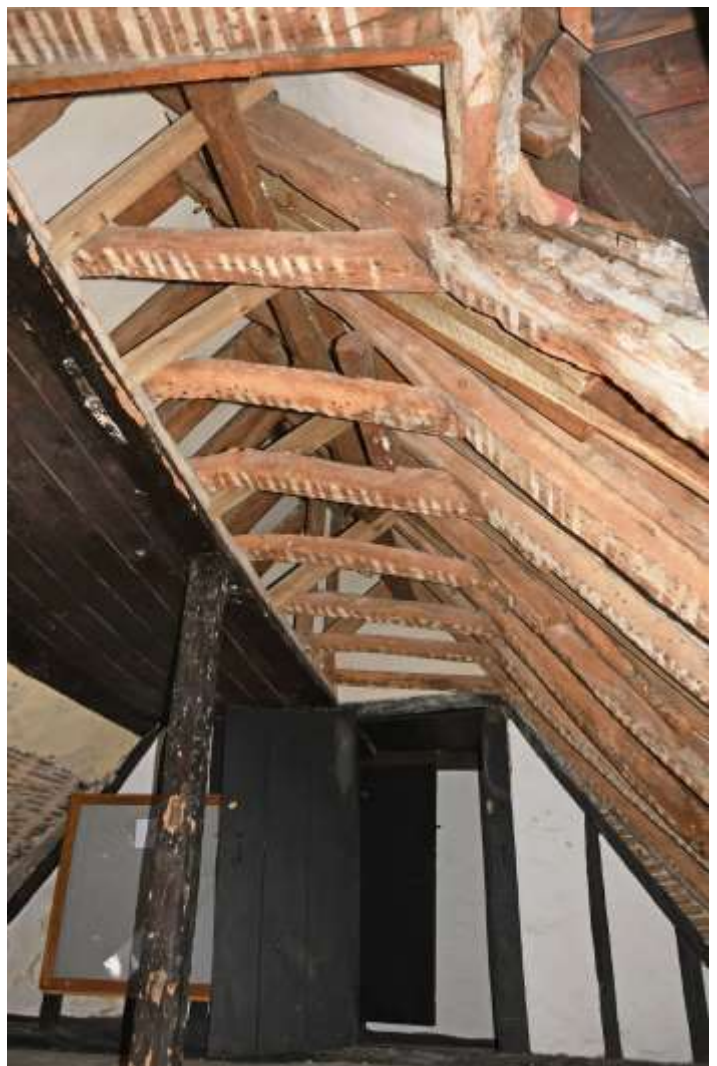
Fig.291: *View of the same looking southeast. Part of the ceiling is now boarded over, but it is clear that at one time the whole was lath & plastered*

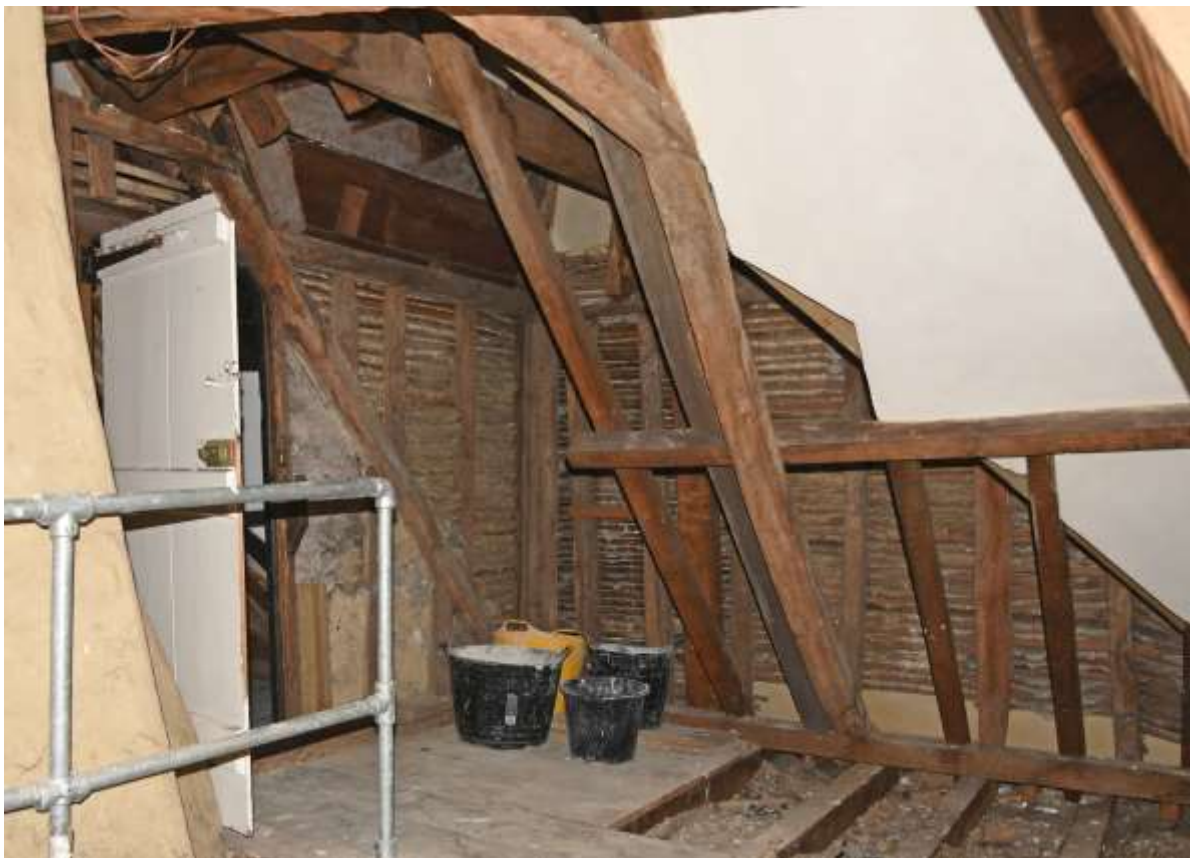
Fig.301: *View of the southwest part of Room S-06, with the original roofline in the foreground and the rear of the lath & plastered walls of extension S-05 beyond*

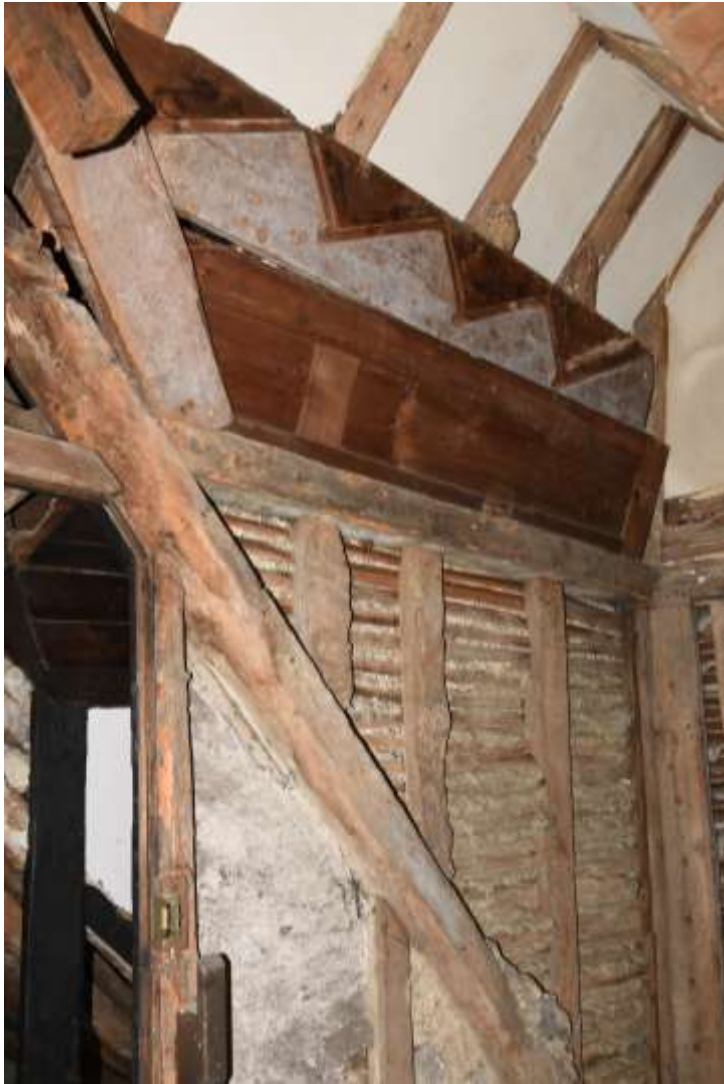
Fig.302: *Detail of Fig.301, the original sloping roofline to the lower left, lath & plaster wall extension above this and at the top what appears to be a reused timber from a staircase*

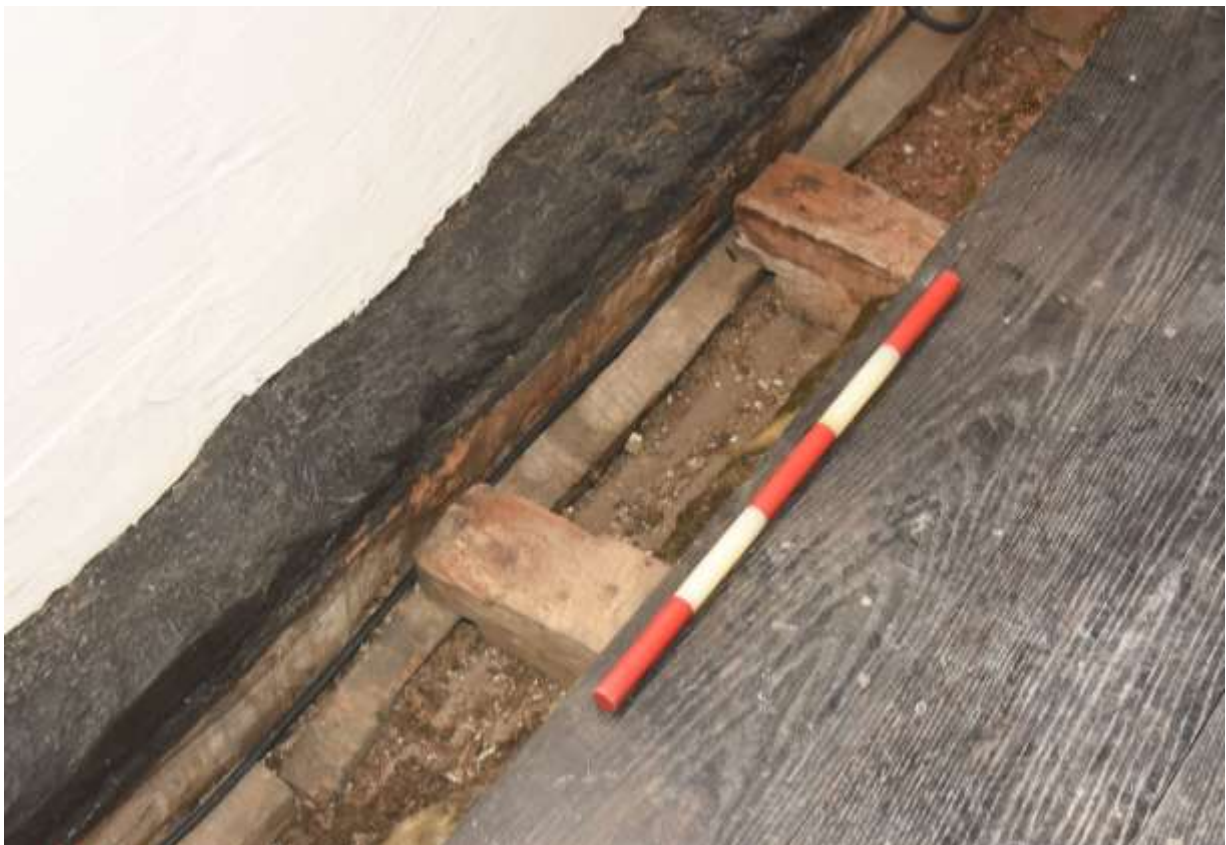
At their western end the joists were simply stepped over the adjacent (north-south) beam (*cf.* Figs.308; 310), with no apparent additional fixing such as dowels or nails. Moreover, they rested on a couple of lengths of quite narrow (*c* 80mm) timber, abutting in the centre of the room and apparently quite separate from the much larger (*c* 200mm to 220mm square) tie beam to the rear.

Fig.310: Detail of the above showing joists simply stepped over the adjacent beam – which also abuts a separate length in the bottom left hand corner of the frame (0.5m scale)

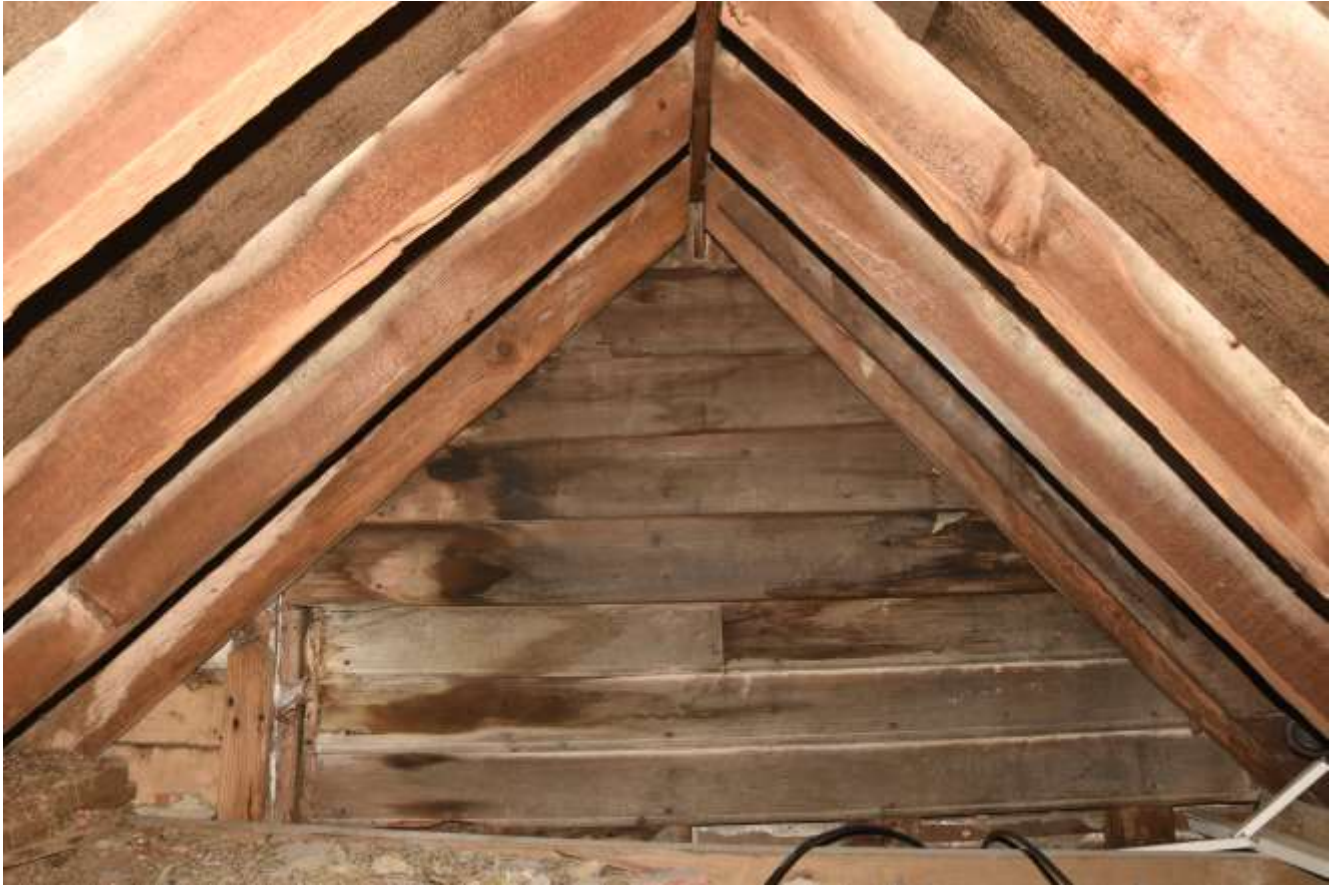
There was also one feature of interest. At its northern end the roof was built against the previously external south face of the stair turret, and the unpainted weatherboarding can still be seen here (*cf.* Fig.312). In fact the overall white-painted finish of the building appears to be quite a recent innovation, to judge by the view of the frontage in Gravett's paper (Gravett 1966, Plate VIII (a)). The modern lamppost in the foreground suggests that this was taken at the time of the 1964 survey.

Fig.312: View looking northwards. At the far end of the roof is weatherboarding that previously formed the external (south) face of the stair turret, apart from a small section at lower left where the extension went beyond the existing building. Also just visible where the weatherboarding is missing at the base of the photo are three studs and (beyond these) the rear of the lath and plaster facing within the turret
