# Moat Bank Barns, Moat Bank, Lichfield, Staffordshire,

Archaeological Building Recording (Level 2)

Report No. 1959

March 2021

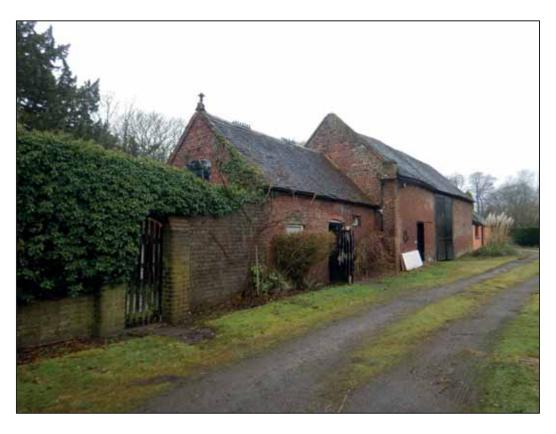
- 4.2.1 The north-facing elevation is a long façade with a stepped profile comprising four elements. To the east is the north wall of the eastern courtyard, to the west of this is the north elevation of the dog kennels. The dominant element is the north facing elevation of the main barn, with the north wall of Moat Bank Cottage at the west end. Apart from the latter, which is rendered, the north facing elevation is constructed entirely in brick with plain tile roof covering (Plate 1).

Plate 1: The north facing elevation of Moat Bank Barns, looking WSW.

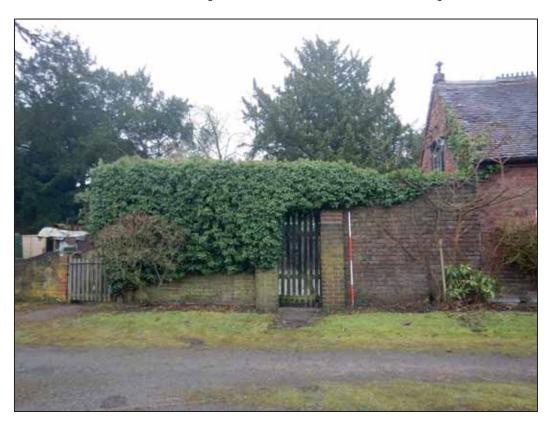
- 4.2.2 The north wall of the courtyard (plate 2) is constructed in Staffordshire Blue Brick laid in a stretcher bond with occasional headers. The bricks measure 0.23m x 0.11m x 0.07m and are bonded with a pink lime mortar. The wall measures 7m long x 2.7m high and has a single centrally positioned opening for a gate which measures 0.95m wide. The gate piers project slightly and have rounded bricks to the corners. The coping bricks are also rounded. The extensive use of Staffordshire blue brick may indicate a mid-late 19<sup>th</sup> century date for this courtyard wall. It is shown on historic maps dating from 1884

Plate 2: The North Facing Elevation of the Eastern Courtyard, looking S. 2m scale

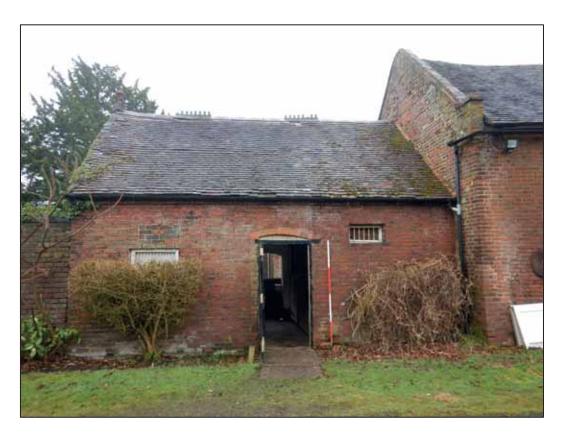
4.2.3 The north facing elevation of the dog kennels lies to the west of the eastern courtyard wall (plate 3). It is of a single storey and constructed in red brick with a plain ceramic tile roof with ornamental ridge tiles and a decorative ceramic finial to the apex of the east gable. The brickwork is laid in a mixture of stretcher bond and Flemish bond. While there is no obvious or clear-cut demarcation of the two types of bond, stretcher bond does seem to be more dominate around the door opening and in the upper two courses below the roof line. However, even in areas where Flemish bond is more prevalent, there are patches laid in an irregular stretcher bond. Part of the reason for this variation may be because the bricks are of varying sizes (commonly circa 0.21m x 0.11m x 0.06m), with potentially re-used from an earlier structure. The bonding material is a cream-coloured lime mortar.

Plate 3: The North Facing Elevation of the Dog Kennels, looking S. 2m scale.

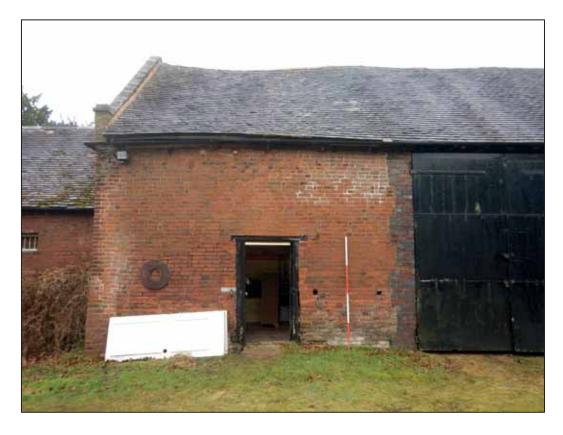
4.2.4 The north facing elevation of the main barn lies to the west of the dog kennels and projects forward by approximately 1m (plate 4). The wall is constructed in red brick with plain ceramic roof tiles. The east gable end has a brick parapet whereas the west gable does not. There is a disparity between the west and east ends of this wall. The wall to the west of the central double doors has a higher proportion of Staffordshire blue brick bricks and no evidence for blocked slit windows, Whereas the wall east of the double doors is largely in hand made red brick and contains a several alternating rows of blocked slit openings each measuring one headers width by three brick courses high. These slits have subsequently been blocked with Staffordshire blue brick. The western half of the wall

Plate 4: North Facing Elevation of the east end of the Main Barn, looking S. 2m scale.

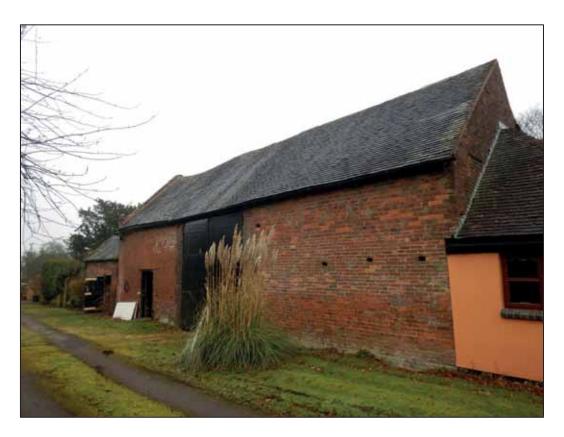
The re-constructed western half of the wall has some evidence for horizontal variation in the brickwork indicating that the lower part of the wall may be original (plate 5). The lower section the wall is constructed using a thin hand-made red brick measuring 0.25m x 0.11m x 0.06m and bonded with a soft sandy lime mortar. The upper section on the west side is markedly different and clearly more recent. It comprises slightly larger bricks, including some blue brick of a similar size to those used in the courtyard wall laid in a combination of English bond and stretcher bond, pointed with cement. This later lift is keyed into the main opening for the barn doors whereas the lower and eastern lifts are not (plate 6). Furthermore, this upper west lift is keyed in with alterations to the roof visible in the west facing elevation discussed below.

Plate 5: North Facing Elevation of the Main Barn, looking SE.

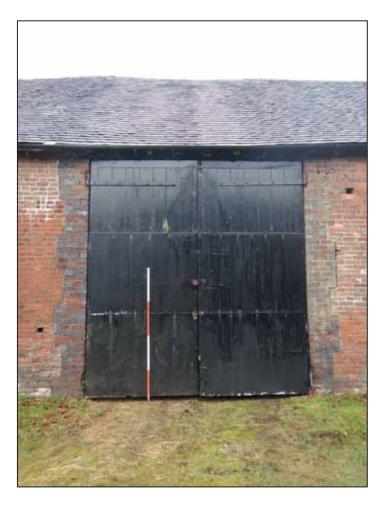
Plate 7: North Facing Elevation of the Main Barn, Central double doors, looking S. 2m scale.

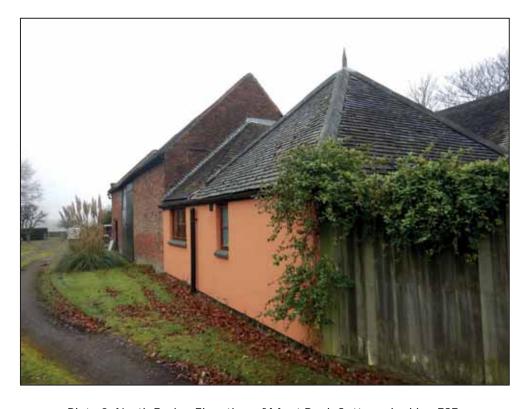
The north facing elevation of Moat Bank Cottage (plate 8), to the west of the main barn is in private ownership and access was not available. This collection of buildings forms the west wing of the former barn buildings. Those visible at the north end are modern 20<sup>th</sup> century additions.

Plate 8: North Facing Elevation of Moat Bank Cottage, looking ESE.

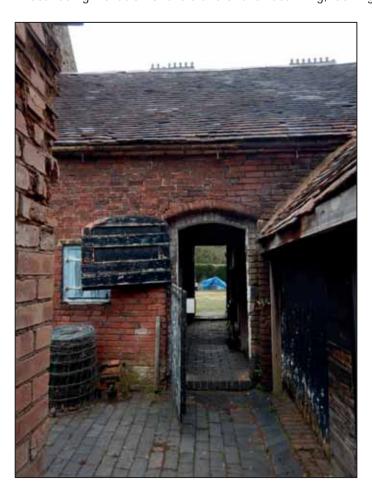
Plate 20: South Facing Elevation of the Dog Kennels, Looking N.
