**EAST PITTEN FARM, YEALMPTON:
A DEVON FARMHOUSE
UNDER DEMOLITION**

Prepared for Le Page Architects

*By John Allan, Anthony G. Collings
and Andrew Passmore*

Exeter Archaeology Report No. 10.76

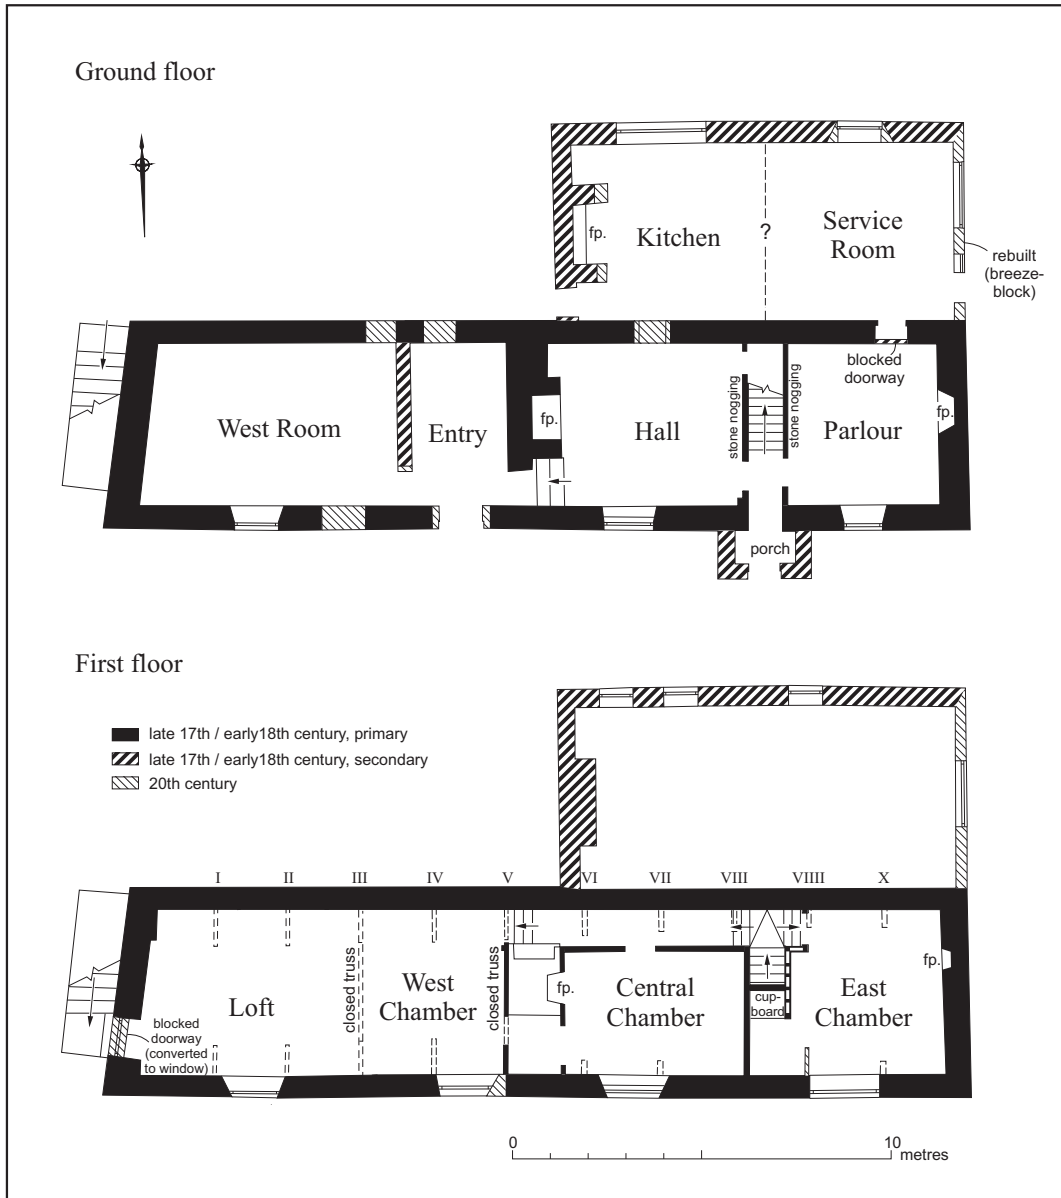
Fig. 8 Phased ground- and first-floor plans.

Stripping of a band of the S wall exposed blocked doorways piercing the spinal wall between the two ranges, and leading to the entry, hall and parlour (Fig. 8). Selective stripping of the N wall showed that the window in the E room is a remodelling of a primary window with wider splays (Fig. 26). Given the position of the window towards one end of the range, it is likely that the ground floor was initially divided into two – probably a kitchen and a service room or rooms. It was not considered worthwhile to strip the entire W and N walls.

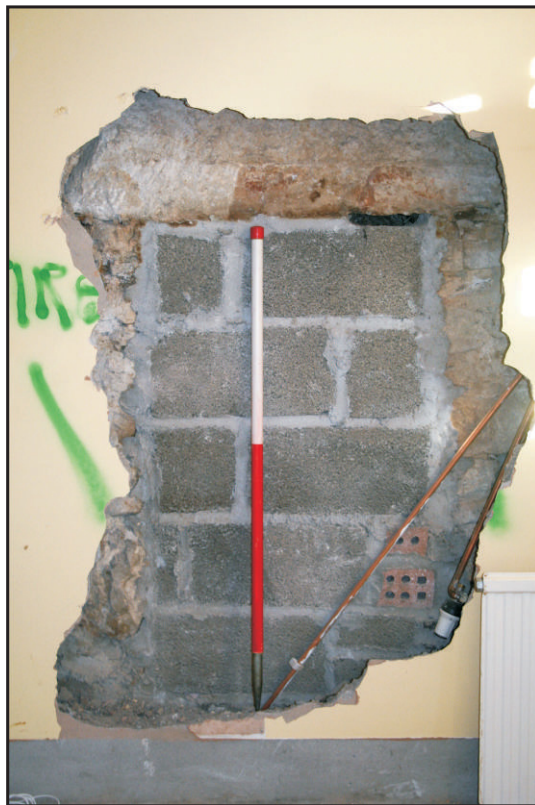
Fig. 16 Fireplace in the parlour.

In the E gable wall, demolition of part of the internal breeze-block lining in the expected position of a fireplace showed that a traditional but quite small fireplace with a lintel of local slate does indeed survive here (Fig. 16). Its yellow clay bonding is very similar to that in the adjacent walling, and seen elsewhere in the primary walls, showing that it is a primary feature. Since the lintel and surrounding masonry have rough unhewn surfaces, they were clearly intended to be concealed from the first; embedded wooden plugs, designed to fix a fireplace surround (probably of wood), were also primary features.

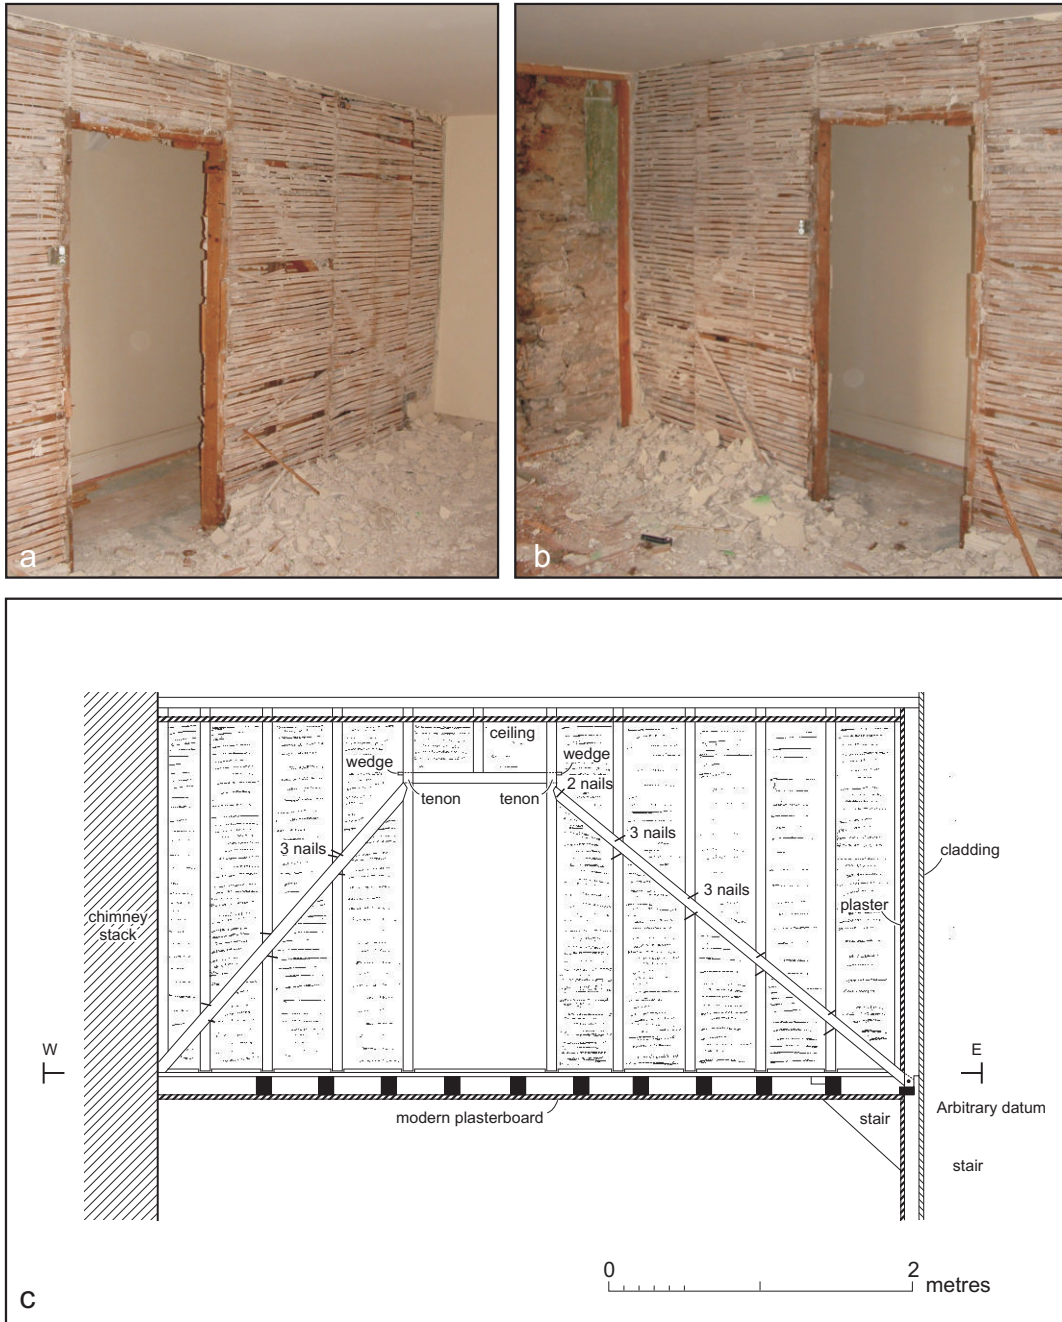
Fig. 20 Partition between central bedroom and passage, (a) Viewed from SW, (b) from SE. (c). Drawing showing platform framing over joists below.

The partition between the chamber and the passage to the N was stripped entirely, exposing the central doorway with straight diagonal braces on each side, that to the E rising from the stair (Fig. 20). Examination of the relationship of the studs with the floorboards below showed that all the studs sit on the boards and are unrelated to the joists below. This is clear evidence of the use of platform framing, an early modern building technique in which the floors are installed as building proceeds to the first floor. This allowed the floors to serve instead of scaffolding; the practice is first attested in Devon in the mid-17th century.

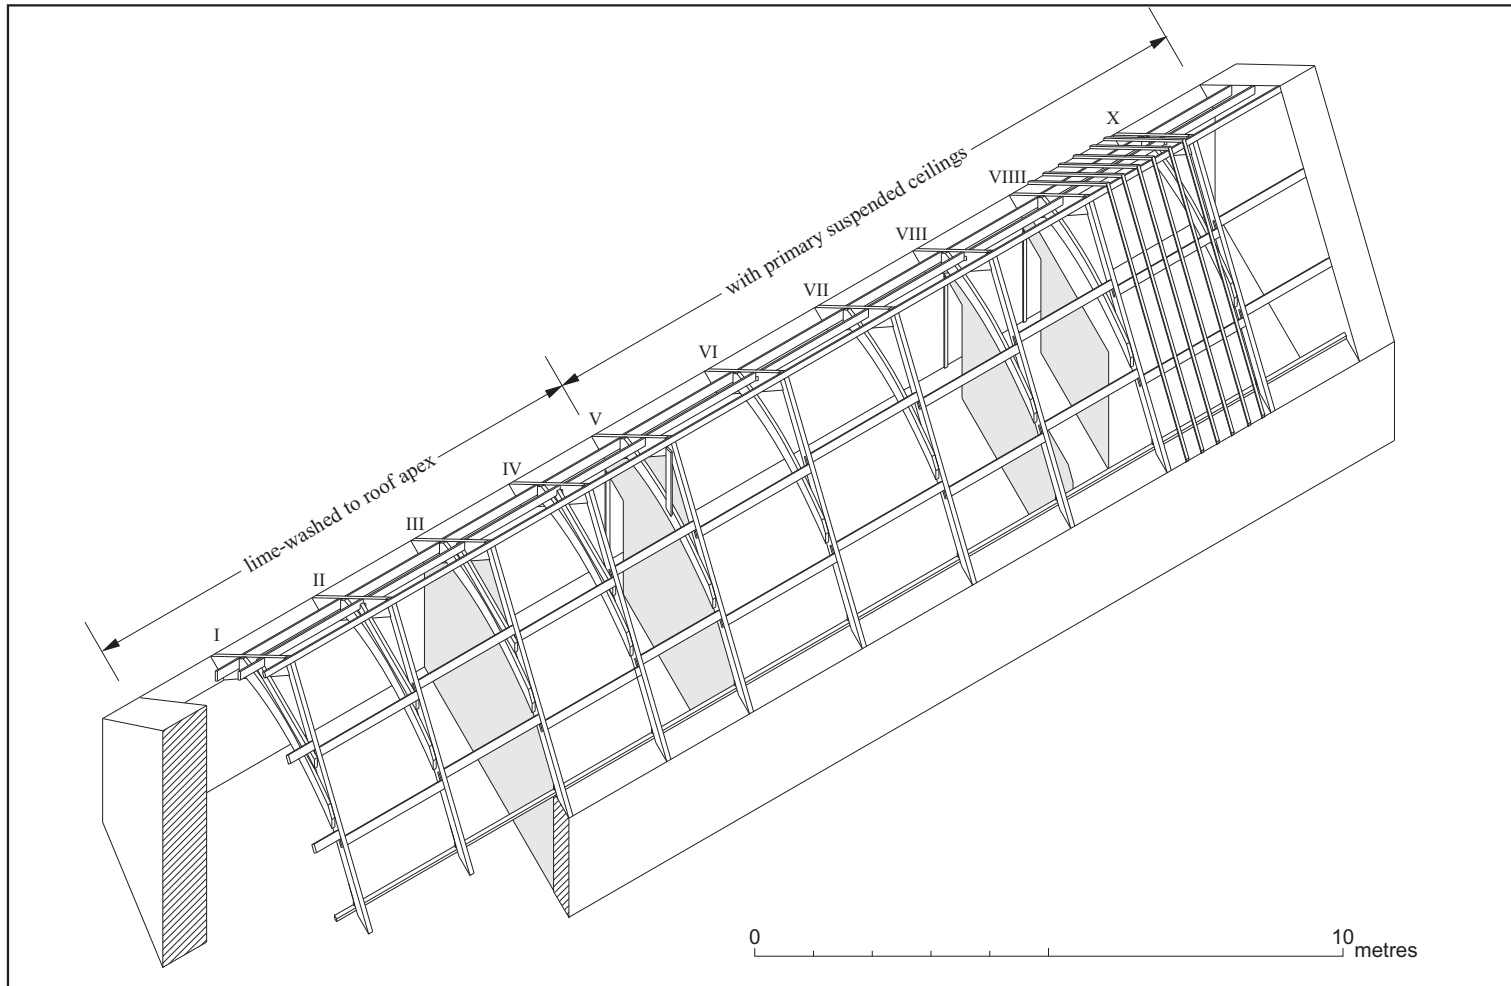
Fig. 21 Isometric projection of roof, with restored positions of closed trusses III and V.

Trusses I–V were raised over the part of the farmhouse which had no ceilings, and there was therefore no need for the extra boards below the collars. Instead, an additional upper plank collar was nailed between the upper purlins in these bays (Figs 21, 23). This may show that a single collar alone was regarded as insufficient to support a slate roof.

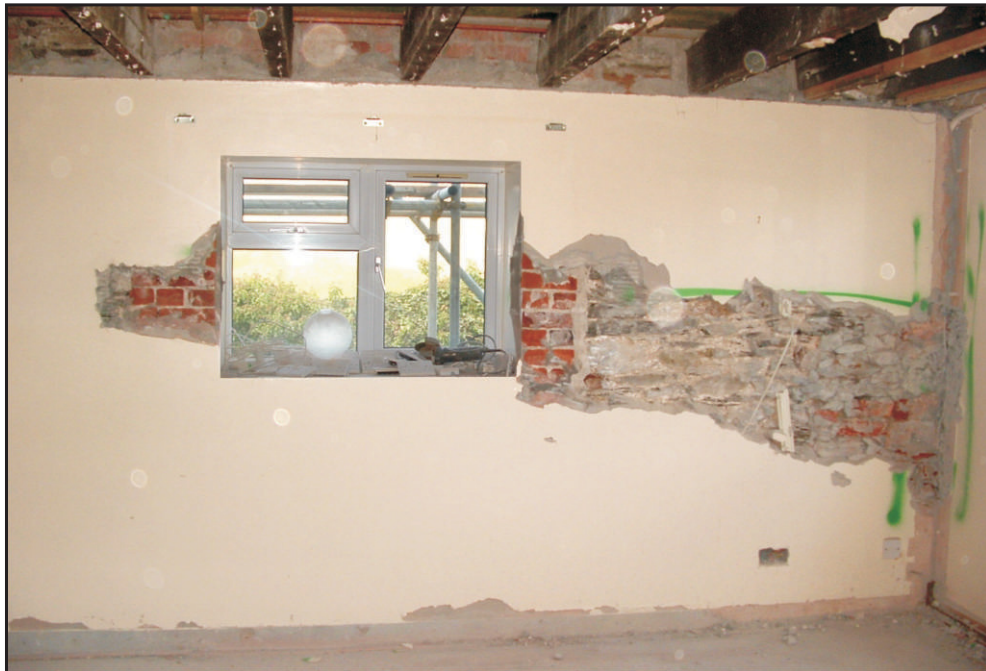
Fig. 26 North range: ground floor, E room showing blocking of splays of early window, with scar of demolished E gable wall to right.
