**THE ADMIRAL VERNON INN,  
ALPHINGTON, DEVON:  
ARCHAEOLOGICAL RECORDING 2007-9**

**Exeter Archaeology**

**Report No. 09.32**

**April 2009**

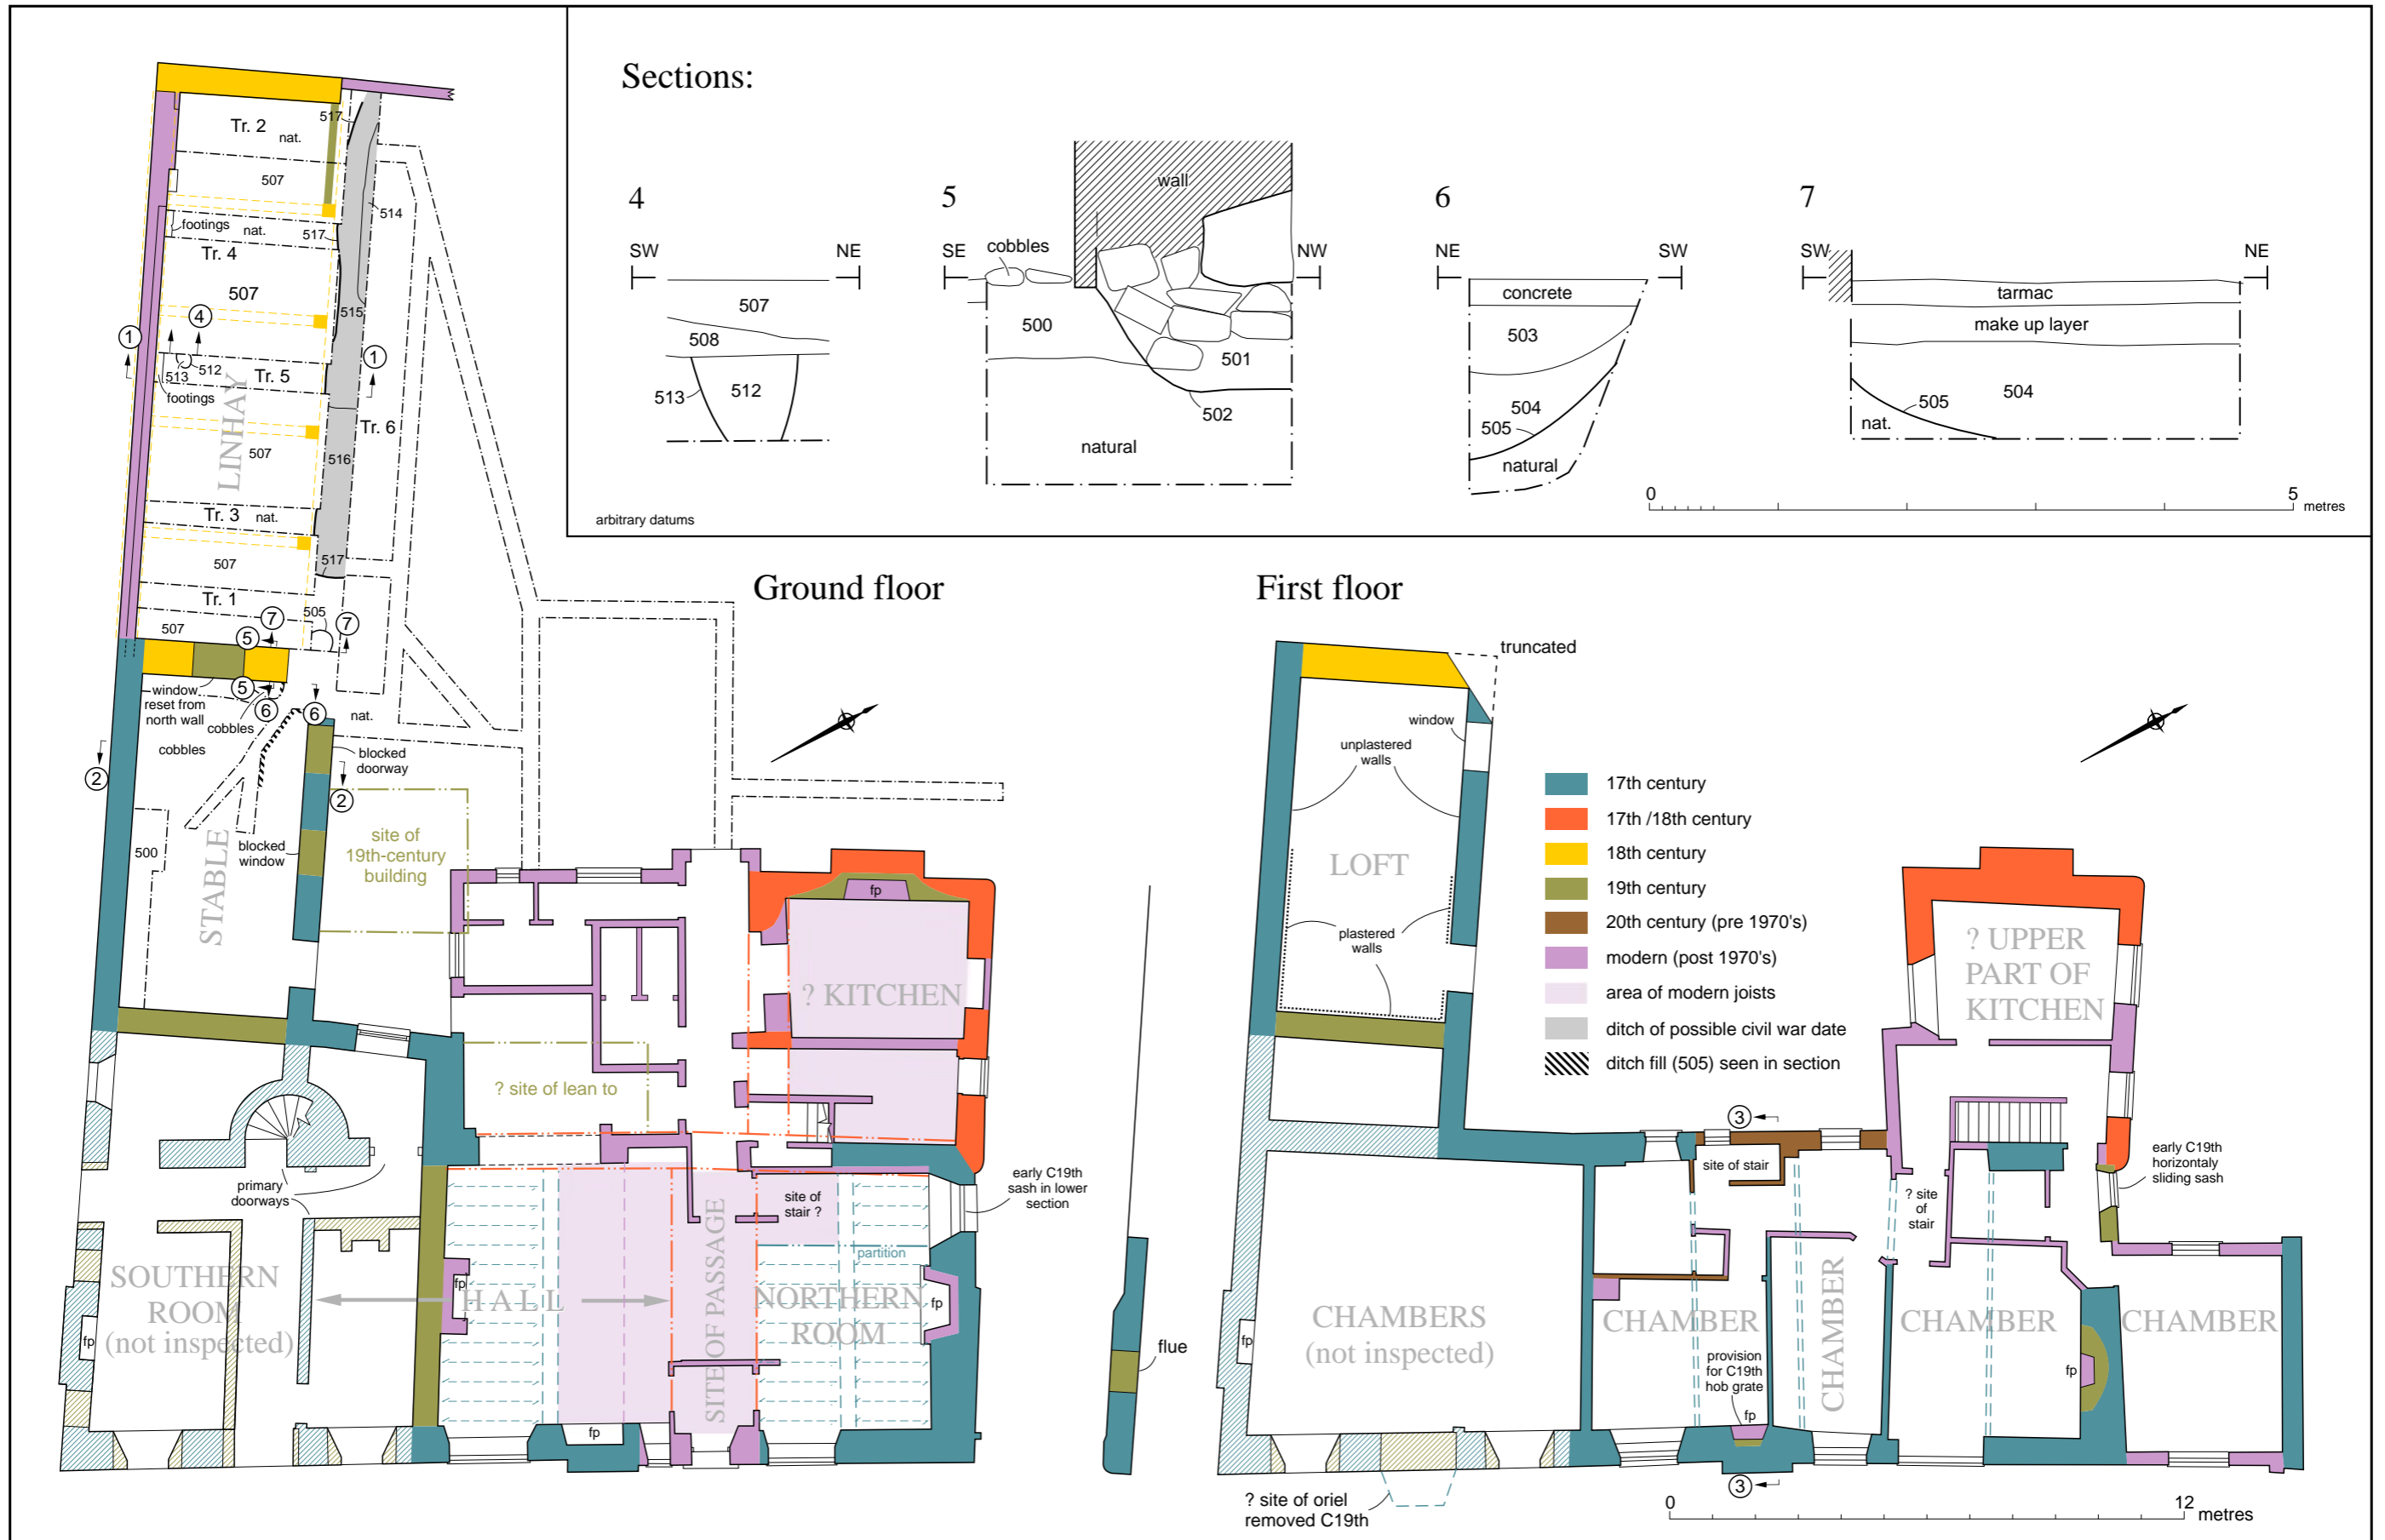
Within the footprint of the linhay, a posthole (513; Fig. 8, section 4) was exposed cutting into the natural gravel. This was sealed by a cultivation soil (508) that was only present along the southern part of the site. This soil was itself sealed by a make-up layer (507) for the cobbled surface (506) within the former linhay. Along the north edge of the linhay, and outside this building, these deposits had been truncated by more modern excavations.

Fig. 8 Suggested phase plans of the ground and first floors, showing the location of features observed during the building survey and watching brief. The position of profiles and sections are also shown, with details in inset.

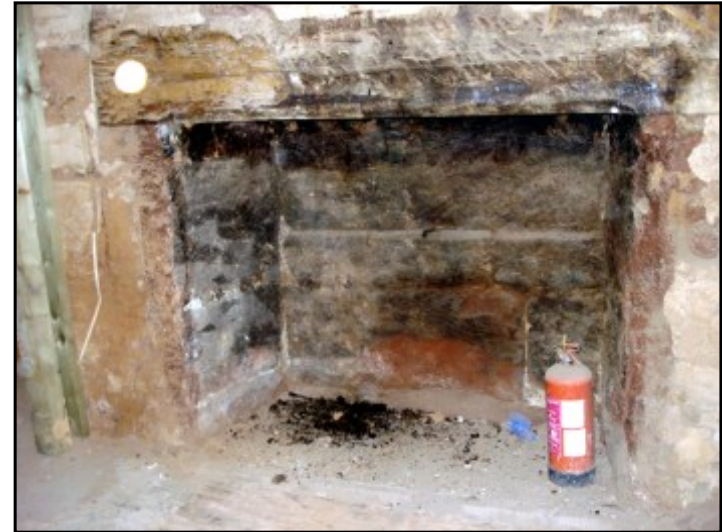
Fig. 10 View of the northern fireplace following the removal of modern fabric.

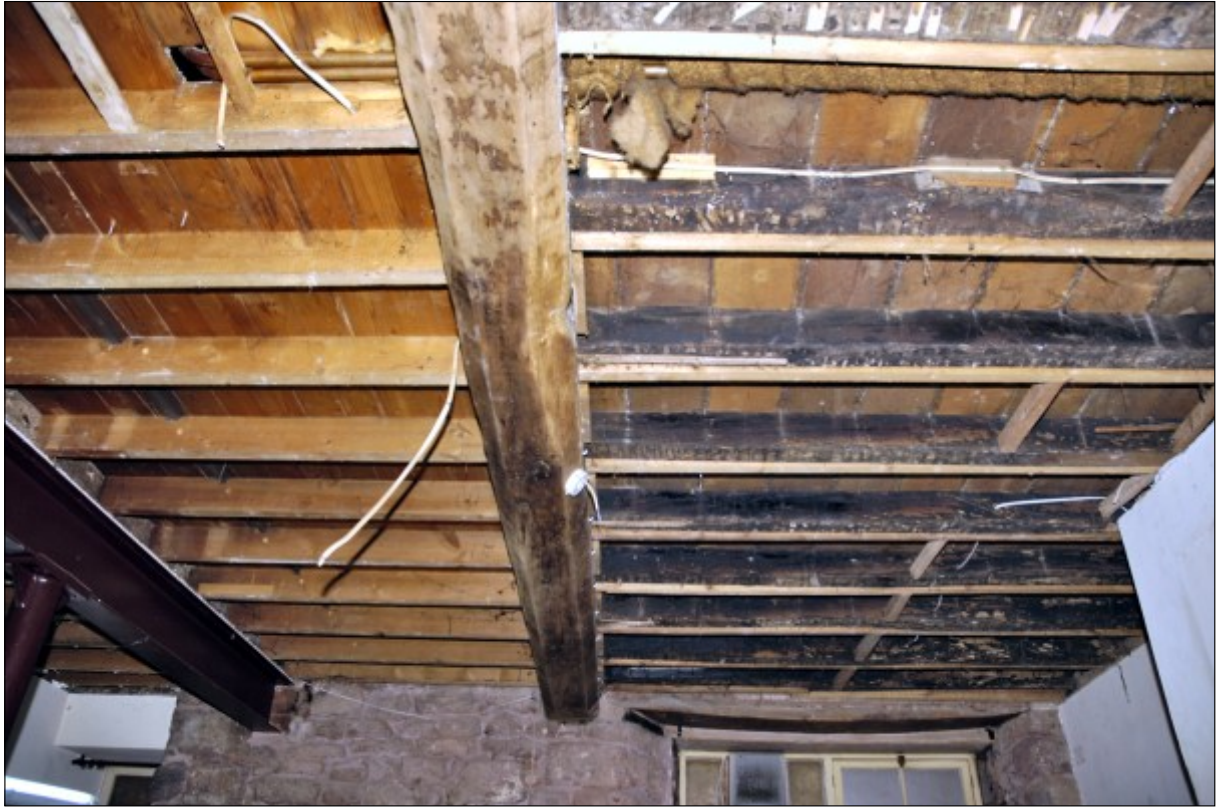
Fig. 13 View of the ceiling of the hall after removal of the plaster showing the extent of modern interventions (left).

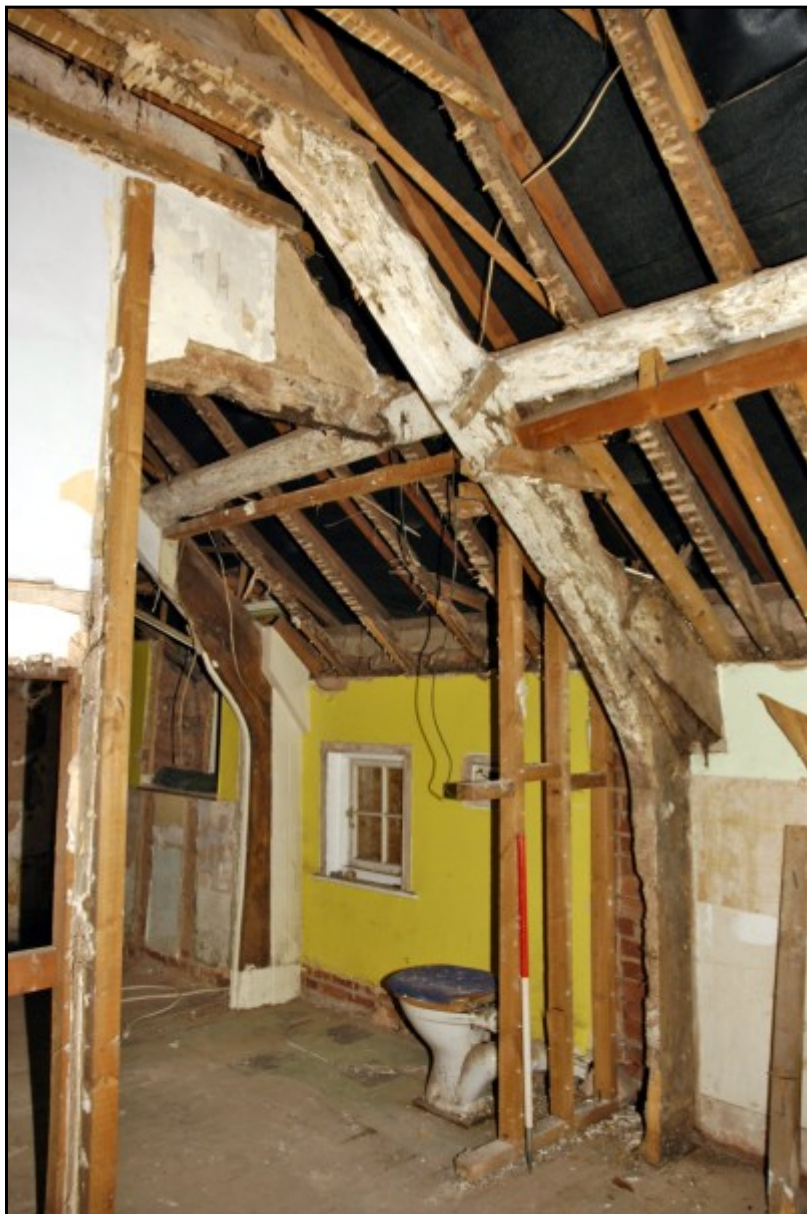
Fig. 17 Detail of the roof construction at the rear of the building showing two of the primary trusses and the rebuilt rear wall.

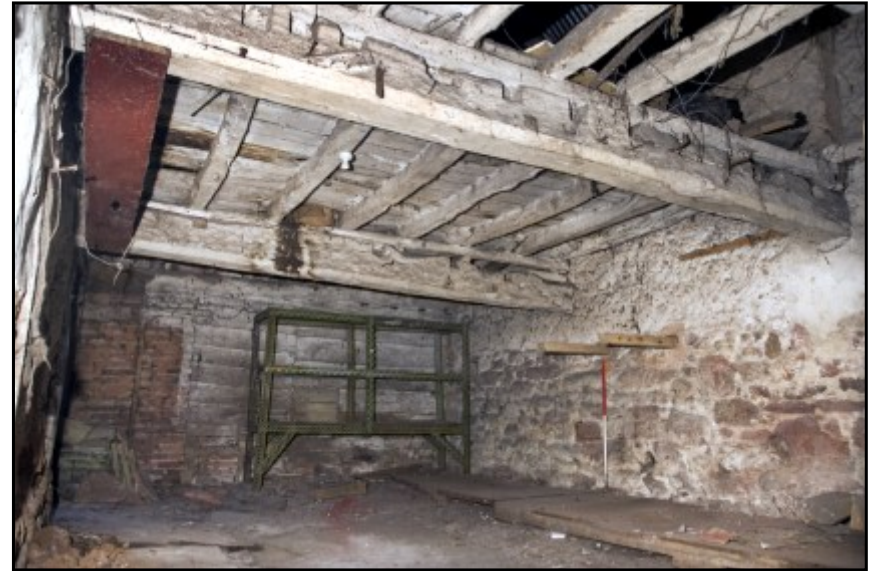
The ground-floor interior (Fig. 24) was a single large room, divided into three bays by four massive, well-chamfered beams. The presence of chamfers on both faces of the beams at both the eastern and western limits of the present building proves that it at one time extended further in both directions. The beams retain sockets which provide good evidence for the pattern of the original joists, now reused at a higher level. The pattern of the sockets is unusual, with groups of closely-spaced joists at the northern and southern ends and regular, more widely-spaced sockets at the centre. The significance of this pattern is uncertain. It might relate to the provision of animal feeders at a high

Fig. 24 View of the ground-floor interior of the stable looking to south east.

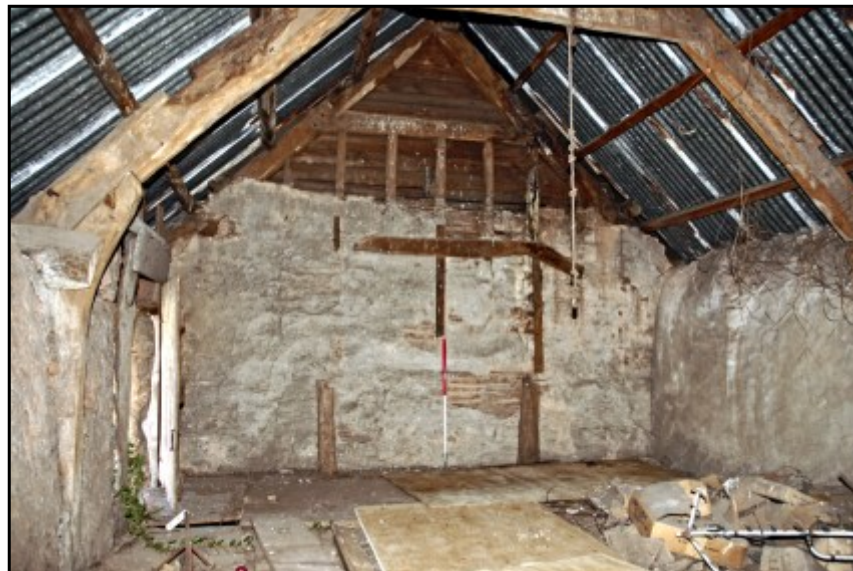
The first-floor was also a single volume (Fig. 25). The eastern part of the interior had plastered walls to north, south and east, whereas the western part was entirely unplastered. This suggests that partitions may have existed which have since been removed. The eastern wall appeared to be a closed truss, with vertical studs halved onto the collar beam of the eastern truss and covered with widely-spaced laths and plaster. This partition may well be a primary feature. Domestic elements from the neighbouring house may well have intruded into parts of the building, perhaps including the plastered part of the present first floor. Accommodation for inn servants, for example, might easily have been provided in this way. No trace of a door is visible in this partition, although it is possible that a doorway lies concealed within the later plaster. It is uncertain whether the upper floor was served by an internal or external staircase, as seems likely, or merely by a loft ladder.

Fig. 25 View of the first-floor interior, looking to south east.
