**RECENT OBSERVATIONS
DURING BUILDING WORKS
AT 8-9 THE CLOSE, EXETER:**

INTERIM REPORT to AUGUST 2009

Exeter Archaeology Report No. 09.93

August 2009

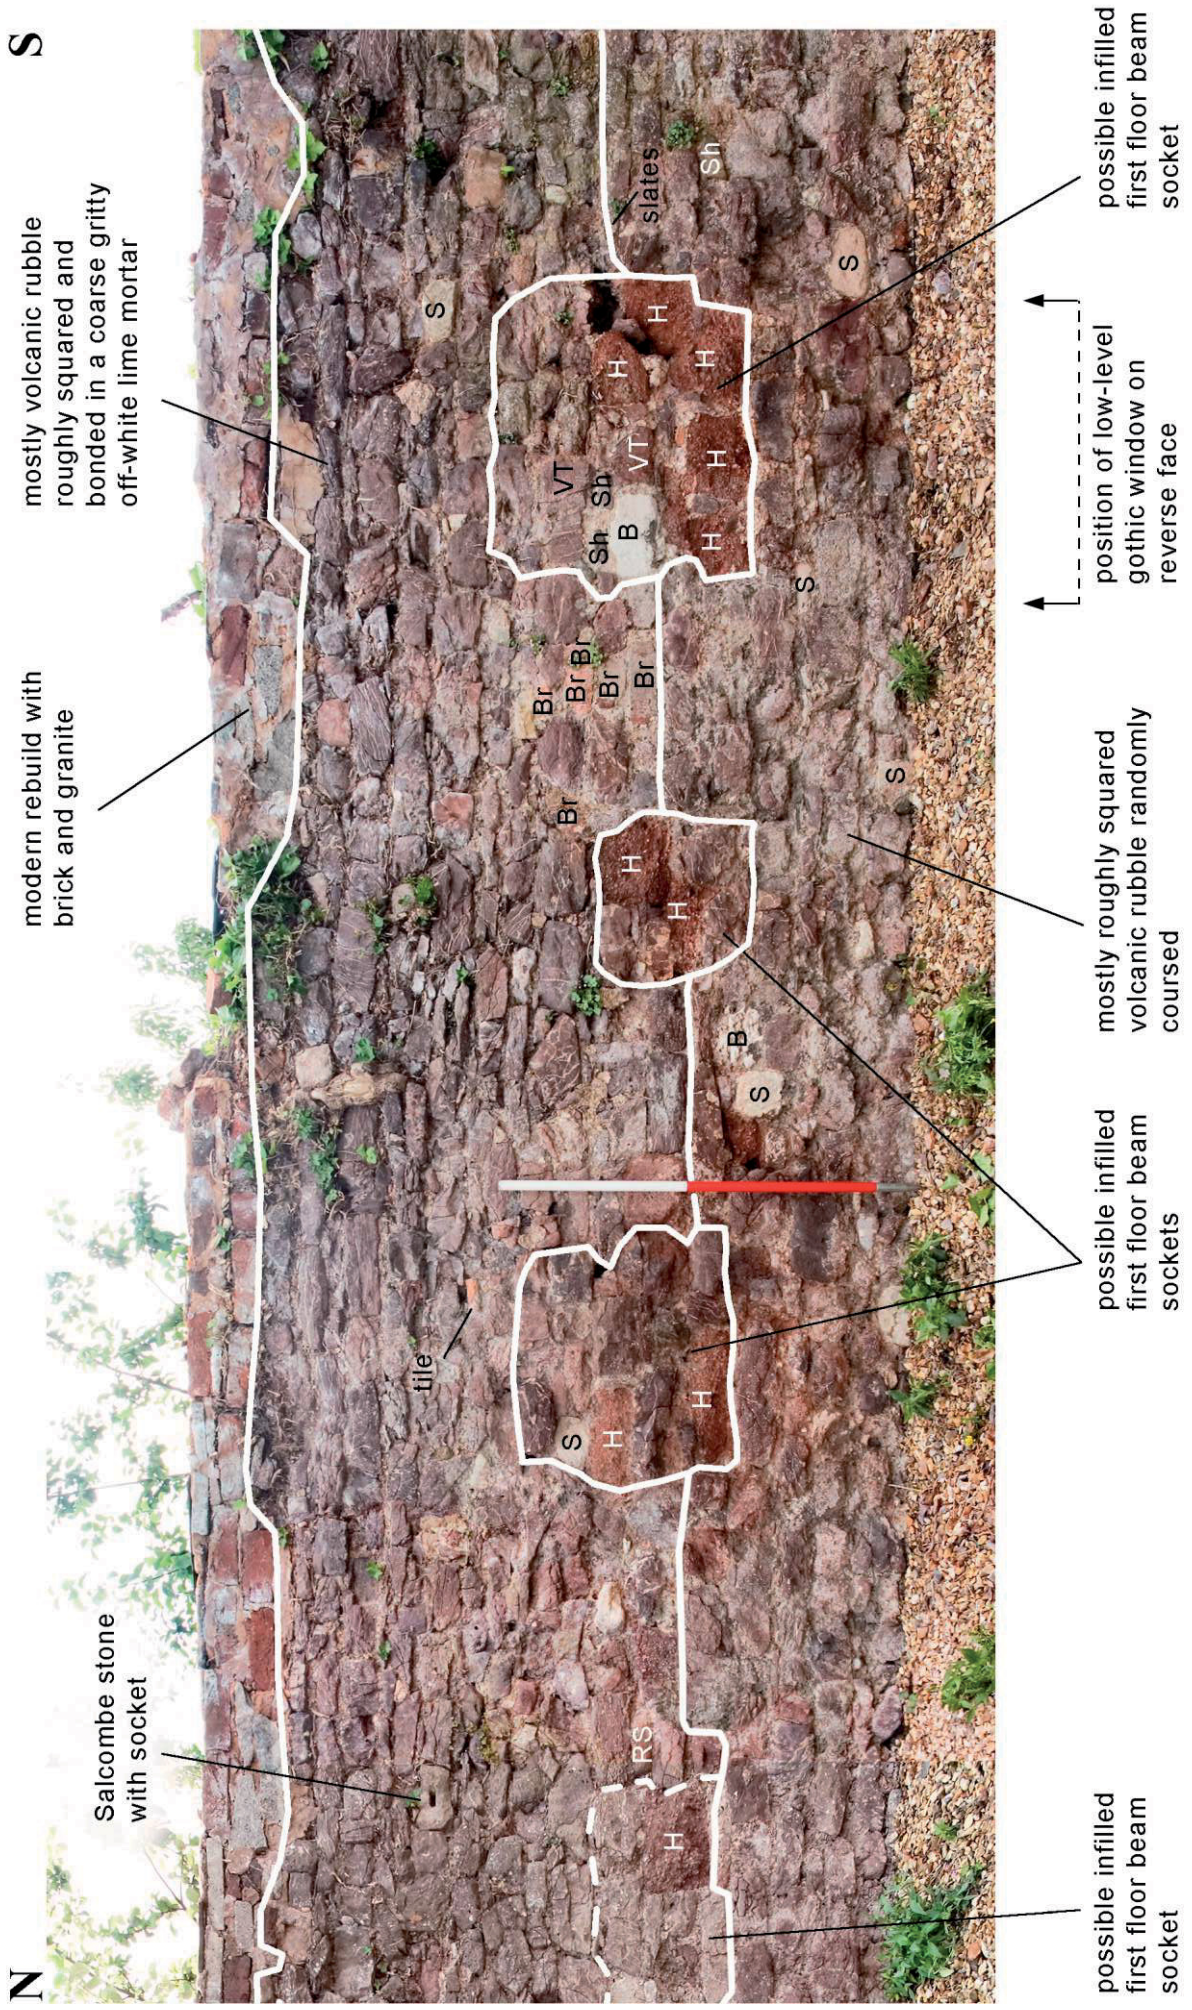
North-eastern section (Fig. 18)

The north-eastern section of the boundary wall has been shown in the assessment to run across part of the property formerly belonging to the Archdeacon of Totnes, which extended across the north-eastern part of the present car park (Parker *et al.* 2007, Fig. 6). The wall has been truncated by the introduction, after the Second World War, of the present Chapel Street, which overlies the rear parts of the medieval canonries. The wall is 0.80m thick in this area, thinner than the sections to the south west, which are 0.95m in thickness and appear to incorporate the remains of demolished medieval buildings.

The mid section of the wall seems to represent the lower part of the wall of a demolished building. This is defined by two sets of dressed quoins visible in the north-western face of the wall (figs 18, 20). The group of quoins to the south-west of the gateway are answered by a further group approximately 9.25m to the south west. The north-eastern set of quoins comprise one Salcombe stone and two of volcanic trap, undercut by the jamb of a later archway. Although these quoins initially appear to mark the *external* corners of a building it would seem more likely that the building extended to the north-

Fig. 18 View of the north-western elevation of the north-eastern section of the boundary wall, showing the blocked gateway and quoins. Scale 1m. (See Fig.21 for masonry key.)

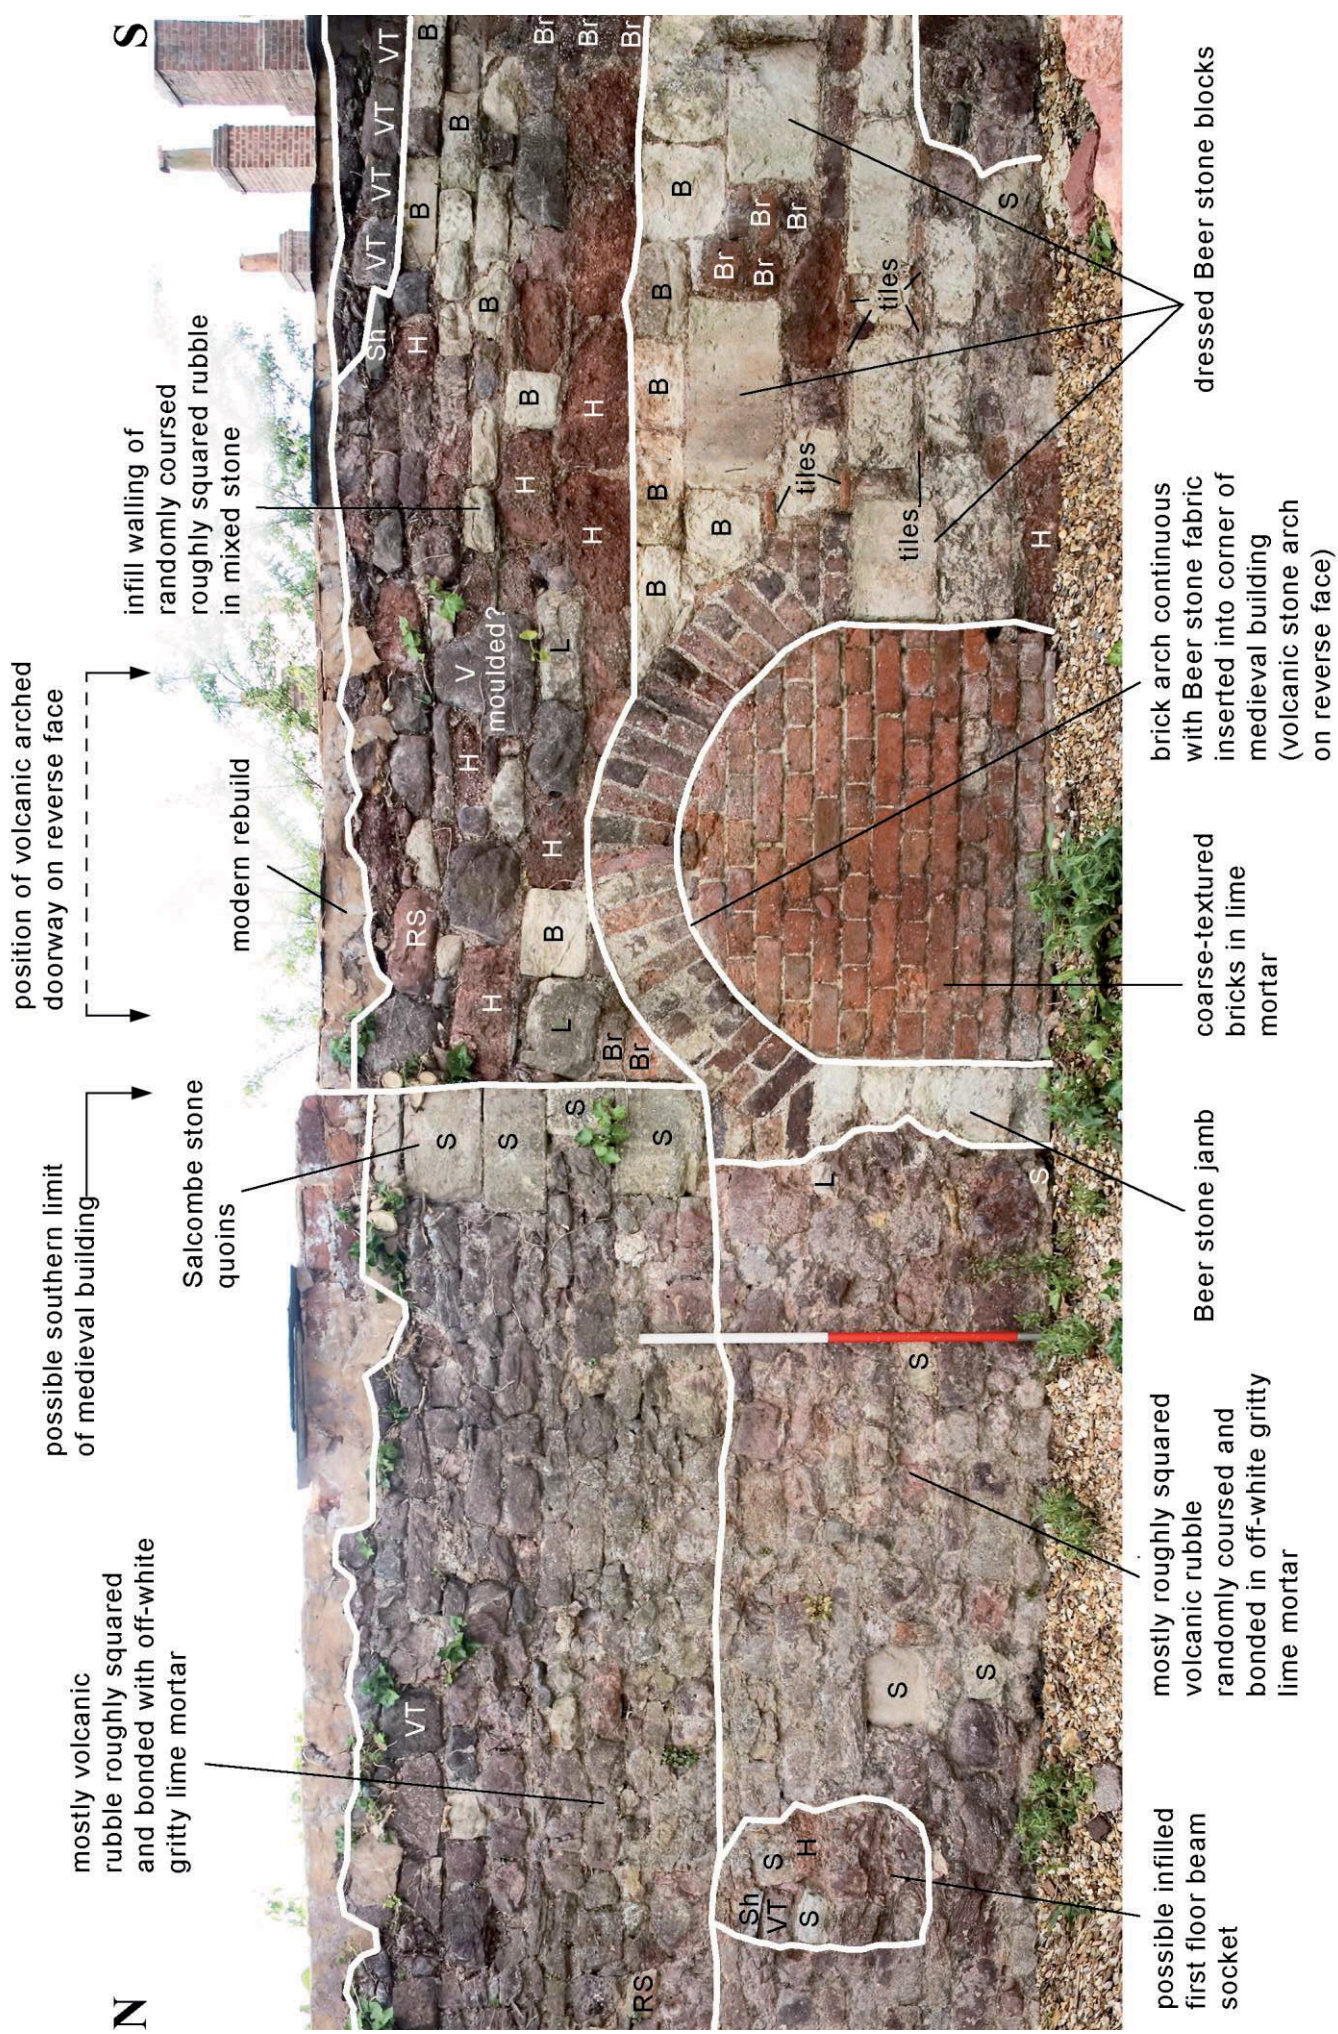
There are a number of possible areas of blocking in the wall of the former building (Fig. 19). These blocked apertures are poorly defined and of irregular dimensions but invariably contain Heavitree breccia. This is notable as there are no other instances of this stone within this section of wall. The predominant fabric of the wall is purplish veined volcanic stone with the occasional inclusion of other stones, chiefly Salcombe stone. The masonry is almost entirely of random rubble, roughly squared, and bonded with off-white gritty lime mortar. No definable breaks were perceived apart from a distinct horizontal division. This gently sloping line began at the base of the Salcombe stone quoins at the south-western end and finished *c.*0.25m below the quoins at the north end. Below this line the masonry was slightly more regular in size and more rectilinear. The coursing was also slightly less random than that above the break.

Fig. 19 View of the north-western elevation of the central section of the boundary wall, showing the blocked joist sockets at first-floor level. Scale 1m. (See Fig. 21 for masonry key.)
