**ARCHAEOLOGICAL RECORDING  
DURING REPAIR WORKS TO  
46 HIGH STREET, EXETER**

**Exeter Archaeology**

**Report No. 09.127**

**November 2009**

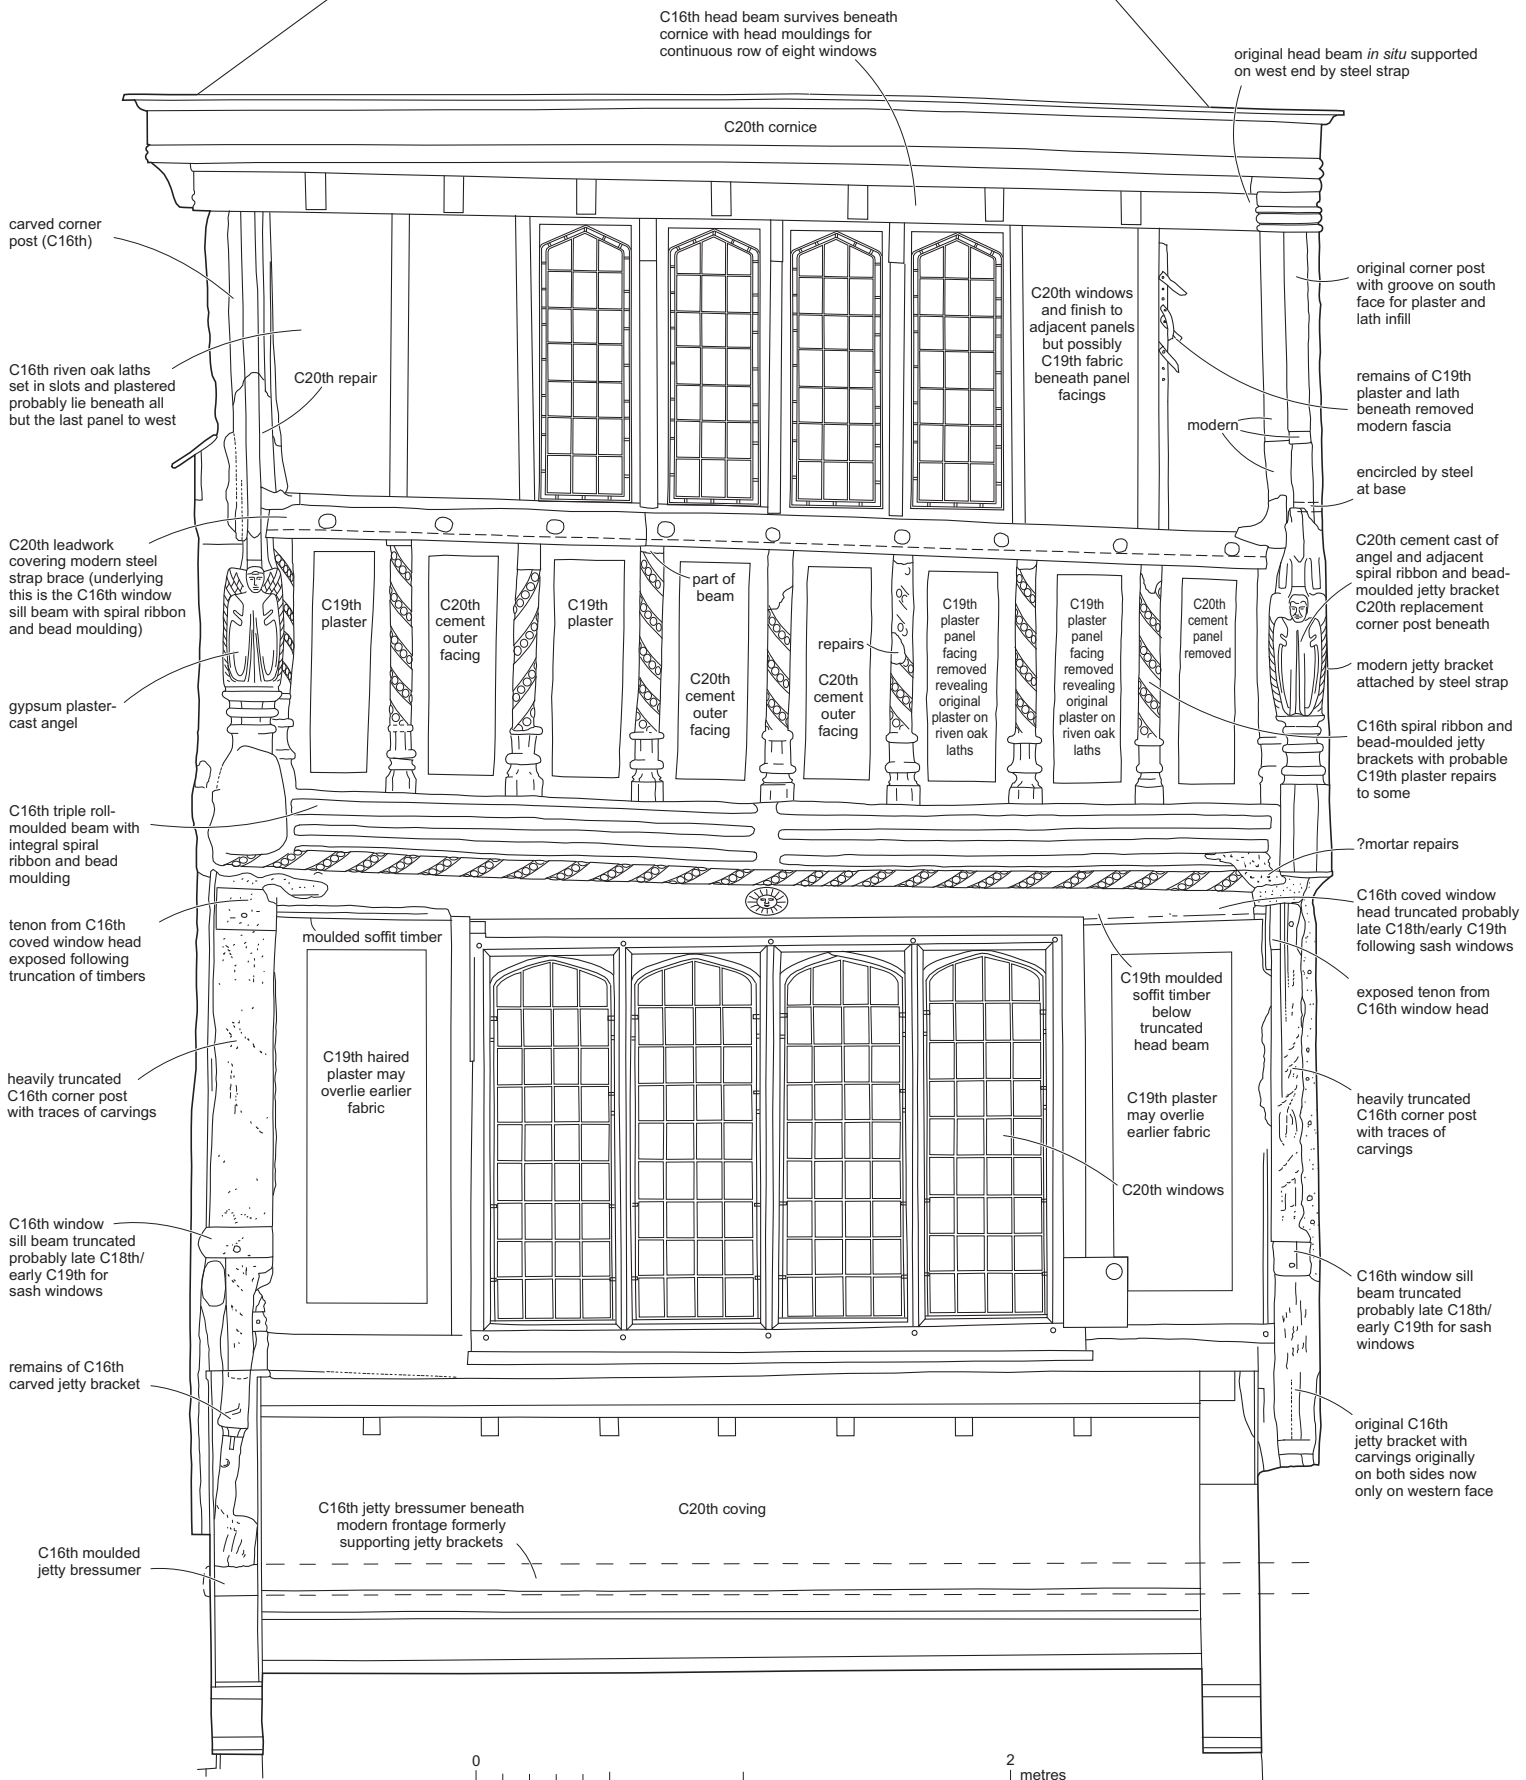
Fig. 2 Front elevation of No. 46 showing existing exterior features. Scale 1:20.

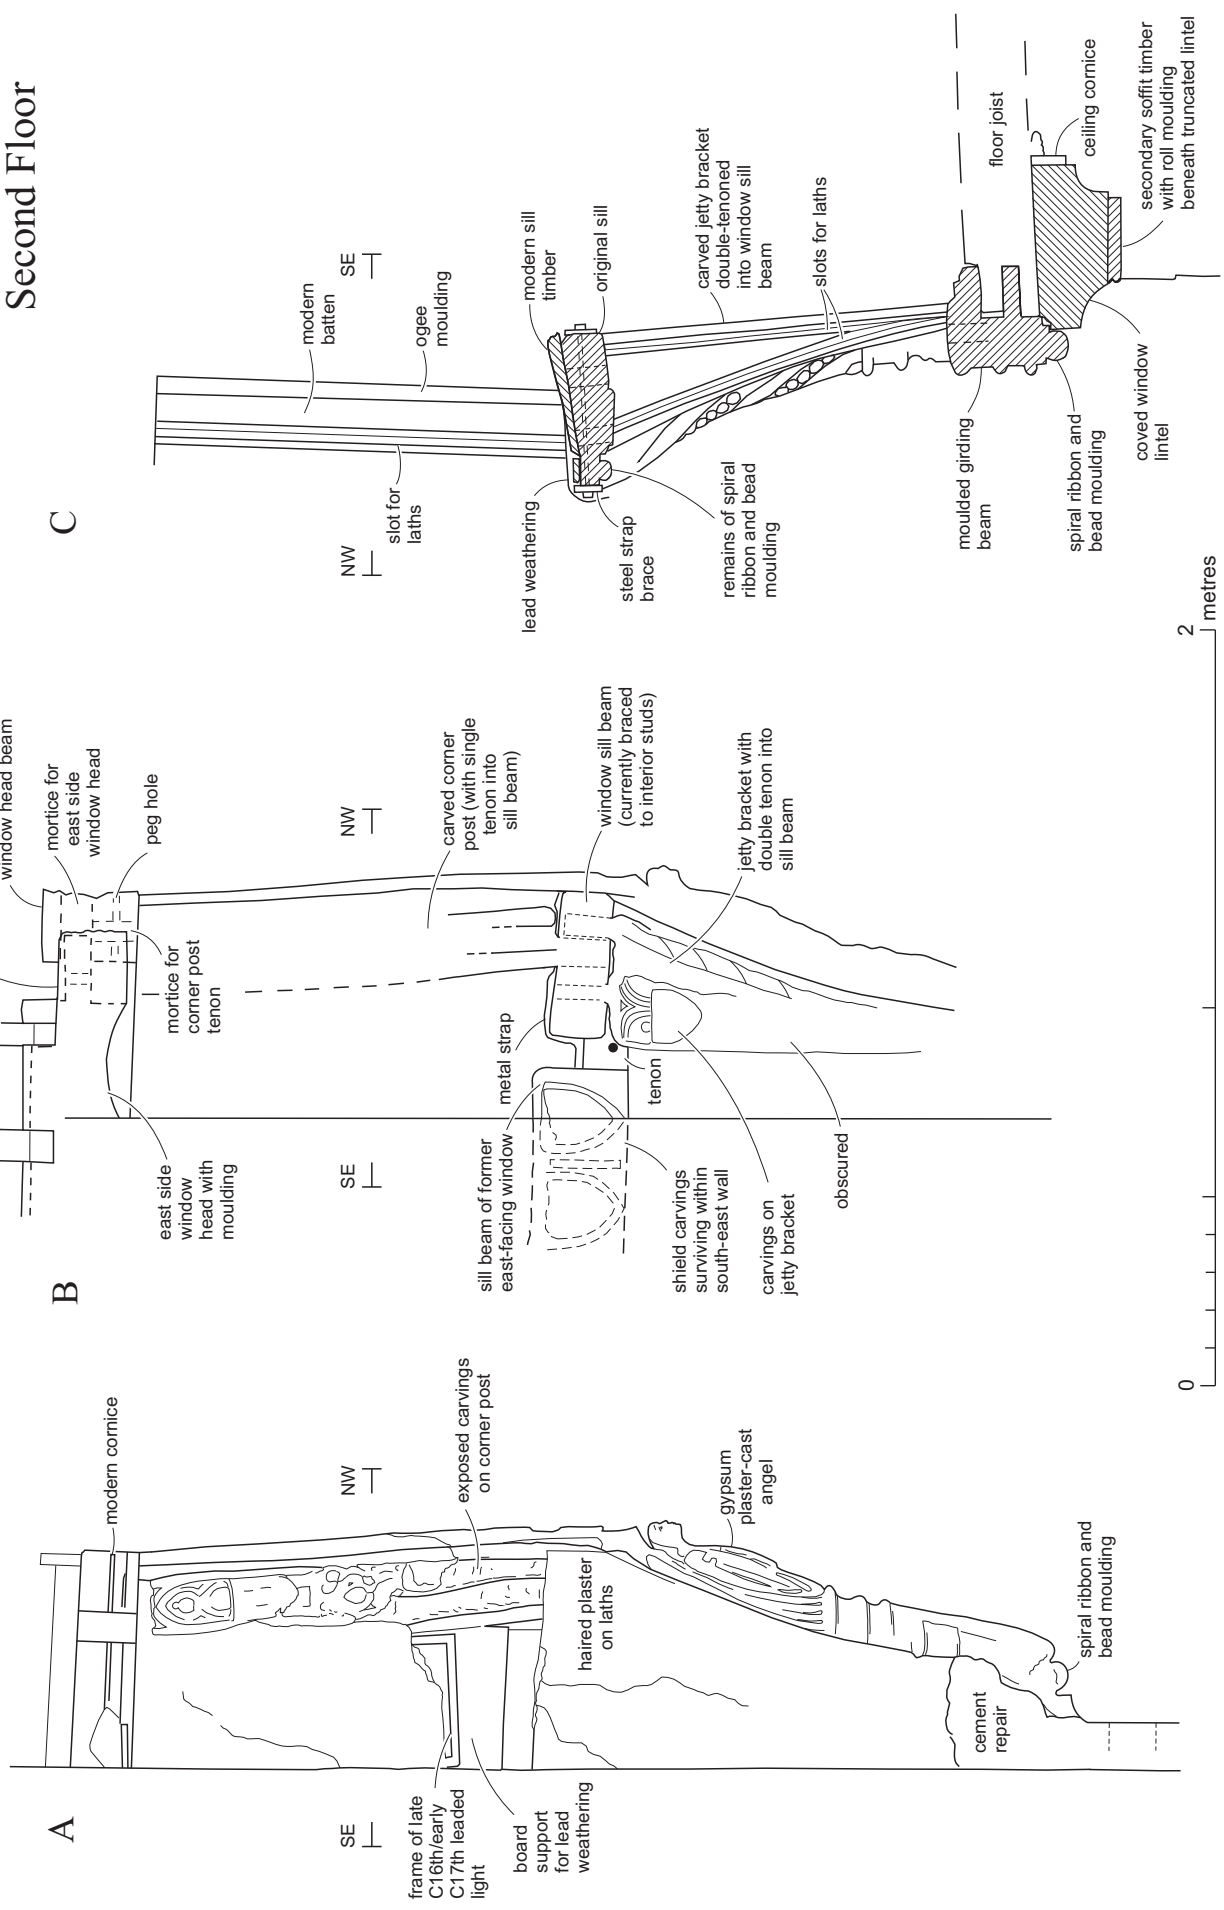
Fig. 4 Architectural details of the second floor façade. (A) East elevation, (B) structure underlying east elevation and (C) section through the façade. Scale 1:20.

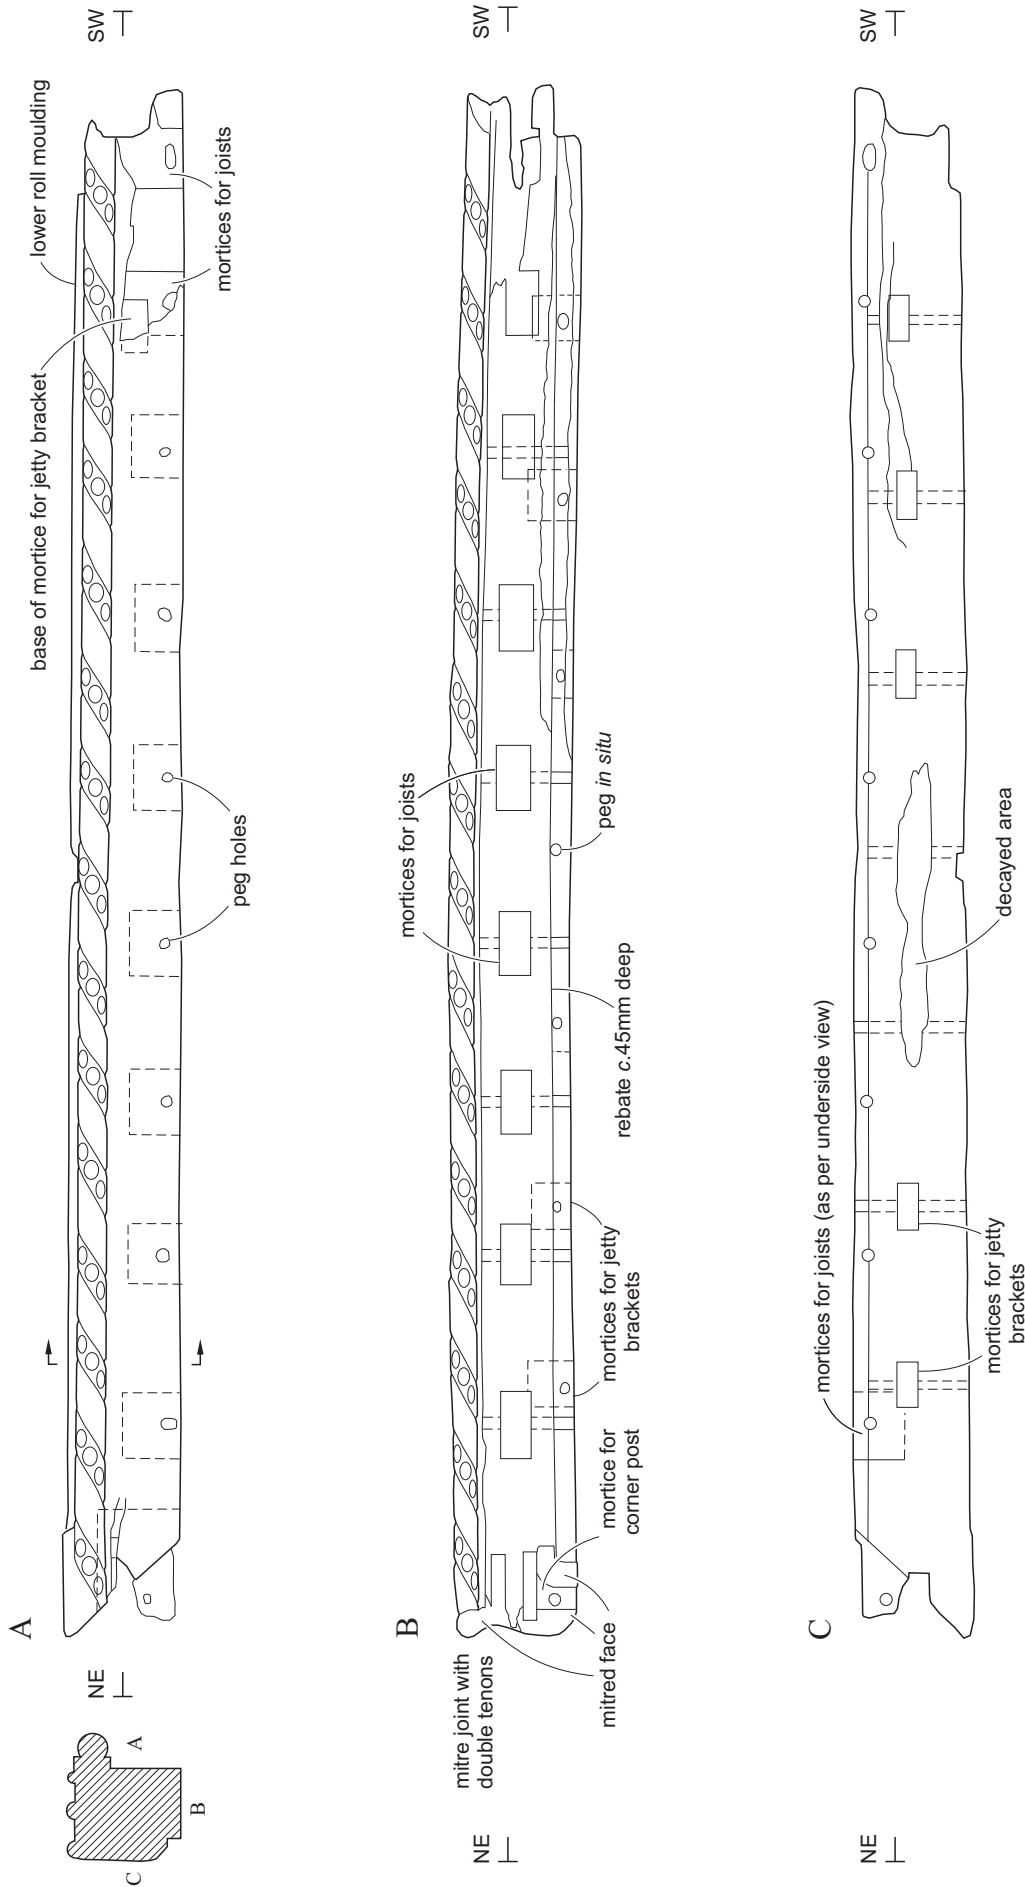
Fig. 6 Plans of moulded girding beam. (A), View of underside showing position of joist mortises on inner face, (B) inner face showing mortises, (C) top side of beam showing mortises for jettie brackets. Scale 1:20.

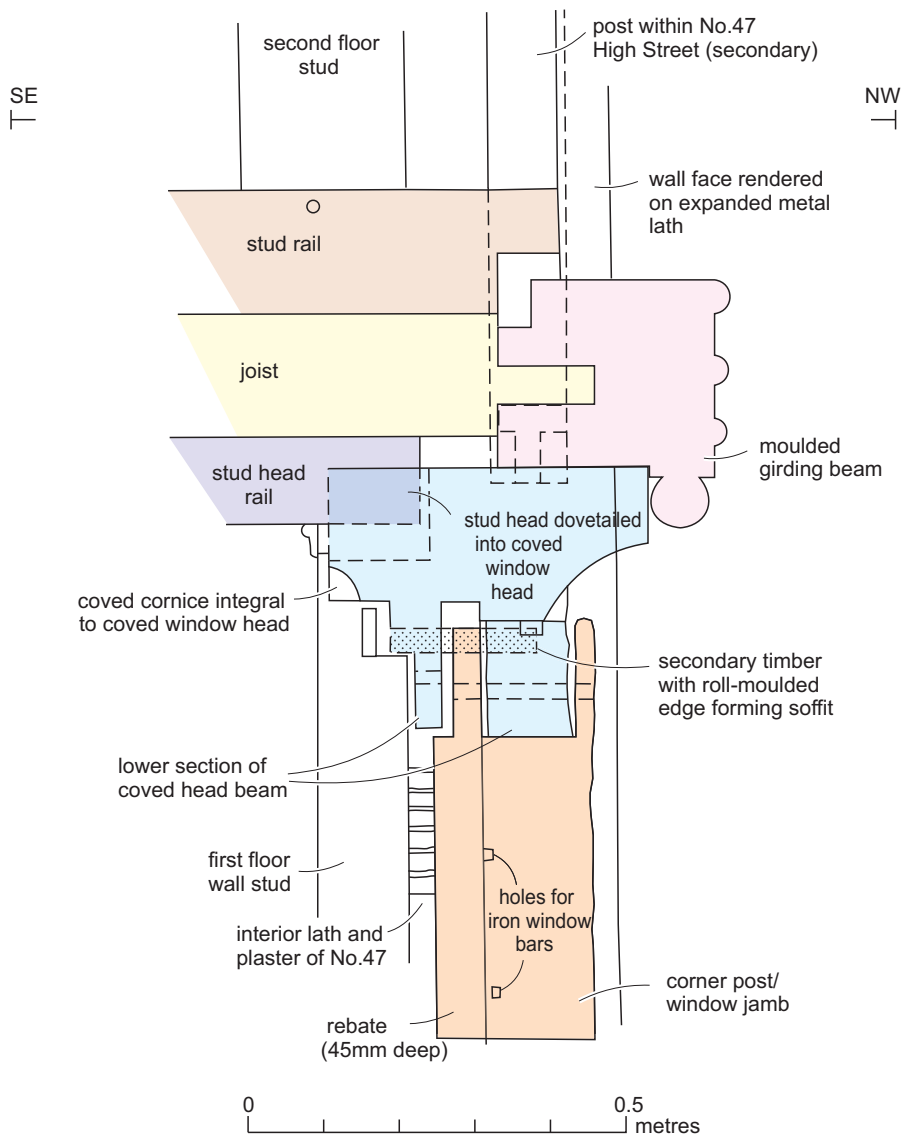
Fig. 7 Section diagram through the front façade at the west end showing the timber construction. Scale 1:10.

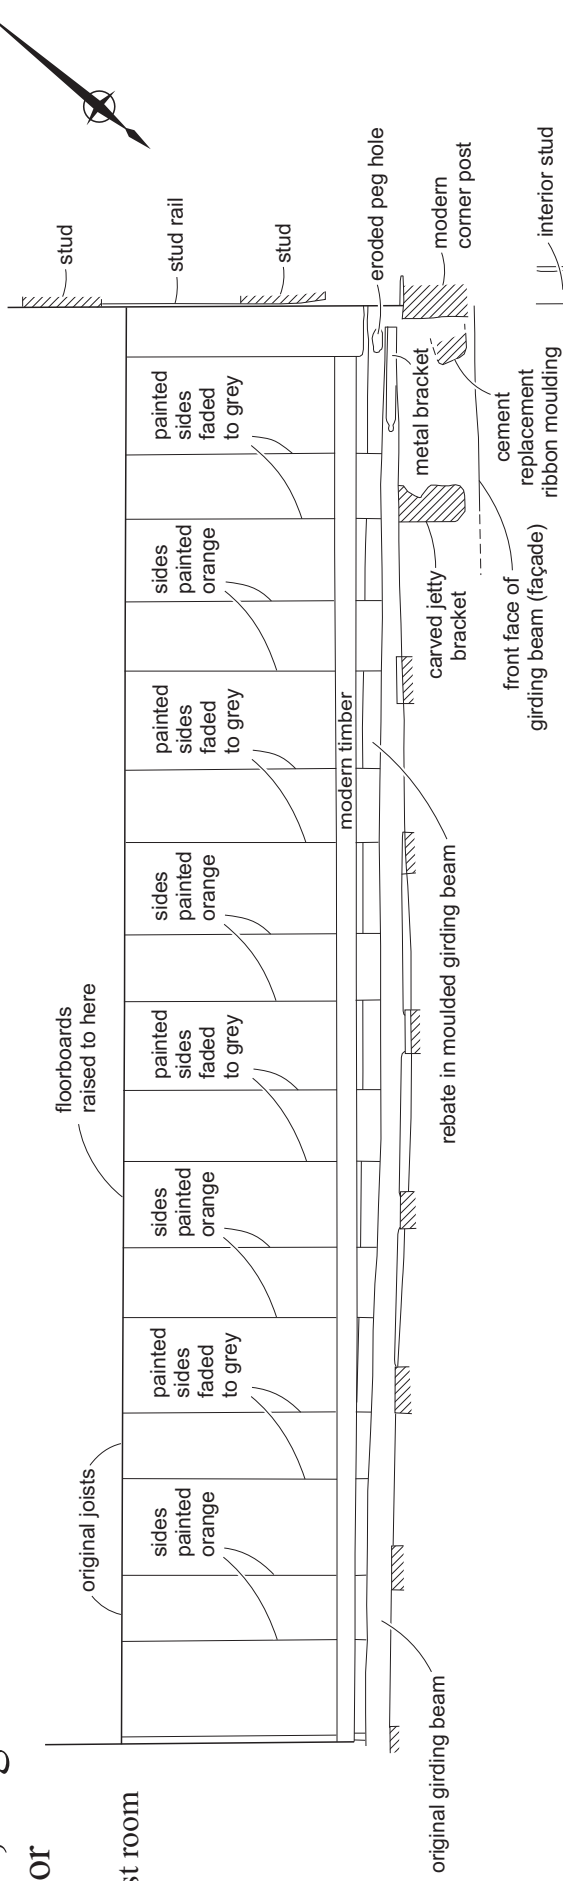
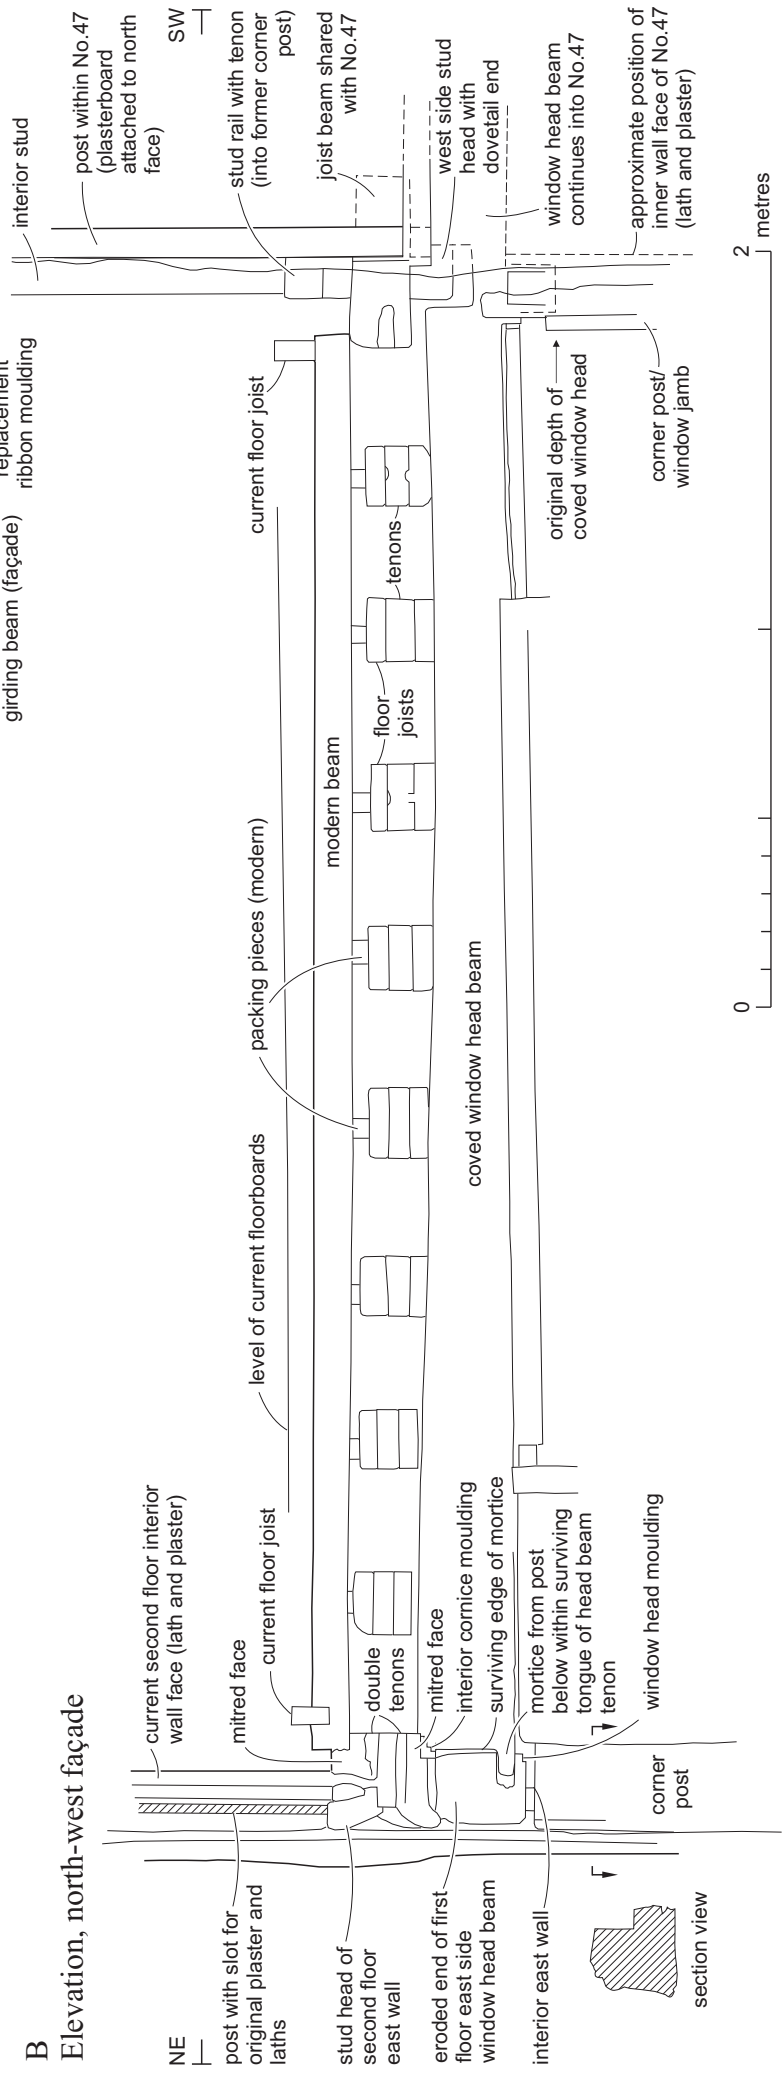
Lying at the junction between the two halves of the building pair is an extra-wide joist. This is shared by the two halves of the building, with a visible tenon into the girthing beam at the north-east end of the timber and, one can assume, another tenon formerly at its western end. However, this tenon has since been removed to accommodate a later stud forming the basis of the front wall of No. 47 on this floor (Fig.8B).

Following the removal of the moulded girding beam from the ends of the second-floor-joists, it was possible to examine these timbers. They were found to have been painted in a colour scheme of orange/red and another colour now faded to grey. The joists were painted alternately in the two colours with no discernible pattern with each timber coloured the same on both sides and presumably the soffits as well though this was not verified, because the present ceiling conceals them (Pl. 17). During the works, floorboards were lifted adjacent the front on the first and second floors. The opportunity was taken to draw the positions of the joists (Figs. 8A, 10). It was also noted that considerable reinforcement had been applied to the first-floor-joists at the same time as providing attachments for timber framing beneath the modern shop jetty. The present second floor has been wedged level with packing timbers and beams over the original joists to counter the slump of the façade.

Fig. 8 (A) Plan of exposed joists in the second floor north-west room and (B), elevation showing the exposed joist ends after removal of the moulded girding beam. Scale 1:20.

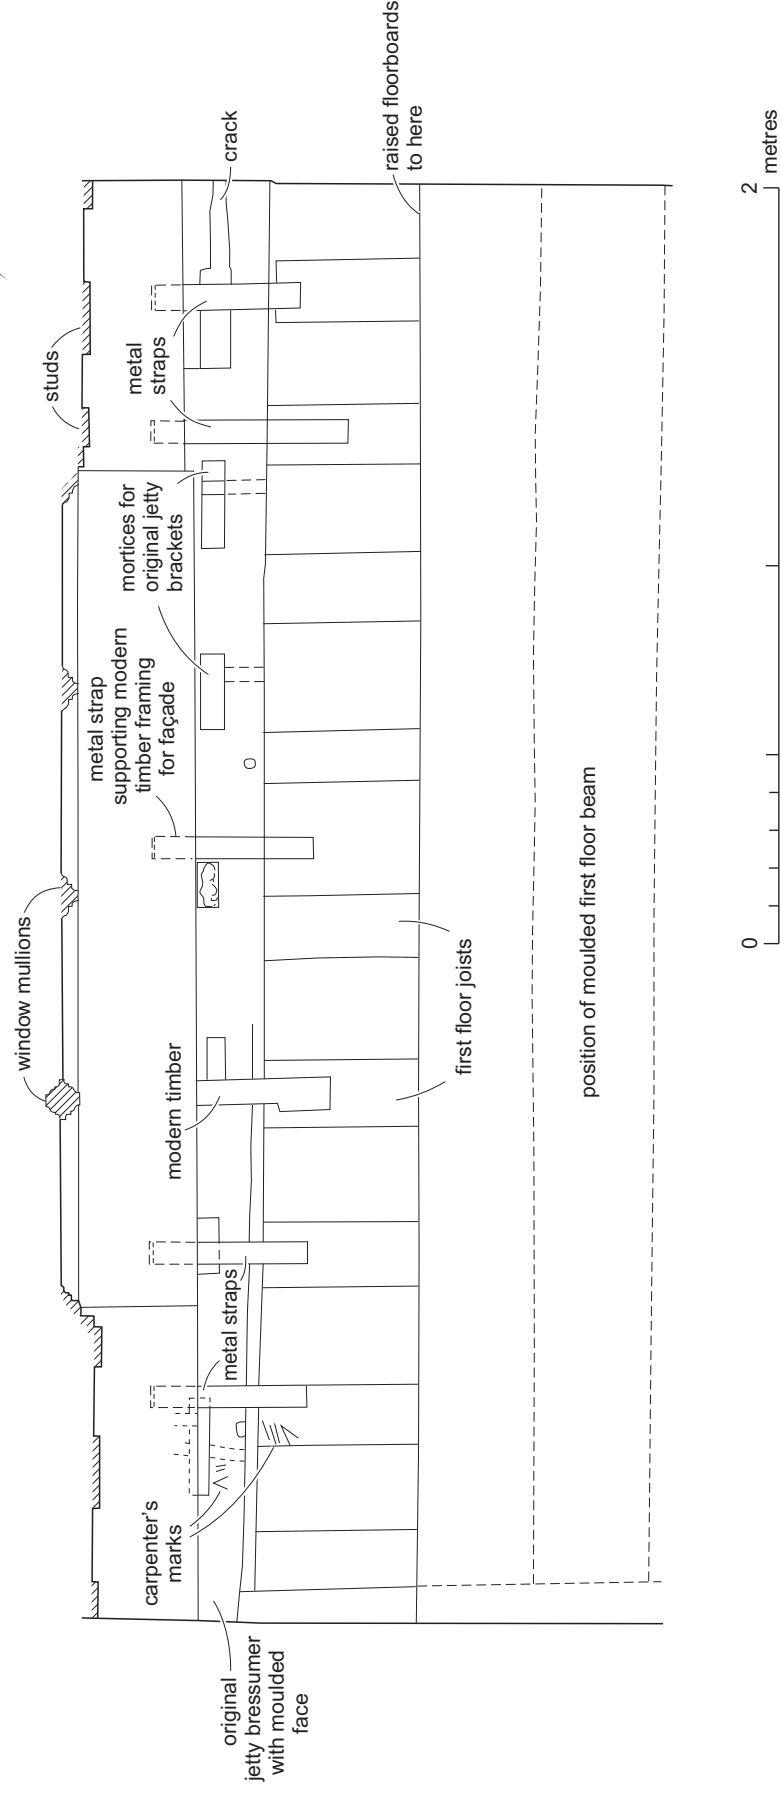
The bottom rail of the close-studded wall was tenoned into the base of the jetty bracket. The jetty bracket was presumably tenoned into the jetty bressumer below, as suggested by the mortices for the other former brackets on this floor, visible in the top of the beam (Fig. 10). During the present works a new corner post was inserted and bolted to the new steel-reinforced oak lintel by means of a steel angle bracket. The truncated remnant of the windowsill beam was removed and a new oak piece set in above the original jetty bracket into which the corner post was tenoned and pegged. The jetty bracket remained tilted and attached by a pre-existing metal strap to the studwork.

Fig. 10 Plan of exposed joists in the first-floor north-west room. Scale 1:20.

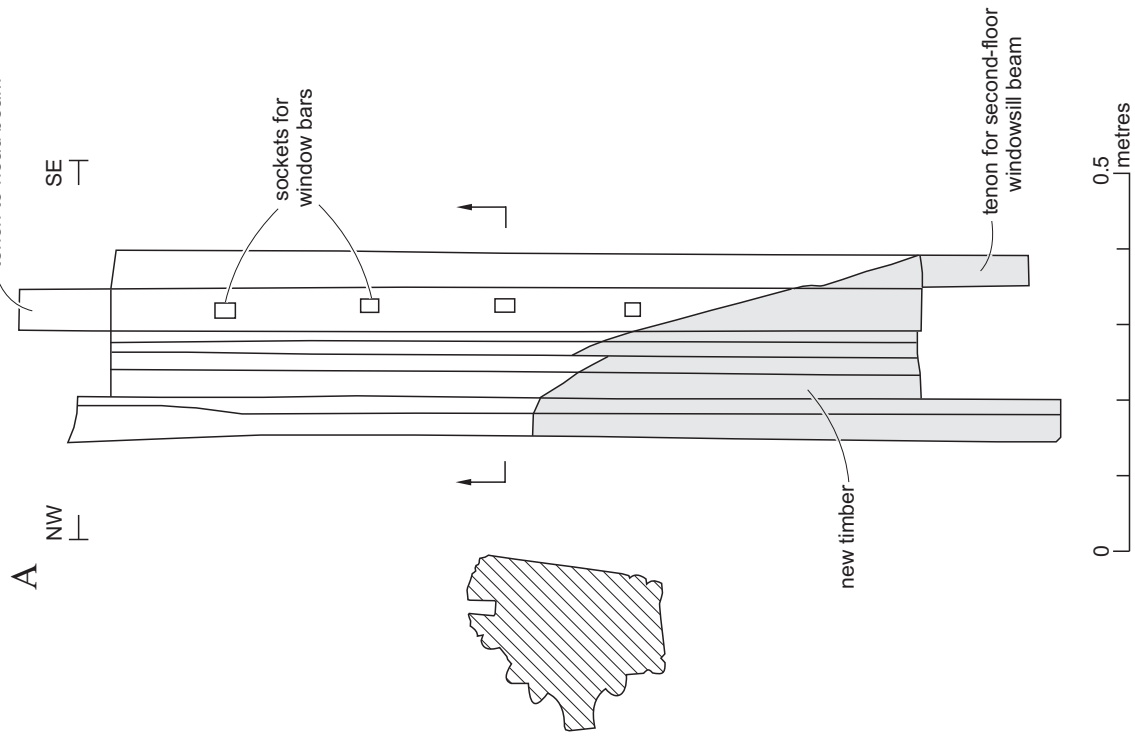
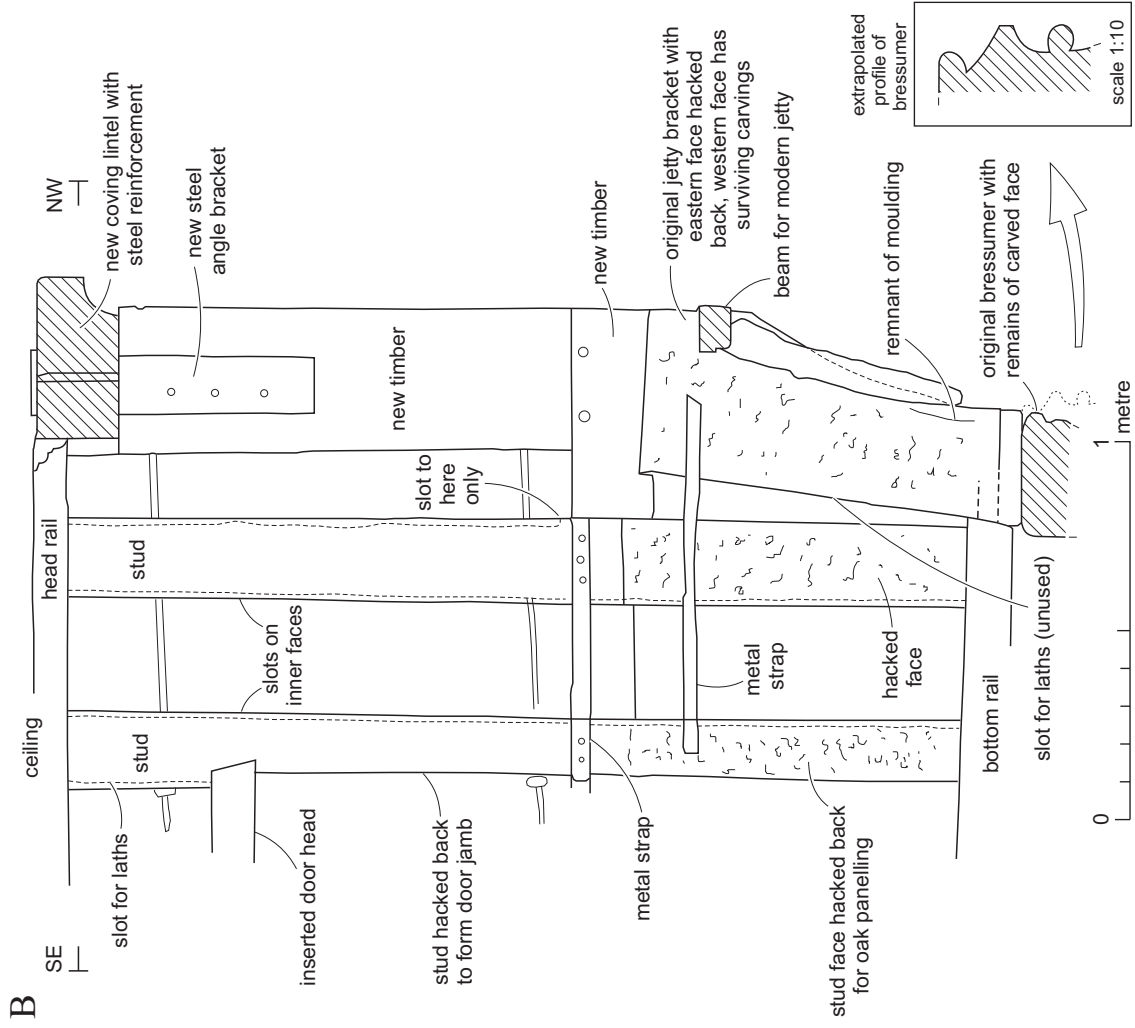
In the party wall of the first-floor front room there is a former doorway at the north-west end of the room. This is a later insertion as the studs forming the jambs have been hacked back, removing the slots for laths still present above the door head. This area was recorded by Exeter Archaeology in 1985 but, during the present works, panel infill was removed to allow installation of new bracing bolts from the refurbished frontage timbers to the existing studs. Also removed was the oak-panelled cladding affixed to the lower half of the wall. This allowed examination of the sides of the studs (Fig. 11B).

Fig. 11 (A) elevation of the inner face of the second floor east side upper corner post. Scale 1:10. (B), elevation of the first floor south-west wall of the north-west room after removal of early C20th oak cladding. Scale 1:20.

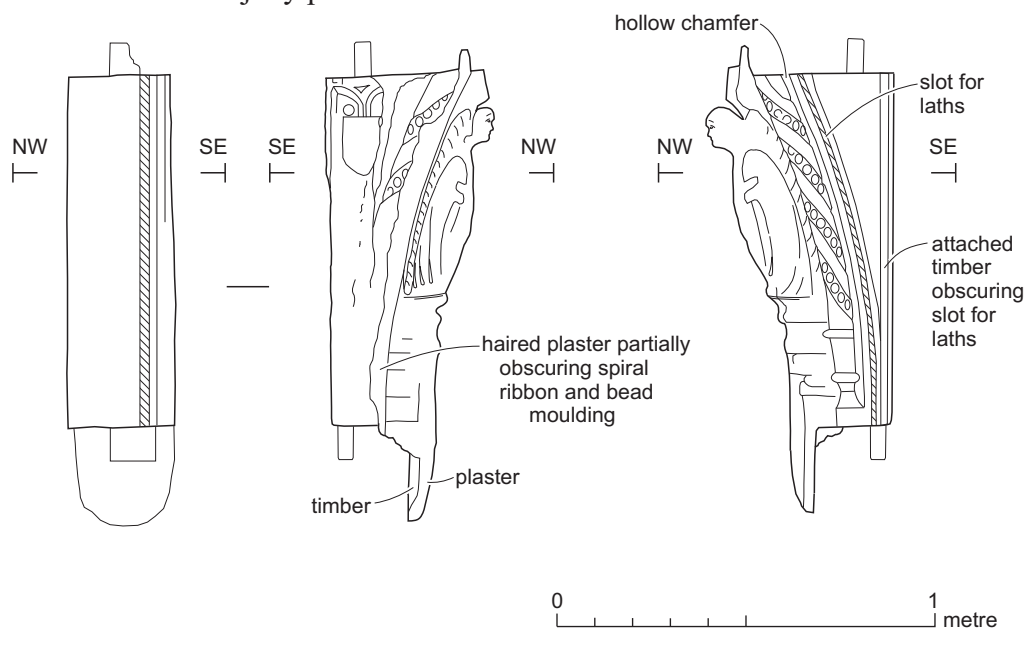
Fig. 12 Detail of the second-floor north-east corner post and jetty bracket with attached angel casting after removal. Scale 1:20

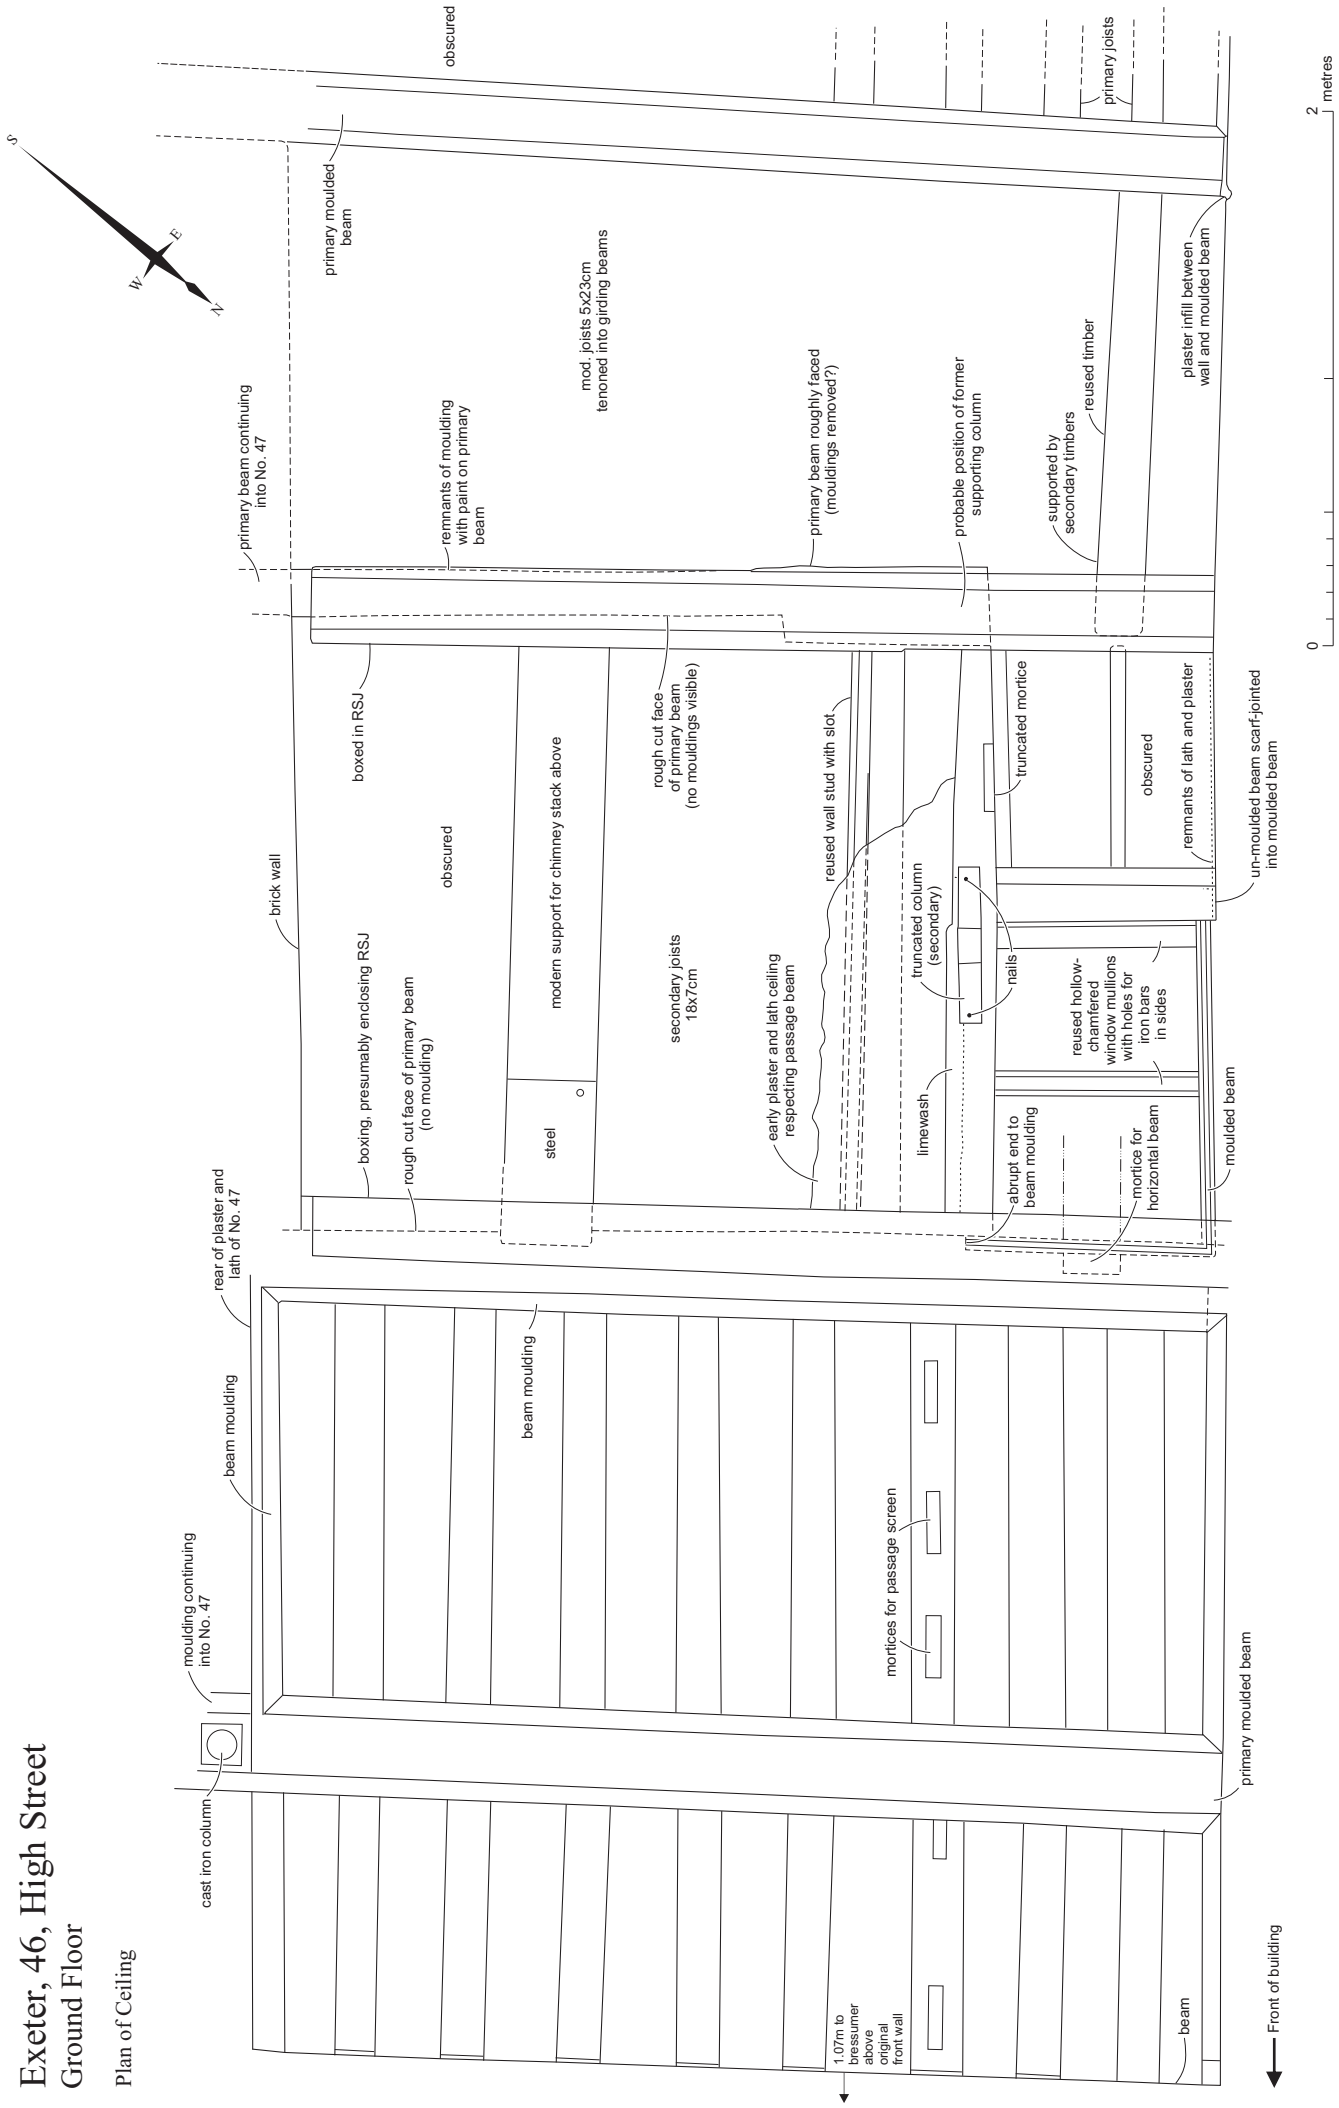
In the course of the works the shop was closed for a time, during which partial stripping of the modern suspended ceiling was carried out. Enough cladding was removed in the front room of the shop to enable a fairly extensive view of the original ceiling and timbers. The opportunity was taken to draw the exposed fabric (Fig. 13).

Between this joist and the north-east wall were two reused hollow-chamfered window mullions set at right angles to the joist (Fig. 13). Holes for iron window bars were visible in the sides of the timbers and the remains of plaster and laths were present on the undersides, though the modern appearance of the nails suggests this is a late phase of work. The north-east ends of the mullion joists were housed into the top of a moulded beam within the north-east wall. This moulding continued onto the south-east face of the third main ceiling-beam from the front but ended abruptly at a point midway above the joist with the truncated post (Pl. 24). This strongly suggests that this area was separate from the remainder of the ceiling bay to the south-west. Indeed no mouldings were visible on the inner faces of both ceiling-beams within the remainder of this bay east of the passage.

Fig. 13 Worm's eye plan view of ground-floor ceiling. Scale 1:20.

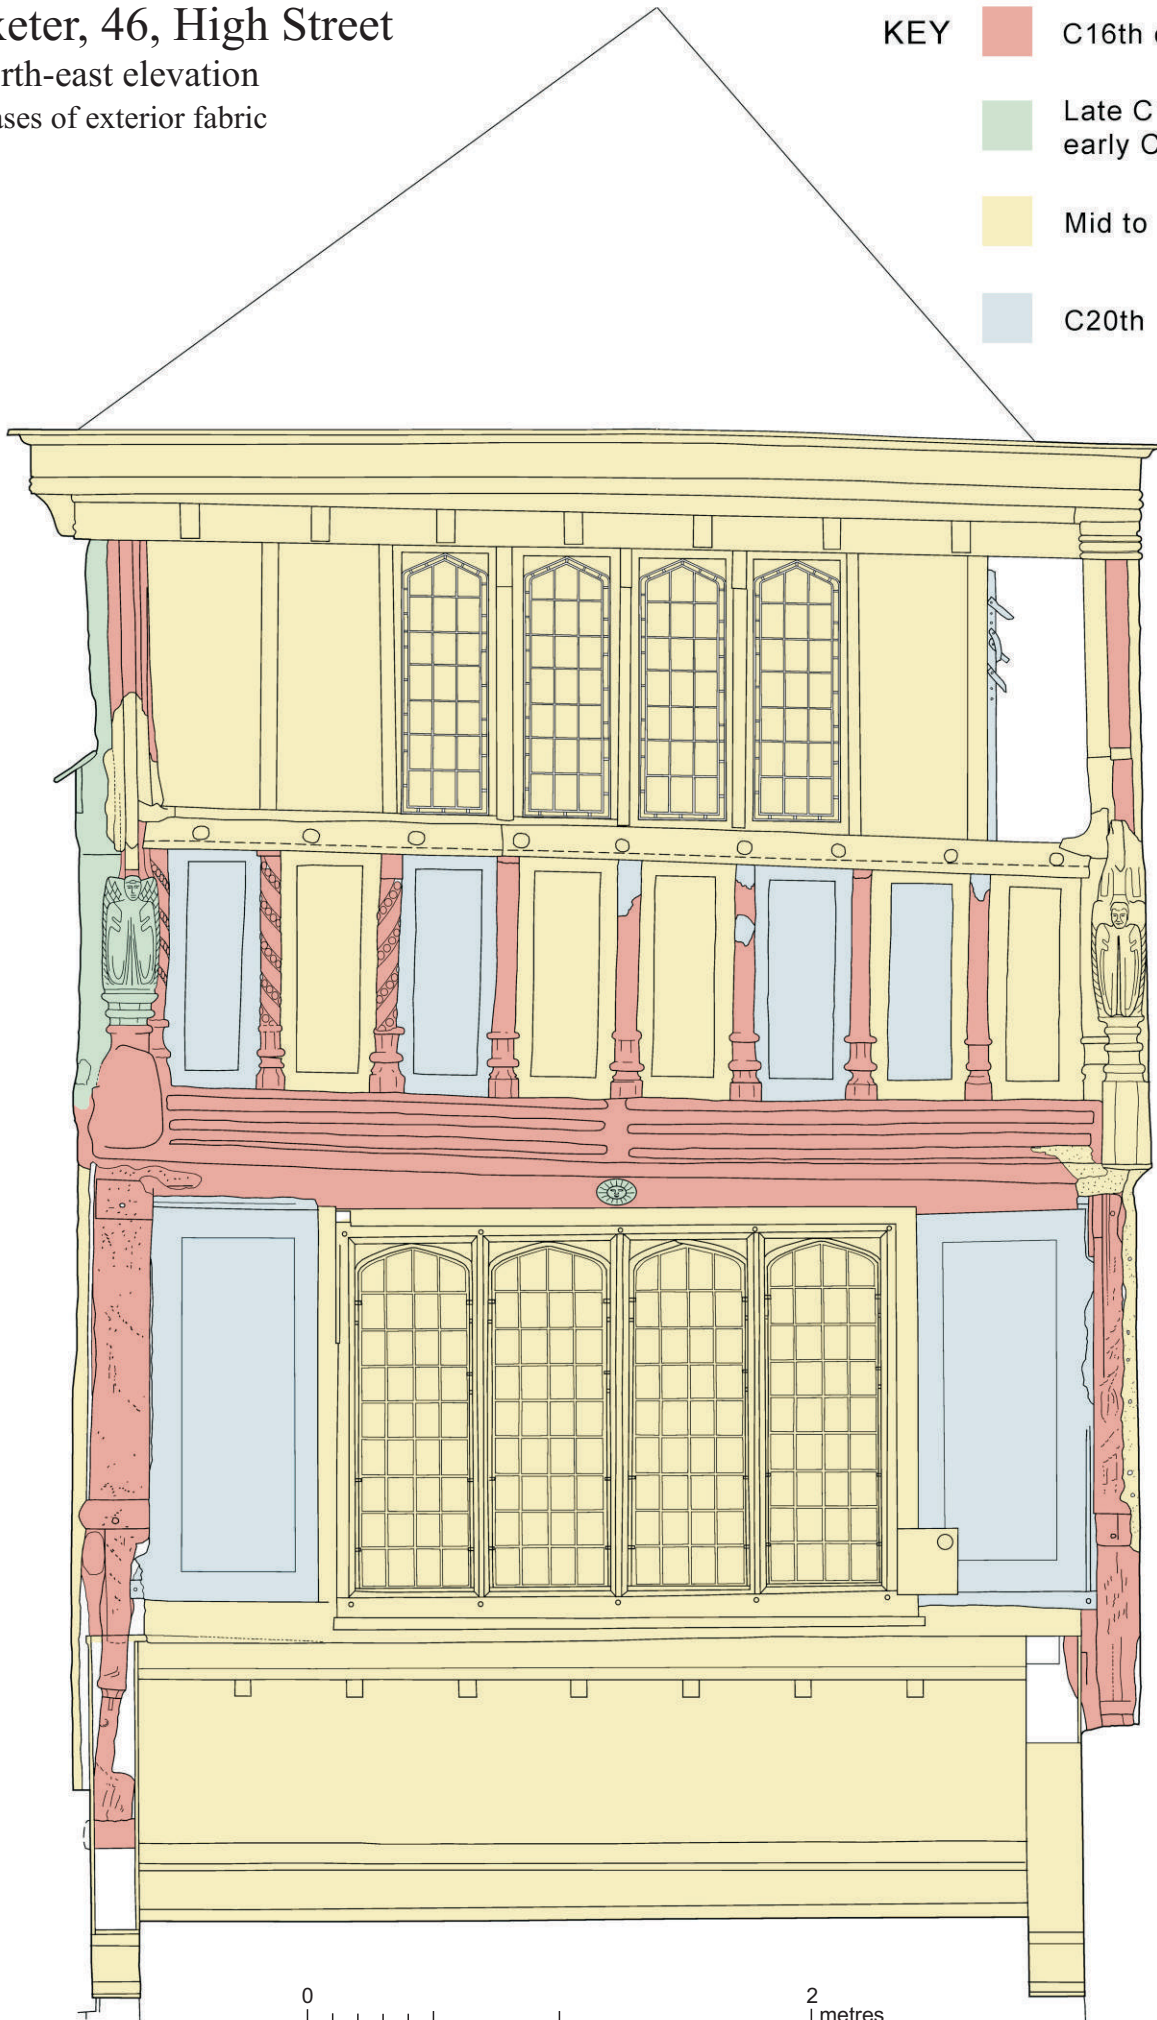
A drawing showing the general phasing of the existing surface fabric prior to works can be seen in Fig. 14. It is clear that much of the work is from the 19<sup>th</sup> or 20<sup>th</sup> century with only small areas of possibly 18<sup>th</sup>-century provenance. Despite the many alterations, it is evident how the importance of the structural timbers of the frontage has resulted in the survival of so much medieval fabric.

Fig. 14 Phased elevation drawing of the frontage showing the exterior surface fabric prior to works. Scale 1:30.

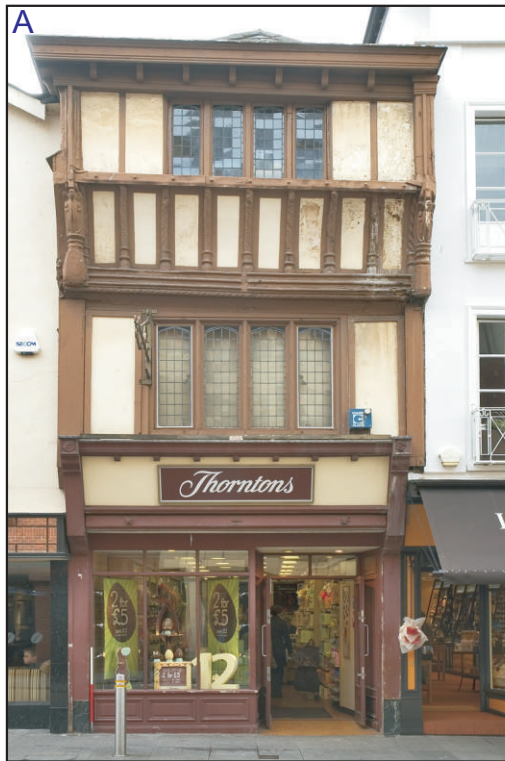
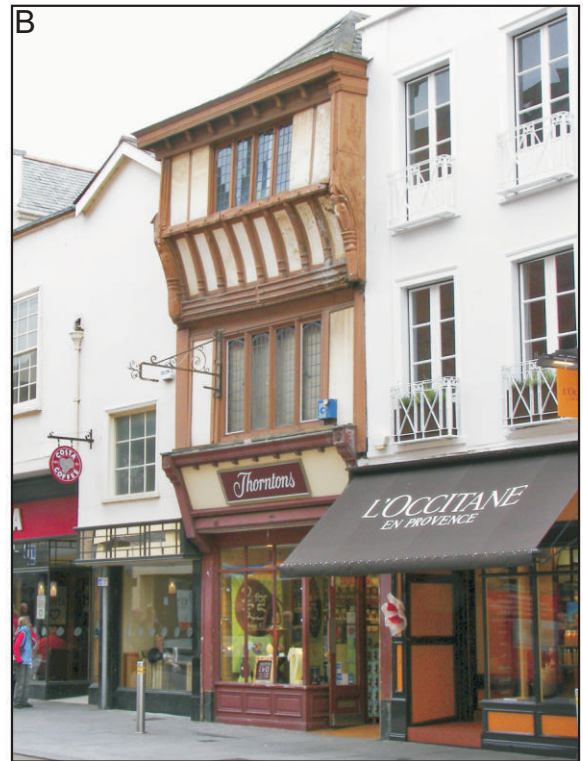
Pl. 1 Views of the north elevation of 46 High Street with the heavily altered elevation of No. 47 visible on the right. Scale 1m. Views south-east and east.
