**ARCHAEOLOGICAL RECORDING  
DURING REPAIR WORKS TO  
46 HIGH STREET, EXETER**

**Exeter Archaeology**

**Report No. 09.127**

**November 2009**

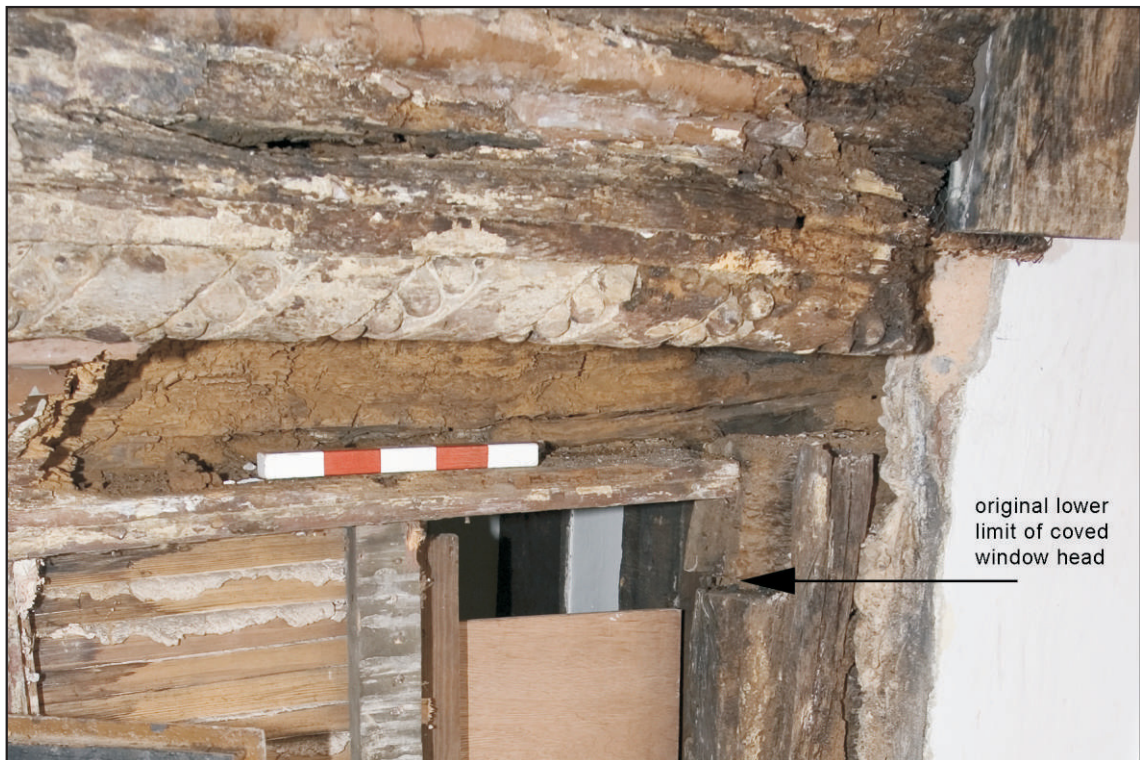
Pl. 16 Detail of the east end of the first-floor covered window head showing the lowest extremity of the beam surviving truncation for later windows (arrowed). Scale 0.25m. View south.

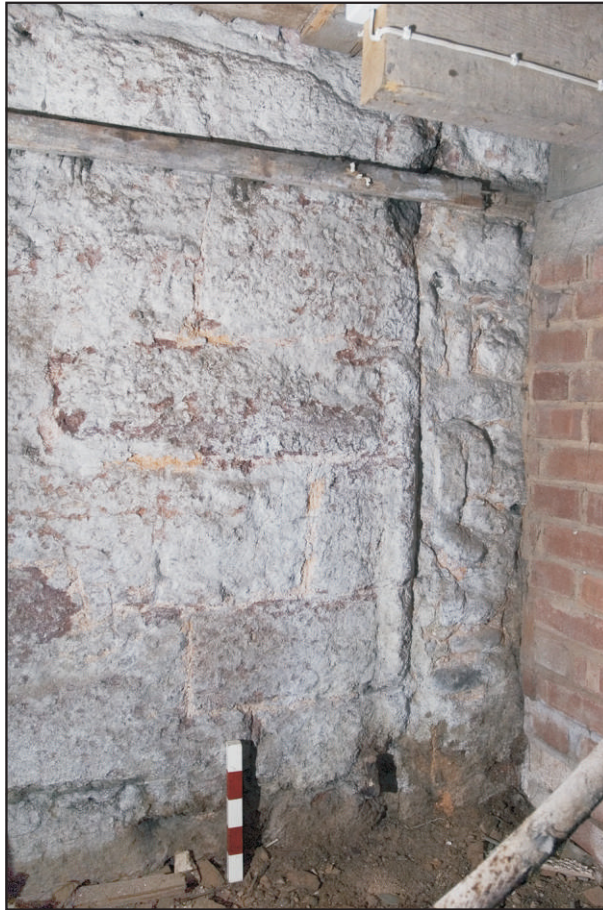
Pl. 18 View of the south-west cellar wall showing a blocked doorway with a rolled edge to the jamb and an iron pintle below. Scale 0.25m. View south-west.

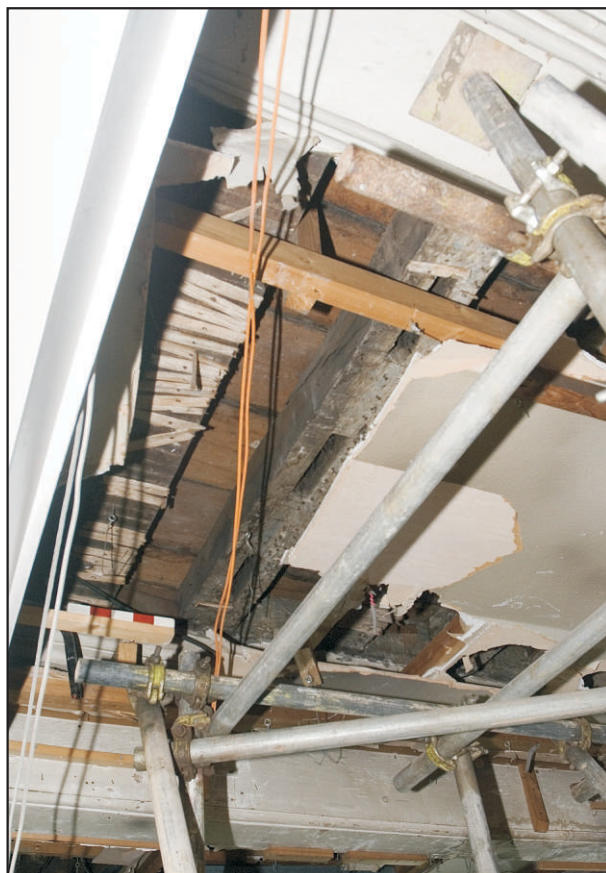
Pl. 21 View of the partially stripped ground-floor ceiling of the north-west room showing the joist with mortices for a former passage screen along the north-east side. Scale 0.25m. View south-east.

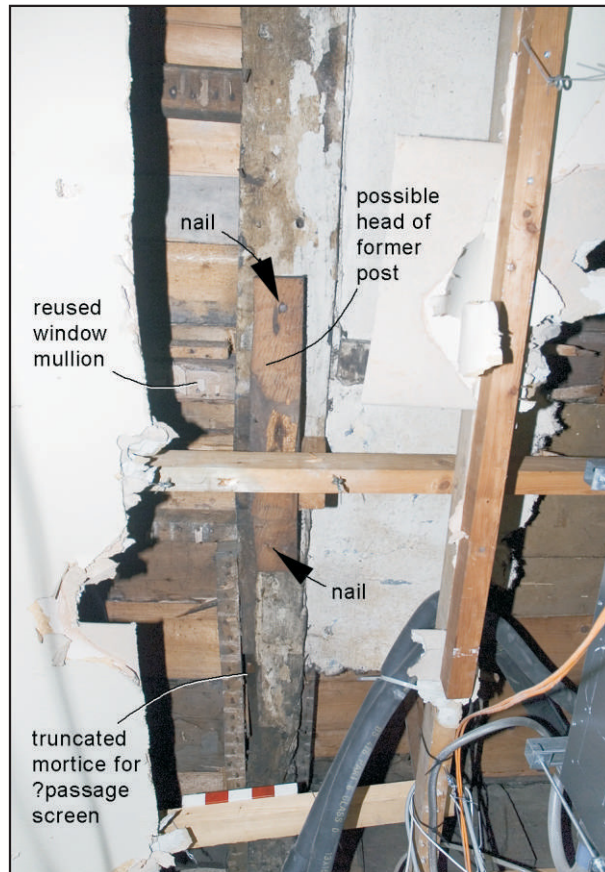
Pl. 22 View of the ground-floor ceiling of the north-west room showing the joist with a truncated mortice for a possible passage screen and the remains of a possibly later post. Scale 0.25m. View south-east.

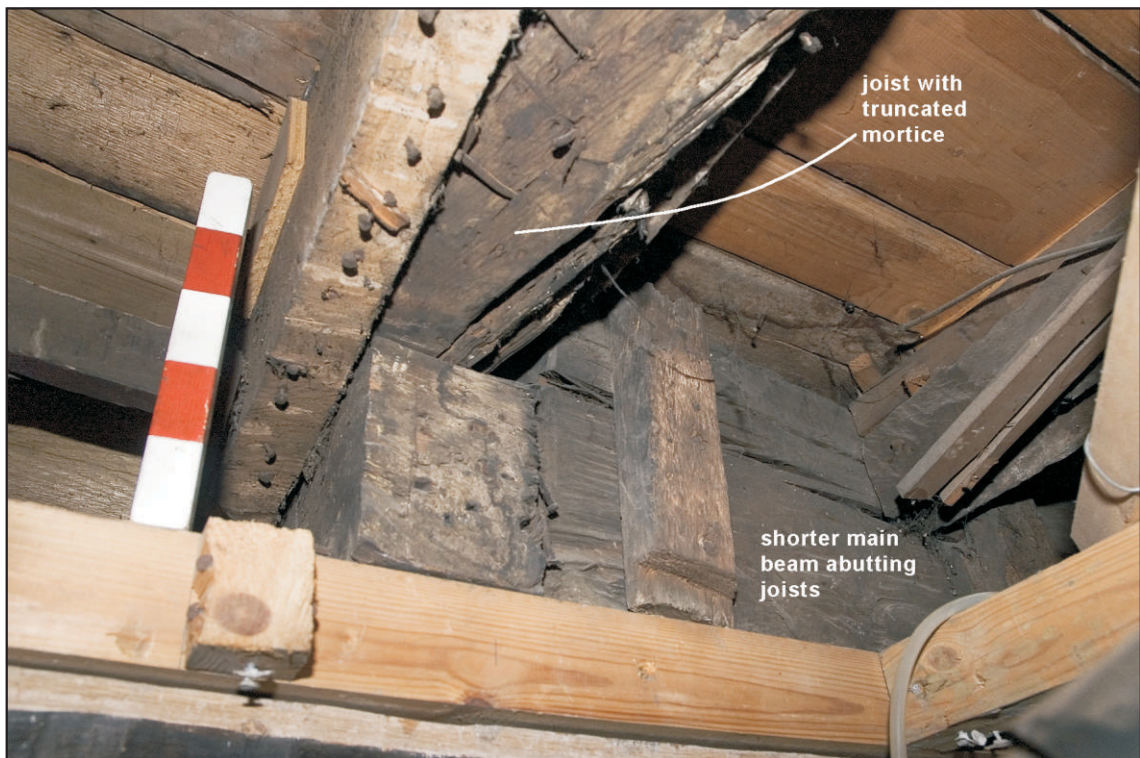
Pl. 23 View of the shorter main beam in the third bay of the ground-floor ceiling of the north-west room showing the abutment of its south-east end against the joists marking the former position of a passage screen. Scale 0.25m. View south.

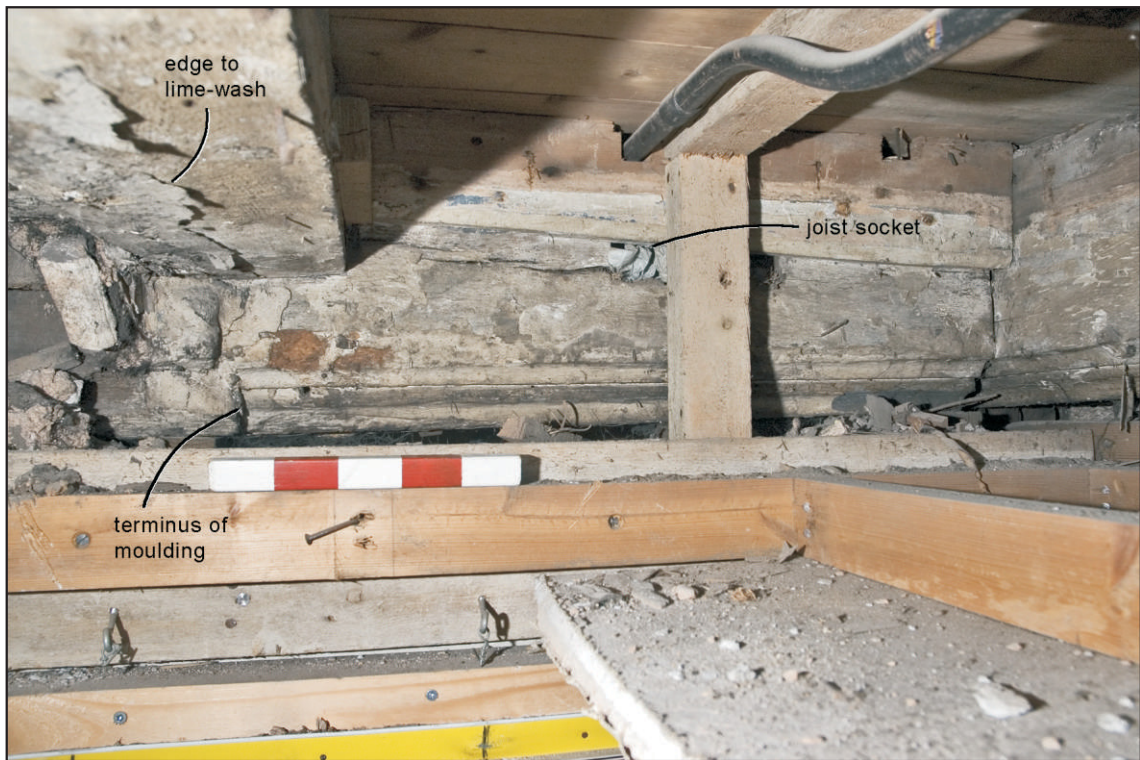
Pl. 24 View of the short section of moulded beam in the ground-floor ceiling of the north-west room overlying the site of the former passage. Note how the terminus of the moulding is aligned with a straight edge to limewash on the adjoining joist. Scale 0.25m. View north-west.

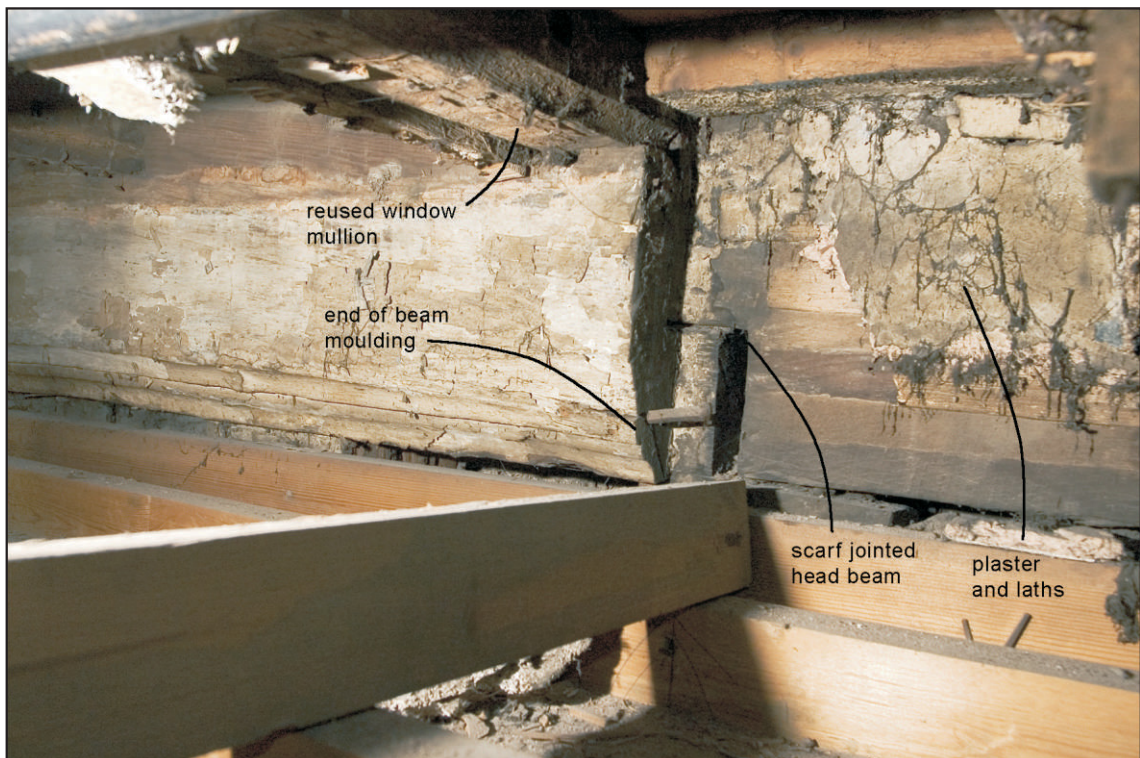
Pl. 25 View of the head beam of the ground-floor north-west room in the area of the former passage showing the scarf joint between beam sections and the termination of the moulding. View north.
