**FORMER 'SHIP AGROUND' PUBLIC HOUSE
142 LEA BRIDGE ROAD, HACKNEY, LONDON, E5 9RB**

**HISTORIC BUILDING RECORD
(English Heritage Level 2)**

**Commissioned by
Singh Sabha Gurdwara North East London**

Report No. 2013154 (rev. 1)

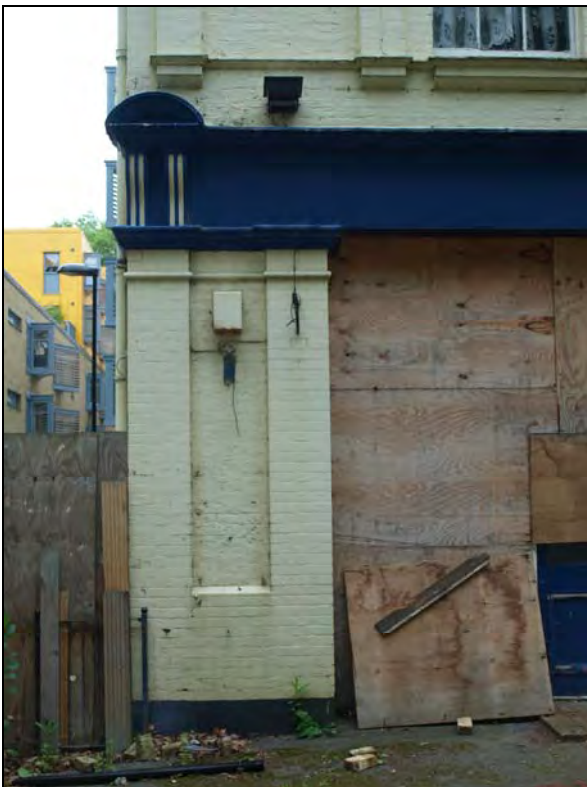
5.2.5 Above the fascia panel the façade is divided into seven sections by projecting pilasters which start five courses above the fascia, rising from moulded corbels to capitals below the cornice (Plate 1). The pilasters have two string courses of moulding, one near the base which extends across all the sections and forms window sills, the other five courses from the top and extending only across the blind sections, being broken in those that contain windows (Plate 3).

Plate 2. Northwest elevation, pilaster. Facing southeast (16)

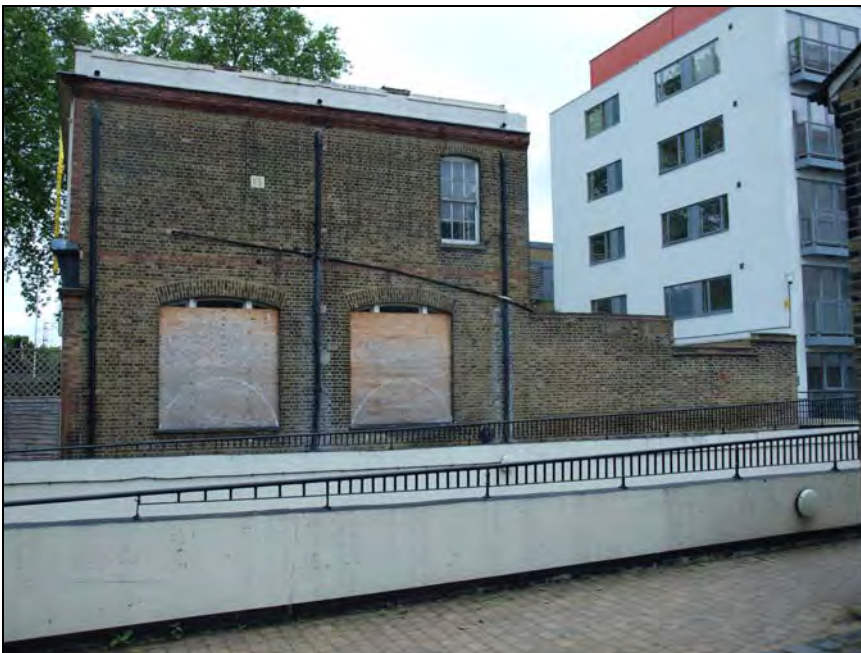
Plate 4. Southwest elevation, general view. Facing northeast (01)

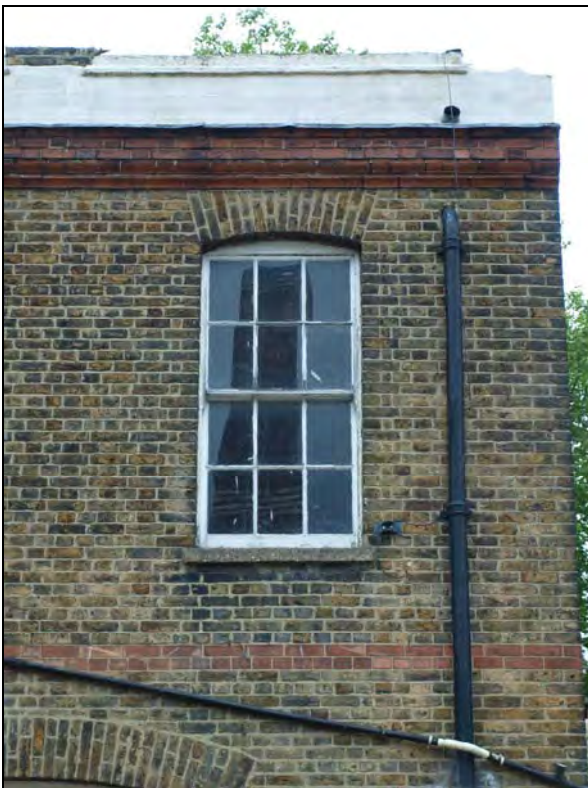
Plate 6. Southwest elevation, first floor window. Facing northeast (62)

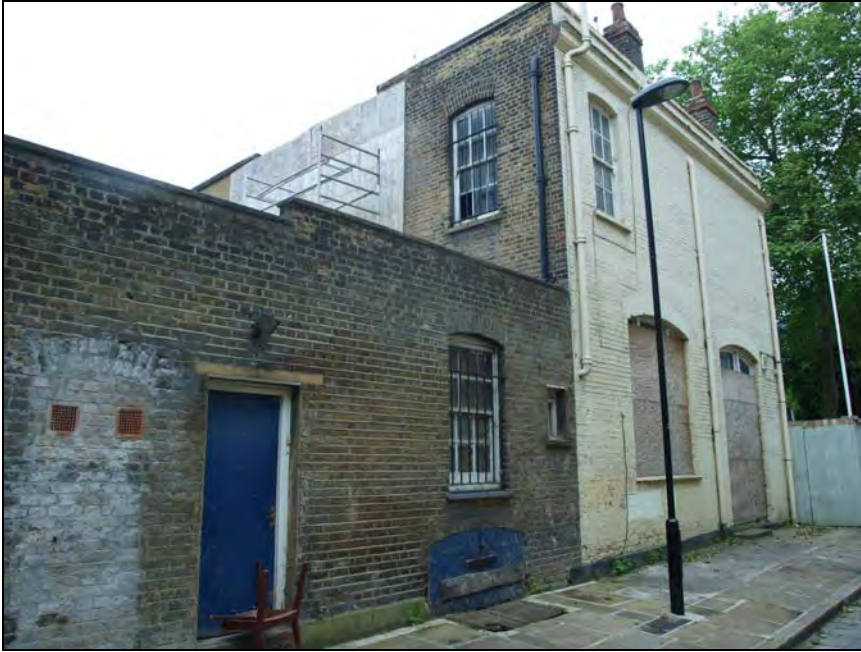
Plate 7. Northeast elevation, general view. Facing west (14)

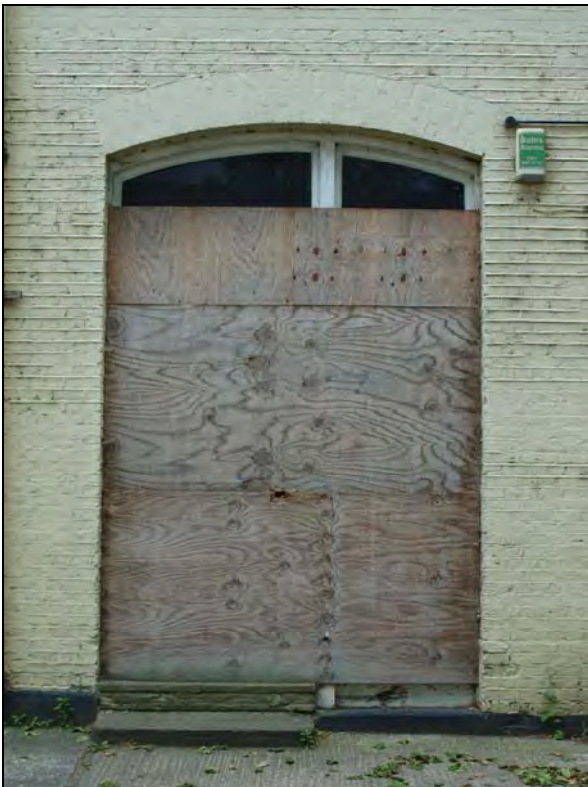
Plate 8. Northeast elevation, door. Facing southwest (55)

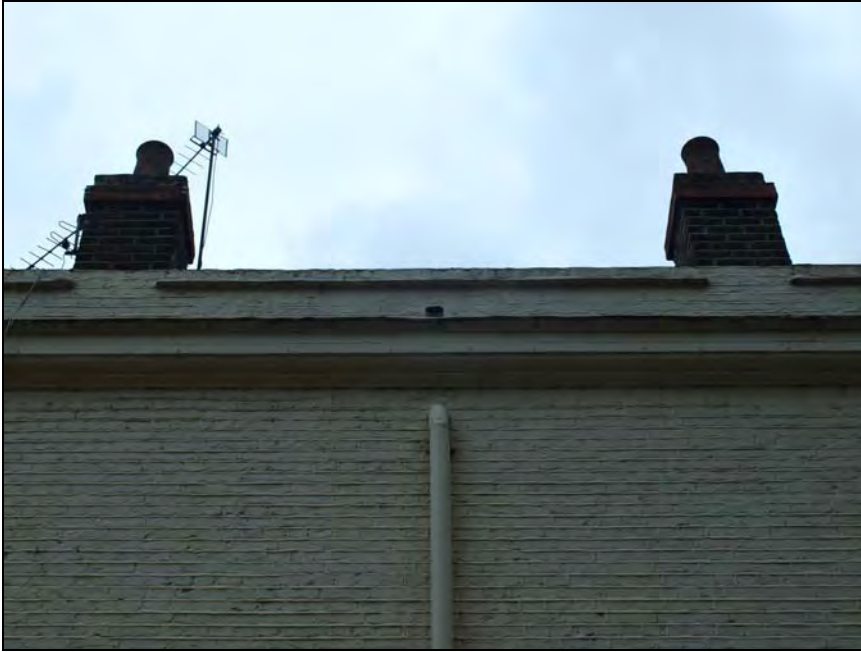
Plate 9. Northeast elevation, cornice, parapet & chimney stacks. Facing southwest (59)

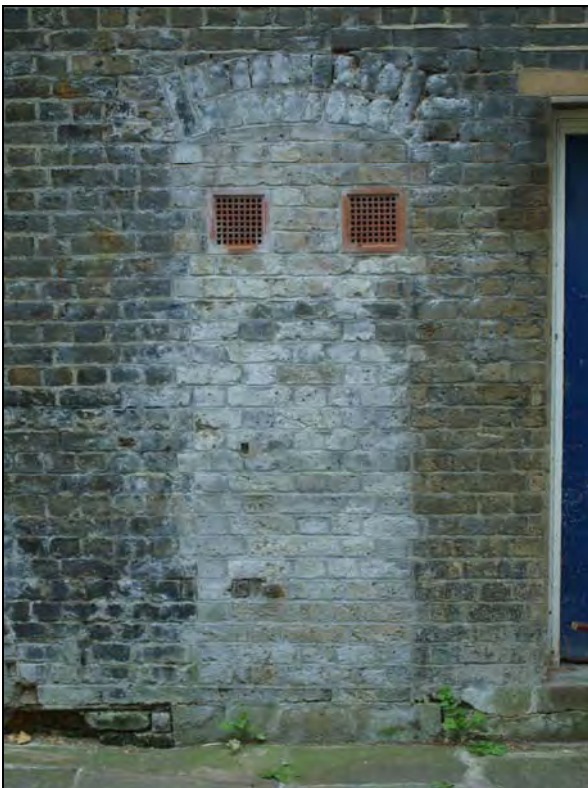
Plate 12. Northeast elevation, blocked doorway. Facing southwest (12)

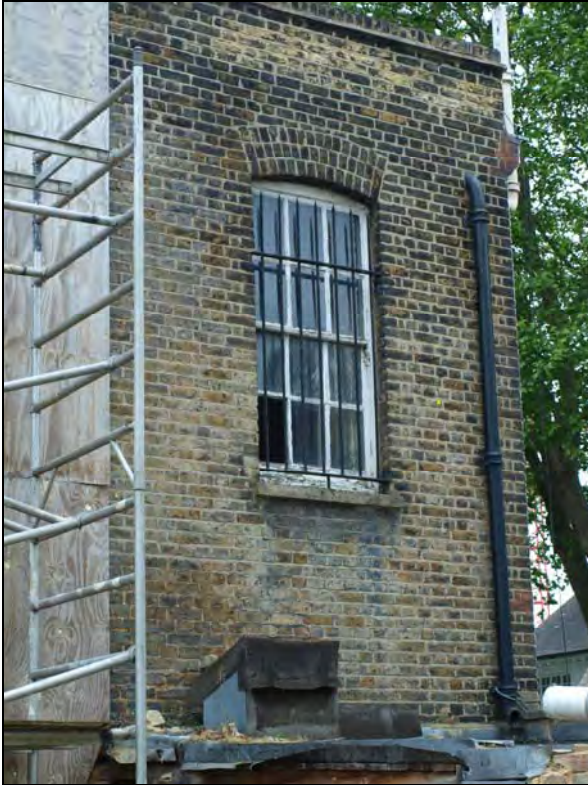
Plate 15. Southeast elevation, first floor window. Facing north (30)

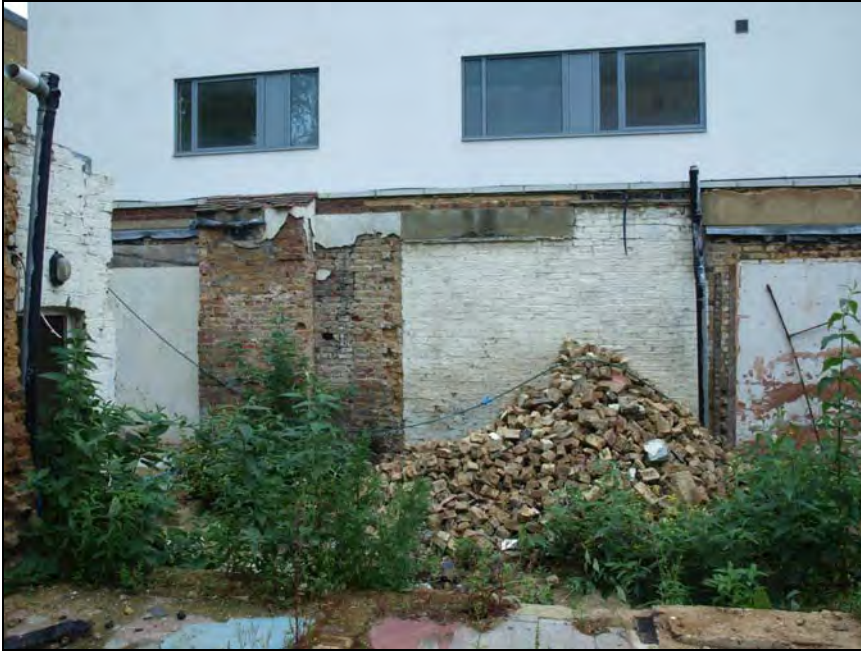
Plate 17. Rear boundary wall, showing capped flue at left. Facing southeast (25)

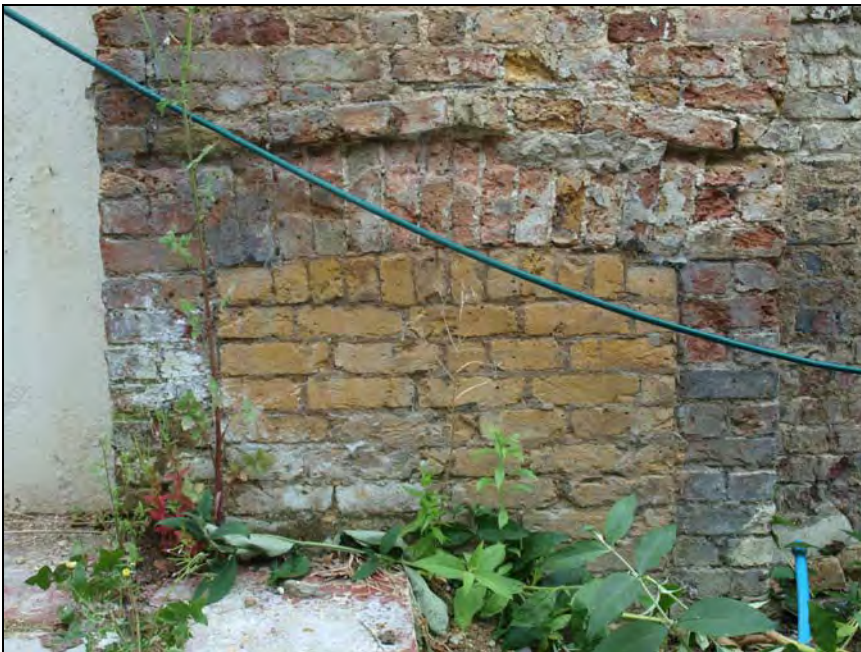
Plate 18. Rear boundary wall, blocked fireplace. Facing southeast (29)

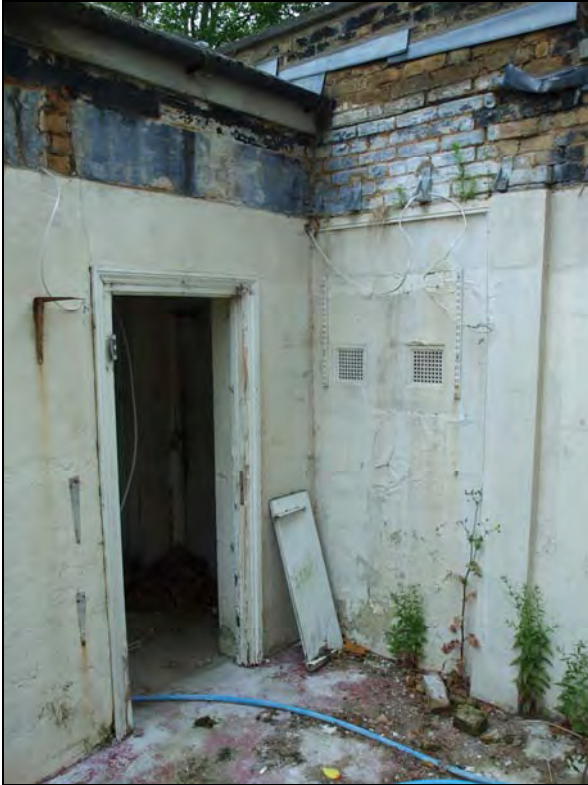
Plate 21. Doorway between demolished store and extant outbuilding. Facing north (27)

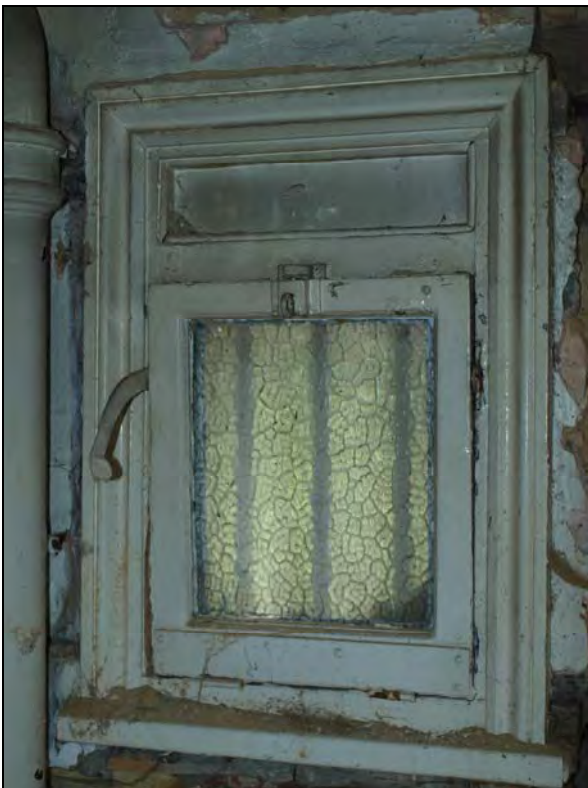
Plate 22. Window in outbuilding. Facing northeast (21)

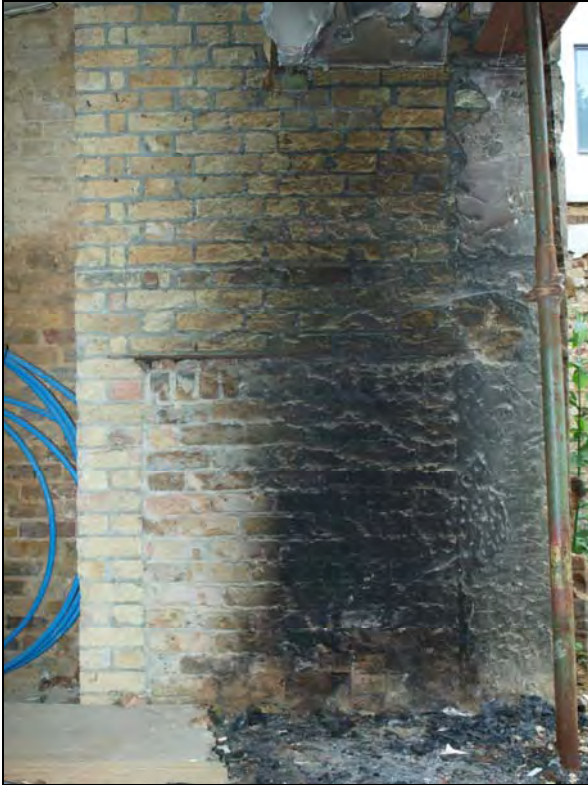
Plate 23. Blocked fireplace in outbuilding. Facing southeast (22)

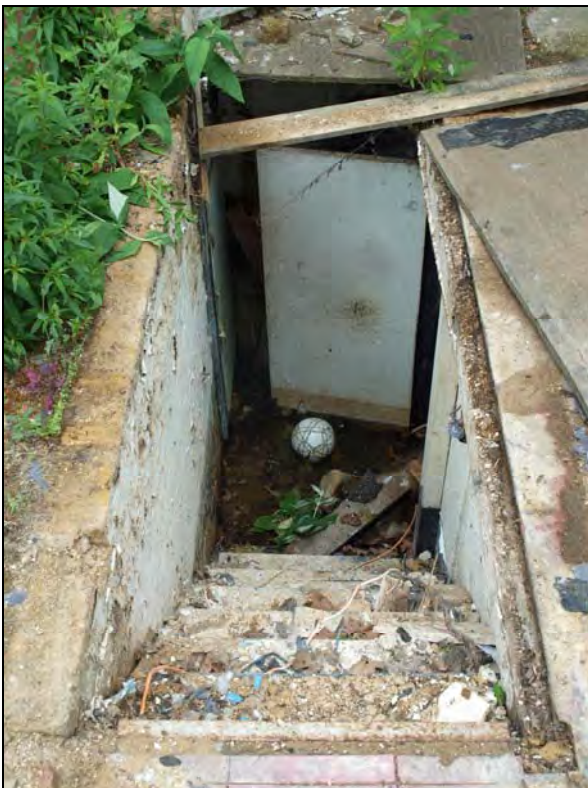
Plate 24. Cellar access at rear of building. Facing northwest (31)

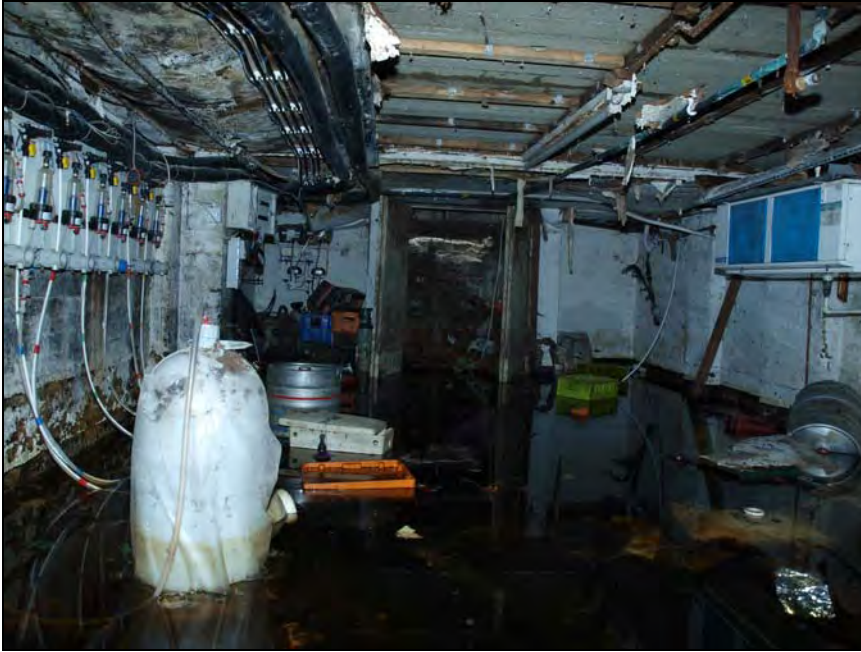
Plate 25. Cellar, general view. Facing east-northeast (33)

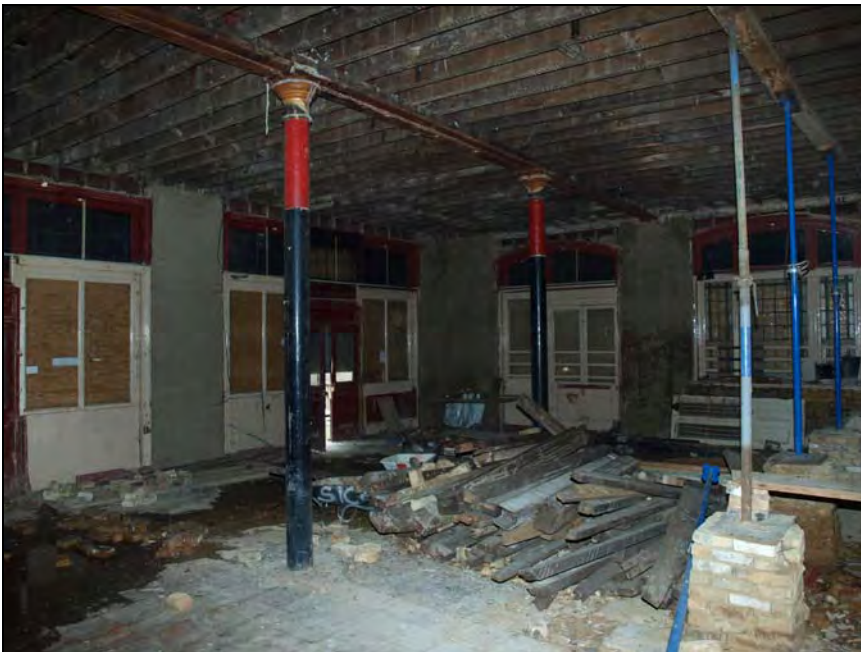
Plate 26. Interior, ground floor, general view. Facing north (40)

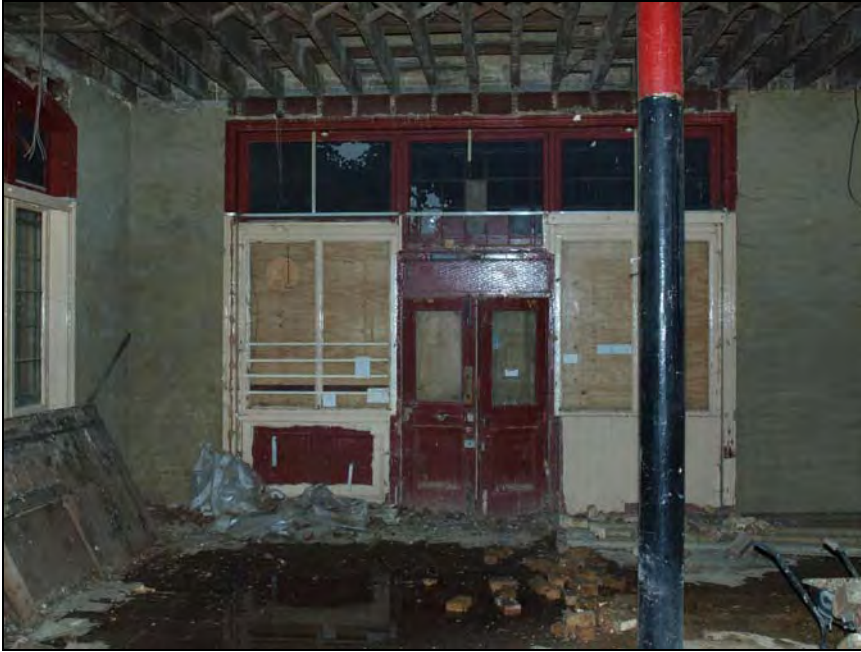
Plate 29. Interior, ground floor, door and flanking windows in front wall. Facing northeast (39)

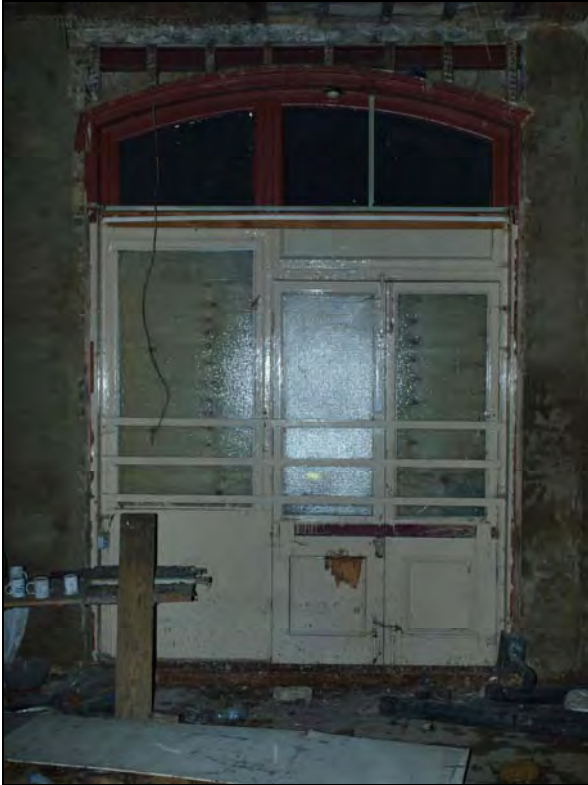
Plate 31. Interior, ground floor, door in side wall. Facing northeast (42)

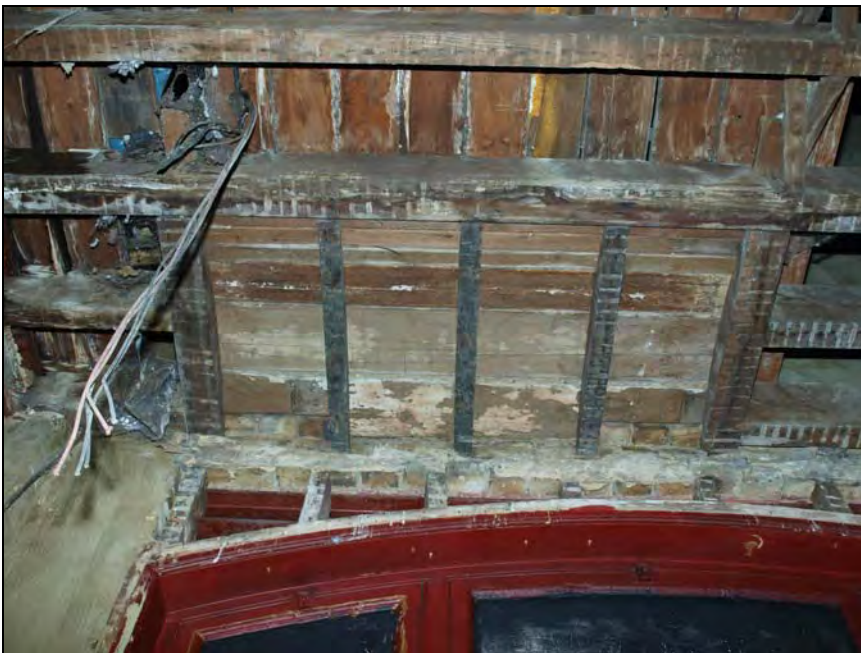
Plate 32. Interior, ground floor, hearth in floor above. Facing southwest (66)

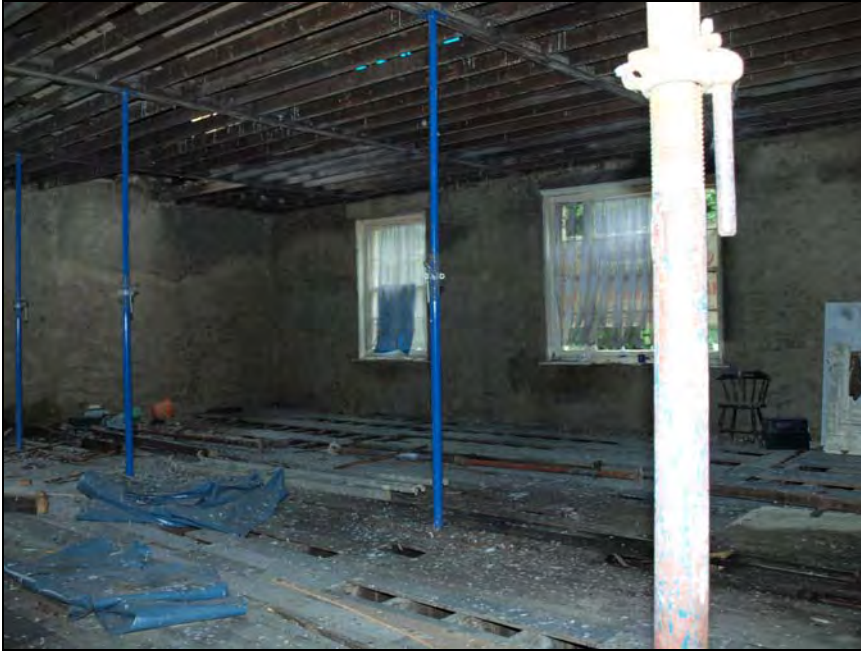
Plate 33. Interior, first floor, general view. Facing west (65)

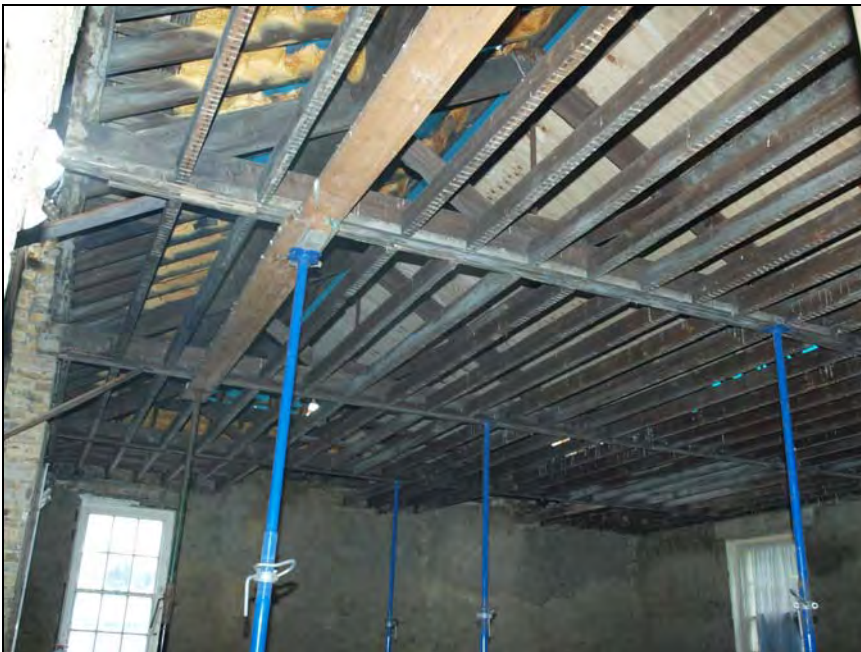
Plate 34. Roof, view of internal structure. Facing west (64)

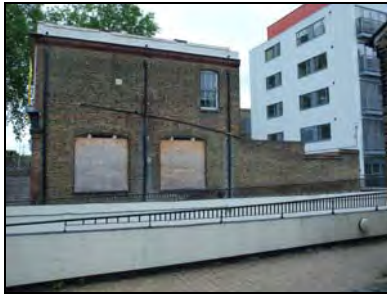
e2668-01
Southwest elevation. Facing northeast

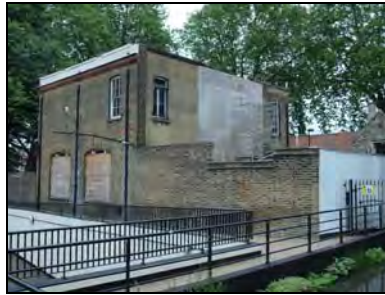
e2668-02
Southwest elevation. Facing north

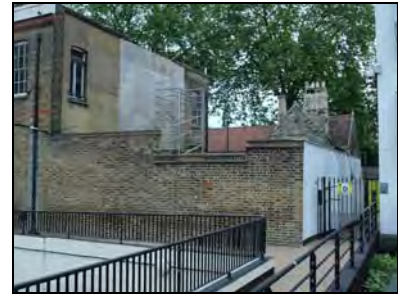
e2668-03
*Southwest and southeast elevations.
Facing north*

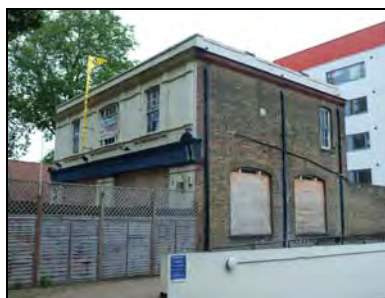
e2668-05
*Northwest and southwest elevations.
Facing west*

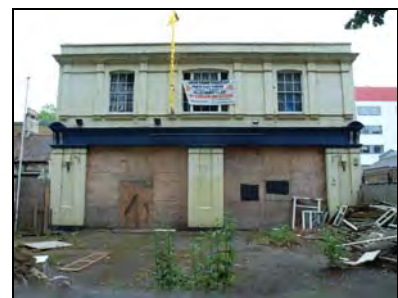
e2668-06
Northwest elevation. Facing southeast

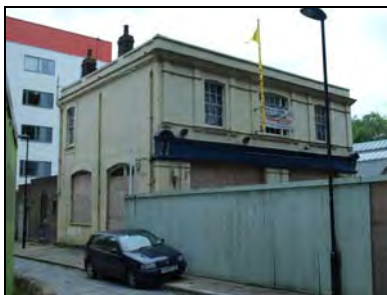
e2668-07
*Northwest and northeast elevations.
Facing south*

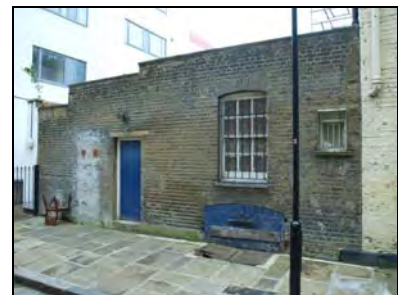
e2668-09
*Northeast elevation, rear extension.
Facing south*

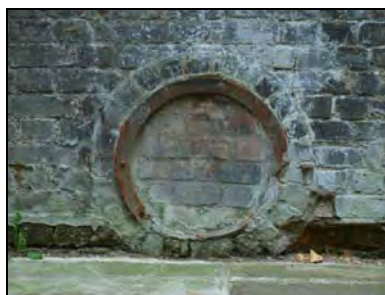
e2668-11
*Northeast elevation, circular opening.
Facing southwest*

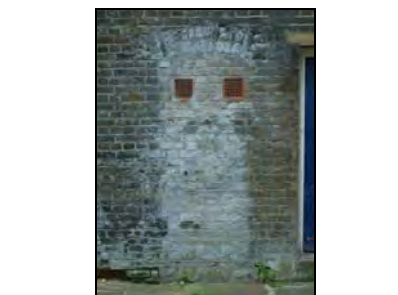
e2668-12
*Northeast elevation, blocked door.
Facing southwest*

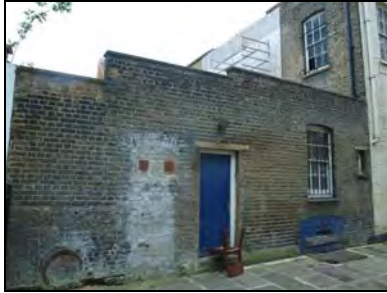
e2668-13
*Northeast elevation, rear extension.
Facing west-southwest*

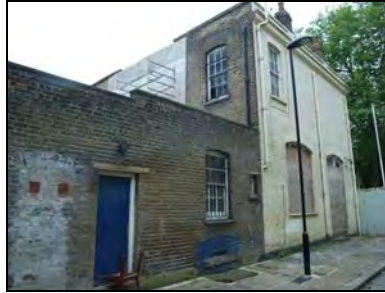
e2668-14
Northeast elevation. Facing west

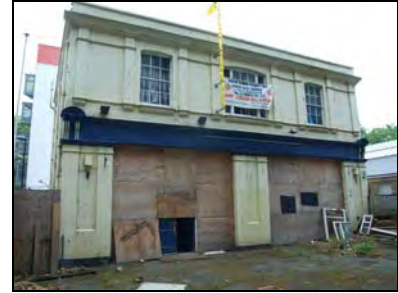
e2668-15
Northwest elevation. Facing south-southeast

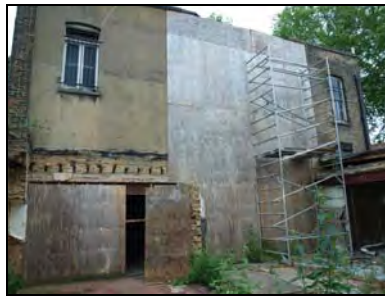
e2668-17
Southeast elevation. Facing north-northwest

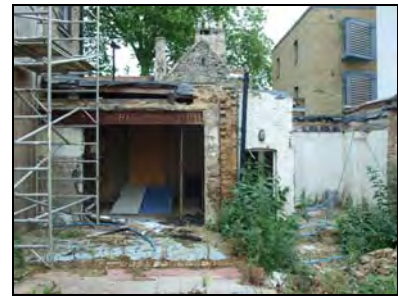
e2668-18
*Remaining structure, rear of building.
Facing northwest*

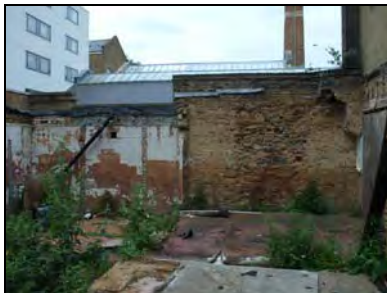
e2668-19
*Internal face of southwest boundary wall.
Facing southwest*

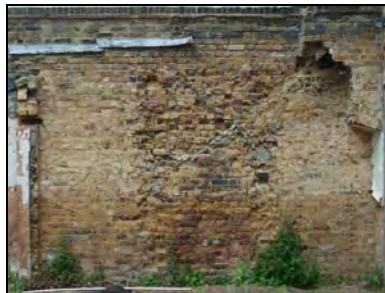
e2668-20
*Detail, internal face of southwest
boundary wall showing roof scar. Facing
southwest*

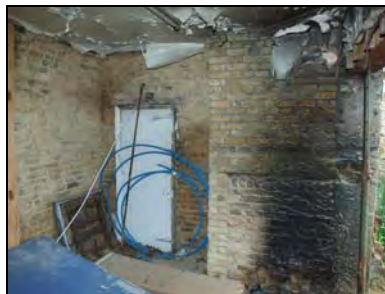
e2668-23
*Interior of remaining structure, rear of
building. Facing east*

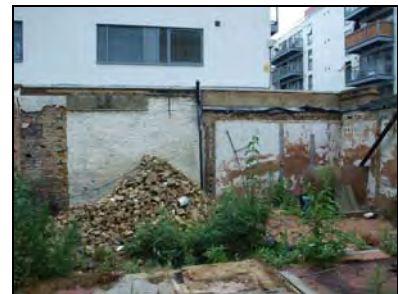
e2668-24
*Internal face of southeast boundary wall.
Facing southeast*

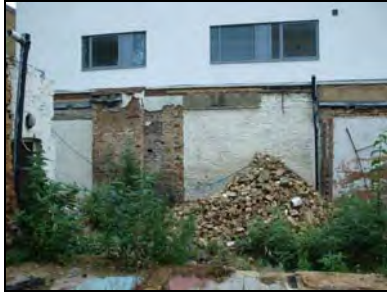
e2668-25
*Internal face of southeast boundary wall.
Facing southeast*

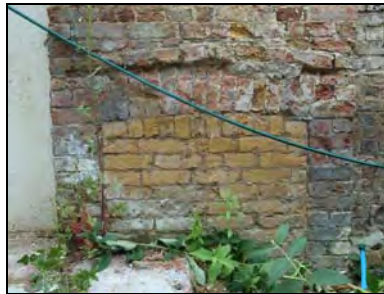
e2668-29
*Blocked fireplace, southeast boundary
wall. Facing southeast*

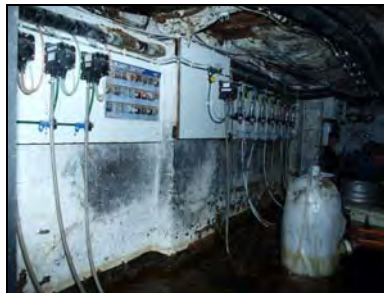
e2668-32
Cellar, interior. Facing northeast

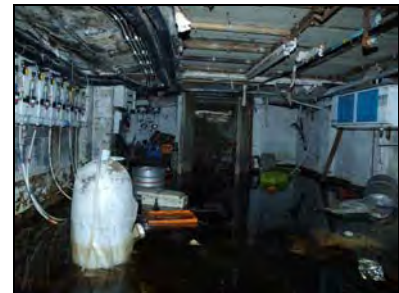
e2668-33
Cellar, interior. Facing east-northeast

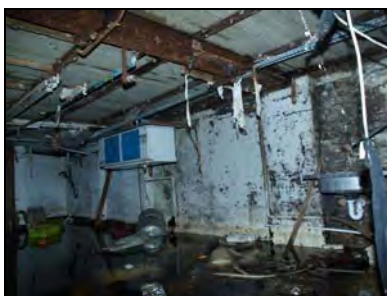
e2668-34
Cellar, interior. Facing east

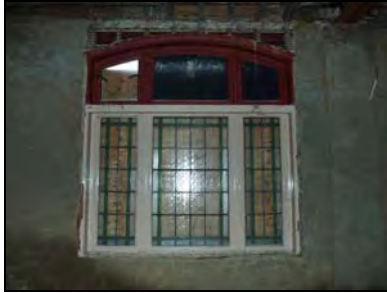
e2668-37
Interior, ground floor window in southwest elevation. Facing southwest

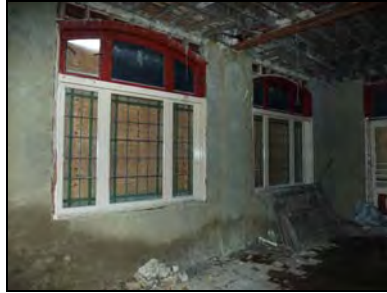
e2668-38
Interior, ground floor windows in southwest elevation. Facing west

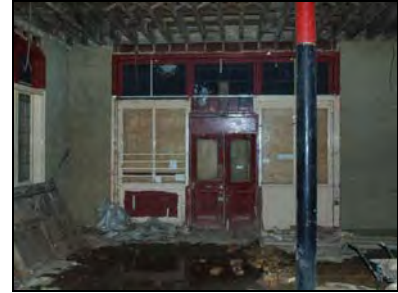
e2668-39
Interior, doorway in northwest elevation. Facing northwest

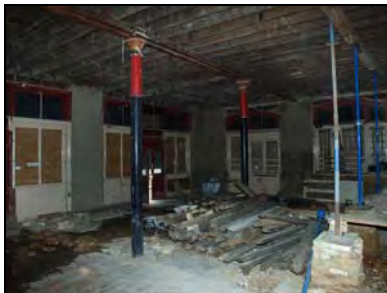
e2668-40
Interior, general view. Facing north

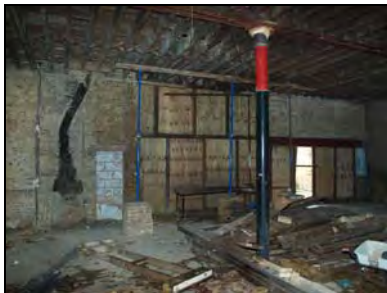
e2668-43
Interior, general view. Facing south

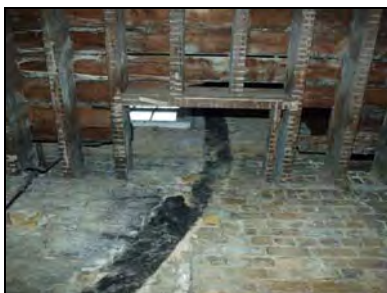
e2668-46
Interior, flue opening in ground floor ceiling. Facing southwest

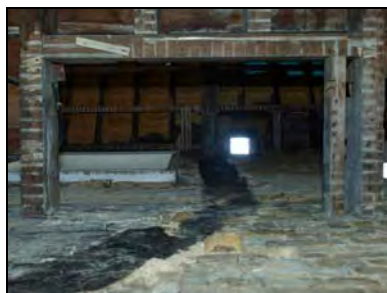
e2668-47
Interior, flue opening in roof. Facing southwest

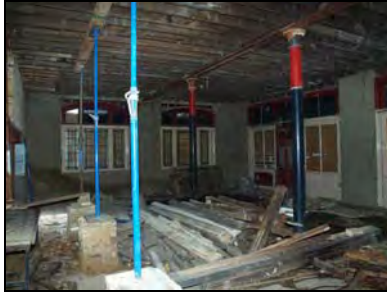
e2668-49
Interior, general view. Facing west

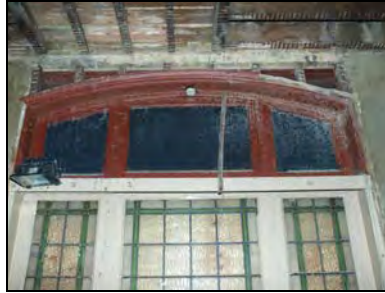
e2668-50
*Interior, window in northeast elevation.
Facing northeast*

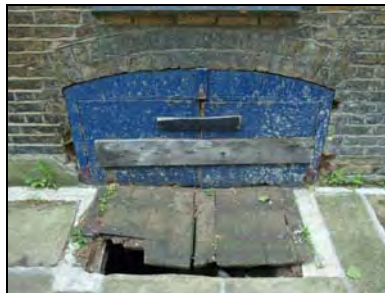
e2668-56
*Northeast elevation, detail of cellar
access. Facing southwest*

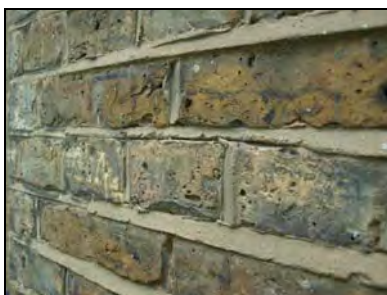
e2668-58
*Northeast elevation, pointing. Facing
south*

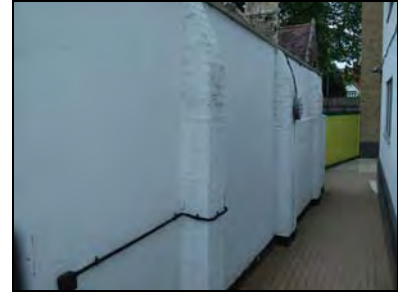
e2668-63
Rear of southeast boundary wall. Facing north

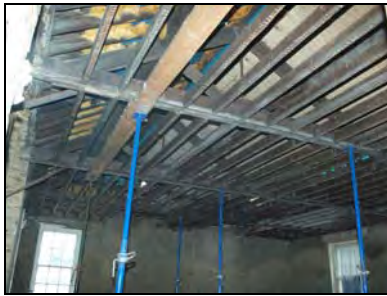
e2668-64
Roof, truss formation. Facing west

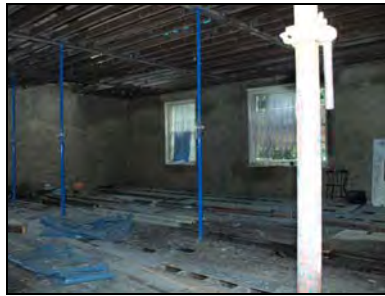
e2668-65
Interior, general view of first floor. Facing west

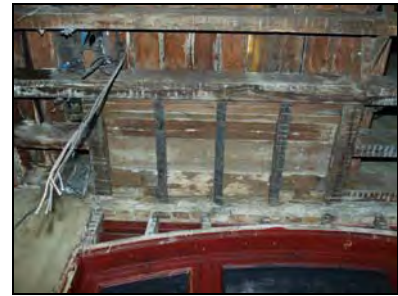
e2668-66
Interior, hearth for fireplace in first floor, viewed from below. Facing southwest

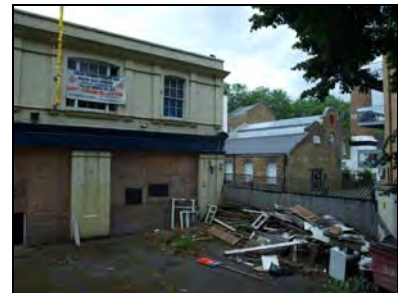
e2668-69
General shot showing relationship to carbolic acid works. Facing south

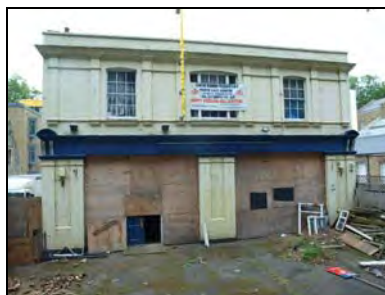
e2668-71
Northwest elevation. Facing southeast
