Essex Barn and Cart Lodge at Little Canfield Hall

Little Canfield, Essex

Historic Building Record and Archaeological Monitoring

Report No.: 2014236

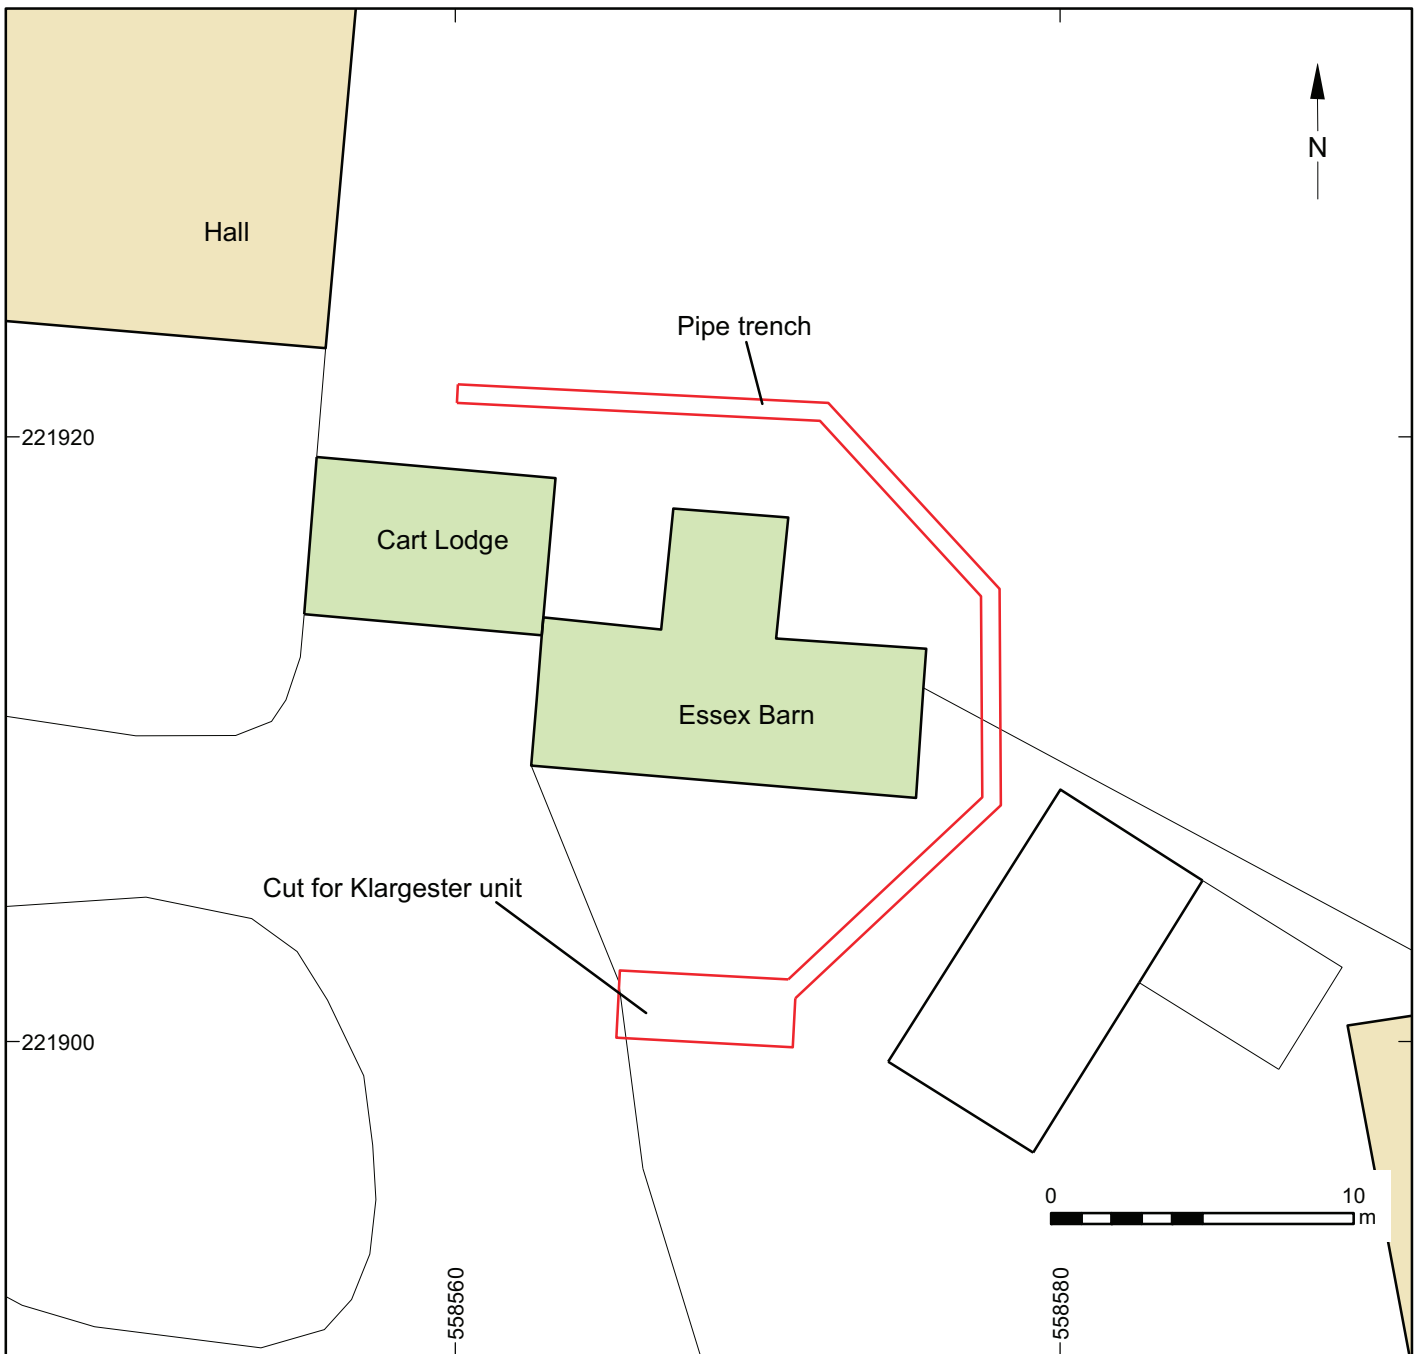
© Archaeology South-East		Essex Barn at Little Canfield Hall, Little Canfield	Fig. 11
Project Ref: 8183	Aug 2014	Areas of archaeological monitoring	
Report Ref: 2014236	Drawn by: APL

Monitoring works on a pipe trench and new Klargestor unit around the barn found natural clay and sand deposits under modern overburden to the east and south and no evidence of archaeological activity.

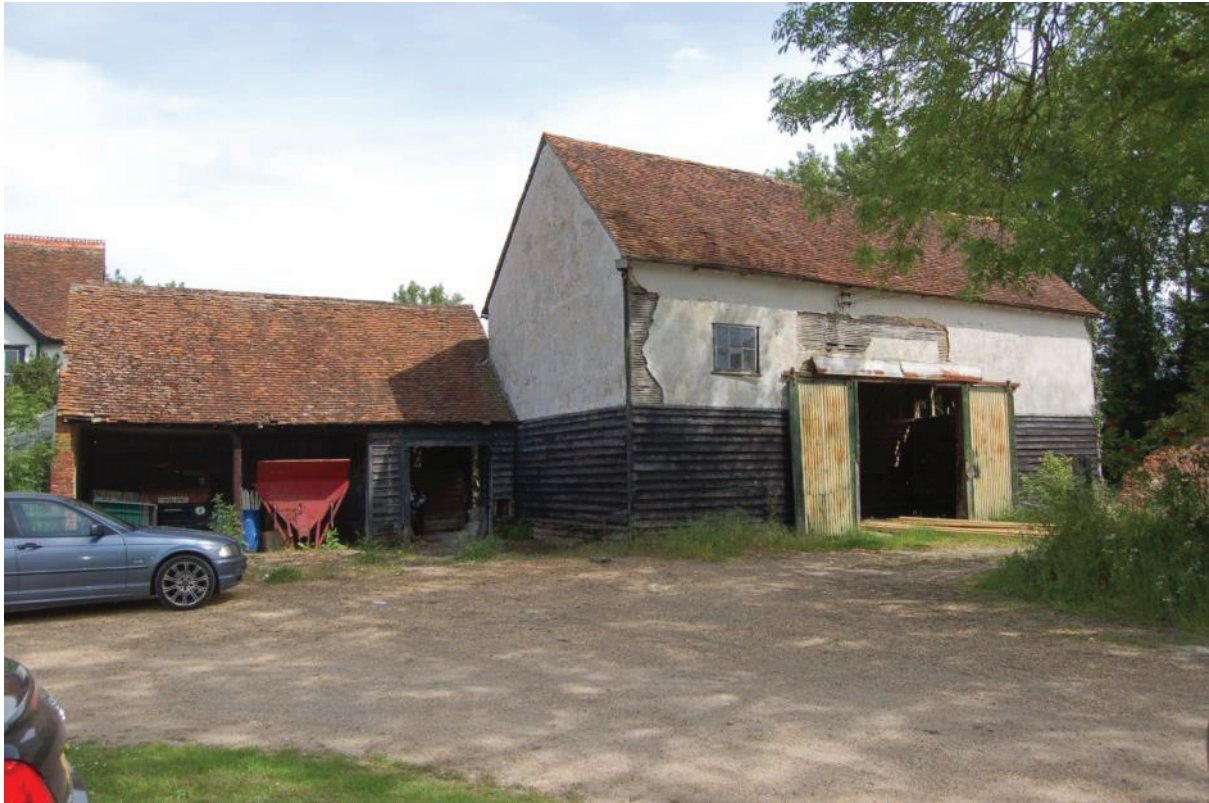
Plate 1 Barn and cart lodge viewed to north-east

6.1.1 The barn and cart lodge (Plates 1 and 2) are timber-framed and half-boarded buildings with tile roofs that together form a good group, retaining much historic character and displaying little in the way of modern alterations.

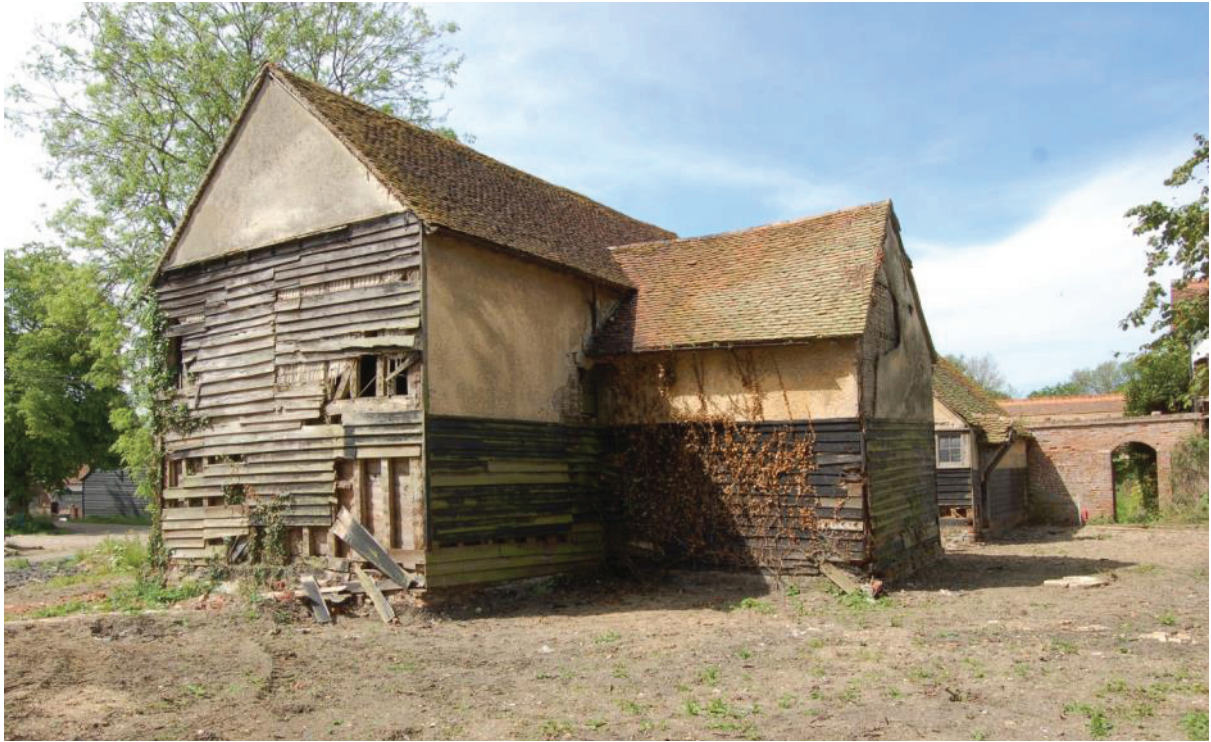
Plate 5 Barn viewed to south-west

- 6.2.6 A large portion of cladding has failed on the east elevation (Plate 5), revealing the studwork beneath. The boards finish at eaves level, after which the gable is rendered in cement rather than lime.
