**SUTTON GARAGES, ALFRISTON ROAD,
SEAFORD, EAST SUSSEX
(NGR 549282 099674)**

**HISTORIC BUILDINGS RECORD
(ENGLISH HERITAGE LEVELS 1 & 2)**

ASE Project No. 6569

Report No. 2014293

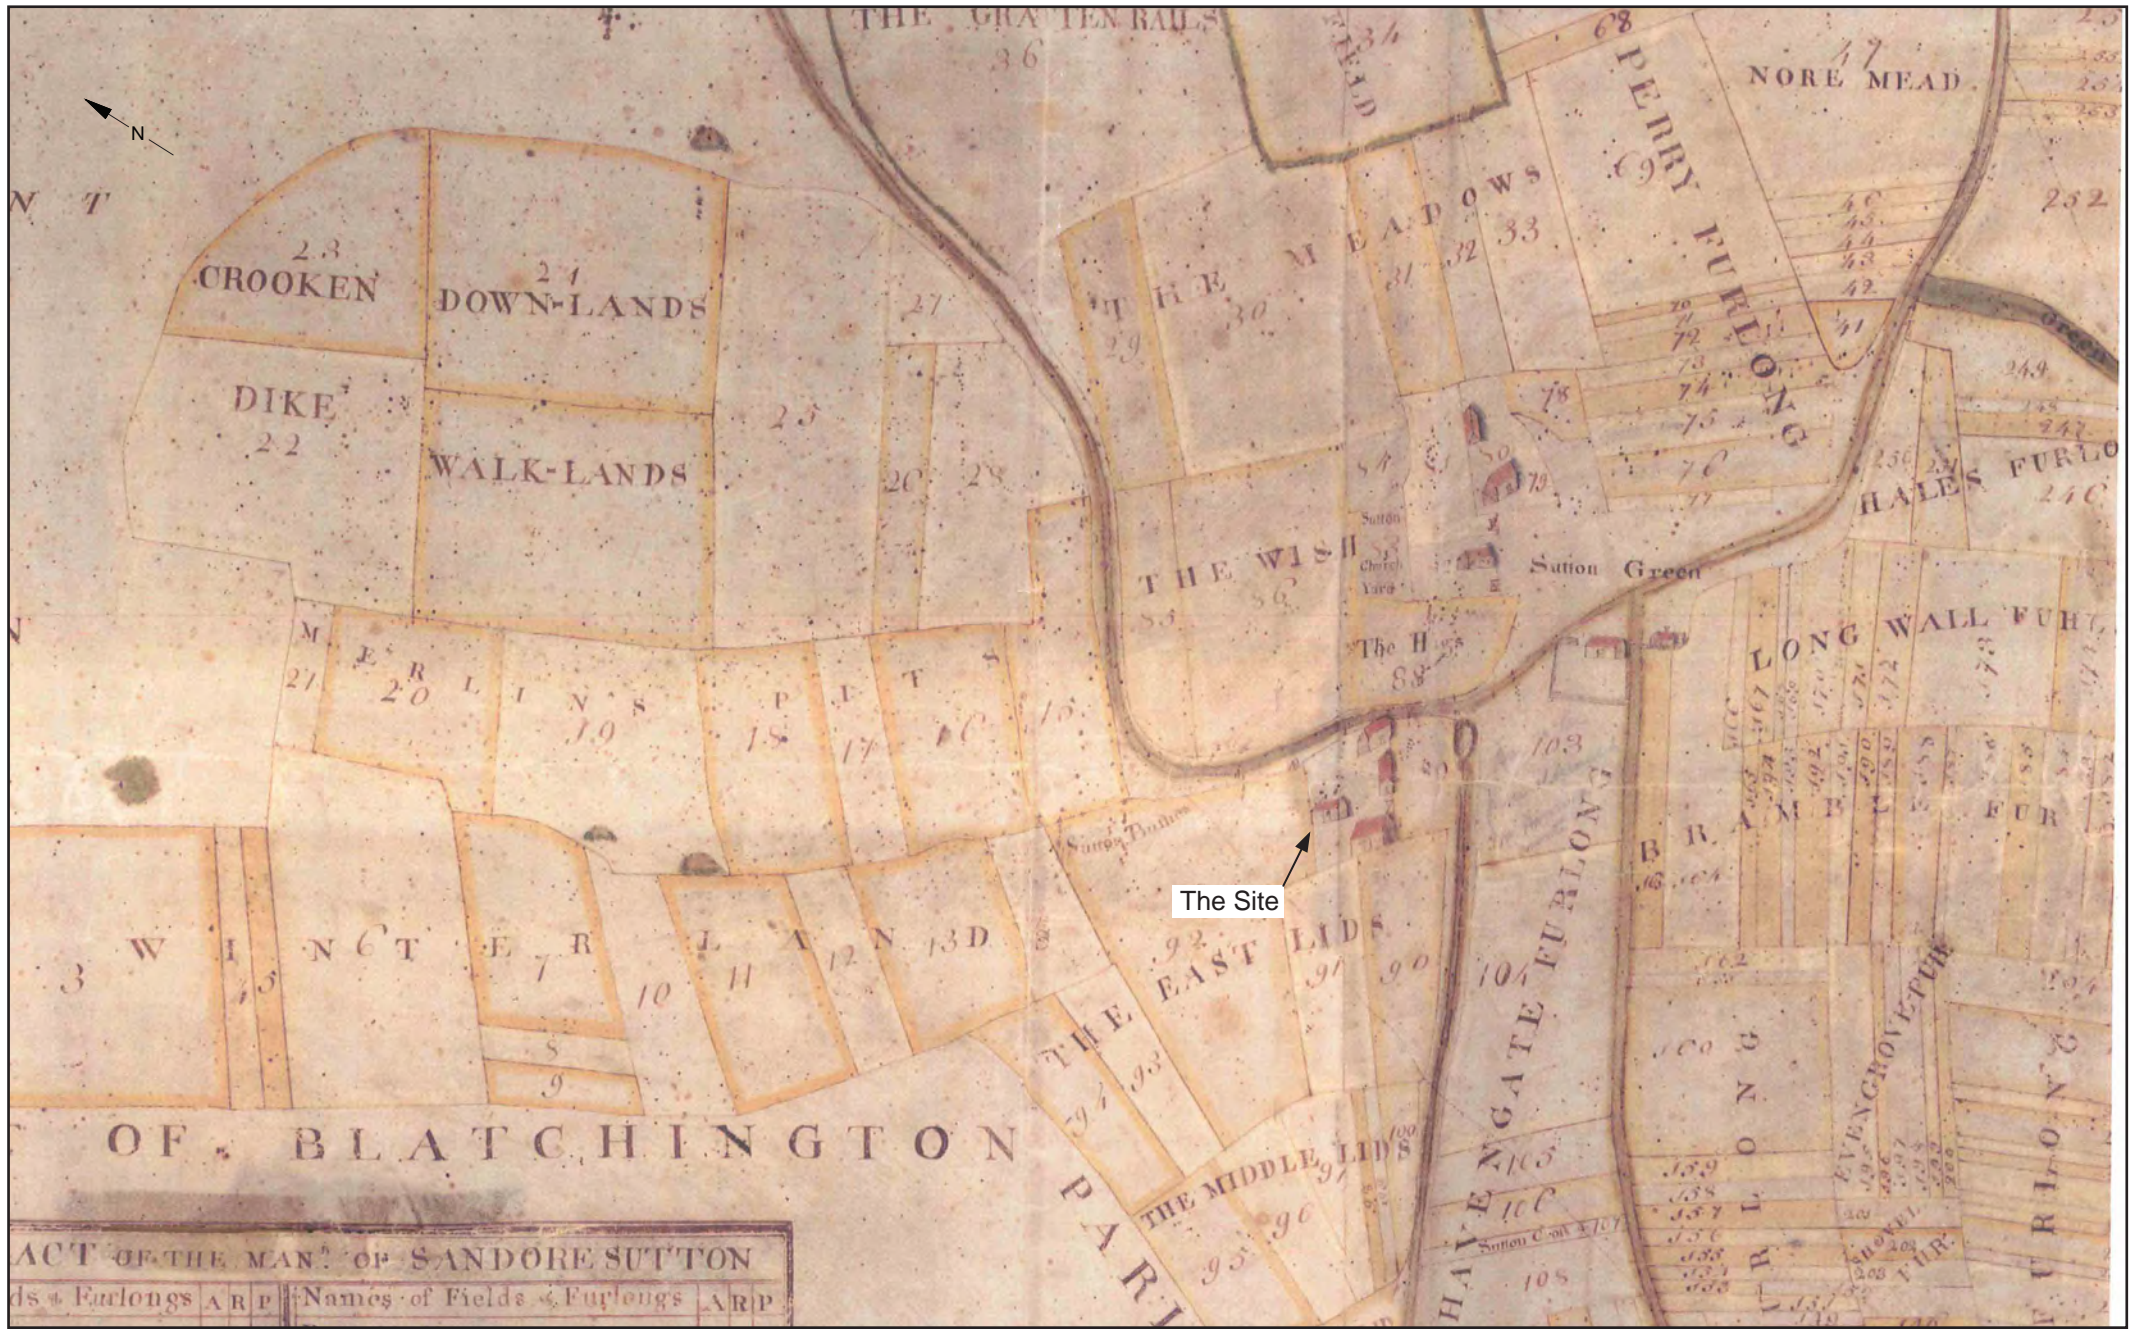
© Archaeology South-East		Sutton Garages, Alfriston Road, Seaford	Fig. 3
Project Ref: 6569	Sep 2014	Map of Old Sandore Sutton, 1740	
Report Ref: 2014293	Drawn by: JLR

or Alfriston (Mawer & Stenton 1930, 364). It had a church and a manor house (Sutton Place) which lay c. 200m east of the site, and are visible on a map of 'Old Sandore Sutton', dated 1740 (Fig. 3),

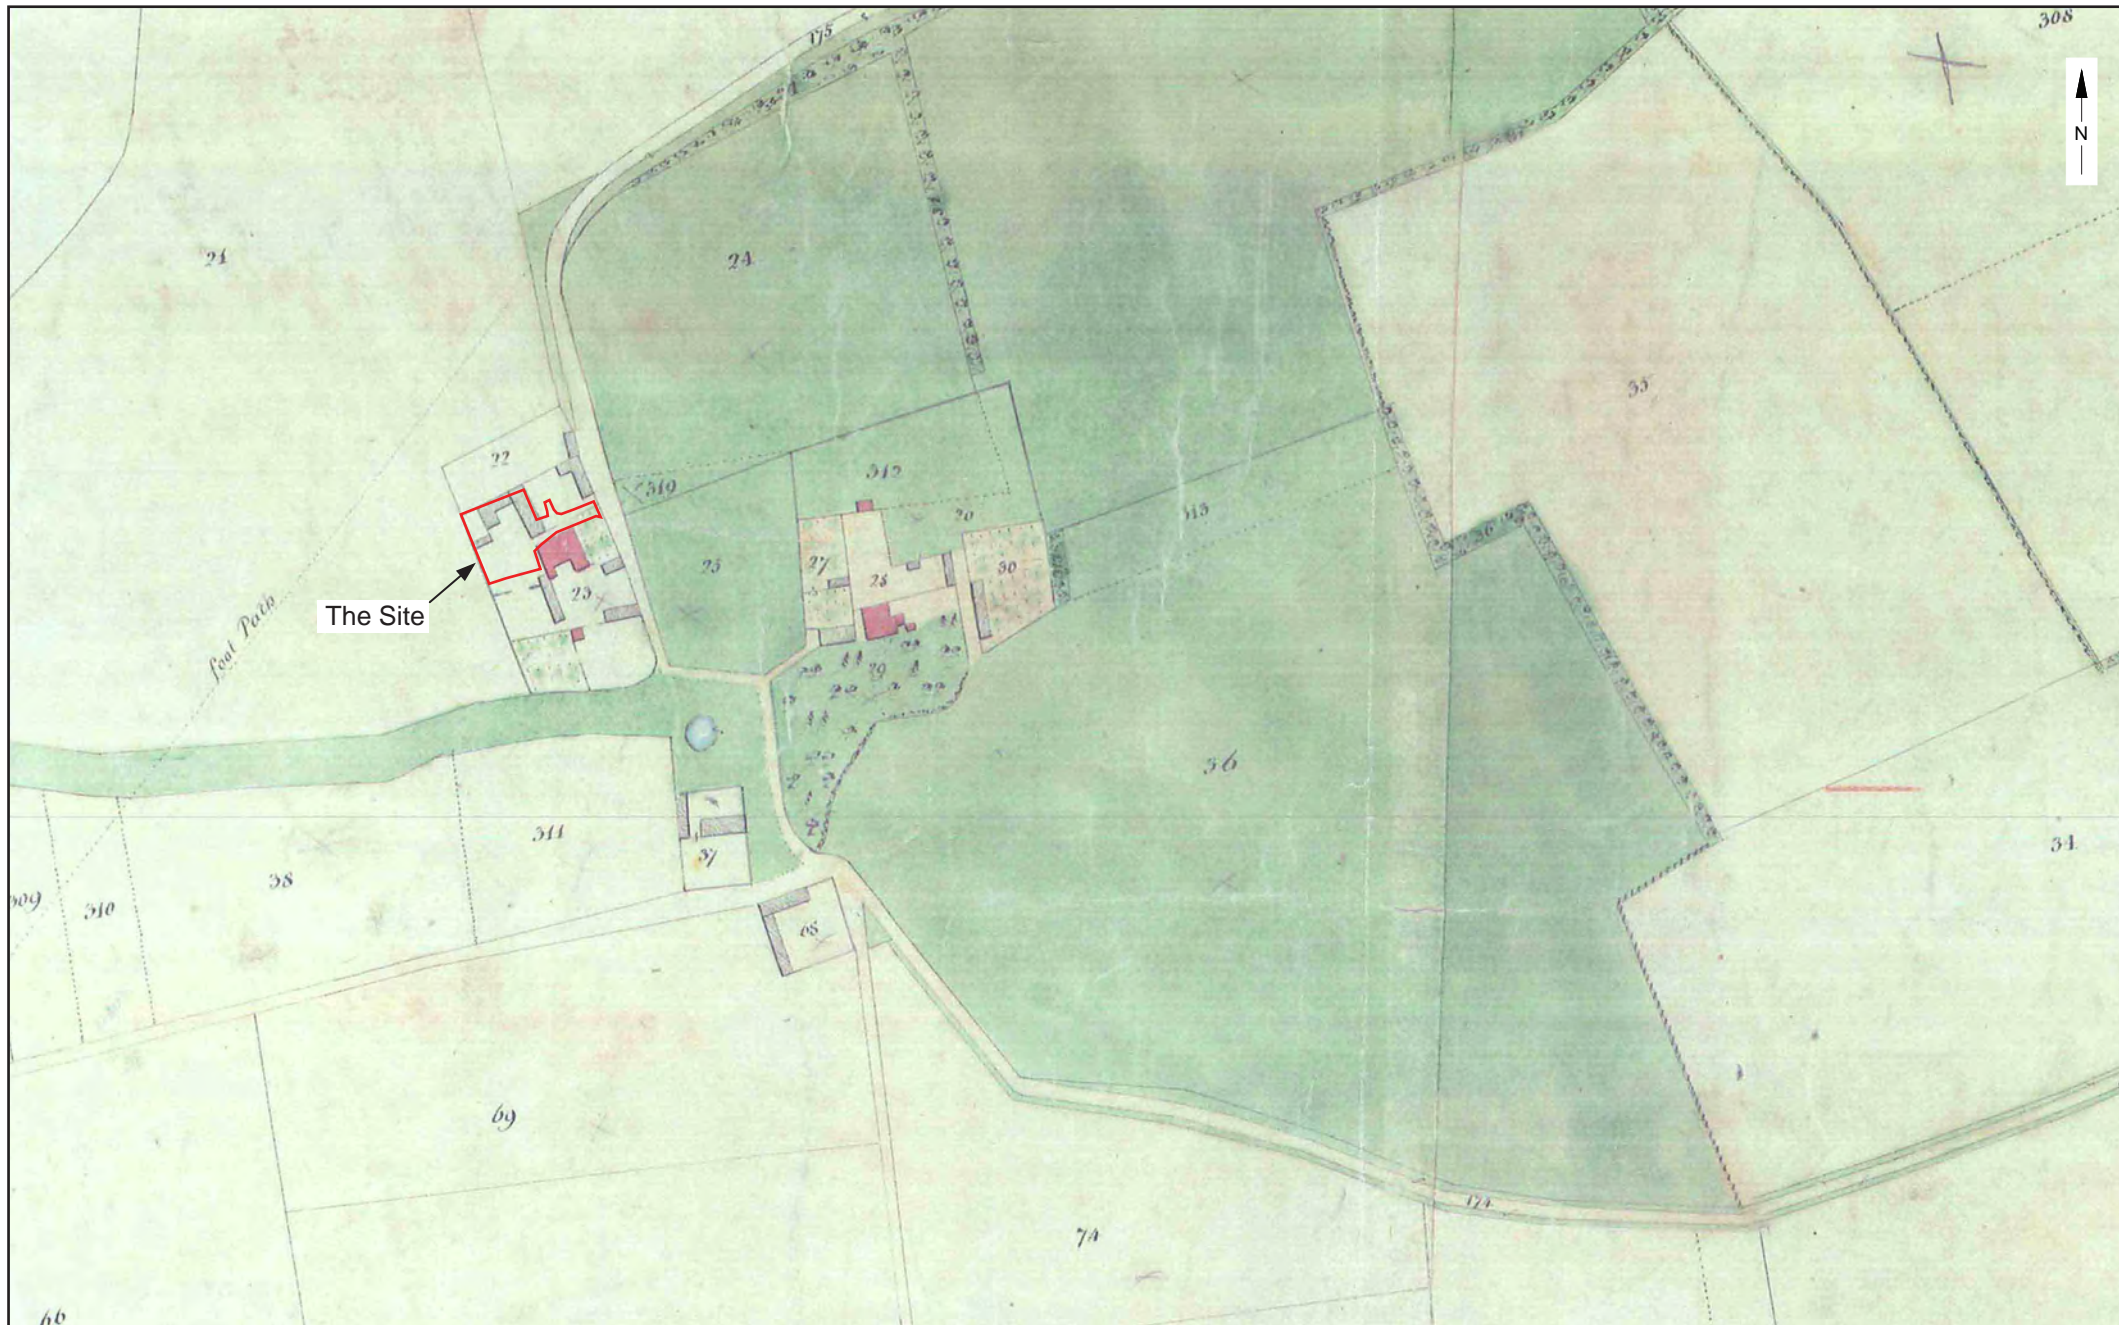
© Archaeology South-East		Sutton Garages, Alfriston Road, Seaford	Fig. 5
Project Ref: 6569	Sep 2014	Tithe map, 1839	
Report Ref: 2014293	Drawn by: JLR

- 4.5 The 1839 tithe map (Fig. 5) and apportionment describe the site as 'Little Sutton House', under the ownership of Charles Harison and occupied by Benjamin Waters. The house is shown to the south of the present site boundary, and a linear building is illustrated in the approximate position of the barn shown on the map of 1740; this is no doubt the present barn on the site (Buildings 12-14). An L-shaped building is shown attached to the north-west corner of the barn, on the northern boundary of the site. A small building is located adjacent to the western boundary aligned east – west, and the buildings shown in the approximate location of Building 3 and Building 7 in 1772 are no longer illustrated. The layout of the site remained broadly similar by the time of the first edition Ordnance Survey (OS) map of 1874 (Fig. 6), although the buildings along the northern boundary form a longer, linear range and are no longer shown attached to the barn. By 1899 (Fig. 7) this linear range had been extended eastwards to abut the barn, and its western end is depicted as open-fronted. This range corresponds with the existing Buildings 7-11. A series of walled yards occupied the western and southern part of the site.

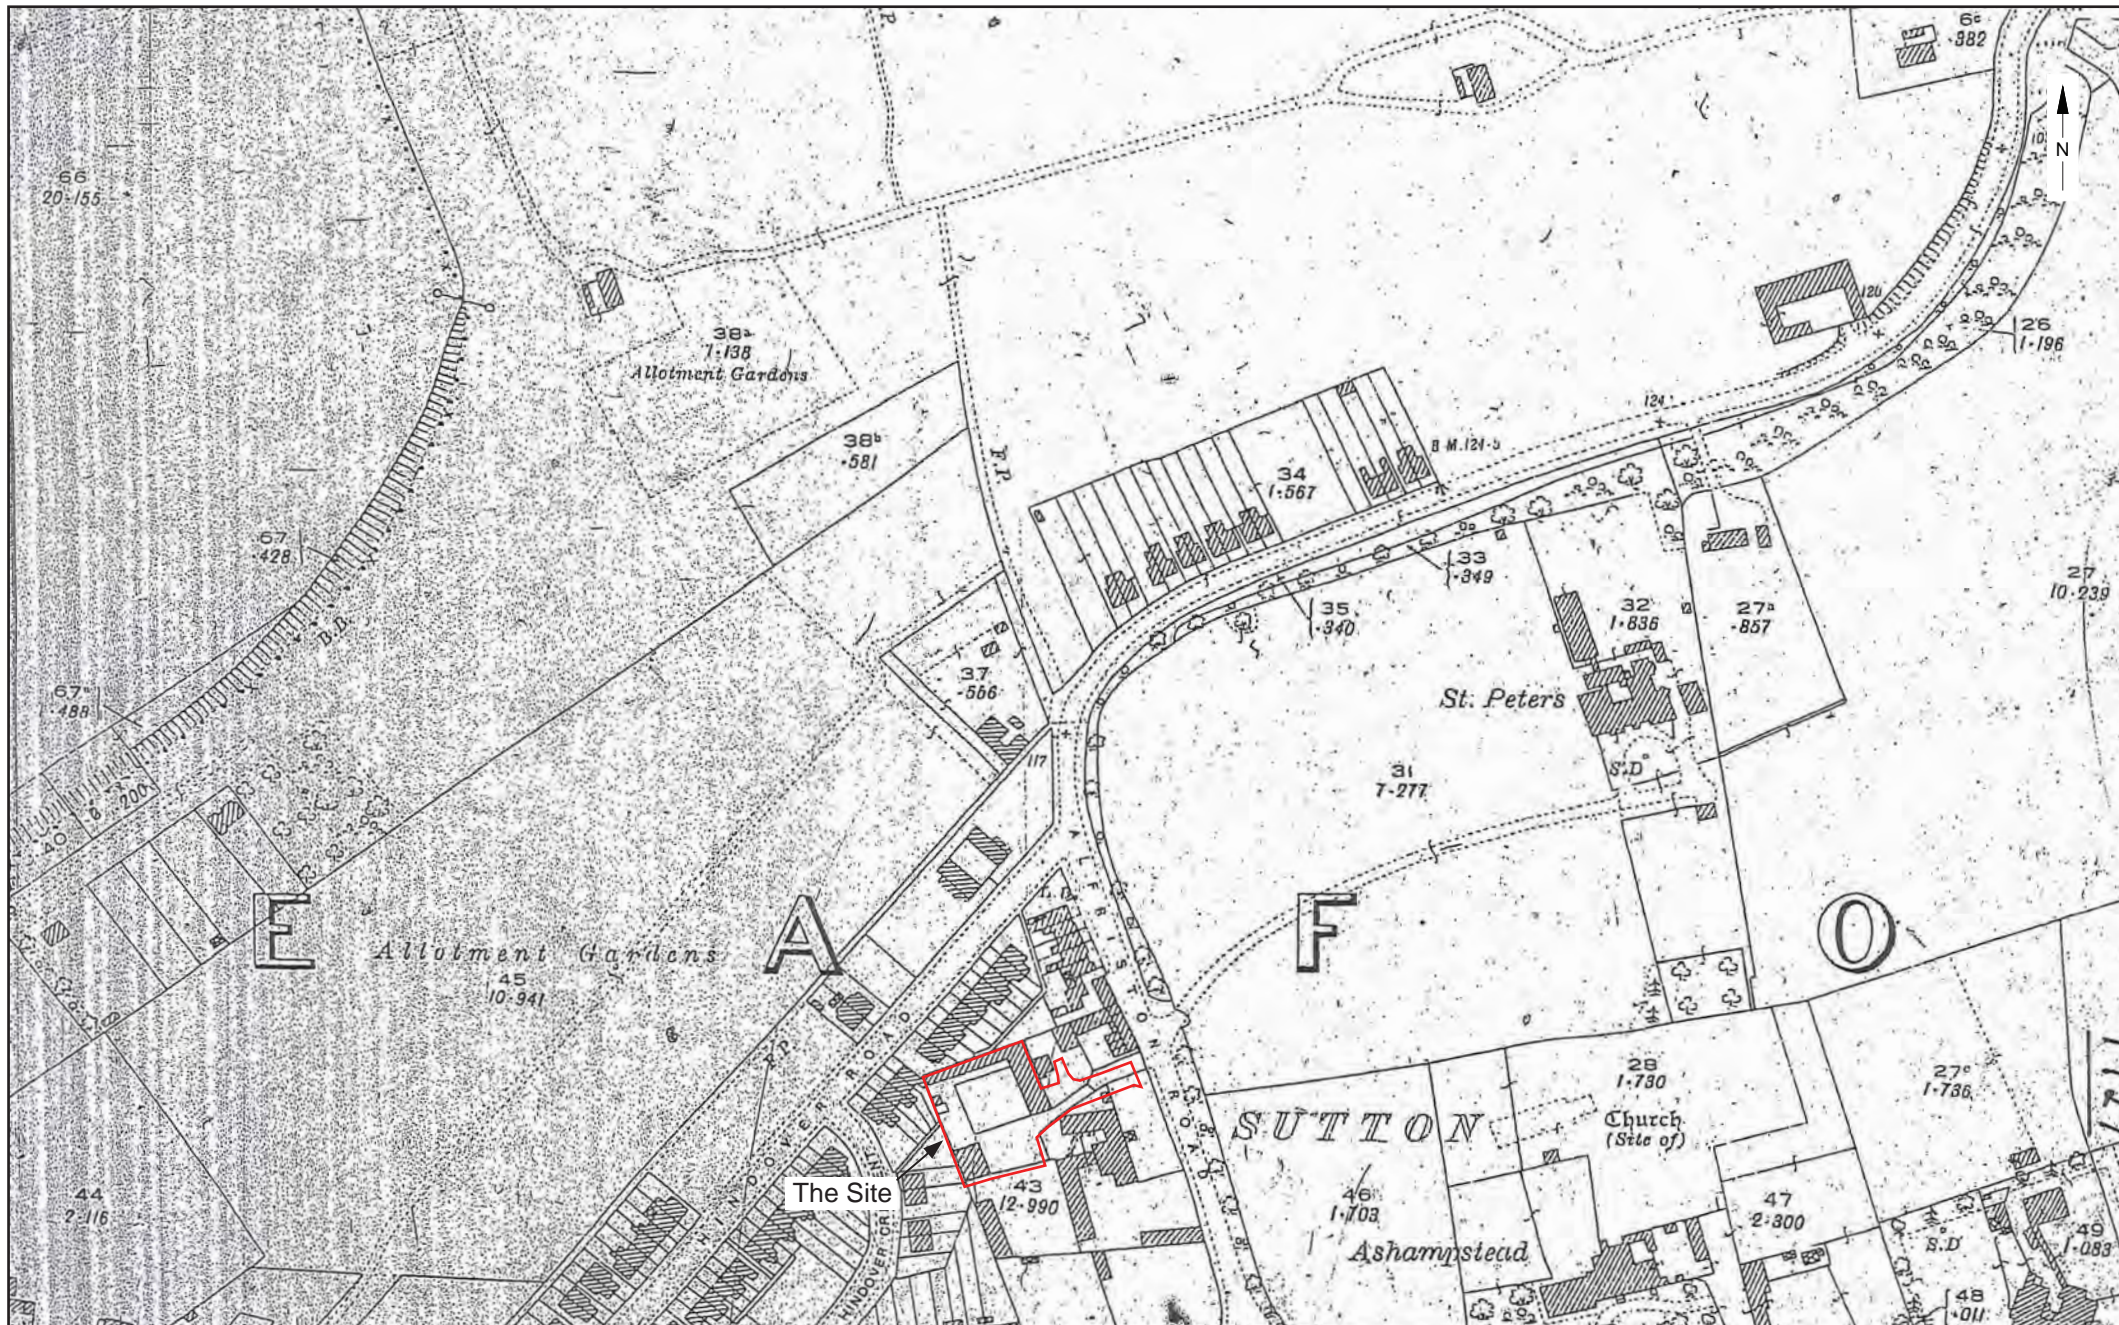
© Archaeology South-East		Sutton Garages, Alfriston Road, Seaford		Fig. 8
Project Ref: 6569	Sep 2014	OS map, 1927		
Report Ref: 2014293	Drawn by: JLR

- 4.6 By 1927 (Fig. 8) a building corresponding to the location of Building 3, in the south-western corner of the site, had been constructed. A small building with an attached small yard, possibly a pigsty, had been constructed against the western boundary. The earlier yards had been removed, with a large, enclosed central yard constructed to the west of the barn. A wall at the eastern end of the southern boundary of the site had been extended westwards to separate the farm complex from the house to the south. Little change had occurred by 1939 (Fig. 9): a building appears to have been constructed on the footprint of the possible pigsty yard, and a number of structures had been added to the western side of the building in the south-western corner of the site. By 1961 (Fig. 10) a range of buildings is shown
