Pevensey Castle, Pevensey, East Sussex

Historic Building Watching Brief

**ASE Project No: 7284
Site Code: PEC15
ASE Report No: 2015134**

October 2015

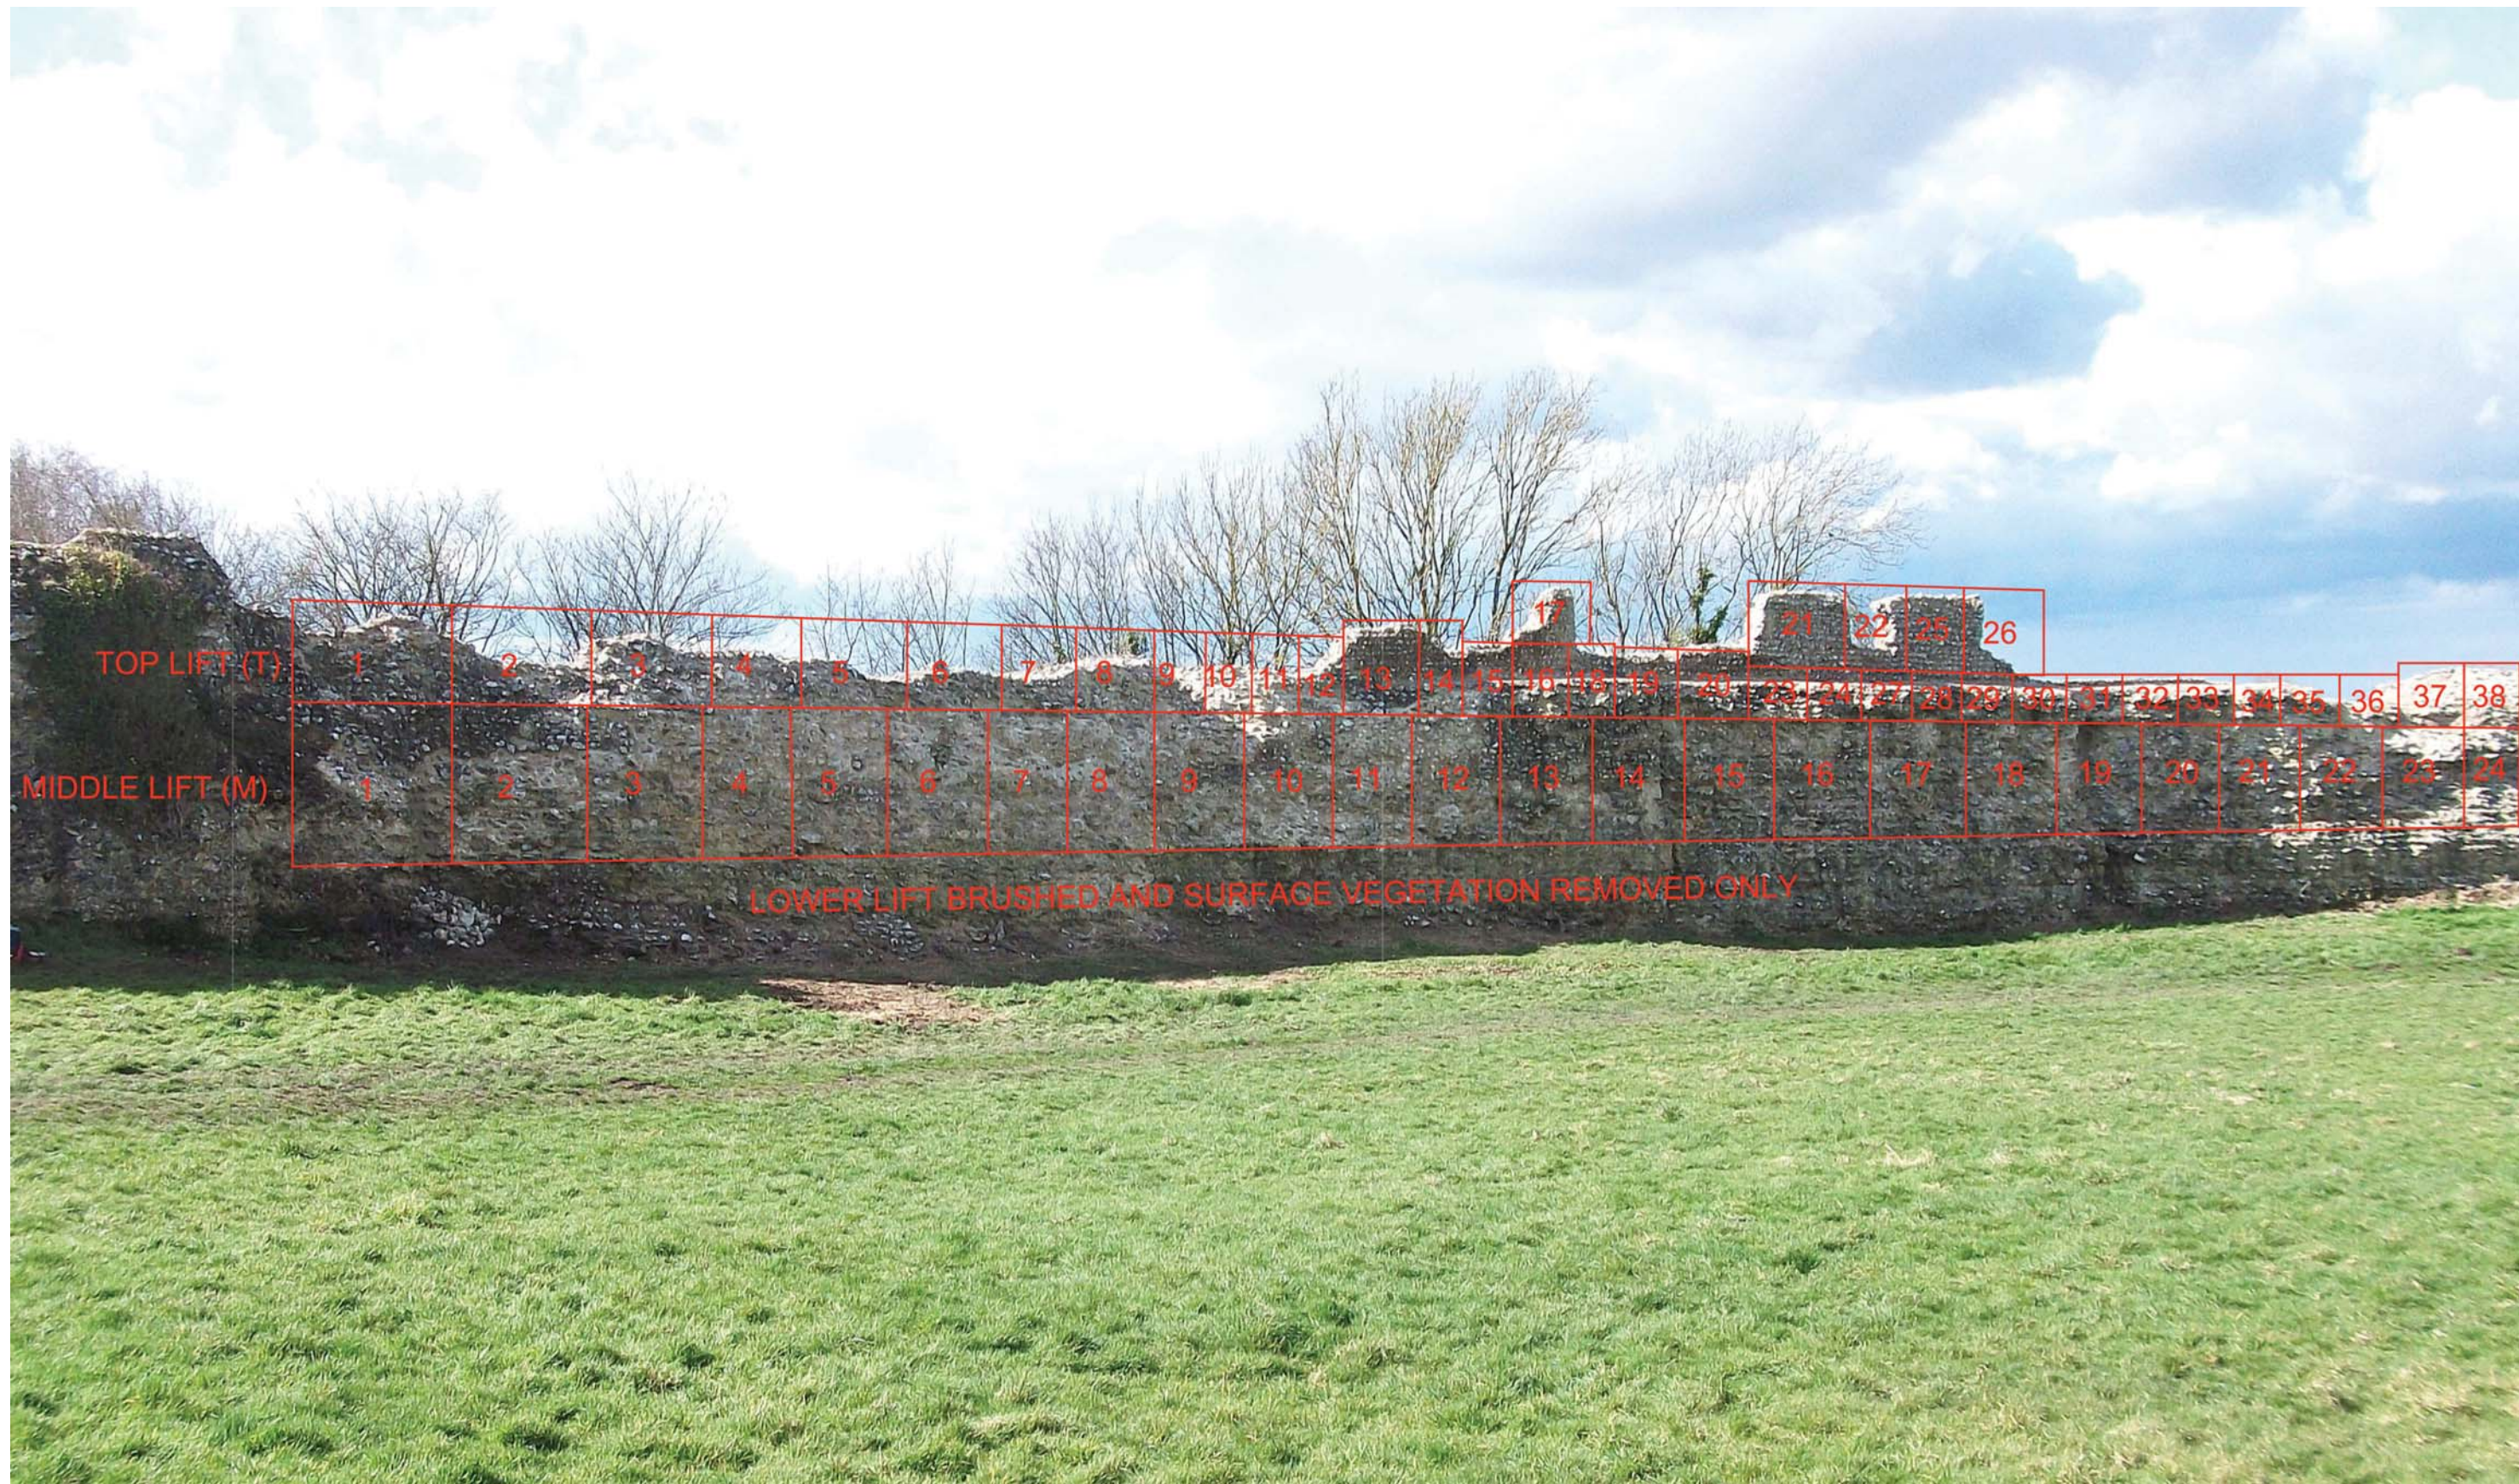
TOP LIFT (T)

- 4.6 Archaeological monitoring encompassed only those areas where the removal of deep-rooted vegetation involved the significant interventions to the wall’s fabric, as detailed above (section 2). This was limited to seven discrete areas: section nos 4, 5, 6, 7, 9/10, 13/14 of the upper lift and no. 4 of the lower lift (Figure 3). These will be discussed in turn.

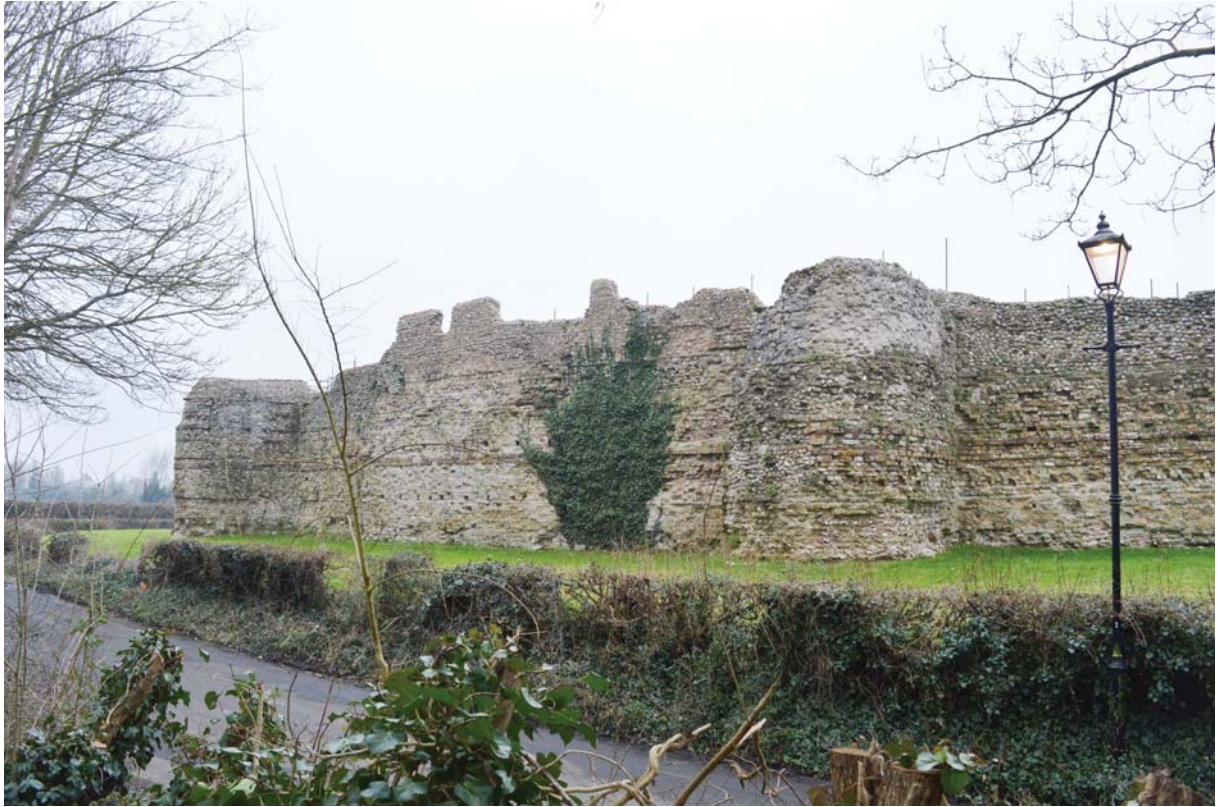
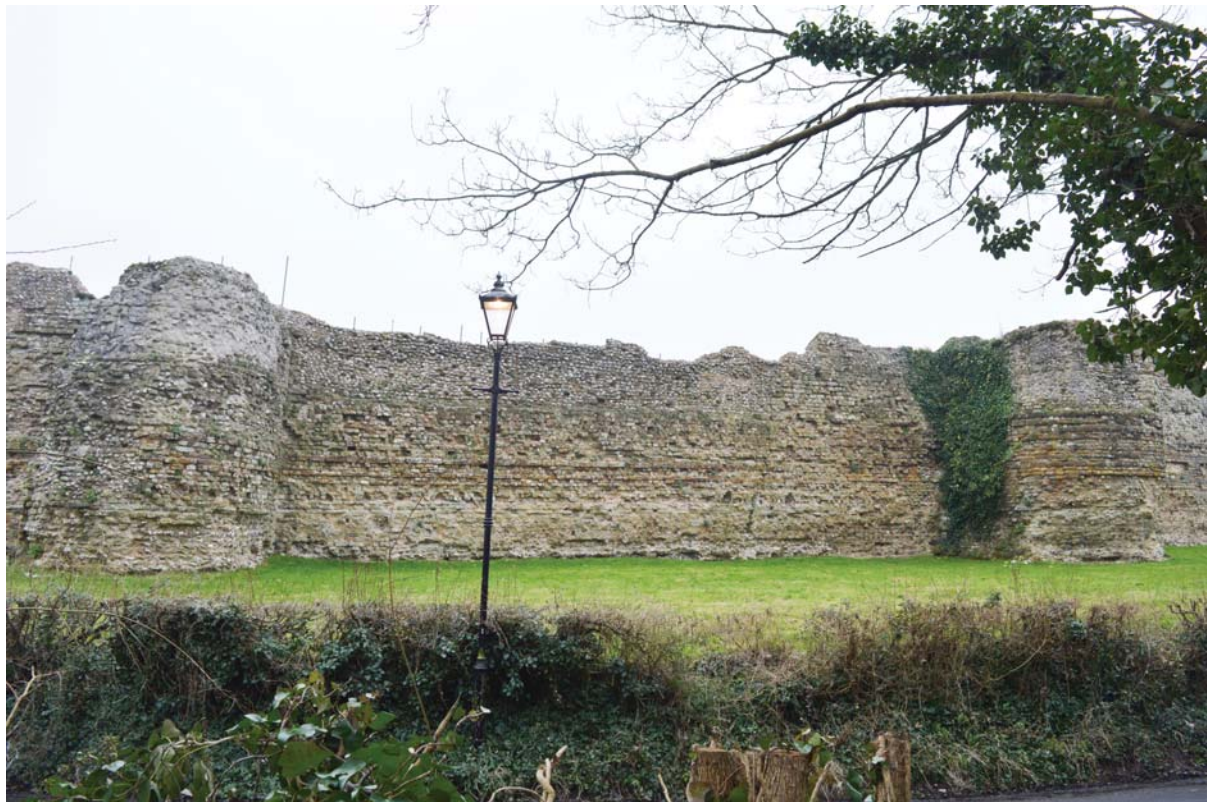
© Archaeology South-East		Pevensey Castle, Pevensey, East Sussex	Fig. 7
Project Ref: 7284	April 2015	External elevations of repaired wall section	
Report Ref: 2015134	Drawn by: MGS

External view between bastions 4 & 5

External view between bastions 5 & 6

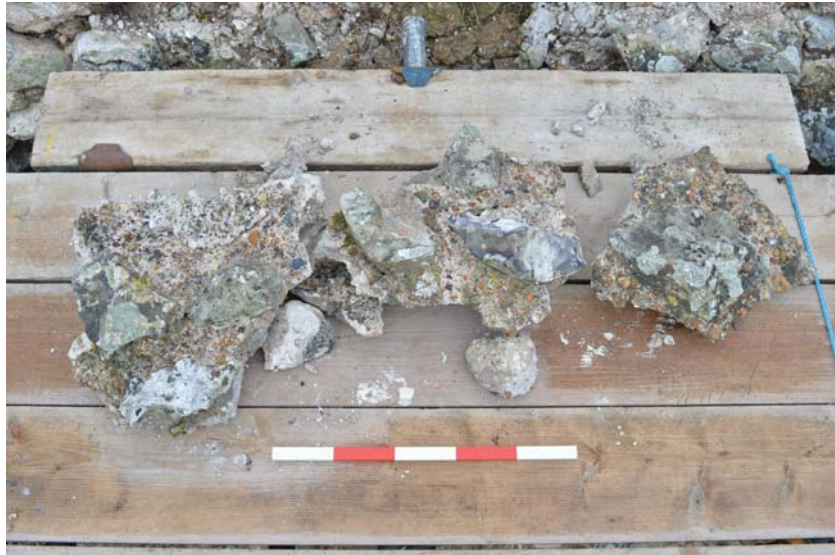
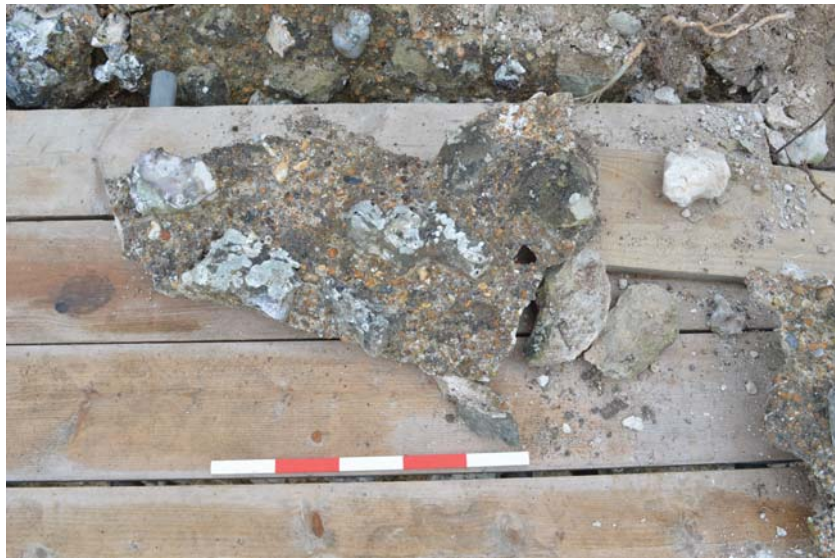
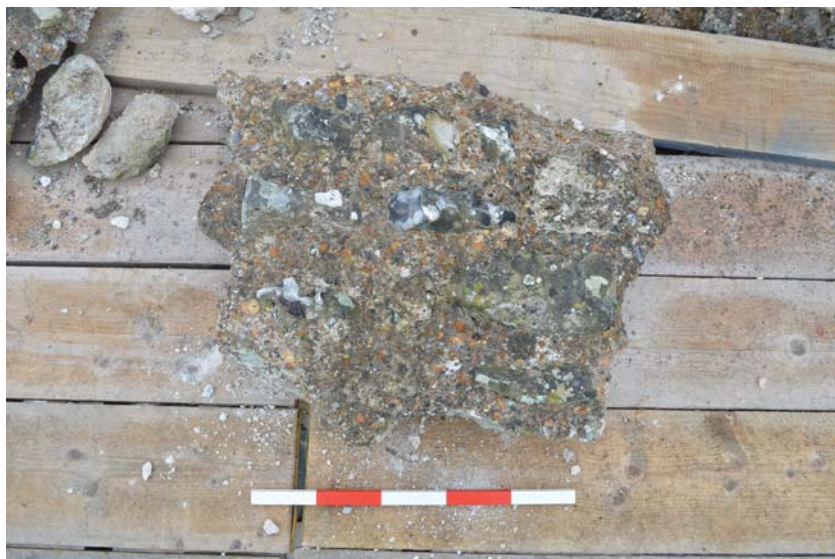
© Archaeology South-East		Pevensey Castle, Pevensey, East Sussex	Fig. 15
Project Ref: 7284	April 2015	Top lift, sections 13/14: record of removed modern flintwork facing	
Report Ref: 2015134	Drawn by: MGS

- 4.12 Upper lift, section 13/14: The removal of vegetation and loose outer flintwork revealed a long, narrow strip of the Roman core, which was revealed to be of sandstone and flint in equal measure (Figures 14 & 15).
- 4.13 Middle lift, section 4: Repair of loose outer stonework revealed mostly flint and frost-damaged sandstone. The mortar was pinkish and pebbly, suggestive of Roman work. Interestingly, the frost-damaged nature of the sandstone indicates this part of the wall had long been exposed to the elements, prior to the modern flint repair. Given the lack of maintenance work between the late medieval period and the early 20th century, this probably represents the wall's exposed inner face for much of that period, if not before (Figure 16).
