COMBERS GLASSHOUSES, NYMANS, WEST SUSSEX

**HISTORIC BUILDINGS RECORD
(HISTORIC ENGLAND LEVEL 3)**

ASE Project No. 7494
Report No. 2015184

Date of Issue:	June 2015		
Revision:

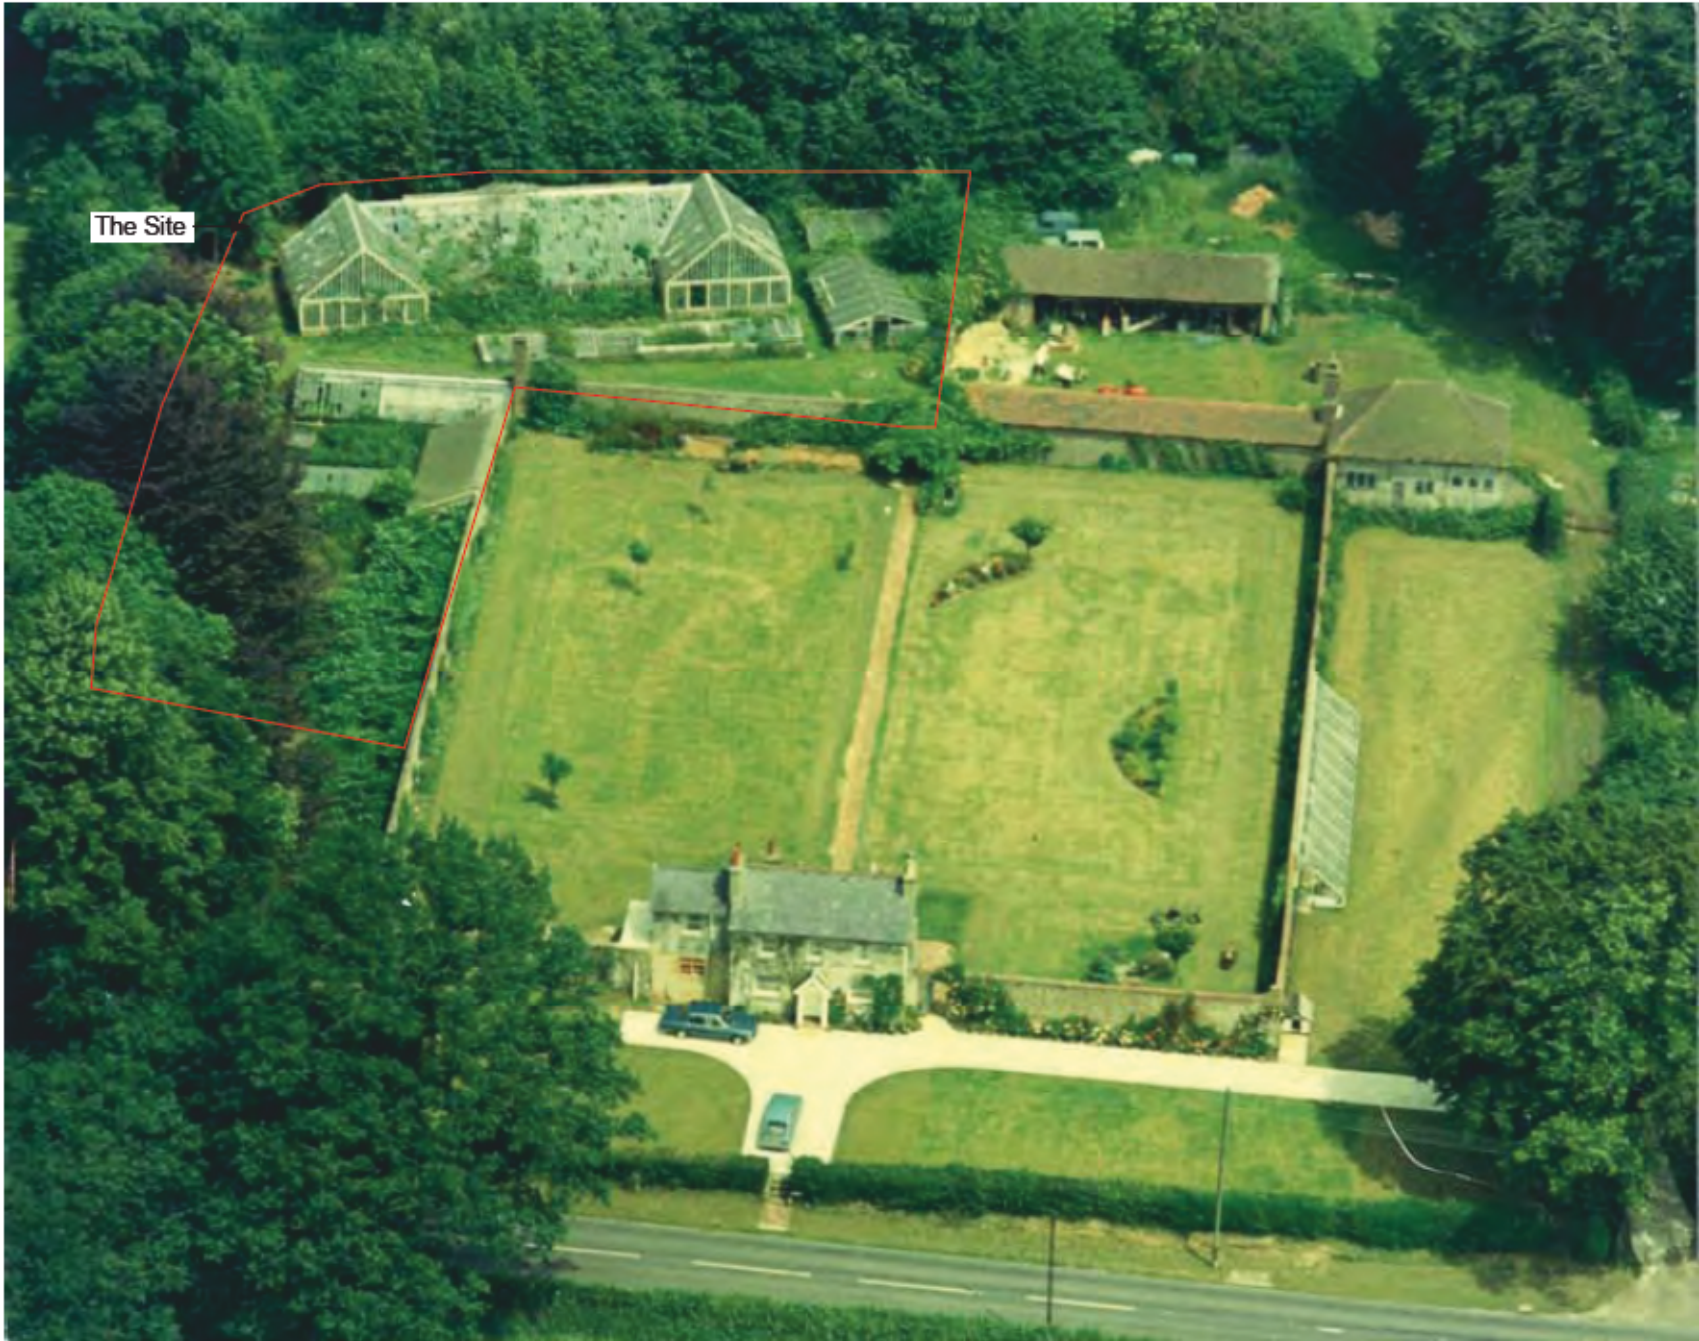
Fig. 12

- 5.8 Both Leonard Messel and James Comber died in 1953, and the garden was granted to the National Trust, being formally opened to the public in March 1954. An aerial photograph likely dating to the 1960s shows the glasshouses in a poor state of repair, being heavily overgrown, but largely intact (Figure 12).

6.2.1 Building 2 retains very little of its original frame and glasswork, and much of the following analysis is based on the aerial photograph dated to c.1960s (Figure 12). The building was constructed between 1890 and 1897, likely dating to 1895-7 when the gardens fell under the ministrations of James Comber.

© Archaeology South-East		Combers Glasshouses, Nymans	
Project Ref: 7494	May 2015	Aerial Photo, 1960s	
Report Ref: 2015184	Drawn by: SP

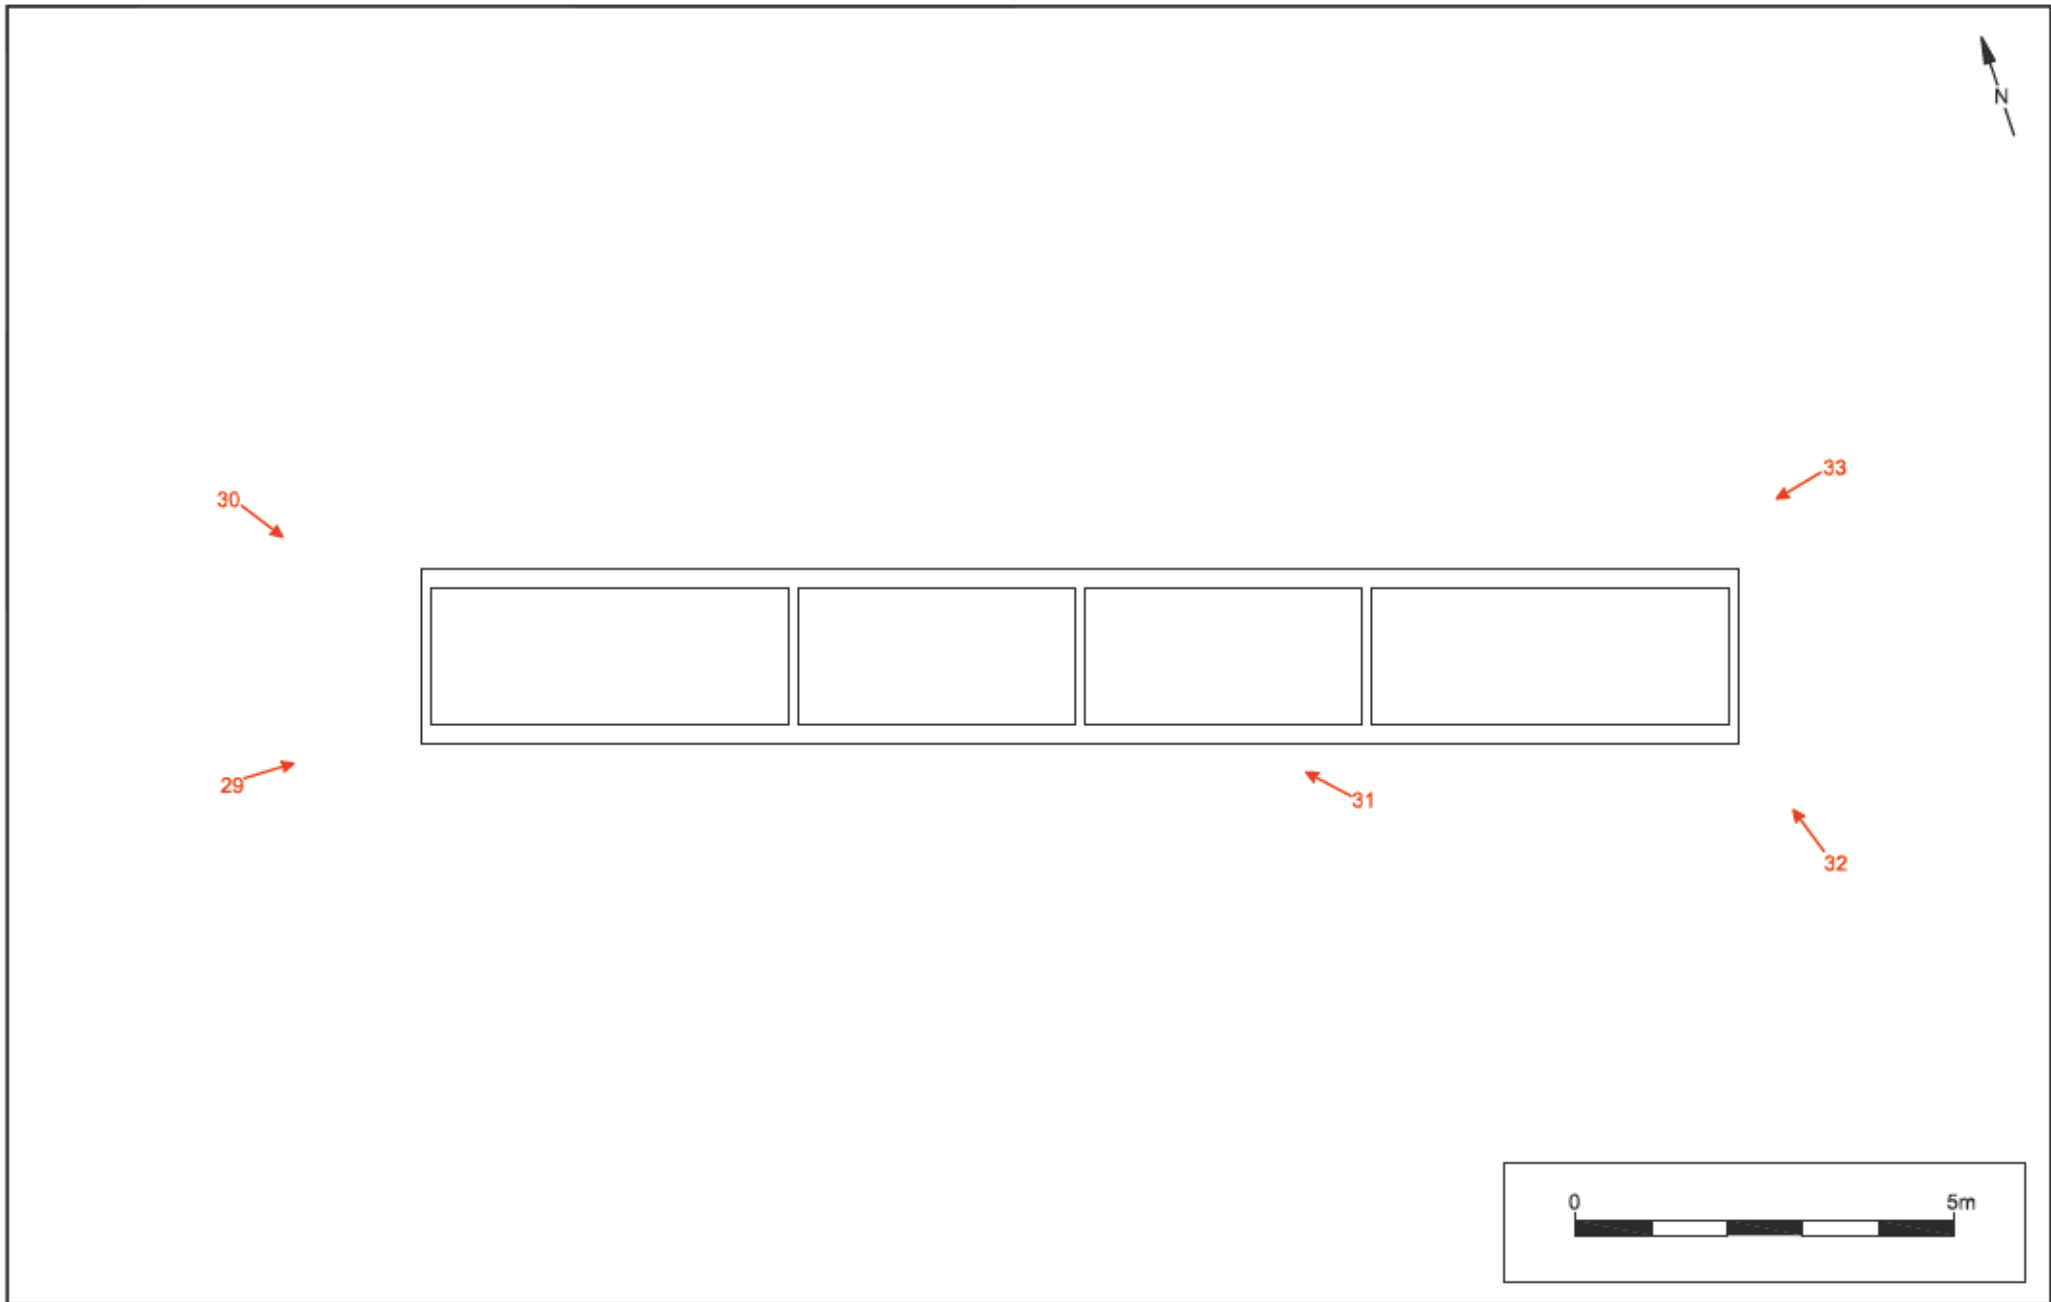
© Archaeology South-East		Combers Glasshouses, Nymans	Fig. 16
Project Ref: 7494	May 2015	Building 3 Plan and Photo Locations	
Report Ref: 2015184	Drawn by: SP

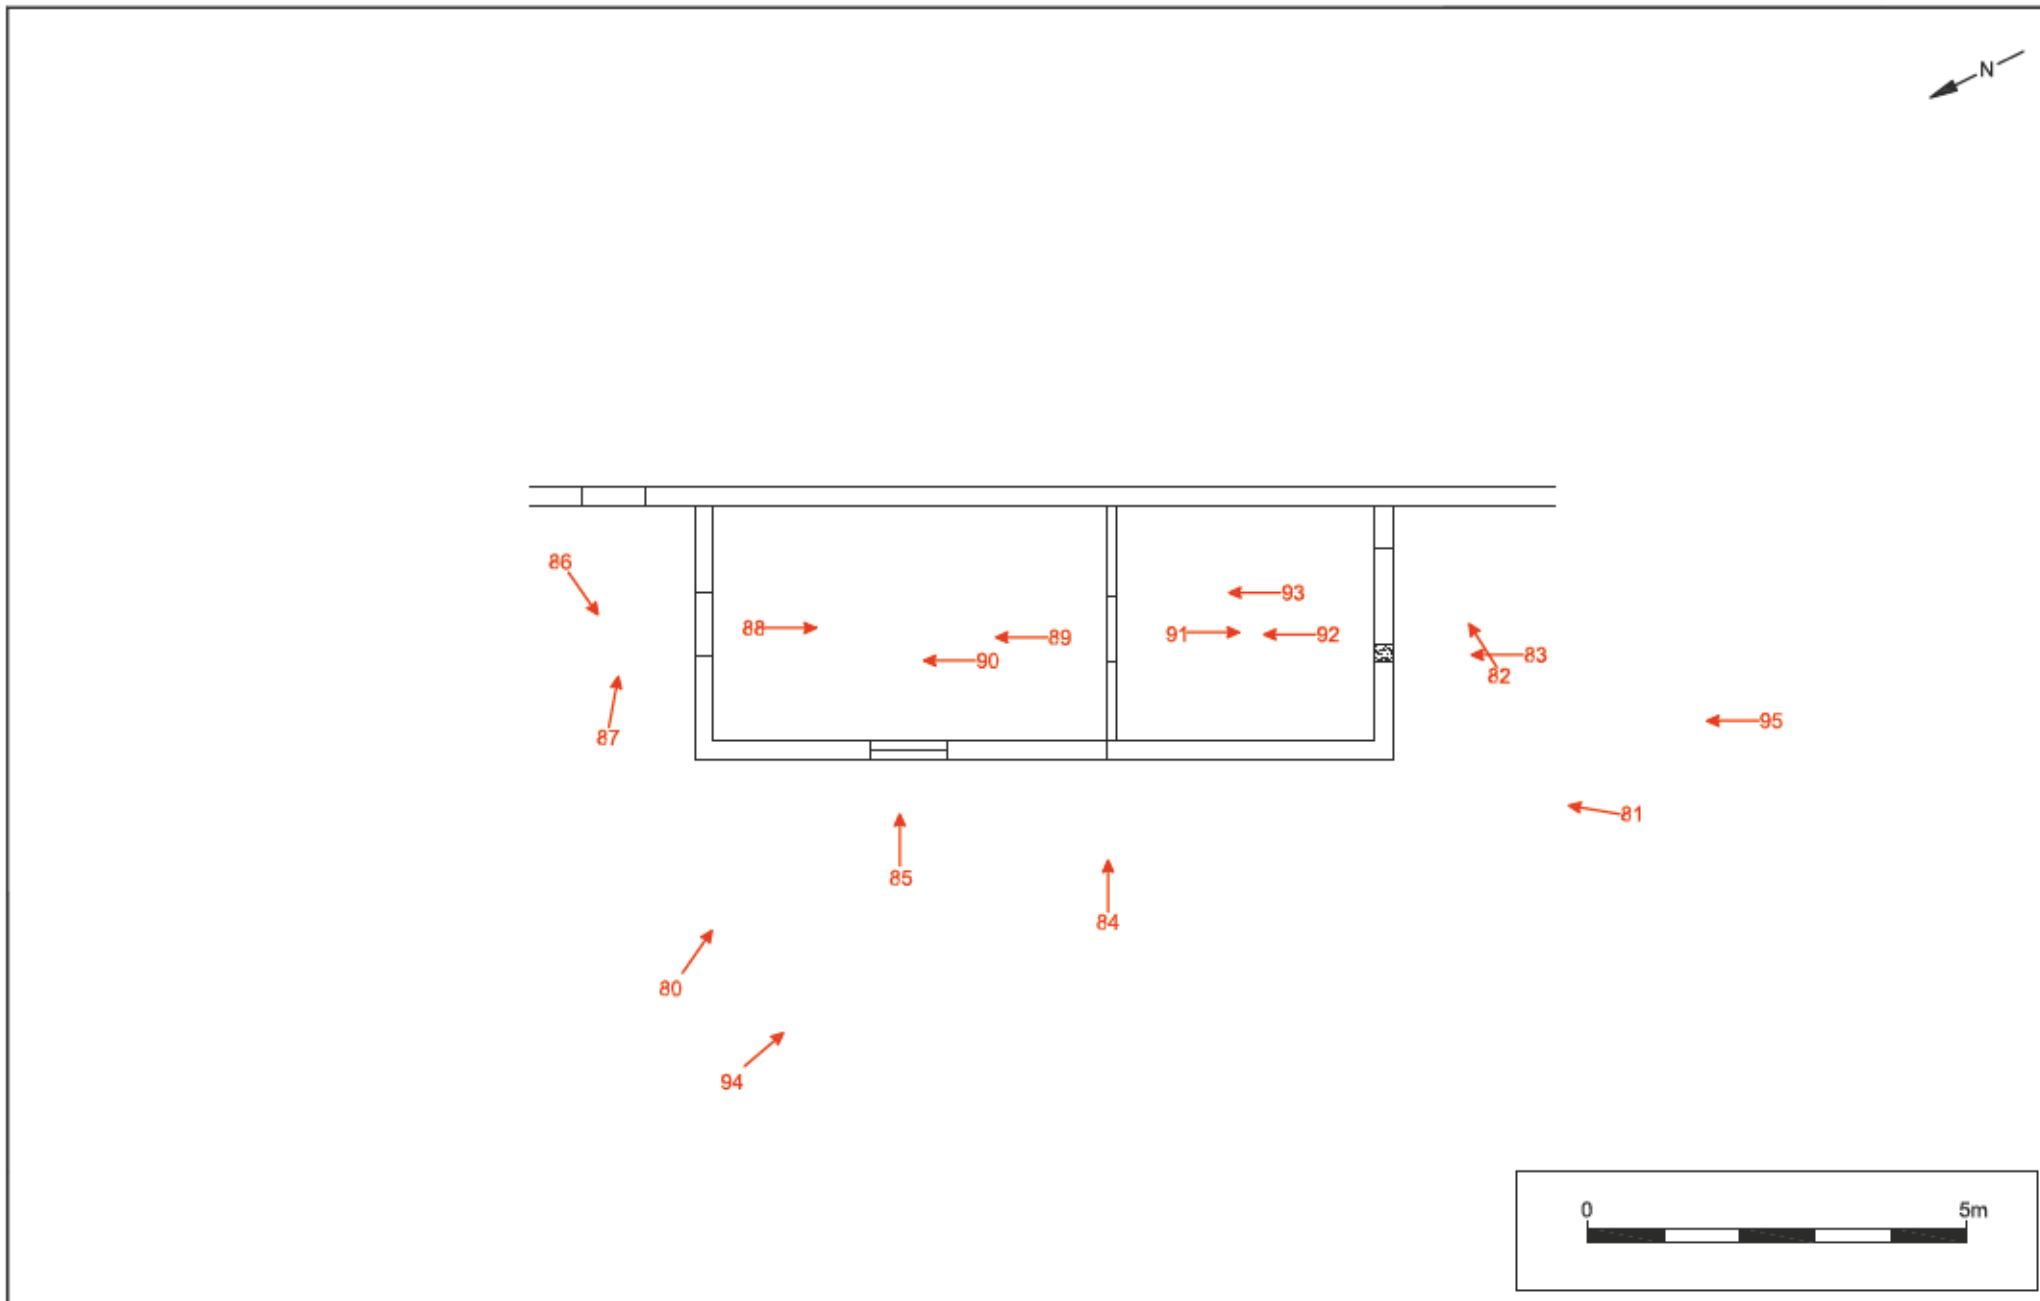
© Archaeology South-East		Combers Glasshouses, Nymans	Fig. 17
Project Ref: 7494	May 2015	Building 5 Plan and Photo Locations	
Report Ref: 2015184	Drawn by: SP

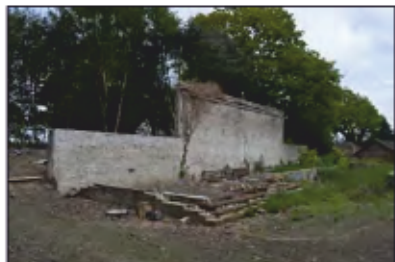
Plate 17: Building 2 overview, looking north-east (Photo #1)

7494-0001
Combers Glasshouses - Building 2 -
Overview. Facing north-east

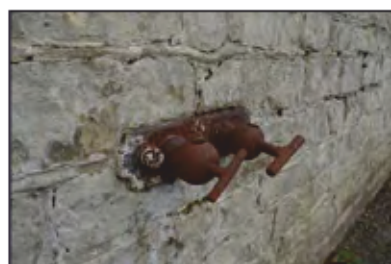
Plate 24: Building 2, screw operated window opening device, looking north-east (Photo #12)

7494-0012
Combers Glasshouses - Building 2 - Bay
1, screw operated window opening.
Facing east

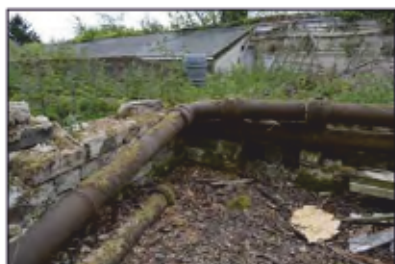
7494-0013
Combers Glasshouses - Building 2 - Bay
1, heating pipes. Facing south-east

Pipes: The extant piping and boiler form a significant element of the extant structures. If possible they should be retained, or replaced in kind, as reflective of the technologies and historic practices at the site.

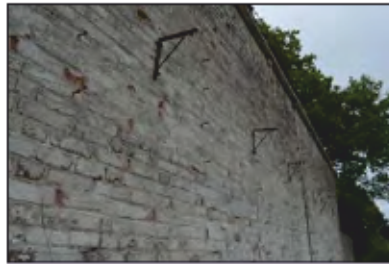
Plate 22: Building 2, pegs and wires in the back wall Bay 2, looking north-east (Photo #17)

7494-0017
Combers Glasshouses - Building 2 - Bays 2 and 3, iron pegs and wires. Facing north-east

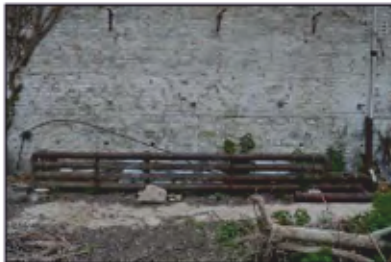
7494-0019
Combers Glasshouses - Building 2 - Bay 2 pipework. Facing north
