**23 BELL STREET,
SAWBRIDGEWORTH, HERTFORDSHIRE**

HISTORIC BUILDING WATCHING BRIEF

ASE Project No: 170005

ASE Report No: 2017107

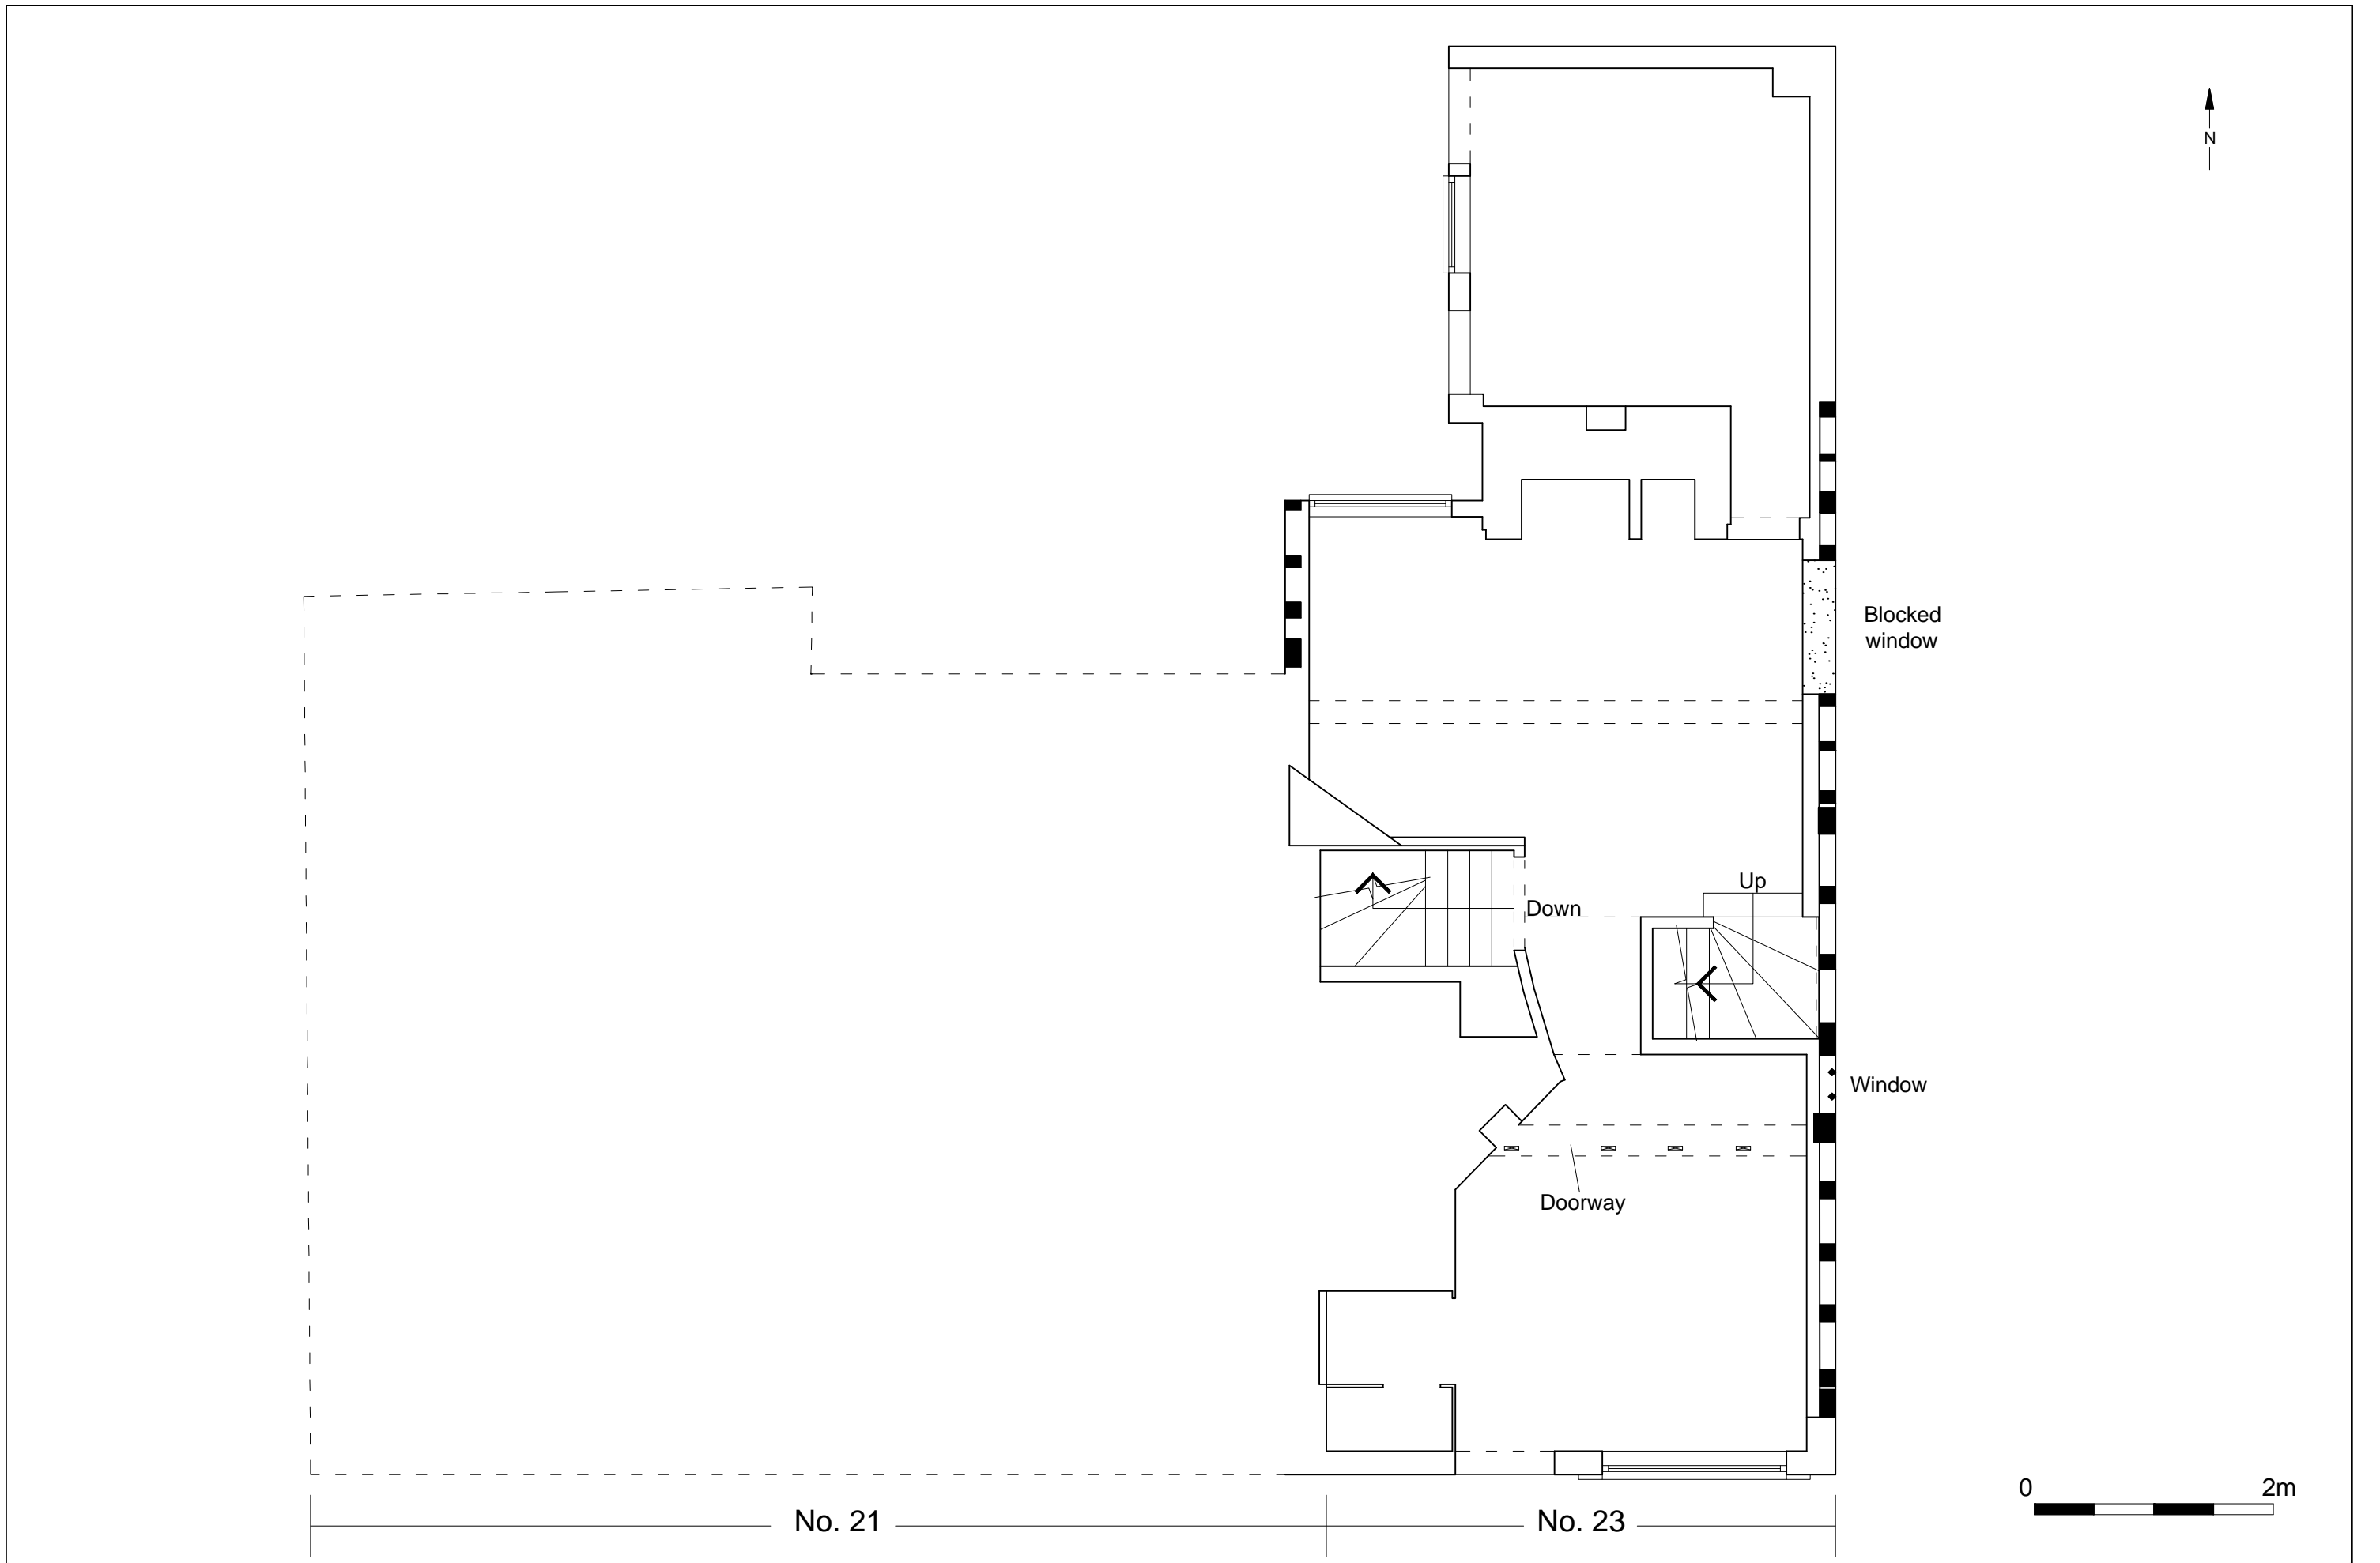
© Archaeology South-East		23 Bell Street, Sawbridgeworth, Hertfordshire	Fig. 4
Project Ref: 170005	May 2017	Ground floor plan	
Report Ref: 2017107	Drawn by: CPC

- 6.10 During the recent renovation works, an intact diamond mullion window was found within the east wall of the building, lighting the ground floor rear room (Plate 7; Figure 4). A shutter rebate can also be seen on what is left of the wall plate above it, indicating that there was also a window lighting the first floor in a similar position (Plate 8). Diamond shaped mortices were also

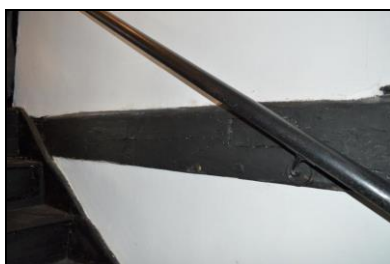
BES17-0008

Plate 3: Redundant mortices on hall side of low end cross-beam, facing west (BES-0008)

No. 21 redundant mortises for hall floor joists. Facing west

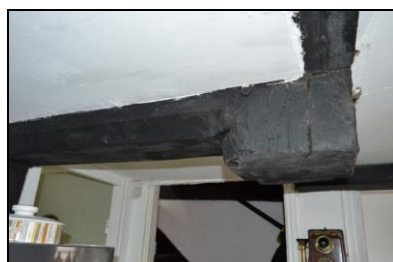
BES17-0010

No. 21 truncated post to rear of hall. Note properly jointed hall ceiling girder. Facing west

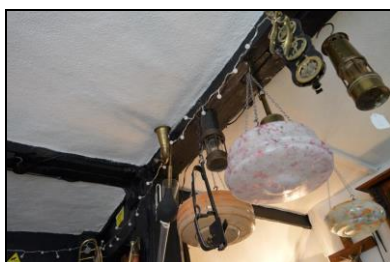
BES17-0014

Plate 2: Redundant mortice and former doorway on low end cross beam, facing north-east (BES17-0014)

No. 21 cross-beam between hall and service end. Facing north-east

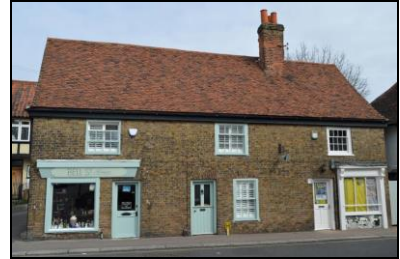
BES17-0021

Plate 28: Brick façade on street frontage, facing north (BES-0021)

contemporary doorways, although seemingly without the original doors. Each one serves a separate division of the house (Plate 28).

South elevation. Facing north

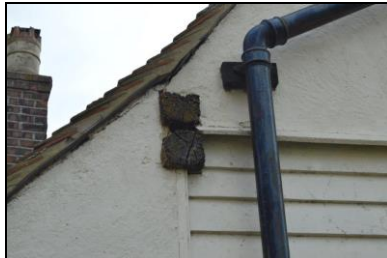
BES17-0023

Supposed clasped wall plates on west elevation. Facing east
