15-17 High Road, Ickenham, Hillingdon, London

Historic Building Record

**ASE Project No: 170719
Site Code: HRI17**

**ASE Report No: 2017434
OASIS id: archaeol6-298779**

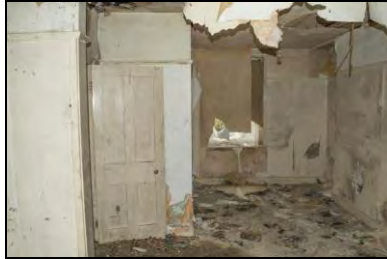
HR117-0094
Fire damage in room 3?
