**ST GILES FARM BARN AND DAIRY, PATTERSONS LANE,
BLENDWORTH, HAMPSHIRE, SO08 0AG**

HISTORIC BUILDINGS RECORD

**Historic Buildings Record
& Archaeological Watching-Brief**

**ASE Project No: 170925
Site Code: GIL18**

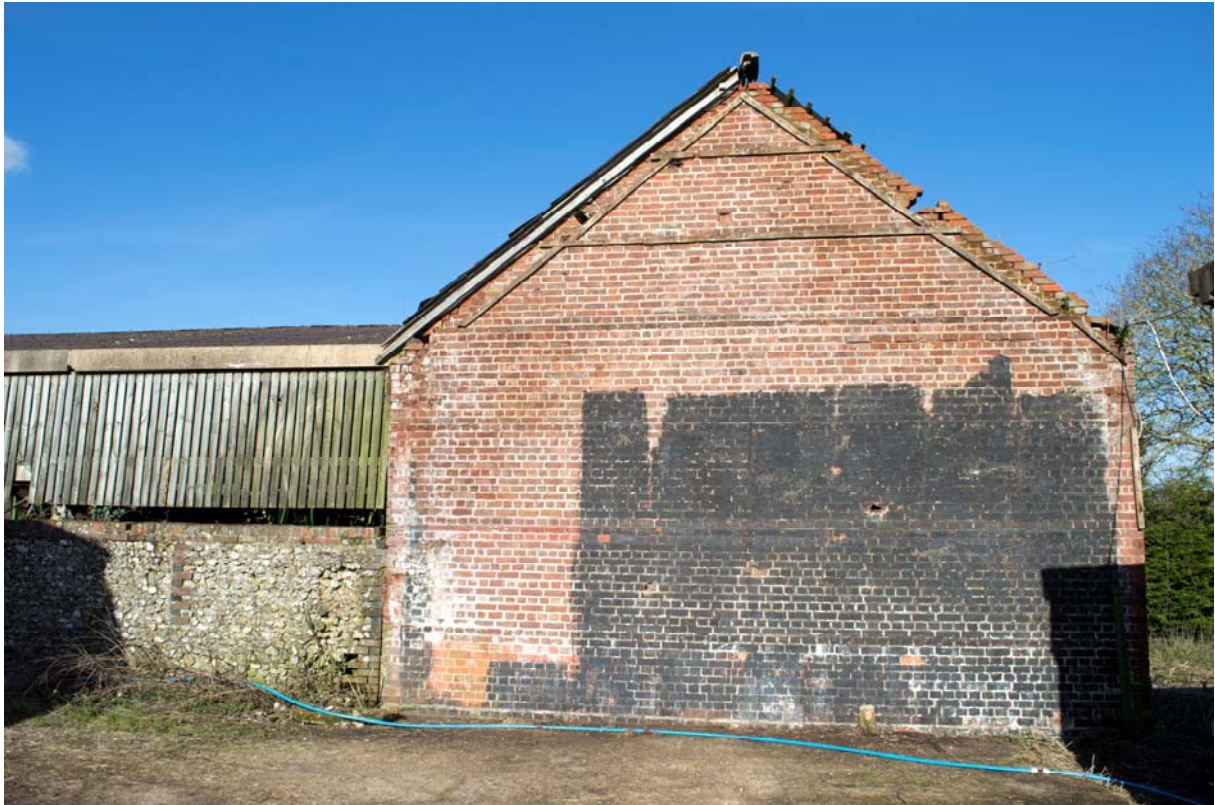
Plate 5 – The south gable of the barn, facing north (GIL18-0015)

- 6.4 The gable ends are plain. The north gable is overgrown with vegetation at its upper level, although a timber barge-board remains visible (Plate 4). The south wall has some timber battening and a substantial area of the brickwork has been painted black (Plate 5). The design statement (Wheeler-Bennett, 2015) notes that this gable was clad in corrugated iron for a number of years because it faces into the prevailing weather. The yard walls meet the barn at the north-west and south-west corners but are not tied into the barn; it is probable that the yard wall predates the barn.

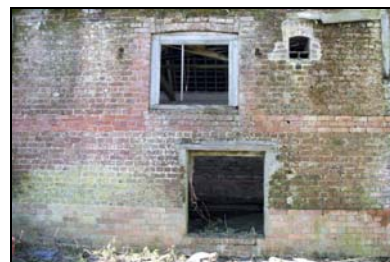
GIL18-0006
Inserted openings in the east facing elevation. Facing west

- 6.5 The east elevation matches the principal elevation in form, including the inserted windows. An additional small opening has been inserted to the side of the high-set window on the south-east side. This small opening contained a cast iron framework and likely served as a housing for agricultural machinery of some kind. Below and slightly offset from the high-set window a third opening has been inserted with less skill than the ones at the upper level. It is simple and square in form, with a timber frame. Its use was not entirely clear being rather low to the ground for a window and short for a door, though it corresponded with an area of external brick paving (Plate 6).

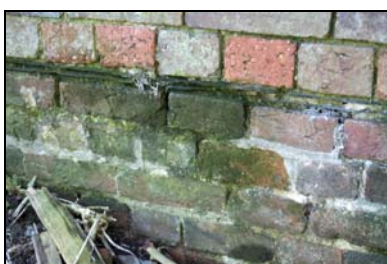
GIL18-0011
Detail of the likely older brickwork below the DPC. Facing south-west

- 6.12 The floor of the southern three bays comprises a concrete screed. The floor within the remainder of the barn is of earth and is set at a lower level than the rest, affording a view of the slate damp-proof course and the earlier brickwork beneath (Plate 18). No evidence was observed for a threshing floor within the midstrey.
