ARCHAEOLOGICAL SOLUTIONS LTD
BROOK FARM, STATION ROAD, TILBROOK,
CAMBRIDGESHIRE
HISTORIC BUILDING RECORDING

Authors:	Tansy Collins BSc Lee Prosser PhD Peter Thompson MA Kathren Henry	
NGR: TL 08024 69389	Report No: 3629	
District: Huntingdonshire	Site Code: AS 1332	
Approved:	Project No: 3967	
Signed:	Date: August 2010

HISTORIC BUILDING APPRAISAL

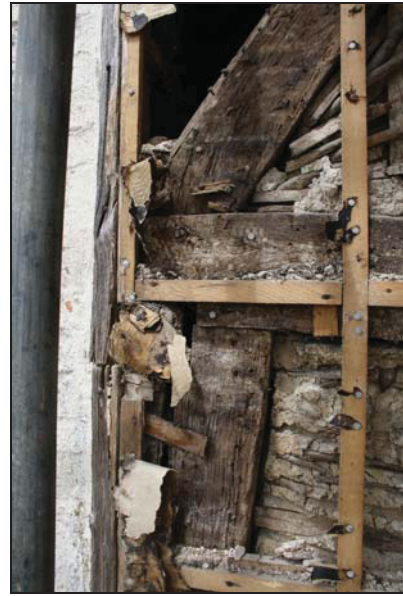
85
Detail of original wattle-and-daub on the south wall (south range), taken from the south

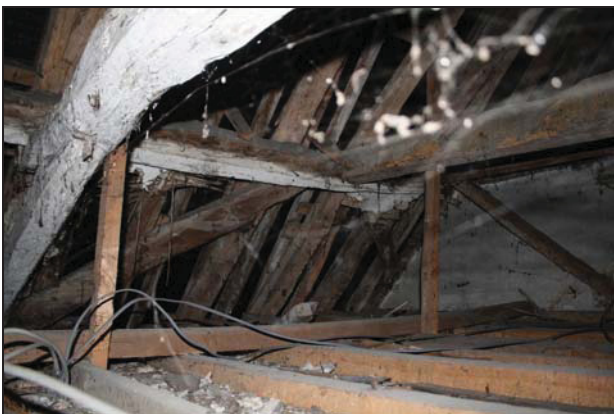
88
View in the roof space above Room FF01 (north bay, mid-bay division), taken from the north-west

Plate 11 View in the roof space above Room FF01 (north bay, mid-bay division), taken from the north-west (88)

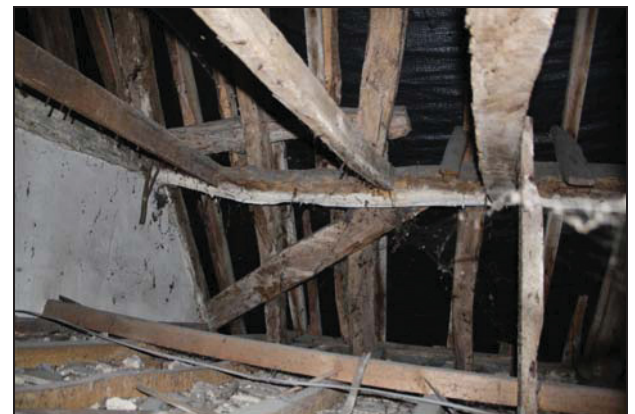
89
View of the roof space above Room FF01 (north bay, east side of the south range), taken from the north-west

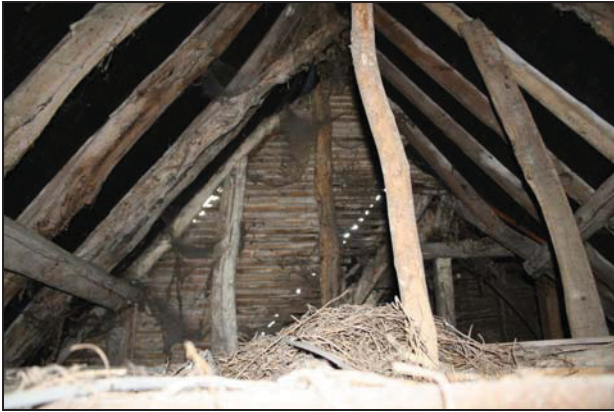
90
View of the roof space above Room FF01 (north bay, east side of the south range), taken from the west

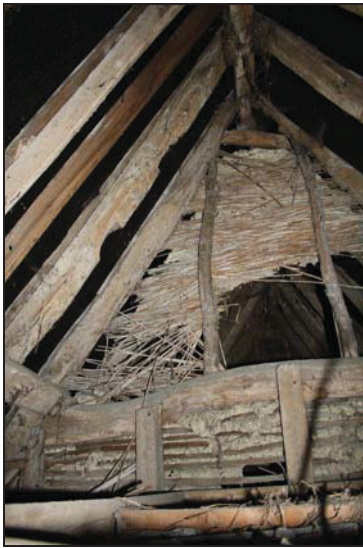
92
View of the roof space above Room FF04 (south bay, west side of the north range), taken from the south-east

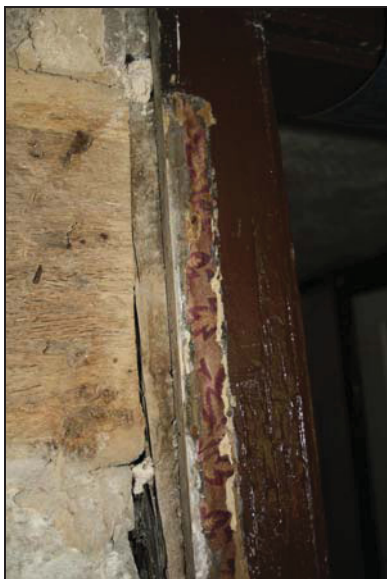
94
West mid-rail in Room GF01 showing faint traces of painted decoration, taken from the east
