GODWICK GREAT BARN, GODWICK HALL
TITTLESHALL, NORFOLK

HISTORIC BUILDING RECORDING

Authors:	Tansy Collins BSc Lee Prosser PhD Peter Thompson MA Rosanna Price BSc	
NGR: TF 9041 2208		Report No: 4029
District: Breckland		Site Code: n/a
Approved: Claire Halpin		Project No: 4610
Signed:		Date: Revised July 2012

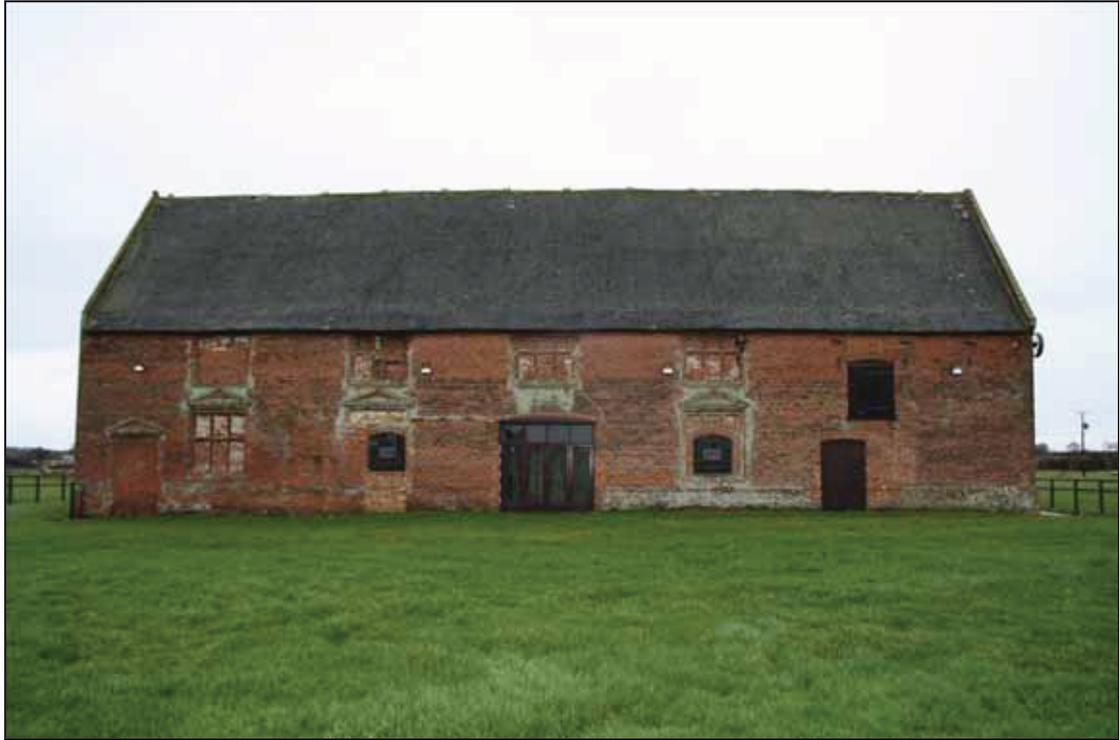
Plate 1 West elevation of the barn, taken from the west (DP 09)

5.3 The west side was designed for show (Plate 1), and was dressed originally with a symmetrical arrangement of large blind windows with transoms and mullions, pedimented at ground floor level, together with a single surviving domestic-style door at the north end (Plate 2). The northern windows may once have been open. This is discussed further below. The arrangement has been much disturbed by later intervention, including a large central threshing door set beneath a cambered arch of 18th or 19th century date. Close inspection suggests that the area immediately above has not been rebuilt, and may replace a second, small door as at the north end, and not a large pedimented window. This would mirror the barn at Paston where a modest ventilation door lies opposite the original threshing door.

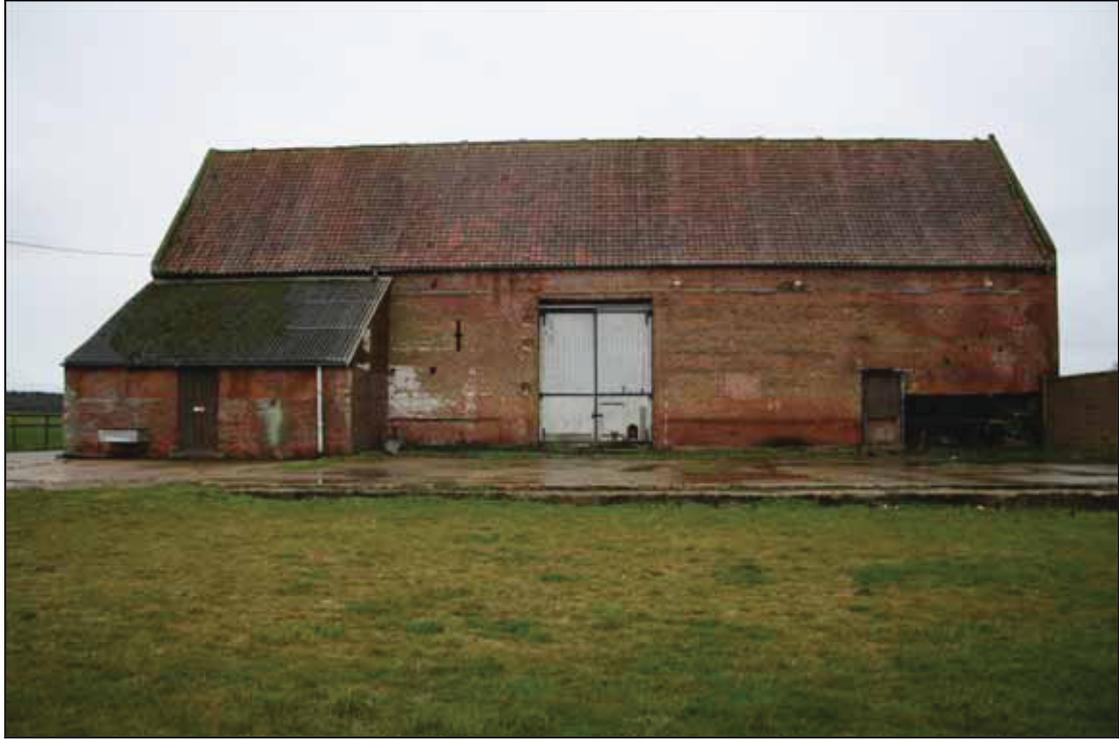
Plate 3 East elevation of the barn, taken from the east (DP 01)

5.8 The east and south sides of the barn are much more utilitarian and 'barn-like', being plain, and dressed originally with cruciform ventilation slits. The removal of a modern structure on the east side has exposed much of this fabric again (Plate 3). A short lean-to at the south end is probably of 18th or 19th century date, while the scars for a second, single storey lateral range depicted on the old maps is visible. The centre is dominated by a large, three-quarter height doorway with chamfered jambs and lintel, all original as it retains queen-closers, though the doors are modern.

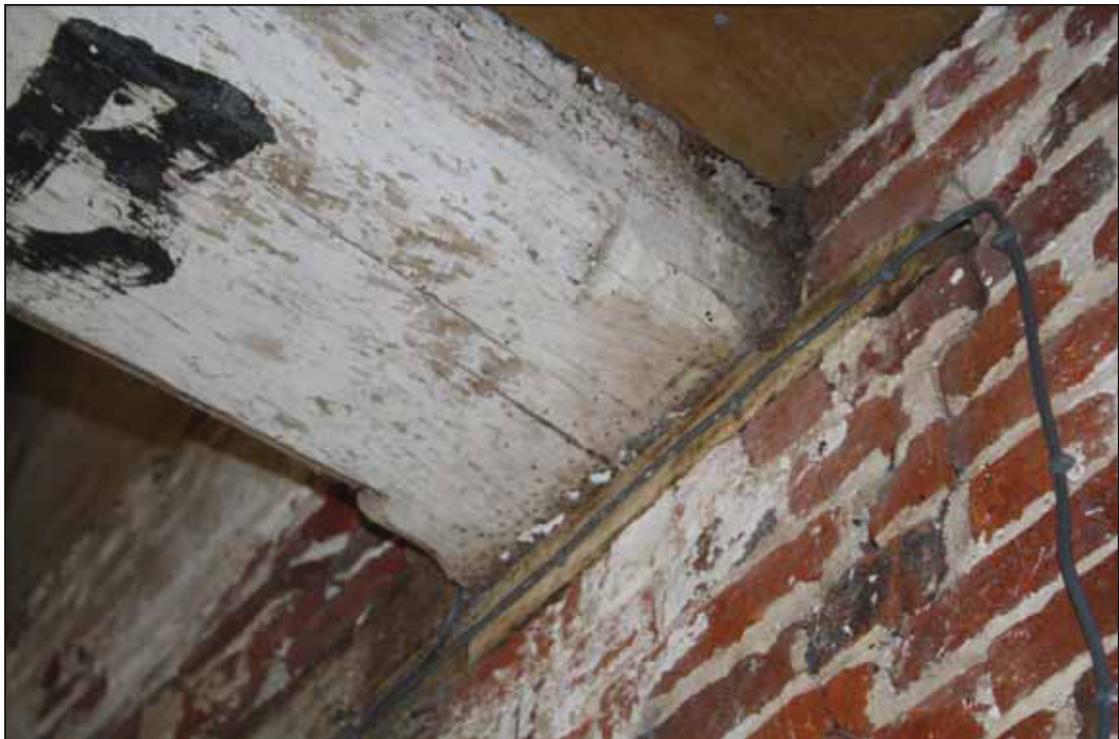
Plate 6 Detail of lambs tongue chamfer stops on binding of Truss 2, taken from the north-east (DP 44)

5.17 The first floor is contemporary with the construction of the barn and is carried in both bays on binding joists of massive scantling consistent with an early date, and retain chamfers and lambs-tongue stops as seen in the roof (Plate 6). The joist beneath truss 3 retains evenly-spaced redundant mortices in the soffit, for a substantial studwork partition. In addition the joist is chamfered and stopped only on the north side facing into the domestic arrangements. Both supporting joists sit on an integral bearer on the west which also forms the lintel of the window in Bay 2. The area was once entered from the small domestic doorway and possibly also lit from windows on the north and west. The doorway has deep splayed reveals with a timber

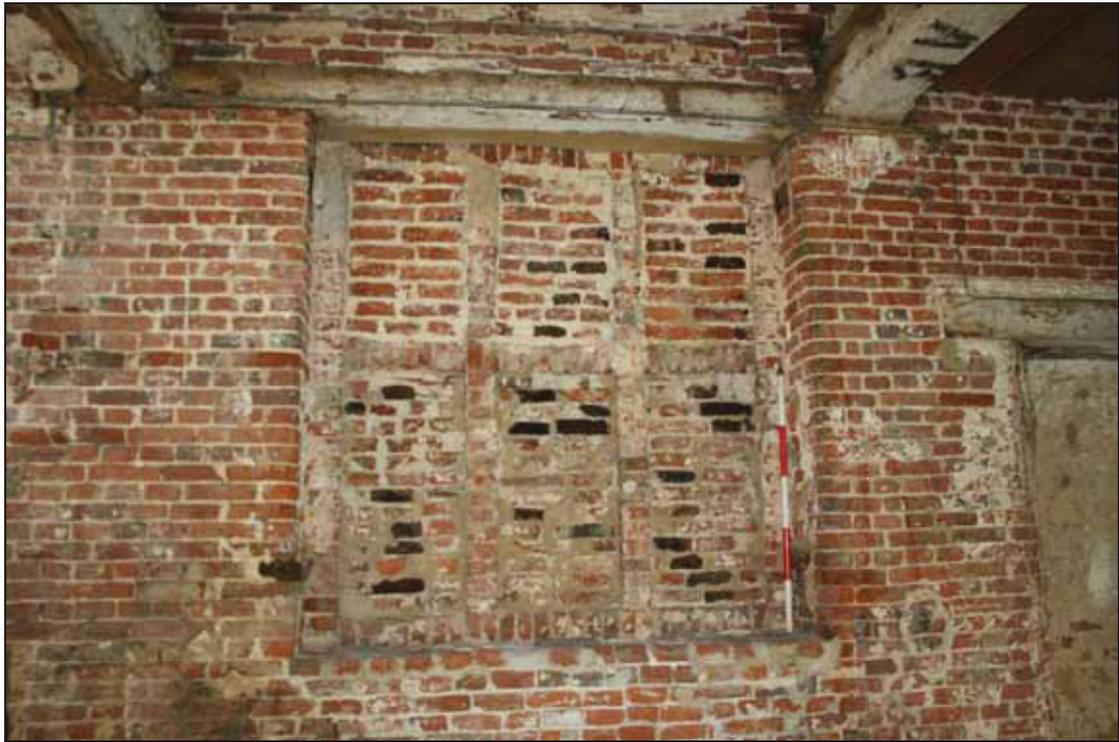
Plate 7 West side of Bay 2 at ground floor level, taken from the east (DP 42)

lintel, this having two large peg-holes for some attachment, perhaps a shelf, but no trace is visible for pintles or a door-check. The rear face of the surviving window has exposed flat-faces to the transom and mullions, while small timber-bearers, possibly forming a low shelf are set into the reveals at lower level (Plate 7). A doorway on the east side of this bay has rendered jambs, but its date is not known.

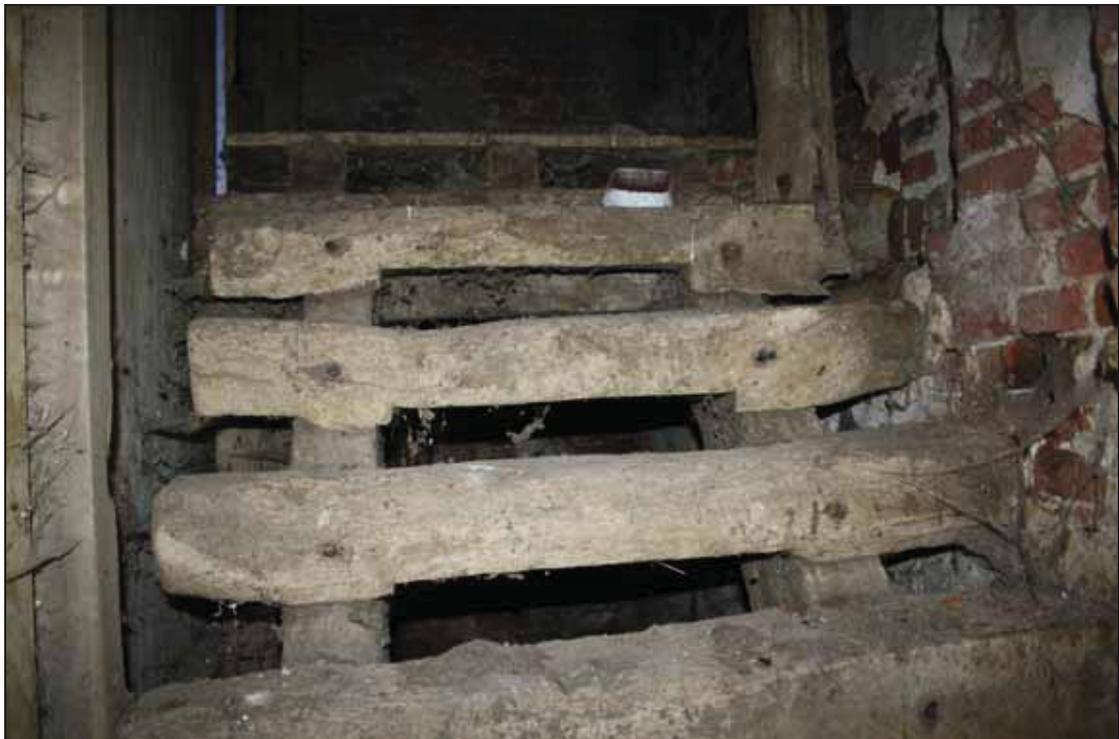
Plate 8 Staircase at ground floor level, taken from the south (DP 64)

5.18 The upper floor was once reached by a staircase in the north-east corner, but this has been taken out of commission and boxed in with modern materials. The ceiling housing the staircase is framed with trimmer joists which appear primary, and are properly pegged, with a second joist having mortices in the soffit. A nearby post is much mutilated but also probably original. The lower flight of the stair can still be reached from first floor level, and so could be examined. It is constructed of simple triangular timber baulks, nailed to carriage beams to create a ladder-like construction (Plate 8). Each tread has a curious square notch cut into the soffit, perhaps suggesting that these are reused from elsewhere. The outer wall, as noted above, is complicated and multi-phased at this point. At the base, the wall is corbelled out with a timber bearer, possibly forming a door lintel, while approximately halfway up, a probable blocked window preserves a single splayed reveal and a timber lintel, which has in turn been truncated to accommodate a second doorway at landing level. This in turn was later blocked and partly filled with a cruciform ventilation slit noted above from the exterior. The lintel appears to have been insufficient, later causing some structural failure immediately above.

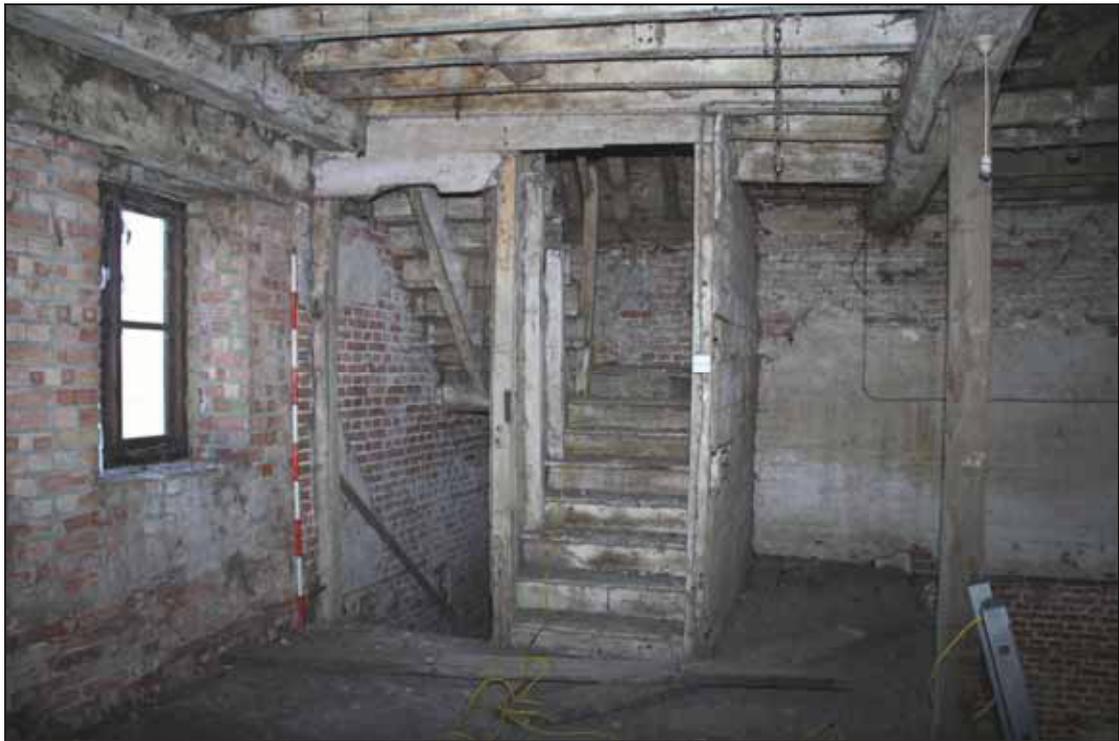
Plate 9 View of staircase at first floor level, taken from the west (DP 47)

perhaps 17th or 18th century, rising in quarter- or half-pace landings and all enclosed with rough studs, nailed and trenched over the existing frame (Plate 9). The upper stairs are of hewn oak treads and risers. A door aperture from the intermediate lower flight preserves a rough door-check and two robust pintles with cut-off ironwork for a probable locking bar and latch piece. Small grooves for removable boards in the manner of a thresh-leap are attached to the doorway to the upper stair, probably relating to later activity.

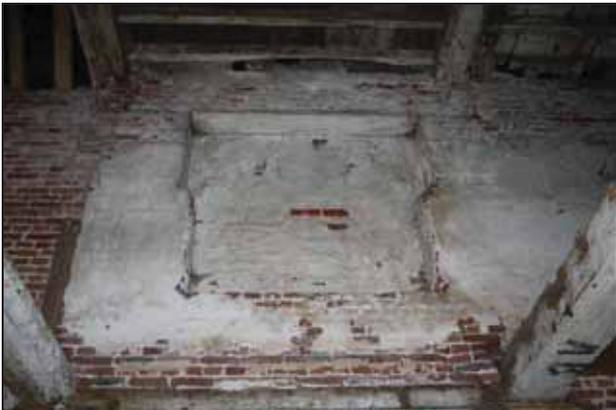
DP 78

View of the removed floor of Bay 2, taken from the south-west

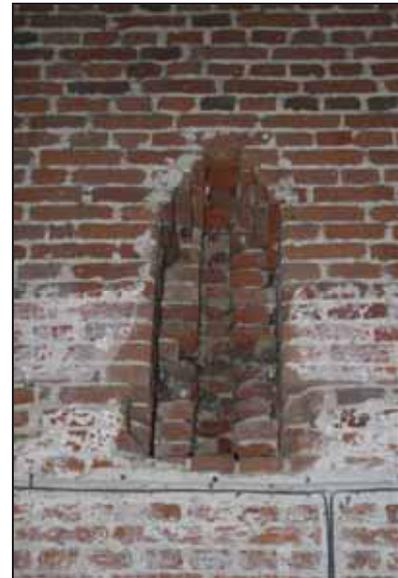
DP 79

Detail of the blocked window on the west side of Bay 2 at first floor level, taken from the east
