**ST MARY'S HOUSE, CLACTON ROAD,  
LITTLE OAKLEY, ESSEX**

**HISTORIC BUILDING RECORDING  
WITH MONITORING AND RECORDING**

Authors:	Tansy Collins BSc Lee Prosser PhD Peter Thompson MA Kathren Henry	
NGR: TM 2120 2846		Report No: 4035
District: Tendring		Site Code: LOSM11
Approved: Claire Halpin MifA		Project No: 4245
Signed:		Date: February 2013

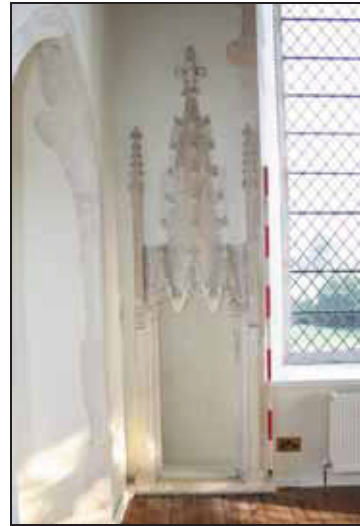
DP 43  
Room FF01, taken from the west

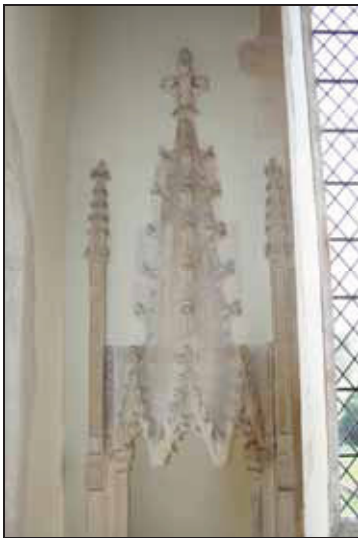
DP 44  
Image niche on the east side of Room FF01, taken from the west

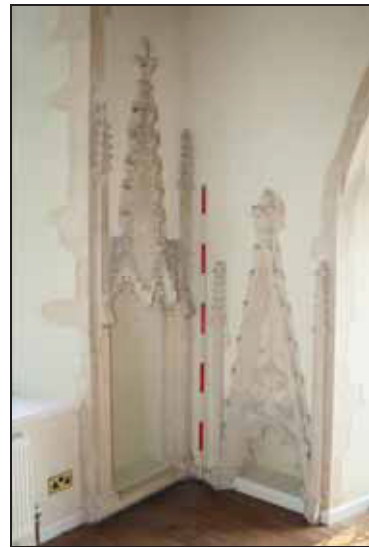
DP 45  
Hood of image niche on the east side of Room FF01, taken from the west

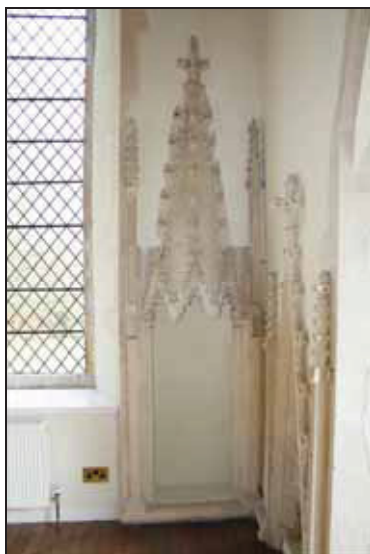
DP 46  
Hoods of image niche and piscina in the south-east corner of Room FF01, taken from the north-west

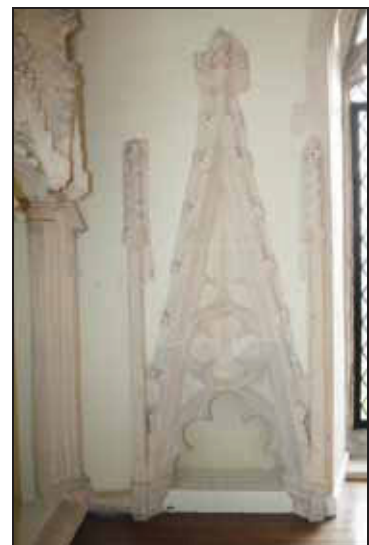
DP 47  
Image niche on the east side of Room FF01, taken from the west

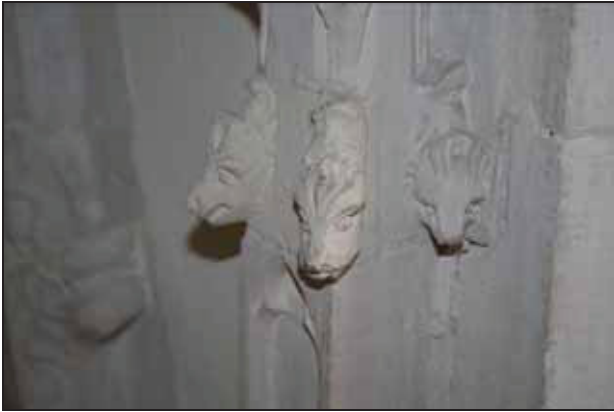
DP 48  
Hood of the piscina on the south side of Room FF01, taken from the north

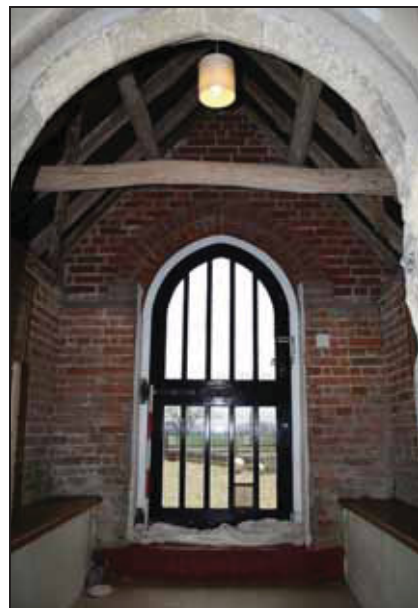
DP 53  
*Room GF03, taken from the south*

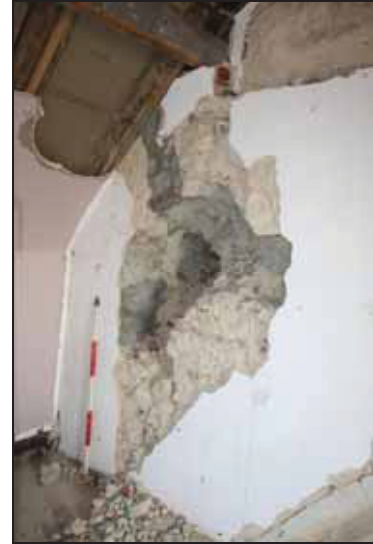
*DP 85  
View of east nave wall at upper level during the piercing of the outer doorways, taken from the west*

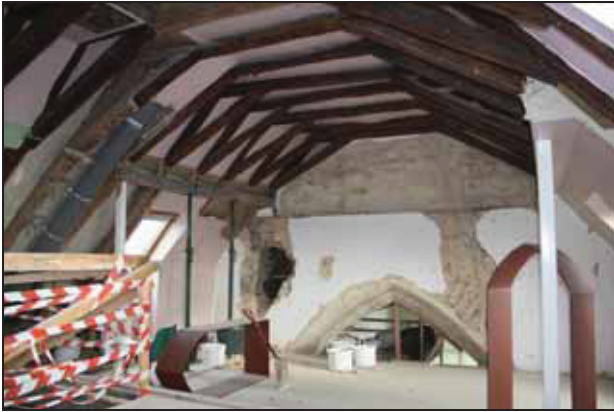
DP 102

*View of the north side of the chancel arch during piercing of the northern doorway, taken from the south-west*

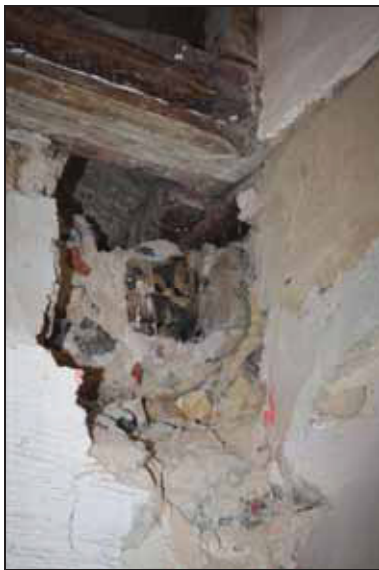
5.28 As noted above, the southern nave wall appears to preserve the earlier form but even here areas of small-scale repair is visible with occasional red bricks. On this side all the sockets cut through the facing blocks with the infill of Nos. 10-12 being of fairly angular pieces, while No. 9 includes a higher proportion of rounded pebbles.

*DP 118  
Floor socket 9 on the south side of the nave during the planned works, taken from the north*
