**THE SWAN PUBLIC HOUSE
HIGH STREET, WHEATHAMPSTEAD
HERTFORDSHIRE**

**HISTORIC BUILDING RECORDING
Level 3**

Authors: Dr Lee Prosser BA PhD Lisa Smith BA Kathren Henry	
NGR: TL 17706 13915	Report No. 4458
District: St Albans	Site Code: AS1640
Approved: Claire Halpin MiFA	Project No. 5485
Signed:	Date: 14 November 2013 (Revised 15 th November 2013)

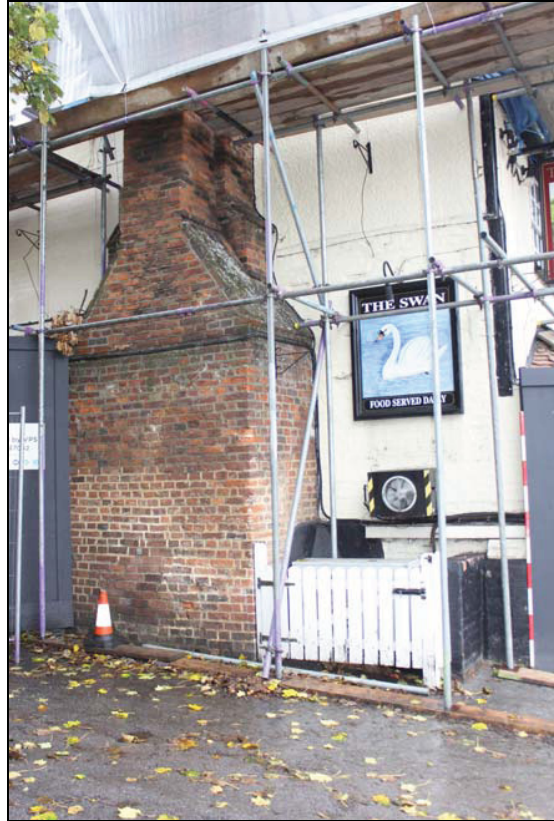
Plate 5 Lower portions of the chimney stack, south elevation, taken from the south-east (DP 3)

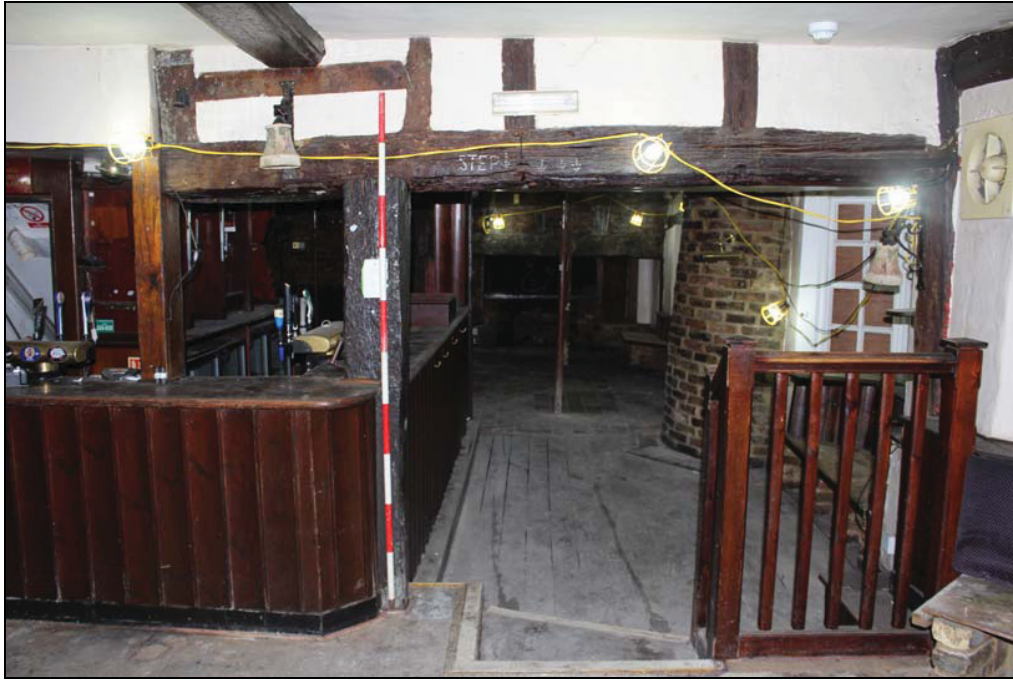
Plate 7 Junction between the medieval core and 17th century extension, GF02, taken from the south (DP 26)

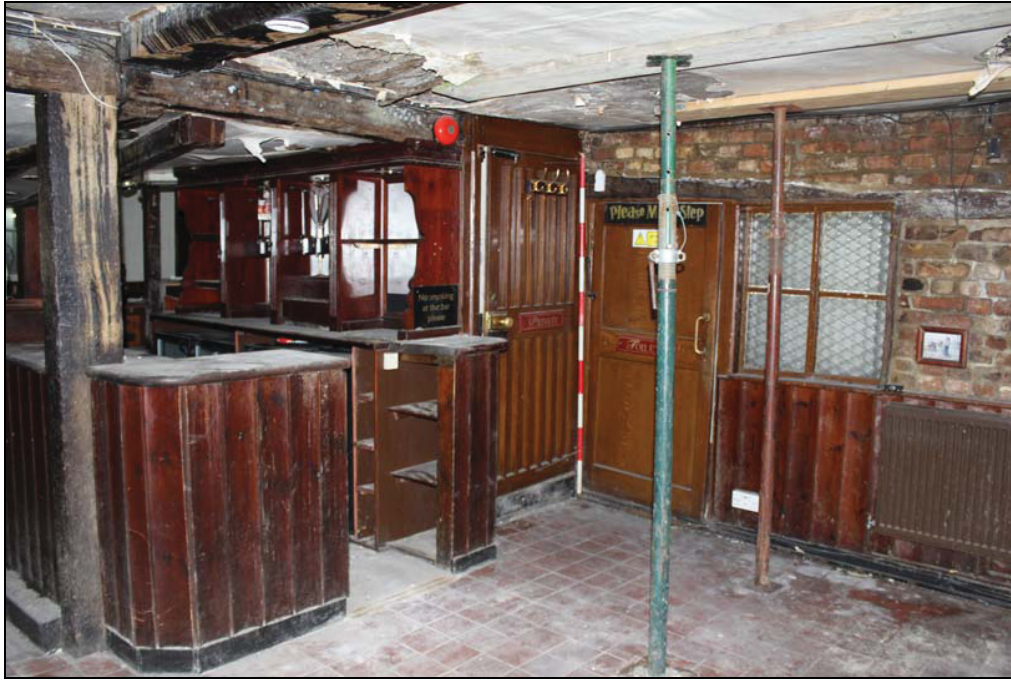
5.18 The rear, west wall demonstrates a simpler arrangement, having been more highly disturbed. An original mid-rail has now been much truncated by the insertion of a broad panelled 18th century door and window leading to the rear flat roofed extension (Plate 9). The upper portion of an original principal-post is preserved as a truncated stump while two early studs survive in the lower register. The entire wall has been infilled with 19th century or later brickwork, all re-used and set in cement. A secondary mid-rail, chamfered but only partially visible has clearly been inserted to carry joists for the inserted floor.

Plate 9 Bar area with stair access to upper floors and access to GF07 beyond, GF01, taken from the north-east (DP 34)

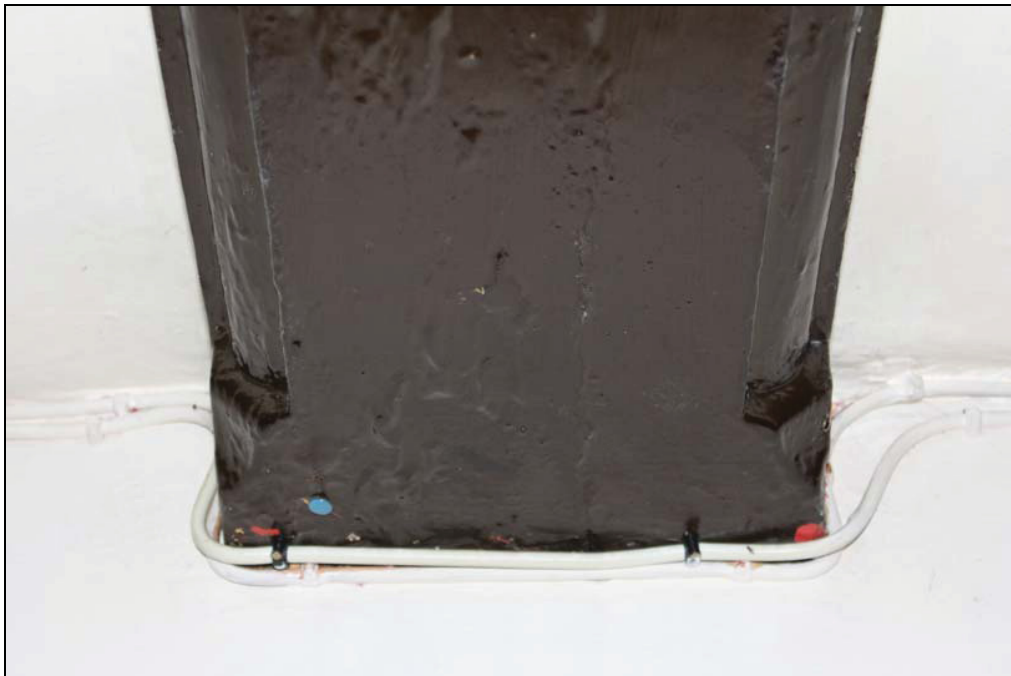
5.22 At ceiling level some timber-framed elements are visible, including a central binding joist with ovolo chamfers, terminating above the fireplace on the south with lambs-tongue stops (Plate 10). On the north it is supported on a simple timber bearer inserted into the original external face of the medieval range. The bay window breaks forward of the original mid-rail, which survives, though much hacked back and modified.

Plate 10 Lamb's tongue chamfer stops to the binding joist, GF02, taken from the north (DP 23)

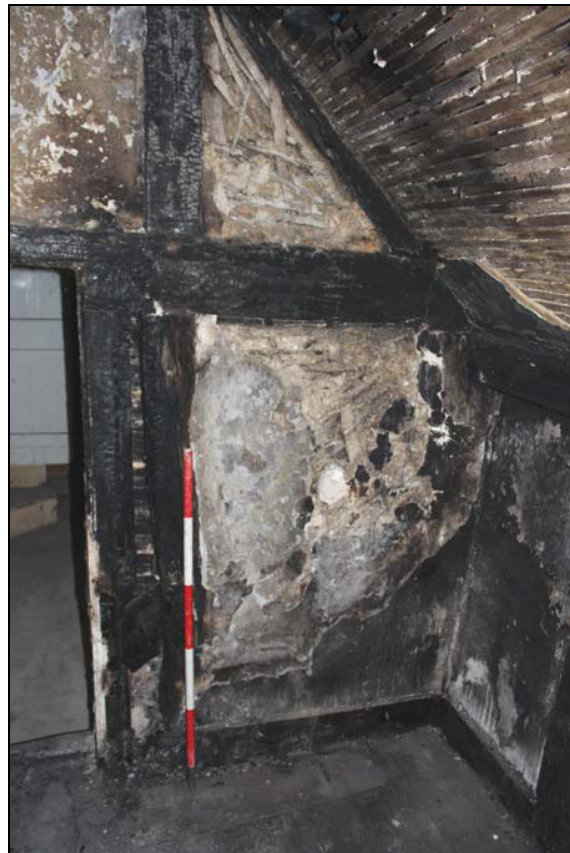
the tie-beam appear to survive in most places. The upper register preserves the original medieval wattle and daub infill panels, together with one lower panel on the west side adjacent to the door (Plate 14). These comprise large staves and interwoven split twigs with a high quantity of chalk lumps, finished with a thin layer of plaster. Other lower panels have been refurbished, possibly in the 17th century contemporary when the hall was floored, as split laths are present. In the lower register the remains of a downward brace can be distinguished, truncated by the insertion of a door.

Plate 14 Wattle and daub panels to the south elevation, FF03, taken from the north-east (DP 72)
