**42 MAIN STREET, EAST HADDON,
NORTHAMPTONSHIRE**

HISTORIC BUILDING RECORDING

Authors:	Tansy Collins BSc Antony RR Mustchin MSc (Editor)	
Illustrations:	Kathren Henry	
NGR: SP 6689 6817		Report No. 4403
District: Daventry		Site Code: AS 1591
Approved: C. Halpin MIFA		Project No. 5263
Signed:		Date: 6 September 2013 Revised: 27/09/2013

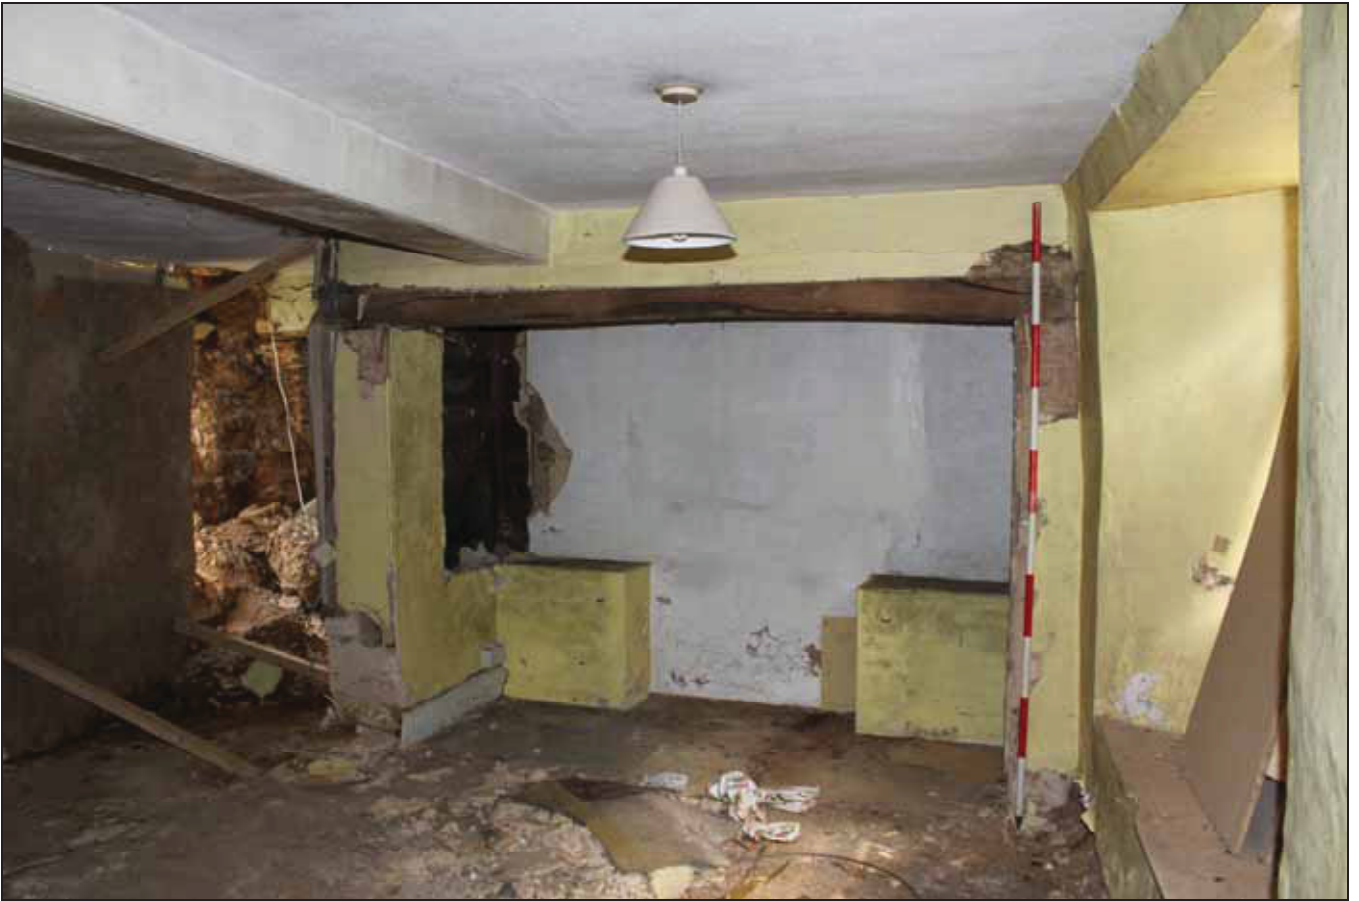
Plate 3 Inglenook fireplace on the east side of Room GF02, taken from the west (DP27)

5.12 Room GF02 contains the chimney stack on the east (Plate 3) with inglenook fireplace and the staircase in the north-west corner. The floor here is of concrete which extends into the fireplace and as before the skirting board has been removed. The walls are fairly uneven and plain plastered or painted. The chimney stack is all rendered and painted but the underlying fabric is exposed in places revealing some stonework as to the external walls but with rebuilding in brick, particularly to the jambs of the inglenook. Above this the inglenook has a large oak bressummer, which was formerly rendered as elsewhere with a staff moulding. The window on the south is itself modern but is set in a large aperture with splayed reveals, the splay on the east being more attenuated. A plain window seat lies below. During demolition the nature of the wall lining was revealed to be of riven laths and plasterwork which appears to be the earlier form of cladding with the reed and plaster representing a later alteration.

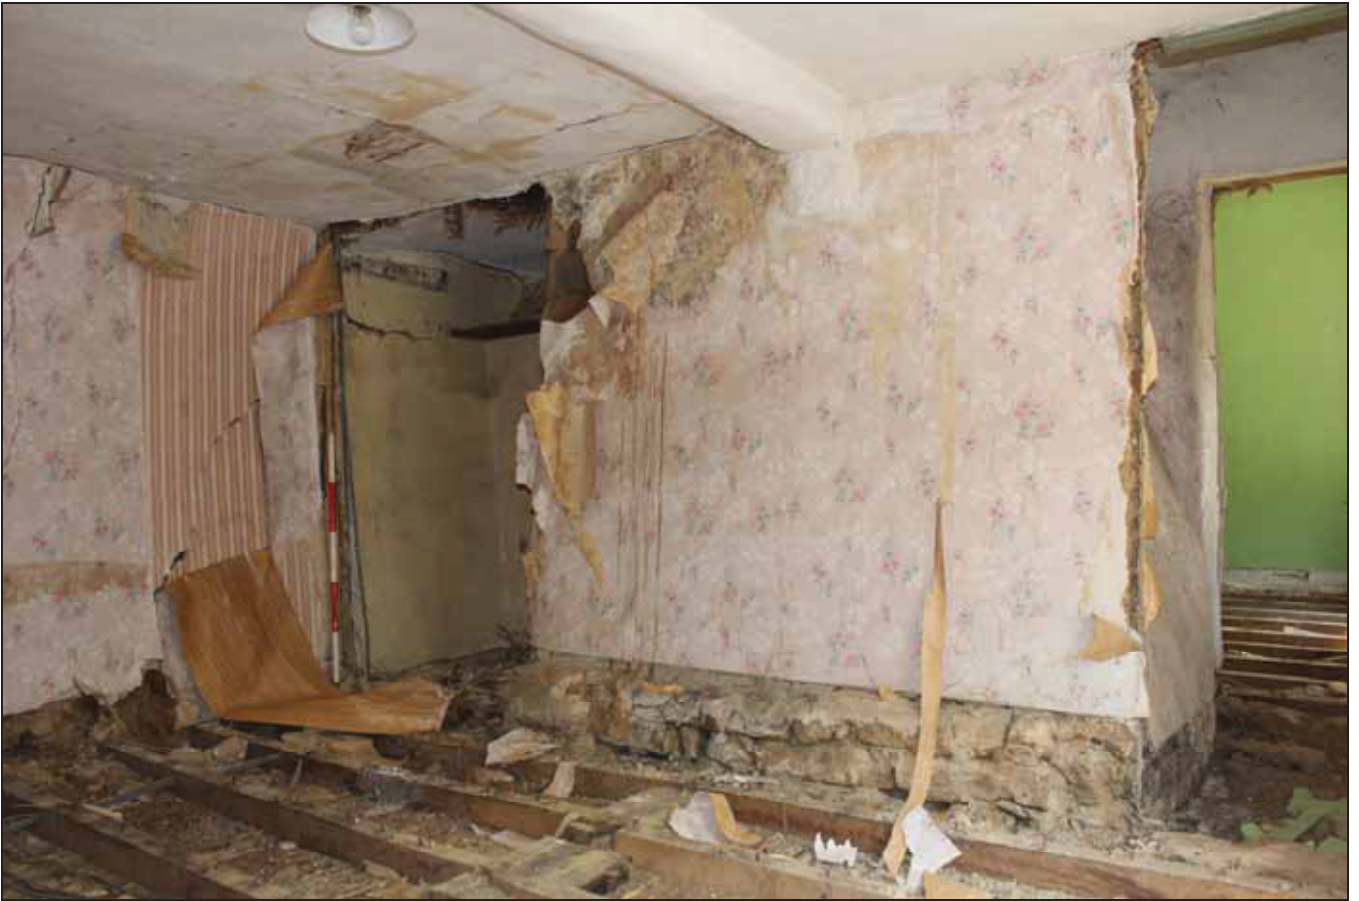
Plate 7 Room FF03 with chimney stack and adjacent cupboard, taken from the south-west (DP50)

5.18 The second room (FF03) contains the principal chimney stack on the east (Plate 7). The floor in this room is as to the west with the floorboards removed and again represents the sequence of phasing in Room FF01. This includes the original bridging joist with empty mortices and later common joists jointed in, and as before the edges of the bridging joist are painted. The walls are plain and the doors have again been removed. The window embrasure on the south again has splayed reveals and almost rises to full height although below the window is canted. The window is identical to that in the adjoining room. This room has two integral cupboards. One lies to the south of the stair lobby and the second occupies the space to the north of the principal chimney stack. No doors or other joinery survives but the fabric of the walls is exposed revealing the reed straw and plasterwork visible below. In the south-west cupboard impressions for shelves are visible as well as fragments of possible 19th century and later wallpaper. Otherwise, near floor level the fabric of the chimney stack is exposed which is all of lias stonework and demonstrates that this room was not originally heated. The stack is otherwise plastered and shoulders in at upper level. The ceiling retains the plastered bridging joist continuing from the adjoining space and terminating at the stack.

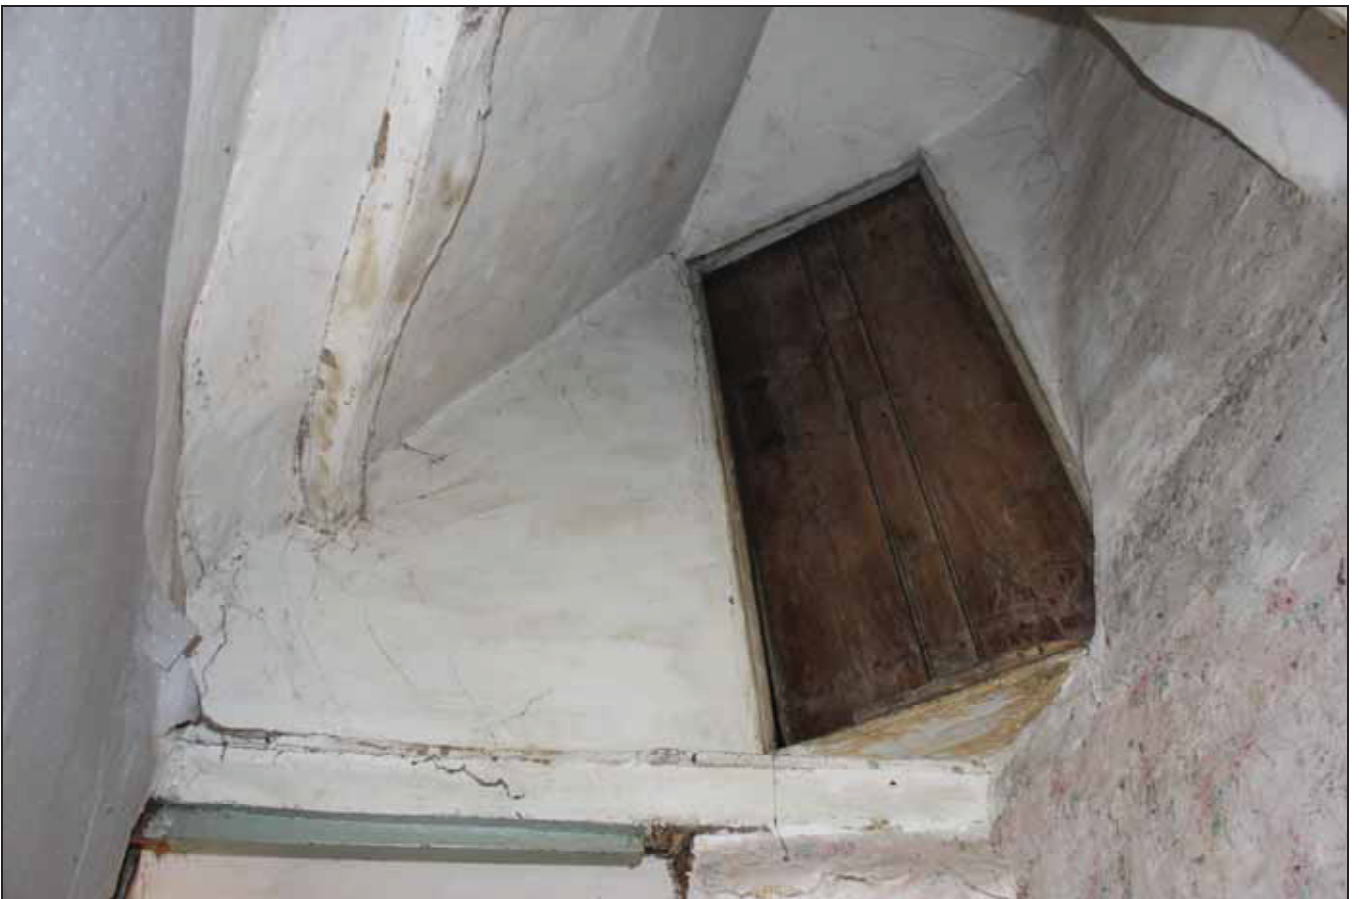
Plate 8 Upper area of Lobby FF04 showing doorway giving access to the roof space, taken from the east (DP49)

5.19 On the south side of the chimney stack is a small lobby (Room FF04) reached from Room FF03 and giving access to Room FF05 to the north. No doors or frames survive. On the north, the flank of the chimney stack is visible shouldered in to upper level and this side appears to be constructed in brick, all painted. At high level, the south roof pitch is visible, rendered internally, though a single waney purlin is exposed but painted, braced to the stack with a secondary member. Otherwise, the hole in the plasterwork reveals that the underdrawing is of lath and plasterwork rather than the straw seen elsewhere. In the north-west corner at high level, a canted doorway adjoins the stack which gives access to the roof space. The door is boarded and has an early thumb latch and handle with oval end plates (Plate 8).

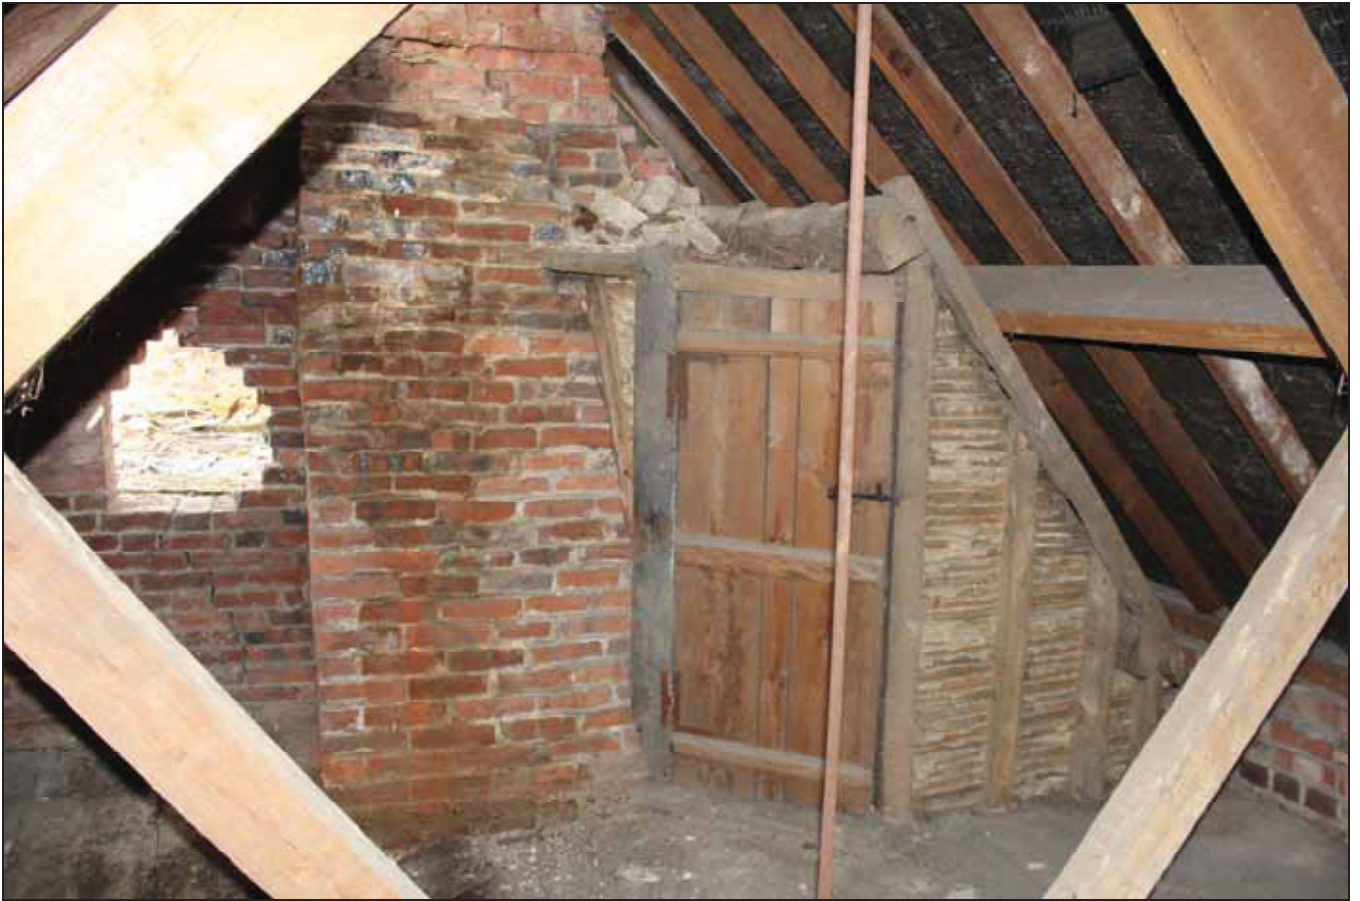
Plate 11 View of the south side of the building at roof level in the centre, taken from the west (DP84)
