THE BLACK HORSE PUBLIC HOUSE
7 POTTERS CROSS, WOOTTON
BEDFORDSHIRE

HISTORIC BUILDING RECORDING AND MONITORING

Level 3

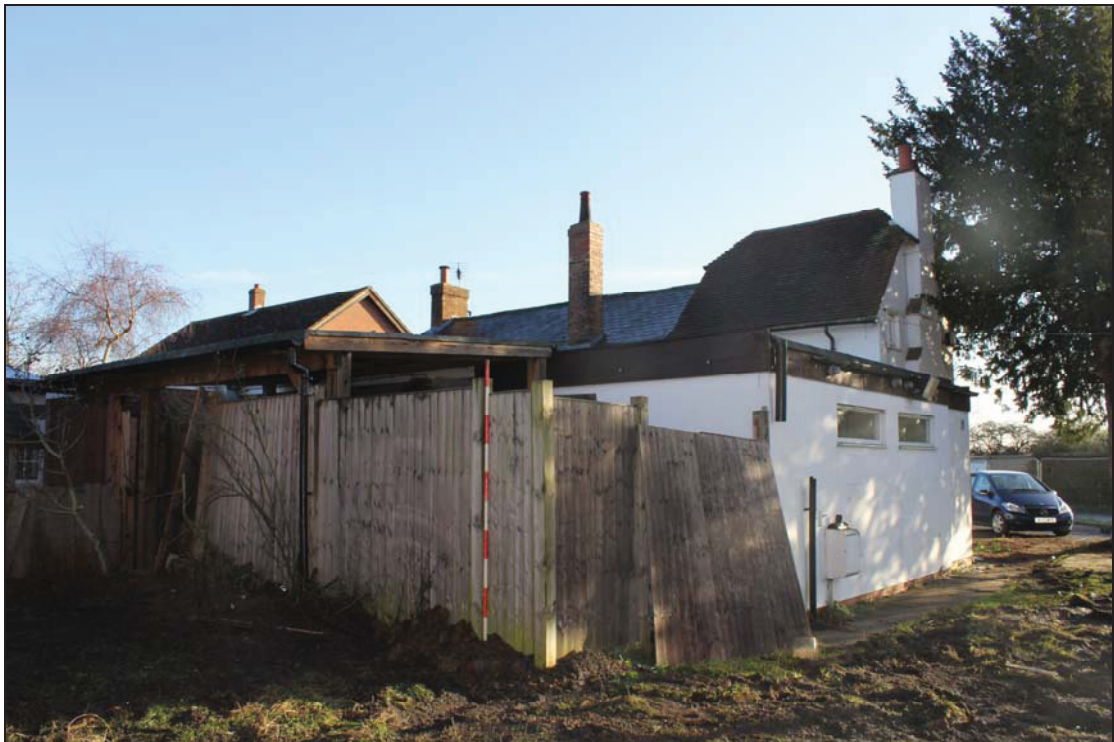
5.9 The western elevation is mostly obscured behind modern flat-roofed extensions projecting to varying degrees from the historic core (Plate 2). Access is given to the kitchen on the south via a modern glazed door with a flanking three-light Crittall-type metal-framed window. To the north, a second glazed door with side lights leads from the restaurant to a modern paved patio beneath a timber-framed shelter. Above these later additions, the southern range rises in a blank rendered section to a steeply-pitched peg-tiled roof. By contrast, the roof above the historic core is covered in slate and preserves a shallower pitch to incorporate the pent-roof extension now enveloped by the later additions.

Plate 2 Rear of the Black Horse, taken from the west (DP 7)

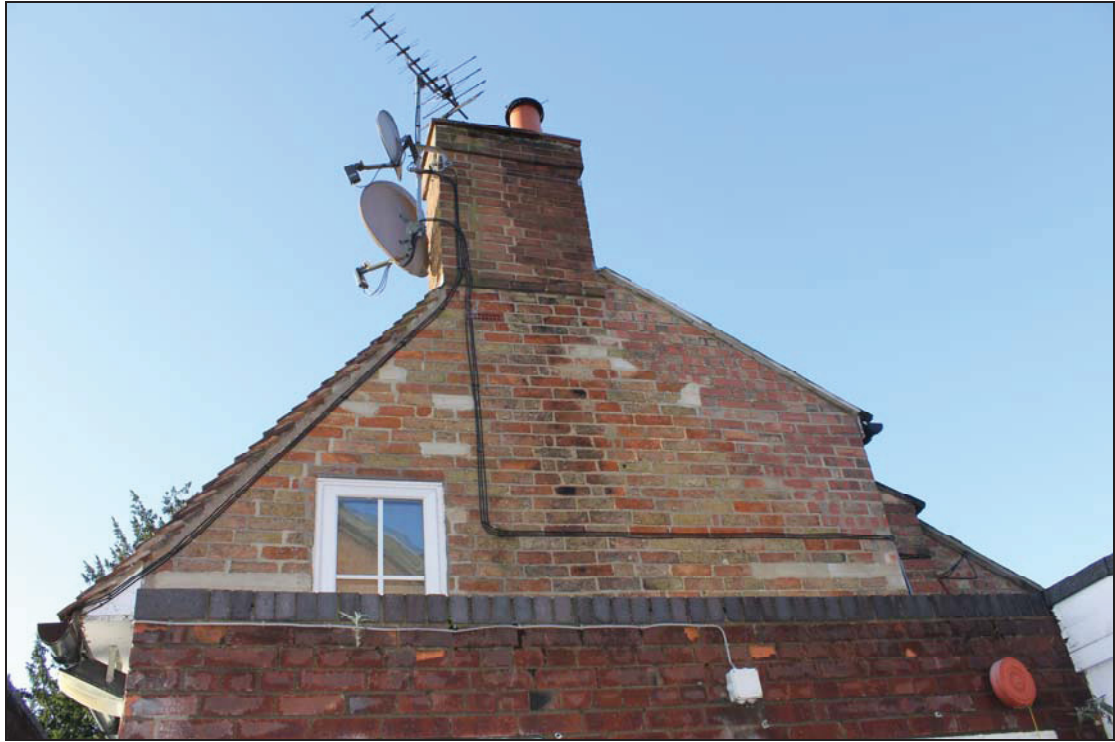
Plate 3 Upper sections of the north-east elevation, taken from the north-east (DP 11)

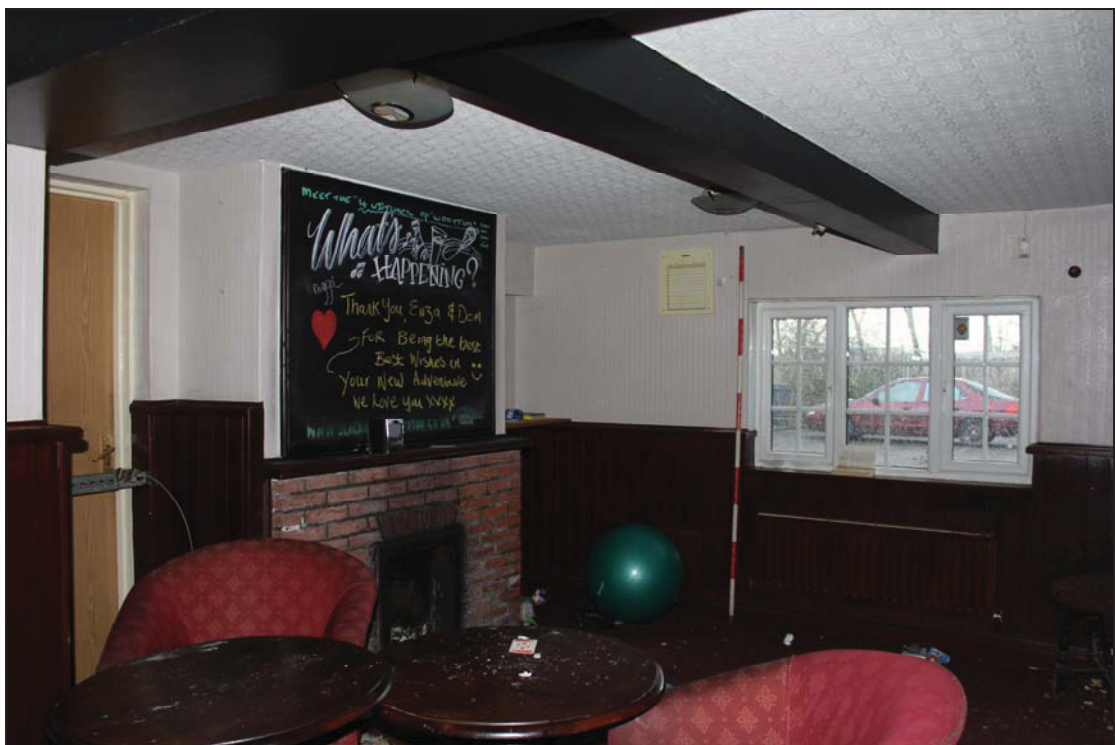
Plate 8 Lounge bar, GF03, taken from the west (DP 22)

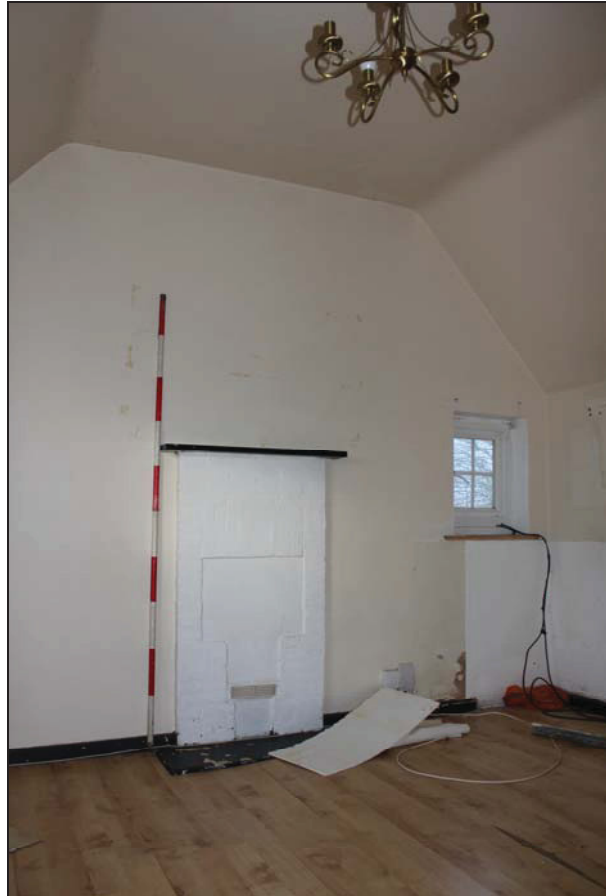
5.35 Two steps rise from FF01 to the later southern range which is entirely brick built. The room is lit by a dormer on the east and a small modern window on the south (Plate 17). The fireplace on the south has a brick surround and fireplace is now blocked.

Plate 17 FF04, taken from the north-east (DP 51)

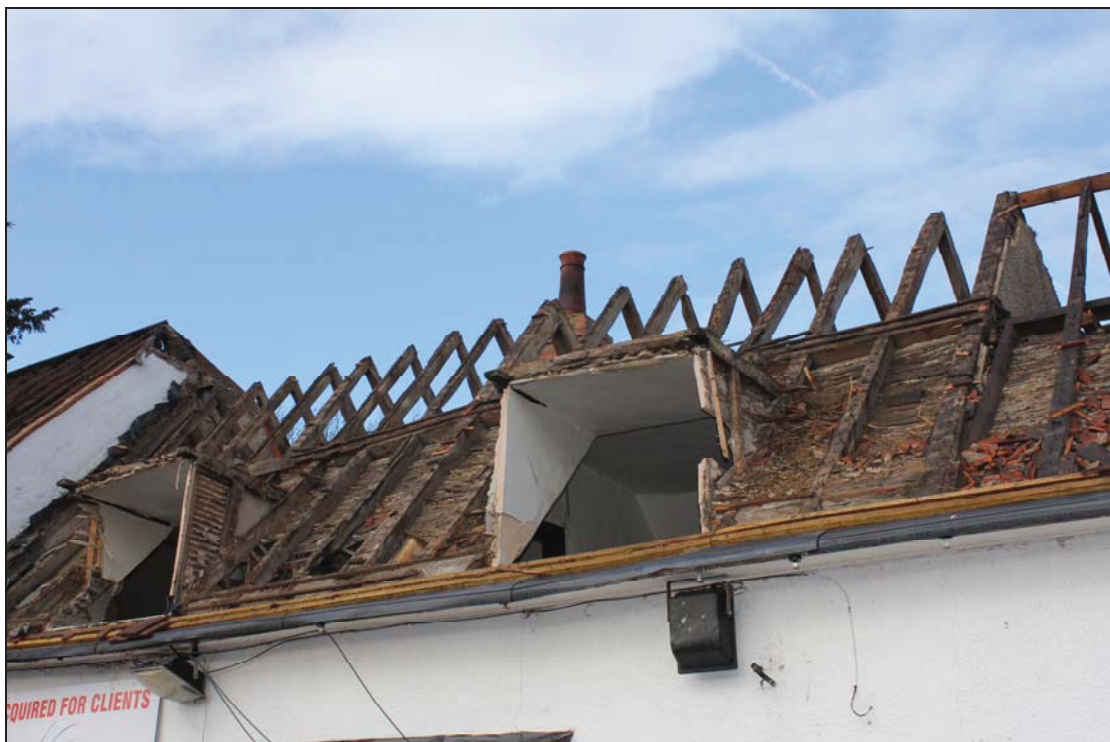
5.37 The original roof is of butt-purlin form is clearly visible and survives well-preserved on both pitches (Plate 18). It is constructed of fairly robust oak

Plate 18 Roof structure above two-bay historic core of the building, south-east pitch, taken from the east (DP 67)
