THE POND HOUSE,
BUGBY'S FARM, GREAT MUNDEN,
HERTFORDSHIRE

HISTORIC BUILDING
MONITORING AND RECORDING OF BUILDING
INVESTIGATION WORKS (PHASES 1 & 2)

Authors: Dr Lee Prosser BA PhD Lisa Smith BA Kathren Henry	
NGR: TL 3475 2392	Report No. 4549
District: East Herts	Site Code: AS1431
Approved: Claire Halpin	Project No. 3692
MIFA	Date: 22 April 2014
Signed:

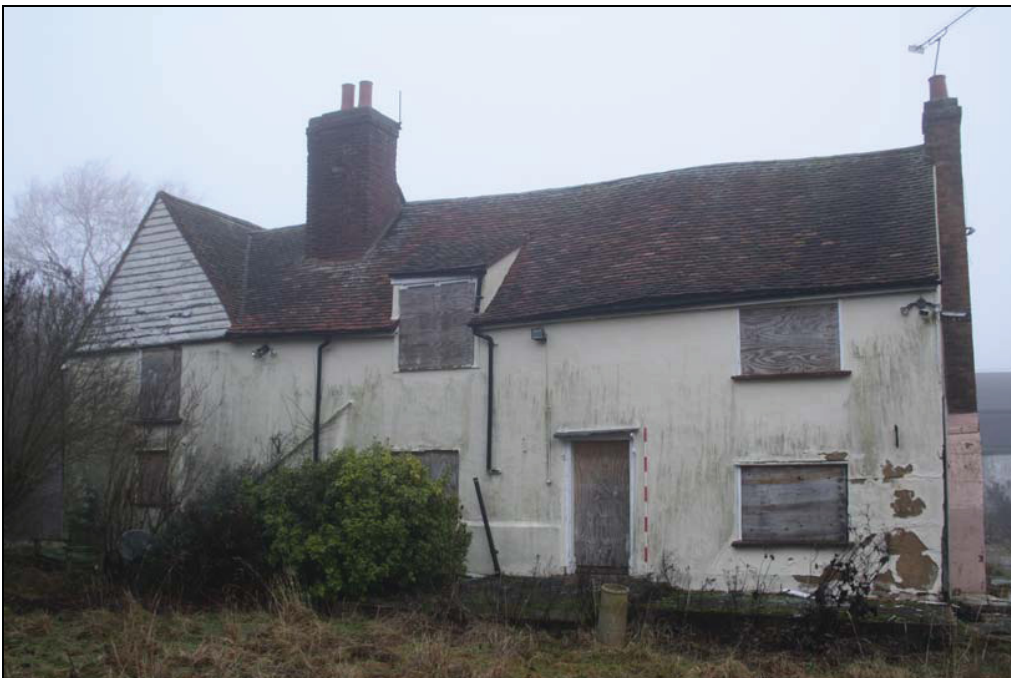
Plate 2 The Pond House, southern elevation, taken from the south-east (DP 1)

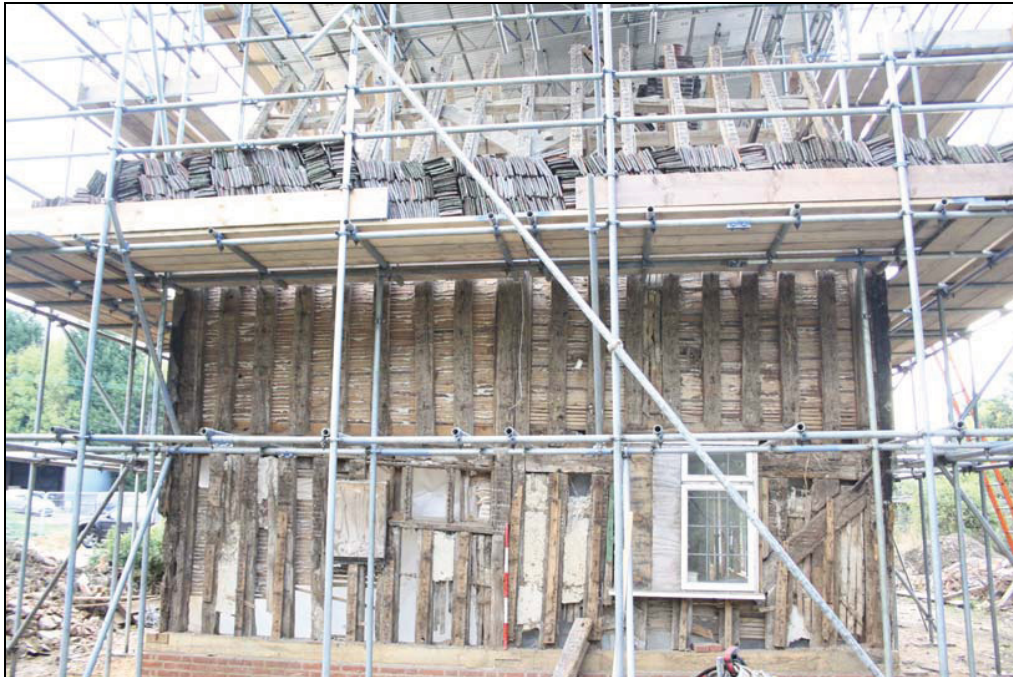
Plate 4 West elevation, timber-frame fully exposed, taken from the north-west (DP 52)

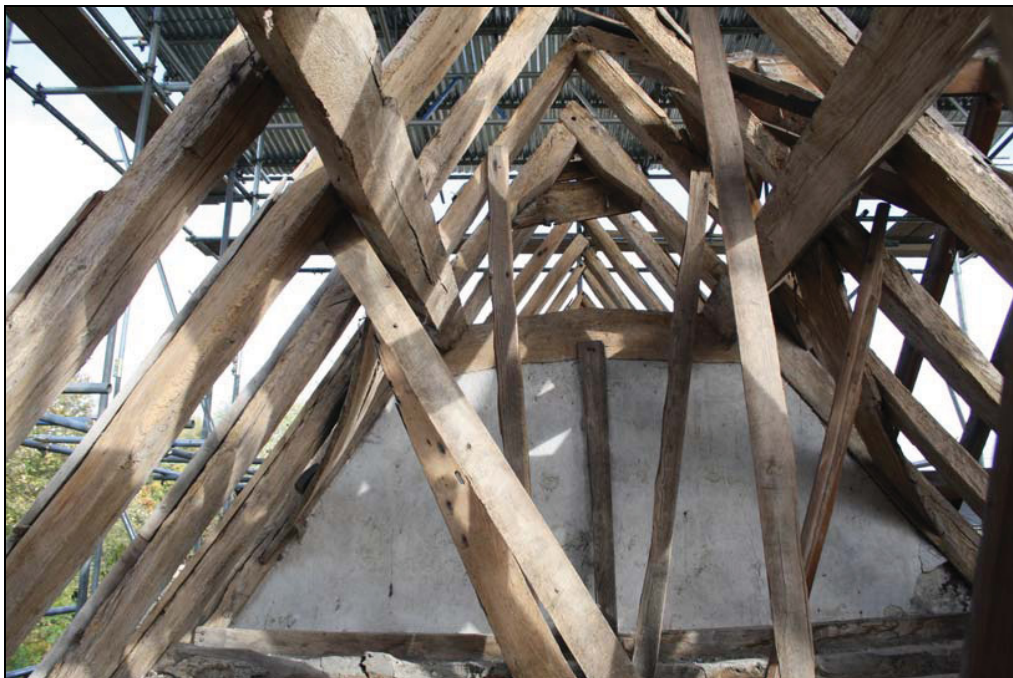
5.11 The bay division is enclosed to collar level by nailed-on studs, infilled with plaster panels; here the principal rafters have splay-cut heads, which is an unusual feature (Plate 6). A rudimentary yoke-piece has been nailed on at the apex.

Plate 6 Internal view of the roof above the cross-wing, south bay, taken from the south-west (DP 75)

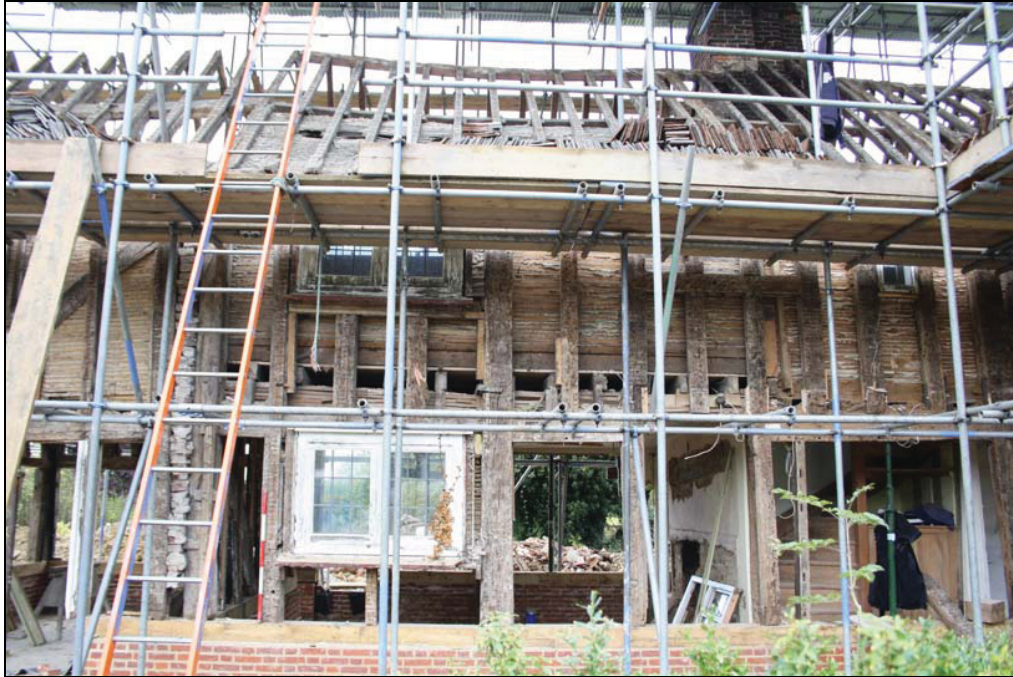
5.16 The central hall range has an awkward relationship with both the cross-wing and the kitchen range and stands as a single unit differing in construction from its counterparts (Plate 9). It comprises two bays with a further short or half-bay accommodating the large chimney stack to the west. Unjowled principal-posts rise at the corners and the bay division, pegged to a good wall-plate. Here, the lower timber framing has almost all been lost and the mid-rail has been severely truncated as a result of later inserted apertures. The mid-

Plate 9 Central hall range, fully exposed, north elevation, taken from the north-east (DP 37)

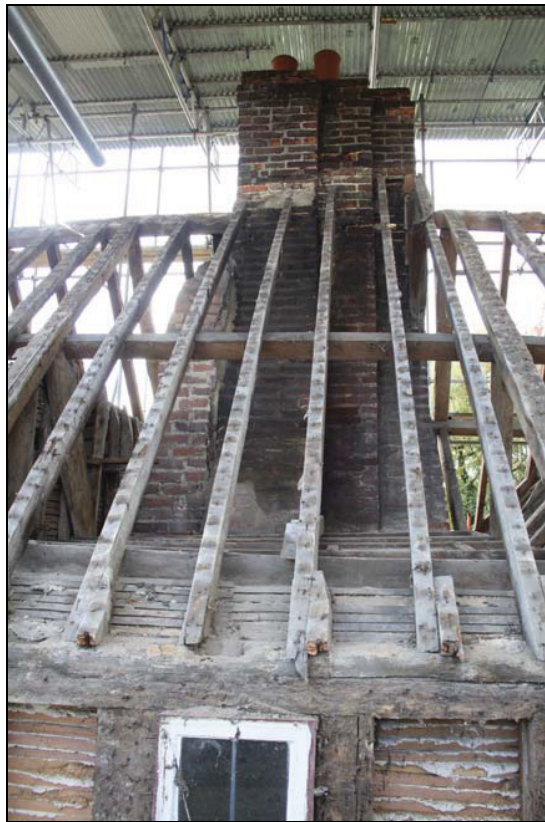
5.19 The wall-plate of the central range extends to the chimney-bay where it is scarfed in a least one place and retains notches for original rafters together with possible dove-tail joints for tie-beams. One tie-beam at the eastern end survives and is robust and cranked, supporting queen-posts rising to the principal-rafters. A second truss clasps the chimney to the west and an intermediate tie-beam has been lost but marks the division of the building into two unequal bays. At the junction between the hall-range and the cross-wing, a fine Tudor chimney stack rises in three shafts with a fourth applied on the east in 20th century brick (Plate 10).

Plate 10 Chimney stack clasped by rafters, taken from the north-west (DP 85)

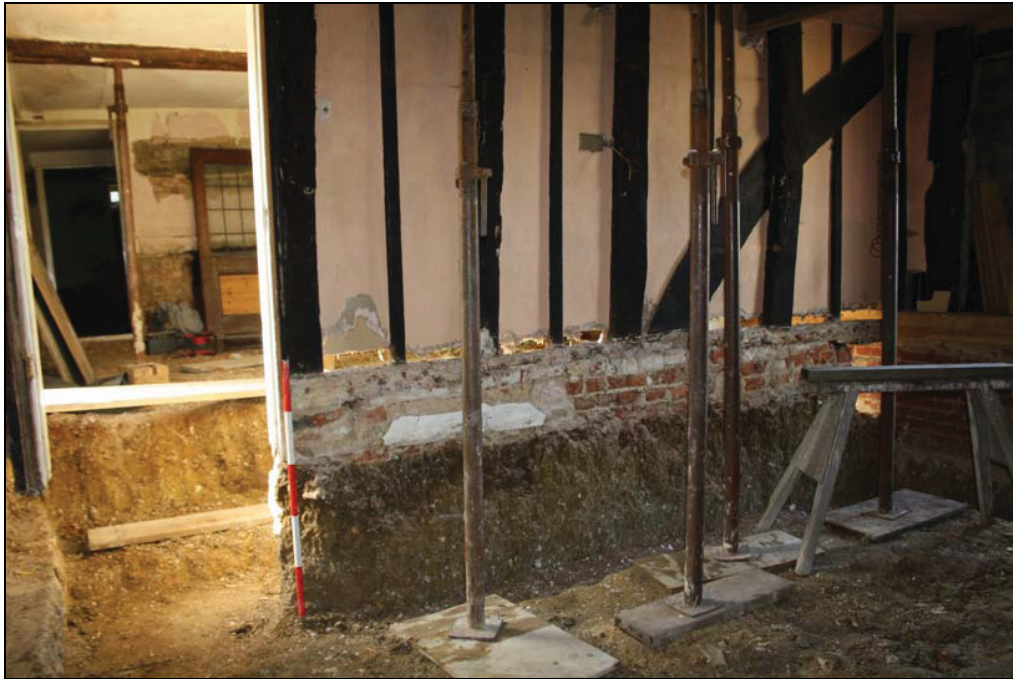
Plate 13 Lowering of floor levels, Rooms 1 & 2, taken from the south-east (DP 32)

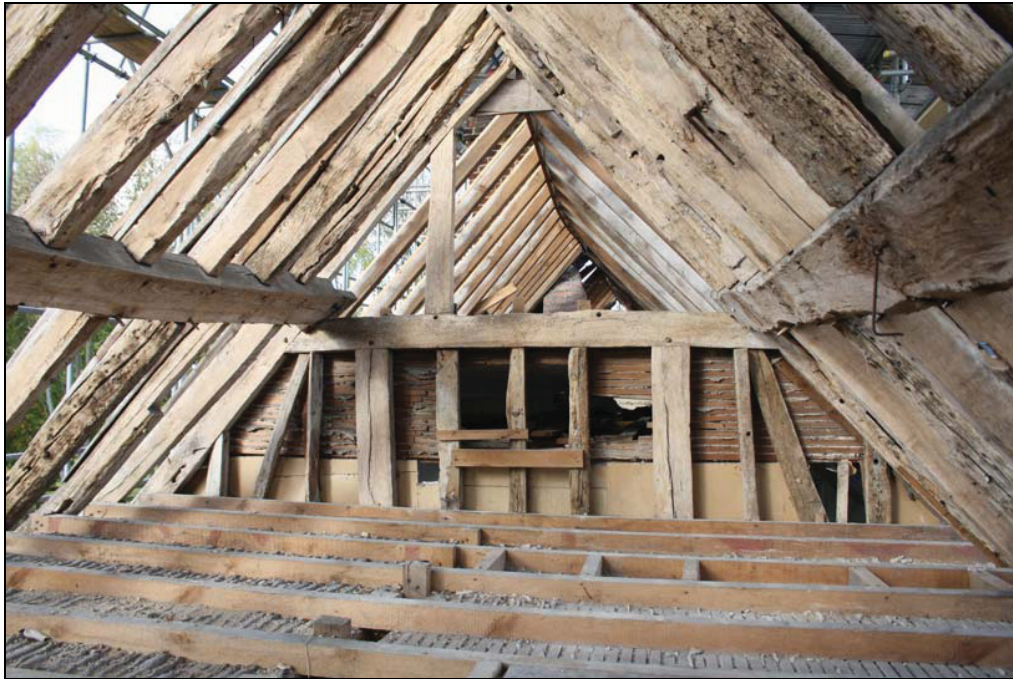
5.29 The roof of the service wing comprises eight common-rafters tenoned above and below a single purlin in each pitch (Plate 15). The purlins are oak and robust, clasped at the bay division while simply abutting the gable end. There is no ridge-board and many of the common-rafters appear to be re-used with empty mortices. There is no sign of the rafters having been under drawn at upper level at any time. The ceiling is supported by a series of lower applied softwood collars clad in slender laths.

Plate 15 Internal roof space above the kitchen range, taken from the south-east (DP 68)

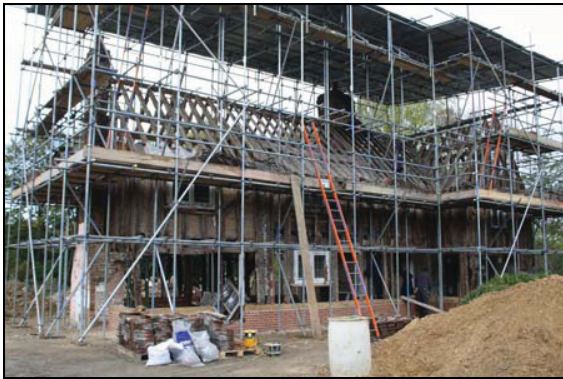
32

Lowering of floor levels, Rooms 1 & 2, taken from the south-east
