ARCHAEOLOGICAL SOLUTIONS LTD

PEARSE HOUSE,  
PARSONAGE LANE, BISHOP'S STORTFORD,  
HERTFORDSHIRE,

HISTORIC BUILDING RECORDING  
AND MONITORING

Authors: Dr Lee Prosser PhD Lisa Smith BA Tansy Collins Bsc Kate Higgs MA (Oxon.)	
NGR: TL 50355 21665	Report No. 4500
District: East Hertfordshire	Site Code: AS1644
Approved: Claire Halpin	Project No. 5506
MIFA	Date: 30 January 2014
Signed:

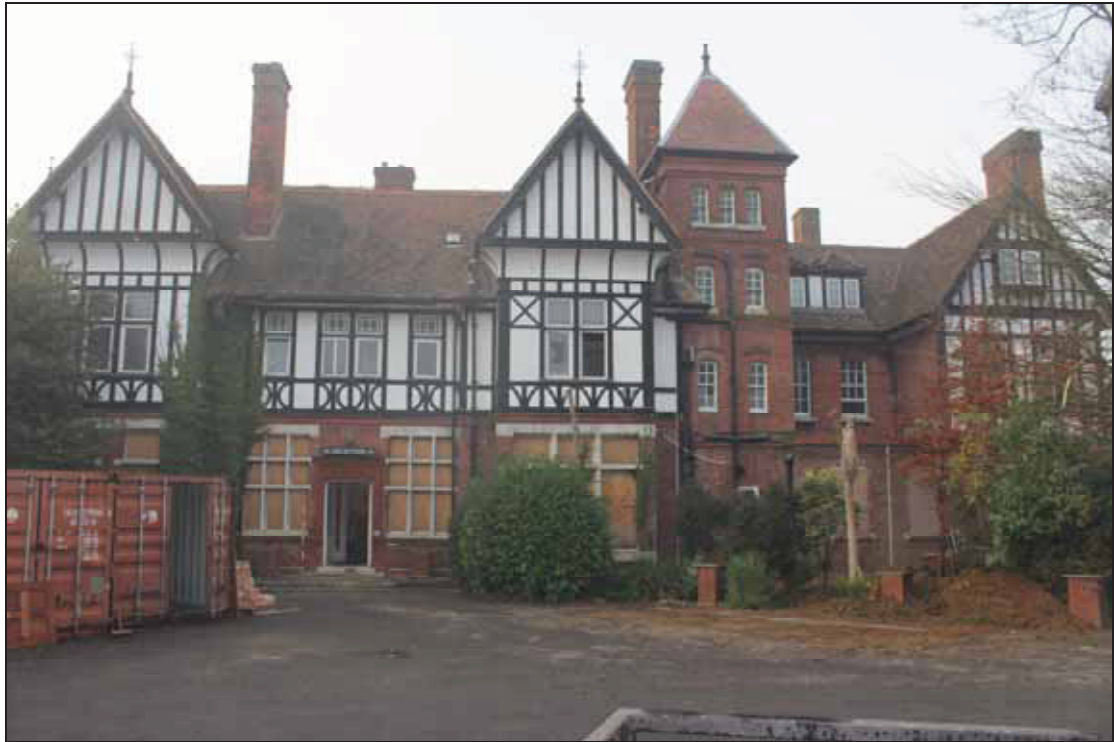
Plate 1 Pearse House, south-east elevation, taken from the south-east (DP 70)

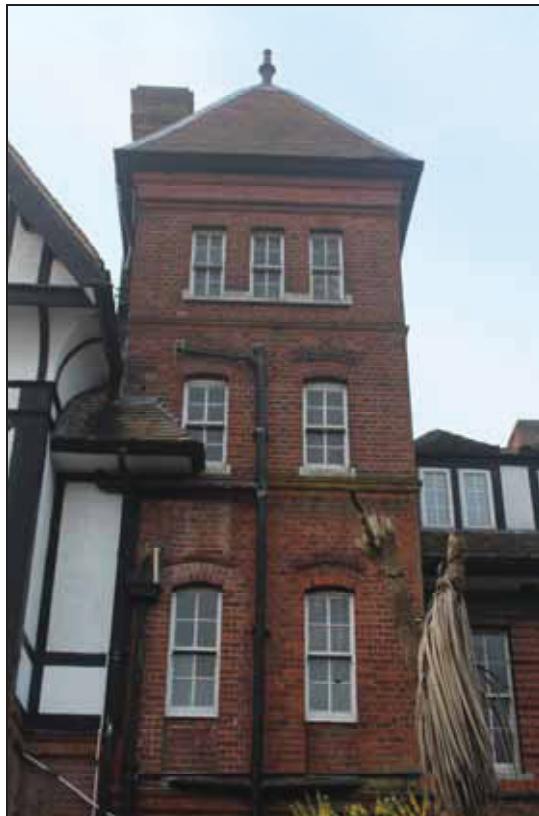
Plate 4 Upper portions of the campanile, south-east elevation, taken from the south-east (DP 103)

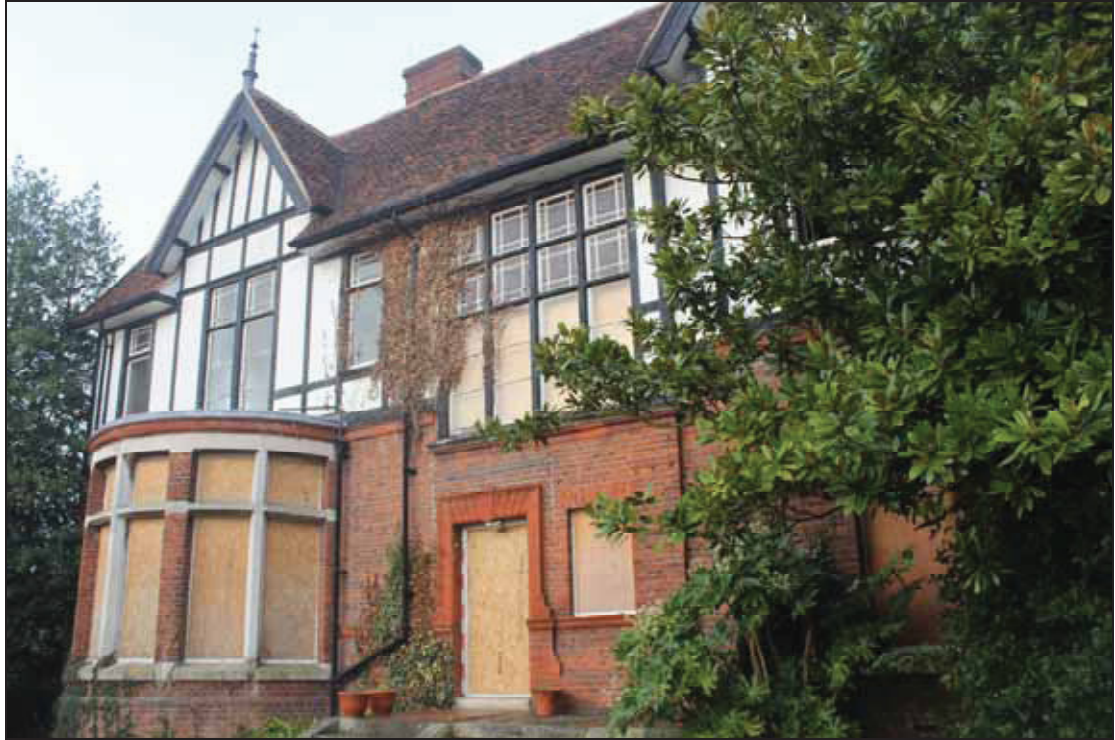
Plate 5 South-west elevation, taken from the south-east (DP 79)

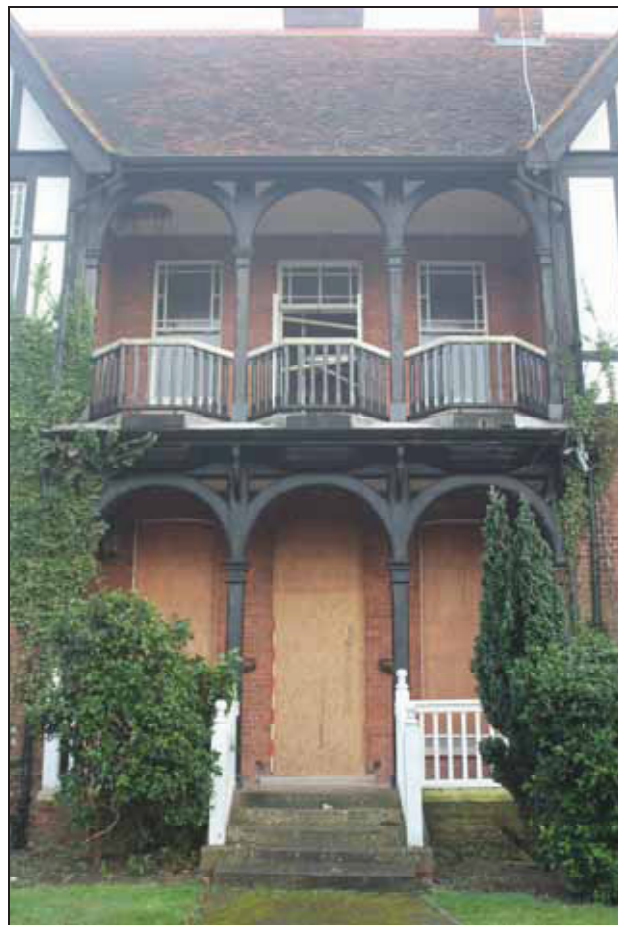
Plate 6 Central loggia and upper balcony, north-west elevation, taken from the north-west (DP 85)

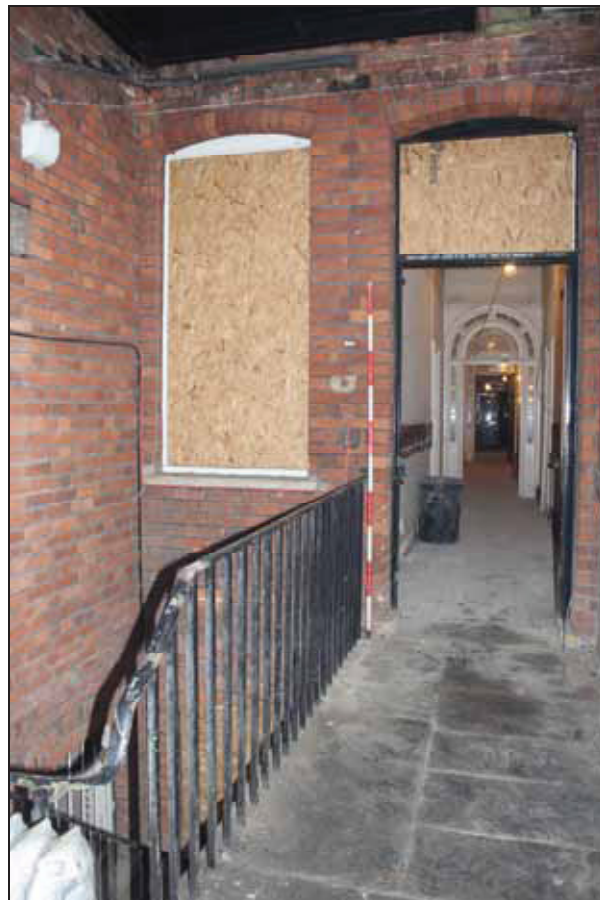
Plate 8 Side entrance to the service range, north-east elevation, taken from the north-east (DP 96)

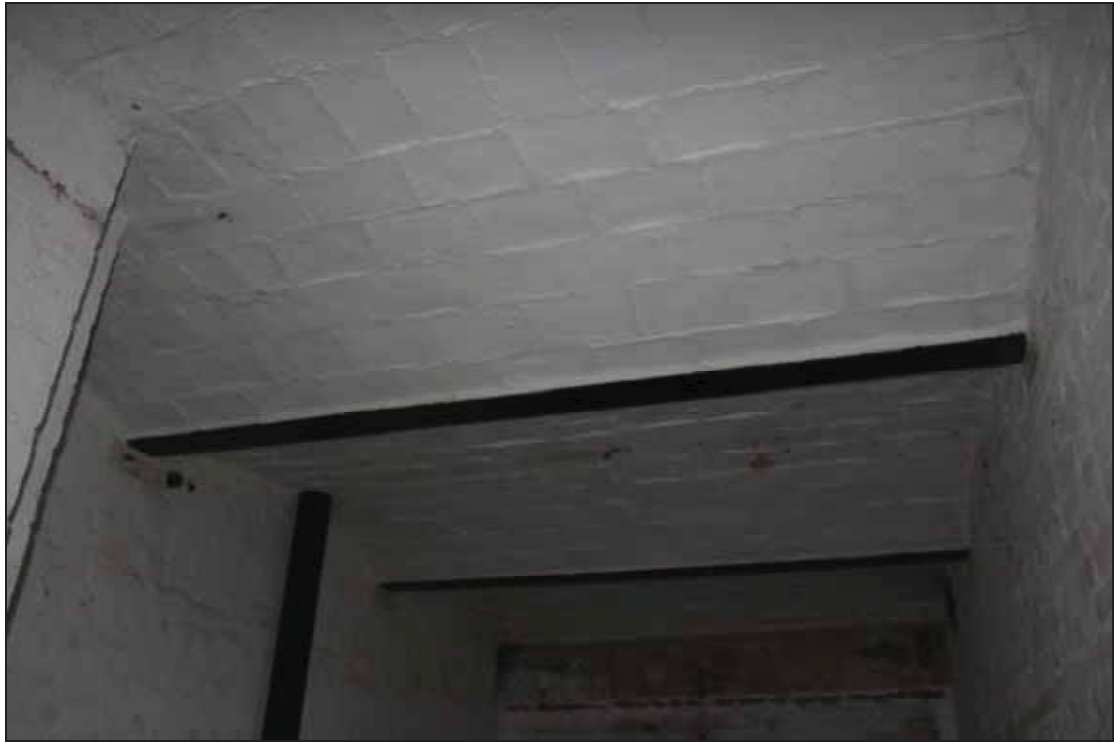
Plate 11 Jack-arch ceiling supports above BF06, taken from the south (DP 118)

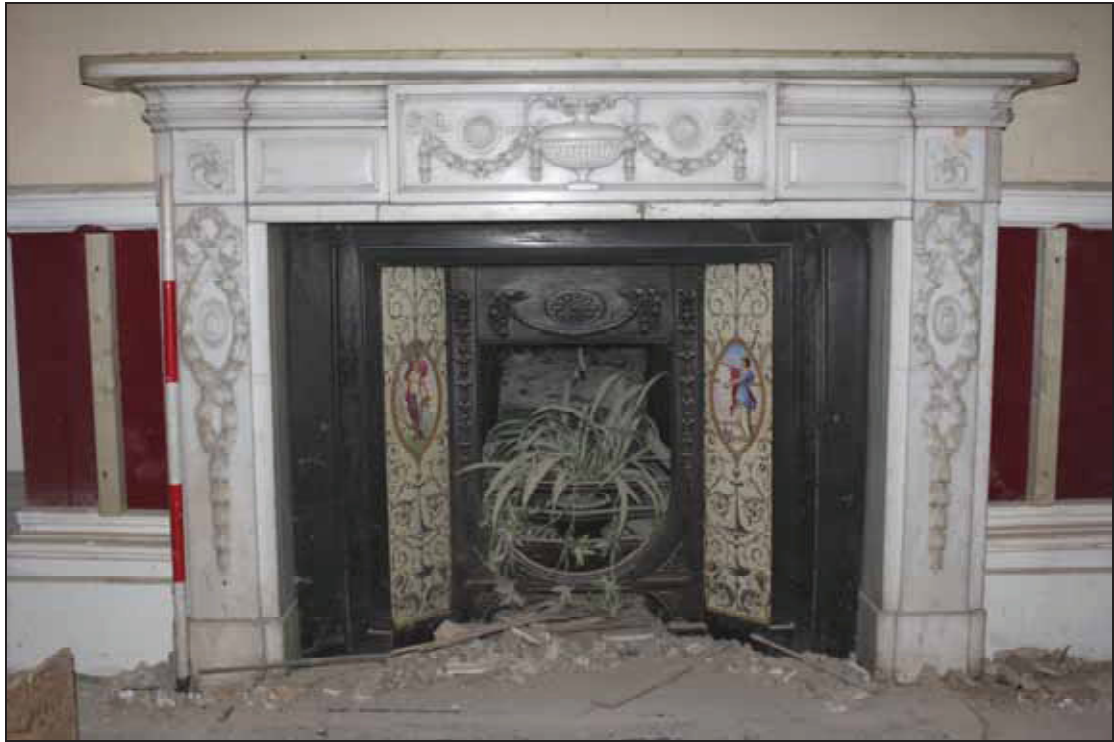
Plate 15      Fireplace with decorative reveals, GF06, taken from the south-west (DP 203)

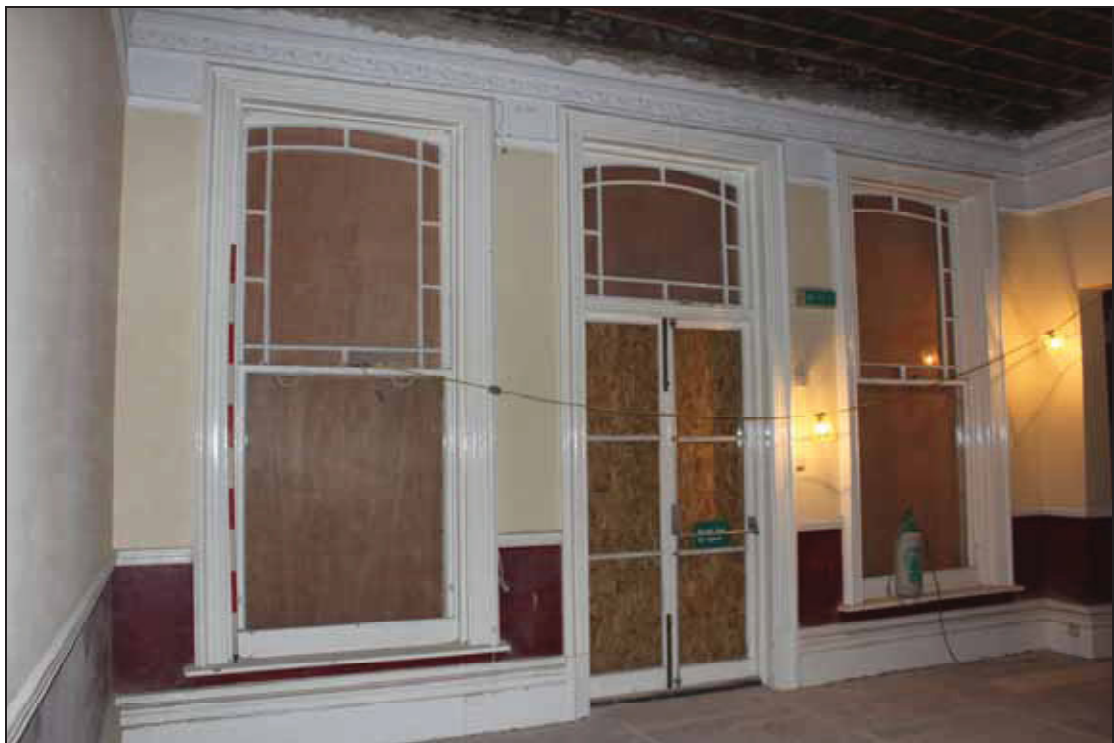
Plate 16      GF07, taken from the south-east (DP 198)

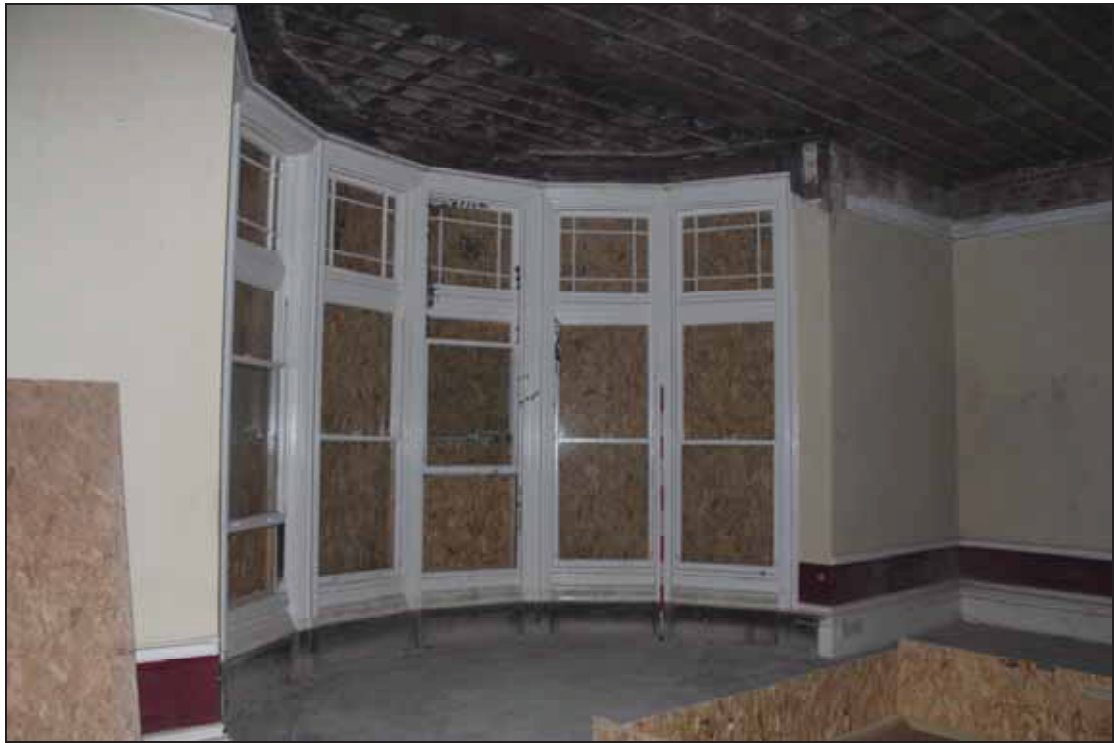
Plate 17 Large bay window, GF08, taken from the east (DP 147)

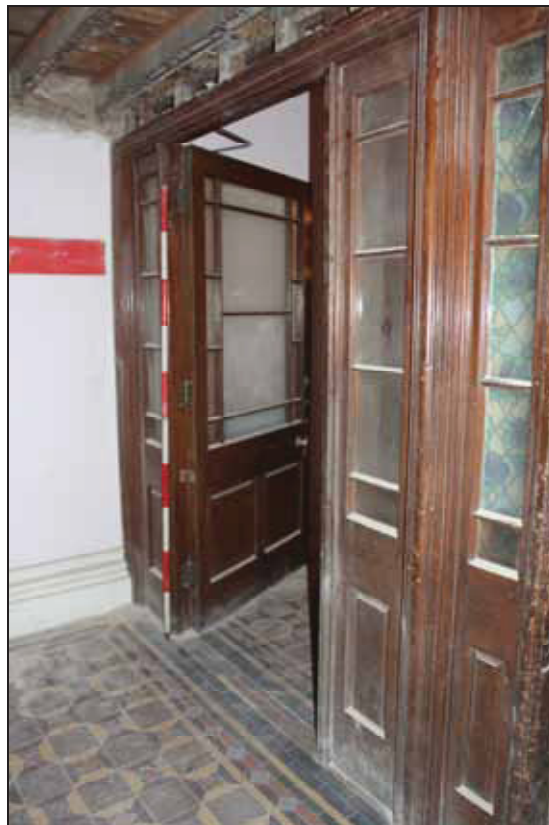
Plate 20 Glazed and panelled partition to a small lobby and external access, GF09, taken from the south-east (DP 170)

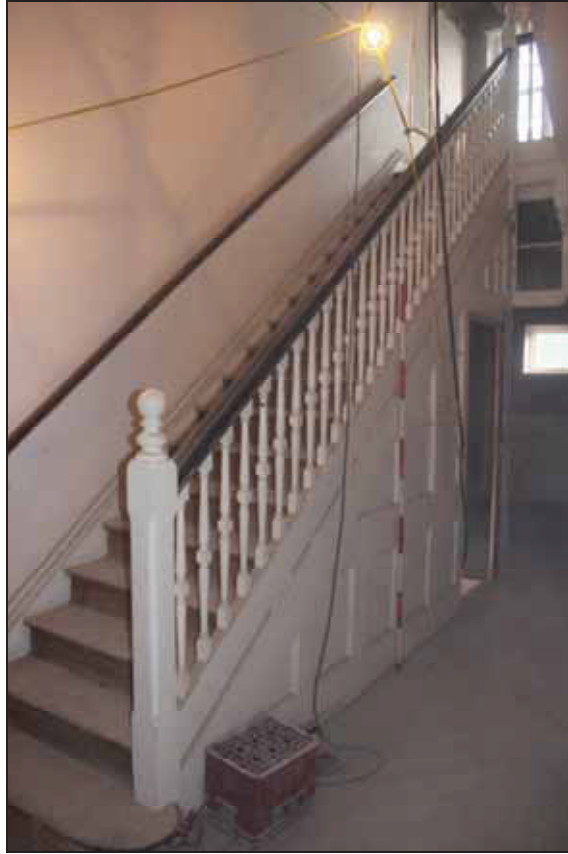
5.57 The corridor opens more fully through a second aperture to accommodate the back-stairs, while a room on the west has been consolidated by demolishing a partition. The second staircase clearly reflects the style of the main stair, though on a lower scale (Plate 21). It rises in dog-leg form on a closed string with square chamfered newels capped by ball finials, moulded hand-rail and turned balusters. Pendant finials mark the underside of the stair at each level. The lower area is panelled and conceals a stair leading down to the basement. This was once enclosed by but only the textured overlight survives.

Plate 21 Back stair at ground floor level, GF10, taken from the west (DP 338)

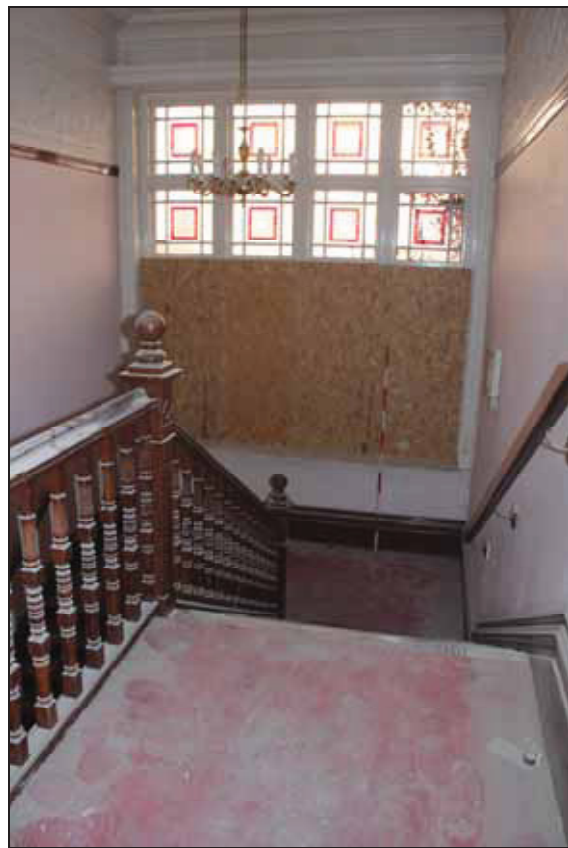
5.72 The staircase rises via an intermediate landing to the upper gallery, and is lit on the west by a large window with four tall lights and eight upper panes enriched by geometric patterns in pink and red glass, all set in a heavily moulded architrave (Plate 22). The upper parts of the wall have a deep plaster frieze of rinceau decoration and plaster panelled ceiling in the Jacobean style. Arched apertures are framed at upper level with square columns.

Plate 22 Staircase from first floor level, FF01, taken from the north (DP 233)

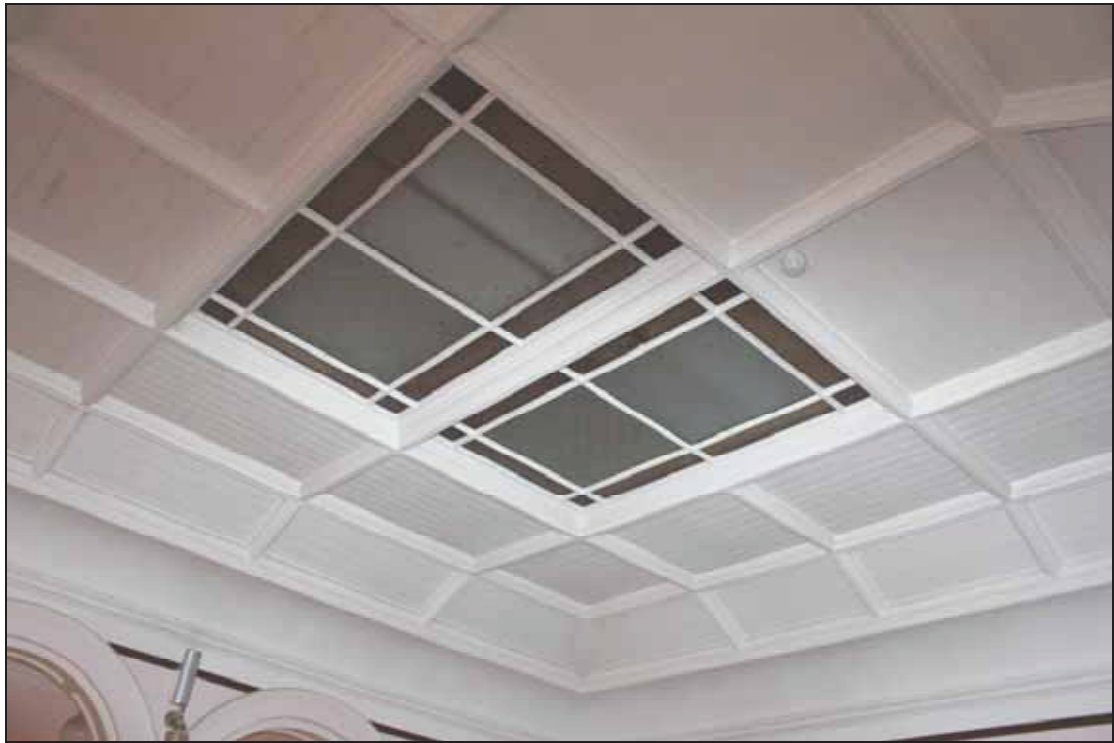
5.74 The ceiling is coved, formed of a series of ribs and match-lined panels surrounding a central lantern (Plate 23). This preserves iron lantern lights with pierced tracery and engraved glazed margins.

Plate 23 Ceiling above FF02, taken from the west (DP 350)

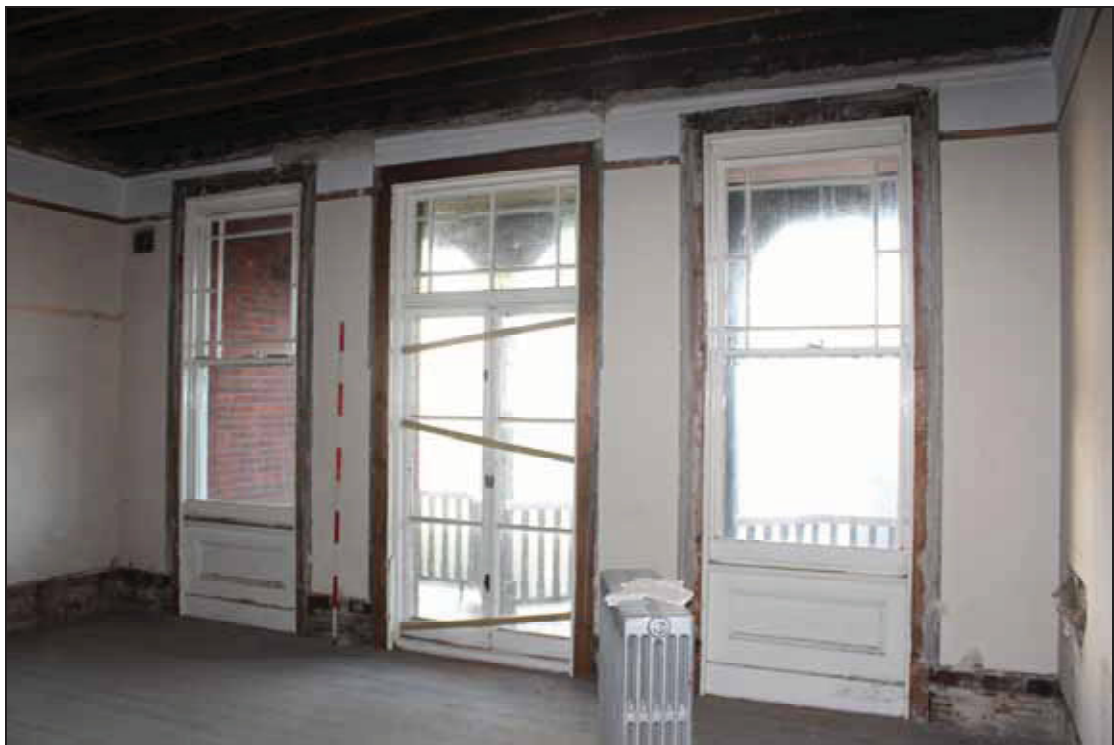
5.79 FF04 lies above the morning room and as such is framed on its western side by the loggia, with access given via a pair of French doors with overlights (Plate 24). These are flanked by large single-paned sashes with margin lights in the upper sash. The exterior wall to the loggia is unusual in being battened over a plaster base, and not of solid brickwork.

Plate 24 Central glazed access to the balcony, FF04, taken from the north-east (DP 248)

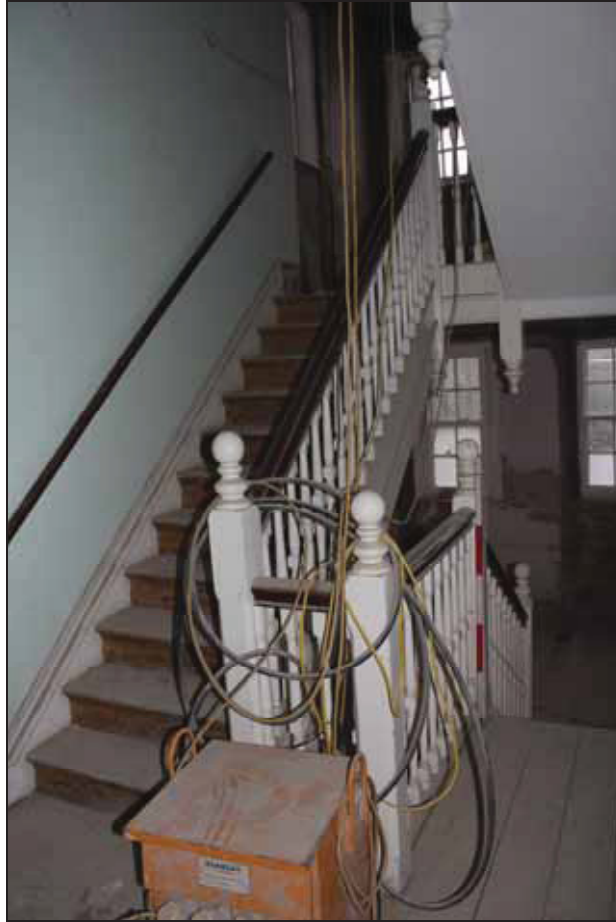
5.90 As described above, two arched apertures on the north of the atrium open into a small vestibule, occupied in the north-west corner by an internal light-well, while a corridor extends to further rooms within the service range, mirroring the layout below. The corridor continues northwards through a number of arched apertures before returning to the east to reach FF14. The back stair and landing occupy the area to the north of the light-well partly situated within the campanile (Plate 25).

Plate 25 Back stair, FF11, taken from the west (DP 292)

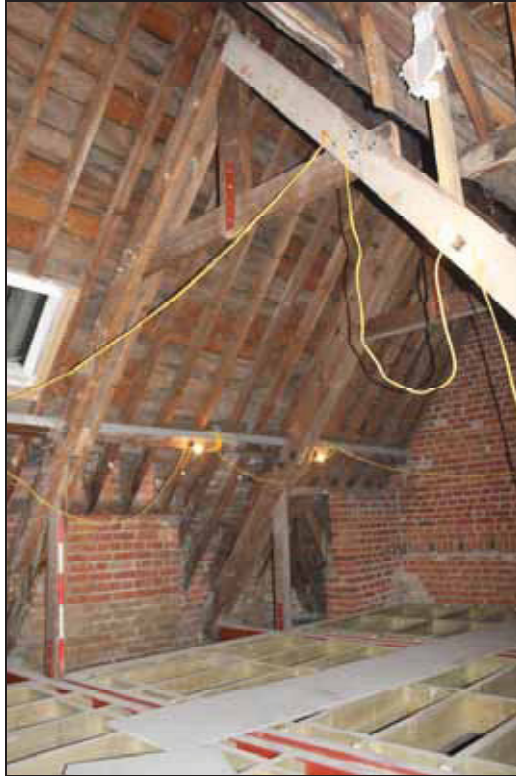
5.109 The roof is a fairly confused construction articulating the various elements of the building. Here, the central core of the building is constructed in yellow stock brickwork before transferring to orange brickwork at the gables and chimney stacks. There are also brick supports for external coving to the gables. The roof itself is fairly simple in the gables and cross-wings, where it is supported by robust paired trusses constructed of principal rafters sandwiched and bolted to chocks (Plate 27). Upper timbers extending between the

Plate 27 Roof space above the east gable of the main house, SF09, taken from the west (DP 322)

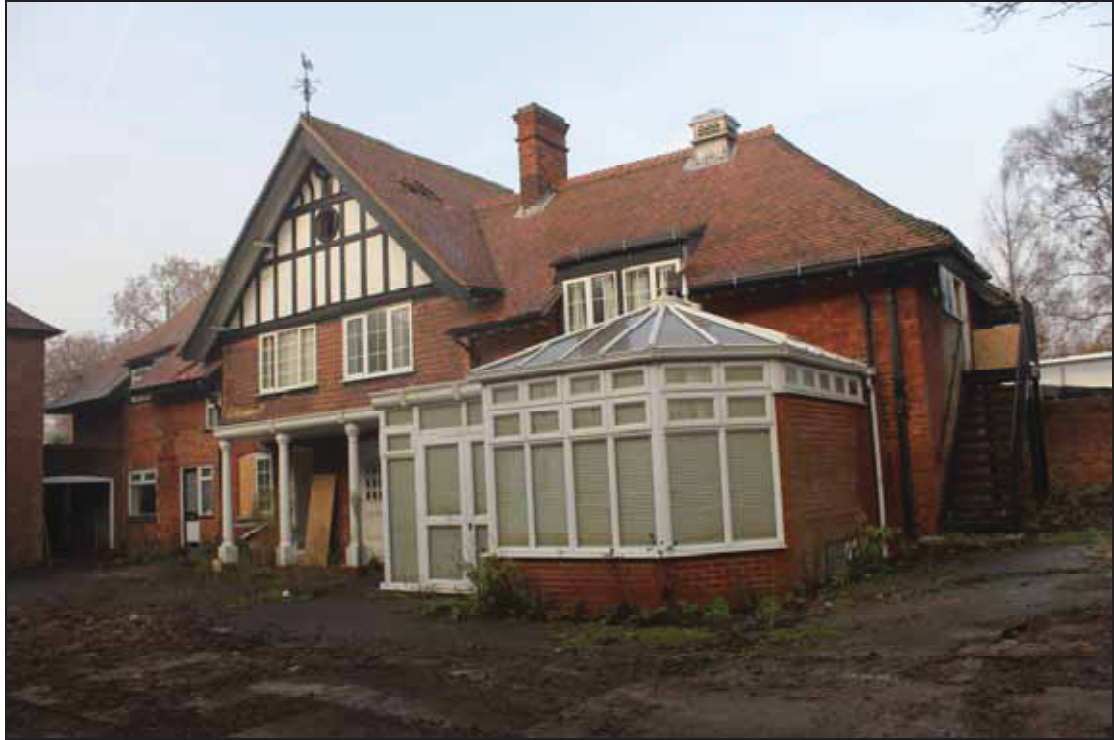
5.114 The north-eastern arm of the stable block dates to 1900 (Plate 29) and may once have stood independently, but is now abutted on the west by a modern garage. Its style reflects the Arts and Crafts-inspired design of the house and is almost domestic in appearance. It is brick-built with central gabled section flanked by bays of equal size, capped by a peg-tile roof hipped at the bay ends. The roof is adorned with decorative ridge tiles interrupted by decorative ventilation cupolas and tall brick chimney stacks. A cast-iron weathervane with a cockerel rises above the gable apex. A modern conservatory and portico have been planted onto the south-western courtyard elevation the majority of the windows have been replaced uPVC.

Plate 29 North-east block of the stable range, south-west elevation, taken from the south (DP16)

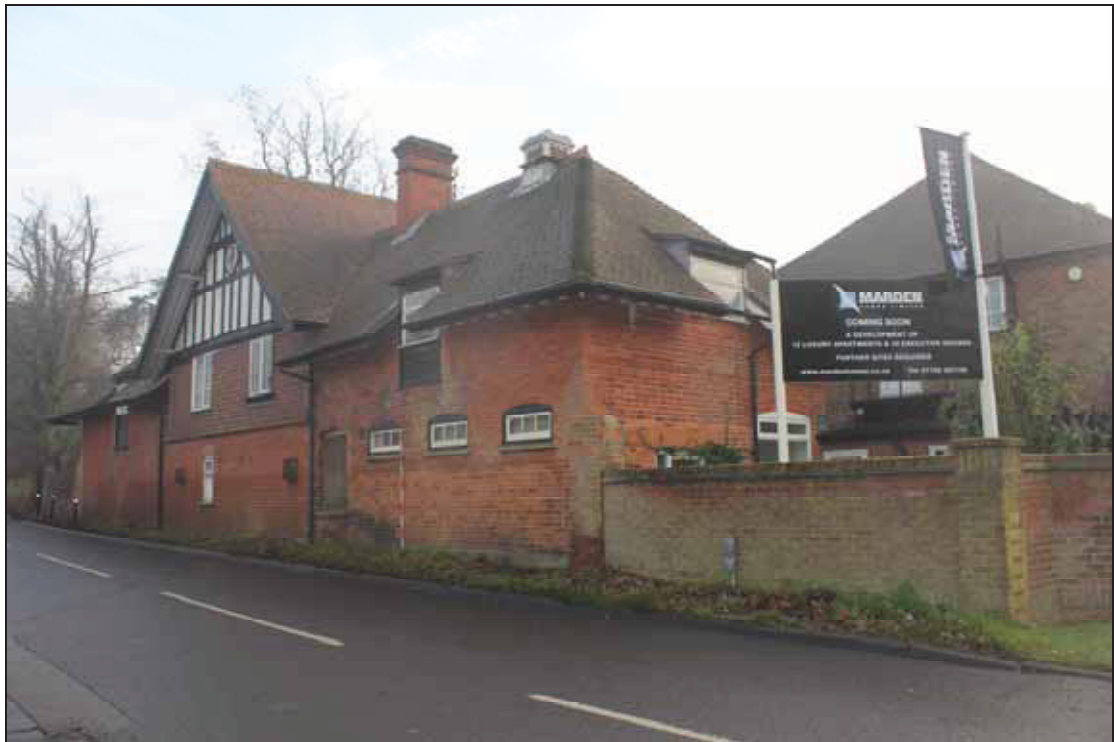
5.124 The north-eastern elevation fronts onto Parsonage Lane and is similar in form to its counterpart on the south-west, with central gabled bay and projecting wings to the left and right (Plate 30). Here, the gabled section is flush with the adjacent wings rising at lower level in blank brickwork, pierced by a single small semi-circular arch headed window centrally is likely a later insertion. As before, a decorative cut brick string course is partly obscured by the tile-hung upper section. Narrow recesses to either side of the upper portions give the impression that the upper storey projects slightly. Here, the elevation is pierced by two, two-light casement windows the right example is original set in a timber frame with decorative timber sill the other is a modern replacement in like style. Mock timber framing adorns the gable, pierced by a circular window mirroring the position of the clock on the south-west.

Plate 30 North-east block of the stable range, north-east elevation, taken from the north-west (DP 20)
