**THE RED HOUSE
84, HIGH STREET, BUNTINGFORD
HERTFORDSHIRE**

HISTORIC BUILDING MONITORING AND RECORDING

Authors: Dr Lee Prosser PhD Lisa Smith BA Kathren Henry	
NGR: TL 36119 29765	Report No. 4377
District: East Herts	Site Code: n/a
Approved: Claire Halpin	Project No. 4586
MIFA	Date: 24 July 2013
Signed:

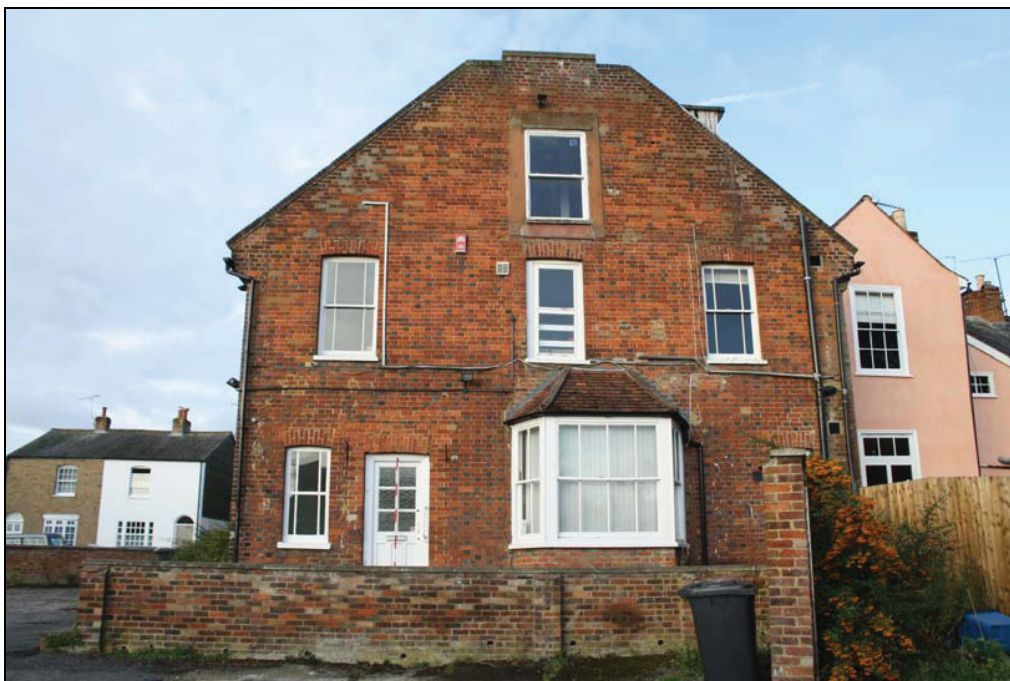
4.7 The range returns to the rear by a plain gable with a crude parapet and truncated apex topped by a soldier-course of brick (Plate 6). Here it is typically Victorian and domestic in appearance. Window and door arches are gauged with cambered soffits. At ground floor level the façade is dominated by a large three-cant bay window with a four-over-four sash window and two-over-two side sashes. A back door to the left has been renewed. Outer windows have the appearance of the sashes but are, in fact casements. At first floor level the fenestration is broadly symmetrical with a central renewed window and flanking sashes. A large attic window in the gable is a modern insert with a rendered surround.

Plate 6 East elevation, taken from the north-east (DP7)

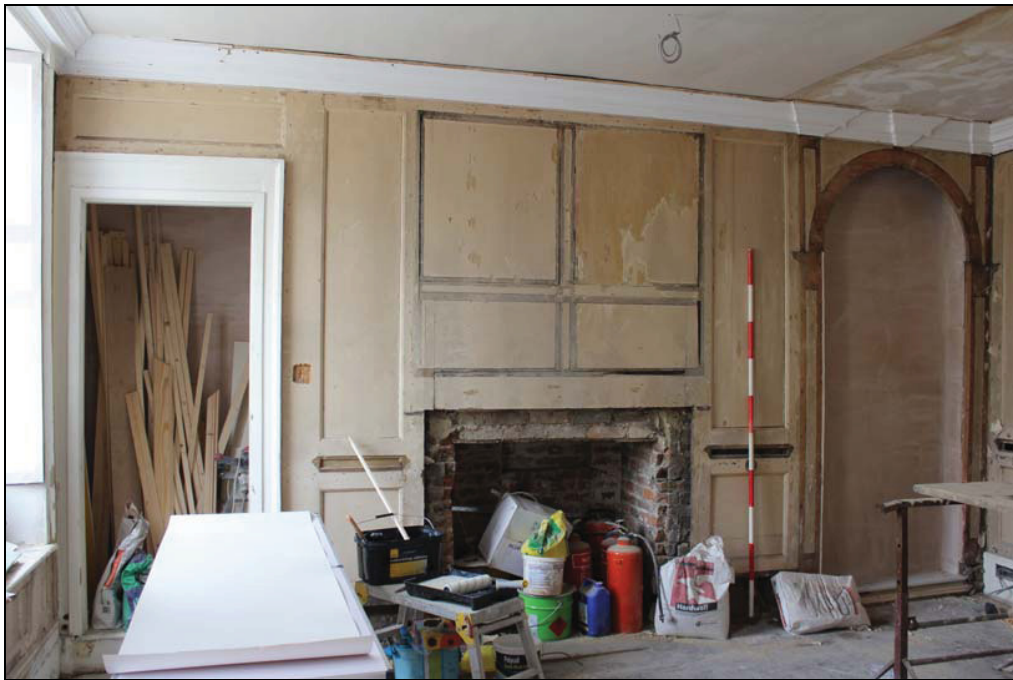
4.20 The removal of modern linings from GF02 reveals perhaps the largest amount of historic material, comprising almost complete 18th century panelling to three of the walls, framed in long, rectangular panels with ovolo mouldings consistent with the early 18th century, but shorn of its original dado rail. The decorative surround has been lost, though a rough bressumer lintel survives. To the right of the fireplace, the remains of an arched 'buffet' or recessed display cabinet was uncovered, and though lacking its original decorative embellishments, these can still be discerned in outline, indicating pilasters, capitals and a central keystone (Plate 12). Directly opposite, the cornice is replicated, suggesting either a doorway or a second area of display.

Plate 12 18th Century wall panelling surrounding fireplace, northern wall, GF02, taken from the south-west (DP80)

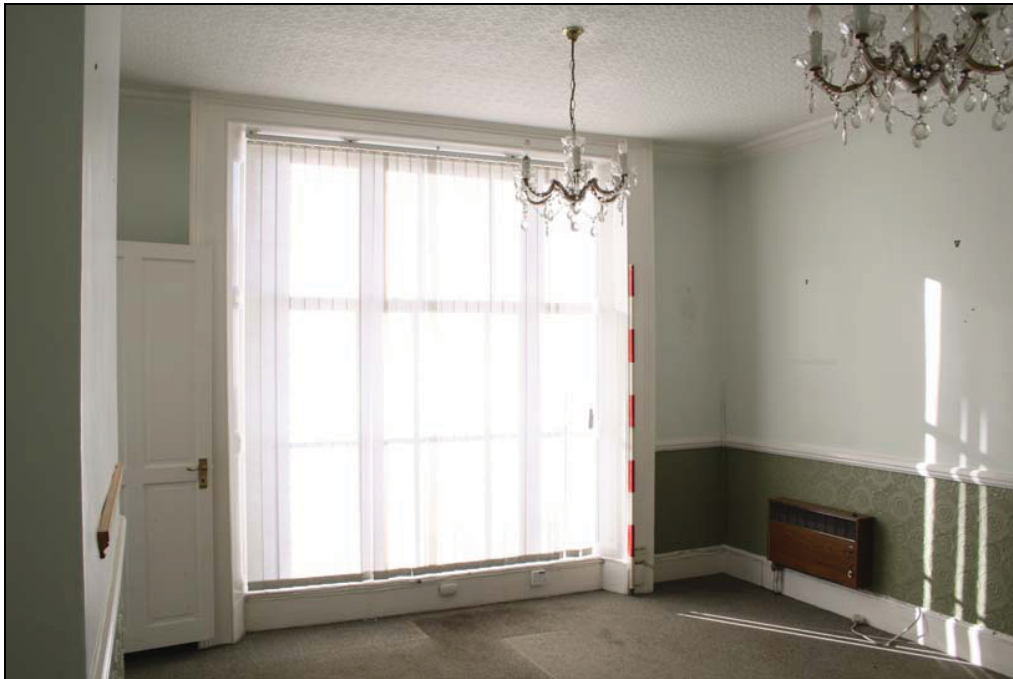
4.23 An original sun-parlour or dining room occupies the north-western corner of the rear range and is given access from the corridor (GF04). The room preserves few historic features, retaining only a Victorian skirting board. A dado rail and cornice are modern introductions. The large window on the south is, however largely intact, set within an applied, boxed architrave which supports panelled shutters, now painted open (Plate 14). The glazing bars of the sashes have early- to mid-19th century profiles.

Plate 14 Large sash window, GF05, taken from the north (DP32)

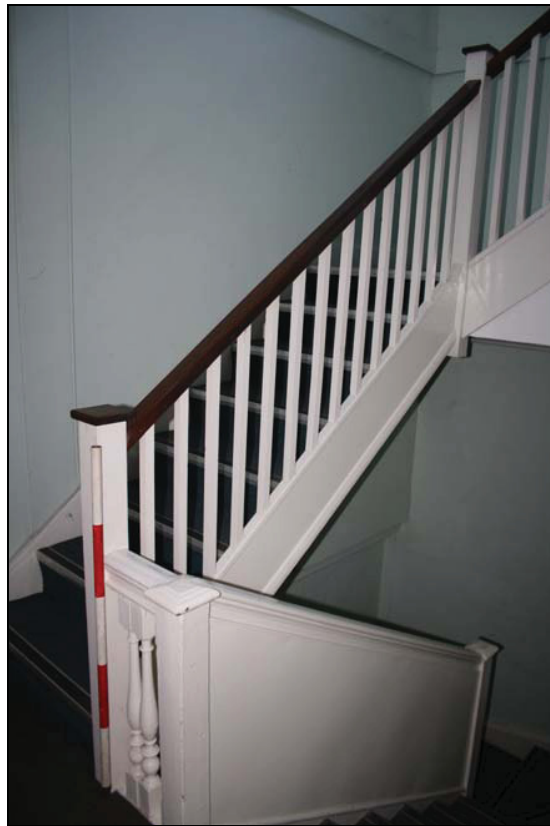
4.27 The staircase appears to have risen originally only to first floor level. It is of dog-leg form, but has been extended latterly into the attics. The lower portion of the balustrade preserves its original handrail of characteristic toads-back profile, with square newels and shaped caps (Plate 16). It is of closed-string form, and preserves its original turned vase balusters, though these were latterly hidden behind flush boarding (Plate 17). Two examples were seen during the original survey, and are of typical, if fairly advanced form for c.1710 but certainly 18th century in date.

Plate 16 Staircase rising to the attic floors, FF01, taken from the east (DP43)

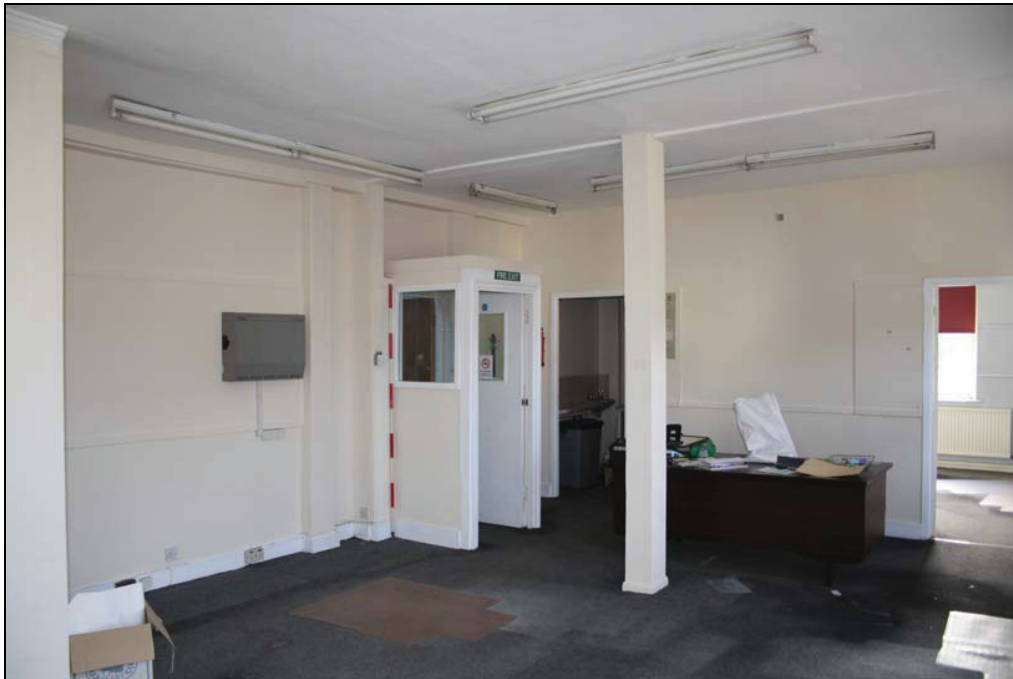
4.30 The principal room overlooks the street, but various boxed-in vertical supports and the line of the cornice suggest consolidation with a smaller, central room and other modifications (Plate 18). The cornice survives on the north and the west, with extra mouldings expressing the fireplace position. It may also have continued to the east, where a scar in the ceiling appears to mark an earlier wall.

Plate 18 FF02, taken from the west (DP53)

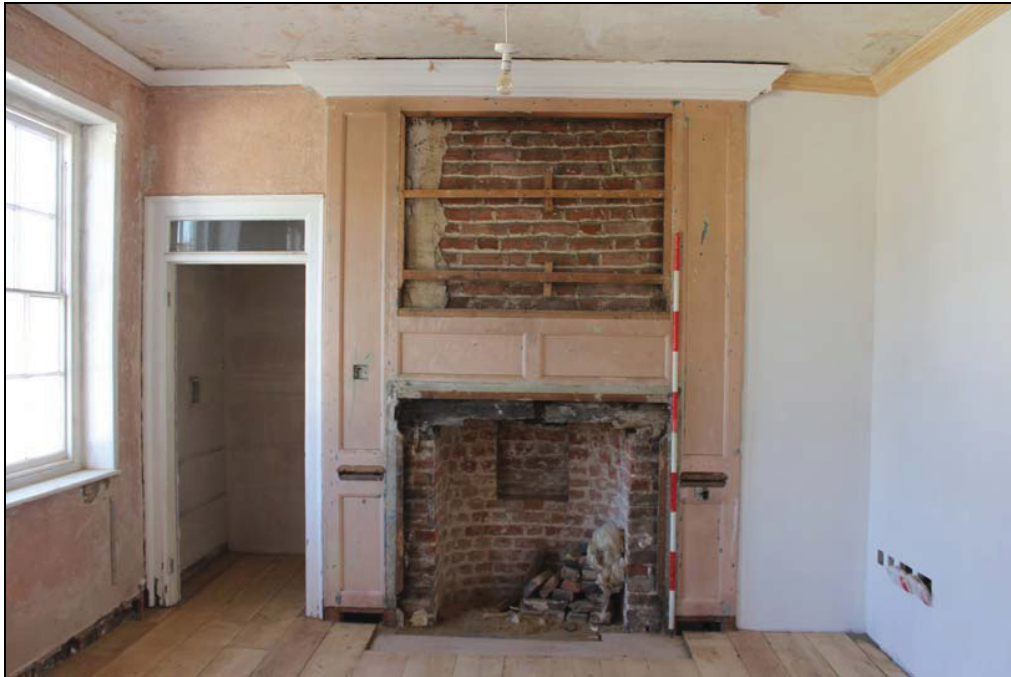
4.33 During the most recent refurbishment, the room was divided along the line of the stanchion to create a vestibule and a small bathroom, thereby significantly reducing its size. Little has been revealed apart from the brick fireplace with curved reveals framed by a timber bresummer and some surrounding panelling in the same style as seen as ground floor level, capped by the robust cornice (Plate 19). Some of the upper panels are, however absent.

Plate 19 Exposed fireplace and surrounding panelling, FF02, taken from the south-east (DP110)

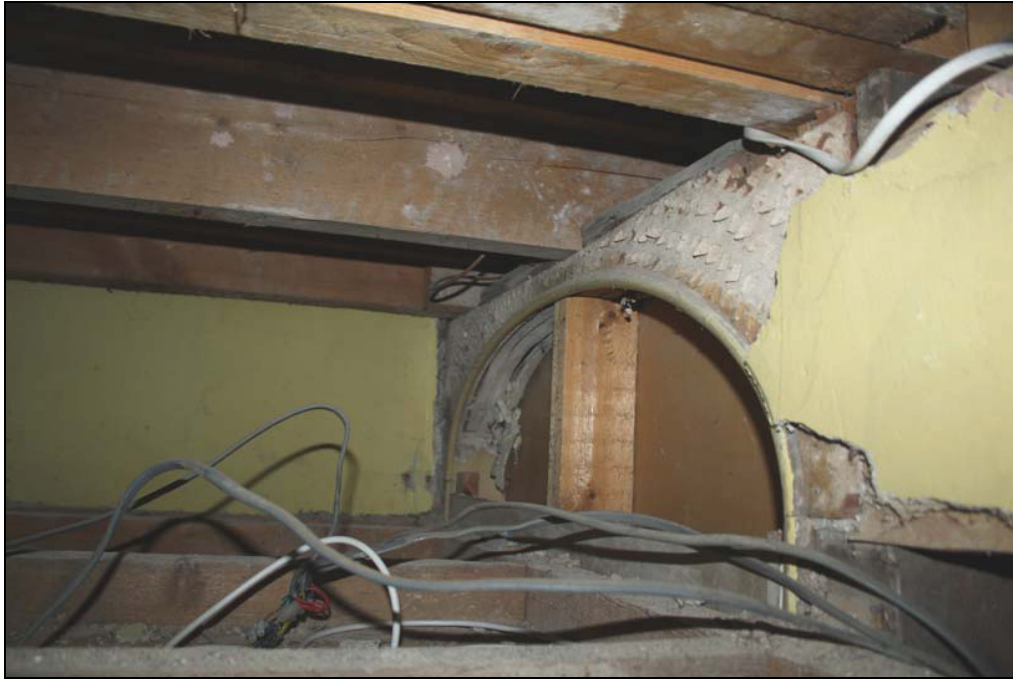
4.39 A pair of enclosed lavatories and small wash-room is of little interest, but a hatch through a suspended ceiling gives access to several features of note. Within it, the timber-framed, formerly external outer wall of the adjoining property is visible, including a wall-plate, the feet of common rafters and studwork with plaster infill (Plate 20). Some remnants of 19th century wallpaper remain attached to the plasterwork. An elliptical arch marking the transition from the staircase hall to the rear range also survives above the modern ceiling line, mirroring its counterpart at lower level (Plate 21).

Plate 21 Arch concealed within in the roof space above FF08, taken from the north (DP60)

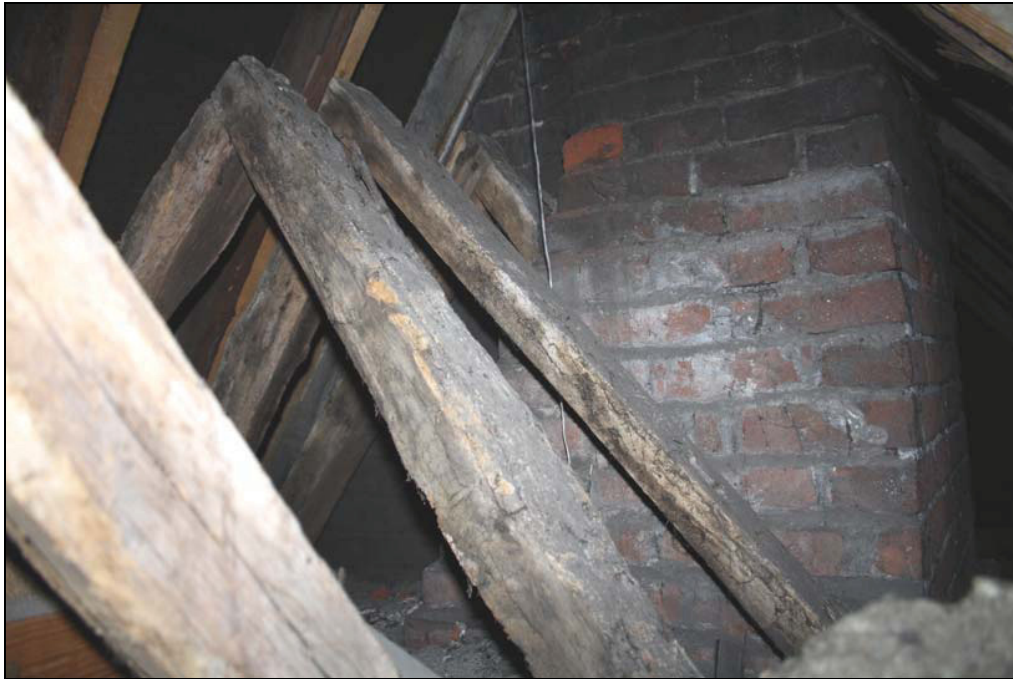
4.40 The attic floor of the main frontage is divided into a series of inter-connecting rooms, while the rear range roof has been raised and consolidated into a single, open-plan space (SF05). The front rooms, SF02, SF03 and SF04 may pass with little comment, being extensively modernised, but elements of the roof form have been left as exposed features, and the upper part of the roof structure is accessible through a loft-hatch (Plate 22). The form is typically late 17th or early 18th century, with principal rafter-couples with staggered butt-purlins, and hipped at the northern end where it abuts the neighbouring property. The rafters appear to be of softwood, with some re-use of older timber. A chimney stack remains expressed at the northern end. Within the roof, small, redundant rafter-couples survive from the original hip to the stack (Plate 23), while the roof of the adjoining cottage can also be seen, and is clearly of later date.

Plate 23 Short span of rafter couples rising between the hip of the roof and the chimney stack superimposed by the later extension to the north, taken from the east (DP73)
