**THURSTON GRANARY, STATION HILL, THURSTON,  
SUFFOLK**

**HISTORIC BUILDING RECORDING**

Level 2

Authors:	Tansy Collins BSc (Fieldwork & report) Lauren Wilson MA (Research)	
NGR: TL 91913 65063		Report No: 4936
District: Mid Suffolk		Site Code: AS
Approved: Claire Halpin MCIfA		Project No: 6272
Signed:		Date: September 2015

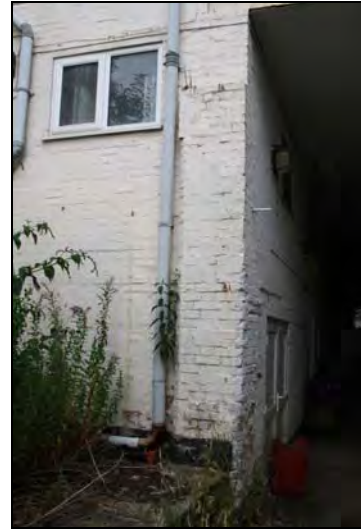
*DP 32  
Detail of the east side of Range 6 showing earlier brickwork at low level with corner pier, taken from the east*

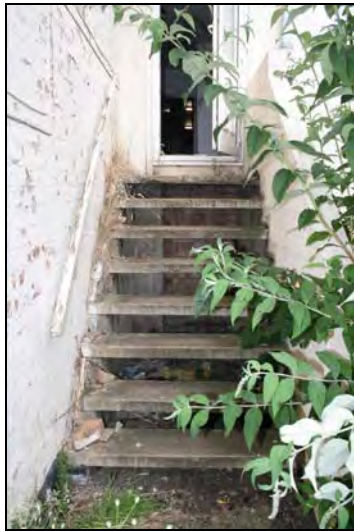
*DP 33  
Steps on the east side of Range 6 leading to first floor level, taken from the east*

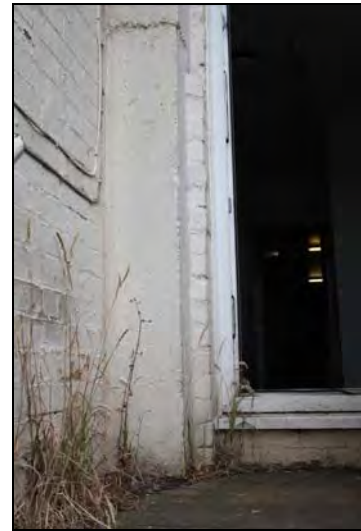
*DP 34  
Detail of the east side of Range 6 showing earlier brickwork at first floor level, taken from the east*

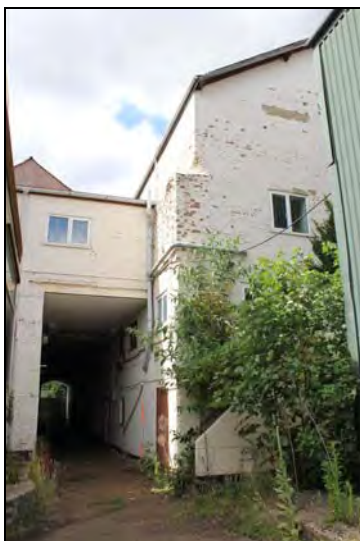
*DP 35  
View of Range 6 (left) abutting Range 9 (right), taken from the east*

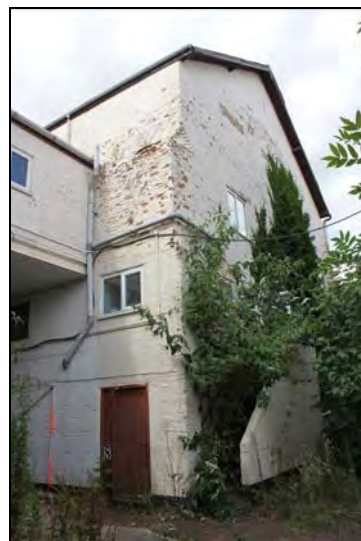
*DP 36  
East end of Range 9, taken from the south-east*

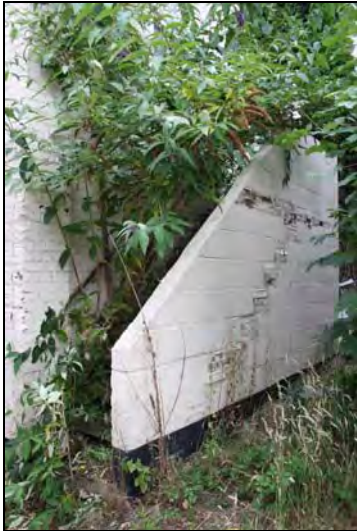
DP 37

*Steps on the east side of Range 9 leading to first floor level, taken from the south-east*

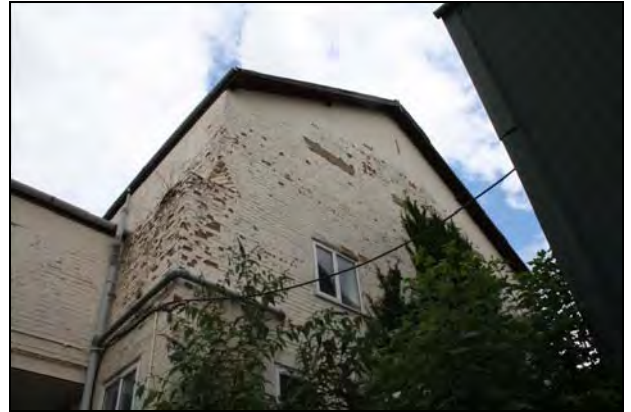
DP 38

*East end of Range 9 at upper level showing alterations including the rebuilding of the corner and blocked apertures, taken from the south-east*

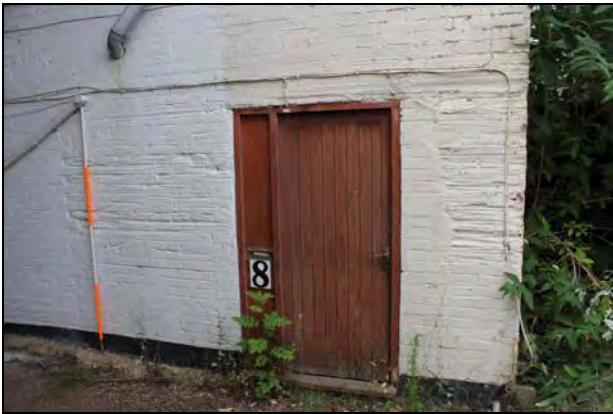
DP 39

*South elevation of Range 9 (east end) showing scarring from the movement of vehicles along the tunnel, taken from the south*

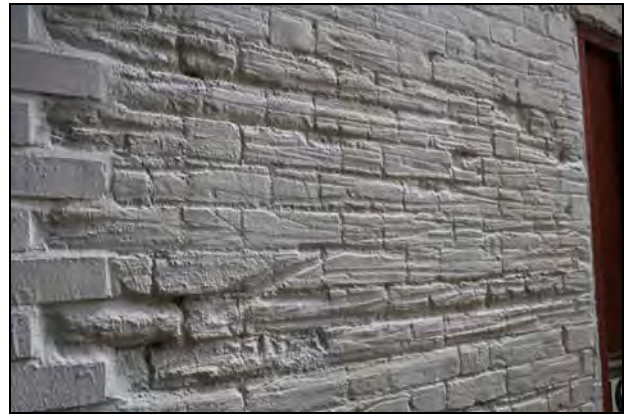
DP 40

*Scarring on the south elevation of Range 9 (east end) from the movement of vehicles along the tunnel, taken from the south-west*

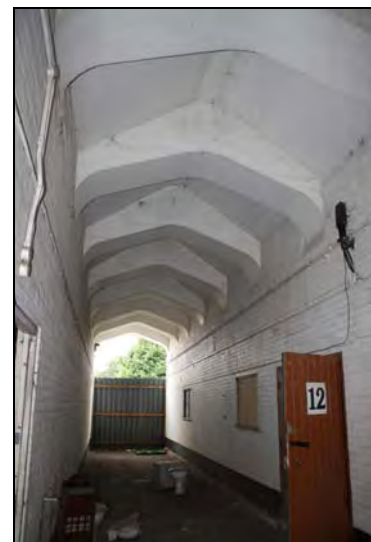
DP 48  
View of the tunnel below Range 1 showing shuttered concrete arches, taken from the east

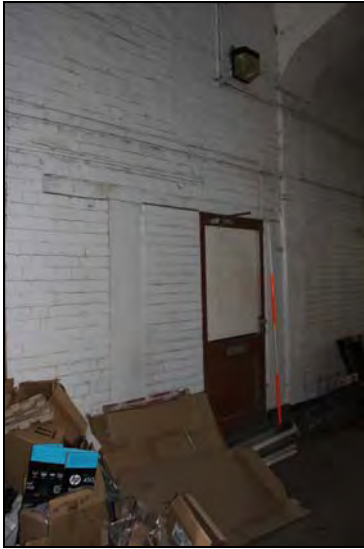
DP 49

*Detail of the south side of the tunnel (Range 6: west end) showing earlier aperture infilled with smaller doorway, taken from the north-east*

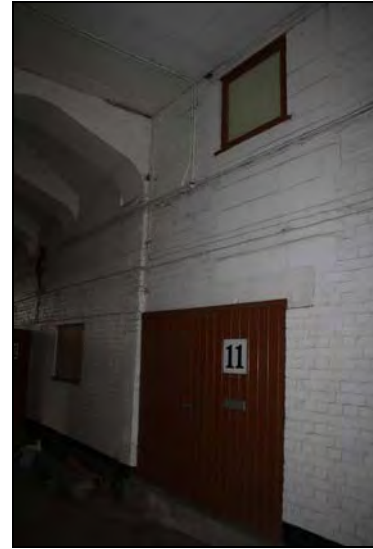
DP 50

*Detail of the north side of the tunnel (Range 6: west end) showing wide aperture, taken from the south-east*

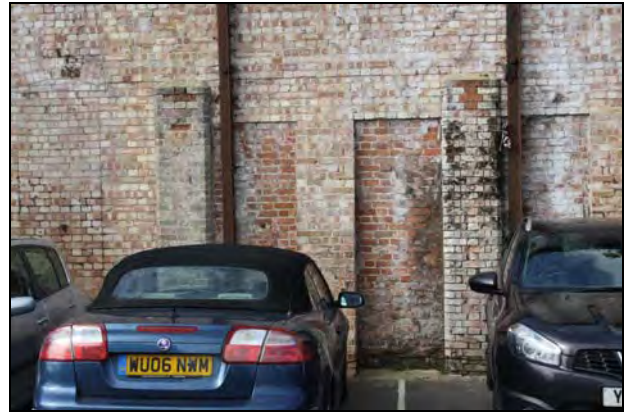
DP 56

*Detail of the north elevation (Range 1) showing original brickwork and pilasters with later Fletton brick construction, taken from the north*

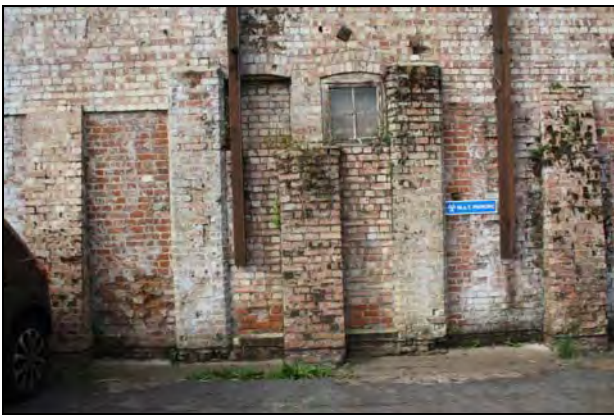
DP 57

*Detail of the north elevation (Range 1) showing original brickwork and pilasters with later Fletton brick construction and small windows, taken from the north*

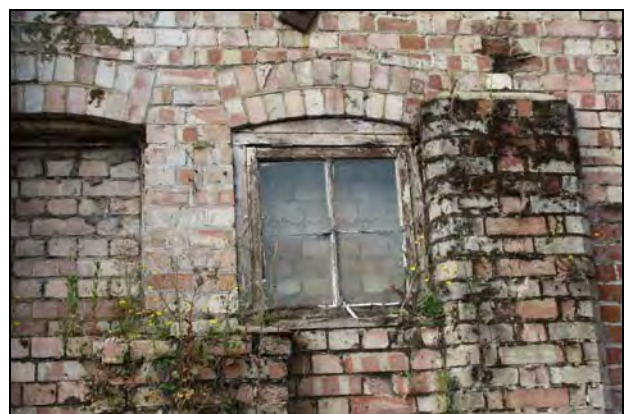
DP 60

*Detail of the north elevation (Range 1) showing small window added as part of the secondary building phase, taken from the north*

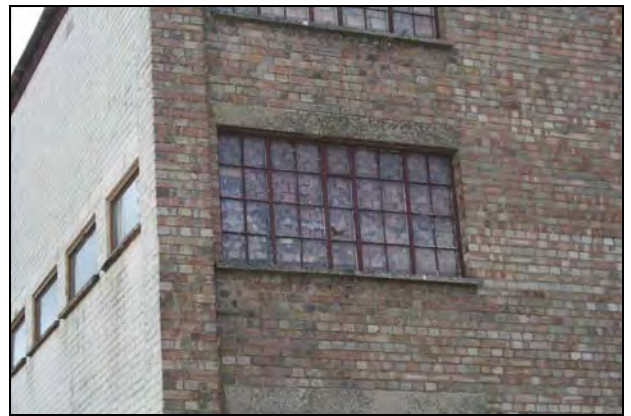
DP 64

*Metal-framed window on the west elevation of Range 9 (second floor) bricked up from within, taken from the west*

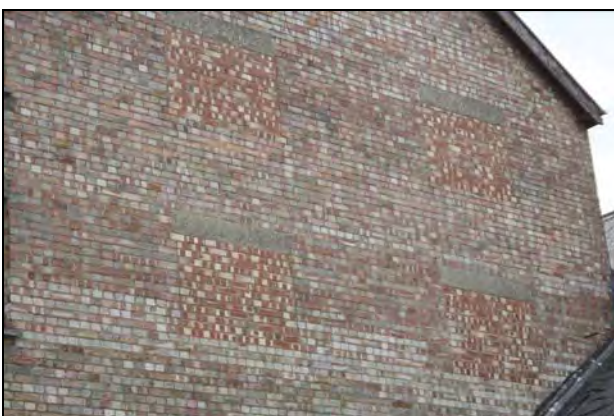
DP 65

*West elevation (Range 9) showing blocked window apertures, taken from the west*

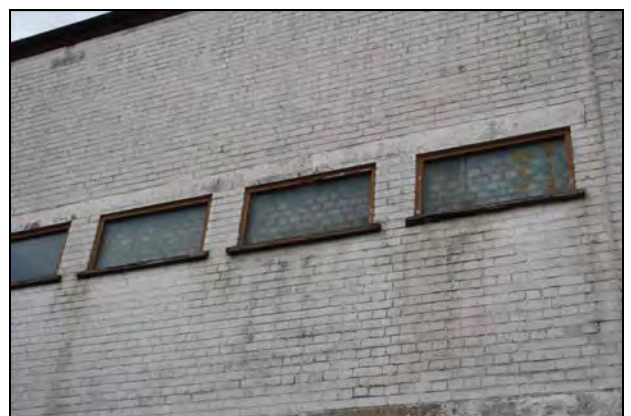
DP 66

*North elevation (Range 9) showing narrow windows bricked up from within, taken from the north*

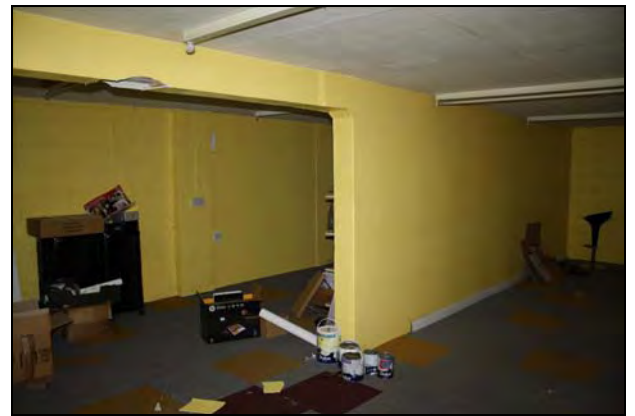
DP 111

*Interior of Range 3 (GF12) with boxed-in steel joists supporting the floor above, taken from the south-west*

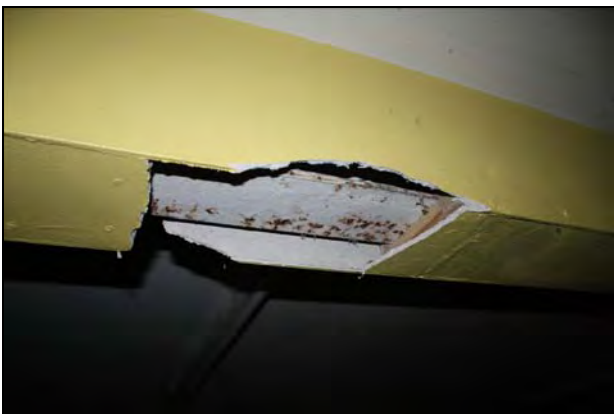
DP 112

*Interior of Range 3 (GF15), taken from the south-west*

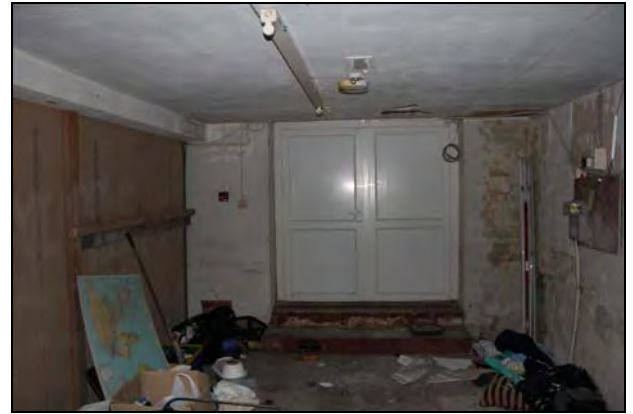
DP 117

*Interior of Range 6 (GF14), taken from the south*

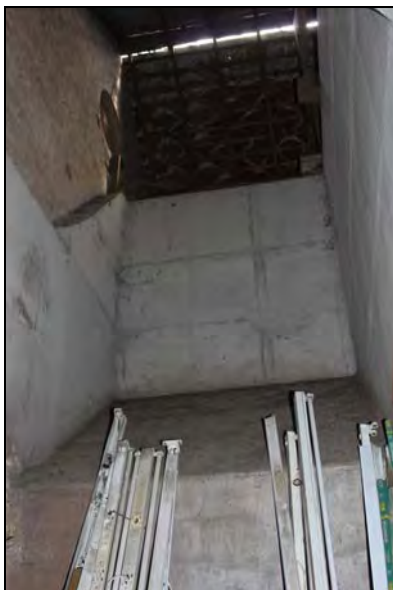
DP 118

*Interior of Range 6 (GF13), taken from the south*

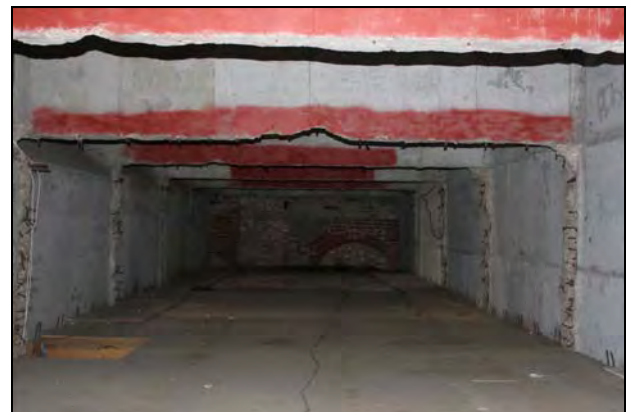
DP 119

*First floor of Range 1 (FF01) showing interior of a concrete silo, taken from the south*

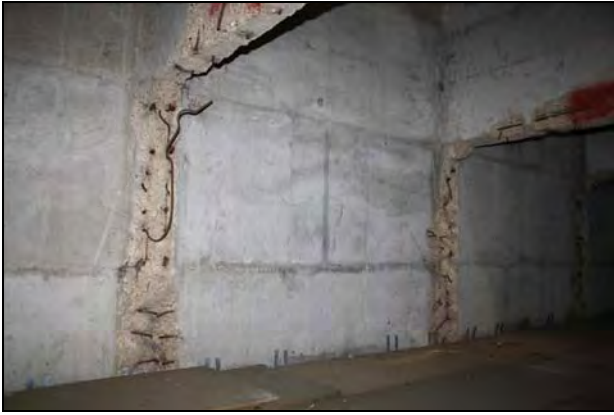
DP 120

*First floor of Range 1 (FF01) showing removed lower concrete structure of the silos, taken from the west*

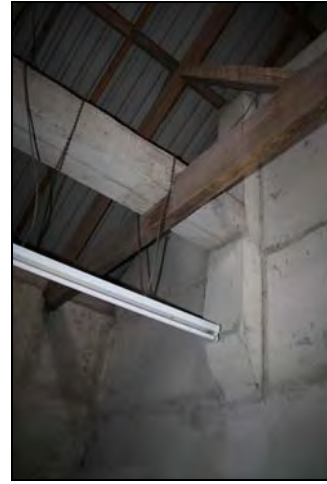
DP 121

*First floor of Range 1 (FF01) showing removed lower structure of the silos exposing the reinforced concrete fabric, taken from the north-east*

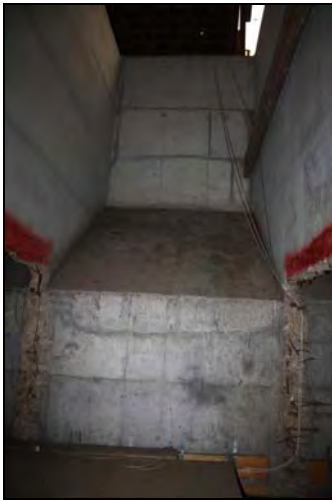
DP 122

*First floor of Range 1 (FF01) showing interior of a concrete silo where the concrete was formed around the pre-existing roof truss, taken from the north-east*

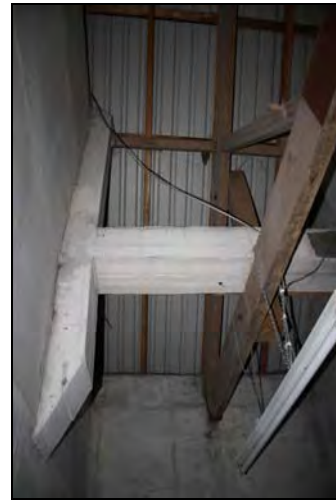
DP 123

*First floor of Range 1 (FF01) showing interior of a concrete silo, taken from the south*

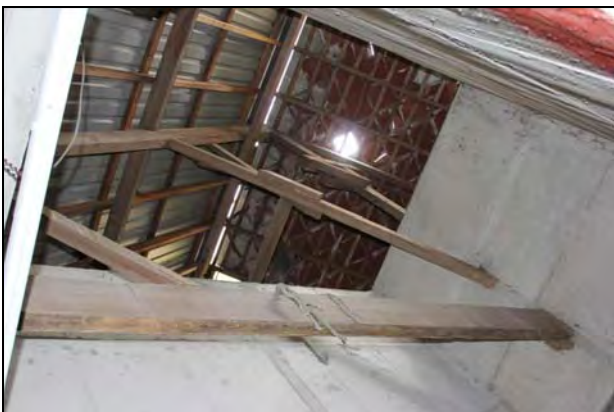
DP 124

*First floor of Range 1 (FF01) showing interior of a concrete silo where the concrete was formed around the pre-existing roof truss, taken from the north-east*

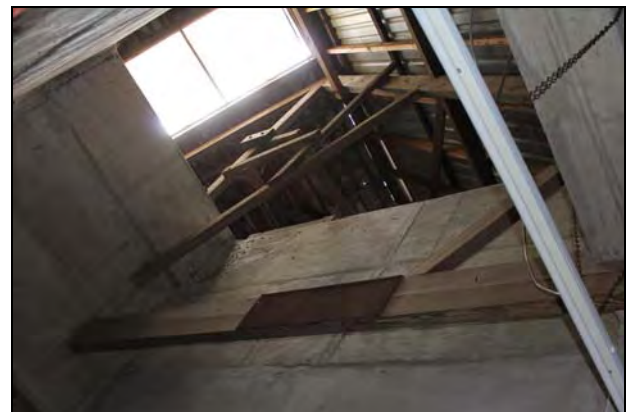
DP 125

*View of the roof structure over Range 1 (FF01) with the later concrete formed around the pre-existing timber, taken from the south*

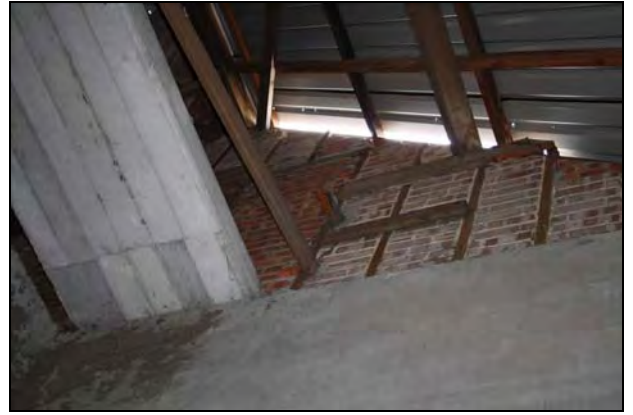
DP 127

5.16 At the east end of the range, further historic fabric survives. Here a single red brick arch is visible with 19<sup>th</sup> century red brick above and to the north, though there has been much replacement in Fletton brickwork, and above slender timberwork is infilled with Fletton brickwork (Plate 7).

*First floor of Range 1 (FF01) showing east wall with earlier brick arch infilled and much rebuilt in Flettons, taken from the west*

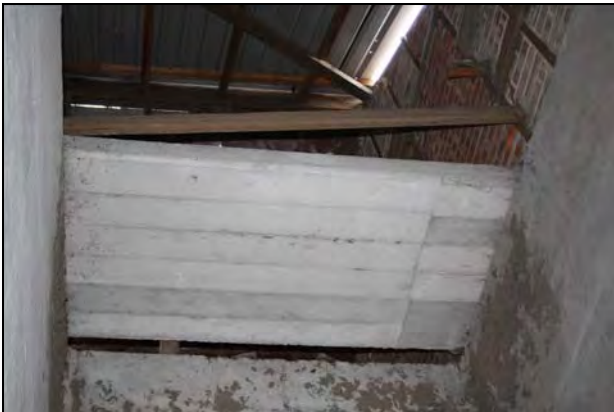
DP 128

*First floor of Range 1 (FF01) showing east gable end showing brickwork infilling timber studwork and blocked doorway formerly leading from the east onto the concrete walkway, taken from the south-west*

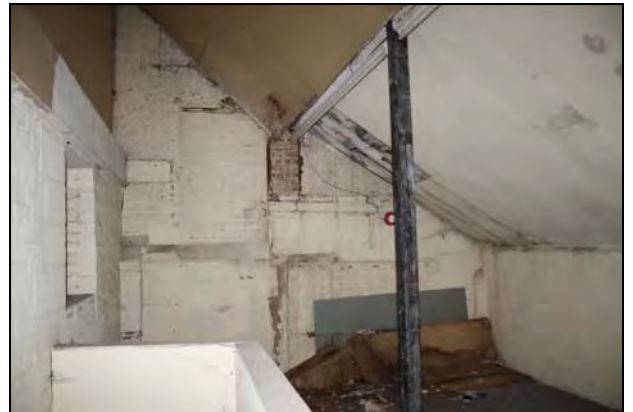
DP 129

*First floor of Range 1 (FF01) showing concrete walkway at the east end, taken from the south*

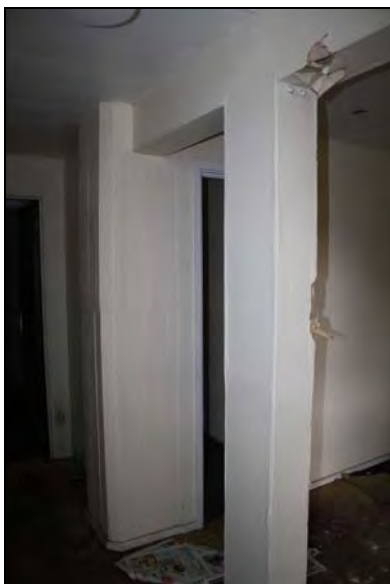
DP 130

*Upper floor of Range 7 (FF02) showing much altered and rebuilt west wall, taken from the east*

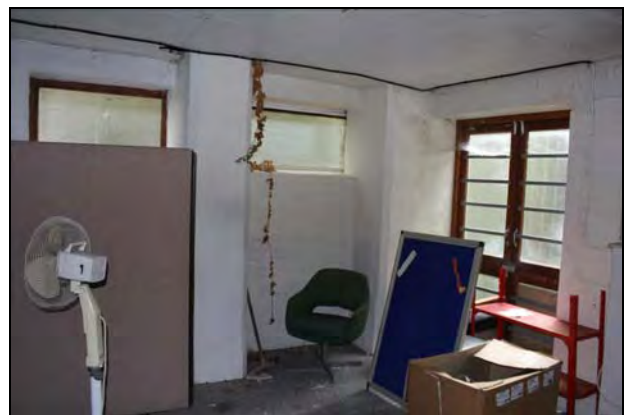
DP 131

*First floor of Range 9 (FF16) showing boxed in I-profile stanchion and large concrete column, taken from the south-east*

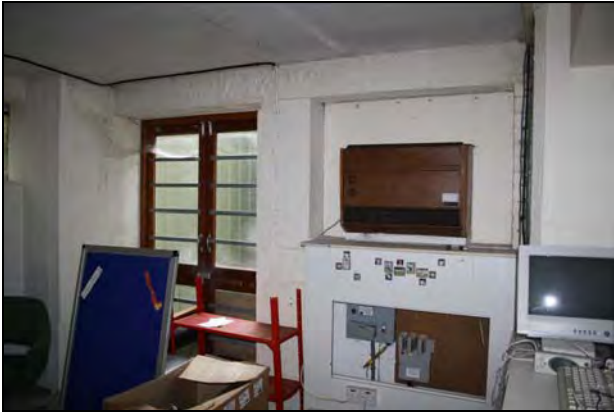
DP 132

*First floor of Range 9 (FF17) showing large concrete columns inserted into the building, taken from the south-west*

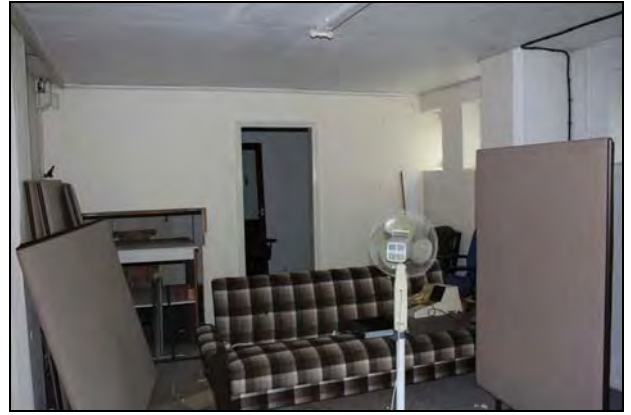
DP 133

*First floor of Range 9 (FF17) showing large concrete columns either side of a modern door and a blocked window, taken from the south-west*

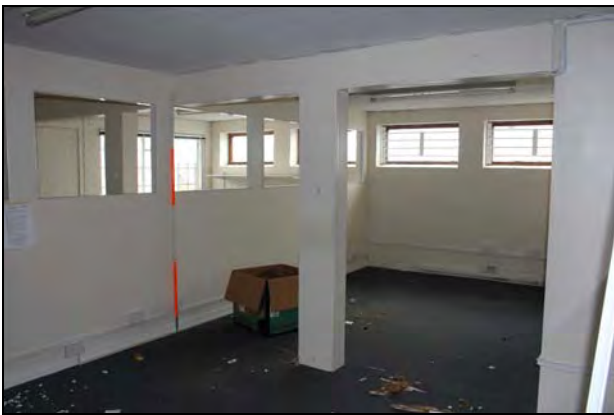
DP 134

*First floor of Range 9 (FF17) showing large concrete columns added on the right and modern internal partitions, taken from the east*

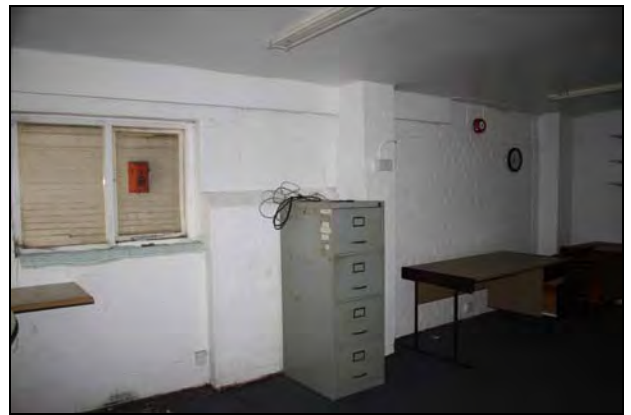
DP 135

*First floor of Range 9 (FF22) showing boxed in I-profile steel stanchions and modern internal partitions, taken from the south-east*

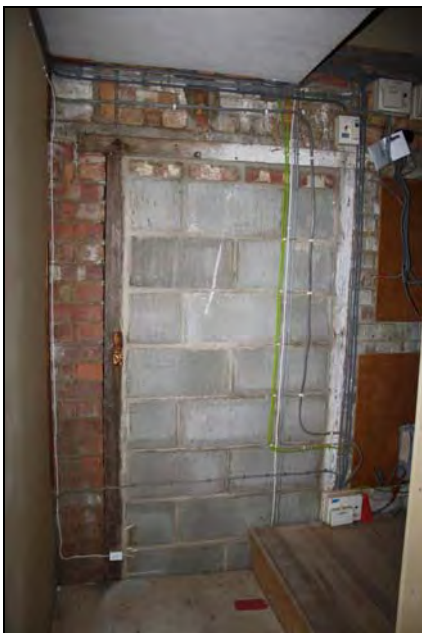
DP 136

*First floor of Range 9 (FF21) showing south wall with various alterations such as blockwork infilling a loading door, taken from the north-east*

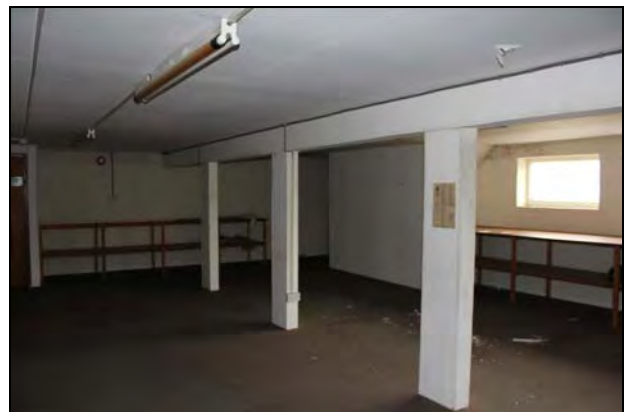
DP 137

*First floor of Range 9 (FF24) showing south wall with blocked loading door, taken from the north*

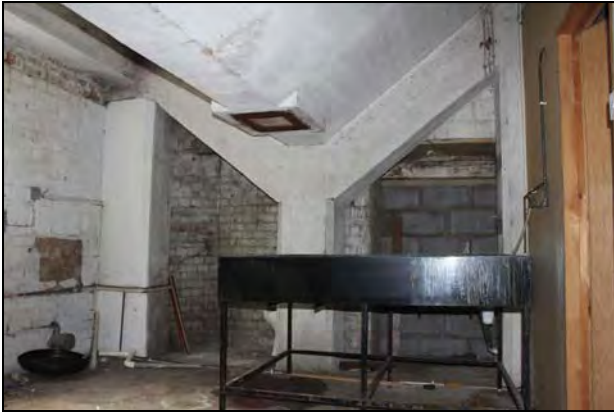
DP 138

*Second floor of Range 9 (SF07) showing boxed in I-profile steel stanchions, taken from the south-east*

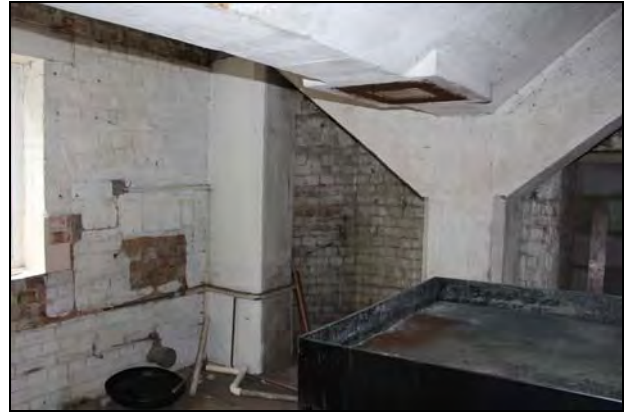
DP 139

*Second floor of Range 9 (SF11) showing the underside of the concrete hoppers supported on the large concrete columns, taken from the north*

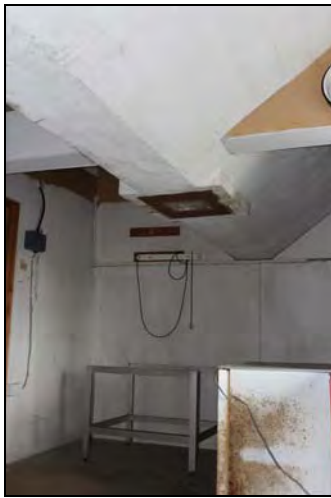
DP 140

*Second floor of Range 9 (SF11) showing the underside of the concrete hoppers supported on the large concrete columns, taken from the north*

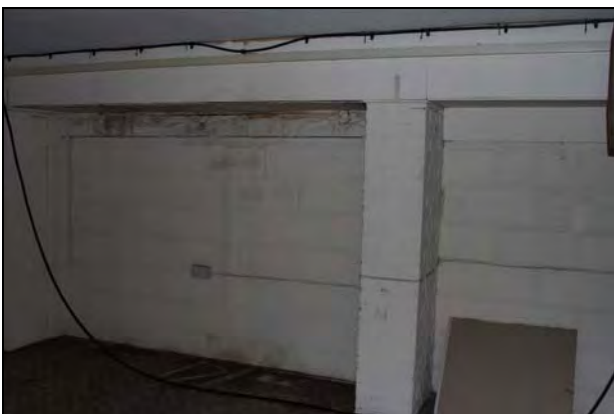
DP 142

*Second floor of Range 9 (SF09) showing rebuilt south wall with modern blockwork behind a brick pier, taken from the north*

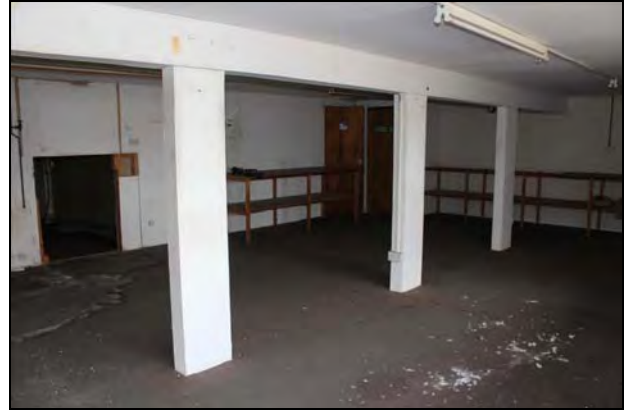
DP 145

*Second floor of Range 9 (SF011) showing the underside of the concrete hoppers supported on the large concrete columns, taken from the west*

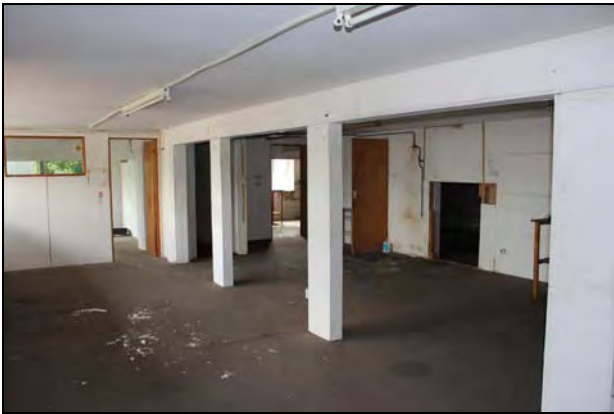
DP 146

*Second floor of Range 9 (SF07) showing boxed in I-profile steel stanchions, taken from the north-east*

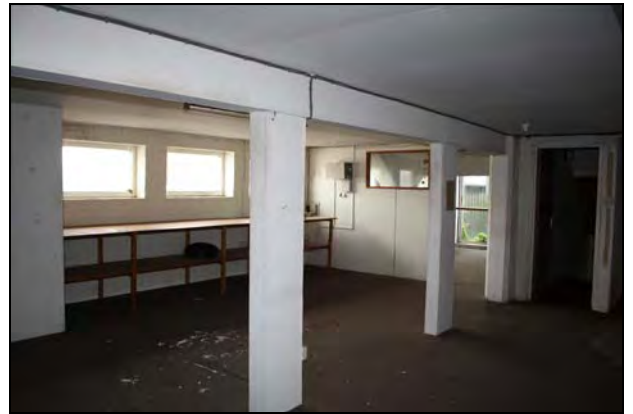
DP 147

*Second floor of Range 9 (SF07) showing boxed in I-profile steel stanchions, taken from the north-west*

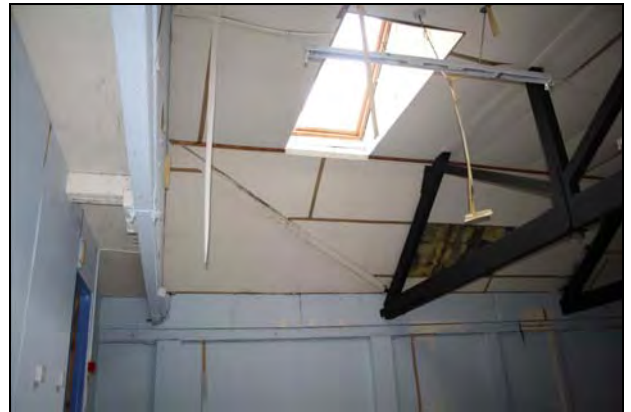
DP 195

*Second floor of Range 6 (SF04), taken from the east*

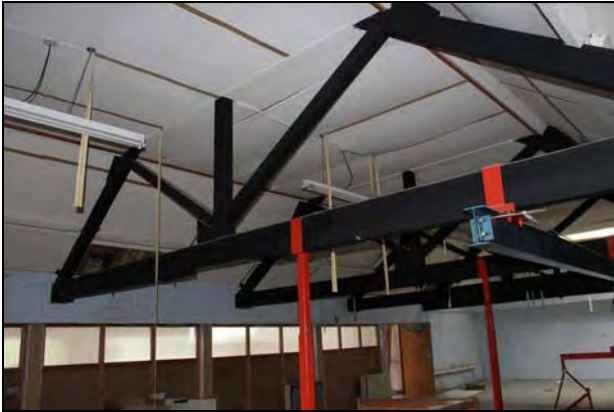
DP 198

*Second floor of Range 6 (SF04) showing detail of a roof truss with metal strapping securing the principal rafter and tie-beam, taken from the west*

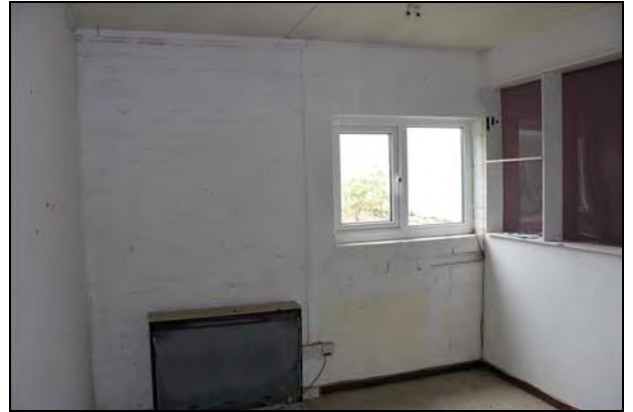
DP 199

*Second floor of Range 6 (SF04) showing the king post roof trusses underdrawn at purlin level, taken from the north-east*

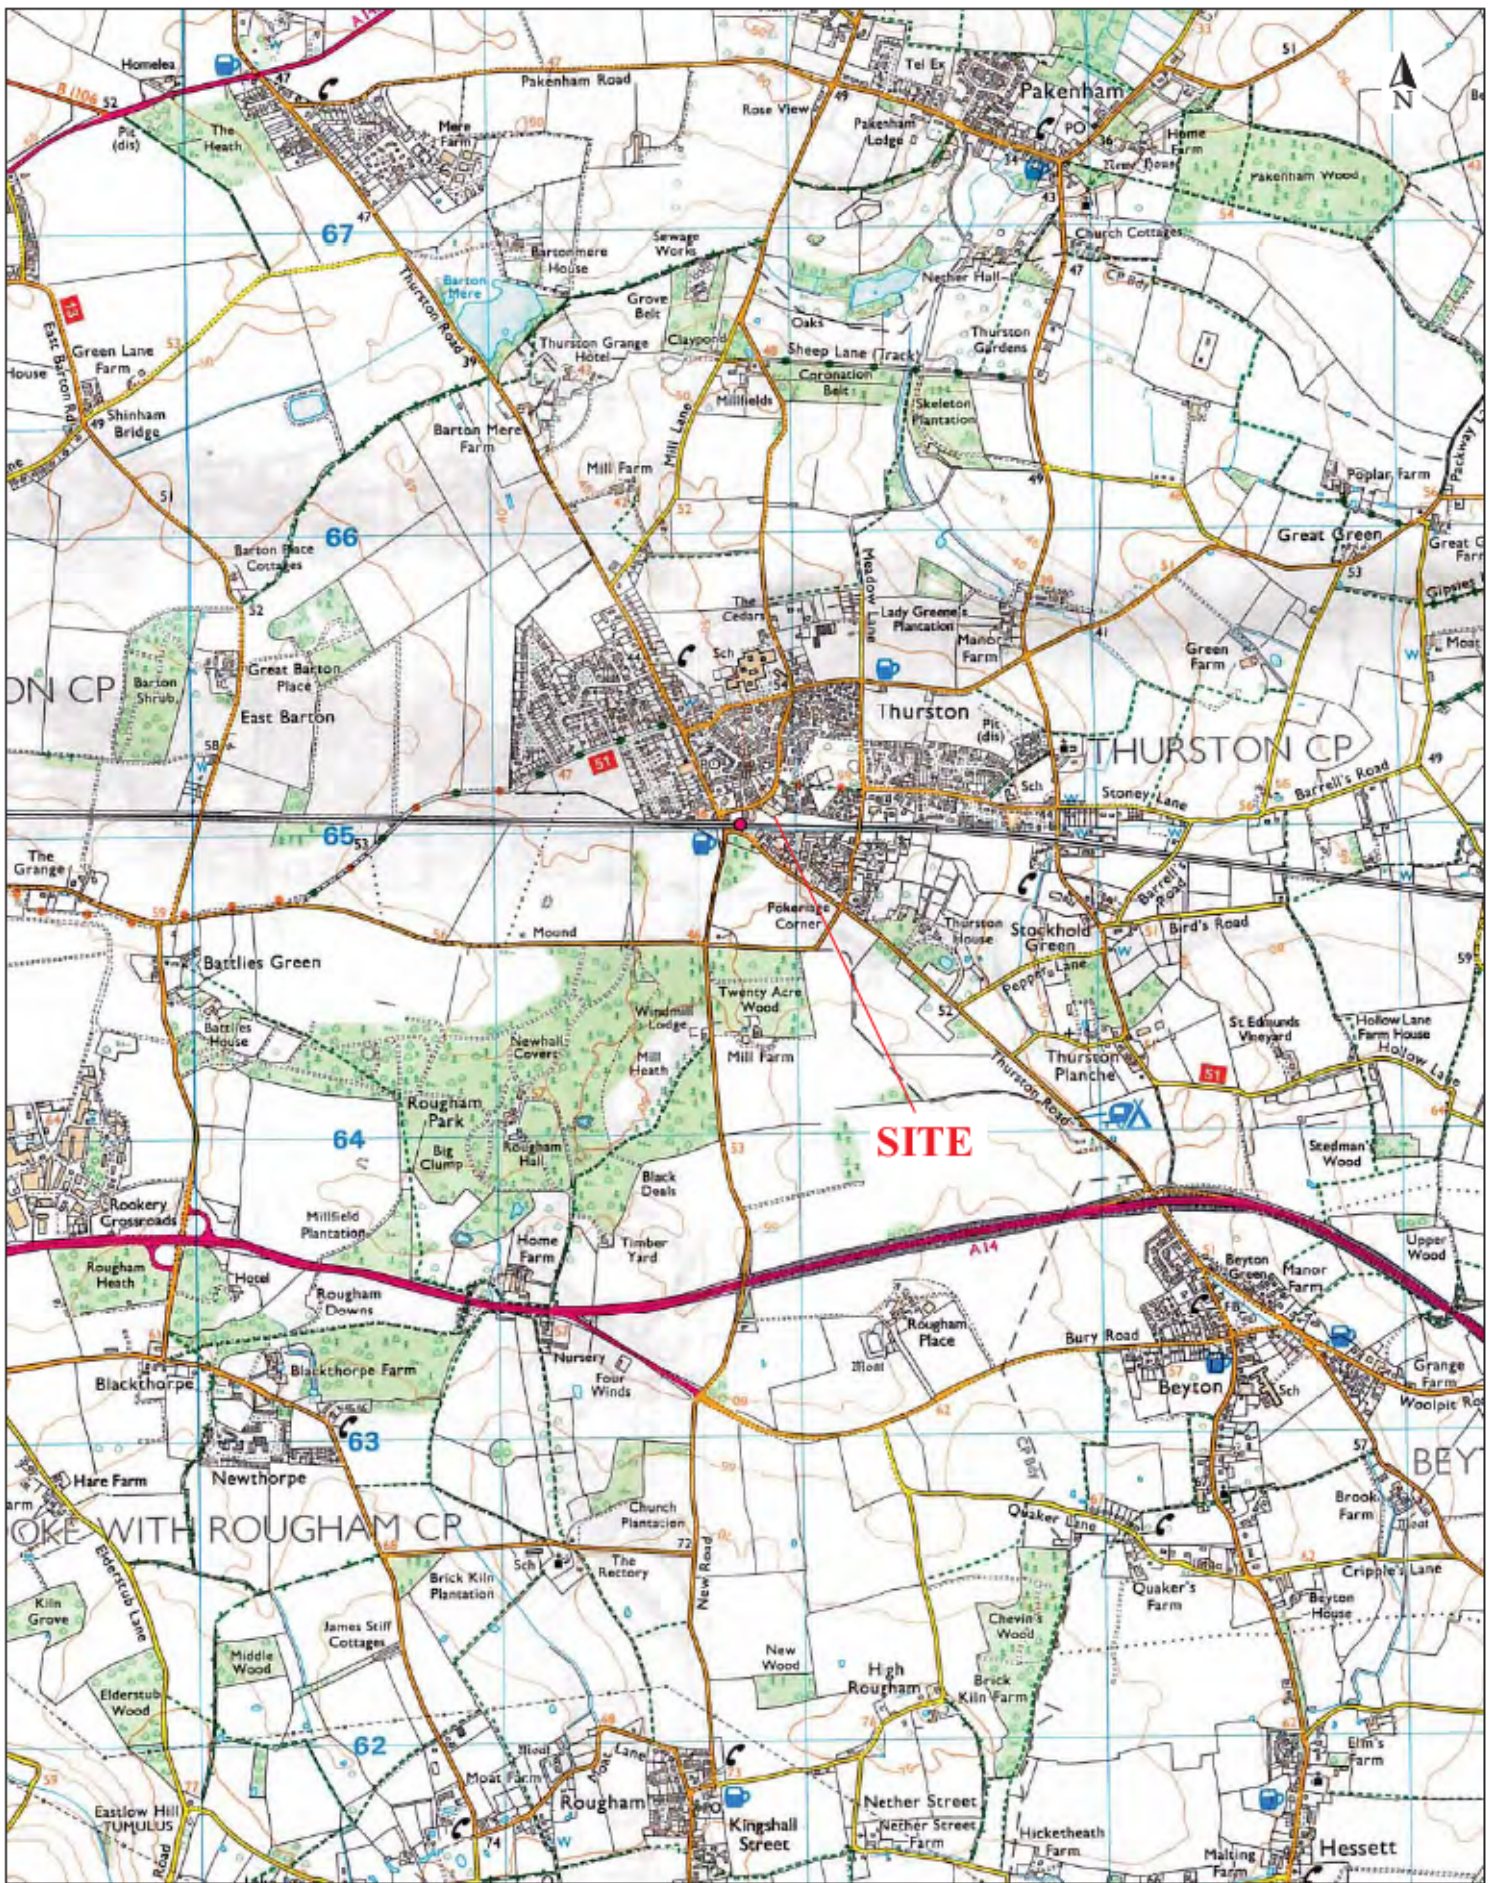
DP 200

*Second floor of Range 6 (SF05), taken from the west*
