DANE FARMHOUSE, BOWER HEATH LANE,  
HARPENDEN, HERTFORDSHIRE

HISTORIC BUILDING MONITORING AND RECORDING

Author:	Lee Prosser PhD Lisa Smith BA Tansy Collins MSt Kathren Henry	
NGR: TL 14846 17321	Report No: 4973	
District: St Albans	Site Code: AS1791	
Approved: Claire Halpin	Project No: 4240	
Signed:	Date: 26 <sup>th</sup> October 2015

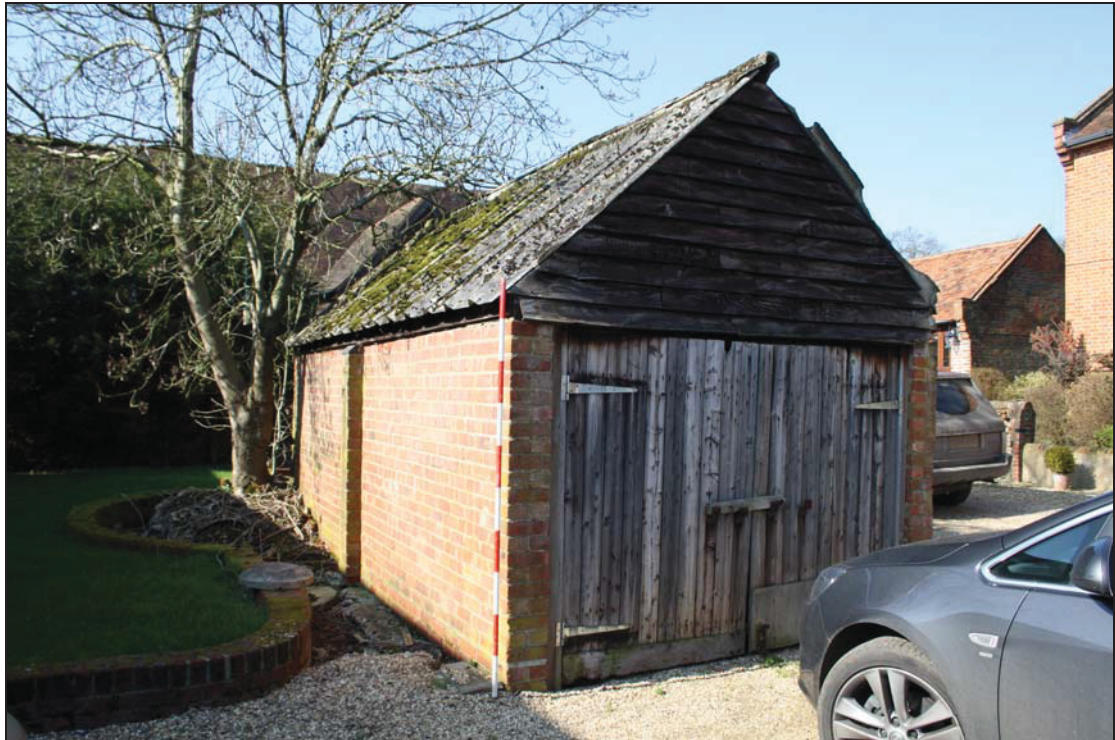
4.36 A poor quality free-standing garage occupies the yard (Plate 10). This is constructed of faced Flettons laid in stretcher bond with some reinforcement to the western gable where a tree has undermined the walls. The roof is covered with corrugated chrysotile asbestos roof. Modern boarded doors, ledged and braced to the rear give access from the east. Above the doors the eastern gable is weather boarded to the apex. Internally the roof is simple with joists inserted to create storage space.

Plate 10 Garage to the south of the house, taken from the south-east (DP 44)
