HISTORIC BUILDING RECORDING AND BUILDING
MONITORING & RECORDING

Authors: Tansy Collins MSt Lauren Wilson MA PCIfA	
NGR: TL 3359 2202	Report No: 5084
District: East Hertfordshire	Site Code: AS1817
Approved: Claire Halpin MfA	Project No: 6561
Signed:	Date: 8 th April 2016

ORCHARD COTTAGE, GREEN END, DANE END, WARE, HERTFORDSHIRE, SG12 0NS

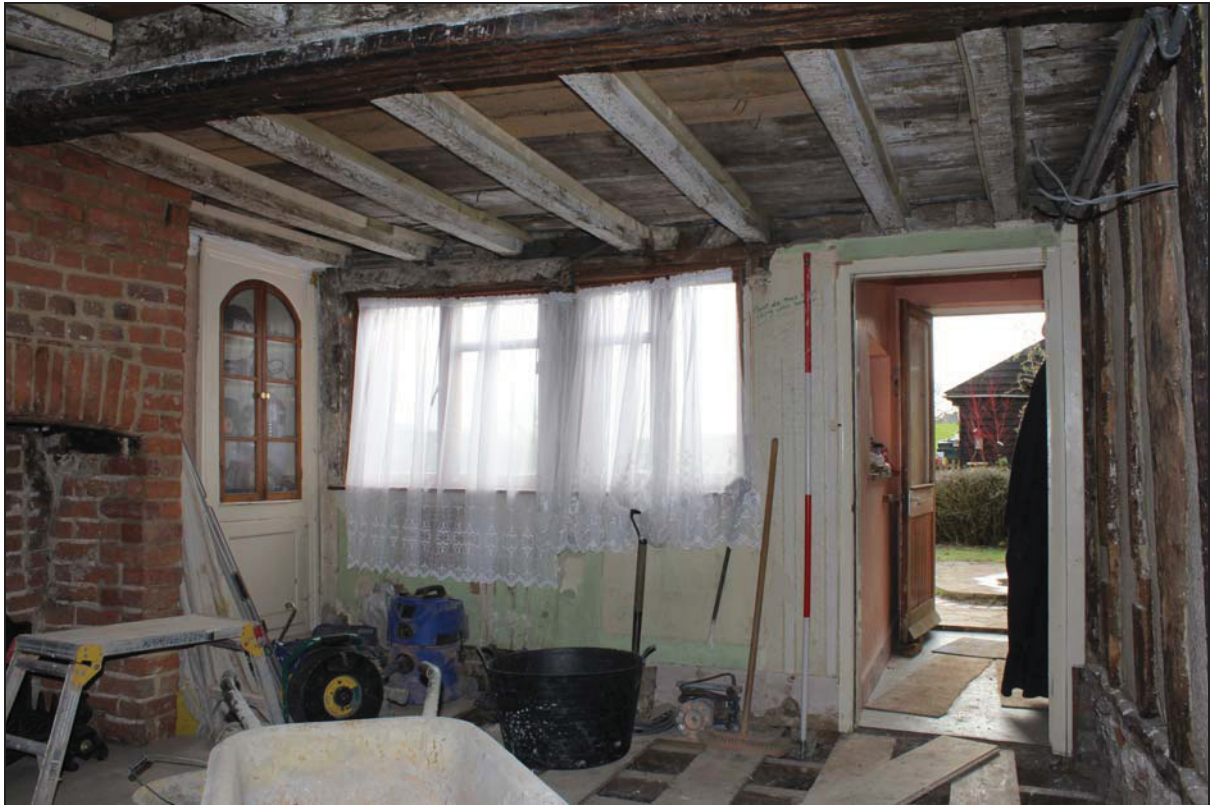
5.13 The south-west wall is the most altered. It contains a modern doorway to Unit 3 with a large modern window adjoining, and there is evidence for much alteration in steel mesh and modern plaster (Plate 8). Nevertheless, historic fabric does survive and includes the corner post in the south-east corner and a partially surviving mid-rail above. The mid-rail has been cut back to one third of its original length and a single lower stud is pegged to support this. Above mid-rail level, upper studs are visible and the end of a brace hanging down that all meet a later timber. During the planned works, the modern plasterwork and window was removed exposing the truncated portions of lower studs over the original sole-plate.

Plate 8 Room GF01 in the historic core of the cottage (main range), taken from the north-east (DP 27)

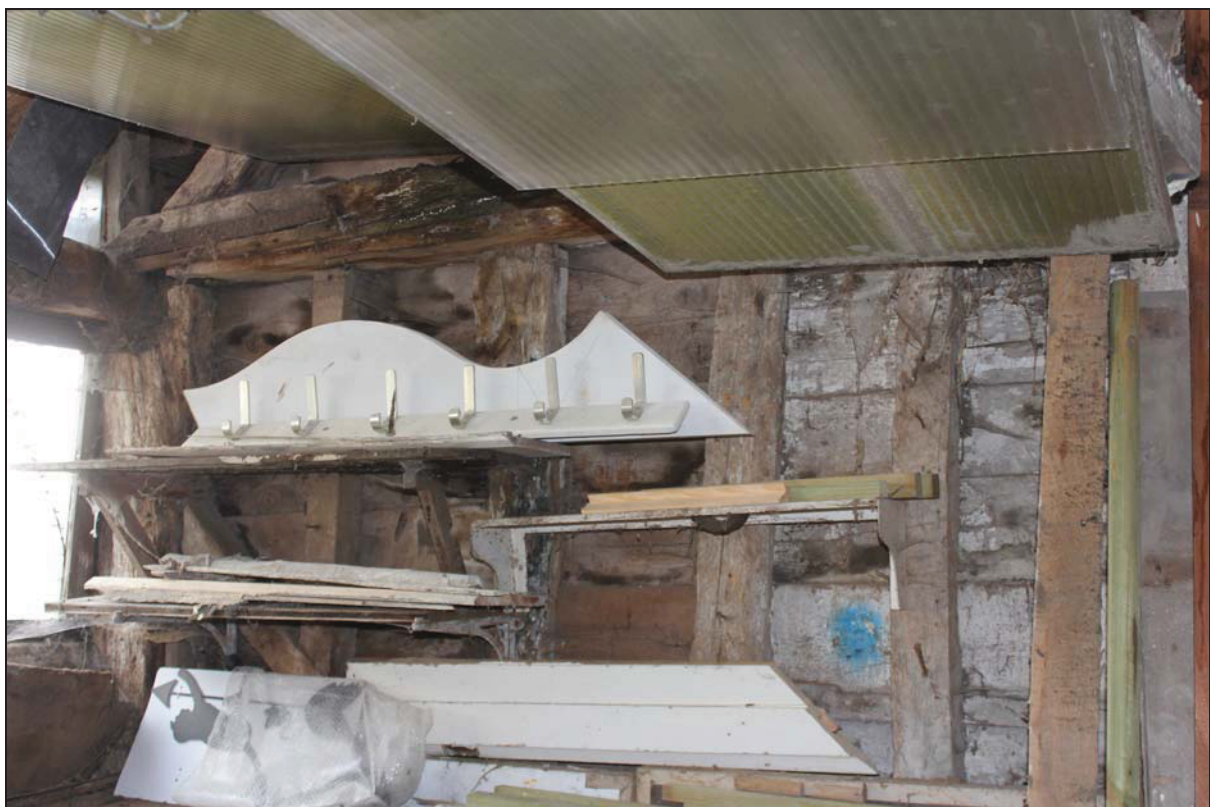
5.29 The surrounding structure extends south-west and includes timber framing of variable form in that the lower wall framing, surviving particularly at the south-west end, is well-constructed and includes outer jowled posts with primary-braced framing (Plate 15). Some members are properly pegged, though occasional examples are nailed and the entire system is not visible due to the volume of items stored. The upper roof structure varies in that there are no proper bay divisions and instead

Plate 15 Detail of the south-west wall of the outbuilding, taken from the north-east (DP 78)

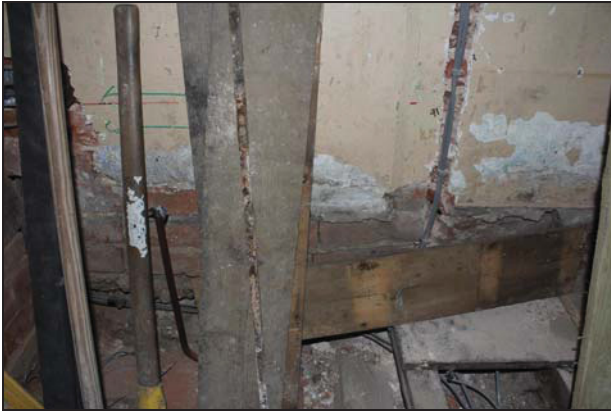
DP 21
Obscured view of the brickwork on the south side of Room GF01 (main range), taken from the north-west

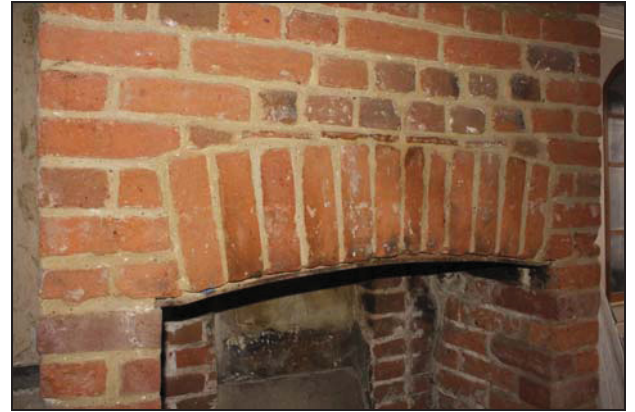
DP 22
Detail of the chimney stack in Room GF01 (main range) showing cambered brick arch and iron soffit strip, taken from the north

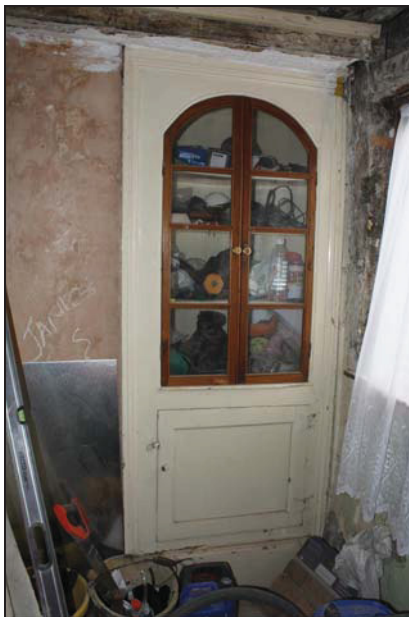
DP 23
Early 18th century fitted cupboard in the south corner of Room GF01 (main range), taken from the north-west

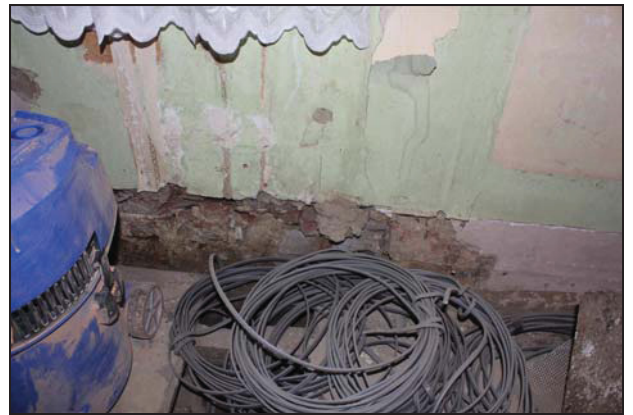
DP 28
Obscured view of the brickwork on the south-west side of Room GF01 (main range), taken from the north-east

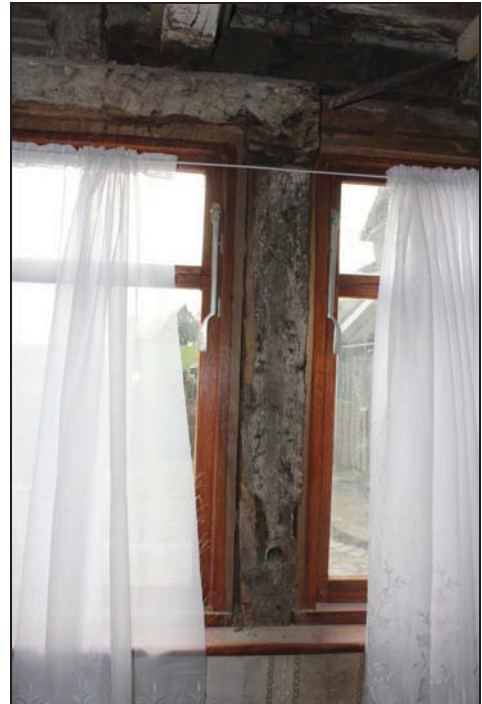
DP 30
South-west side of Room GF01 (main range) showing surviving pegged stud and truncated mid-rail, taken from the north-east
