KITCHENER'S MEADS, 59 FISHPOOL STREET
ST ALBANS, HERTFORDSHIRE

HISTORIC BUILDING MONITORING AND
RECORDING

Author:	Tansy Collins BSc Lee Prosser PhD Kathren Henry	
NGR: TL 14141 07165	Report No: 5011	
District: St Albans	Site Code: FPS15	
Approved: Claire Halpin	Project No: 6100	
Signed:	Date: 11 th December 2015

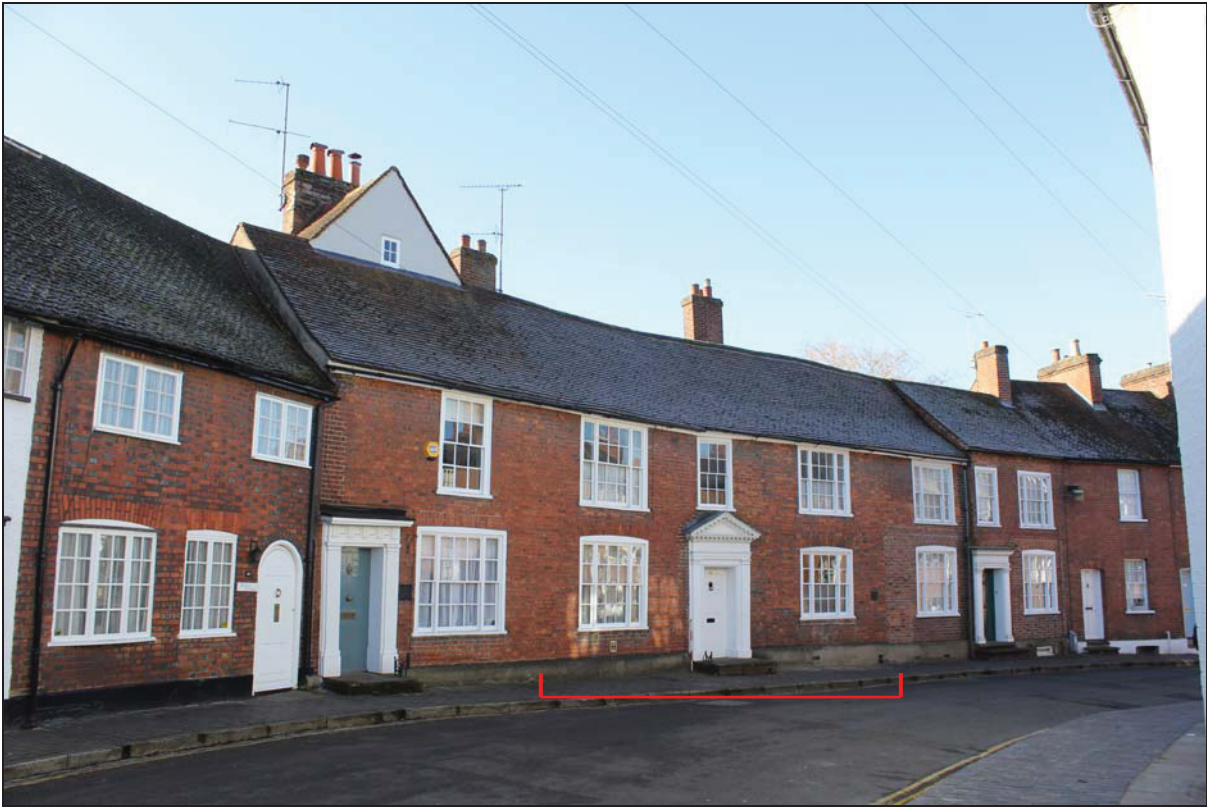
Plate 1 North elevation of No. 59 in context with the adjacent properties, taken from the north-east (DP 01)

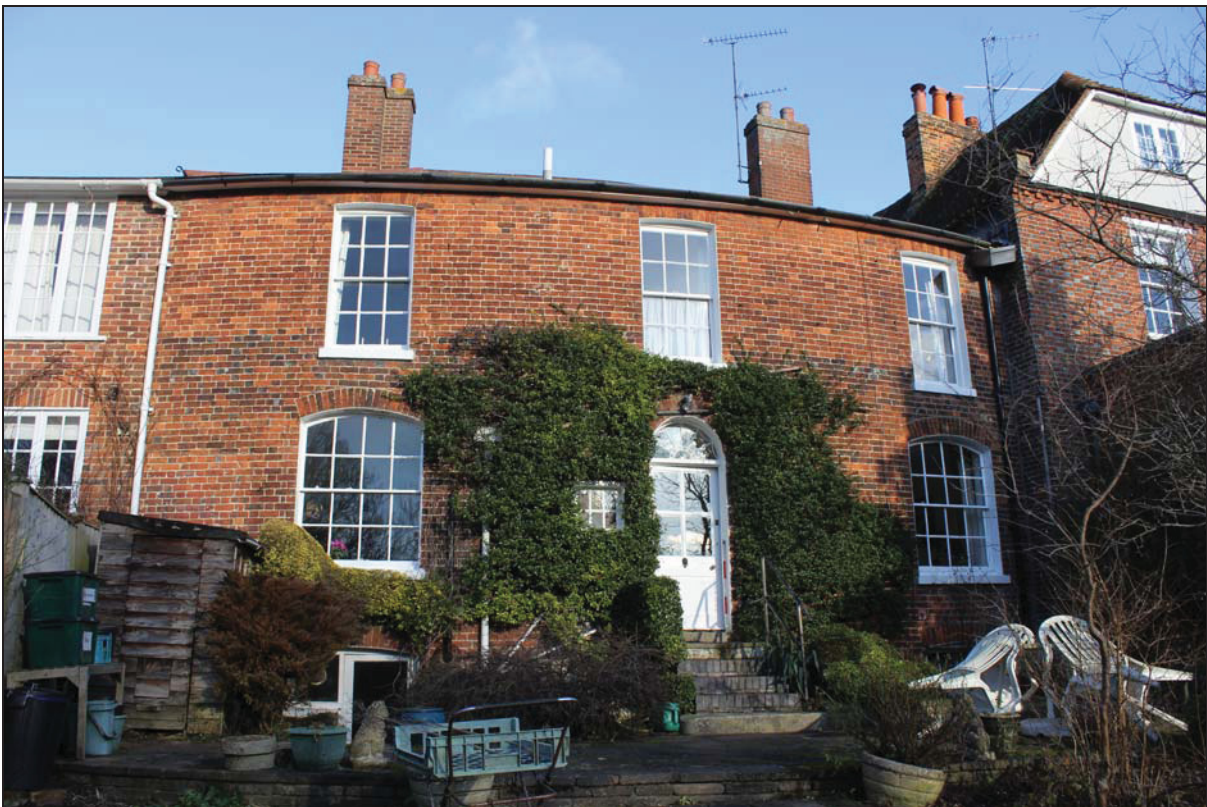
Plate 2 View of the slightly curved south elevation, taken from the south (DP 7)

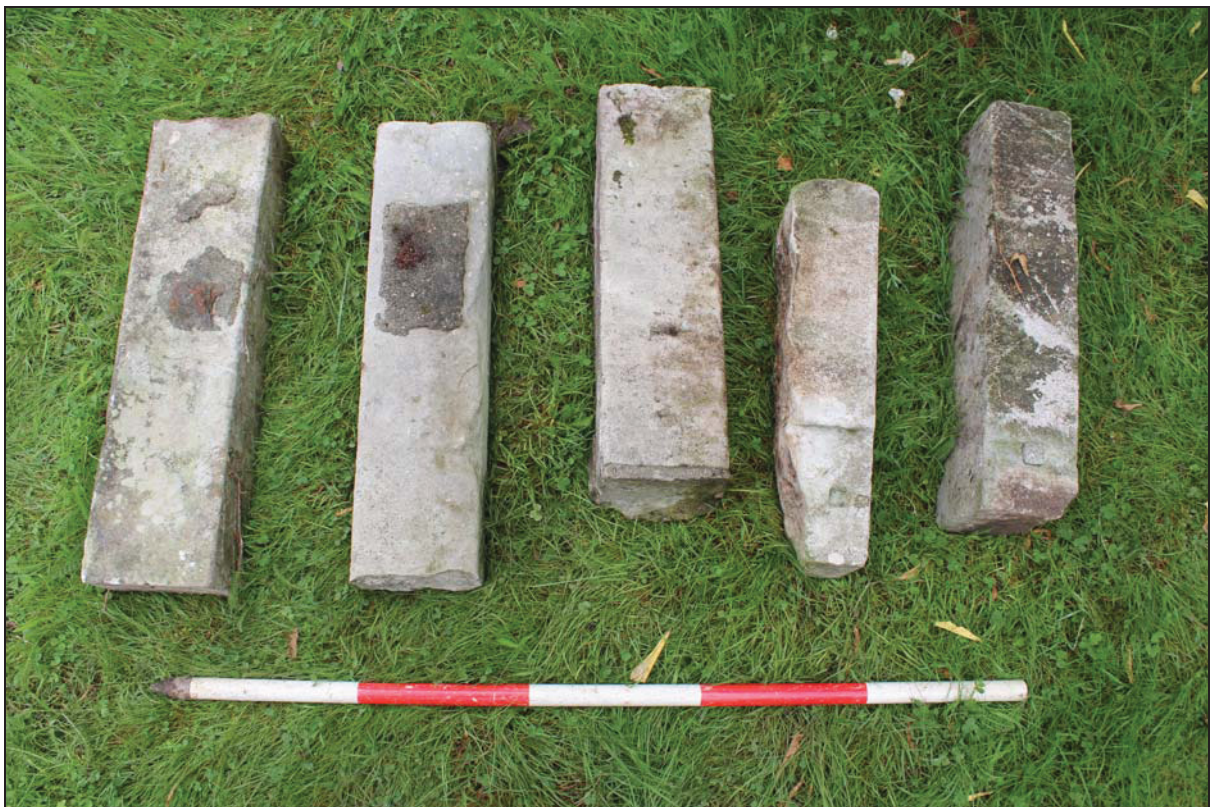
Plate 6 Number of fragments of the probable original external steps reused in later landscaping (DP 116)

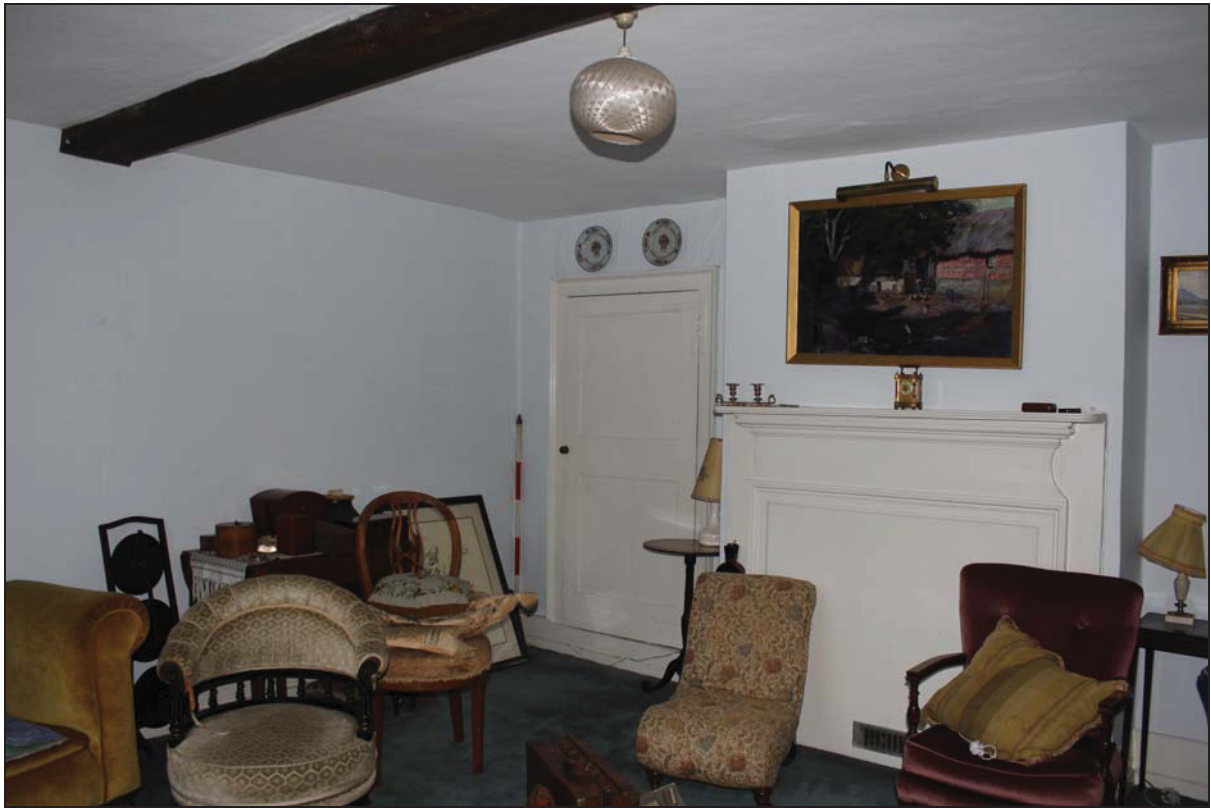
Plate 9 South side of Room GF02, taken from the north (DP 36)

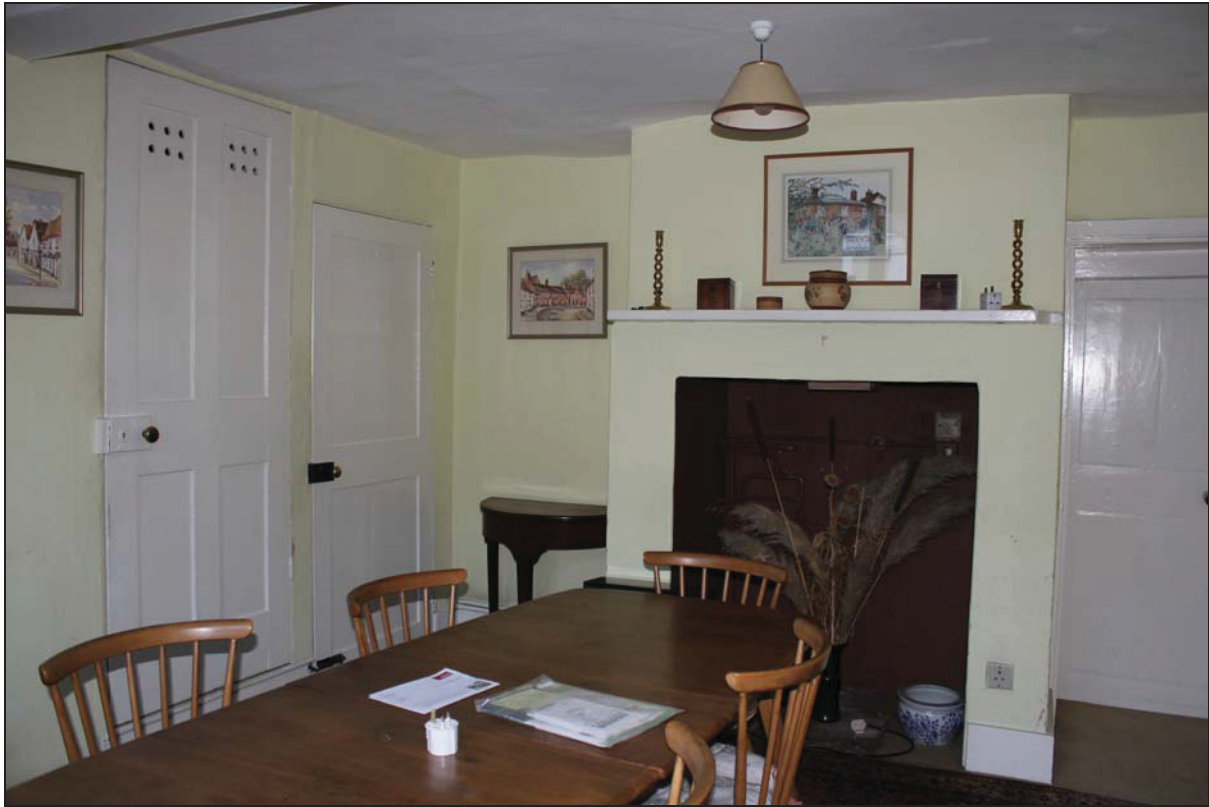
Plate 11 South side of Room GF03 showing former kitchen fireplace, taken from the north-west (DP 46)

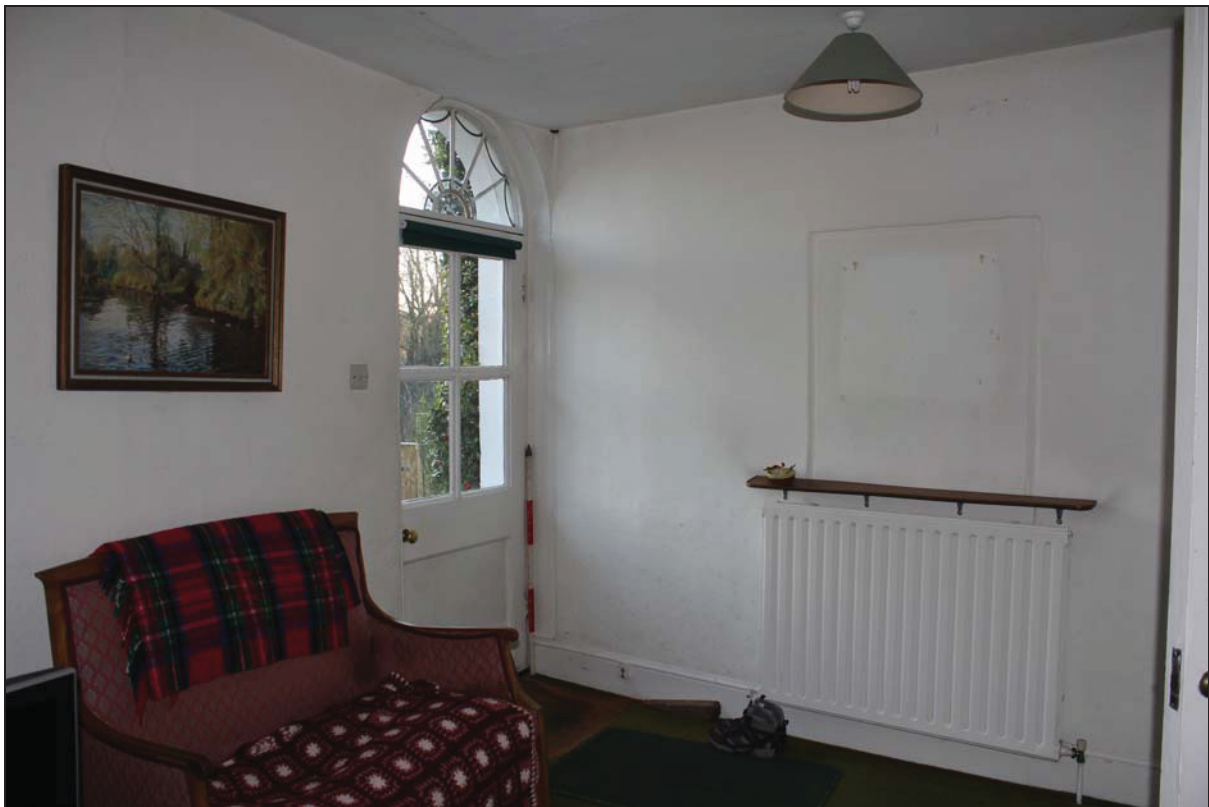
Plate 12 West side of Room GF04 showing reeded surround outlining the position of an original doorway, taken from the north-east (DP 47)

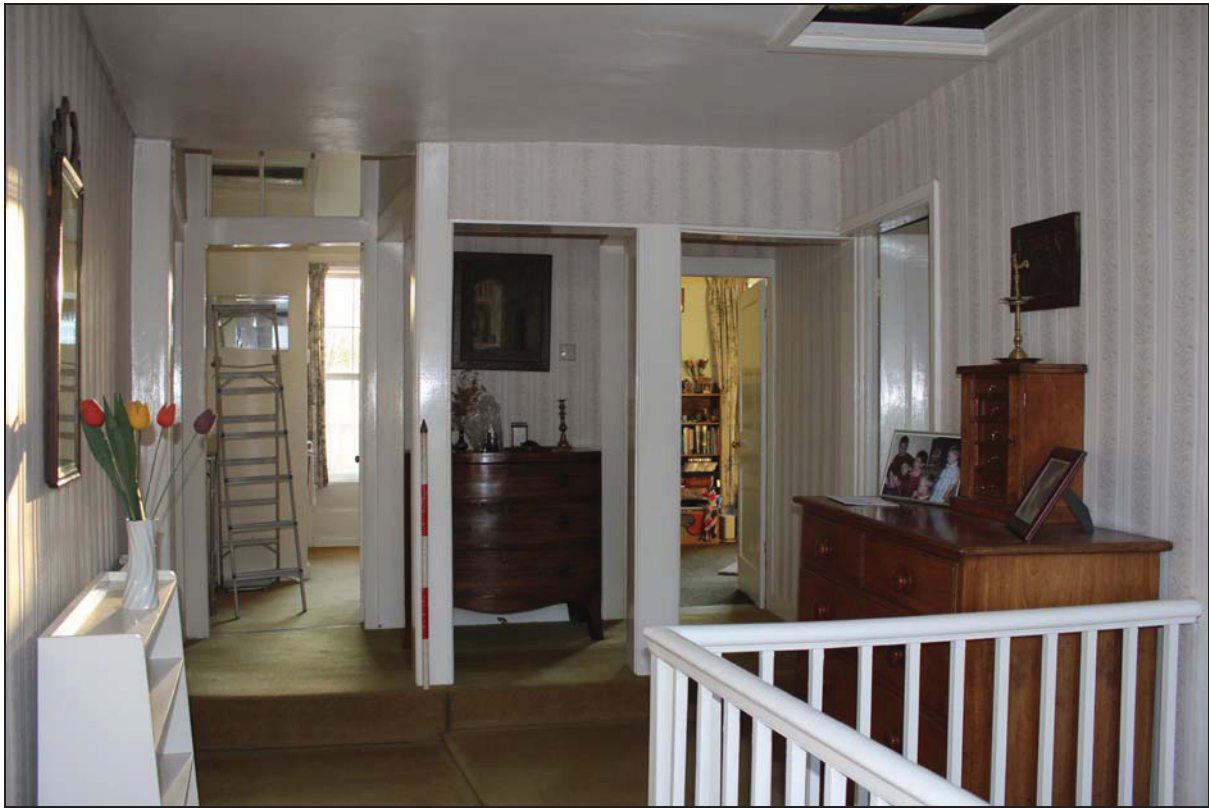
4.21 The staircase rises to a wide landing at upper level (FF01). This has been extensively reconfigured making reconstruction of the earlier form problematic (Plate 13). The stairwell is enclosed by a balustrade of the same form as below. However, this only encloses the east side of the stairwell, the remainder being of later date, and this along with scarring in the ceiling and a slight step up indicates remodelling and the removal of internal walls. The landing is lit from the north by a 20th century six-over-six sash confirming the evidence seen to the exterior. Above, at ceiling level, the wall-plate

Plate 13 First floor landing (FF01), taken from the north (DP 21)

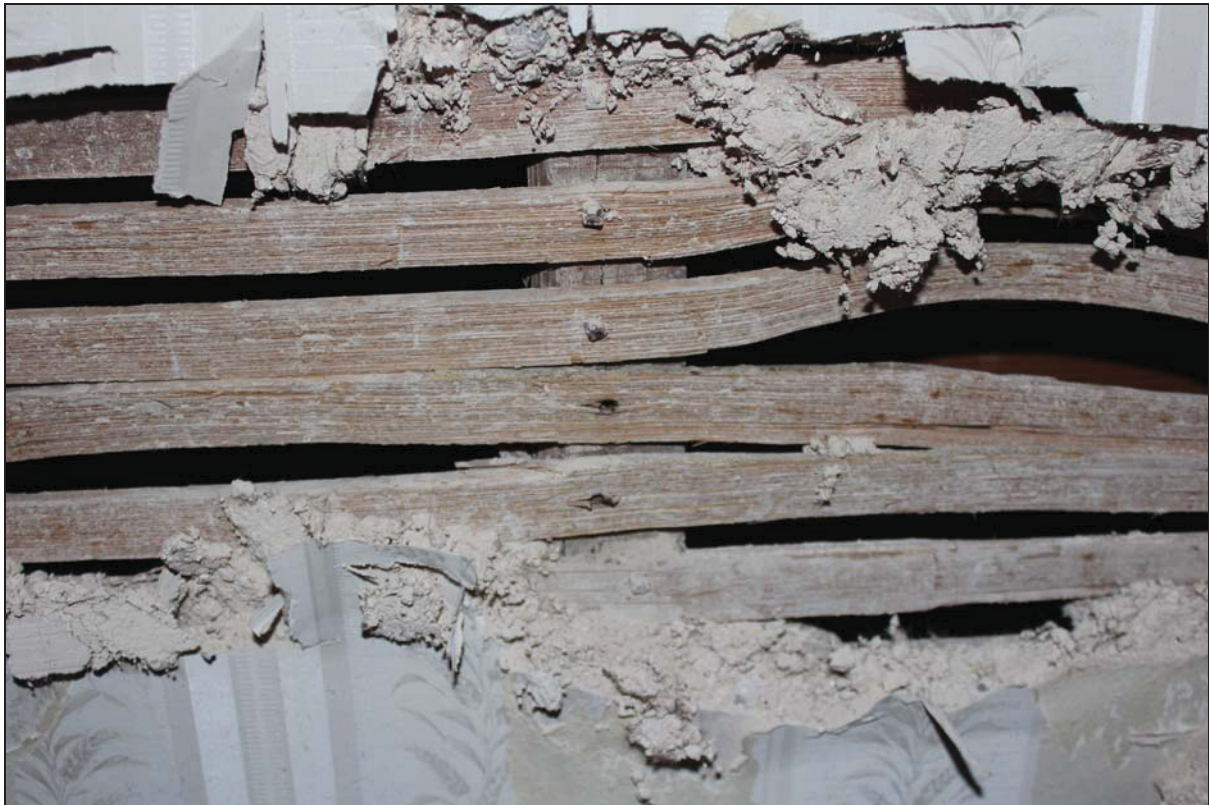
4.23 Small-scale interventions were carried out in order to expose the underlying fabric and establish the nature of two internal partitions in this area. A small area of plasterwork was removed from the wall on the west side between the landing and Room FF03. The lime plaster is a fairly pale buff coloured fabric with very high animal hair content consistent with a late 18th or early 19th century date. Removal exposed very widely-spaced slender studs measuring 2" x 3½" (51mm x 89mm) with waney riven laths nailed over (Plate 14). The nails themselves are interesting as they are of a form seen in the 18th century that are normally used where they would remain visible as the square stamped heads with delicate faceting. To the south, a further inspection hole was opened up in the wall between the landing and the bathroom (FF05). This exposed slender studwork of almost identical form as on the west and the laths are secured with the same stamped nails. This investigation and the removal of the bathroom fittings, it is revealed that most of the lath and plaster within the bathroom was removed.

Plate 14 Detail showing the nailed laths in the small intervention on the west side of Room FF01, taken from the east (DP 75)

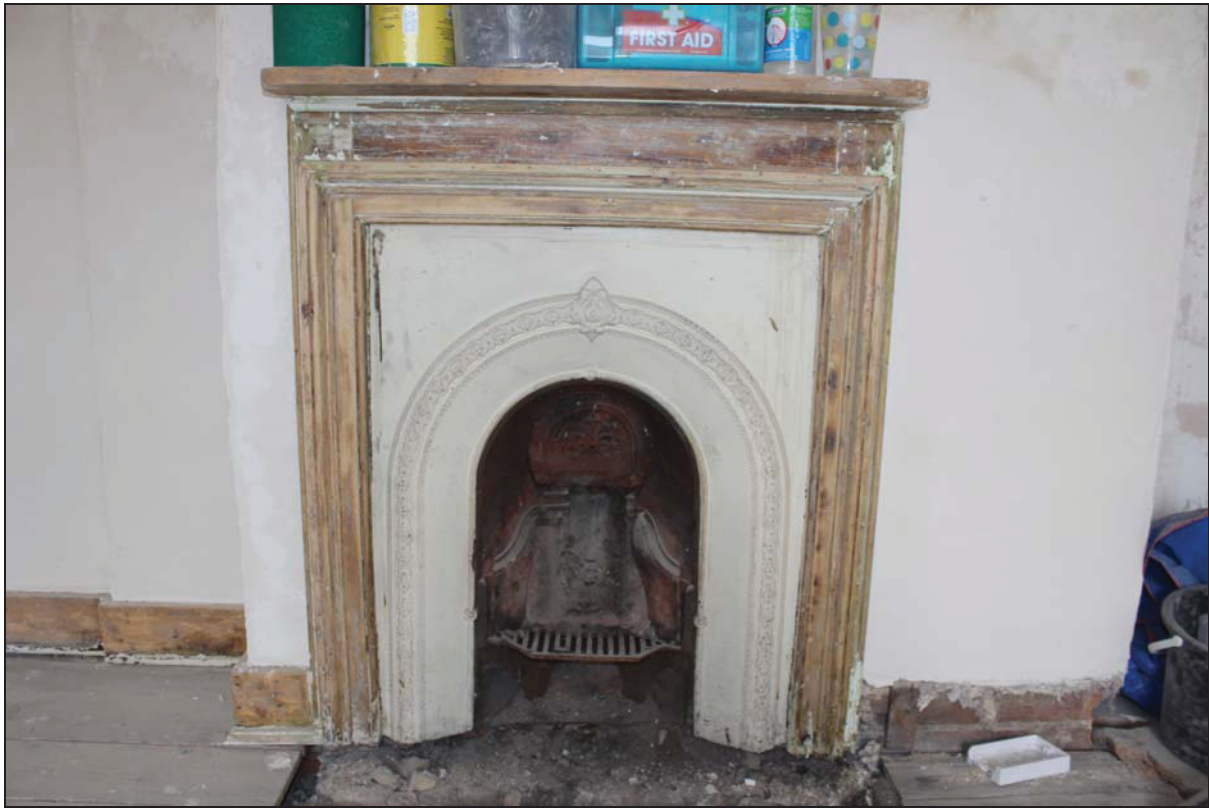
4.26 Room FF03 is entered from the landing through a four-panel, probably 19th century door. The room has a blocked fireplace on the south with an 18th century surround and later shelf. With the removal of the blocking, an inserted grate is revealed which dates from around the 1860s (Plate 17). The south wall has a tripartite window with plain dado panelling of probable early 18th century date to either side (Plate 18). During the planned works the carpets were removed and one or two floorboards were temporarily lifted to expose the floor structure below, which is all of oak with some fairly waney members. The floorboards are fairly wide, measuring an average of 9" (229mm), while the fabric below exposes the bridging joist (boxed in from below) that measures 8¾" (222mm) across the upper face and the common joists extend north-south and are all properly pegged to the bridging joist with ¾" (19mm) pegs. The floor joists measure an average of 3½" x 4½" (89mm x 114mm) and are mostly tenoned with a slightly diminished haunch apart from where the waney nature of the bridging joist means the common joists are shaped to fit.

Plate 17 Fireplace on the south side of Room FF03, taken from the north (DP 110)

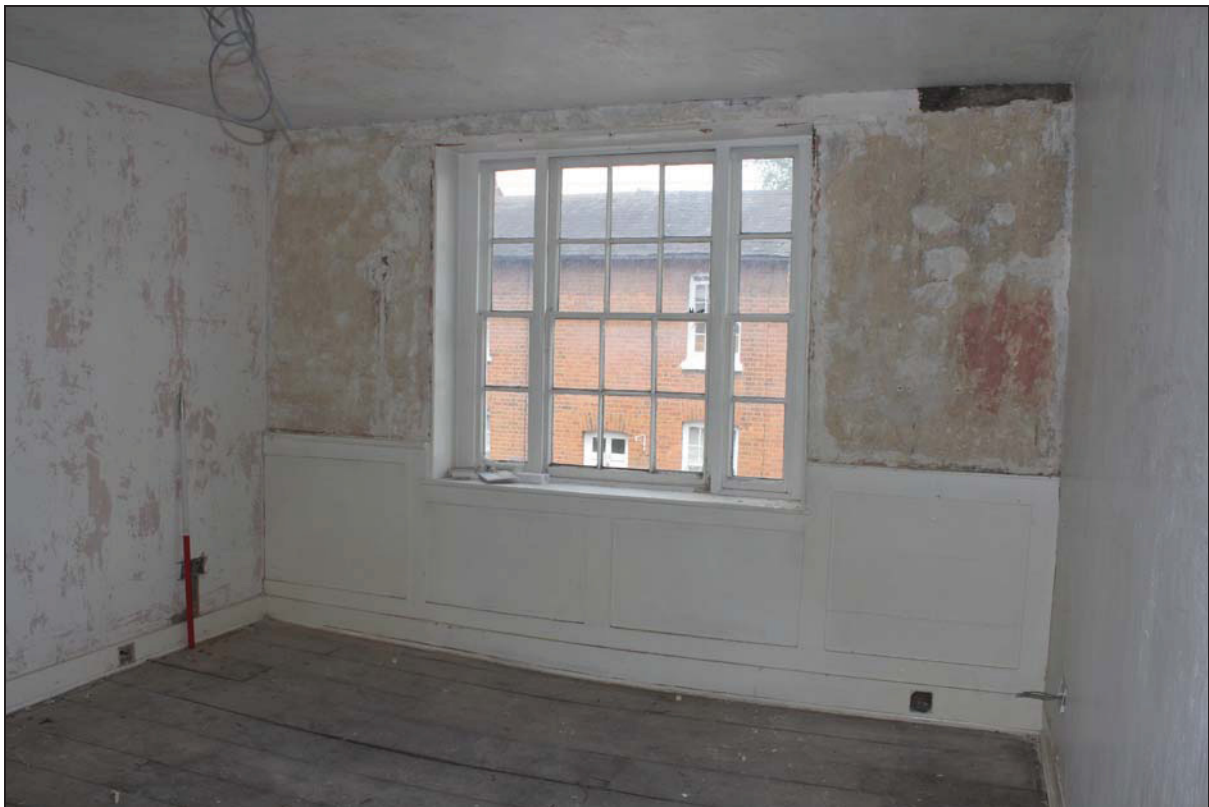
Plate 18 View of Room FF03 during the planned works, taken from the south (DP 95)

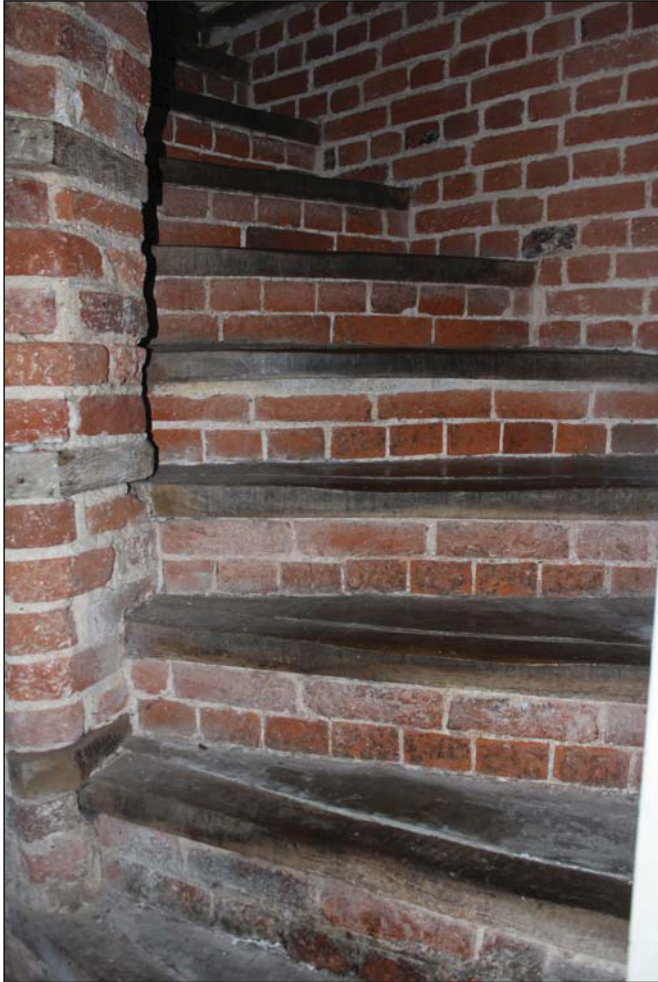
4.30 As noted above, the basement is given access from Room GF03 via a winder stair and occupies the rear range of the property. The staircase consists of timber treads on a brick base and descends beneath the principal staircase, while elements of the earlier timber-frame are visible. This includes a chamfered oak beam on the east side that may demonstrate, through the presence of a large chamfer, the position of an earlier stair. The existing late 18th century stair (Plate 19) descends to a small lobby with chambers to either side. At the top of the stair a now redundant doorway once gave access to a cupboard and consists of a two-panel door with H-hinges, these probably relating to the earlier staircase noted above. The south wall of the lobby returns at the west end to form the internal wall between the two rooms. A small area of paintwork on the west side was scraped to determine the relationship between the two elements and it was discovered that the brickwork is continuous and hence contemporary.

Plate 19 Detail of the timber and brick staircase at basement level, taken from the south (DP 55)

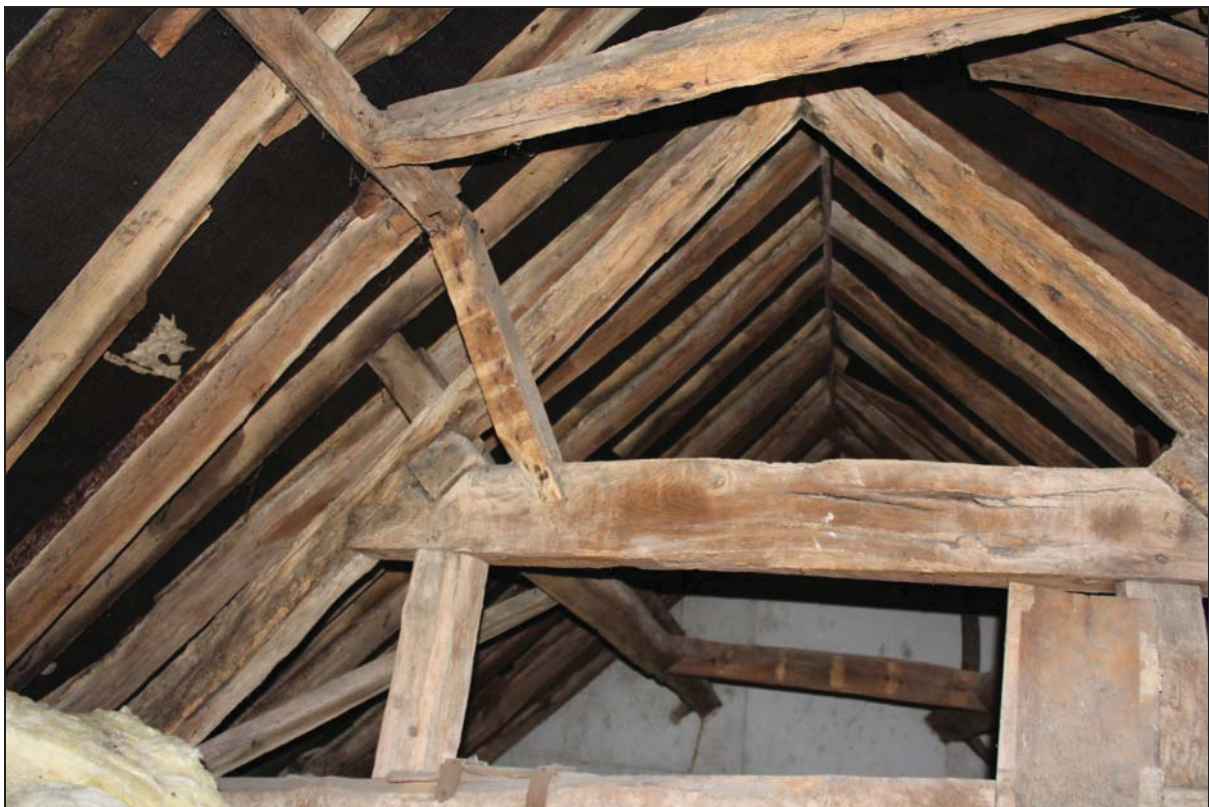
4.35 The roof over the street range reveals the underlying medieval character of the building. There are two distinct roof structures, both of medieval date. The western bay contains fragments of an earlier roof set lower than the existing structure which has subsumed it (Plate 22). This is of robust construction, utilising a clasped side-purlin form where the collar is supported by queen posts, the principal rafters halved and pegged at the apex. Only a single truss of this roof survives along with large square purlins that were retained to support the later roof above. The soffits of the principal rafters retain holes for wattle poles and in addition, substantial weathering of the timber, particularly the purlin ends and the peg at the apex, are indicative of an external east gable end. This structure may continue into No. 61.

Plate 22 View of the west roof structure over the street front range, taken from the east (DP 14)

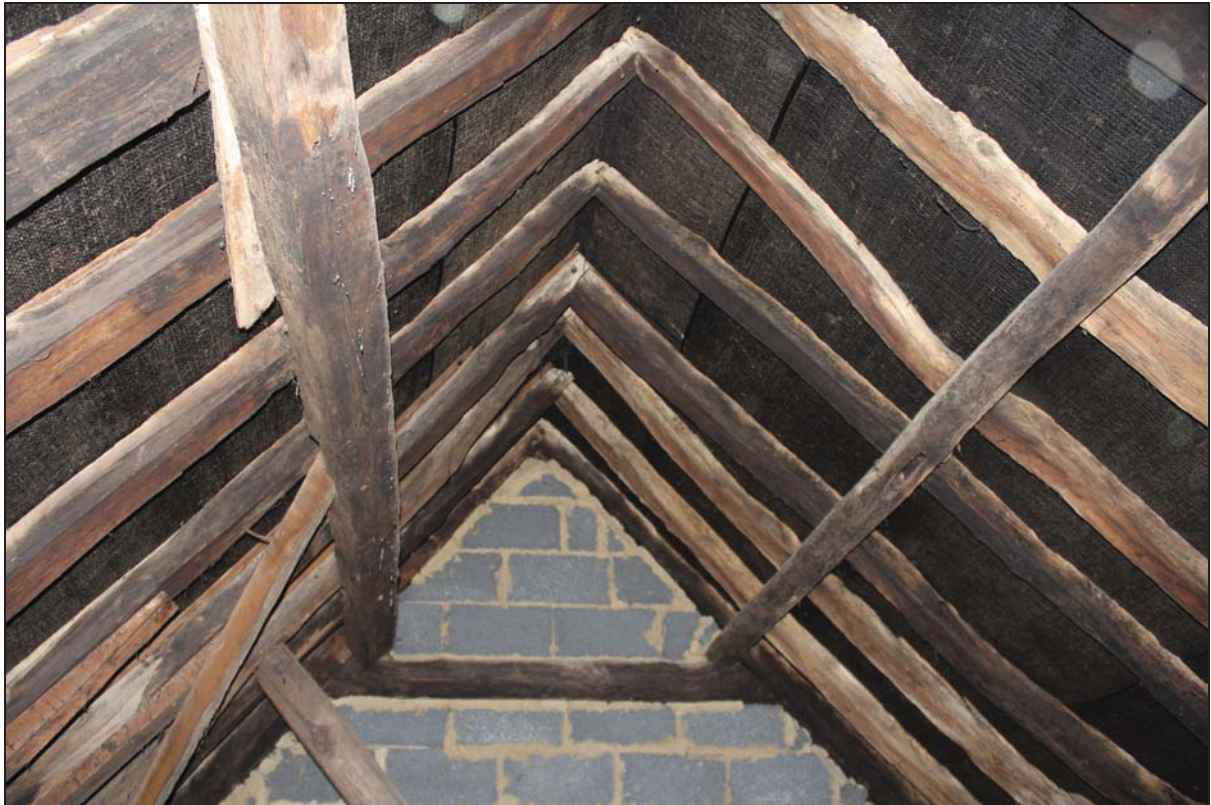
4.36 To the east the roof is of different character, where the presence of smoke-blackened timbers demonstrates the presence of an original open hall below (Plate 23). There has been some alteration, but in general a single long bay survives with one truss close to the end of the earlier roof structure and a second at the east end of the building. The form is of clasped side-purlin construction with a single purlin in each pitch and common rafters riding over and halved at the apex. This is characteristic of the 15th and 16th century. The south purlin has been turned but mortices indicate the presence of wind braces, of which none survive. There is extensive smoke blackening of all original timbers, while later replacements are recognisable by a lack of sooting. At the east end, the gable has been rebuilt in modern blockwork. The collar of the west truss has holes for wattle poles in the soffit.

Plate 23 View of the east roof structure over the street front range, taken from the west (DP 15)

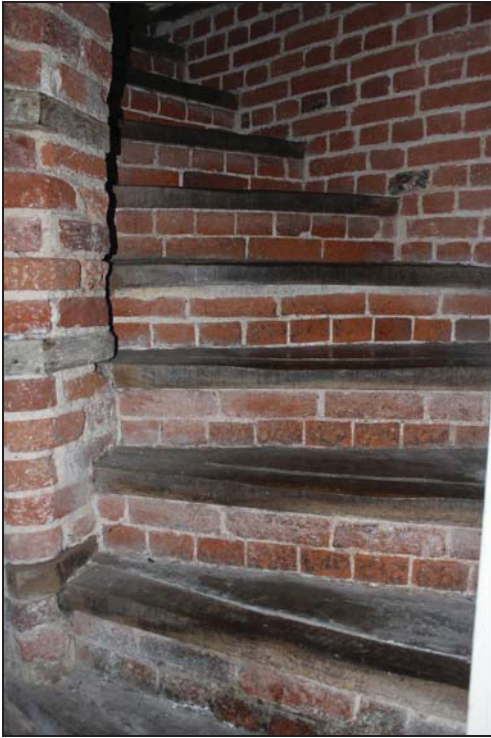
DP 54
Staircase to basement level showing redundant
doorway above, taken from the south

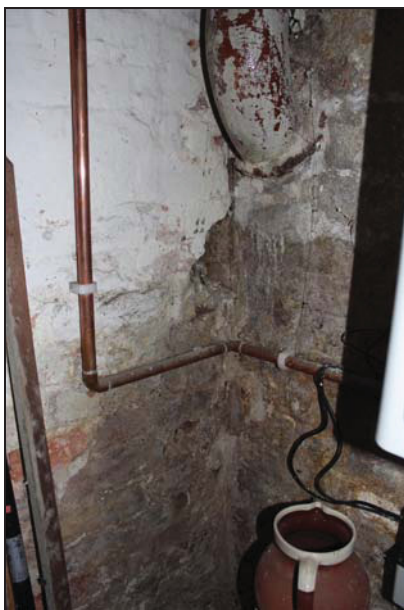
DP 64
East side of Room BF02, taken from the north

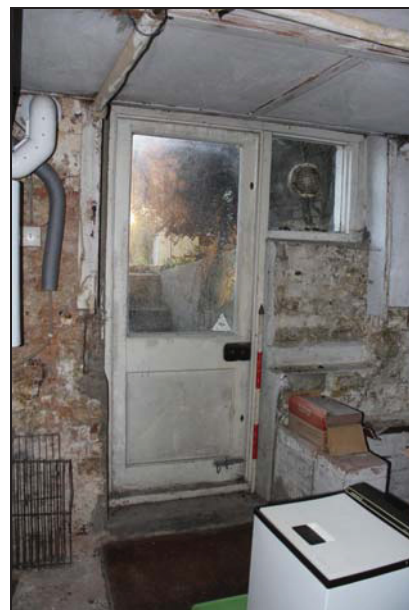
DP 65
Internal walls between Room BF01 and BF02
showing junction with the south wall, taken from the
north-west

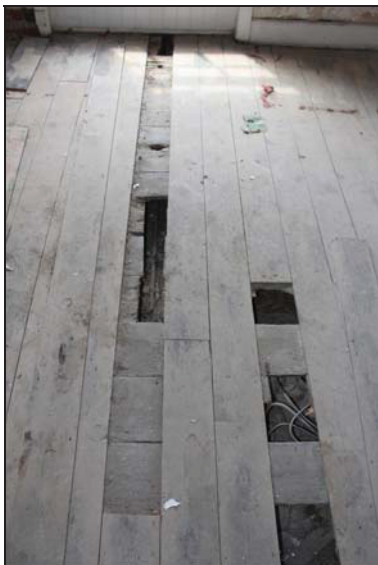
4.27 To the south-east, Room FF04 is reached through a four-panel door. There is a blocked fireplace and 20th century replacement sash. The ceiling is in poor condition with some plaster loss, exposing modern machine-cut laths above. During the monitoring, softwood floorboards (5¾" or 146mm) were revealed to be laid over oak floorboards that varied in width from 6" to 8¾" (152mm to 222mm) and are probably original to the range. The east wall has been rebuilt, perhaps with the replacement of the ceiling in modern lath and plaster.

*DP 89
View of Room FF04 showing modern boarding over
the original floorboards, taken from the north*
