**HELPESTONS MANOR, HOLLOW ROAD,  
FELSTED, ESSEX**

**HISTORIC BUILDING RECORDING**

Level 3

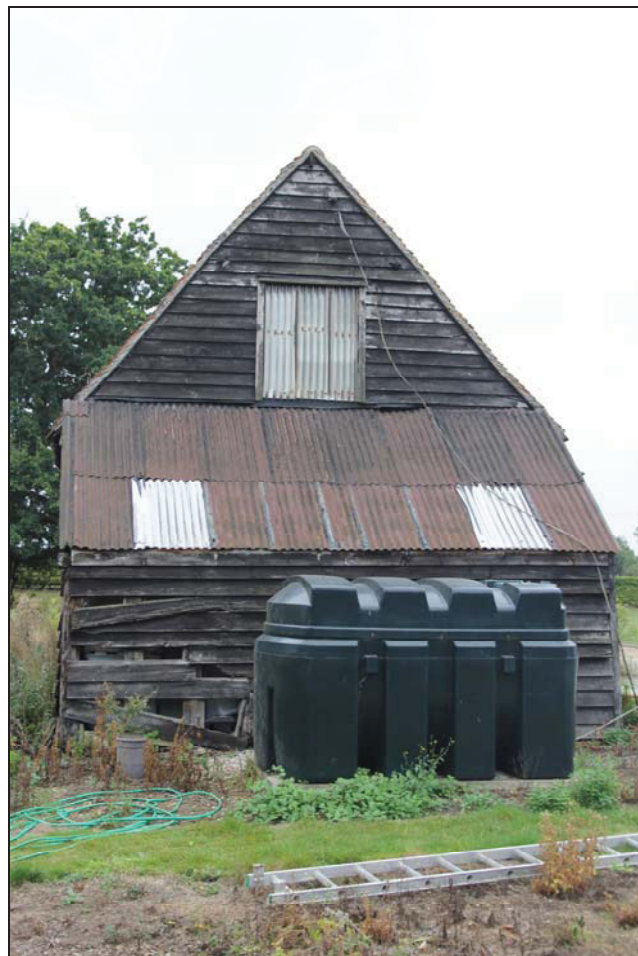
5.6 Three doors on the south side include a low central door to a lower storage area, a larger door to the west which gives access to the staircase and upper granary and a third door to the outshut. All are boarded with strap hinges on pintles and ledged to the rear. The staircase door appears to be the oldest, retaining a good pattern of nails for its ledges and a rim lock encased in timber on the back. In addition a small access hatch survives in the east bay. The east gable end has been modified by the insertion of two large double doors of modern date for storing cars or lawn mowers. The north side is blank though with some evidence of blocking of an opening at lower level (Plate 11). The west gable end has a large upper aperture filled with transparent corrugated sheeting for additional light (Plate 12).

Plate 12 Gable end of Building 2, taken from the south-west (DP 13)

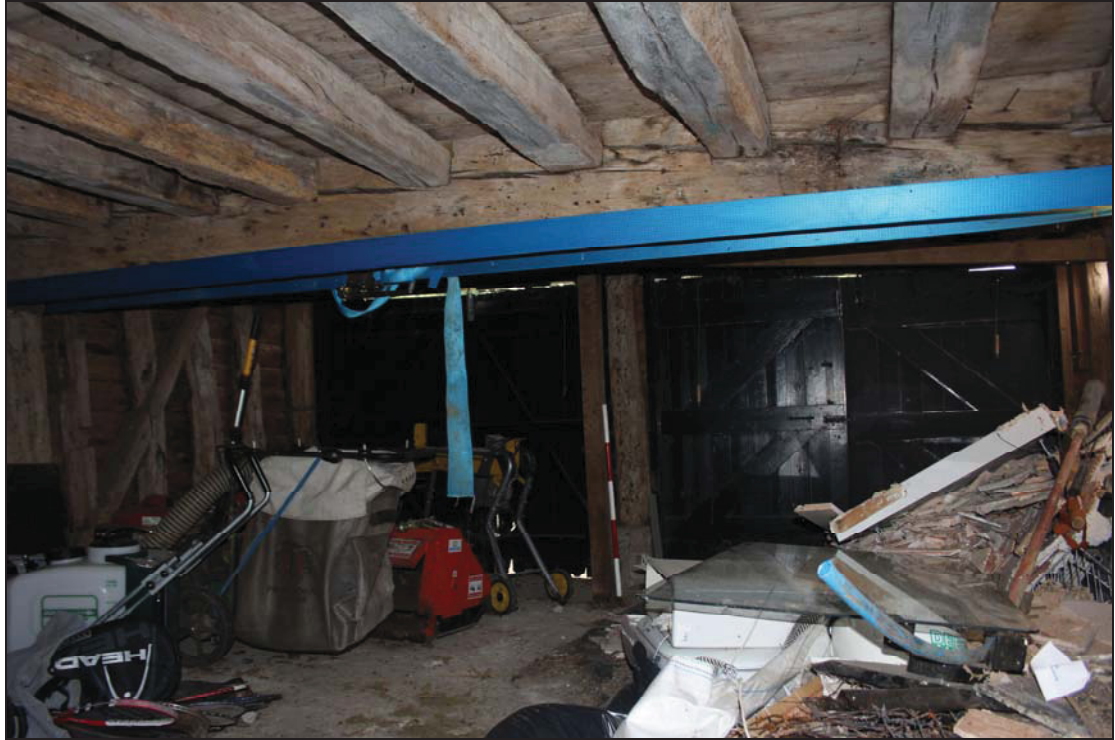
5.9 The east gable end wall preserves only a central post with a much renewed mid-rail/lintel (Plate 13). The removal of the original lower timberwork to accommodate the doors, left the original joists hanging with no support, requiring the insertion of an extra post and joist bolted to the ancient timber. The common joists have diminished haunches, some with pendant soffits in the late 16<sup>th</sup>/early 17<sup>th</sup> century manner.

Plate 13 Interior of Building 2, taken from the south (DP 43)

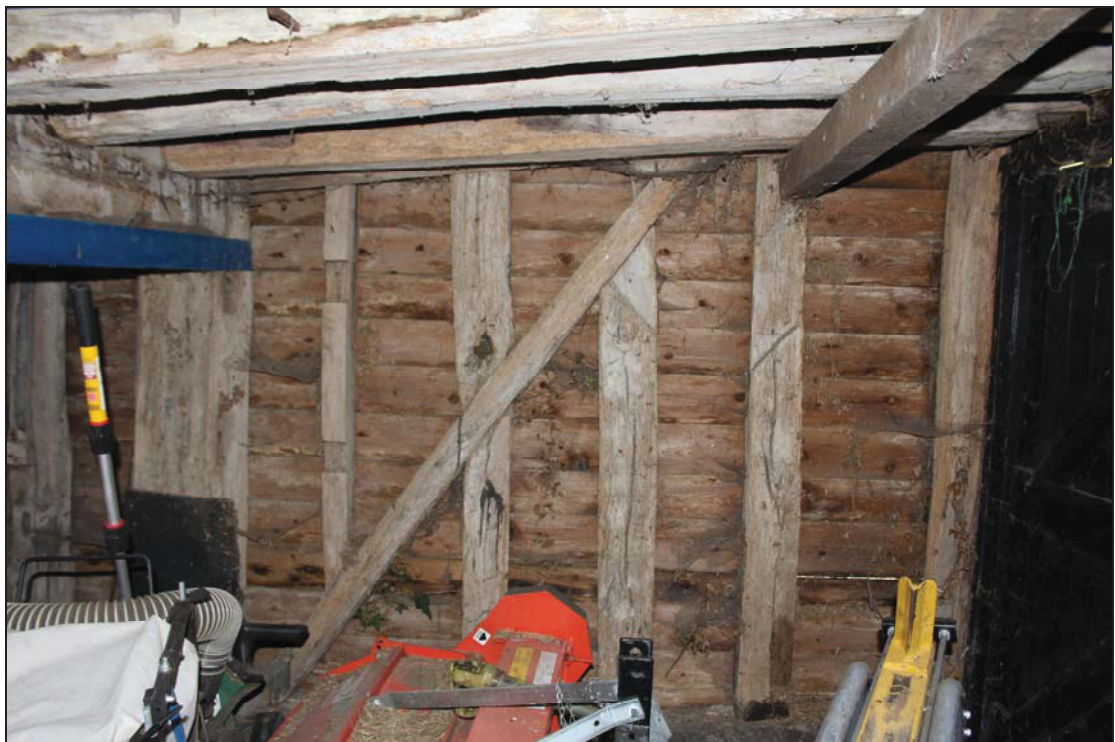
5.10 The north wall preserves a sole plate, a good primary brace (9cm x 14cm/ 3 1/2" x 5 1/2") and common studs of robust scantling (14cm x 12cm/5 1/2" x 5"), all of which demonstrate signs of weathering and retain trenched mortises for earlier bracing indicating their earlier deployment elsewhere (Plate 14). The south wall is similarly configured but retains a more substantial brace (Plate 15). The studs are mainly reused and some preserve wattle notches and holes. The principal bay division posts are both reused, that to the north (26cm x 26cm/ 10" x 10") has chamfers on one side and many redundant mortises. The principal joist (28cm x 34cm/11" x 13") is also chamfered but is not apparently reused. It is butted and not properly jointed into the uprights on both sides.

Plate 14 North wall of the east bay of Building 2, taken from the south-east (DP 45)

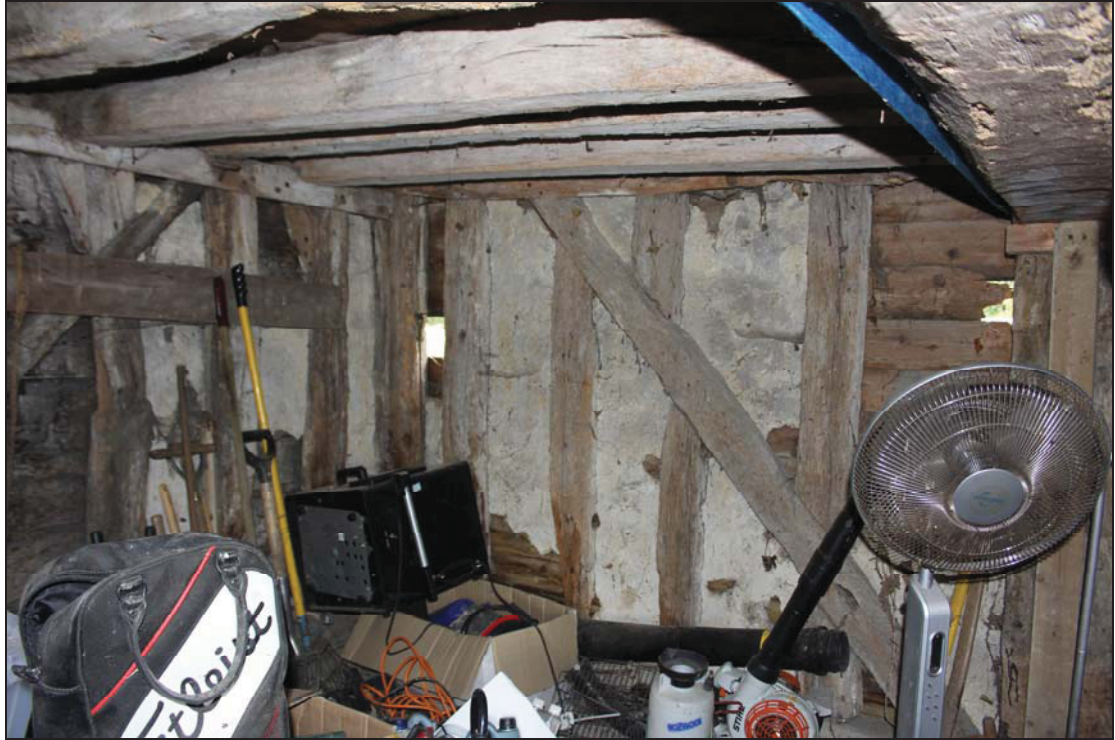
5.13 The west bay, north wall is primary-braced from corner-post to sole-plate and retains all four studs, all weathered (Plate 17). Most notably, an area lime plaster survives as an infill in the corner, applied to vertical laths which are nailed directly to older weatherboarding.

Plate 17 North wall of the west bay in Building 2, taken from the west (DP 62)

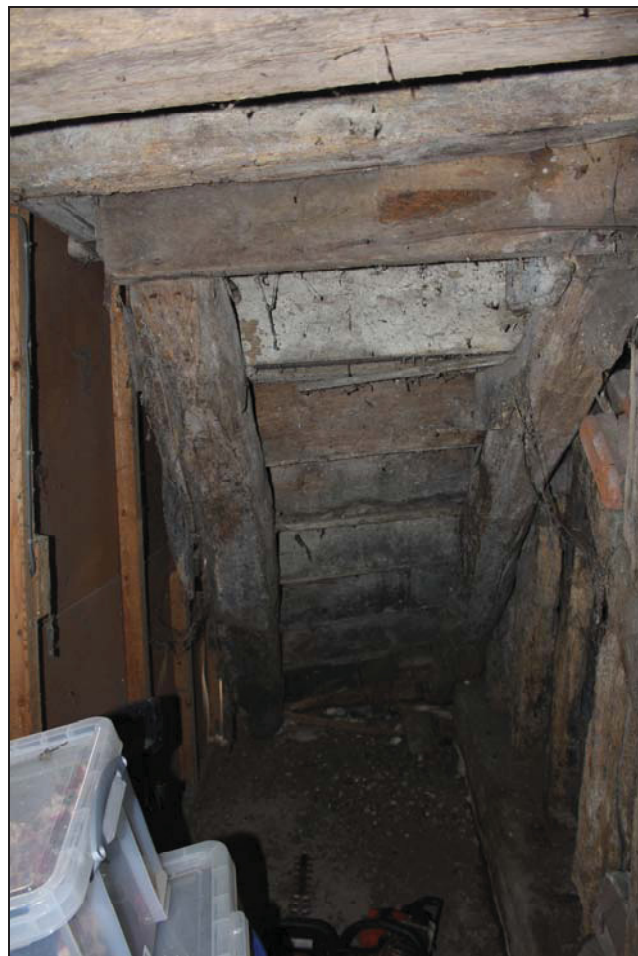
frame, and comprises two carriage beams supporting nailed treads and risers (Plate 18).

Plate 18 Carcass of the staircase in Building 2, taken from the north-west (DP 64)

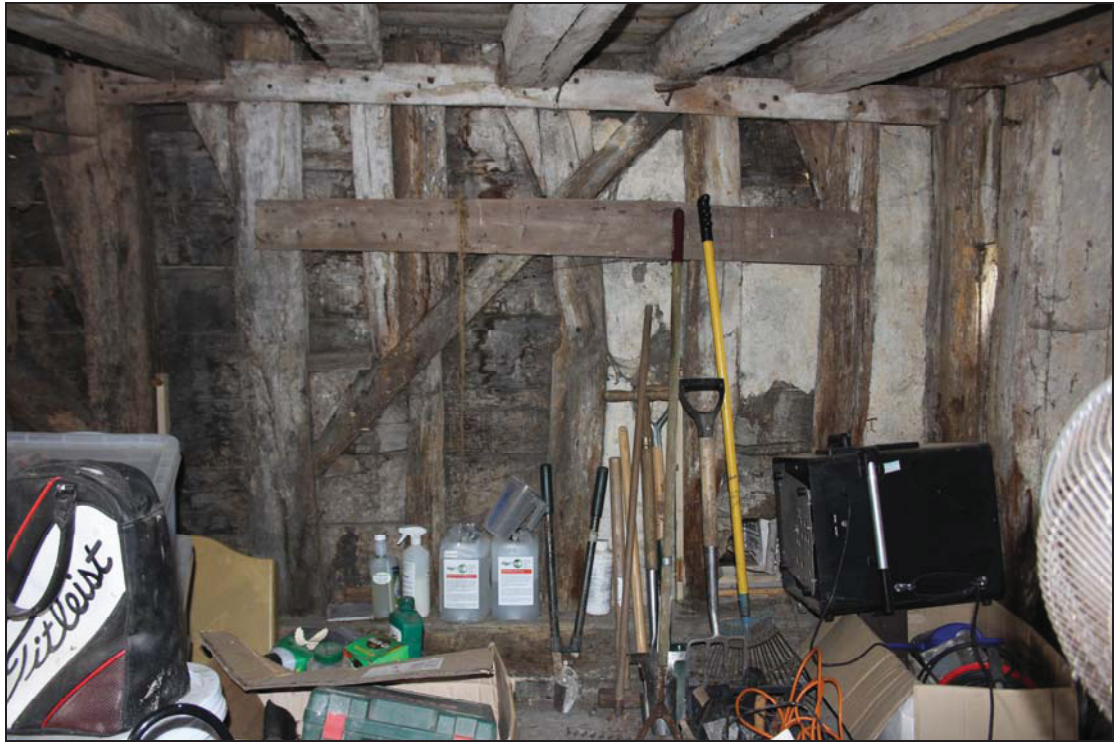
5.15 The western gable wall retains its sole-plate and two inner posts which support fairly slender primary-bracing (Plate 19). This does not rise from the sole-plate as on the long walls but from the principals. The studwork is also more slender and retains fragments of plaster infill. The upper joists carry across as before, and are supported against the wall with a nailed-on plank of wood, chocks or wedges applied to the studwork.

Plate 19 West wall of the west bay in Building 2, taken from the north-east (DP 63)

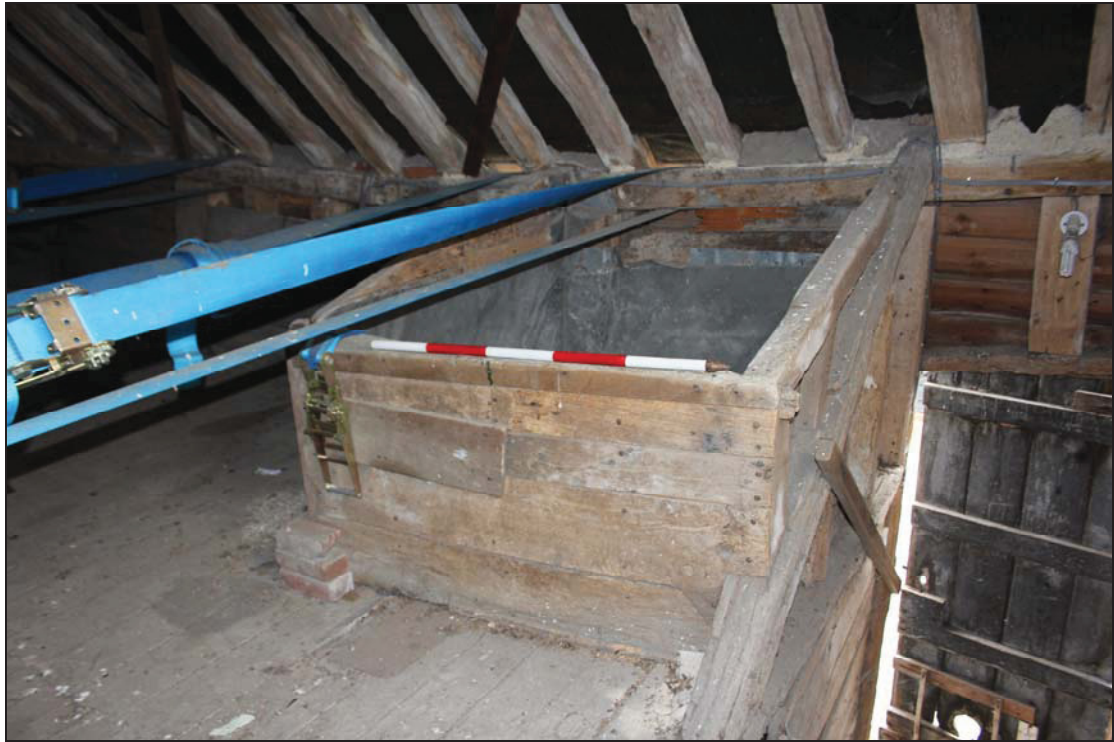
5.17 Within the former granary, the timber-frame reflects a continuation of the studwork seen below, rising to a wall-plate, where they are properly pegged. A few scarf joints are visible, but appear to be crude. However, most are obscured by metal sheeting or by bead-moulded boarding. Further close investigation was precluded by the structural fragility of the building. The surviving grain bin is fairly crude, but framed in oak, with reused members, and is consistent with the timber seen elsewhere (Plate 21). As in the area below, small areas of plaster survive in the north-west corner.

Plate 21 Granary bin on the first floor of Building 2, taken from the west (DP 48)

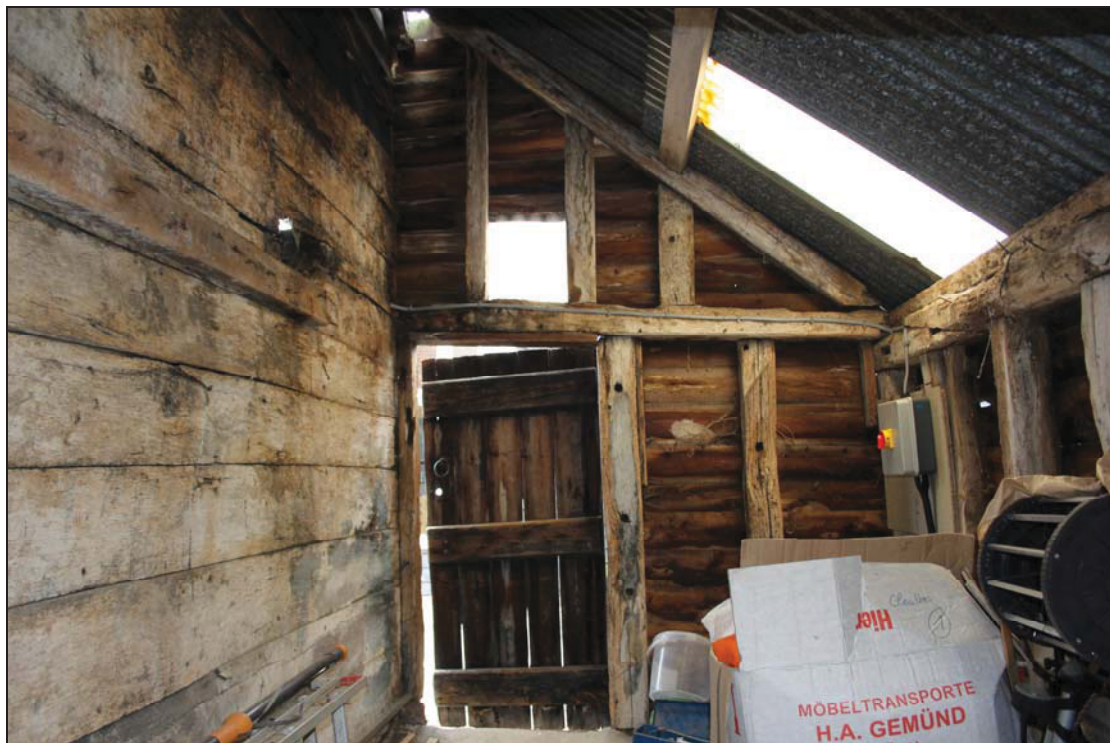
5.21 Within the outshut, flush boarding of some age survives to the main structure, though repaired at upper level and much decayed (Plate 25). A cement floor has partly submerged the sole-plate whilst simple studwork all round is partly pegged. A central tie and principal rafter support a flimsy modern roof (Plate 26). A few fixtures and fittings such as timber hooks survive (Plate 27).

Plate 26 Interior of the outshut of Building 2, taken from the north-west (DP 57)

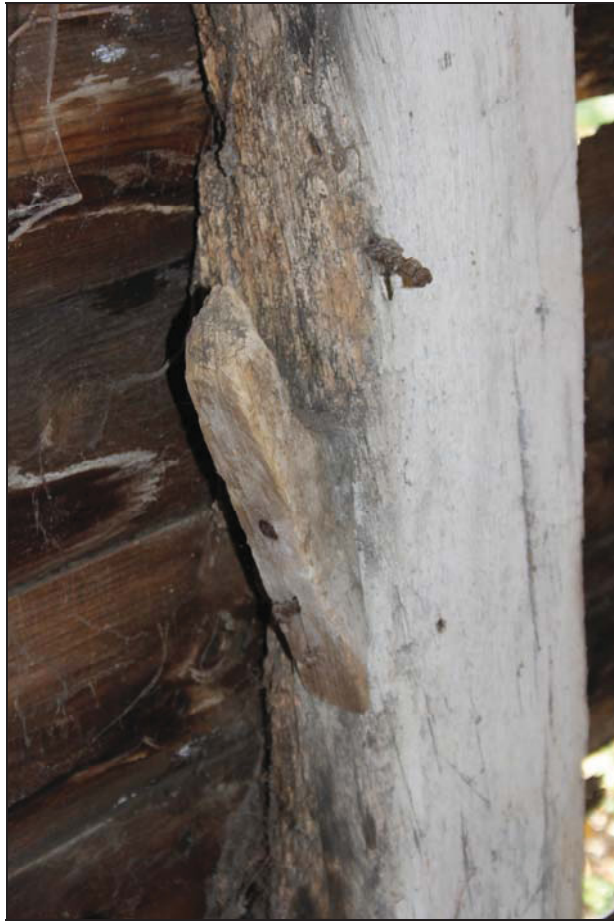
Plate 27      Wooden hook within the outshut of Building 2, taken from the east (DP 76)
