**BARN AT BENINGTON PARK FARM,
BENINGTON, HERTFORDSHIRE**

HISTORIC BUILDING RECORDING

Authors:	Tansy Collins MSt	
Illustrations:	Kathren Henry	
NGR: TL 3088 2354	Report No: 5366	
District: East Herts	Site Code: AS1882	
Approved: Claire Halpin CMIfA	Project No: 2529	
	Date: 25 April 2017

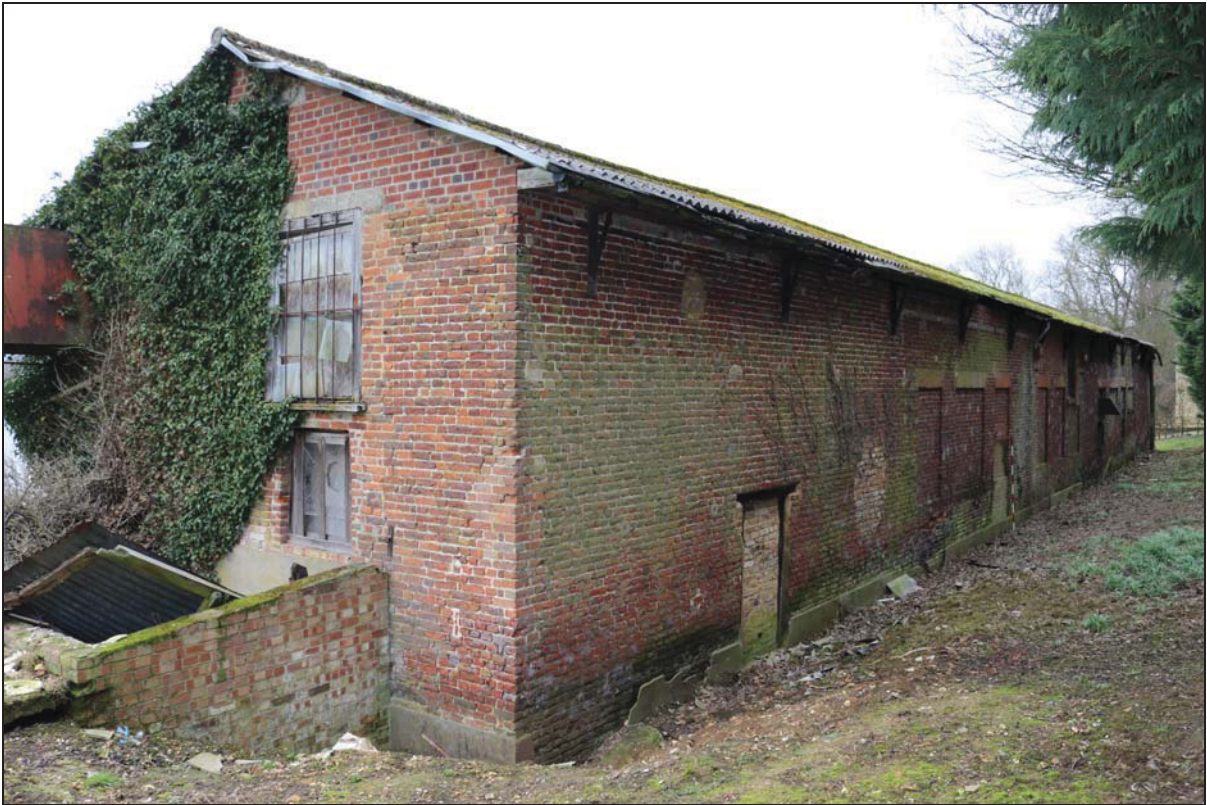
5.2 Building 1 is a long double barn constructed of slender red bricks typical of a 17th century date (Plate 1). The bricks are thin (measuring 9¼" x 4½" x 2¼" or 235mm x 114mm x 57mm), set in lime mortar and laid in a random bond. Much of the brickwork is generally laid in a variable bond but in places an English bond type is visible. Variation is seen in places where Flemish bond is used, particularly along the south-east wall. The barn has a gabled low-pitch roof which is clad with corrugated asbestos. The roof guttering is supported by angle iron brackets.

Plate 1 South-west and south-east elevations of the barn (Building 1), taken from the south (DP 9)

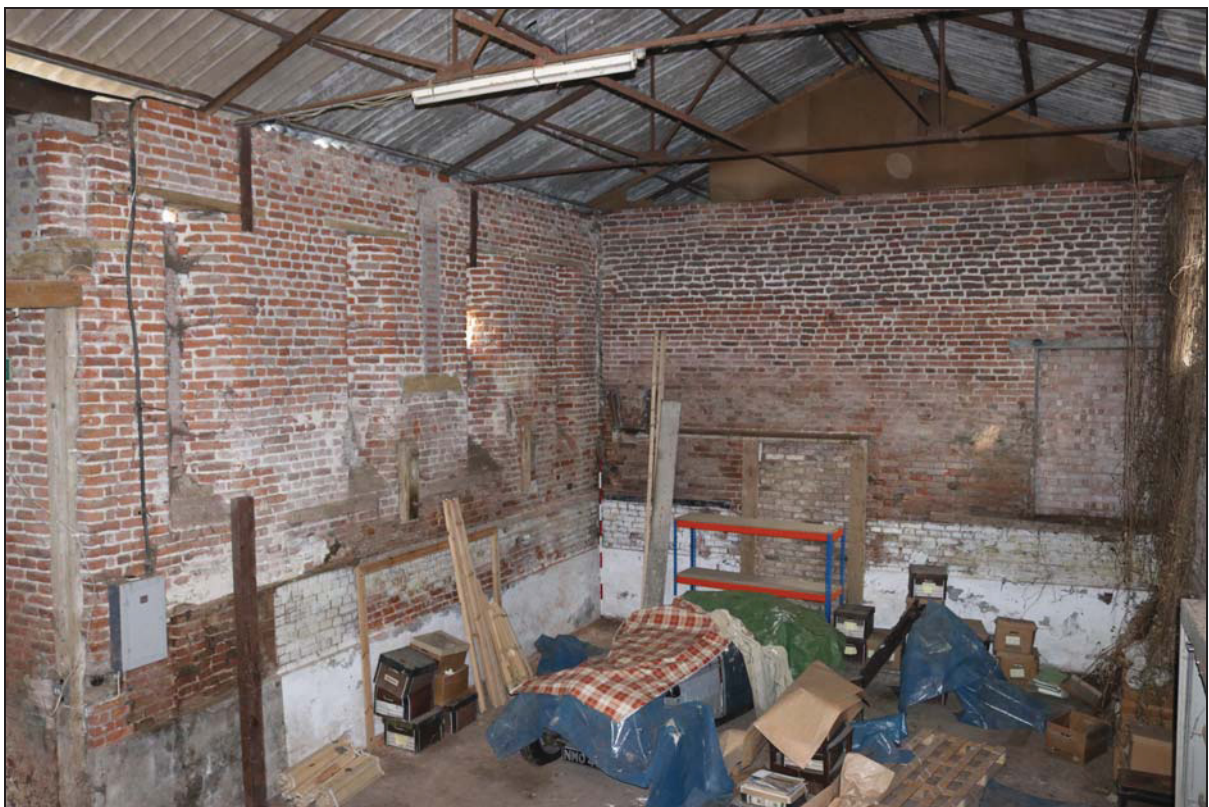
5.11 The southern range is entered through the porch on the north-west wall which is located in the fourth bay from the south-west. The outer walls are of exposed brickwork, though heavily limewashed in places, with much of the space displaying render to approximately 1m height, likely relating to early 20th century regulations for the keeping of livestock (Plate 6). The positions of the original bays are marked on Fig. 15 and a number of original and early features survive. The most notable of these include a series of ventilation apertures (or wind-eyes) which consist of tall ventilation slits with deeply splayed reveals and sills with timber lintels. These are only visible in certain walls, with some fully blocked and others with a thin later of brick towards the outer edge. There are two blocked examples at the southern end, two visible in the west wall of the third bay, and to the north beyond the porch four are visible on the west side of the final two bays (Plate 7). Furthermore, shorter examples are visible in the northern and southern sides of the porch. There is a doorway in the north-west side of the first bay (now boarded over), and the lack of ventilation apertures here perhaps suggests that there was always a building extending north-west from this point. Also of note is that the recessed panels visible from the exterior are not evident from within. At the northern end of the space, a doorway inserted into the north-west side is blocked, and on the south-east side of the porch bay a further inserted doorway has been blocked, though it may be that this replaces an original aperture for ventilation for threshing in the central bay. The north-east wall contains two doorways, neither of which is original. The ground floor doorway is now blocked with reclaimed old bricks and a higher doorway to the south-east is blocked with 20th century Fletton bricks.

Plate 6 View of the southern unit (Building 1: barn), taken from the south-west (DP 61)

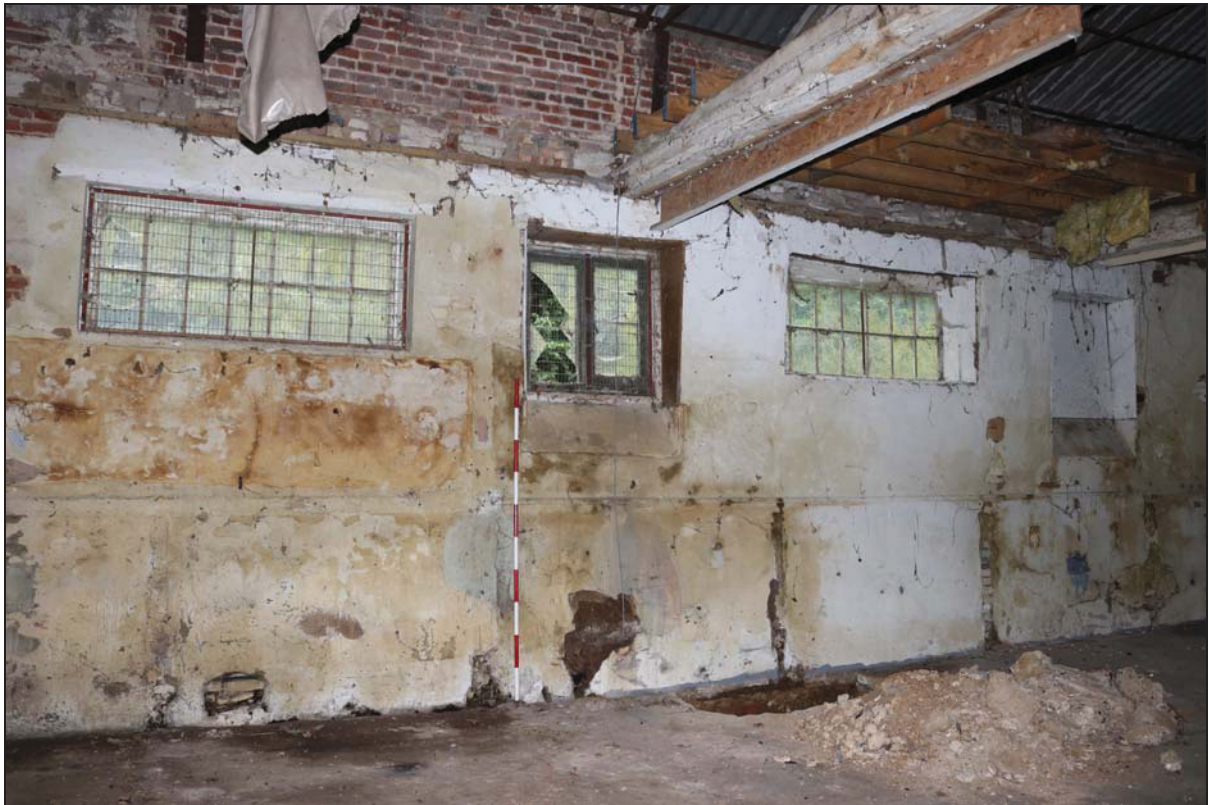
5.16 The floor is cement and has been raised approximately 1m above its original level to be level with the exterior ground at the north-east end. Much of the walling is rendered to three-quarter height, especially towards the south-west end, and there is evidence of divisions for housing cows. The north-west wall contains a roughly central 19th century doorway with a boarded, ledged and braced door, now joined as one with a single fixed sheet of glass located above. The south-east wall contains four windows; two narrow and two broad (Plate 12). The narrow window apertures

Plate 12 South-east wall of the northern unit (Building 1: barn), taken from the north (DP 26)

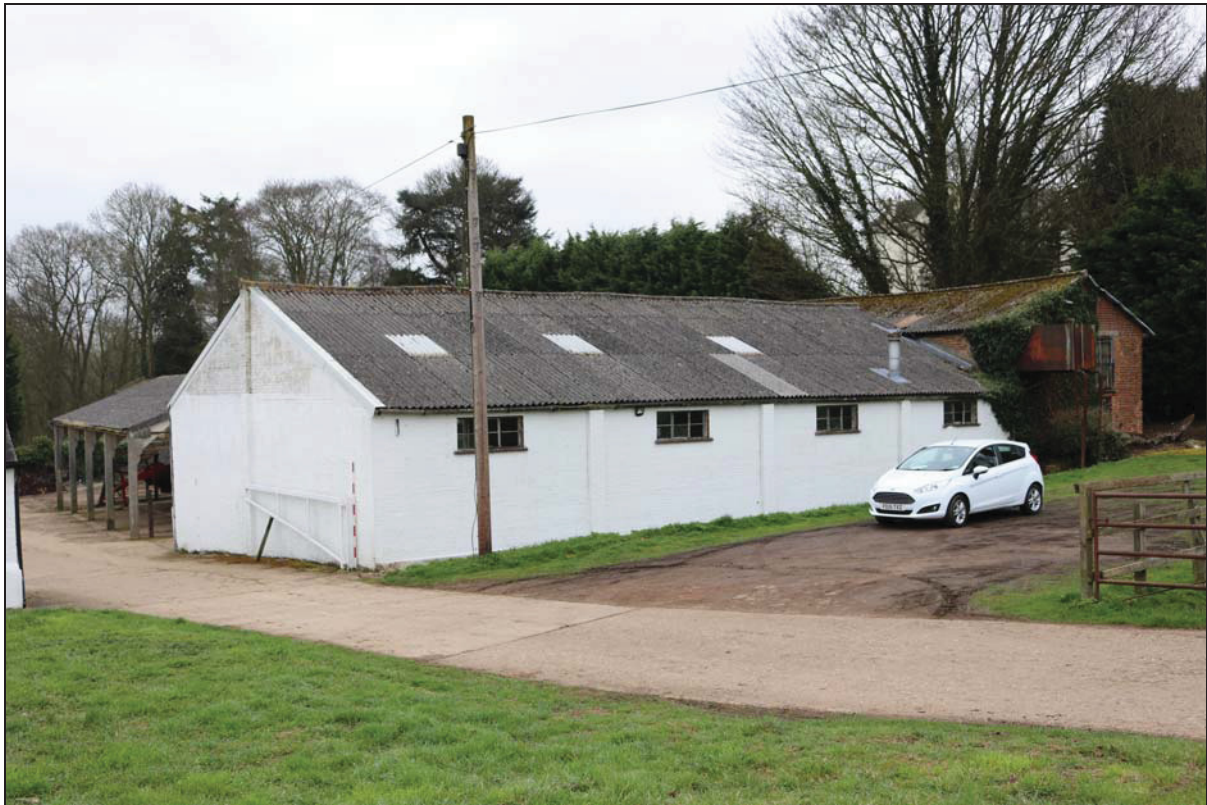
5.18 This building extends north-west from the southern end of the barn (Plate 13). It forms a four-bay brick built range aligned north-west to south-east with a relatively shallow pitched roof covered in corrugated sheeting. The brickwork is laid in Flemish bond and is all painted, with a low concrete render plinth and where this has fallen away Fletton brick is visible. The north-east side has three brick pilasters and the interior is lit from the south-west through three three-light iron casements with tile sills typically of the middle of the 20th century. The interior is given access from the south-west through two large modern sliding doors, while to the south-east there are four timber fixed casements, each with six panes.

Plate 13 View of Building 2, taken from the west (DP 15)

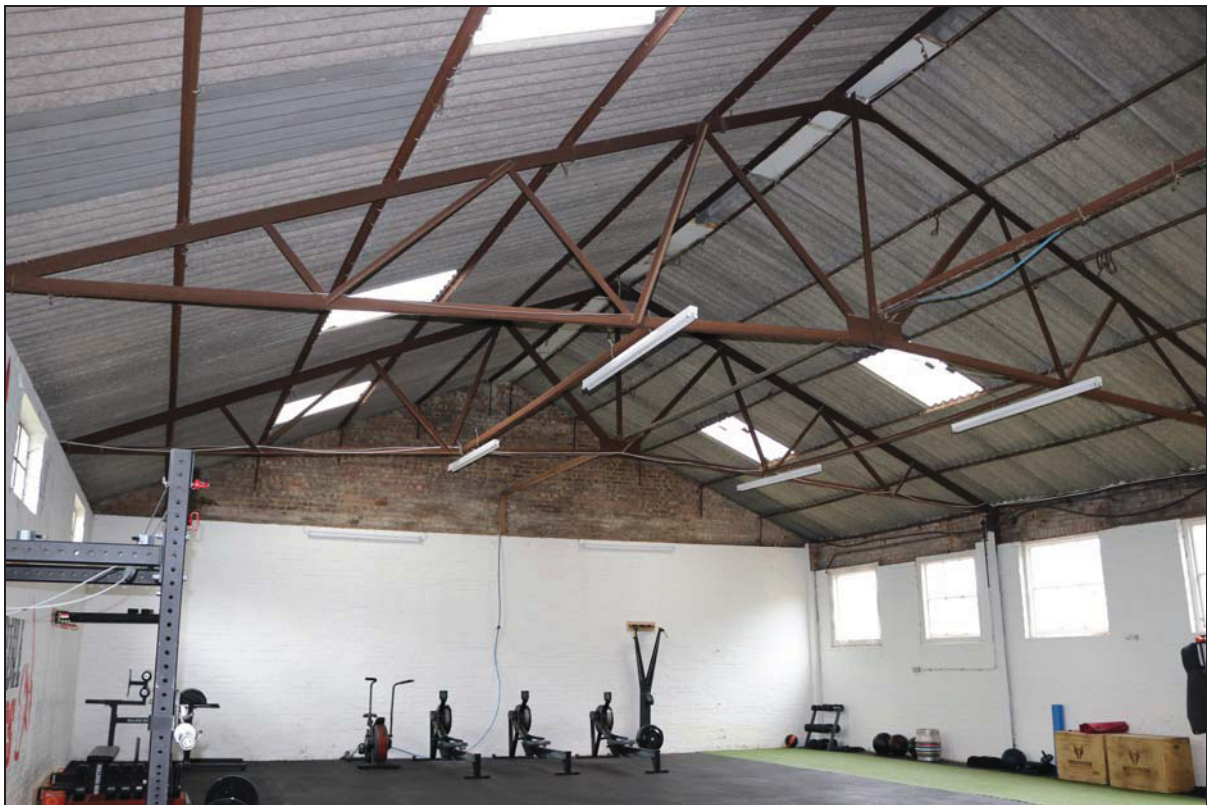
Plate 14 Interior of Building 2 showing iron trusses and Fletton brickwork to the outer walls, taken from the south-east (DP 73)

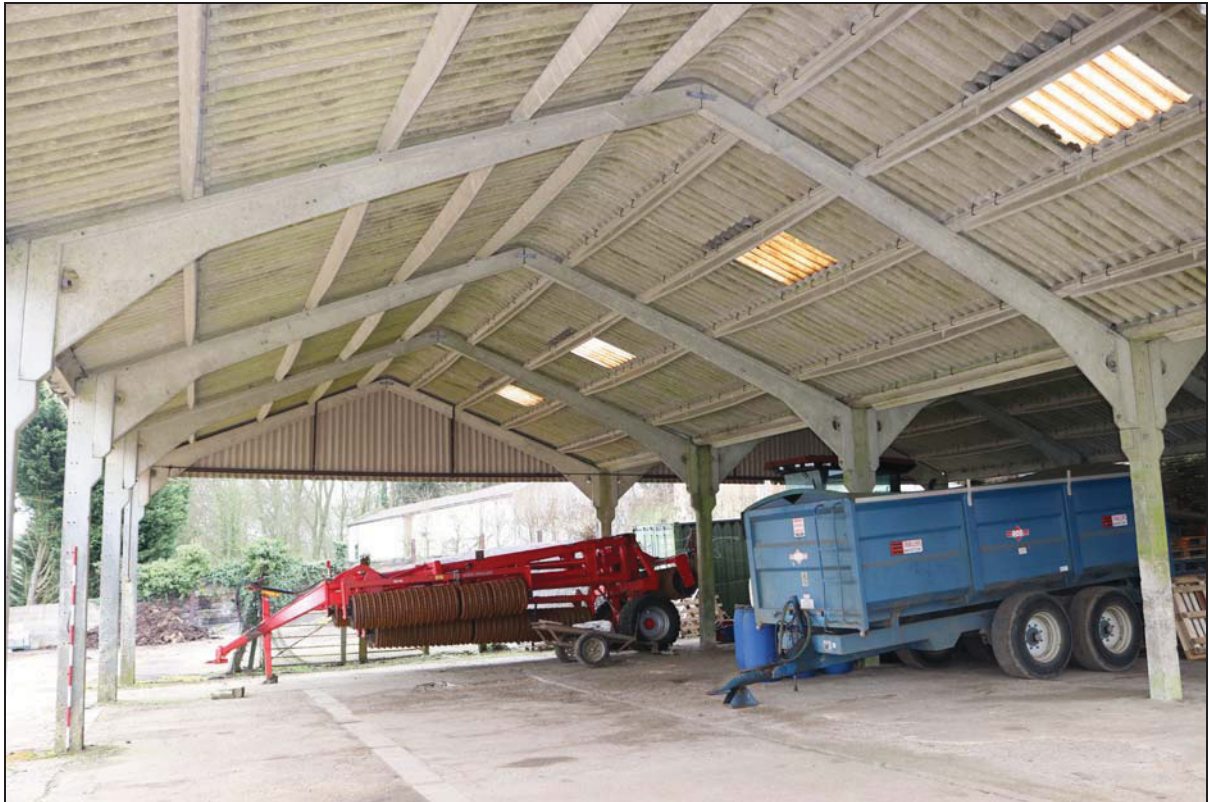
5.20 This building comprises a large Dutch barn which is of concrete Atcost type construction with two parallel roofs with trusses of pre-cast concrete, the central line of bay posts shared between the two ranges, and the roofs including pre-cast concrete purlins in sections all covered with corrugated cement sheeting (Plate 15). This building was constructed in the 1970s.

Plate 15 Interior of Building 3 showing concrete Atcost construction, taken from the south-west (DP 21)

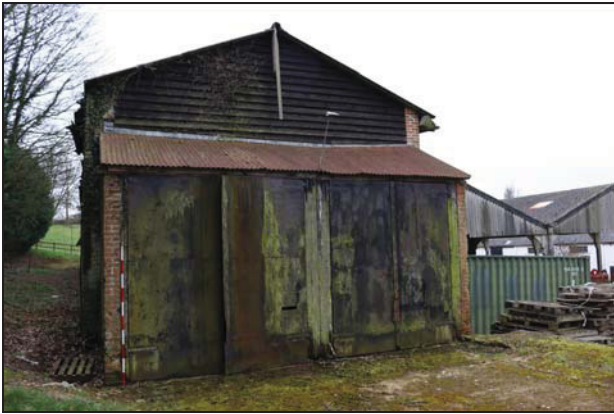
DP 1

North-east elevation (Building 1: barn), taken from the north-east

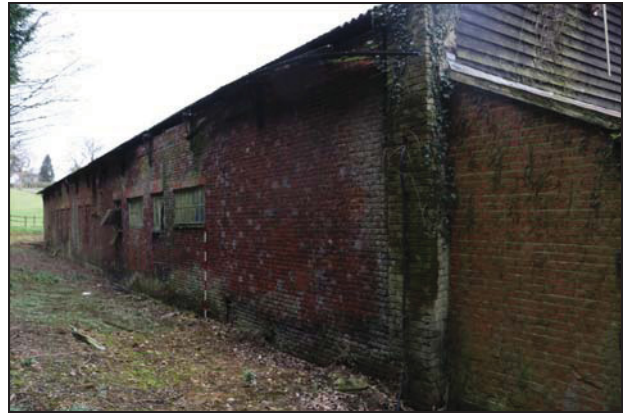
DP 2

South-east elevation (Building 1: barn), taken from the north-east

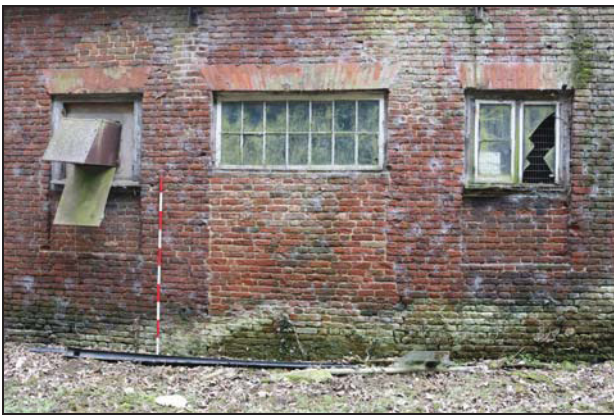
DP 3

South-east elevation of the barn (Building 1) showing windows inserted into the former blind panels and evidence for a doorway, taken from the south-east

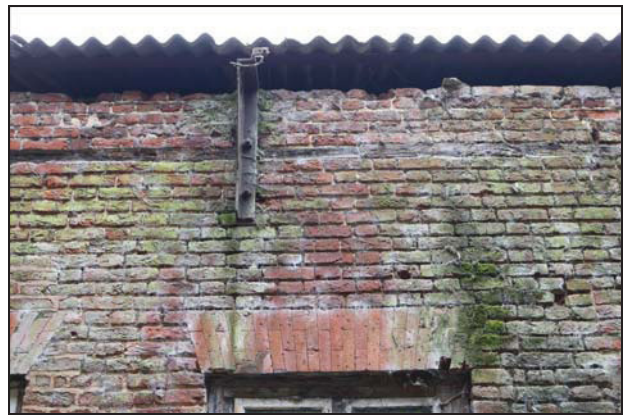
DP 4

Detail of the south-east elevation (Building 1: barn) showing timber bearer at upper level, taken from the south-east

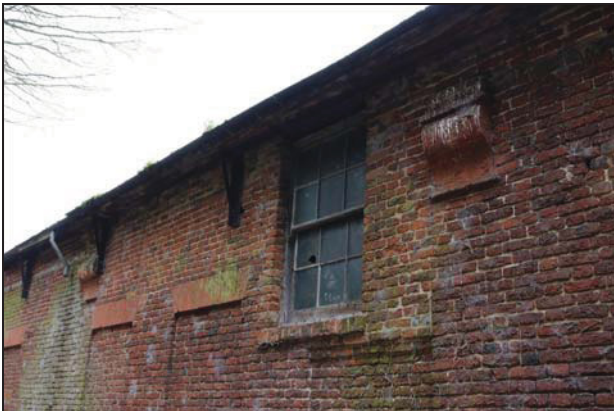
DP 5

South-east elevation of the barn (Building 1) showing central section with blind panels flanked by fine brick corbels, taken from the east

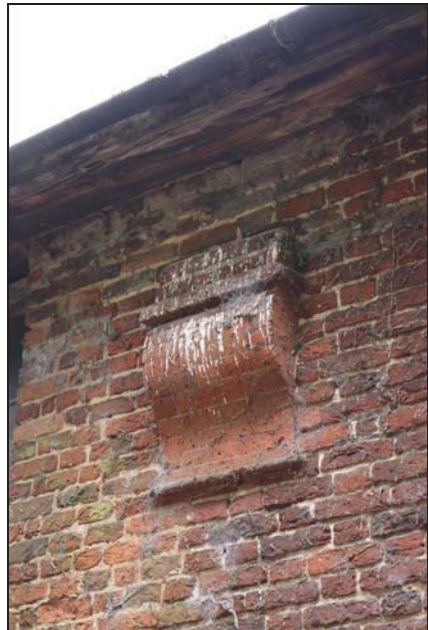
DP 6

Detail of the south-east elevation of the barn (Building 1) showing example of a fine brick corbel, taken from the east

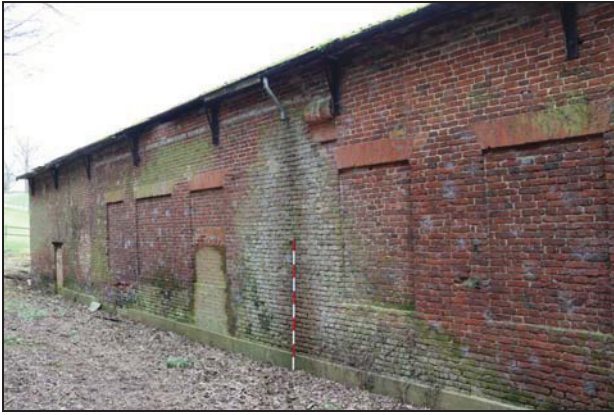
DP 7

South-east elevation (Building 1: barn) showing blind panels with blocked apertures, taken from the north-east

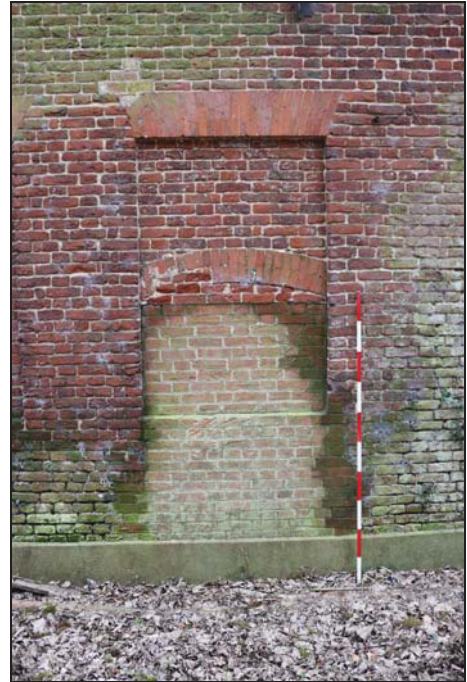
DP 8

South-east elevation (Building 1: barn) showing blind panel with inserted aperture subsequently blocked, taken from the south-east

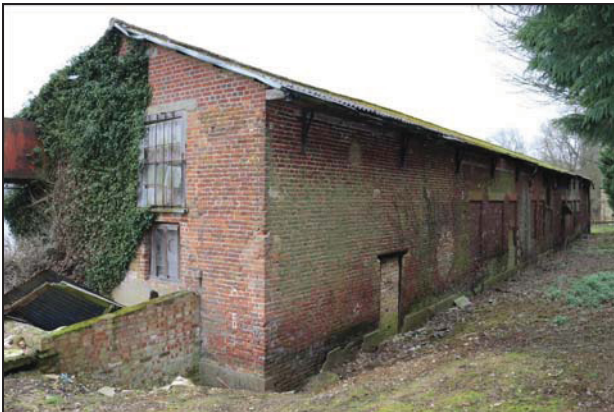
DP 9

South-west and south-east elevations of the barn (Building 1), taken from the south

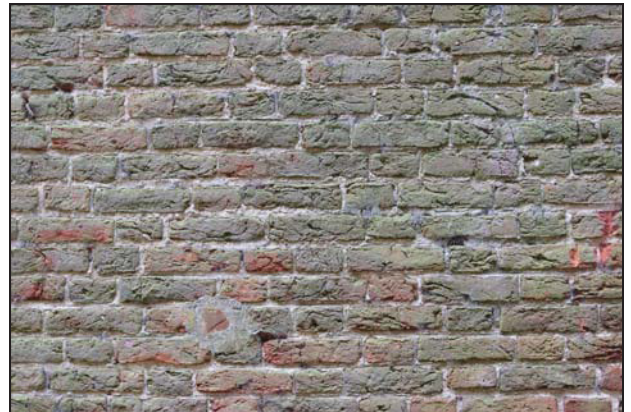
DP 10

Sample of brickwork on the south-east elevation of the barn (Building 1), taken from the south-east

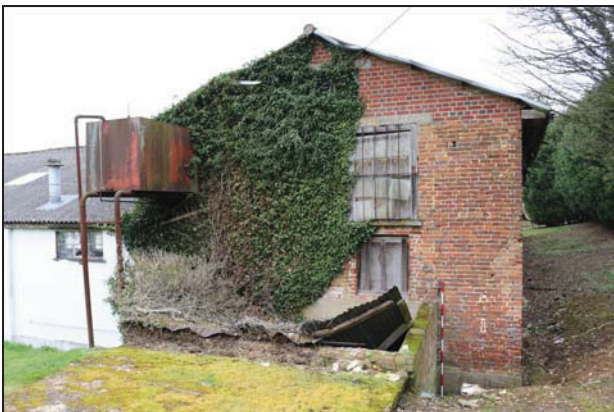
DP 11

South-west elevation of the barn (Building 1), taken from the south-west

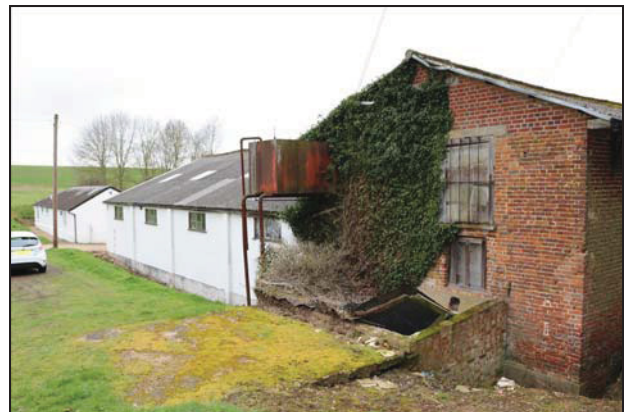
DP 12

South-west elevation of the barn (Building 1) and Building 2, taken from the south

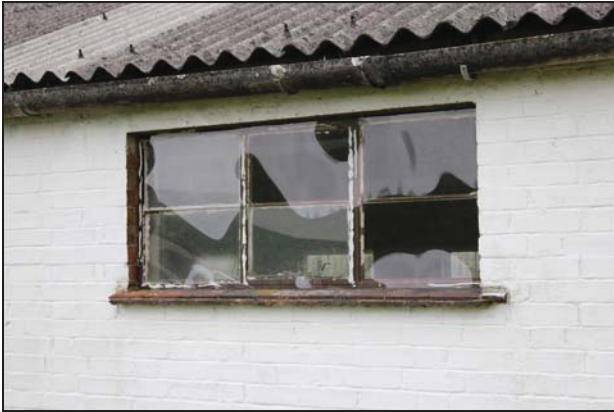
DP 13

Detail of a metal-framed casement on the south-west side of Building 2, taken from the south-west

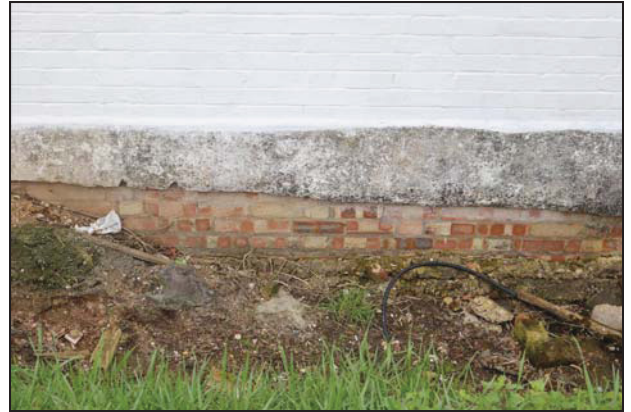
DP 14

Detail of the south-west elevation of Building 2 showing Fletton brickwork, taken from the south-west

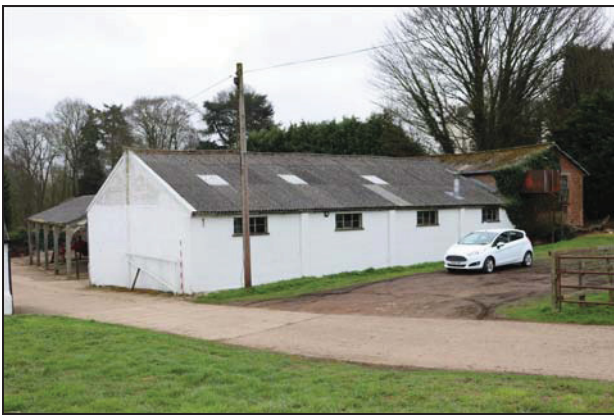
DP 15

View of Building 2, taken from the west

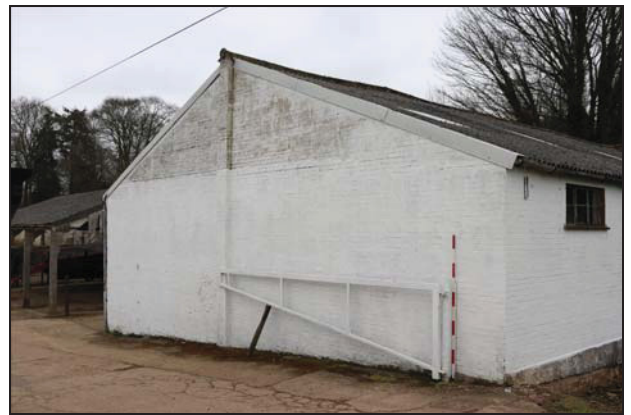
DP 16

North-west elevation of Building 2, taken from the west

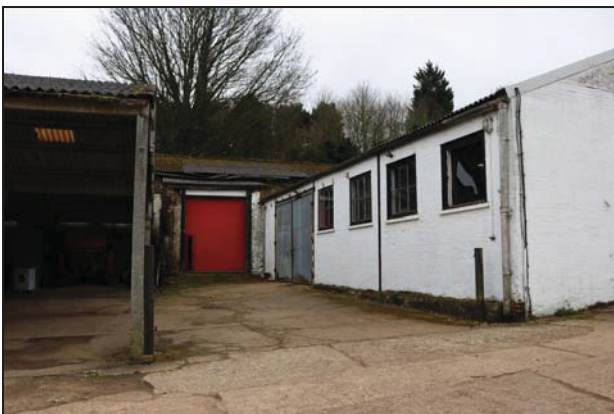
DP 17

North-east elevation of Building 2 with the porch of the barn (Building 1) to the rear, taken from the north-west

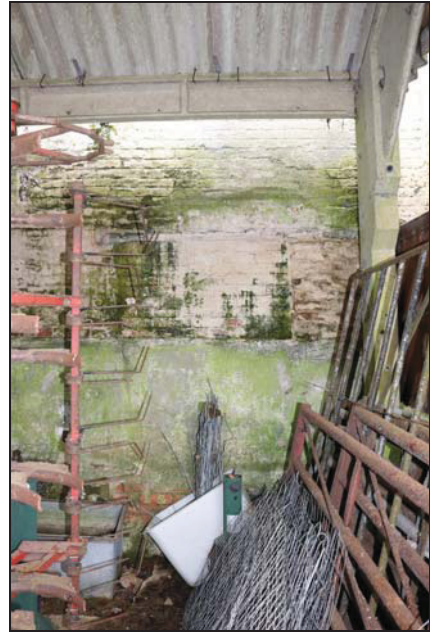
DP 20

North-west elevation of the barn (Building 1) showing blocked doorway, taken from the north-west

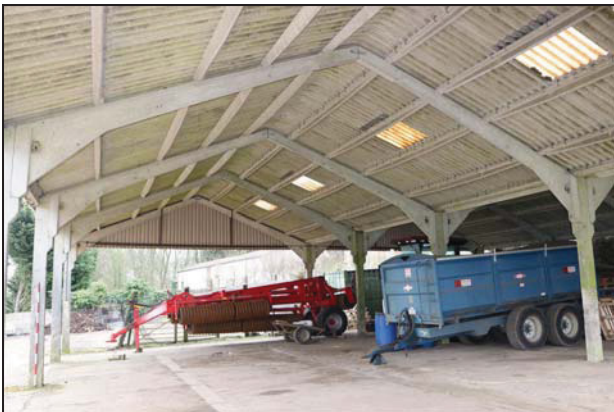
DP 21

Interior of Building 3 showing concrete Atcost construction, taken from the south-west

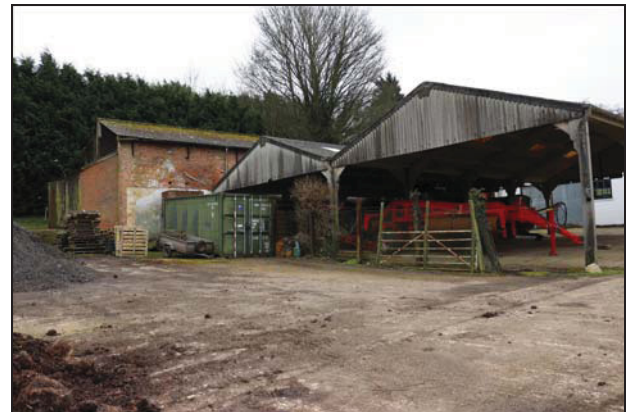
DP 22

North-east end of Building 3 with the barn to the rear (Building 1), taken from the north

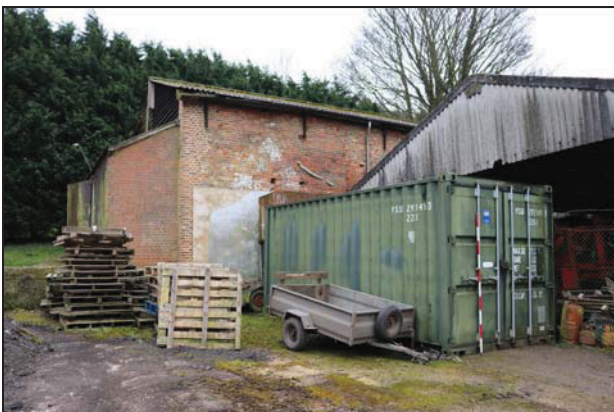
DP 23

North-west elevation of the barn (Building 1: north-east end) showing impressions for former ranges, taken from the north-west

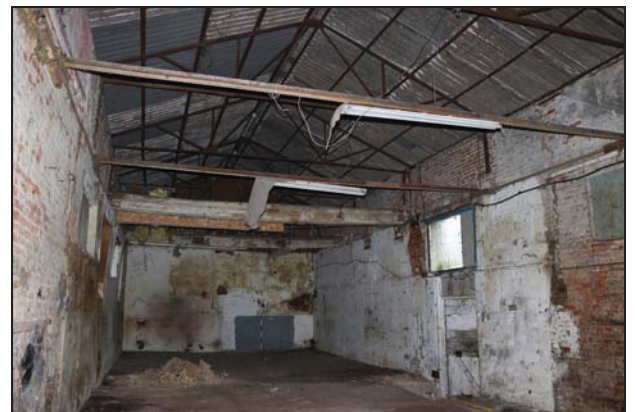
DP 24

Interior of the northern unit (Building 1: barn), taken from the north-east

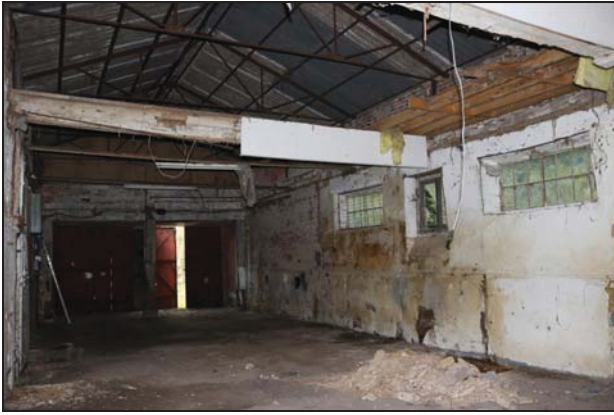
DP 25

Interior of the northern unit (Building 1: barn), taken from the south-west

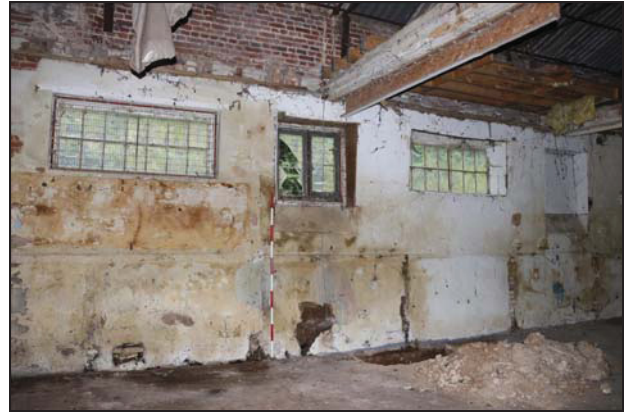
DP 26

South-east wall of the northern unit (Building 1: barn), taken from the north

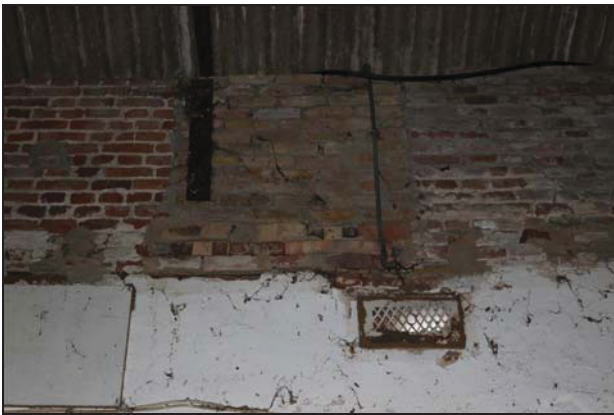
DP 27

High-set blocked aperture on the north-west wall of the northern unit (Building 1: barn), taken from the south-east

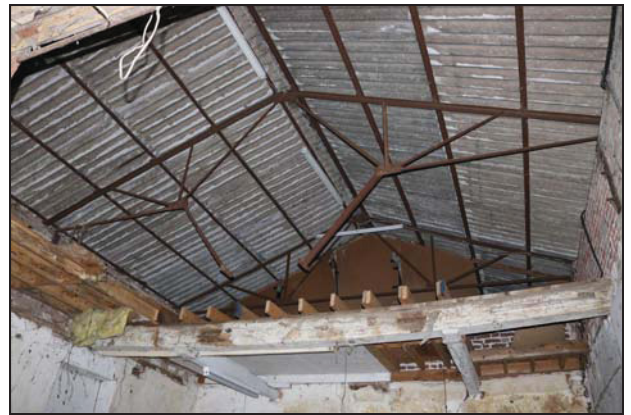
DP 28

South-west end of the northern unit (Building 1: barn) showing iron trusses above the original timber binding joist, taken from the north-east

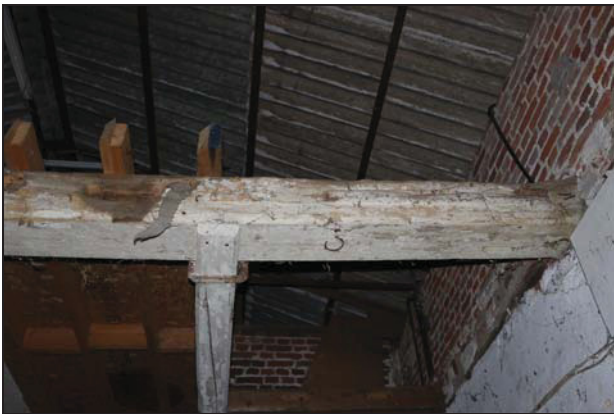
DP 29

Detail of the original binding joist in the northern unit (Building 1: barn) with empty mortice for a bridging joist, taken from the south-east

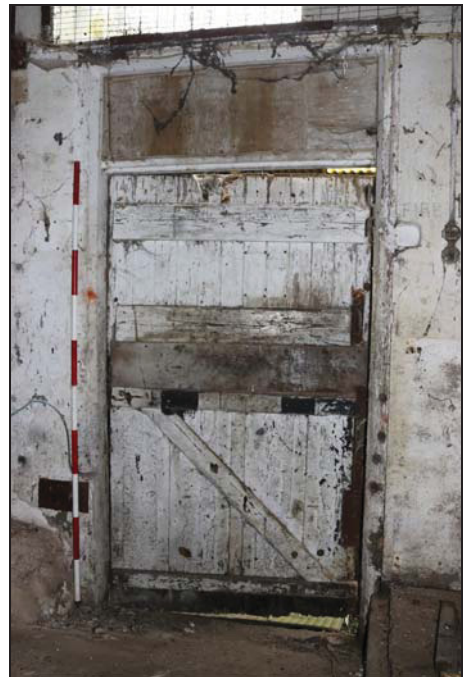
DP 30

North-west wall of the northern unit (Building 1: barn) showing boarded door, taken from the south-east

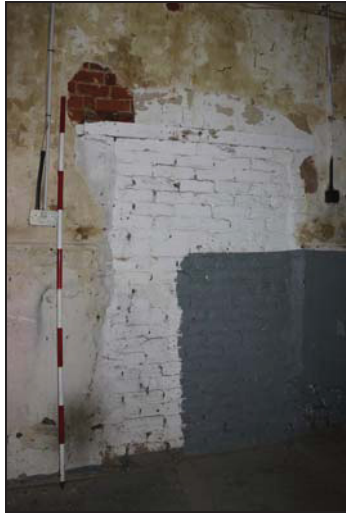
DP 31
 South-west wall of the northern unit (Building 1: barn) showing blocked doorway, taken from the north-east

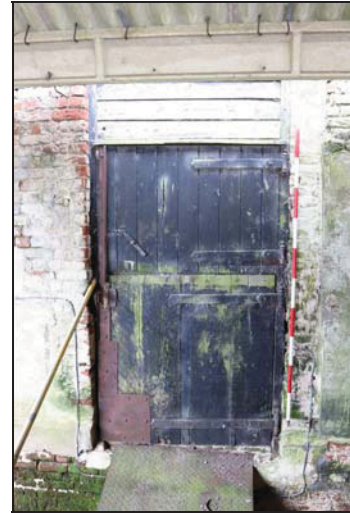
DP 32
 North-west elevation of the barn (Building 1) showing entrance to the northern unit, taken from the north-west

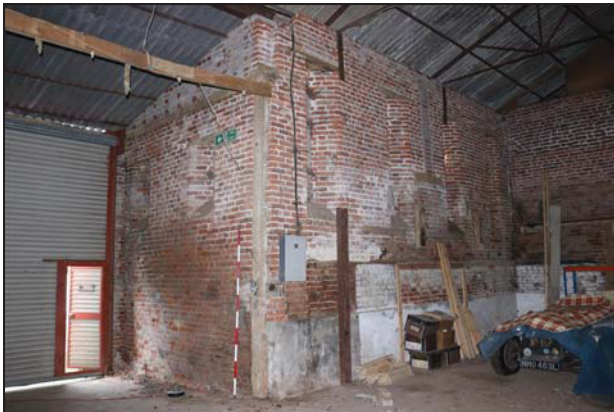
DP 33
 Interior of the northern unit (Building 1: barn) showing porch and north-west wall with original brickwork and wind-eyes, taken from the south

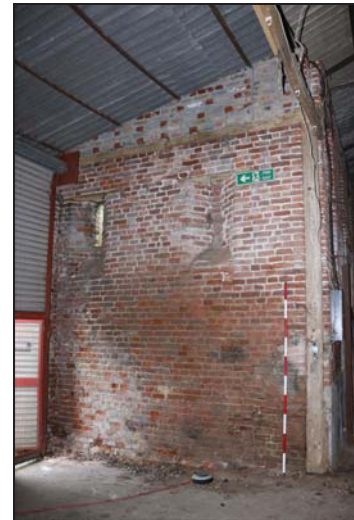
DP 34
 North-east wall of the porch (Building 1: barn) showing infilled short wind-eyes, taken from the south-west

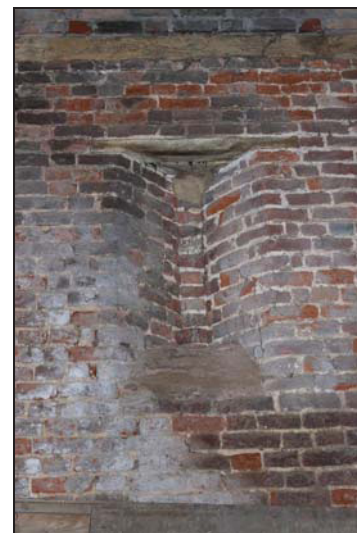
DP 35
 South-west wall of the porch (Building 1: barn) showing infilled wind-eyes, taken from the south-east

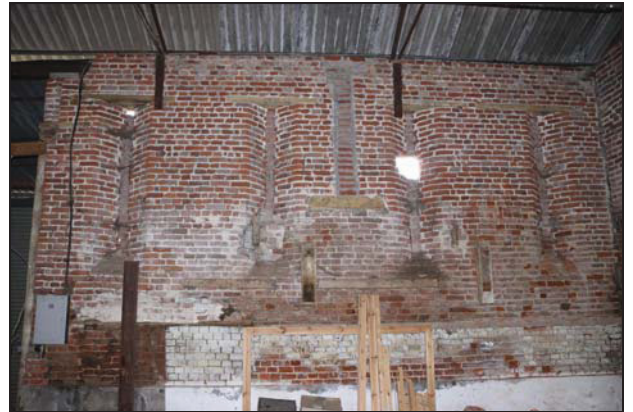
DP 39
Detail of the south-east wall of the northern unit (Building 1: barn) showing infilled recess for wall-post over a timber pad, taken from the north-west

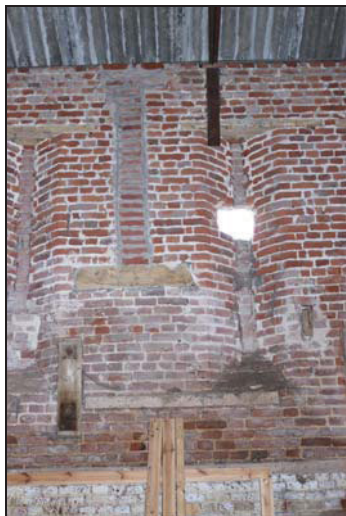
DP 40
North-west wall of the southern unit (Building 1: barn) showing infilled wind-eyes and infilled recess in the position of a former truss, taken from the south-east

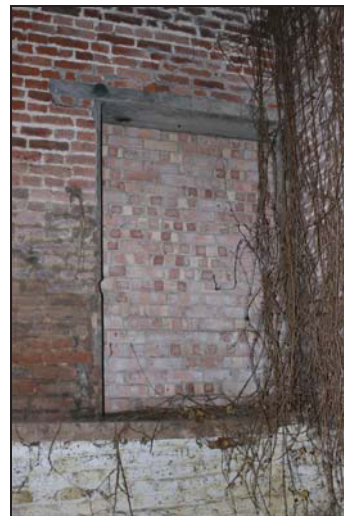
DP 41
Detail of the north-west wall of the southern unit (Building 1: barn) showing infilled wind-eyes and infilled recess in the position of a former truss, taken from the south-east

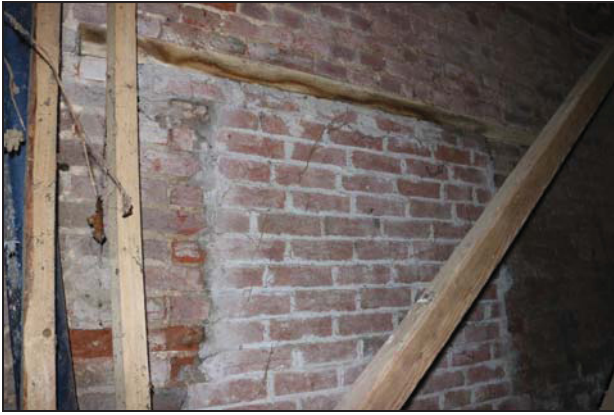
DP 42
North-east wall of the southern unit showing high-set aperture infilled with 20th century Fletton brickwork, taken from the south-west

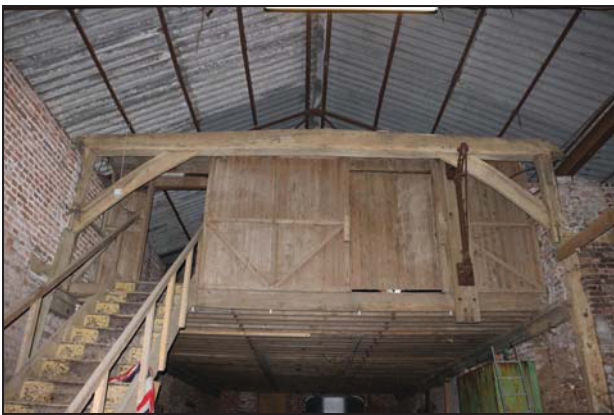
DP 44

Interior of the southern unit (Building 1: barn) showing replacement iron roof truss above the early fabric, taken from the north-east

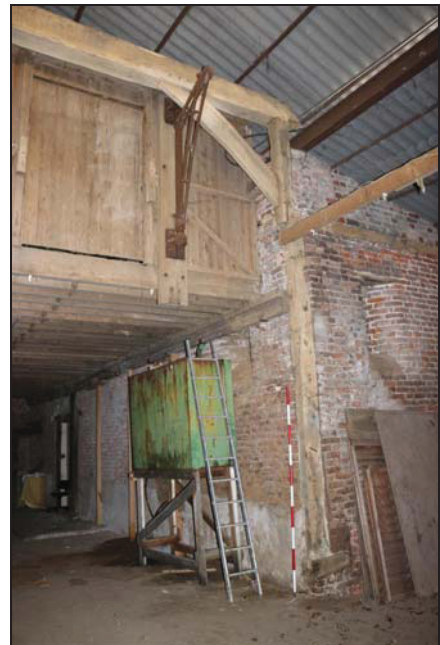
DP 45

Detail of the surviving original truss (Building 1: barn) with inserted upper floor beyond, taken from the north-east

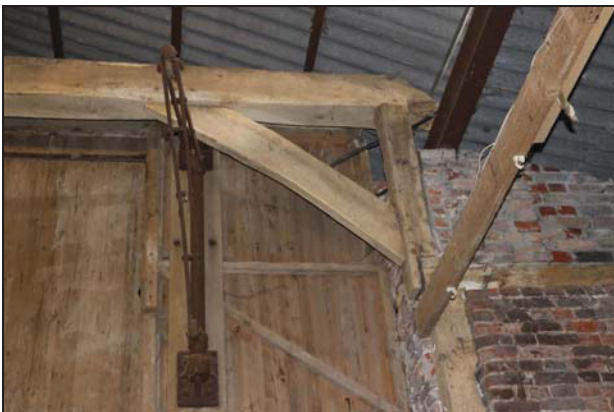
DP 46

Detail of the surviving truss (Building 1: barn) at the junction with the porch, taken from the east

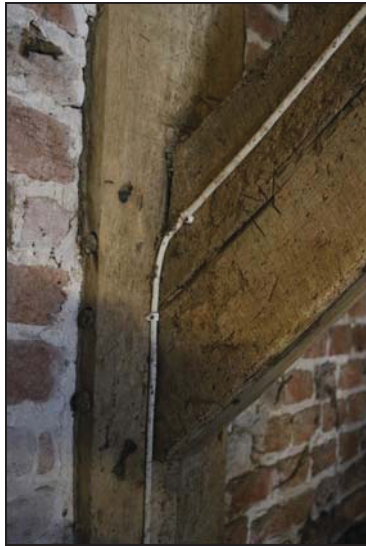
DP 50

Detail of the surviving truss (Building 1: barn) showing pegged wall-post, tie-beam and brace, taken from the north-east

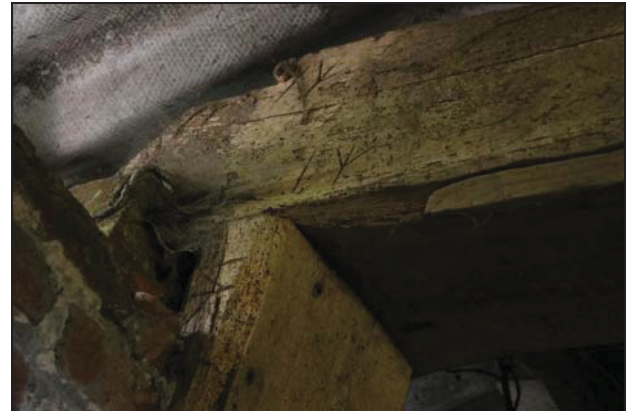
DP 51

Detail of the surviving truss (Building 1: barn) showing wall-post and brace base with pegging and assembly mark, taken from the north-east

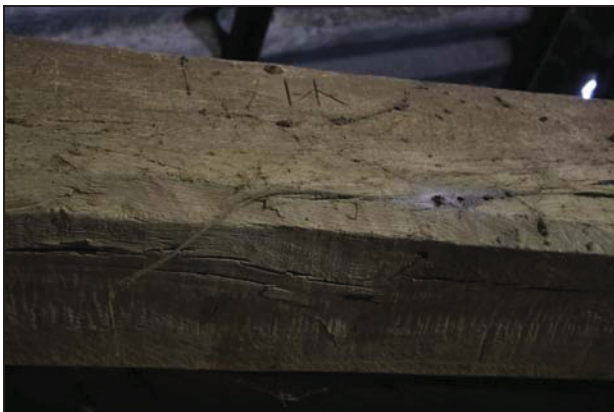
DP 52

Detail of the surviving truss (Building 1: barn) showing wall-post and tie-beam with assembly marks, taken from the north-east

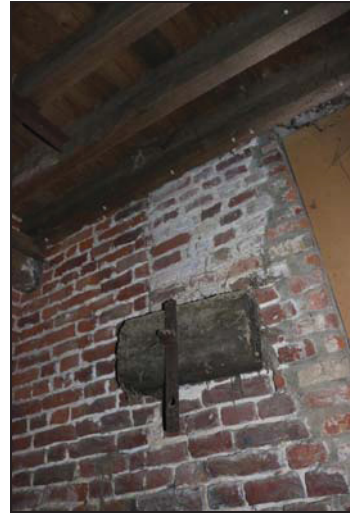
DP 55
 South-east corner of the southern unit (Building 1: barn) showing inserted apertures and low level rendering, taken from the north-east

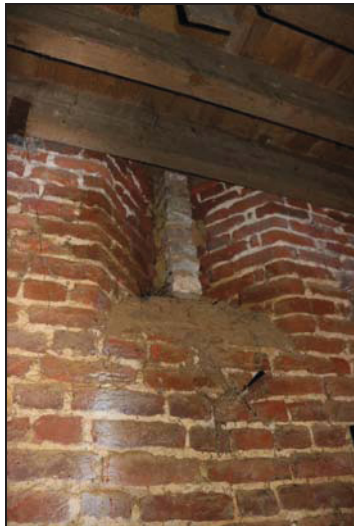
DP 56
 South-west wall of the southern unit (Building 1: barn) showing infilled wind-eye with timber block and iron tie, taken from the north-east

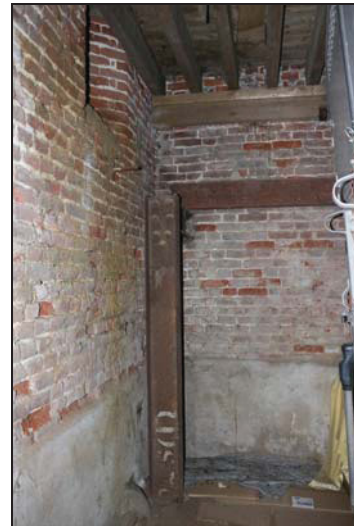
DP 57
 South-west wall of the southern unit (Building 1: barn) showing infilled wind-eye, taken from the north-east

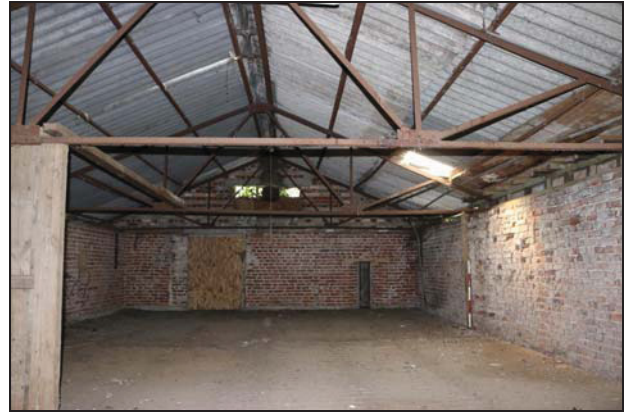
DP 61

View of the southern unit (Building 1: barn), taken from the south-west

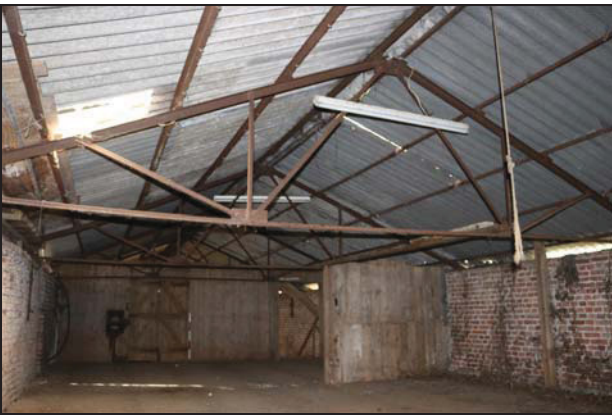
DP 62

View of the southern end of the barn at upper level (Building 1: barn), taken from the north-east

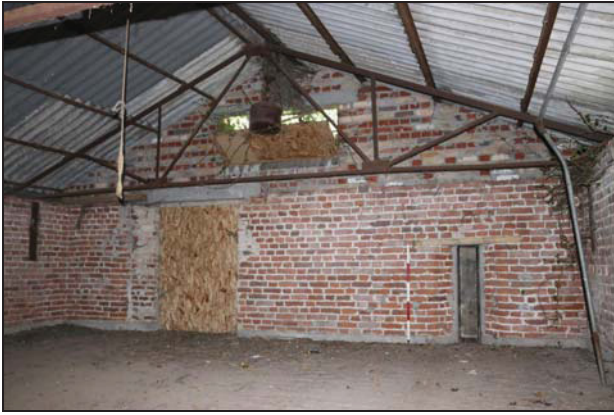
DP 66

North-west wall of the southern unit (Building 1: barn) showing infilled wind-eyes, taken from the south-east

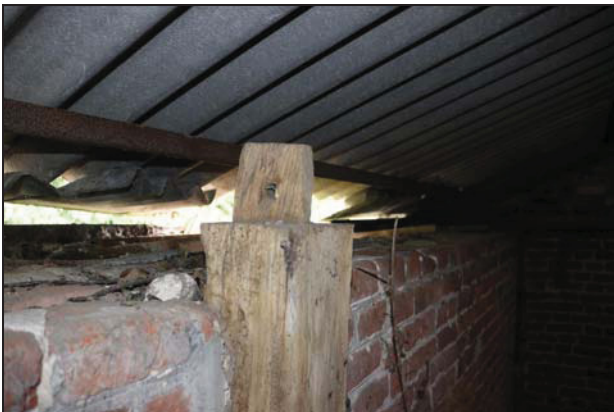
DP 68

Surviving wall-post of the southern truss (Building 1: barn) showing sawn off brace and upper tenon, taken from the north-east
