ARCHAEOLOGICAL SOLUTIONS LTD

COCKHAMSTED, FRIARS ROAD, BRAUGHING,  
HERTFORDSHIRE, SG11 2NT

HISTORIC BUILDING RECORDING AND  
BUILDING MONITORING & RECORDING

Authors:	Kate Higgs MA (Oxon.) Tansy Collins MSt Kathren Henry	
NGR: TL 4193 2531	Report No: 6678	
District: East Hertfordshire	Site Code: AS1859	
Approved: Claire Halpin MCIfA	Project No: 6678	
Signed:	Date: 18 November 2016

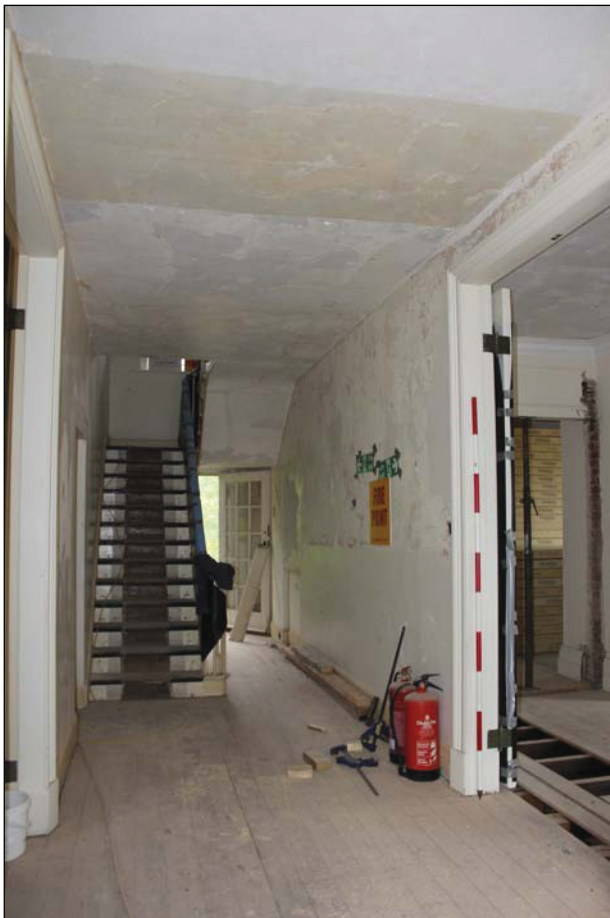
Plate 4 Entrance hall GF01, taken from the west (DP50)

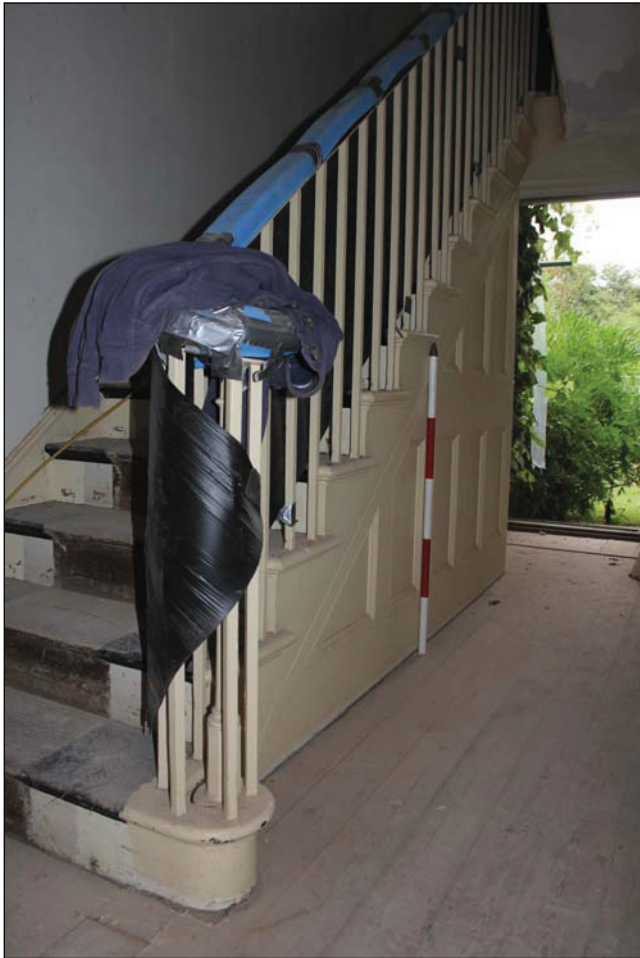
5.14 The staircase is original and is a fine example typical of its early 19<sup>th</sup> century date rising from a curtailed base with typically early Victorian handrail and stick balusters on an open string (Plate 5). The handrail appears to be of hardwood with a simple profile but has been covered in protective fabric for the duration of the work, while the balusters are painted white. The treads are nosed, with the nosings projecting to the sides but otherwise unadorned. Recessed moulded panelling encloses the space below the staircase and accommodates a cupboard which is reached from the east via a four-panel door with recessed moulded panels and a good handle.

Plate 5 View of the staircase (GF01), taken from the south-west (DP53)

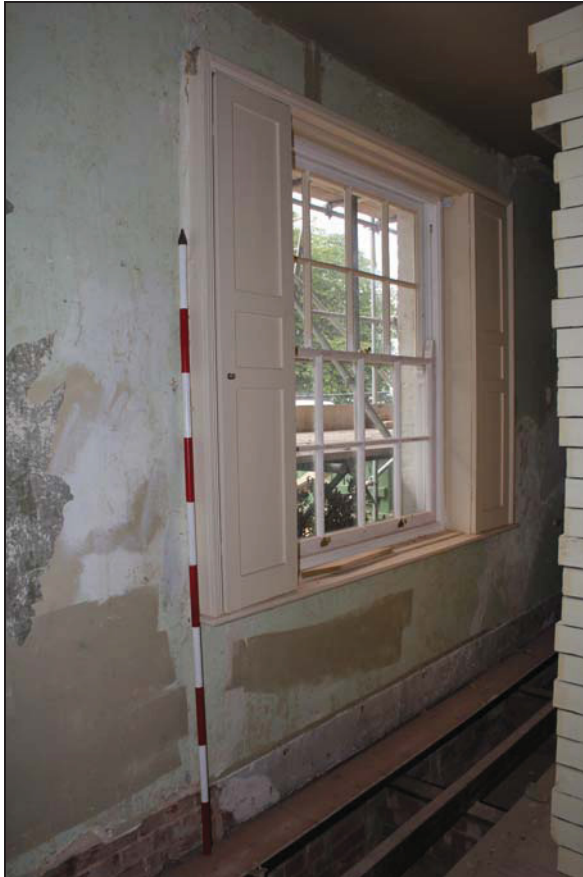
5.16 The window on the north is a large eight-over-eight sash window, the sashes renewed but with plain panelled folding shutters surviving in boxes to either side (Plates 7-8). The original handles are lost but simple hinges survive. The fireplace on the east side of the room is typically Regency, with a simple surround with circular paterae and a plain shelf (Plate 9). Adjoining the fireplace to the east, a tall connecting doorway retains panelled reveals and soffits, but with a modern attached surround.

Plate 7 Sash window with shutters on the west side of Room GF02, taken from the south-east (DP64)

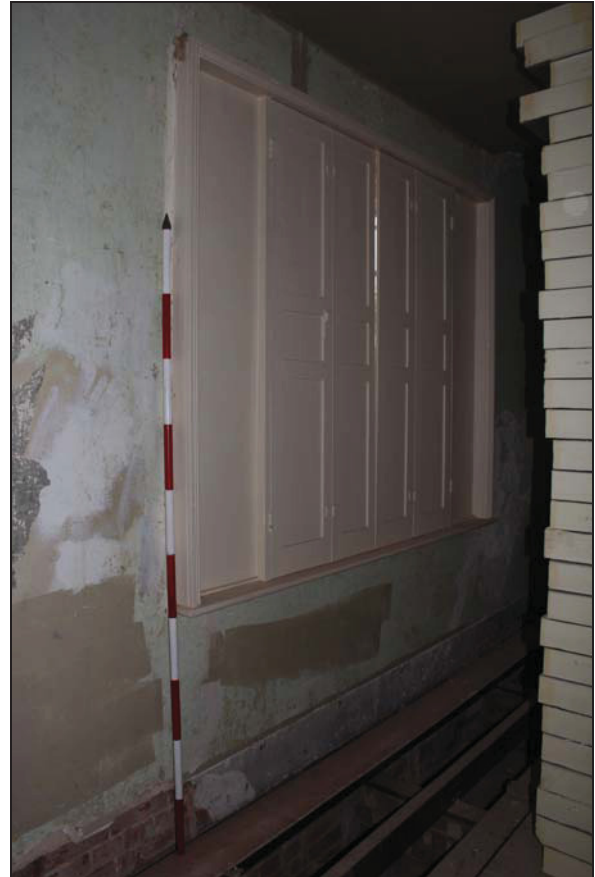
Plate 8 Sash window with shutters on the west side of Room GF02, taken from the south-east (DP65)

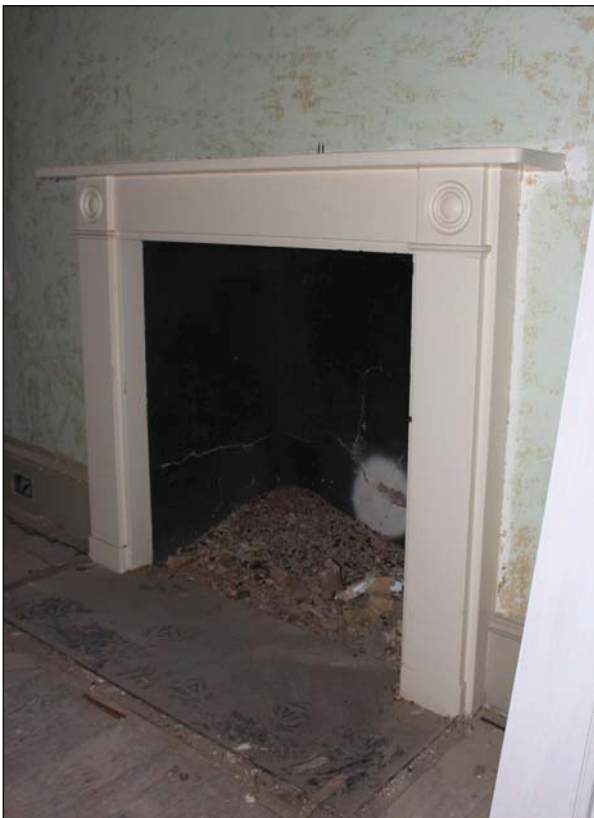
Plate 9 Simple Regency fire surround on the east side of Room GF02, taken from the south-west (DP66)

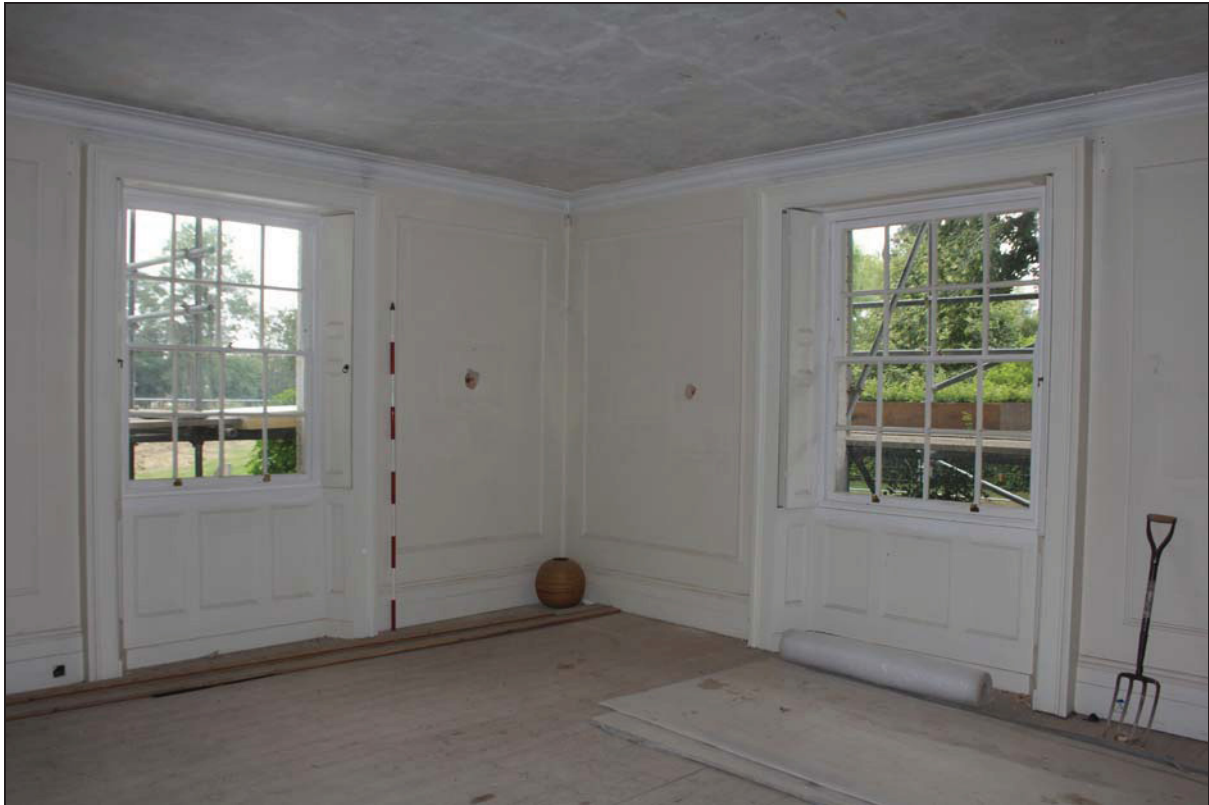
5.17 The opposite side of the hallway has a larger reception room (GF03), which is lit from two sides and has two bay windows in splayed reveals with panelled shutters housed in the reveals and panelled apron (Plate 10). Each shutter is of three narrow leaves, the outer show leaves with moulded panels and the inner examples plain. The original locking bars survive on both windows. The windows themselves differ, the south window probably late 19<sup>th</sup> – early 20<sup>th</sup> century with horns, while the western sash window is probably slightly earlier with shaped horns. The walls are panelled, with high moulded skirting boards and applied mouldings creating large panels with a deep coved cornice and inner reeding. The cornice is probably gypsum and consistent with a 19<sup>th</sup> century. Alteration is most evident on the east wall where the chimney breast survives, but the walls to either side have been removed in order to communicate with the adjoining Room GF04 (while blocking the entrance to that room from the hallway, see below). The fire surround has been removed and stored and there is a large applied panel above perhaps to hold a painting or mirror. These apertures were latterly framed with columns, now removed. The lime plaster of the outer walls is exposed here and is fairly pale and contains animal hair.

Plate 10 Sash windows with shutters on the west and south sides of Room GF03, taken from the north-east (DP55)

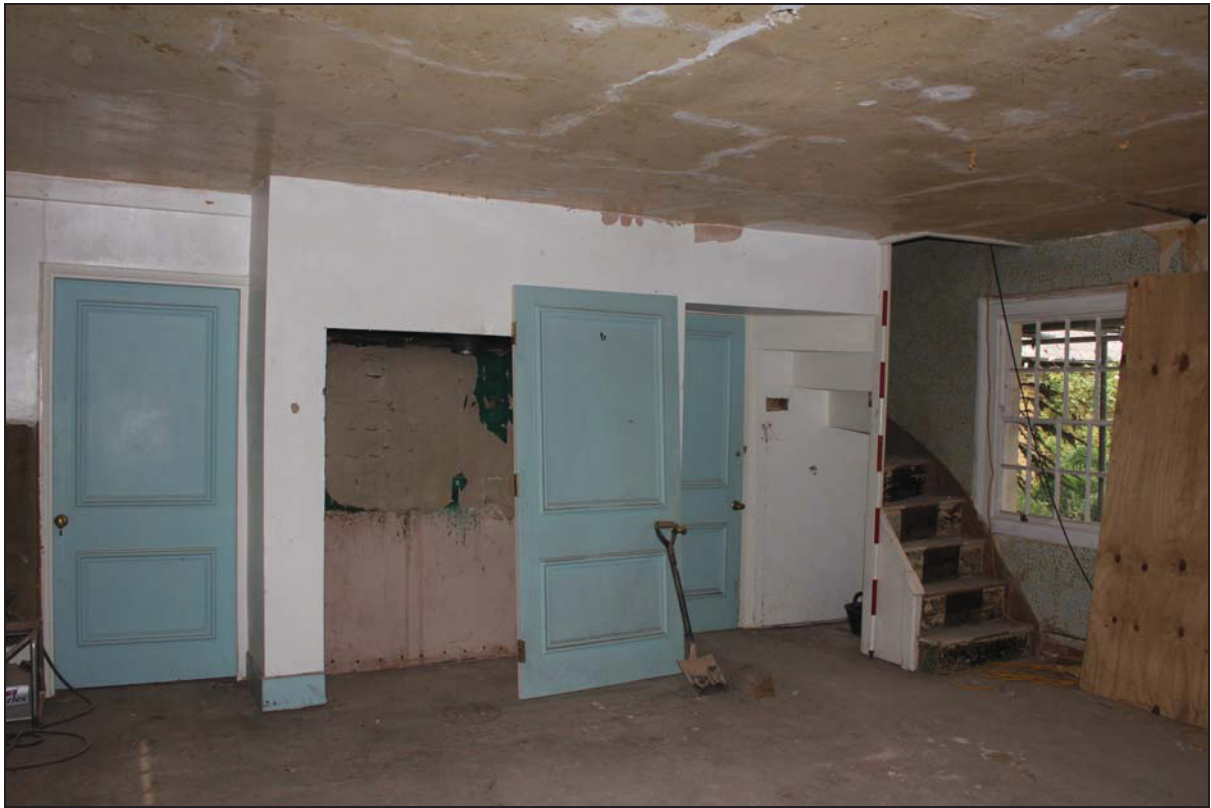
5.20 From here, the service range is given access to the north. The first room formed the kitchen (GF06) and is currently undergoing remodelling so that the external walls are now exposed brick, while the floor is tiled but has the remains of cement screed in places. There is a large ten-over-ten sash window on the east, and a doorway adjoining formerly led to the garden room though is currently being converted to a window aperture, while a further twelve-over-twelve sash window lies on the west, recently stripped and refurbished. Some Fletton brickwork in this area demonstrates alteration. On the north side, a large kitchen fireplace for a range survives with doors to either side, and a small staircase to upper level in the north-east corner (Plate 13). Both doors have two applied panels. The staircase is a constricted stair that winds round a slender newel with simple nosed treads.

Plate 13 North side of Room GF06 (service range) showing kitchen fireplace, taken from the south (DP69)

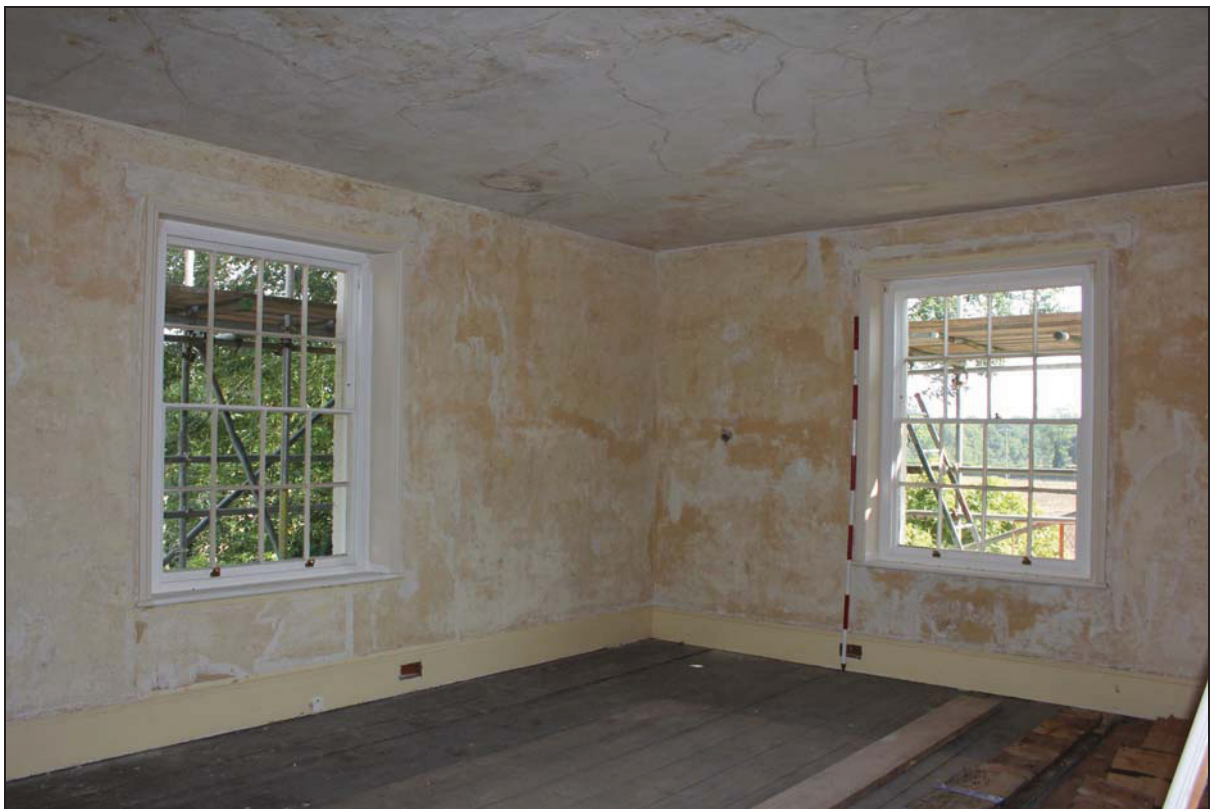
5.27 From the landing, the south-east room is fairly plain, but preserves the original eight-over-eight windows on the east and south, both with no horns and slender moulded glazing bars (Plate 14). The fireplace on the west is blocked, but the skirting is replicated.

Plate 14 Windows on the east and south sides of Room FF05, taken from the north-west (DP91)

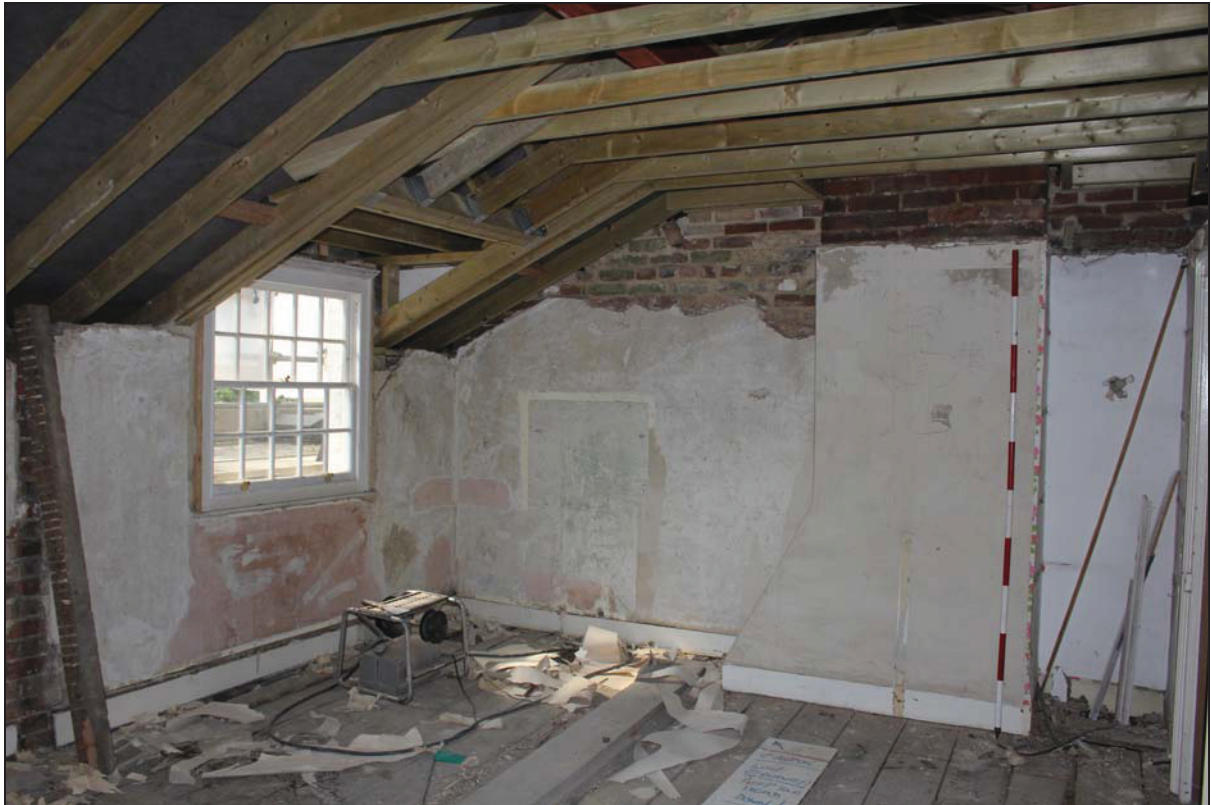
5.31 Room FF09 lies to the west of the landing (FF08) and latterly comprised two rooms, though the internal partition has been removed. The internal partition was itself a later insertion, demonstrated where it was built over fairly wide floorboards, and there is a plain skirting board. The two windows on the west are modern or refurbished, while the doors on the east have been removed though moulded frames survive. A cupboard on the south has a two-panel door and corresponds to the blocked aperture outlined in the adjoining Room FF02. A chimney-breast on the north does not appear to have ever held a fireplace (Plate 15).

Plate 15 North side of Room FF09, taken from the south (DP77)

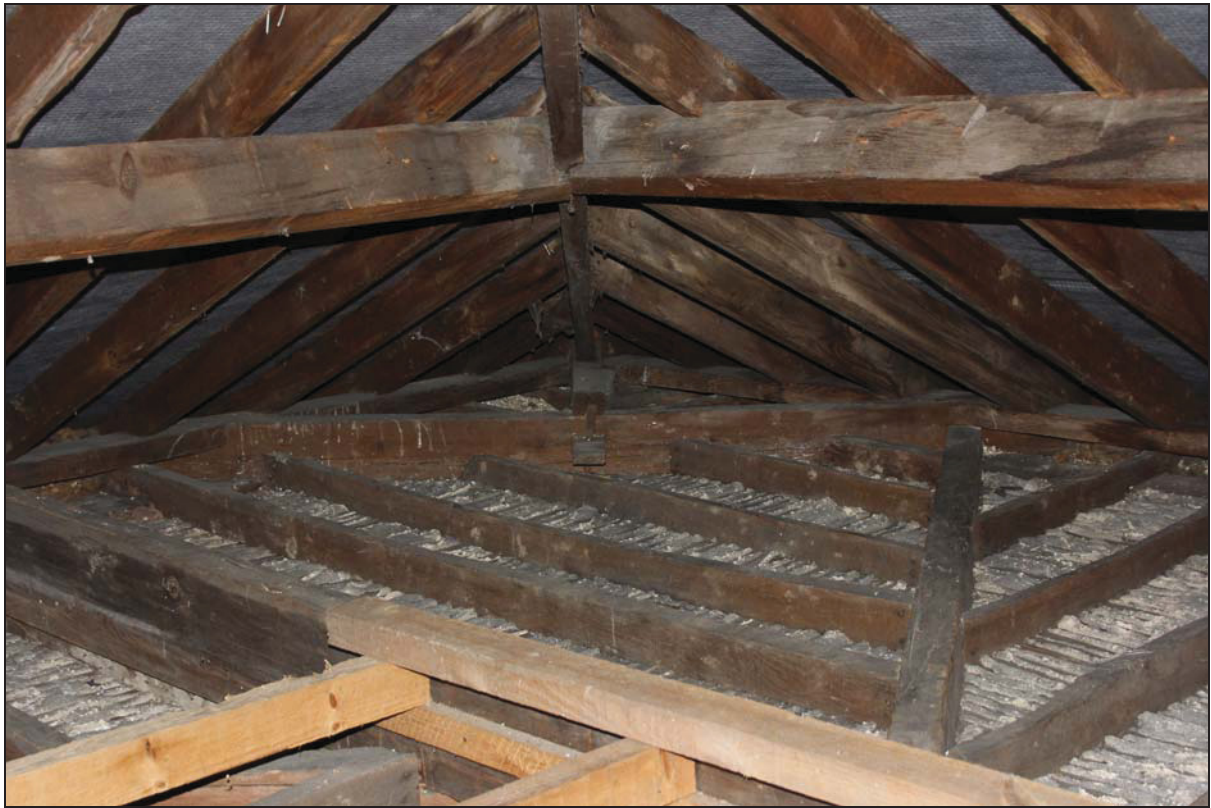
beam by a coach bolt. Slender raking struts rise from the base of the king post to support an upper flight of purlins, while a lower, second flight is supported by short raking struts from the tie-beam. Principal rafters are notched over the purlins and rise to meet the head of the king post which accommodates a ridgeboard. Common rafters ride over the back of the purlins. Assembly marks are visible on the base of the king posts and to the adjacent tie-beam and raking struts. The hips rafters are supported in each corner on a short dragon beam that terminates at an angle tie (Plate 19).

Plate 19 South-west corner of the roof space showing corner angle tie and ceiling structure to the room below, taken from the north-east (DP20)

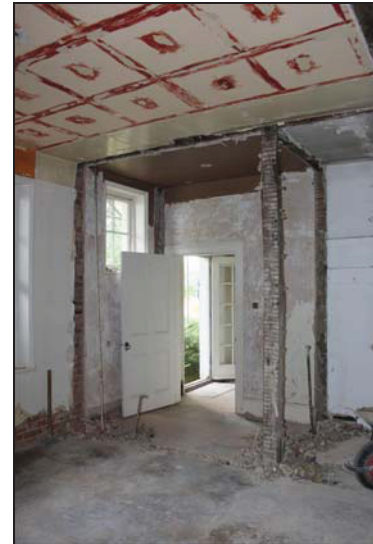
DP 16

*Room GF05 after removal of the primary-braced partition during the planned works, taken from the north-west*

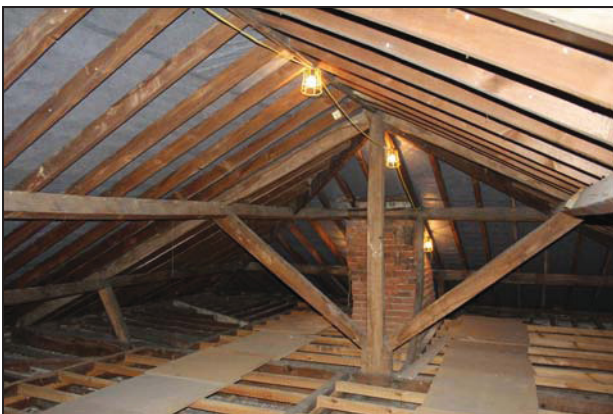
DP 17

*King-post roof structure over the house (south-truss), taken from the north*

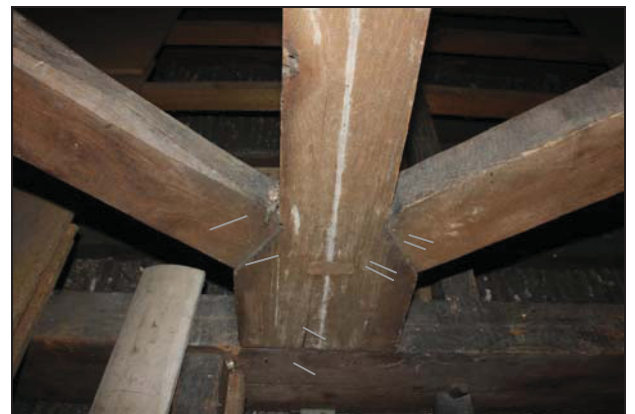
DP 18

*Base of the king post (south truss) showing timber plug and assembly marks (emphasised), taken from the north*

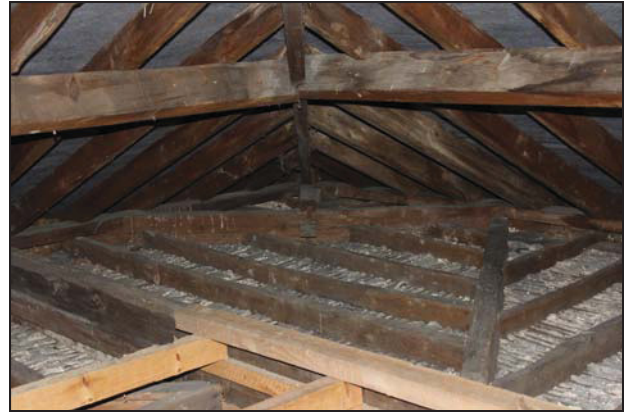
DP 20

*South-west corner of the roof space showing corner angle tie and ceiling structure to the room below, taken from the north-east*

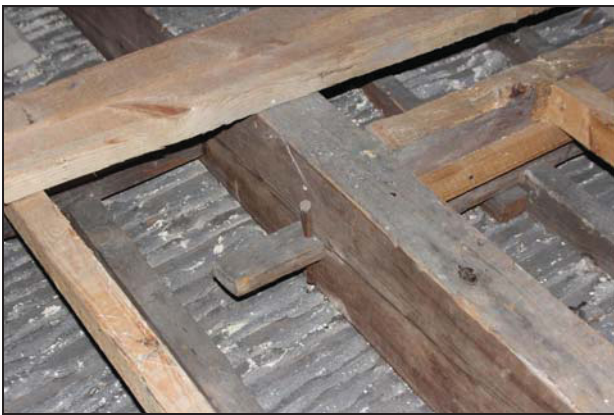
DP 21

*Detail in the roof space showing tusk tenon joint in the ceiling arrangement of the room below, taken from the south*

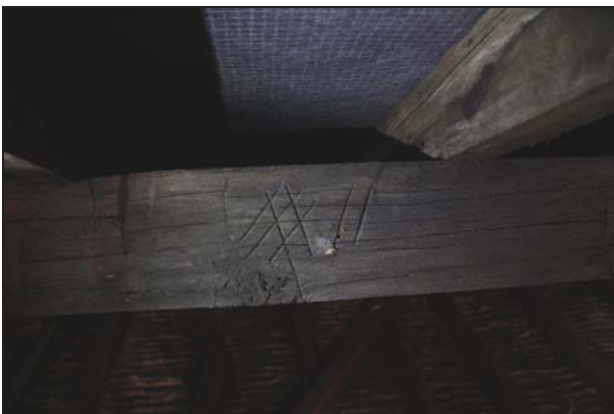
DP 23

5.36 The roof of the main range was given access through a ceiling hatch in Room FF06 and is of regular and systematic construction utilising softwood of regular and slender scantling (Plate 17). The timber is notable by the presence of a number of scribed marks suggesting a Baltic origin for the timber (Plate 18), which are observed on purlins and one bridging joist to the ceiling below.

*Scribed Baltic timber mark (tally mark) on a purlin in the roof structure*

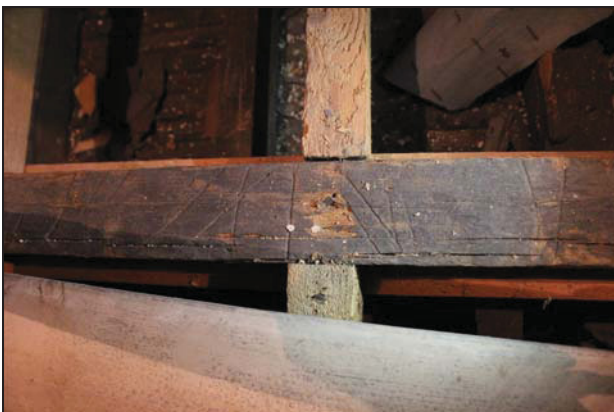
DP 29

*Scribed Baltic timber mark on a bridging joist in the roof structure*

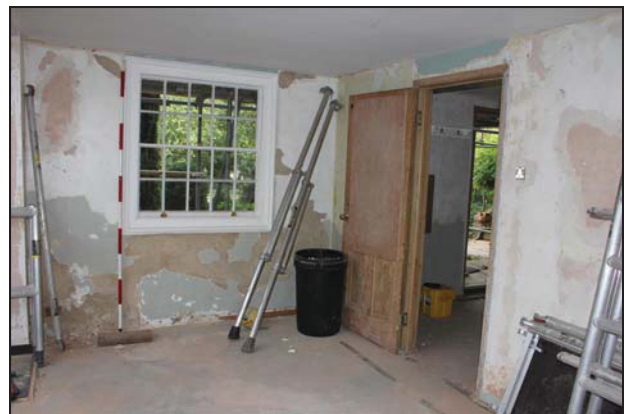
DP 71

Room GF09 showing modern extension opened up from the service range, taken from the south

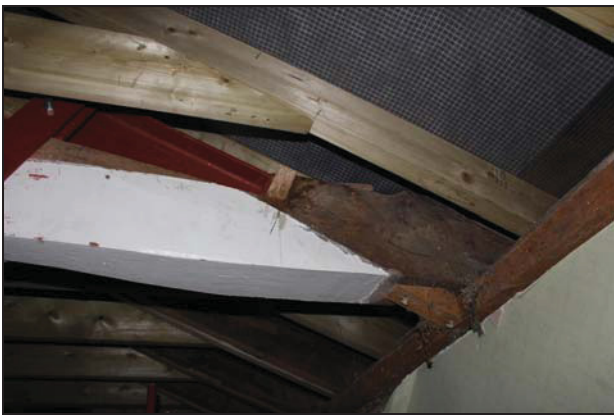
DP 80

North-east corner of Room FF12 showing angle tie, taken from the south-west

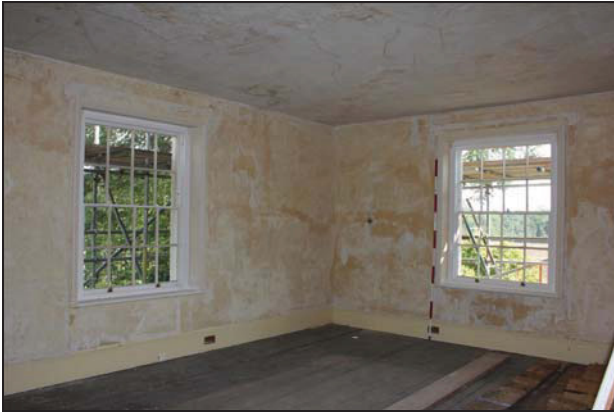
DP 90

Break in the skirting board on the west side of Room FF05 defining the position of the former fireplace, taken from the north
