ARCHAEOLOGICAL SOLUTIONS LTD

LORDSHIP COTTAGE, DANE END, WARE,
HERTFORDSHIRE

HISTORIC BUILDING RECORDING AND BUILDING
MONITORING & RECORDING

Authors: Tansy Collins MSt Lauren Wilson MA PCIfA Kathren Henry	
NGR: TL 3358 2201	Report No: 5169
District: East Hertfordshire	Site Code: AS 1837
Approved: Claire Halpin MIfA	Project No: 6571
Signed:	Date: 18 July 2016

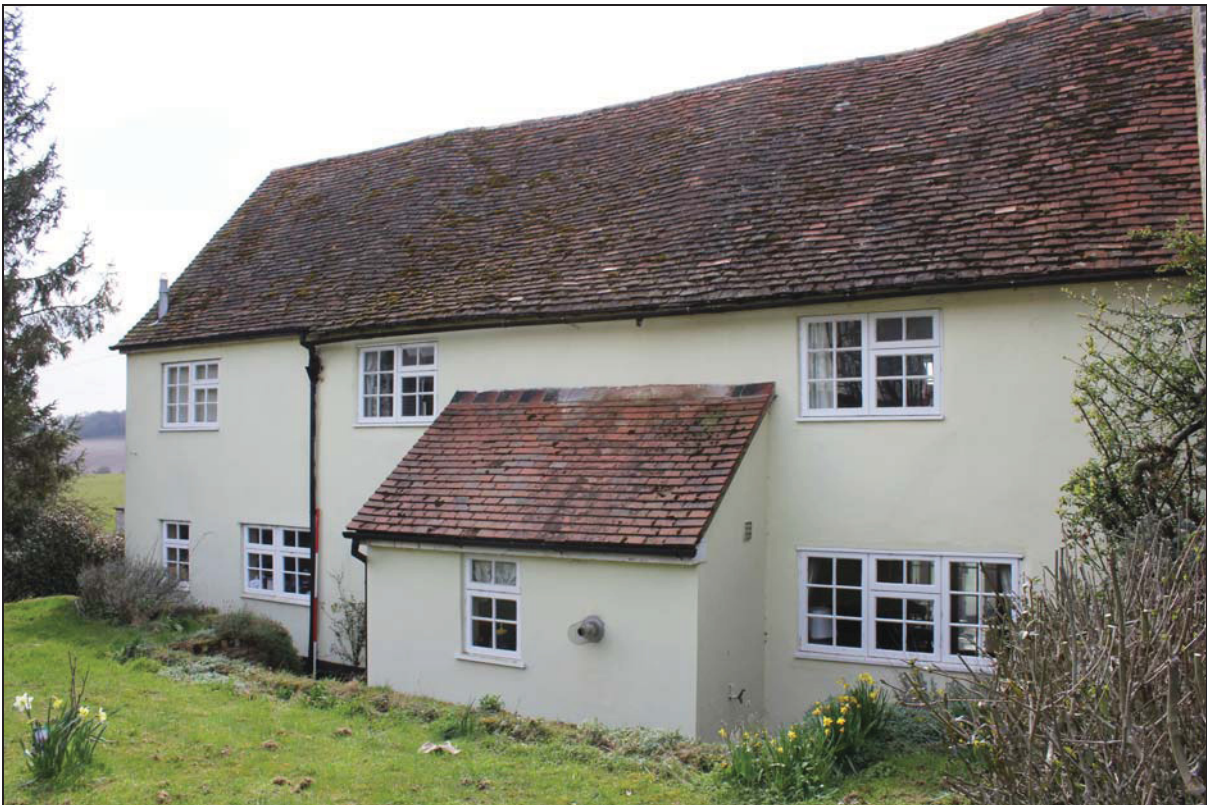
Plate 2 North-east elevation of Lordship Cottage, taken from the north (DP 04)

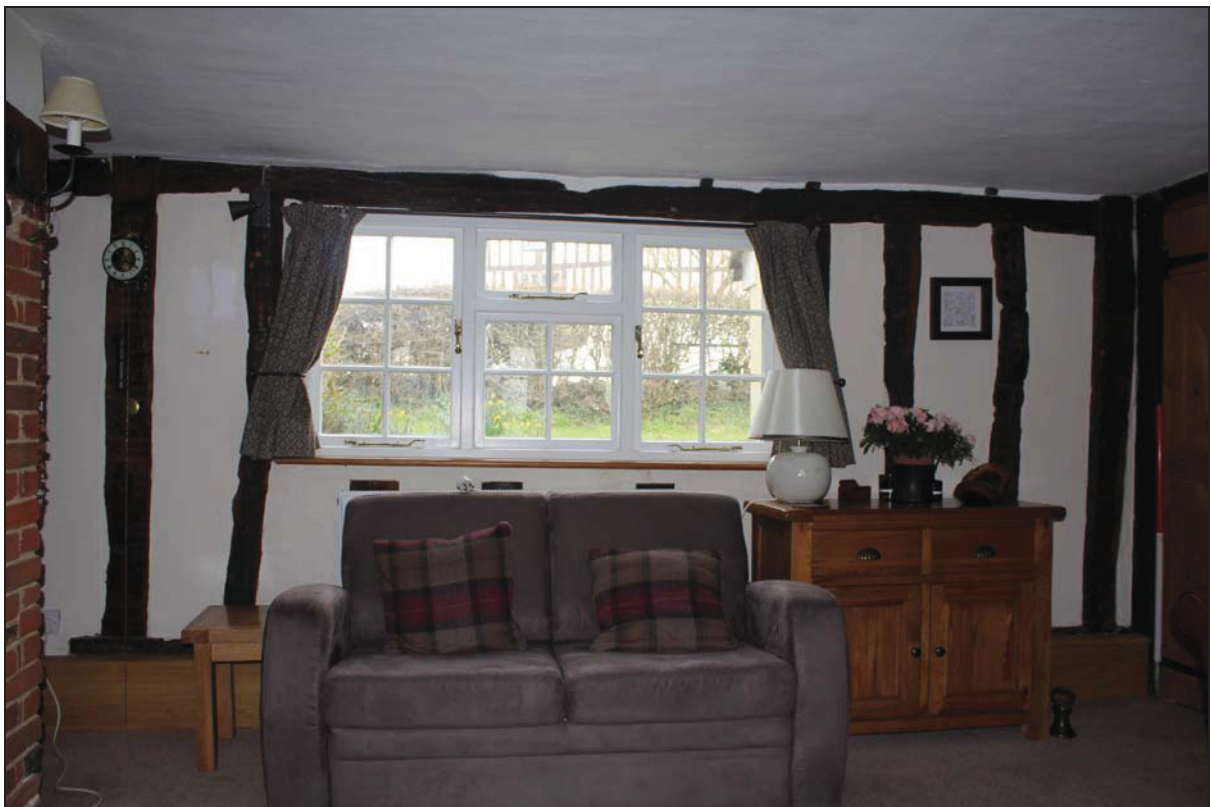
Plate 6 North-east side of Room GF01, taken from the south-west (DP 19)

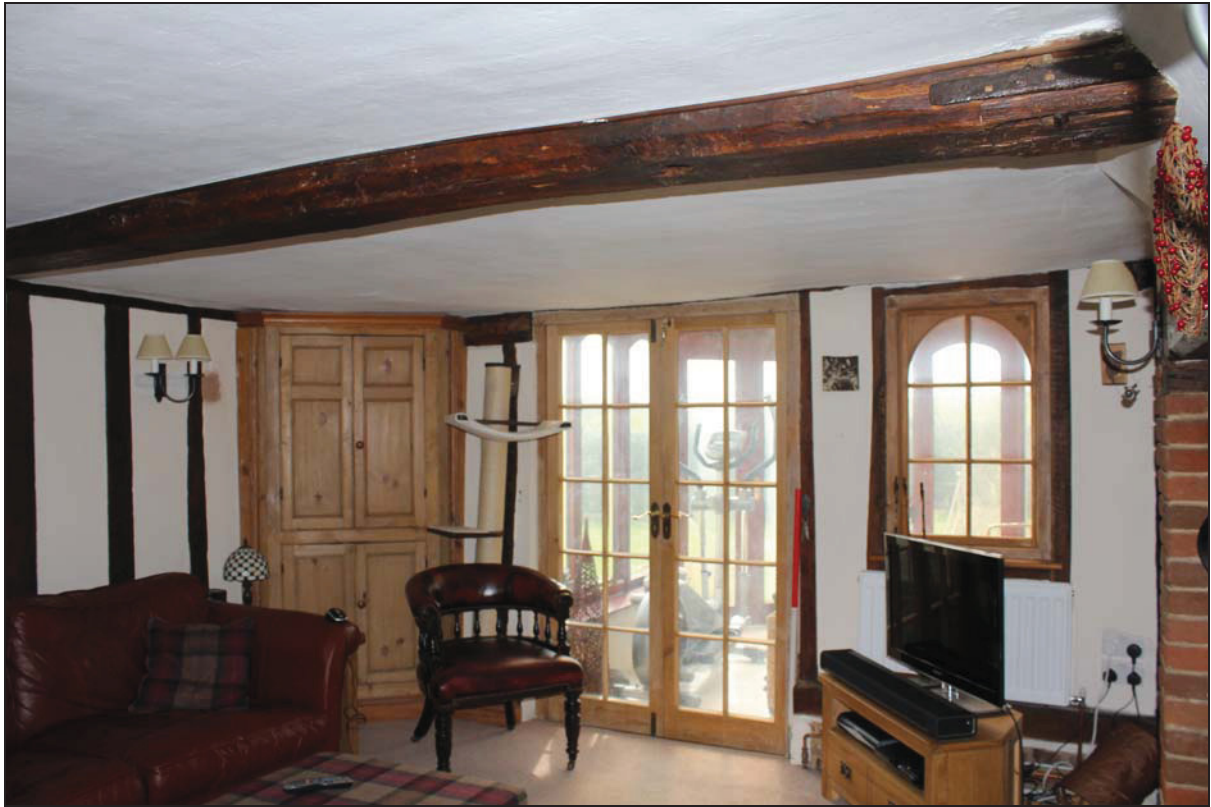
5.9 The south-east wall demonstrates much rebuilding or alteration where the bay post is set in front of the internal wall and the partition itself has been rebuilt in the fairly recent past with a modern brick dwarf wall, reused studs (non pegged) and modern infill. The south-west wall is again much altered with the insertion of modern double doors to the conservatory (Plate 7), which necessitated the cutting back of the mid-rail above though two pegs are visible for lost studs. The north-west bay post lies over the stump of a sole-plate, though the adjoining sole-plate is later but a reused historic timber. Adjoining the stack on this side is a full-height fitted cupboard and a view within reveals the bay post, which has little chamfers and run out stops but seemingly from a previous use. The cupboard is enclosed by a historic ledged and boarded door though it has been stripped of all paint and the door furniture replaced. On the opposing side of the stack, a full height niche remains with modern shelves. Evidence here provides information regarding the original layout, in particular where the sole-plate stops just beyond the bay post and the mid-rail above has a notch which suggests this area formed the original lobby entry to the building (Plate 8).

Plate 7 South-west side of Room GF01, taken from the north-east (DP 17)

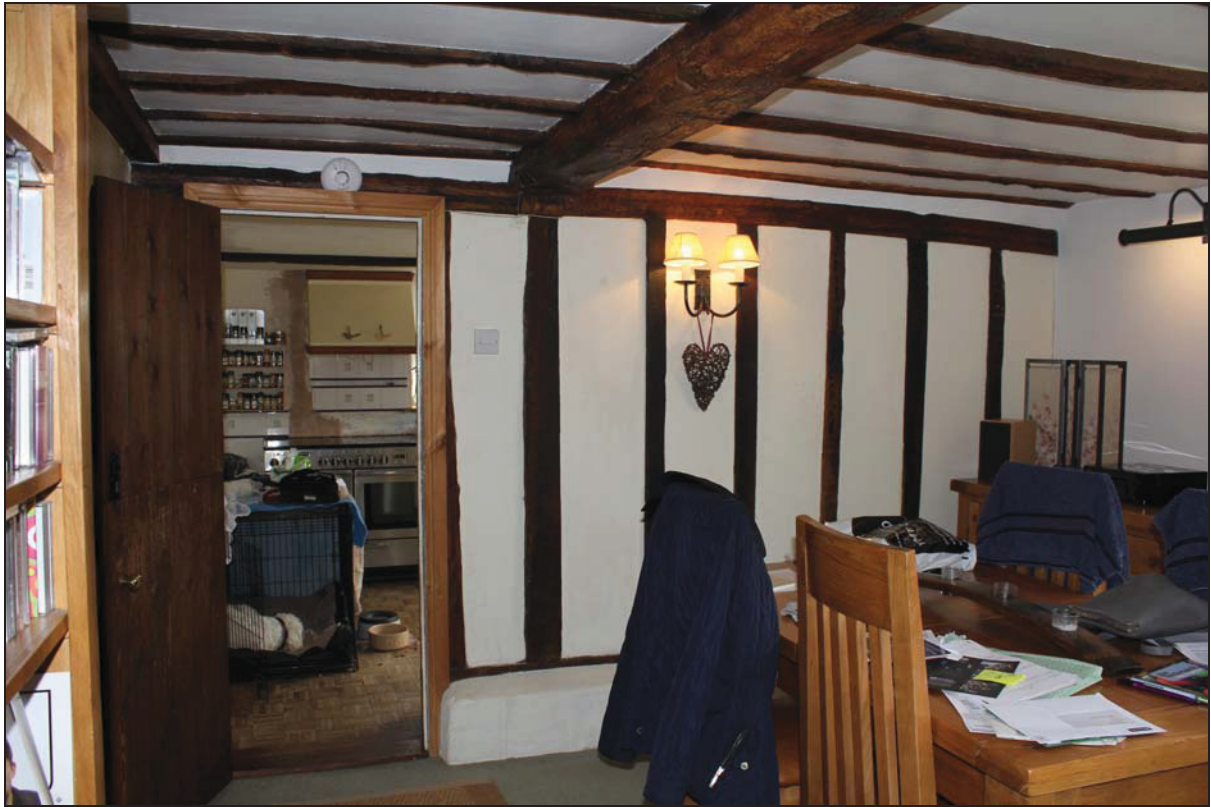
5.10 To the south-east, Room GF02 forms a later addition or a wholesale rebuilding of an earlier element. The timber framing is fairly ephemeral and though utilises some earlier fabric is largely nailed and has been reworked (Plate 9). Of note is a large 17th century bridging joist that is chamfered with lambs tongue chamfer stops. Its relationship with the surrounding walls is, however, awkward and is positioned over pieces at either end which themselves suggest an earlier reconfiguration. The mid-rail is visible over the modern window to the on the south-west and retains redundant mortices and pegs.

Plate 9 View of Room GF02, taken from the north-west (DP 27)

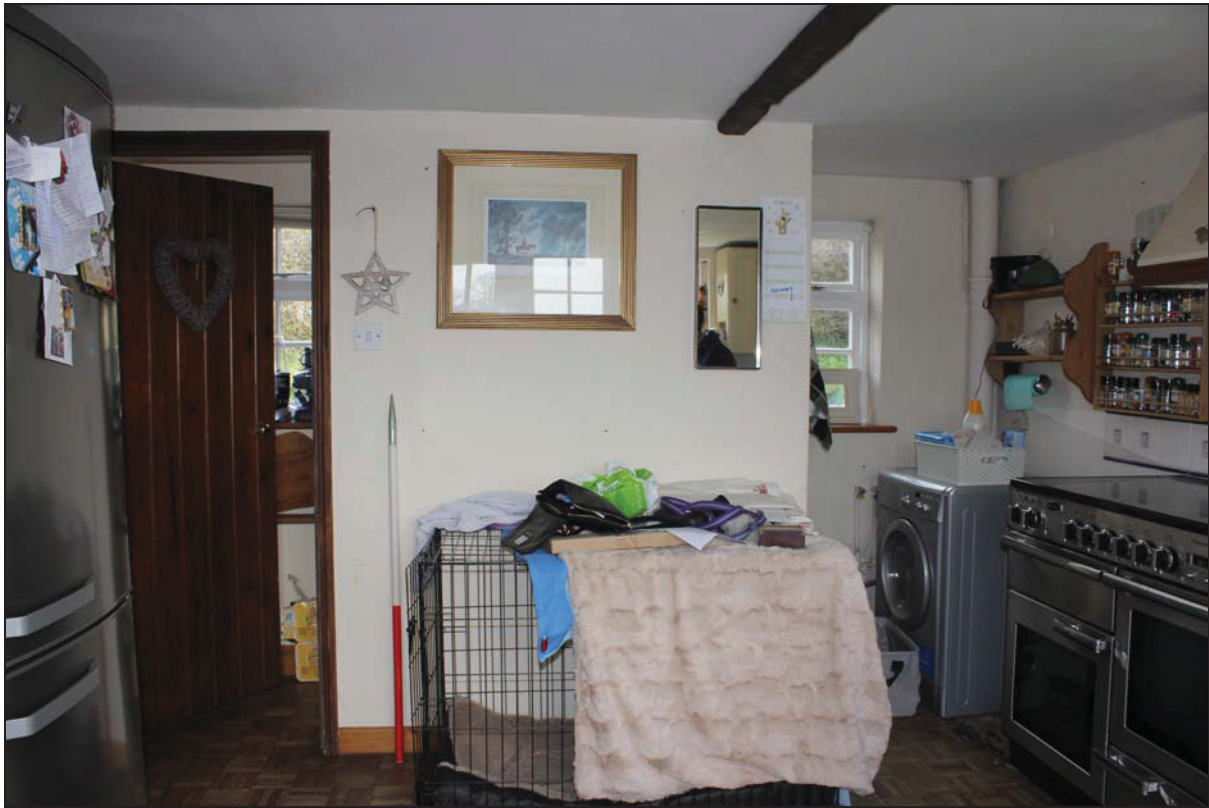
5.12 The final room is set slightly lower than the previous rooms and retains nothing of interest apart from where the historic wall of the adjoining range is visible displaying the mid-rail and the stump of the prick post. The floor is covered with parquet and walls are modern with modern doors and modern fitted kitchen units. A store is enclosed on the north-east and is all of modern studwork (Plate 11). A fictive timber joist has been applied to the ceiling and is of no interest.

Plate 11 Kitchen GF03 in Range 3, taken from the south-west (DP 64)

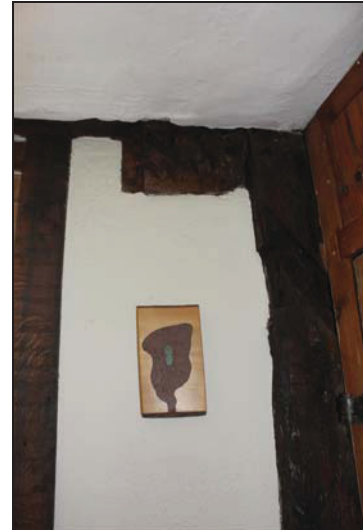
DP 16

Detail of the south-west side of Room GF01 showing hacked back mid-rail, taken from the north-east

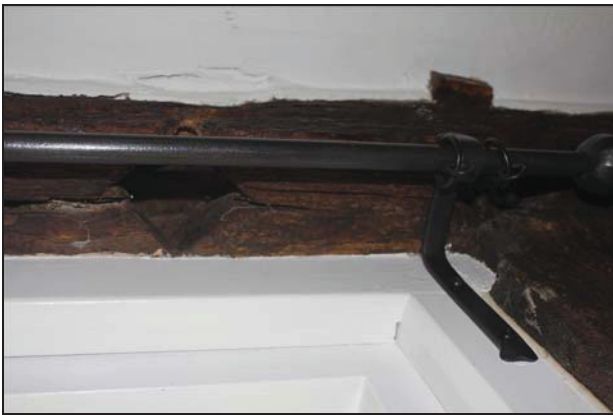
DP 21

Mid-rail on the north-east side of Room GF01 showing redundant diamond mullion mortices, taken from the south-west

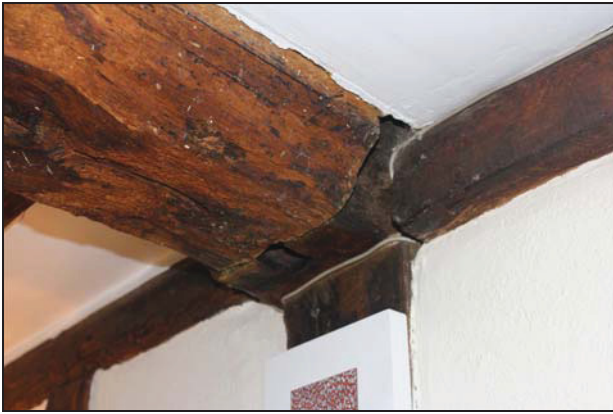
DP 25

North-west end of the bridging joist in Room GF02 showing awkward configuration of timbers, taken from the east

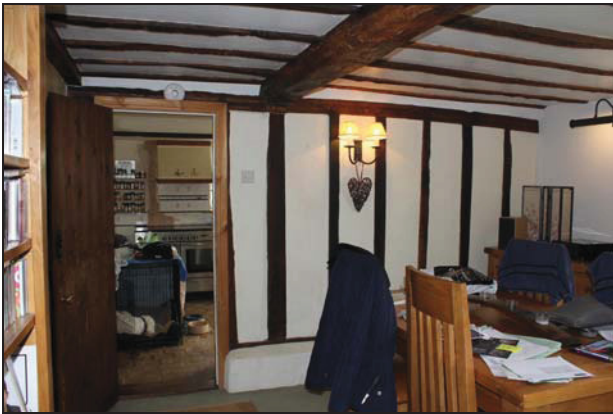
DP 27

View of Room GF02, taken from the north-west

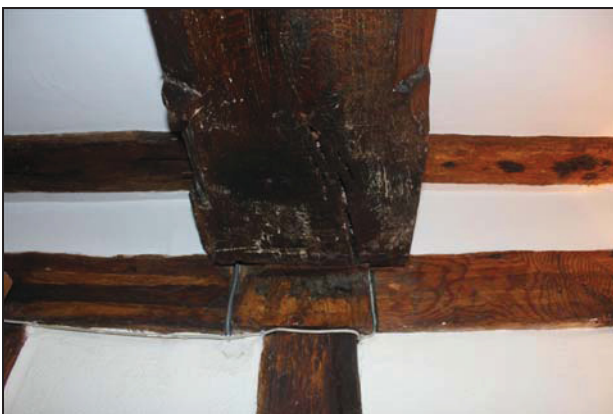
DP 29

South-east end of the bridging joist in Room GF02 showing awkward configuration of timbers, taken from the north-west

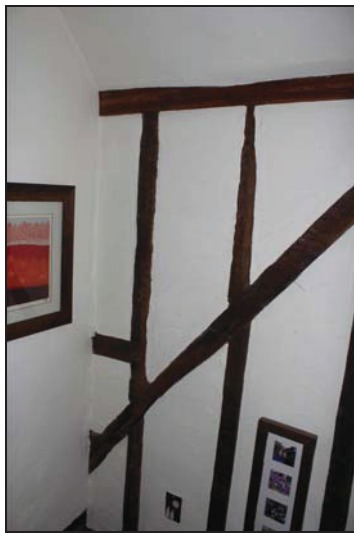
DP 33

North-east wall of landing FF02 showing horizontal timber possibly forming the sill of a former window aperture, taken from the south-west

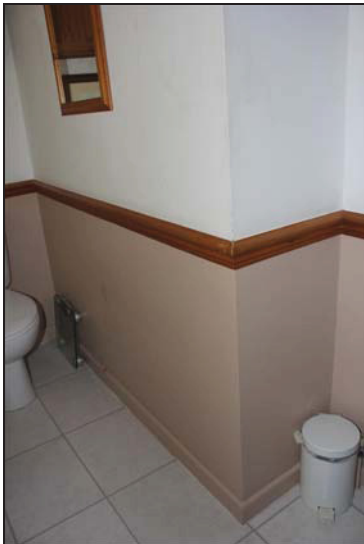
DP 38

Bathroom (FF05) in the south-east extension (Range 3), taken from the north-west

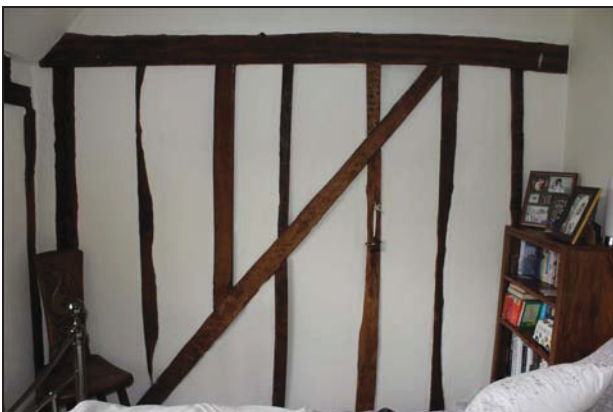
DP 40

Primary-braced studwork in Room FF03, taken from the south-east

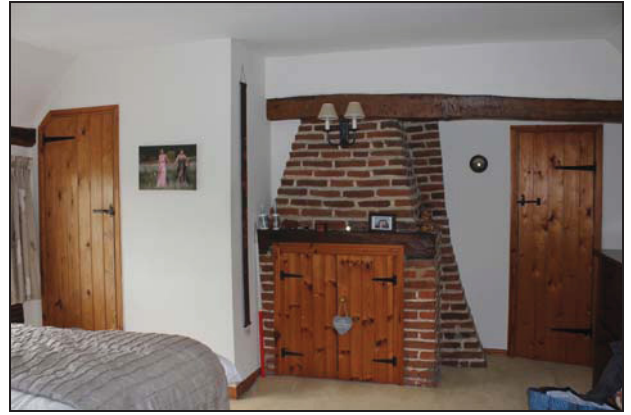
DP 43

South-east side of Room FF03, taken from the north-west

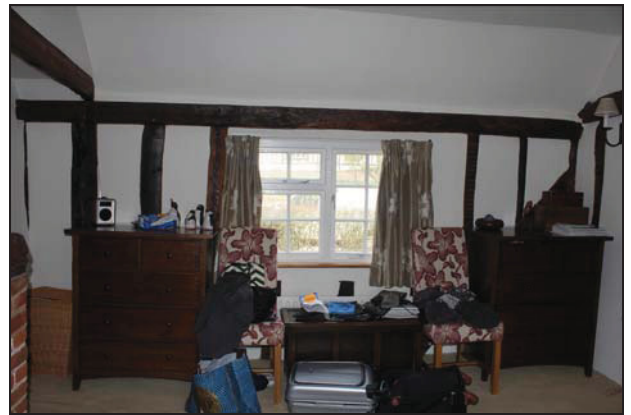
DP 45

North-east wall of Room FF01 (north-west end) showing bay post with redundant mortices, taken from the south-west

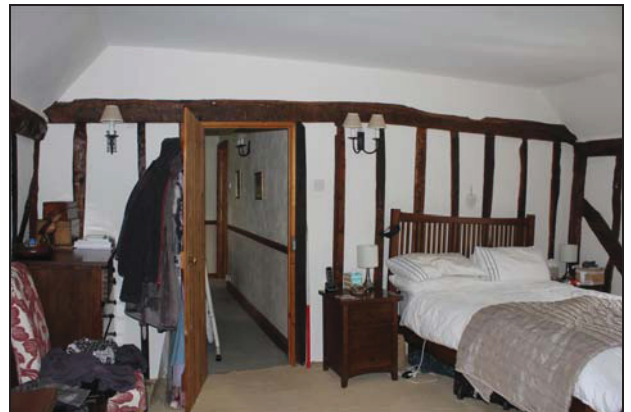
DP 47

North-east wall of Room FF01 (north-west end) showing evidence for repair or reconfiguration, taken from the south-west

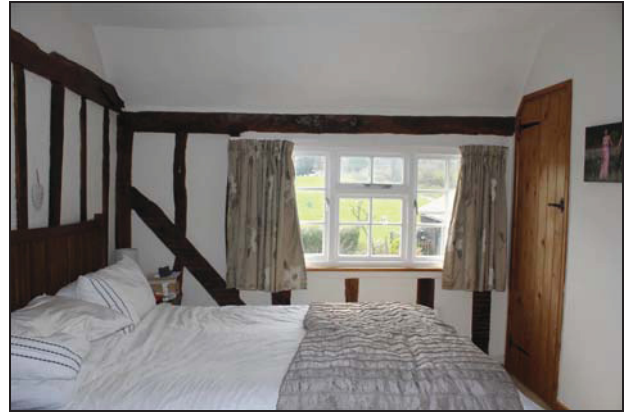
DP 49

South-east wall of Room FF01 showing ephemeral lower studwork with pegs in the tie-beam for upper studs, taken from the north-west

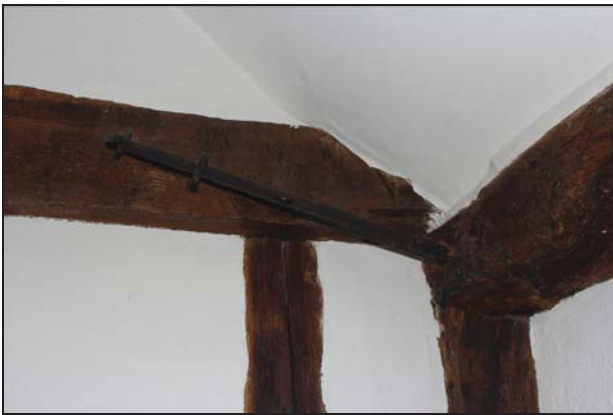
DP 50

South-east wall of Room FF01 showing tension brace, taken from the north-west

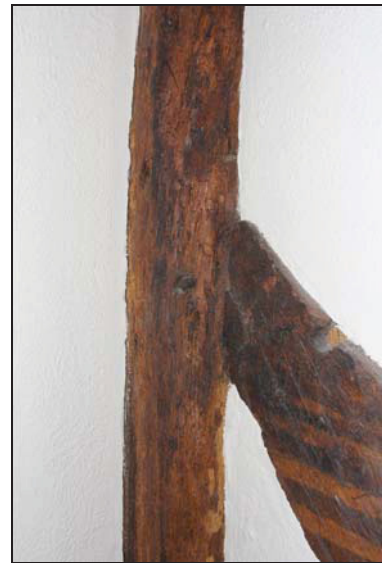
DP 51

South-east corner of Room FF01 showing reinforcing iron strap, taken from the north

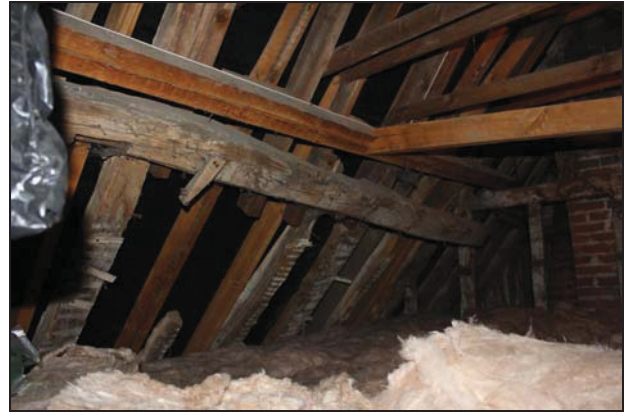
DP 55

Roof structure over the historic core (FF01) showing clapped side-purlin form, taken from the south-east

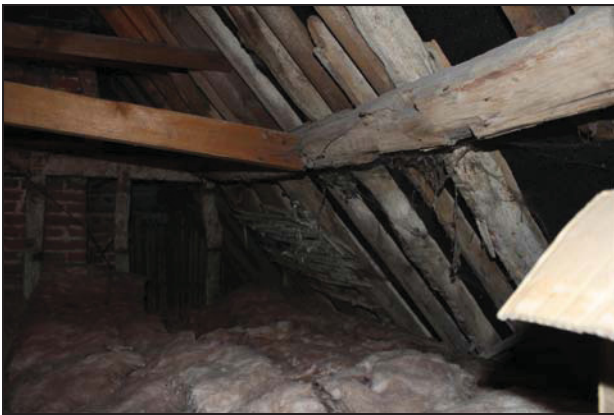
DP 56

South-west roof pitch over the historic core (FF01), taken from the south-east

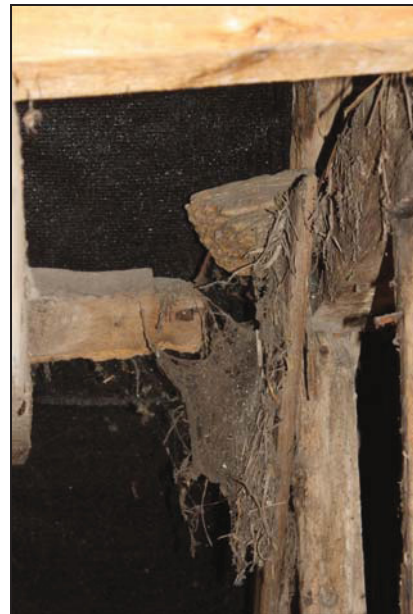
DP 57

North-east roof pitch over the historic core (FF01), taken from the south

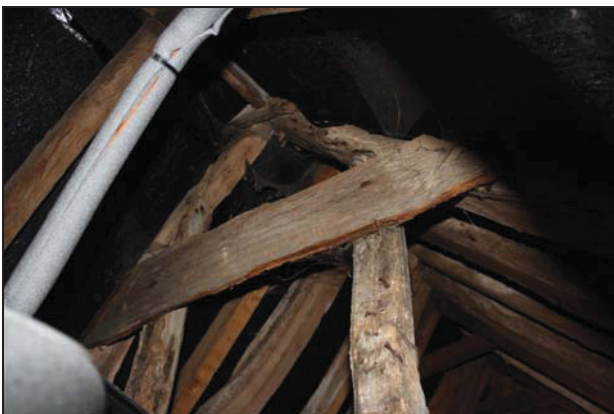
DP 58

South side of the roof structure at the junction between Ranges 1 and 2 showing weathered purlin end from the historic core, taken from the north-east

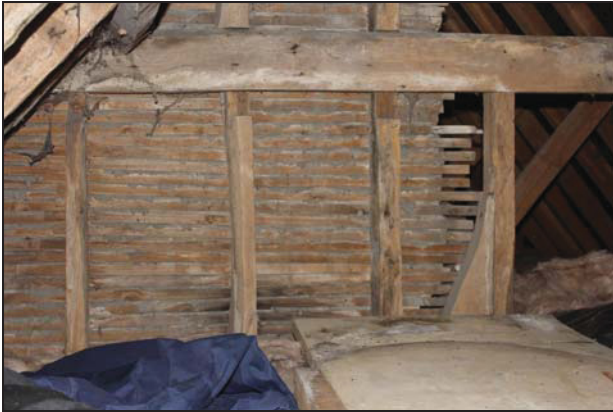
DP 60

Roof structure over Range 2 showing inserted bird-mouthed collar seemingly deformed from the weight of later fabric, taken from the north-west

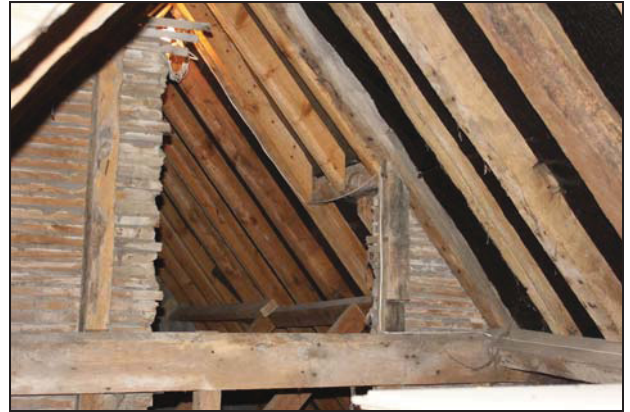
DP 61

South-east end of the roof structure over Range 2 showing formerly external framing with external lath and plasterwork, taken from the north-west

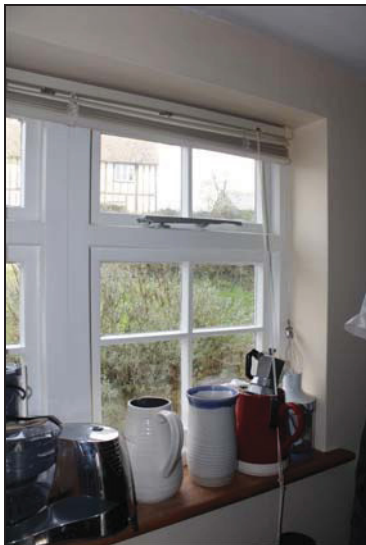
DP 64

Kitchen GF03 in Range 3, taken from the south-west

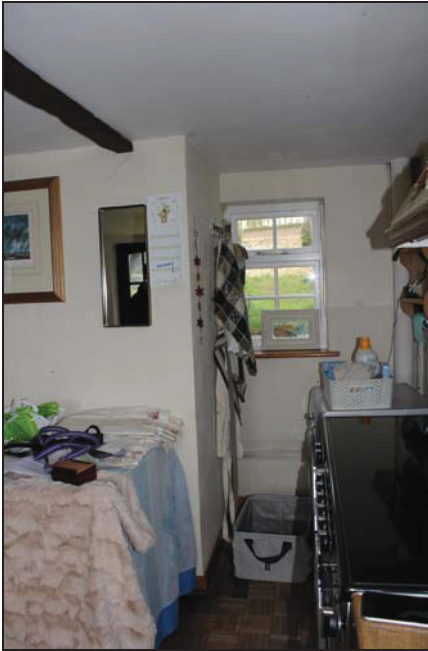
DP 66

Kitchen GF03 in Range 3, taken from the north-east

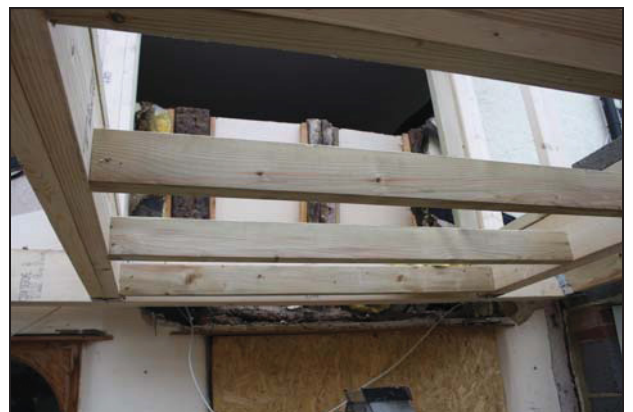
DP 71

Detail of the timber-framing on the south-west side of Range 1 exposed during the planned works, taken from the south-west

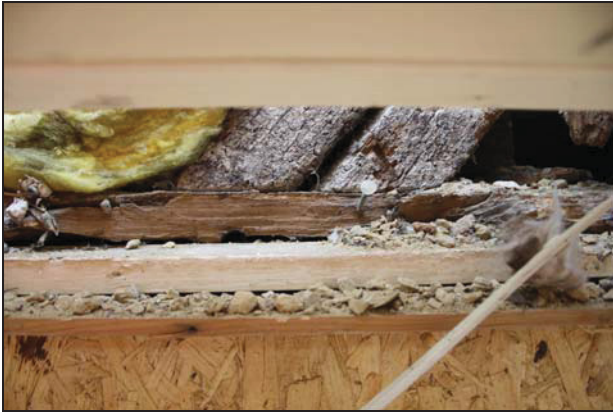
DP 72

View of the timber-framing on the south-west side of Range 1 exposed during the planned works, taken from the south-west

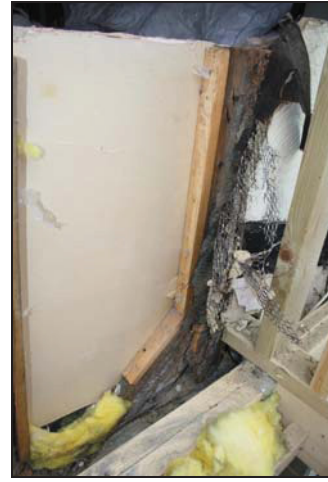
DP 73

Detail of the timber-framing on the south-west side of Range 1 exposed during the planned works showing brace pegged to the mid-rail, taken from the south-west

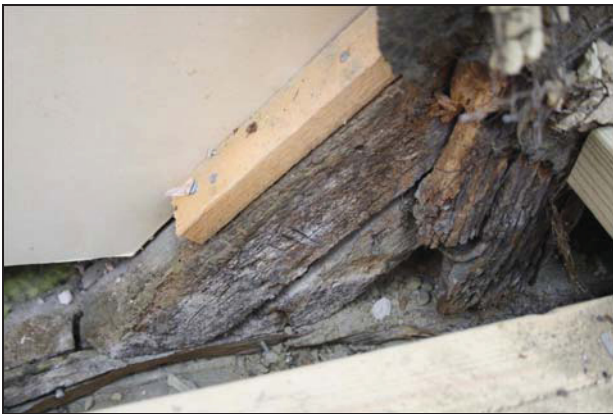
DP 74

View of the timber-framing on the south-west side of Range 1 exposed during the planned works showing base of tension brace, taken from the south-west

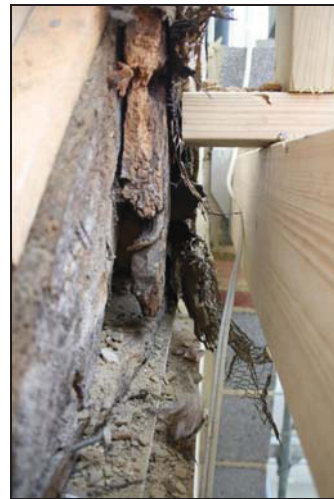
DP 75

View of the timber-framing on the south-west side of Range 1 exposed during the planned works showing base of tension brace with assembly mark, taken from the south-west

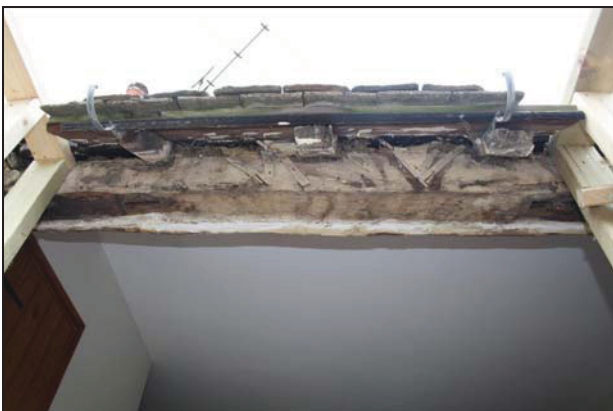
DP 76

View of the timber-framing on the south-west side of Range 1 exposed during the planned works showing base of tension brace notched into adjoining stud, taken from the north-west

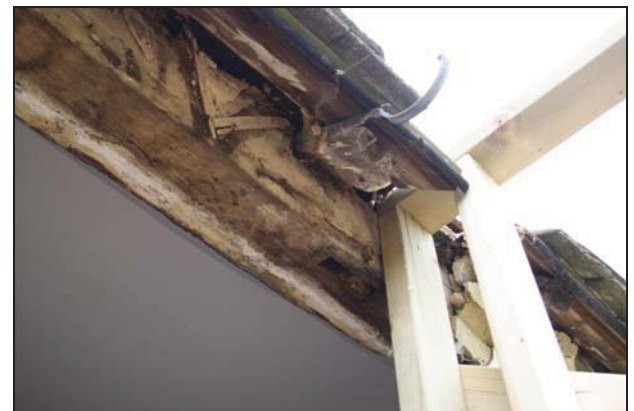
DP 77

View of wall-plate on the south-west side of Range 1 exposed during the planned works showing stud mortices either side of a plain area, taken from the south-west

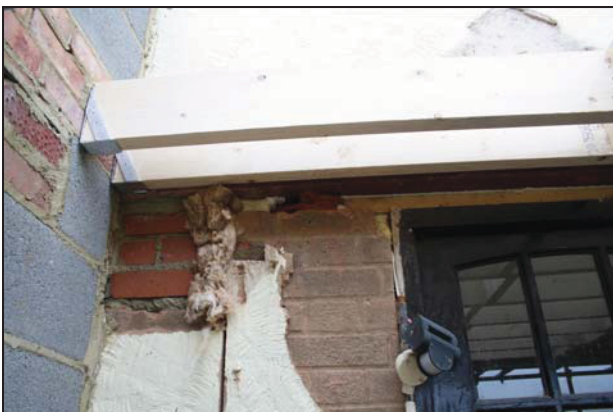
DP 82

South-west side of Range 3 during planned works showing modern brickwork exposed after removal of the plasterwork, taken from the south-west

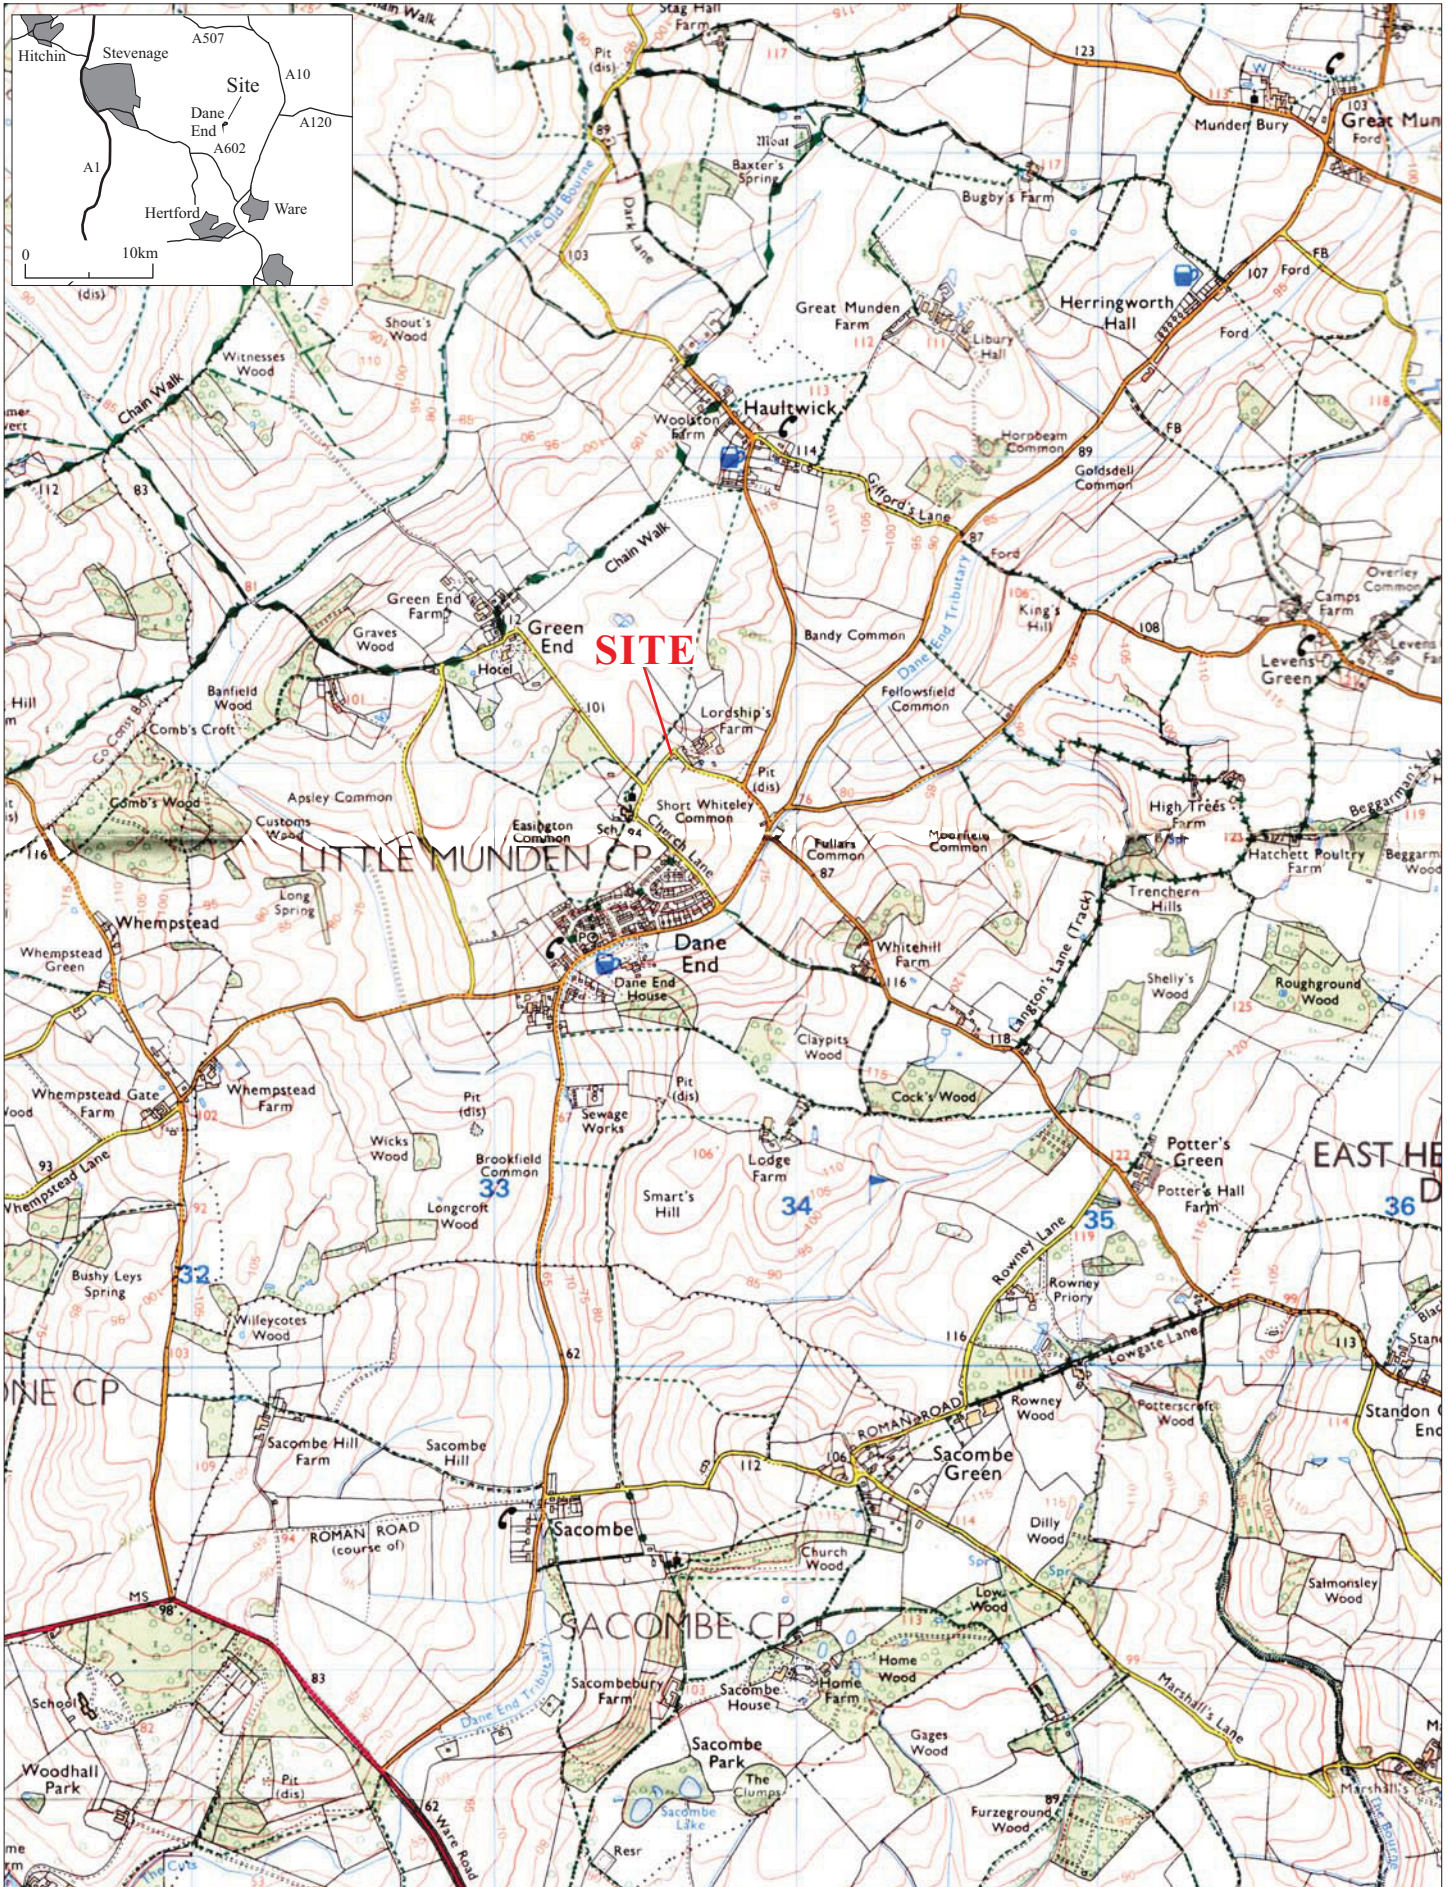
DP 83

South-west side of Range 3 during planned works showing modern brickwork exposed after removal of the plasterwork, taken from the south-west
