ARCHAEOLOGICAL SOLUTIONS LTD

**15 FISHPOOL STREET, ST ALBANS,
HERTFORDSHIRE, AL3 4RS**

HISTORIC BUILDING RECORDING & MONITORING

Authors:	Lauren Wilson MA PCIfA Lee Prosser PhD Tansy Collins (Photography) Kathren Henry (Graphics)	
NGR: TL 1426 0716		Report No: 5396
District: St Albans City and District		Site Code: AS1891
Approved: Claire Halpin MCIIfA		Project No: 6764
		Date: 4 July 2017

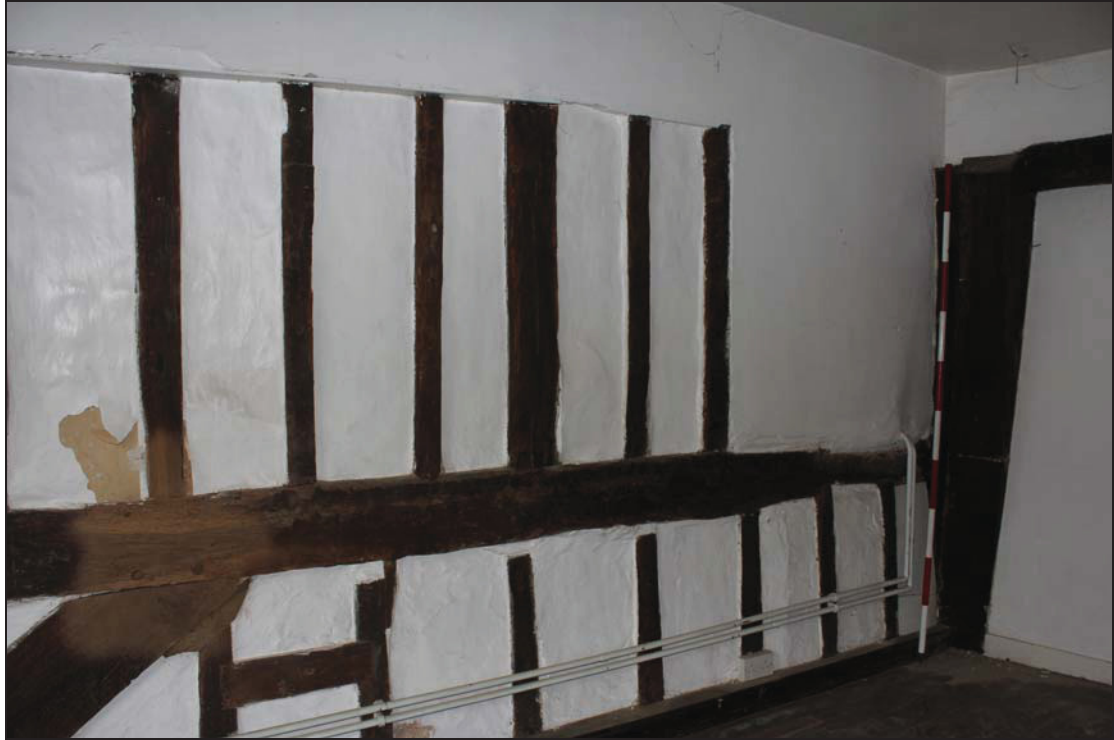
Plate 25 Timber-frame in FF02 with several members rising from the ground floor room below, taken from the north-west (DP 140)

5.32 On the east wall we see the tops of several of the members expressed in the kitchen GF02 below, including an upper robust downward brace to the north (Plate 25). The rudimentary lower studwork is unpegged but pegged in the upper register and of more rudimentary common studwork.

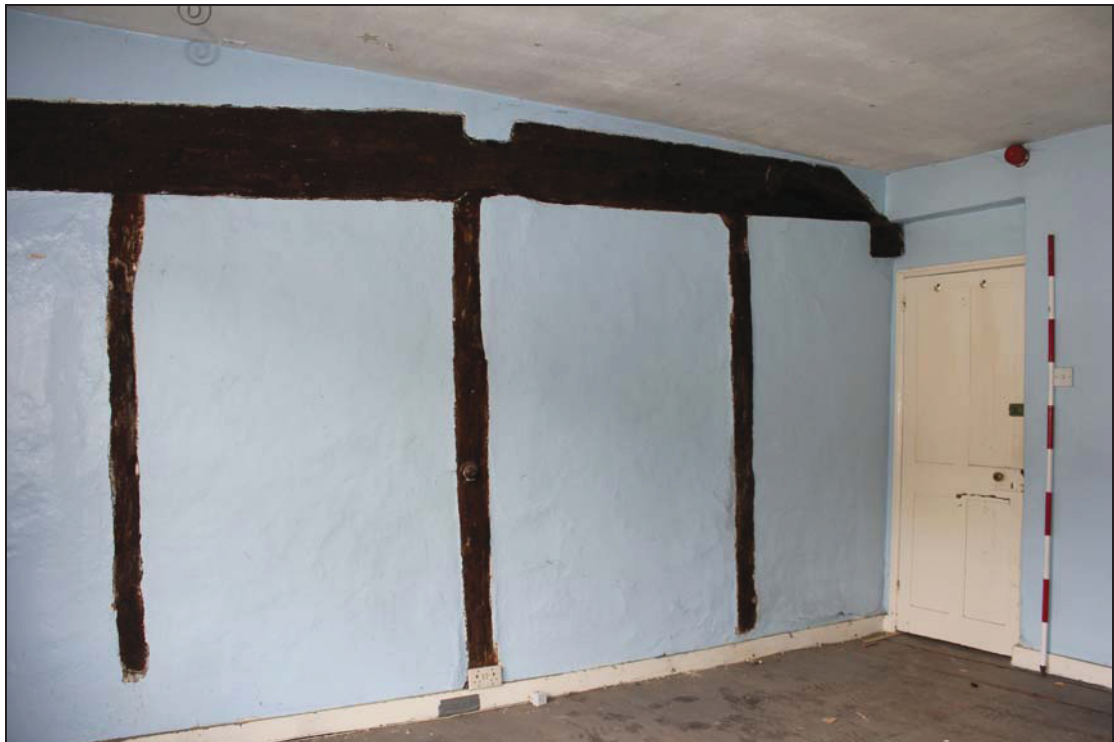
Plate 26 Interior of FF03, with elements of timber-framing including tie-beam and truncated stub of a wall plate above the door, taken from the north-west (DP 128)

truncated stub of an early wall plate, which is charred (Plate 26). Wide oak floorboards extend east to west, with simple 18th century skirting and an 18th century fireplace on the east wall. As in the lower room the north, west and south walls have probably been re-plastered. Two windows to the north are of six-over-six sash form but are modern refurbishments.

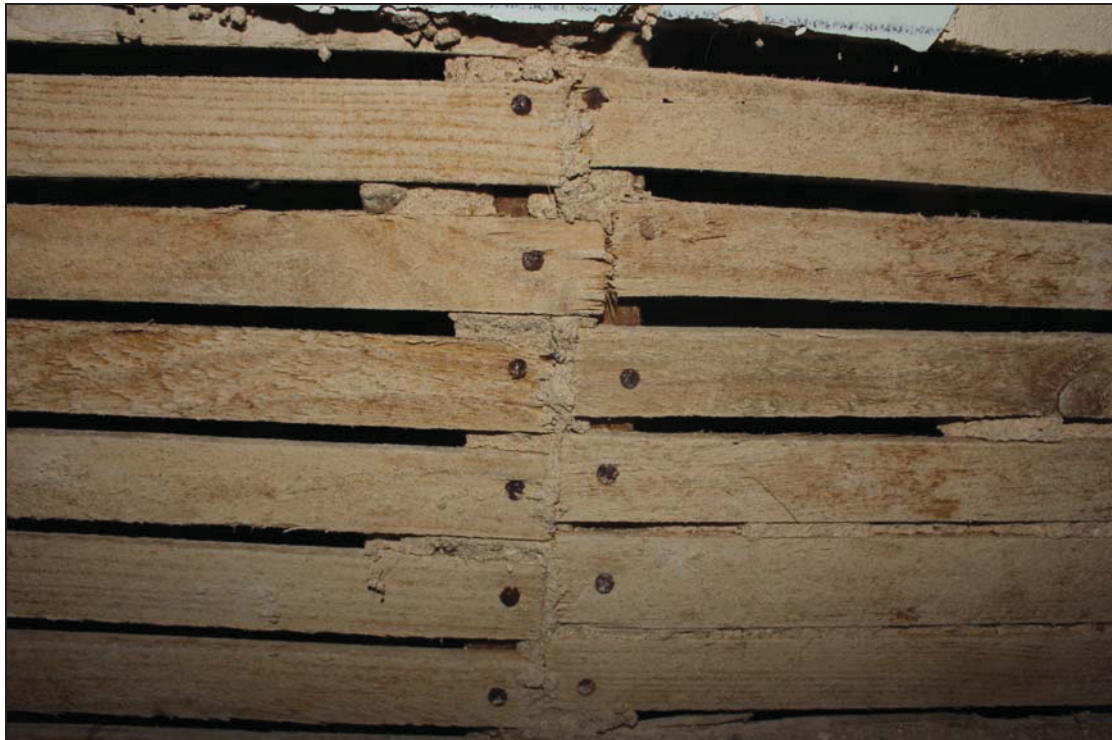
Plate 30 Previously hidden lath and plaster in FF05, taken from the west (DP 269)

5.38 During monitoring the plaster cladding of the east wall of this room was removed so the underlying fabric could be inspected. This revealed fairly standard machine-sawn laths, measuring between 7/8"-1 1/8" (2-3cm), and a buff-coloured hard plaster with a low animal hair content (Plate 30).

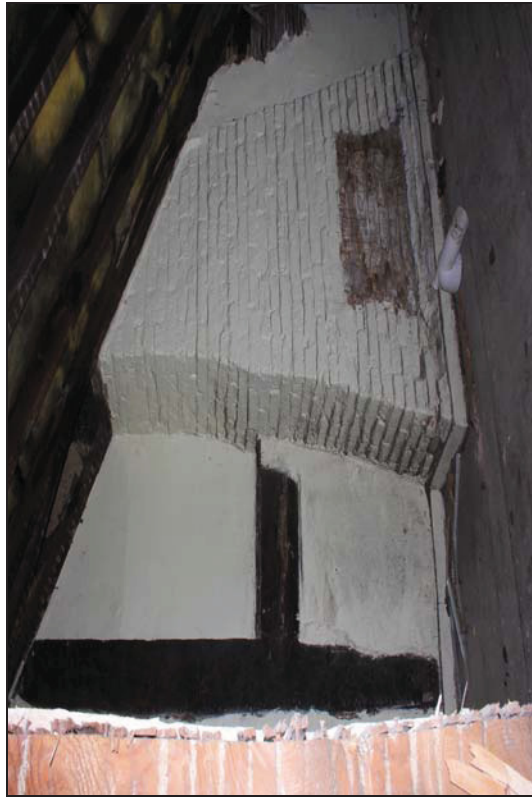
Plate 31 View of FF06, with timber-framing truncated by the chimney stack, taken from the south-west (DP 267)

5.39 The bathroom is located in the rear outshut over the carriage-way. Access is given via a four-panelled door. Visible features include fragments of the timber-framing over the carriage-way, comprising posts and horizontals, partly truncated by the chimney stack (Plate 31). Also of note is a Crittall-style window to the rear.

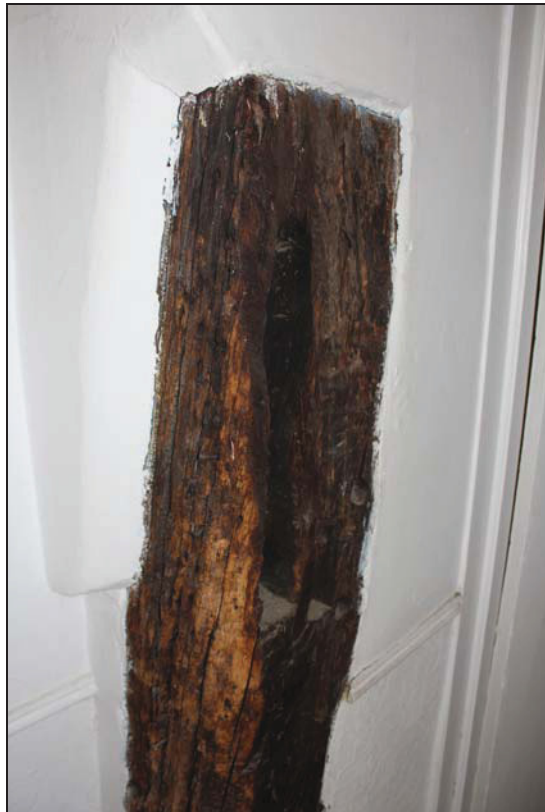
Plate 32 Timber-framing in FF06, a principal post with a mortise for a downward brace, taken from the north-east (DP 123)

5.40 A small WC is tucked into the corner of the rear outshut and is given access via a four-panelled door from the landing. The only feature of note is a large principal post with a mortise for a downward brace (Plate 32).

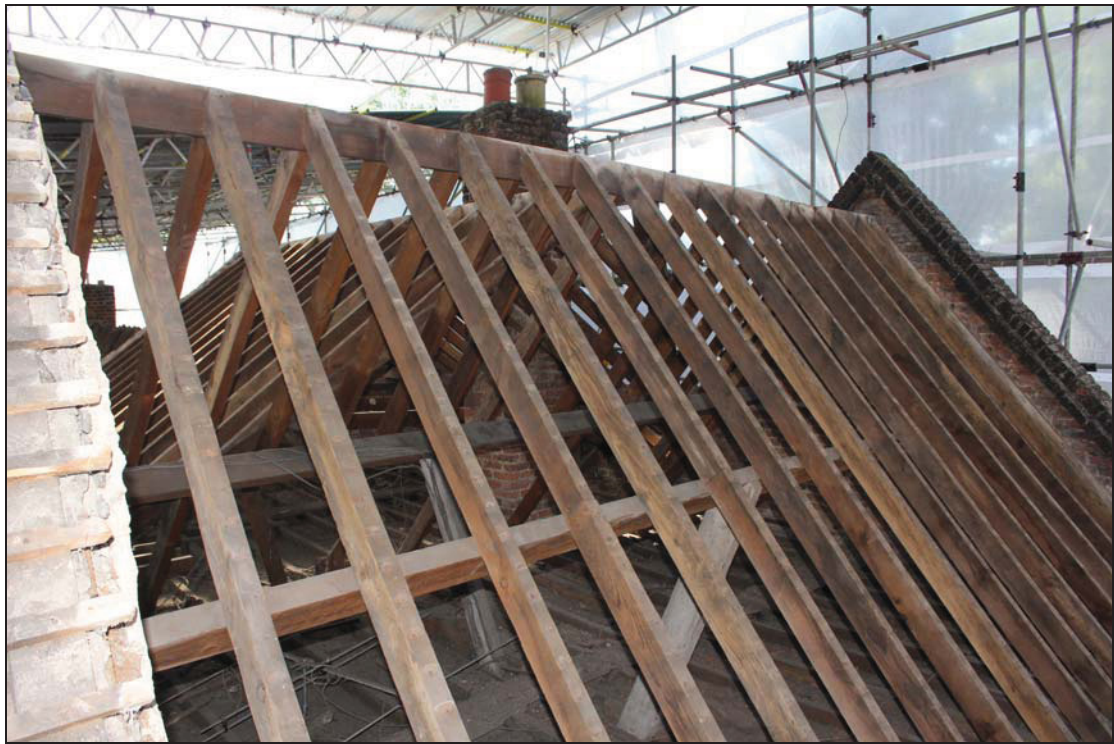
Plate 33 Roof structure of the front west roof, taken from the north-east (DP 233)

5.41 Some limited views into the roof were possible during the early part of the survey, but later the tiles and battens were removed from the roof structures allowing these areas to be investigated in closer detail. The western element of the front range and intermediate range roof both comprise slender softwood rafter-couples riding over a single purlin in each pitch to a ridgeboard (Plate 33). Occasional raking struts are employed for support. Almost all visible timber has been circular sawn and there are some examples of Baltic timber marks in the intermediate roof, but far more in the western element of the front range, suggesting an element of reuse (Plate 34). The ceilings below all comprise slender joisting with lath and plaster, and overall the arrangement is regular and uniform. The whole structure appears to be consistent with repair following the 1870s or '80s fire.

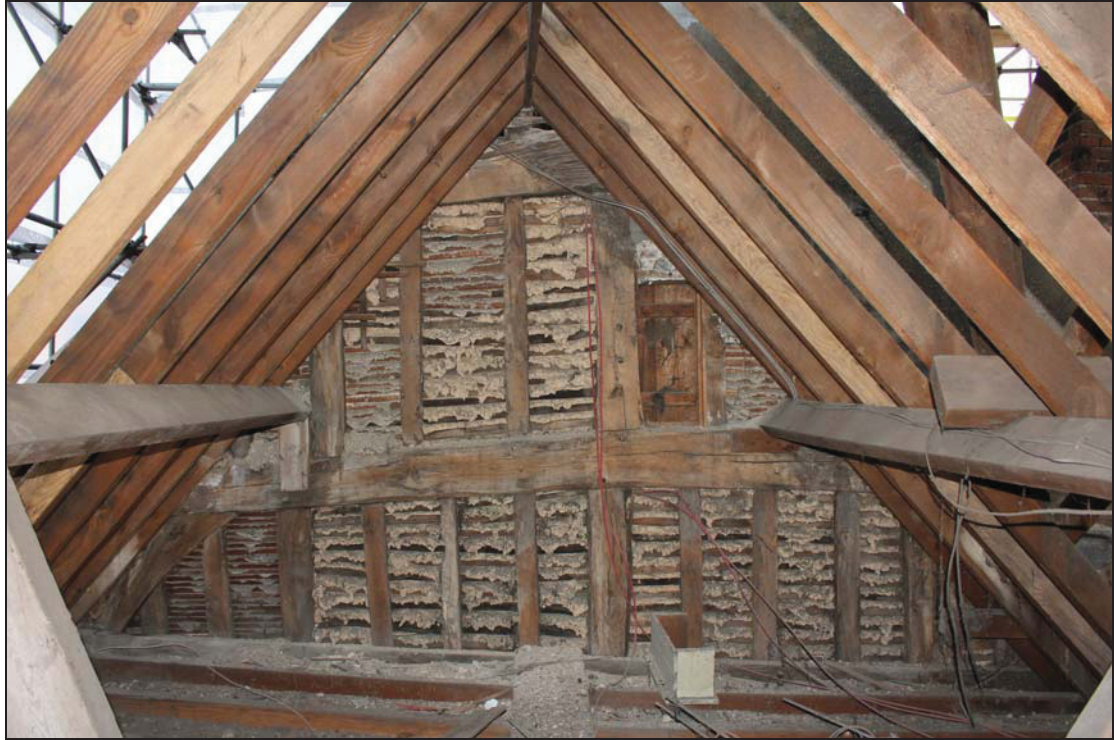
Plate 35 Gable end of the front west roof where it meets the east front roof, taken from the west (DP 238)

5.42 Uncovering of fabric to the carriageway range revealed the outer roof pitches as well as the west gable end. The upper area of the gable is rendered in cement, while below this the underlying timber-framing was briefly exposed, providing good evidence of evolution of the two front ranges. Timber-framing on the gable comprises a robust, slightly cambered tie-beam with a lower pegged central stud and outer curved braces (Plate 35). Above tie-beam level a large collar clasps the purlins with one or two pegged studs. Internal lath and plaster consists of wide riven laths and yellowy buff-coloured plaster. Much of this gable end timber was observed to be weathered, including wall-plate and purlin ends as well as the timber-framing to the south, though the remainder is unaffected. This demonstrates that the former roof over the front west range rose at a slightly shallower pitch but also that the carriageway range was always abutted by an adjoining structure.

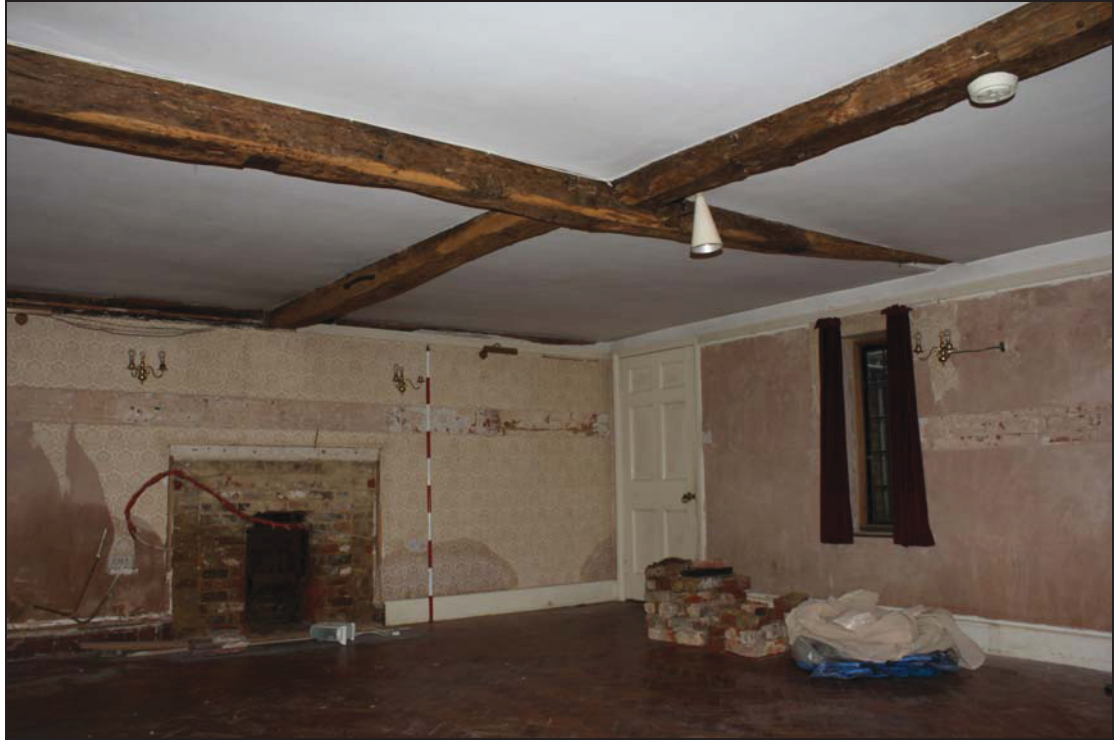
Plate 37 Interior of GF08, showing the ceiling during initial visits, taken from the north-east (DP 077)

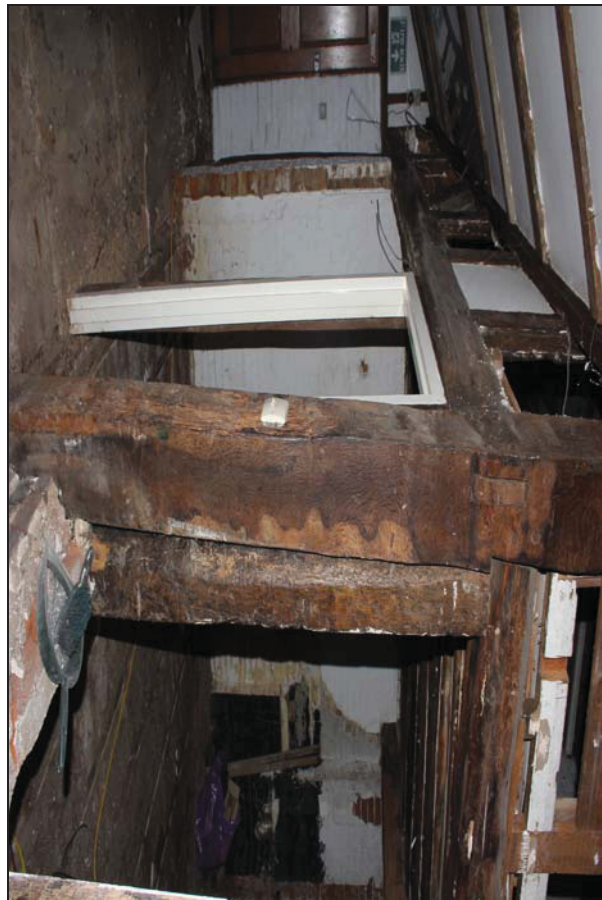
Plate 40 Timber-framing in GF09 comprising the formerly external wall of the rear range, taken from the south-west (DP 295)

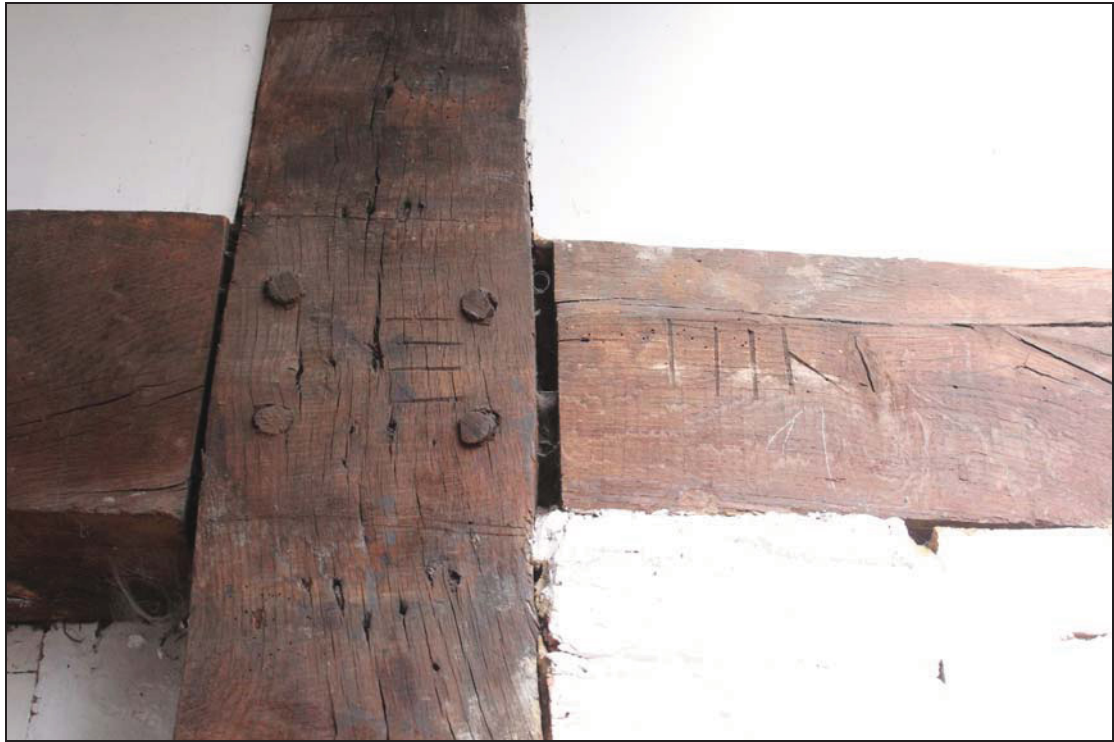
Plate 41 Timber-framing in GF09 with assembly markings, taken from the west (DP 087)

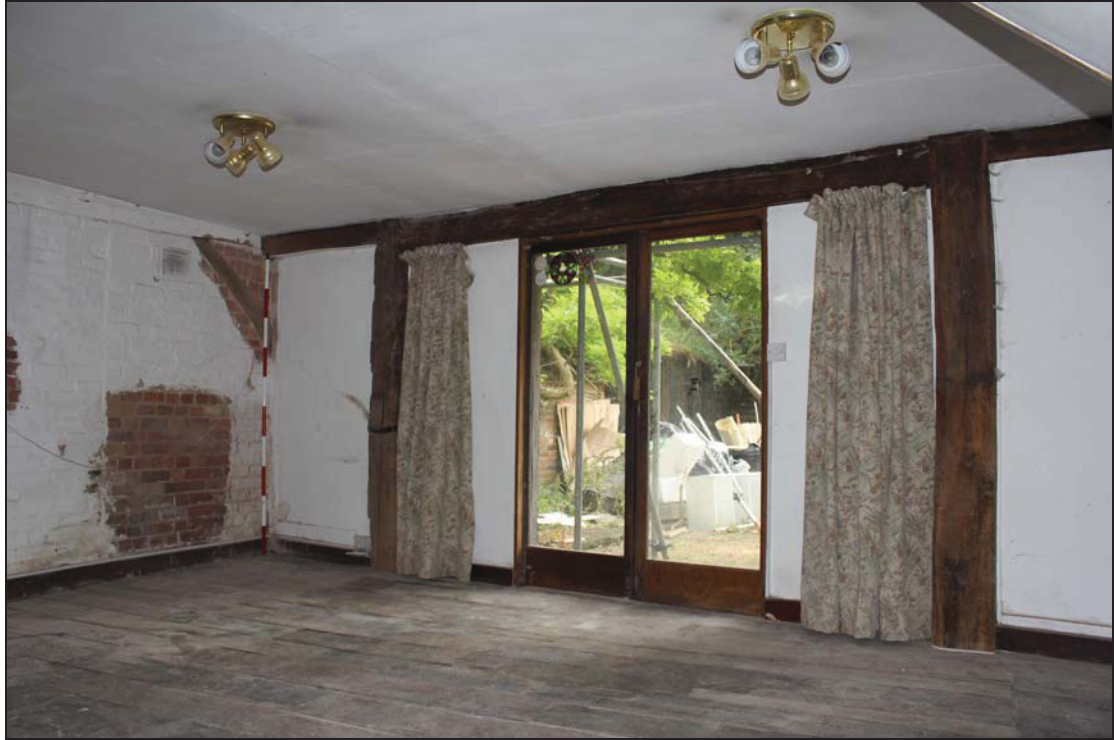
Plate 43 Interior of GF10, showing the south gable end of the rear range, taken from the north-west (DP 108)

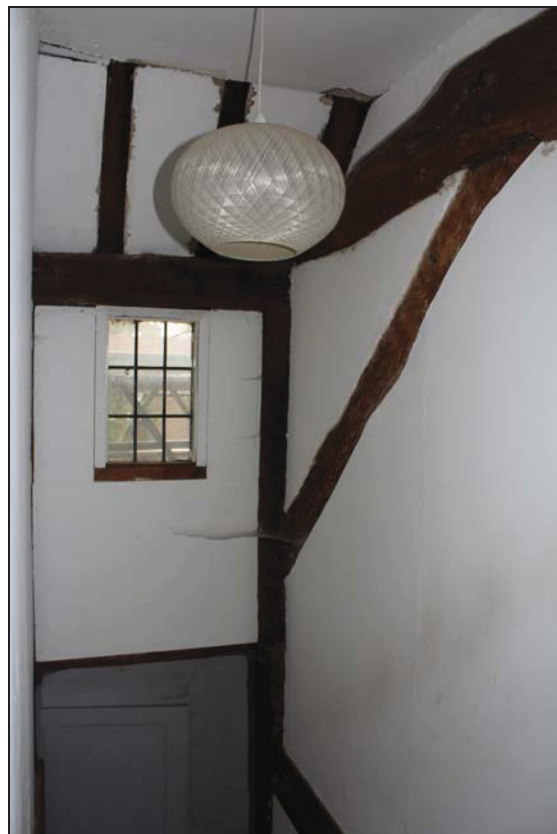
5.56 An additional modern stair in Bay 5 rises to a generous landing with various doorways to several bedrooms. At the north end it is subdivided from the adjacent space with modern materials, though the timber remains expressed on both sides (Plate 46).

Plate 46 Timber-framing above the stairs in FF15, taken from the east (DP 156)

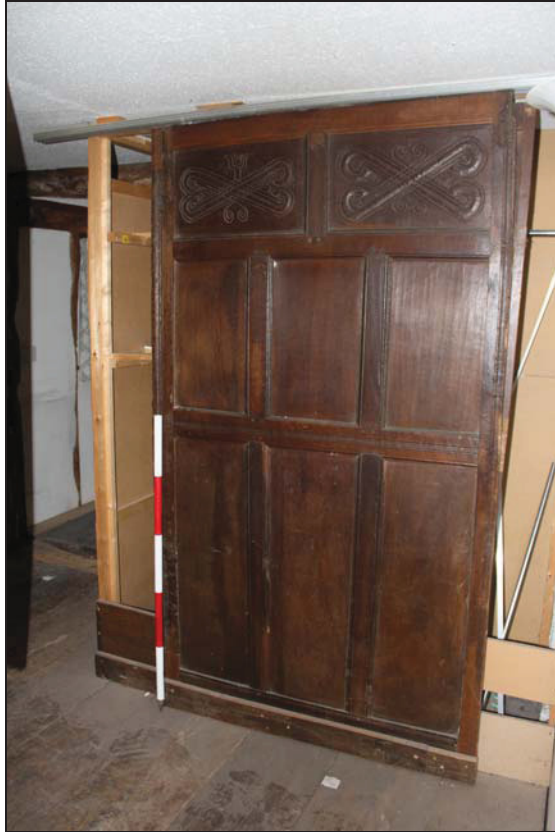
5.57 This room is housed between the tie-beam of the bay division which remains expressed on both sides. The wall-plate is scarved with a face-halved bladed scarf joint, and retains primary bracing and studs. Though the area is floored in wide oak or elm boards, these have been recycled. A closet on the north is formed of 17th century panelling (Plate 47).

Plate 47 A closet formed with 17th century panelling in FF11, taken from the south (DP 165)

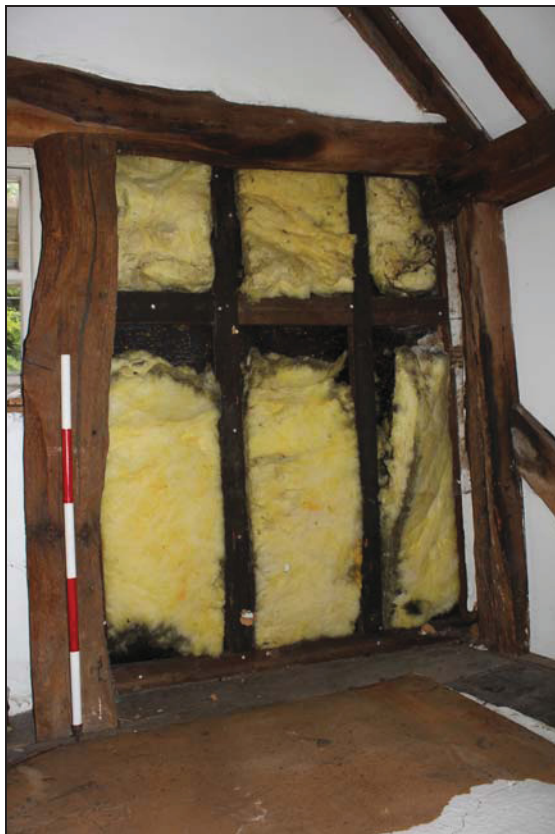
5.60 The north tie-beam is fairly waney and braced on both sides with raking queen struts rising into the ceiling. The wall-plate to the south retains pegging for a similar arrangement though the west brace is missing (Plate 48). Two hefty upright braces frame the window but are probably reused as there are no corresponding mortises in the soffit of the wall-plate. There is primary bracing from the corner posts and some studding. Although the doorway to the room is made within modern formwork the door was, at the time of the earlier survey, *ex situ* nearby and of 18th century date with H-L hinges.

Plate 48 Timber-framing in FF15, taken from the north (DP 158)

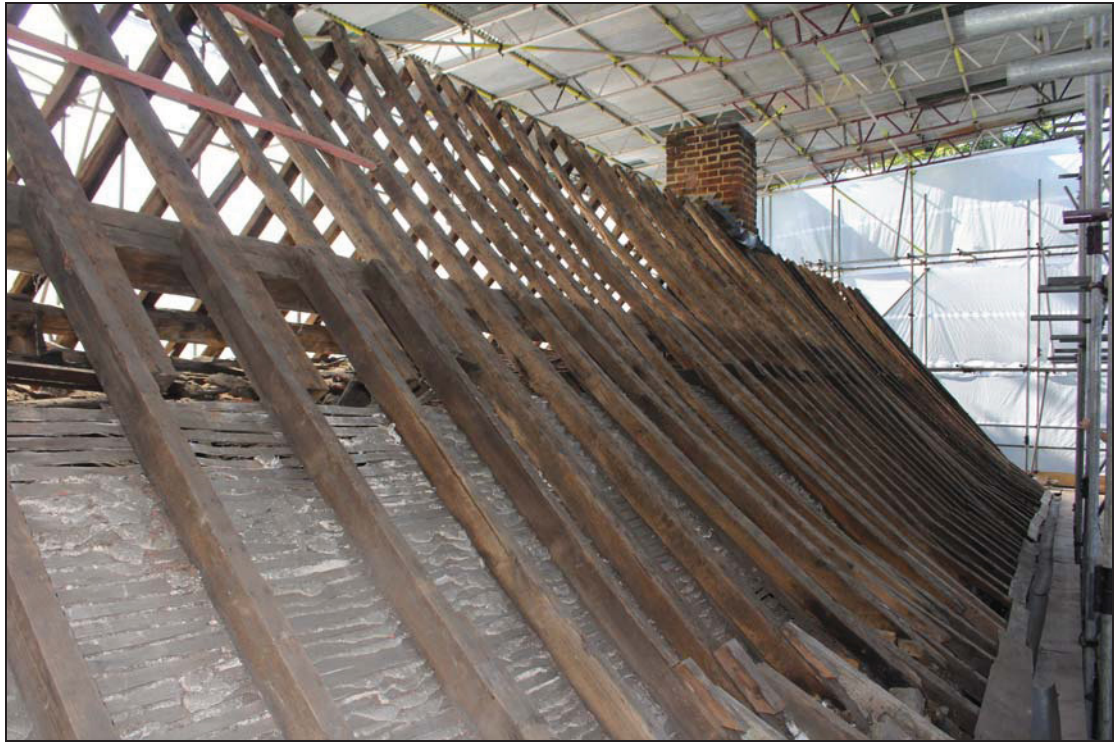
5.62 During the refurbishment, the tiles and battens were removed from the roof structure allowing this area to be examined in more detail. The roof spans five bays of clasped side purlin form with the brick chimney stack rising through the apex between Bays 3 and 4 (Plate 49). The truss form is regular and systematic and includes robust raking queen struts rising from the tie-beam to clasp a single purlin in each pitch, the queen struts being straight and single-pegged to the rafters (Plate 50). The principal rafters diminish above collar level and are bridled and pegged at the apex, while the purlins are fairly robust and scarfed at every bay division with a bridled scarf and two pegs visible. Each bay contains eight or nine common rafter-couples which ride over the purlins (some secured with a peg) and are bridled or simply halved and pegged at the apex. A number of original nailed-on spurs or sprockets survive to extend the rafter feet, and are shaped.

Plate 49 Roof structure over the rear range, taken from the north-west (DP 196)

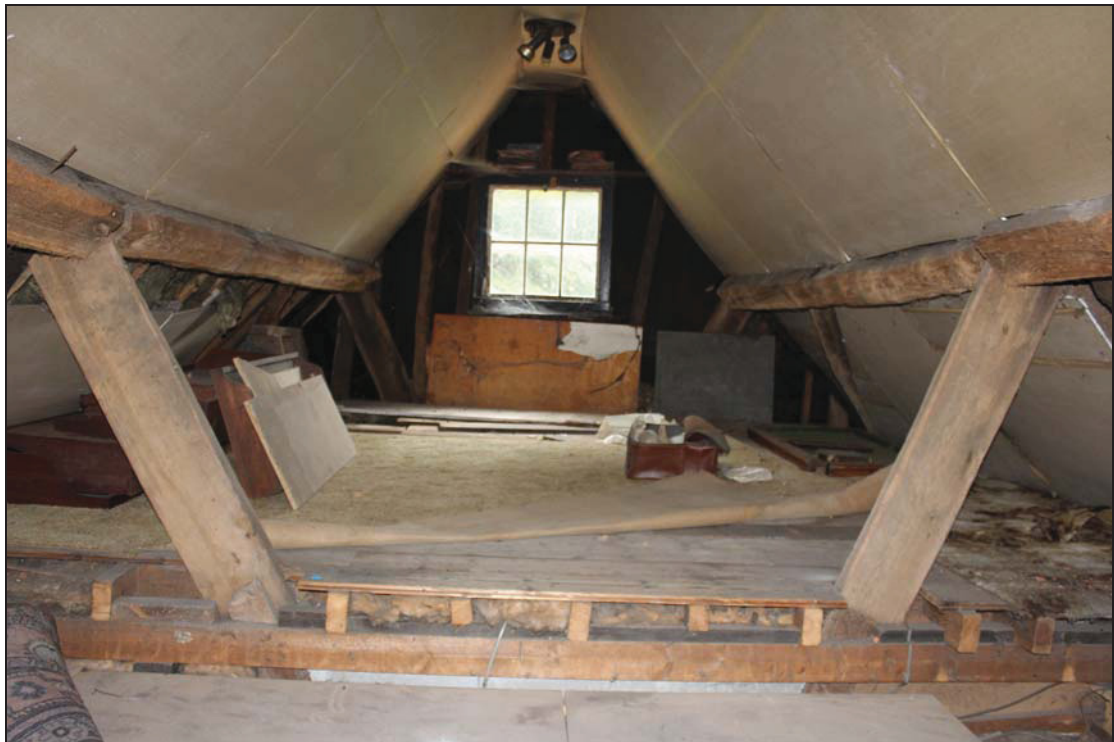
Plate 50 Roof structure over the rear range, taken from the north (DP 174)

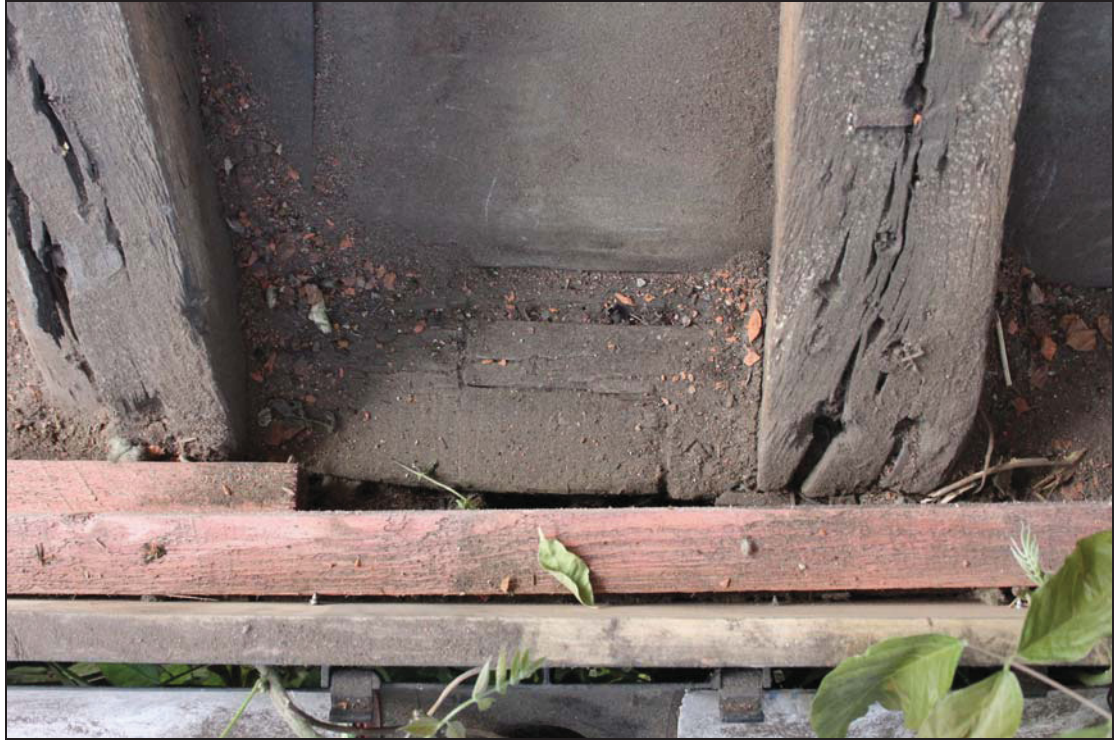
Plate 51 Scarf joint in the wall-plate of the rear roof range, mid-bay in Bay 4, taken from the east (DP 244)

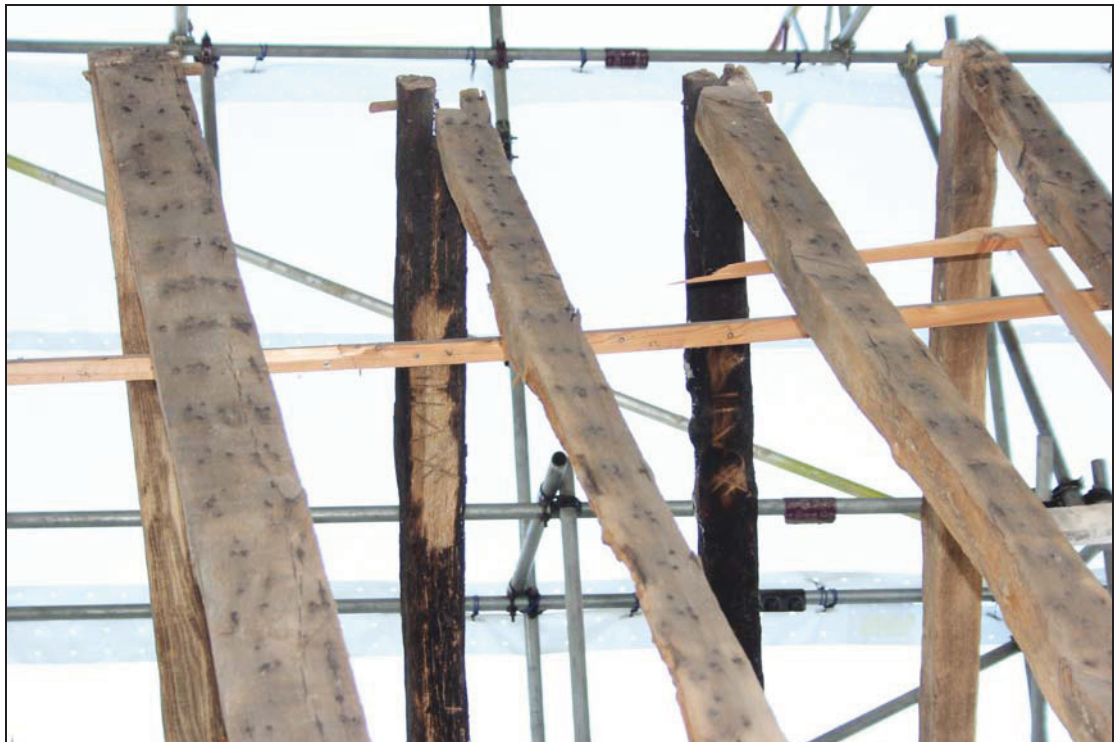
5.64 Generally, there is a good sequence of chiselled assembly marks which are visible at bay divisions on the principal rafters close to the tie-beam, the purlins close to the principal rafters, and the bases of the wind braces and adjoining principal rafters. They follow the Roman numeral system and proceed sequentially from north to south. In addition, almost every common rafter is marked and generally follows a sequence from south to north with the higher numbers such as 39 (XXXVIII) at the north end, in contrast to the north to south pattern visible on the principal members (Plate 52).

Plate 52 Detail of rafter couples in the rear range with assembly marks, taken from the east (DP 222)

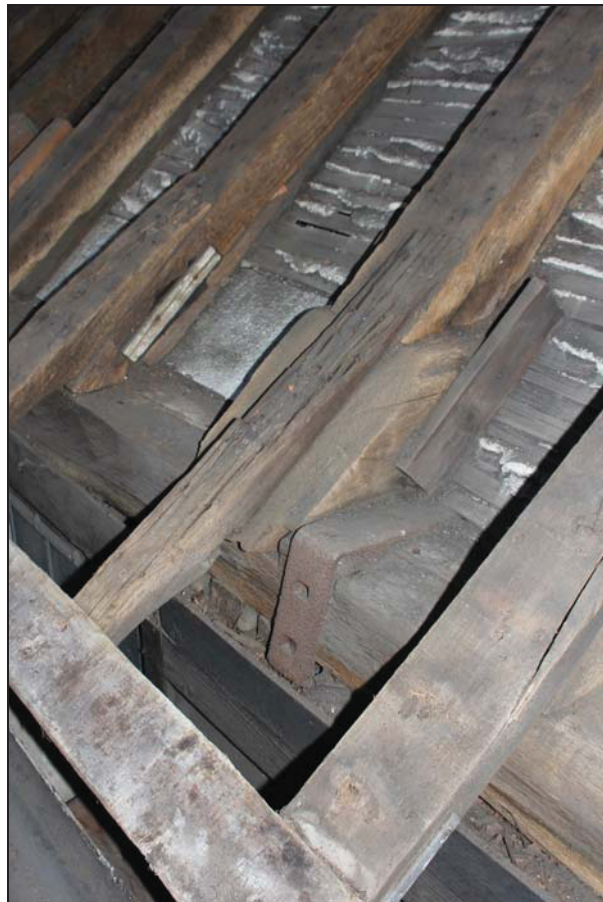
5.71 The south truss of this bay was truncated for the insertion of the chimney stack but retains the robust raking struts to principal rafters as well as the purlins. Good examples of rafter feet survive here and there is an 18th century strap on the wall plate to the north (Plate 54). The east side of the bay retains the remains of a former roof light which was accommodated around the existing rafters but subsequently made redundant by the insertion of a lower ceiling within, all of modern fabric.

Plate 54 Rafter feet in the rear range and 18th century strap to the wall plate, taken from the south-west (DP 201)

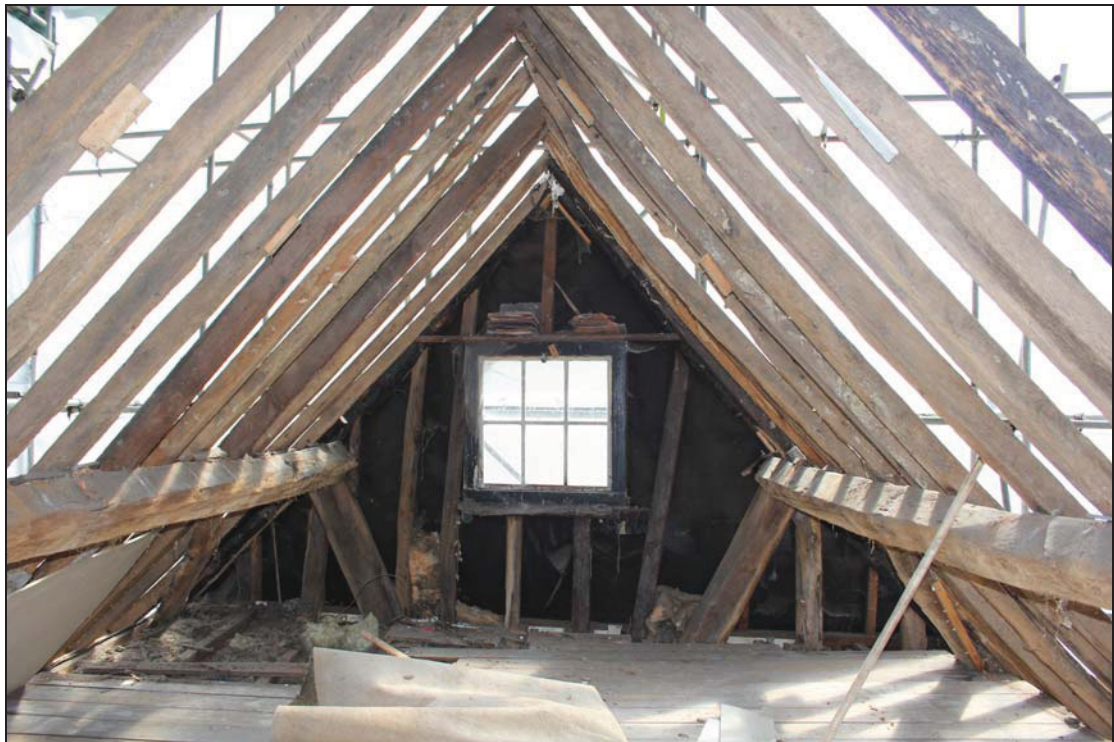
5.73 Bay 5 is the final bay and includes the south truss which forms the south gable end of the rear range. In outline the original fabric survives with principal rafters and raking struts, and the studs incorporate a number of historic timbers, but much reworked and not *in-situ* (Plate 56). The window is 19th century. On the east side one or two charred rafters are visible.

Plate 56 South gable end of the rear range at roof level, taken from the north (DP 256)
