ARCHAEOLOGICAL SOLUTIONS LTD

18-20 ST PETER'S STREET, BEDFORD,
BEDFORDSHIRE

HISTORIC BUILDING
MONITORING AND RECORDING

Author:	Tansy Collins MSt Kathren Henry	
NGR: TL 05141 50083	Report No: 5501	
District: Bedford	Site Code: AS1925	
Approved: Claire Halpin MCIfA	Project No: 6291	
	Date: 22 December 2017

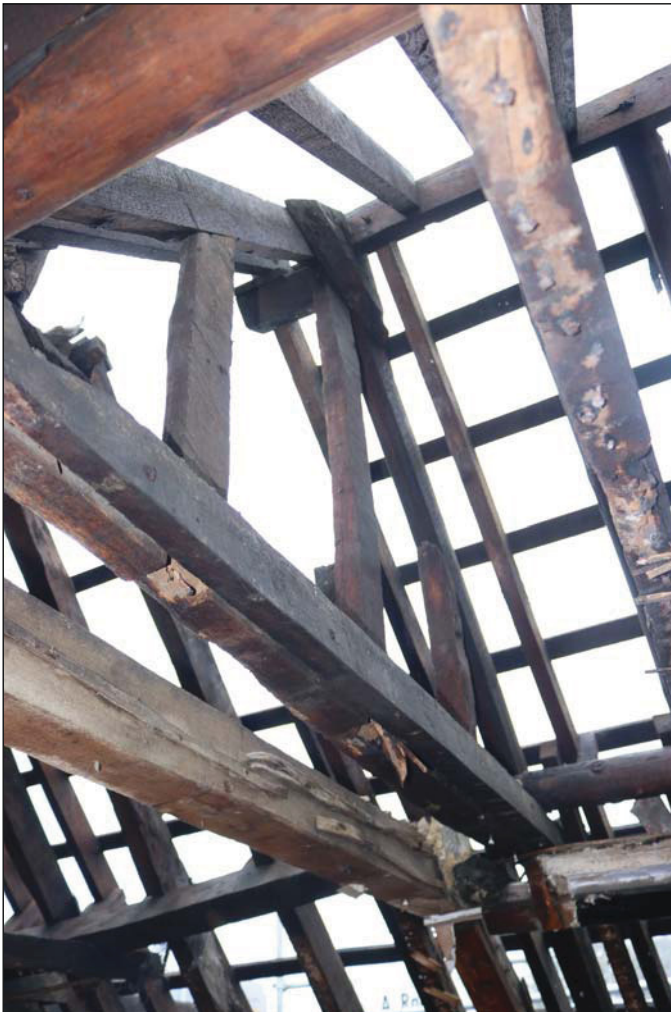
the principal rafters and nailed. Three crude studs are visible above the collar and there is a nailed yoke piece at the apex (Plate 20).

Plate 20 Roof structure at the junction between the main range and west range (SF01 and SF02) showing studwork above the collar to the apex, taken from the north-west (DP 149)

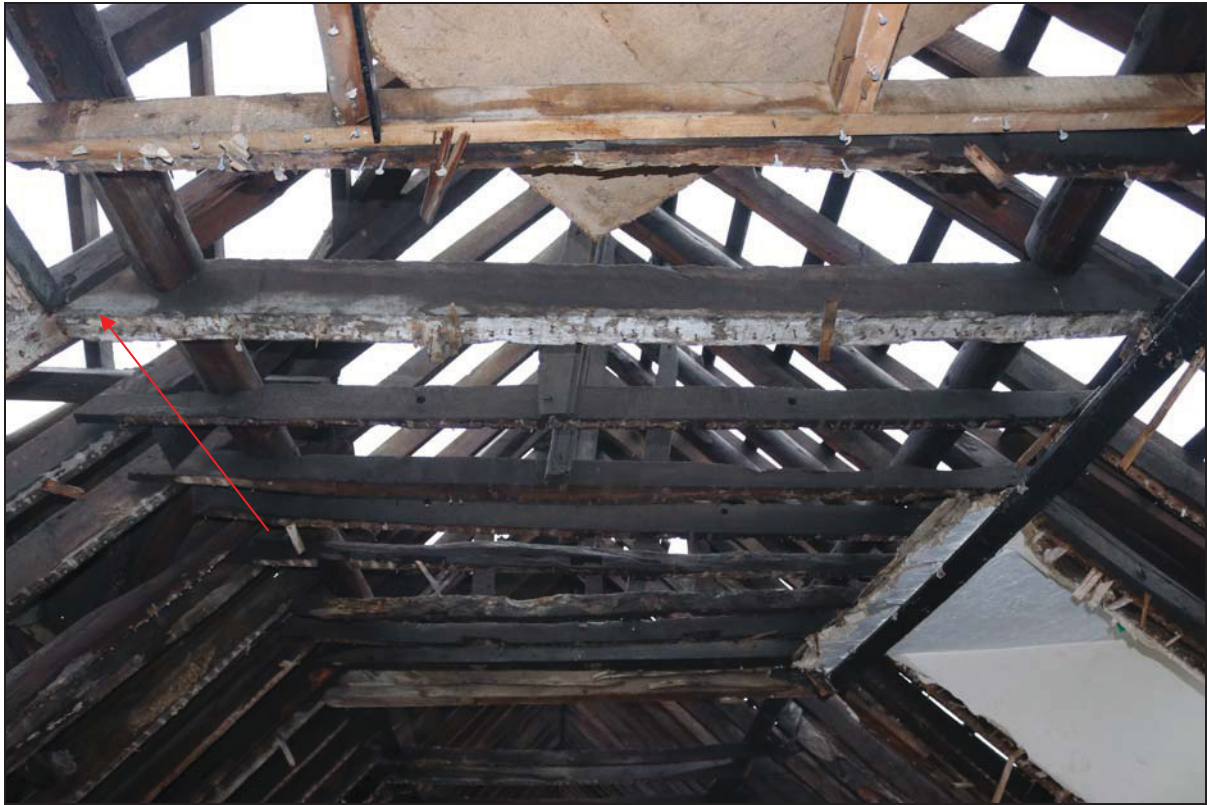
5.30 The roof at this west end of the structure is of more slender and variable timber that seen elsewhere. Much is waney and the purlins are rounded spars, notched where clasped by an intermediate collar. The rafters ride over the purlin to a ridgeboard, though it is not clear if this is original as there has been much alteration. The intermediate collar is pegged to the rafters (Plate 21), while additional slender collars which formerly held lath and plaster are simply nailed. A secondary purlin on the south side is part of the cosmetic treatment noted above.

Plate 21 Roof structure over Bay 4 (SF02) showing intermediate pegged collar (indicated) and additional nailed collars, taken from the west (DP 148)

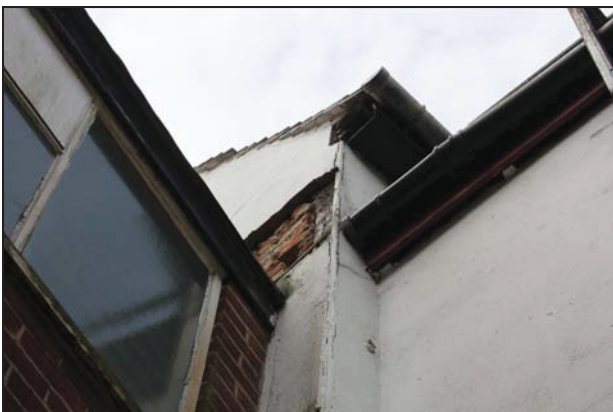
*DP 11
East side of the main range showing timber corner post and brick infill where the external render has fallen away, taken from the east*

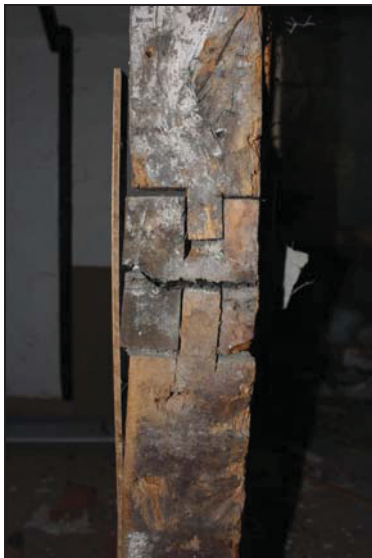
DP 26
Detail of the formerly external north gable end (north-east range) showing truncated timbers, taken from the north-east

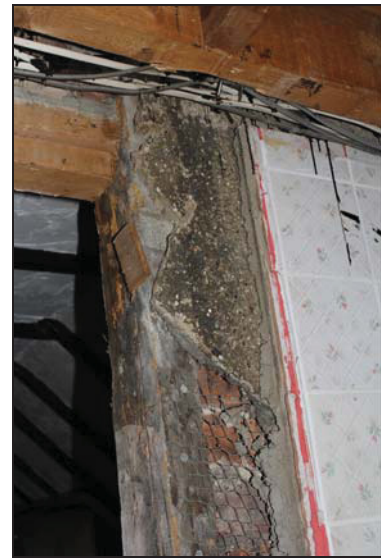
DP 27
Detail of the formerly external north gable end (north-east range) showing horizontal member truncated to expose the jointing of the upper and lower studs, taken from the east

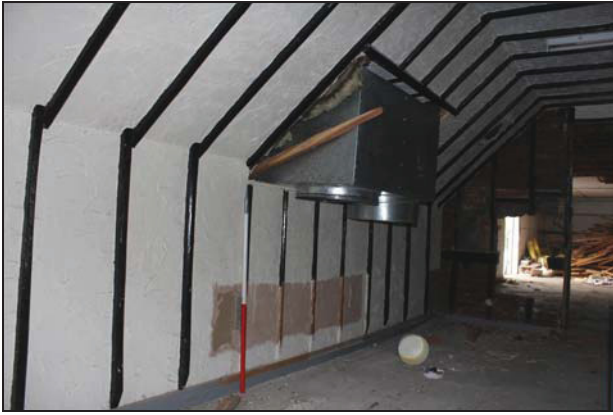
DP 31

West wall of Room SF03 (north-east range) showing rafters and later partition enclosing the eaves, taken from the south-east

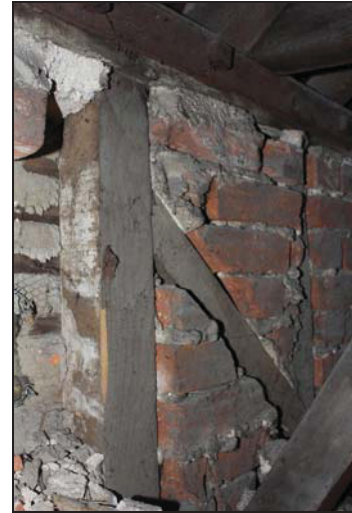
DP 32

View of into the eaves of the north-east range showing primary-braced timber framing of the outer wall, taken from the north-west

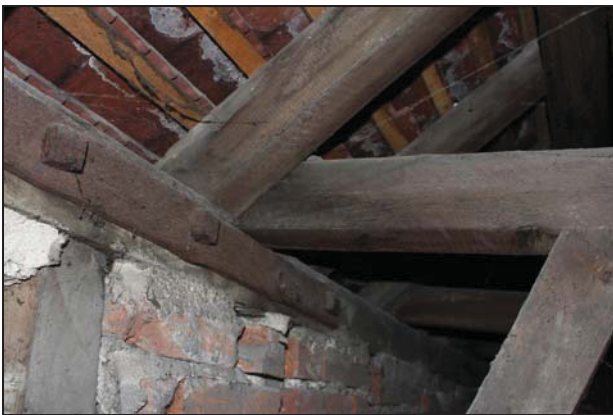
DP 33

View of into the eaves of the north-east range showing iron strapped wall-plate with rafters and additional members, taken from the north

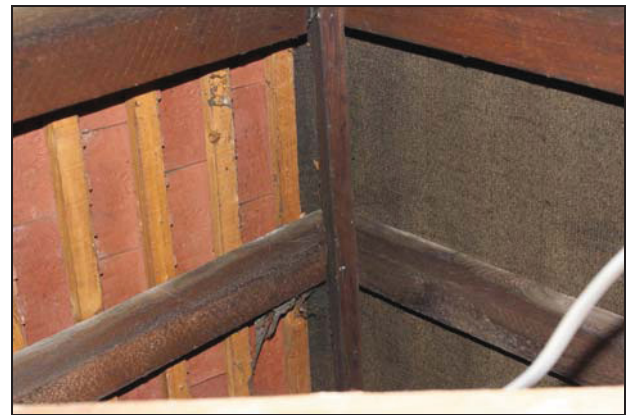
DP 34

Partial view of the roof structure over the north-east range showing rafter couples and ridgeboard, taken from the north

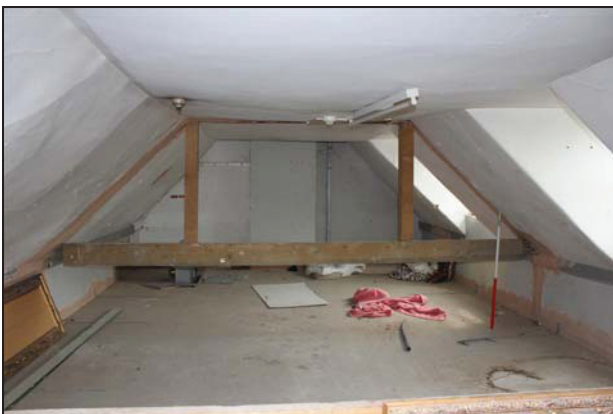
DP 35

View of the attic space (SF01) over the main range, taken from the west

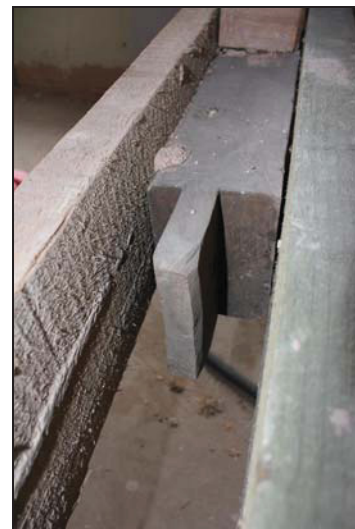
DP 36

Detail of the east tie-beam (main range) showing foreshortened tie-beam with tenon for an upright, taken from the north

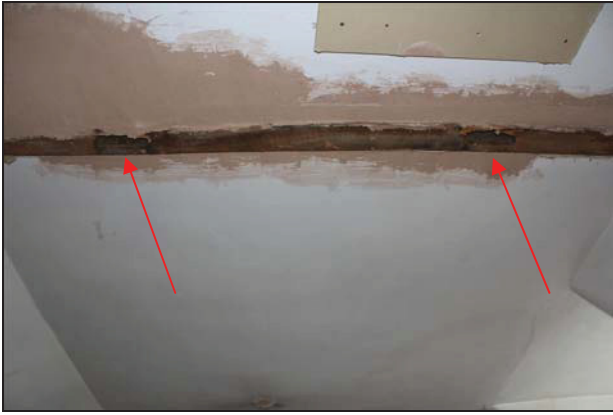
DP 37

Detail of the east collar (main range) showing empty mortices (indicated) in the soffit for lost uprights, taken from the west

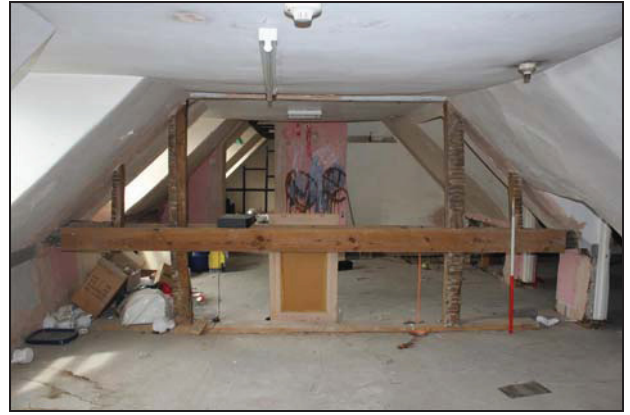
DP 38

View of the attic space (SF01) over the main range, taken from the east

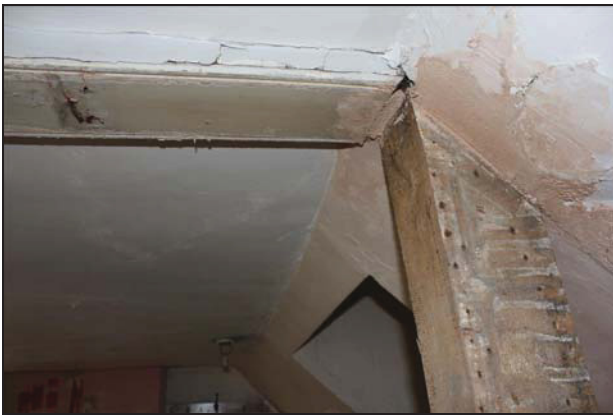
DP 39

Detail of the west truss (main range) showing surviving upright and boxed in collar above, taken from the east

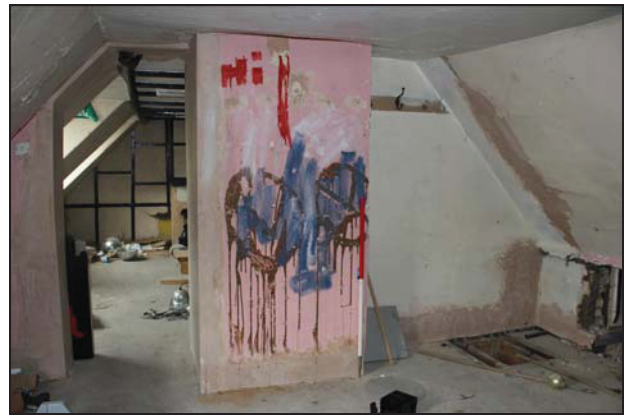
DP 40

Chimney stack at the west end of the attic space (SF01) over the main range, taken from the east

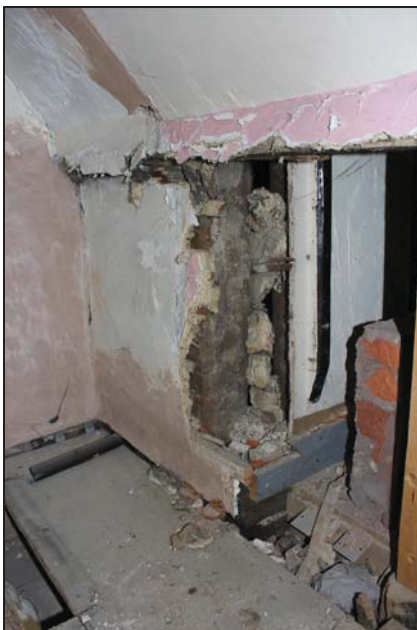
DP 41

Surviving stud on the north side of the main range (attic level), taken from the south-east

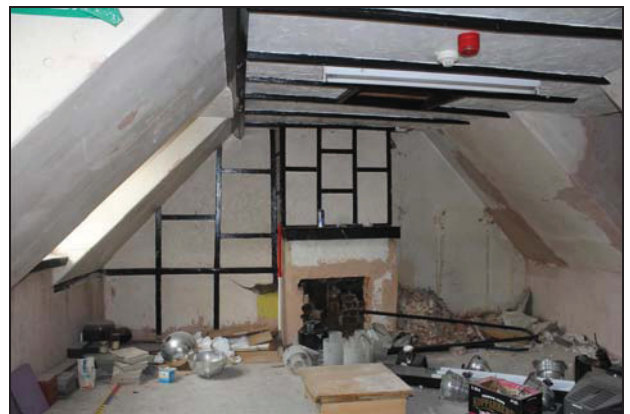
DP 42

View of the attic space (SF02) over the west range showing fictive timber applied around the chimney stack, taken from the east

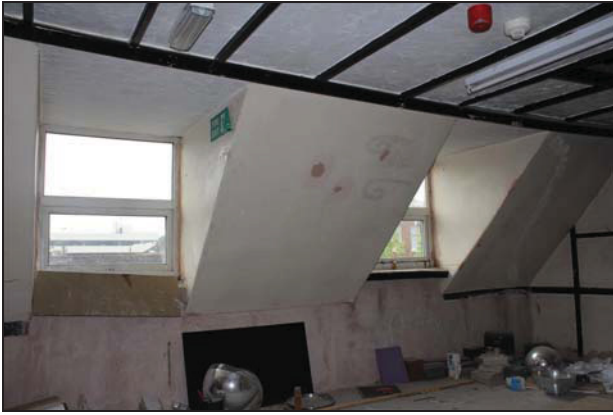
DP 43

View of the attic space (SF02) over the west range showing the dormer windows on the south, taken from the north-east

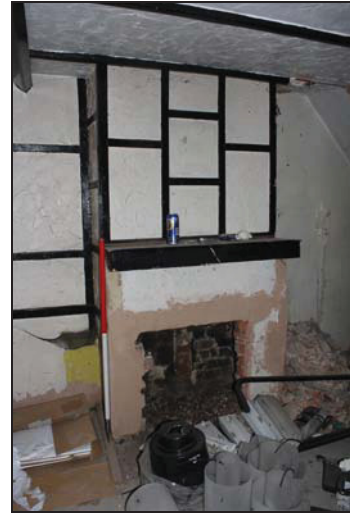
DP 44

West side of Room SF02 (west range) showing fictive timberwork and fireplace, taken from the east

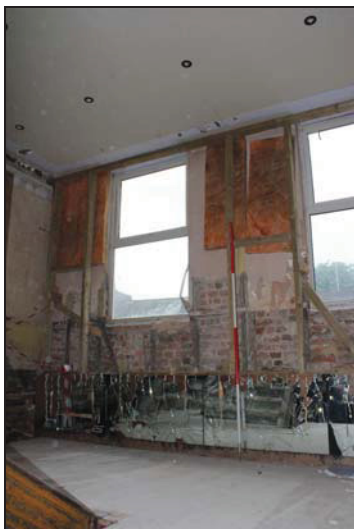
DP 47

South wall of FF02 (west range) showing primary-braced timber-framing with brick infill, taken from the north

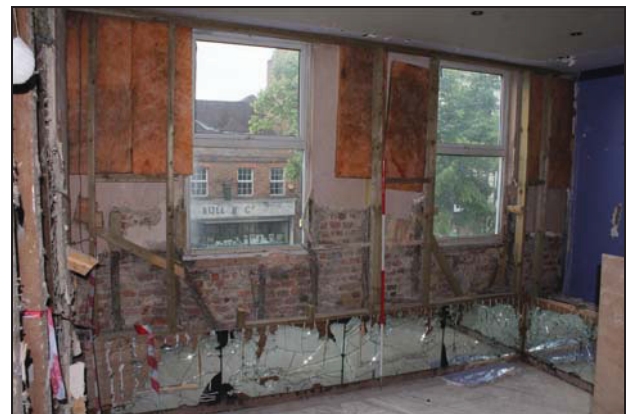
DP 48

South wall of FF02 (west range) showing primary-braced timber-framing with brick infill, taken from the north

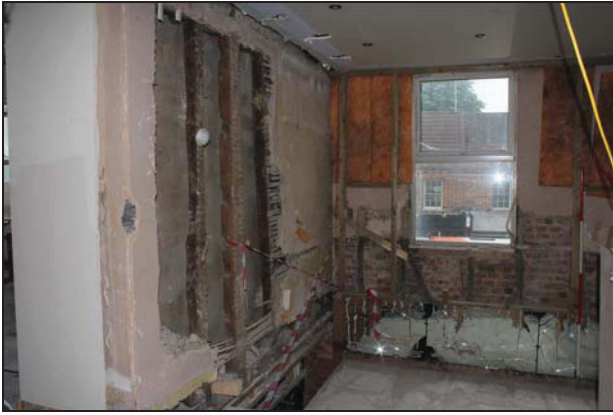
DP 49

East side of FF02 (west range) showing studwork constructed up against pre-existing fabric of the main range, taken from the north

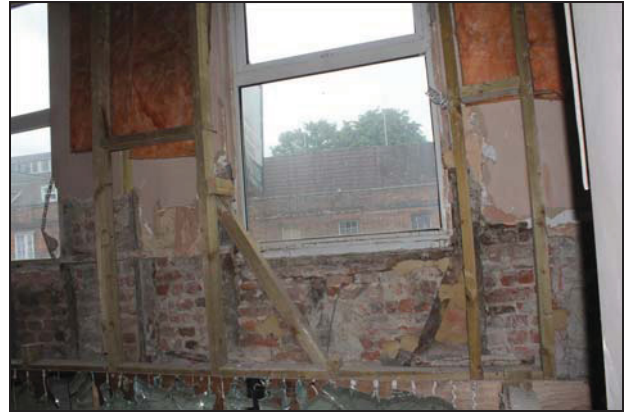
DP 50

Detail of the south wall of FF02 (west range) showing primary-braced timber-framing with brick infill, taken from the north

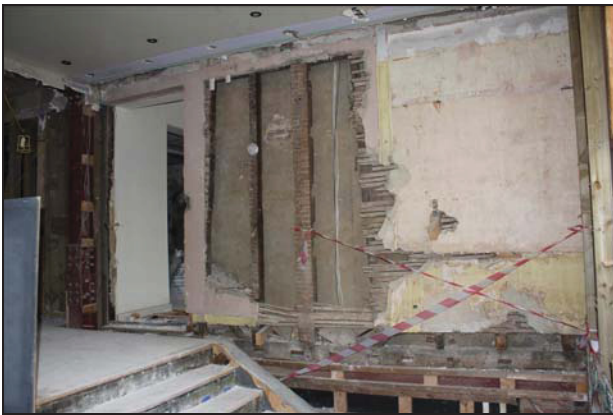
DP 51

East wall of FF02 (west range) showing studwork constructed up against pre-existing fabric of the main range, taken from the north

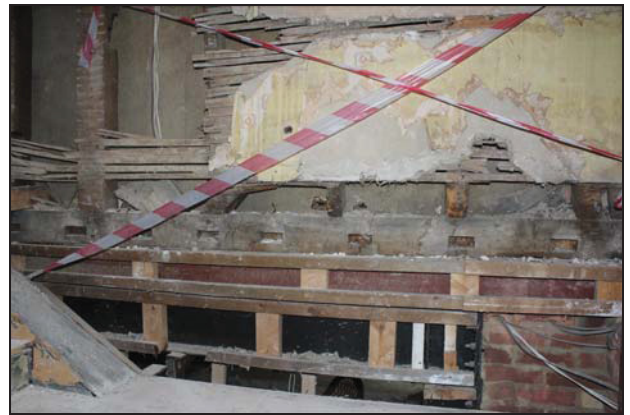
DP 52

East side of FF02 (west range) showing binding joist with empty mortices for lost floor joists, taken from the west

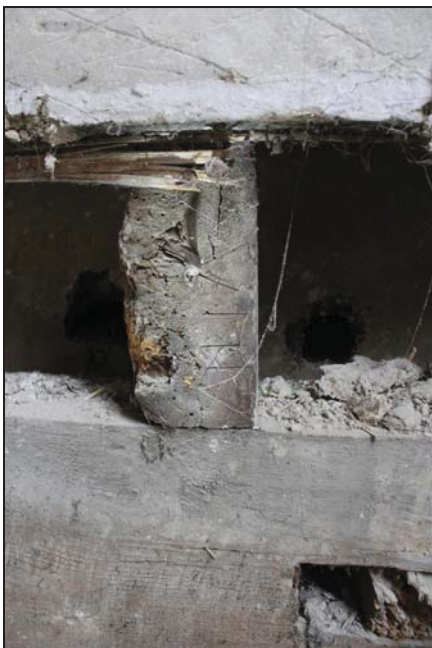
DP 53

East side of FF02 (west range) showing assembly marks on the binding joist and stud, taken from the west

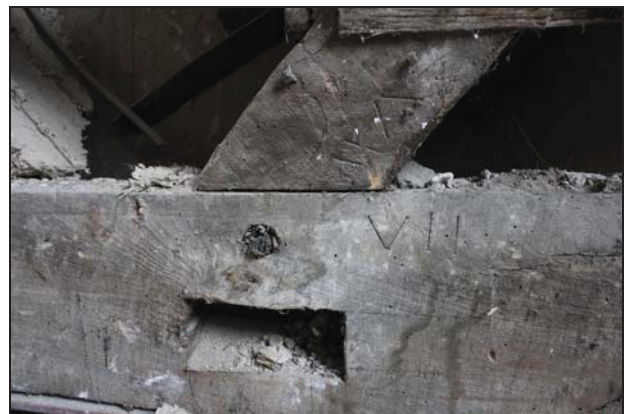
DP 54

East side of FF02 (west range) showing assembly marks on the binding joist and primary brace, taken from the west

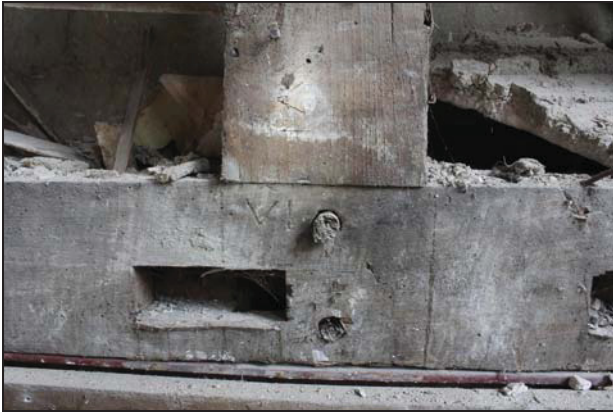
DP 55

East side of FF02 (west range) showing assembly marks on the binding joist and stud, taken from the west

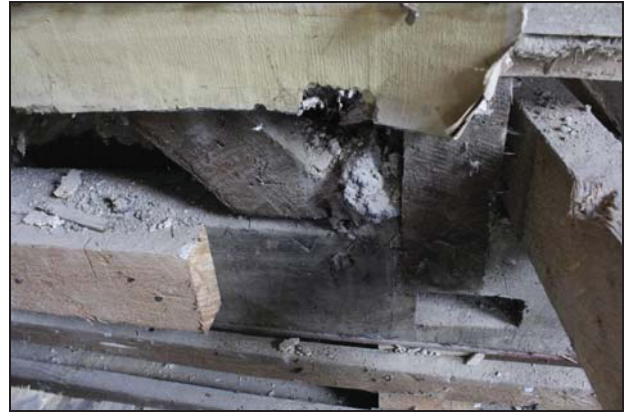
DP 56

East side of FF02 (west range) showing assembly marks on the binding joist and primary brace, taken from the west

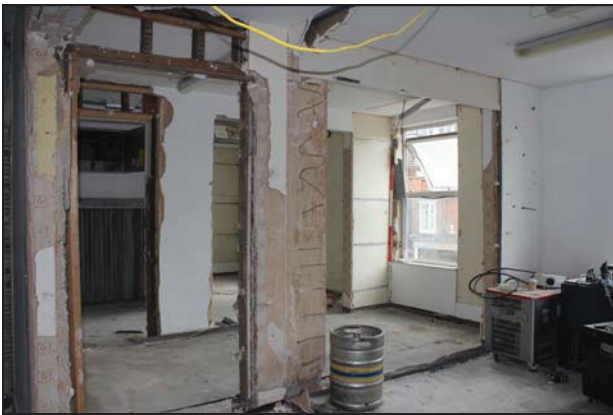
DP 57

View of FF01 showing substantial remodeling of three former rooms (main range), taken from the north-west

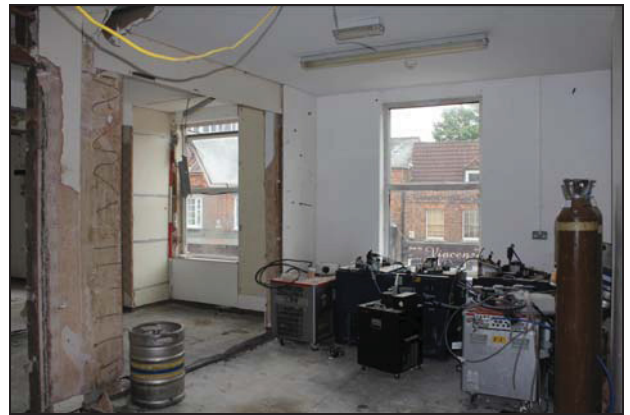
DP 58

View of FF01 showing substantial remodeling of three former rooms and modern windows (main range), taken from the north

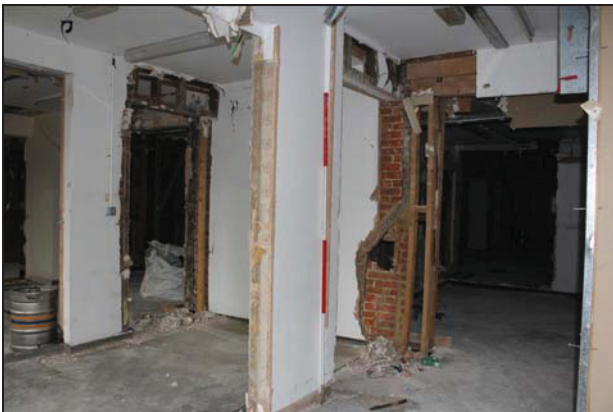
DP 59

View of FF01 showing fragmentary surviving timber-framing and brickwork infill of the rear wall (main range), taken from the south

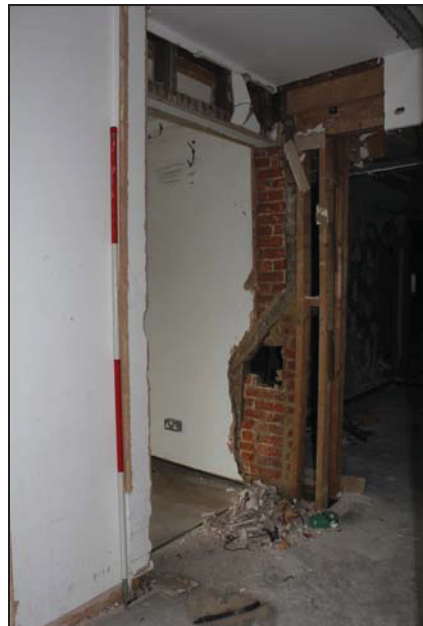
DP 60

View of FF01 showing fragmentary surviving timber-framing and brickwork infill of the rear wall (main range), taken from the south

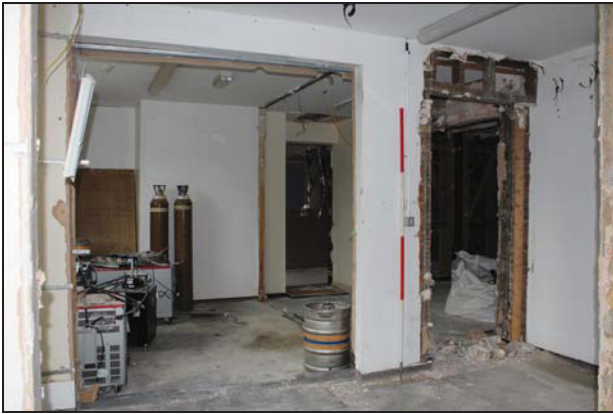
DP 61

View of FF01 showing substantial remodelling of three former rooms (main range), taken from the east

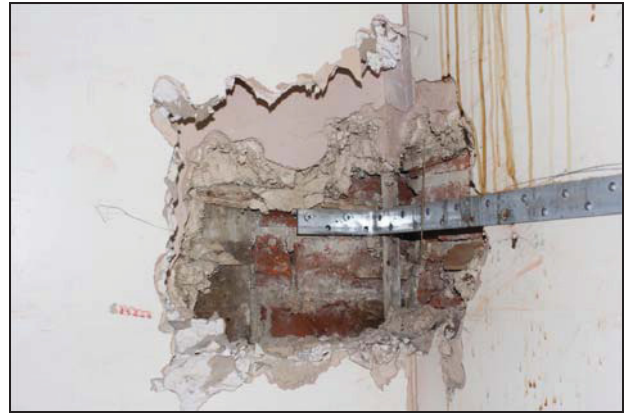
DP 62

Fragment of the south wall of FF01 (main range) after removal of dry-lining and plasterwork exposing timber studs and brickwork, taken from the north

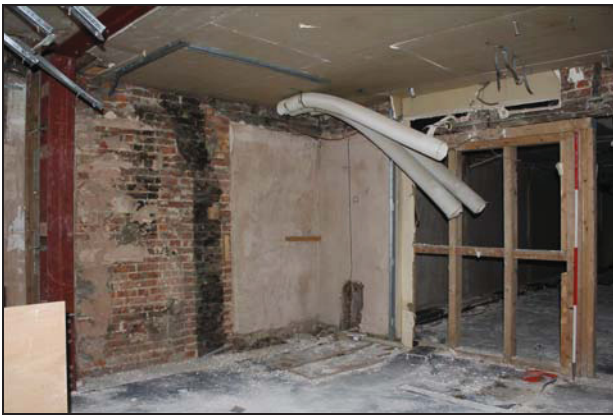
DP 63

FF04 (north-west range) showing much disturbed fabric including brick and timber and the outline of former chimney flue, taken from the south-east

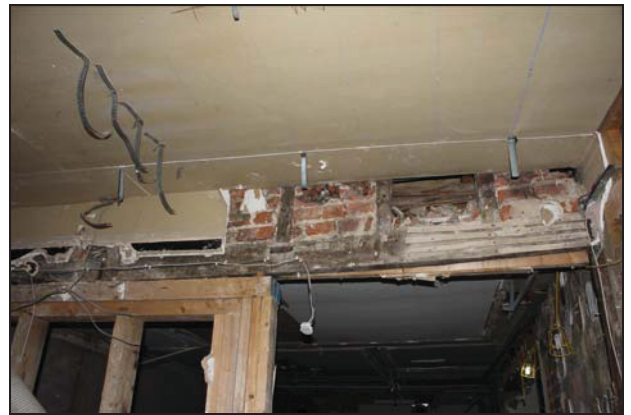
DP 64

North side of FF04 (north-west range) showing surviving timber elements of the upper gable, taken from the south

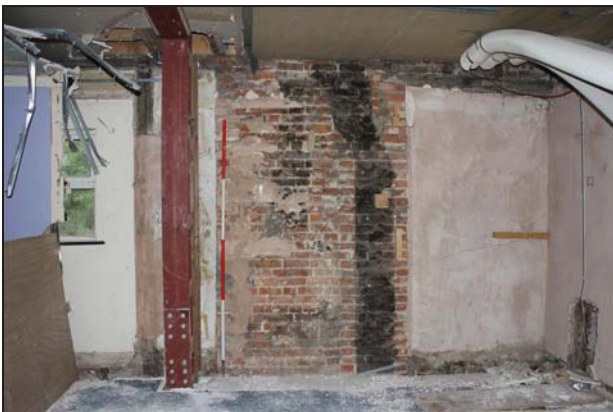
DP 65

West wall of FF04 (north-west range) showing much disturbed fabric including brick and timber and the outline of former chimney flue, taken from the east

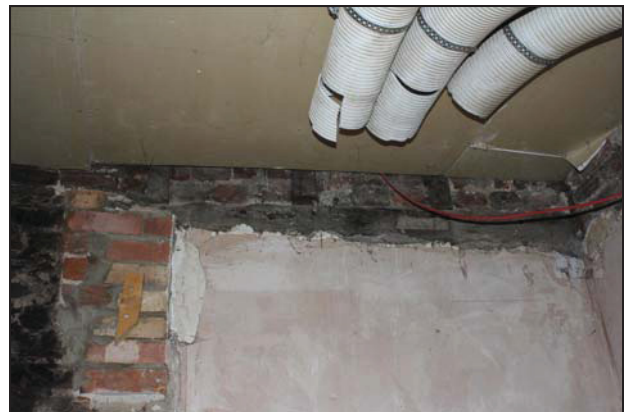
DP 66

Detail of the west wall of FF04 (north-west range) showing horizontal timber with upper studs and redundant mortices, taken from the east

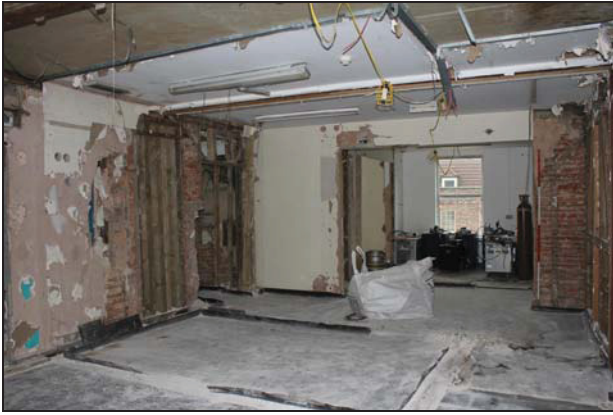
DP 67
View into the area of FF03 (north-east range) showing much replacement with fragments of timber-framing surviving of the rear wall of the main range, taken from the north

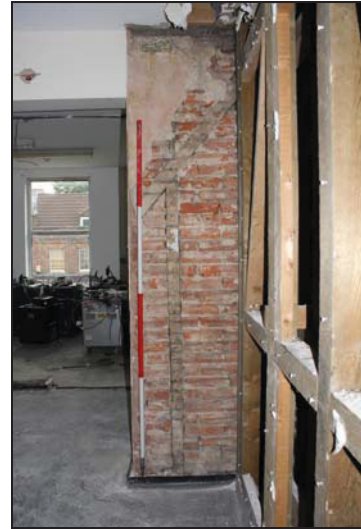
DP 68
Fragments of timber-framing surviving in the rear wall of the main range, taken from the north

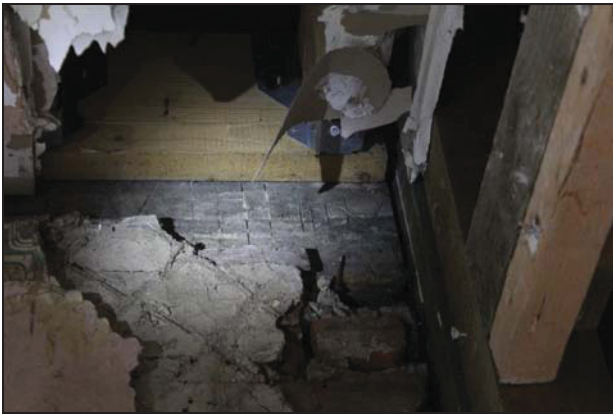
DP 69
Assembly marks on the wall-plate of the rear wall of the main range, taken from the north

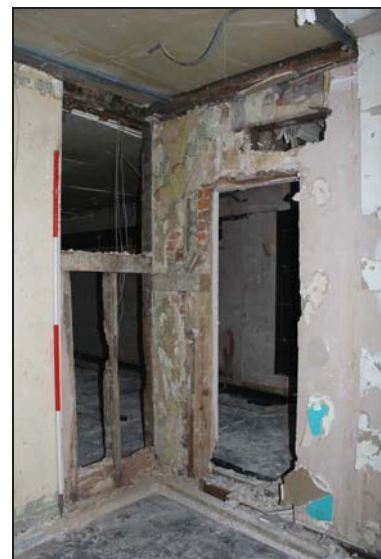
DP 72
North-east corner of FF03 (north-east range) showing truncated original mid-rails with studs above and below, taken from the south-west

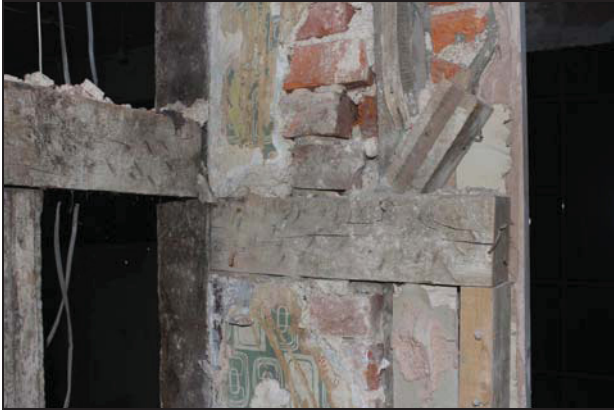
DP 73

North-east corner of FF03 (north-east range) showing truncated original mid-rails with pegged primary brace, also truncated, taken from the south-west

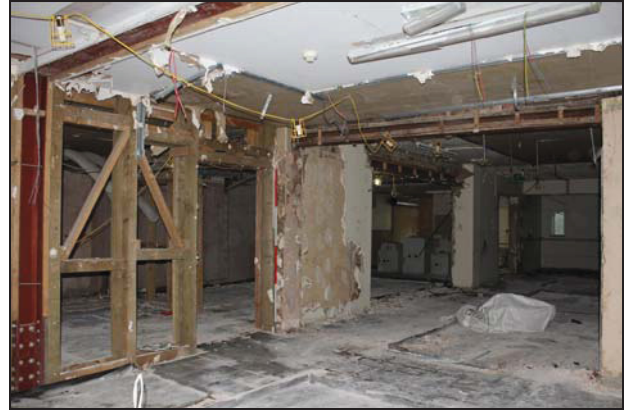
DP 74

View of the rear areas of the building at first floor level, taken from the south-east

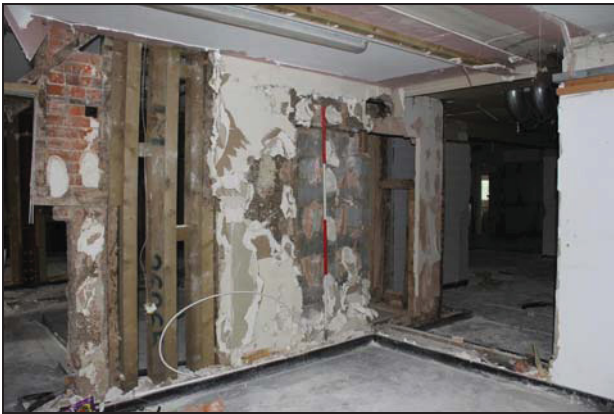
DP 75

View of the formerly external east side of the north-east range (first floor) with fragments of timber-framing and brick as well as some pebble-dashed render, taken from the south-east

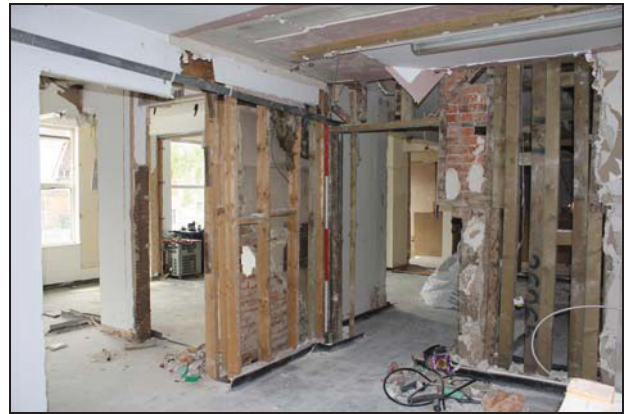
DP 76

View of the formerly external north wall of the main range (first floor) and east side of the north-east range, taken from the north-east

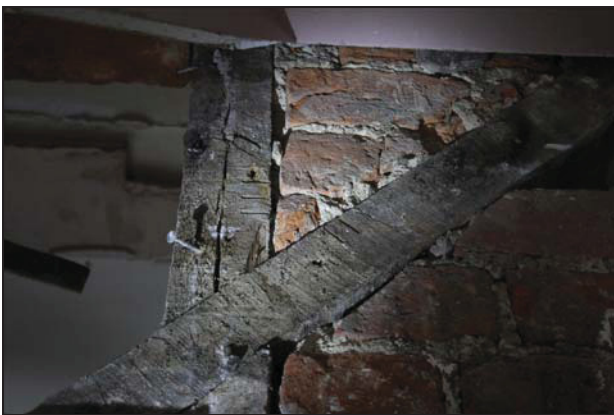
DP 77

Assembly marks on a stud and primary-brace on the east side of the north-east range (first floor), taken from the east

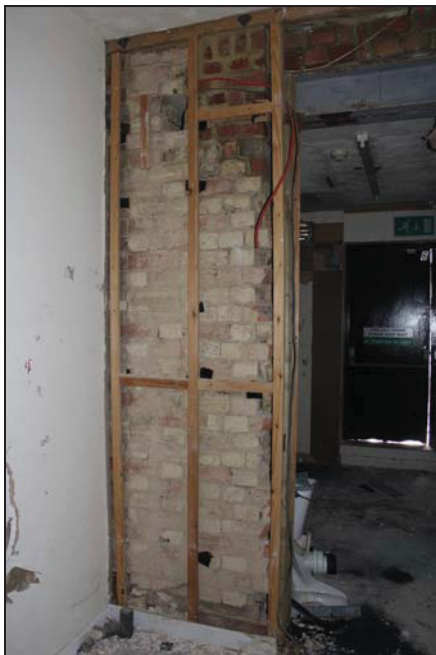
DP 83

5.19 Due to loss and replacement, there is no evidence surviving at this level of the junction between these rear ranges and the main street front range. Otherwise the modern extensions are of no interest though a small section of brickwork is 19th century. This appears to correspond with the position of rear ranges visible on historic maps and the architect's plans (Fig. 13) and demonstrates that instead of wholesale replacement, some fabric was incorporated into the modern extensions.

Fragment of 19th century brickwork in the extensions to the rear (first floor), taken from the west

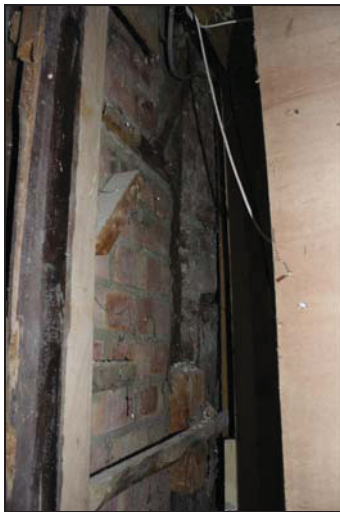
DP 87

Fragmentary survival of timber-framing on the street frontage (west range), taken from the east

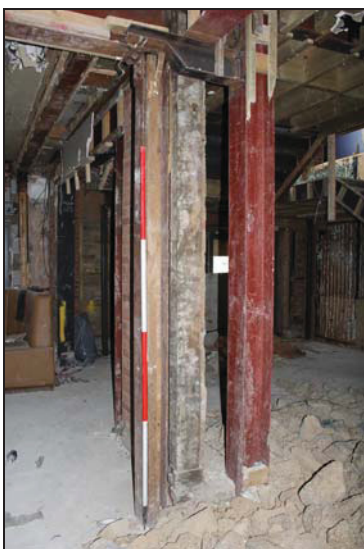
DP 89

Sole surviving post at ground floor level (main range), taken from the north-east

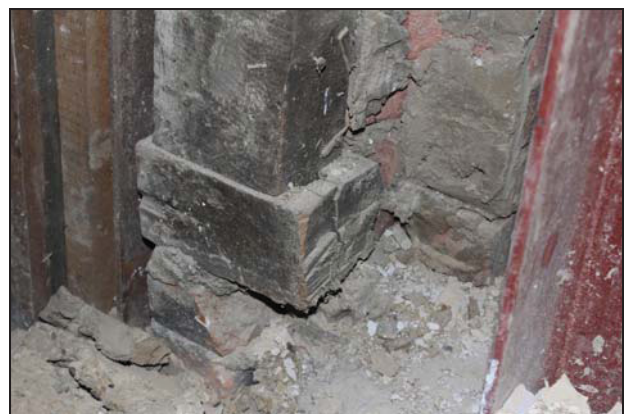
DP 90

Surviving post at ground floor level resting on a stump of the sole-plate (main range), taken from the north

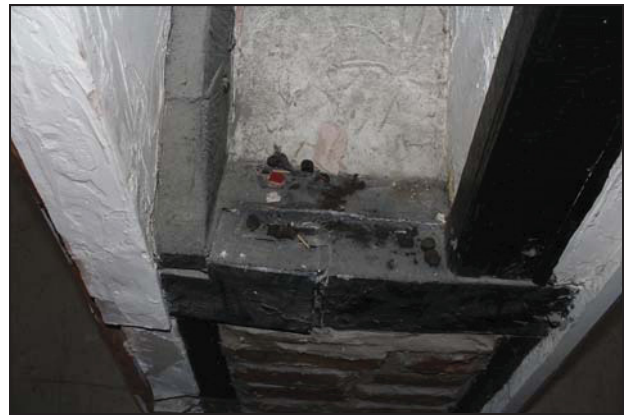
DP 94

5.25 The timber used throughout is fairly knotty, possibly including some oak but the majority is local, hedgerow timber and though fairly waney is well converted. The original roof structure of the historic core is of clasped side-purlin form with the bays divided by principal trusses. These vary in form which, as noted above, reflects the provision of rooms at this level from the outset. In general the truss form is of interrupted tie-beams dovetailed over the wall-plates and meeting inner posts that rise from the floor (set lower than the eaves) and are either single pegged to the principal rafters or pegged to a collar which itself clasps a single purlin and is pegged to the rafters (Plate 18). The principal rafters are pegged to the tie-beams and halved at the apex and given little yoke pieces. Common rafters in each bay are nailed to the wall-plate and are notched over the purlins and rise to a ridge board which has been inserted between the principal truss rafters. The purlins are in sections and jointed at each bay with a simple nailed splayed scarf. A scarf joint is visible in the north wall-plate from within the north-east range. This is a face-halved and bladed scarf joint, the blade

Face-halved and bladed scarf joint in the wall-plate of the main range, taken from the north

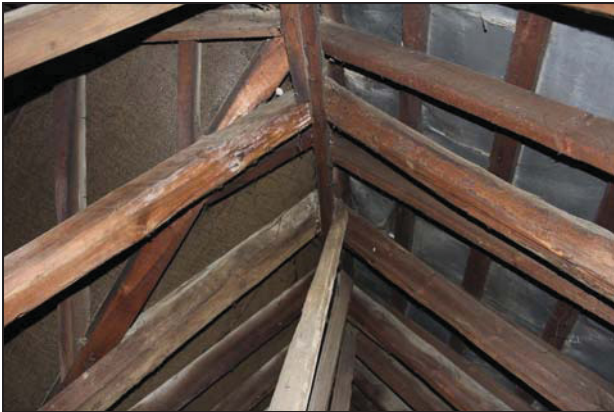
DP 95

Roof structure over the west range, taken from the west

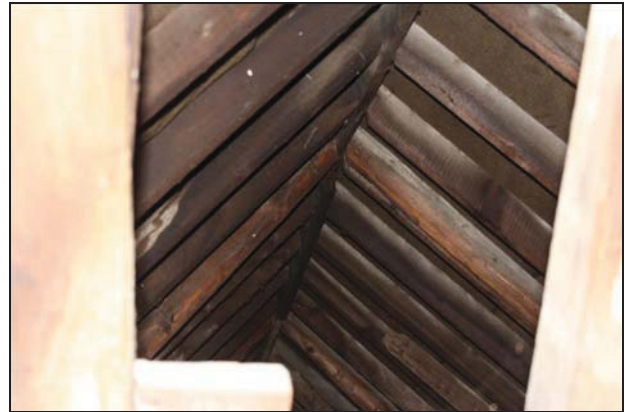
DP 96

Roof structure over the west range, taken from the west

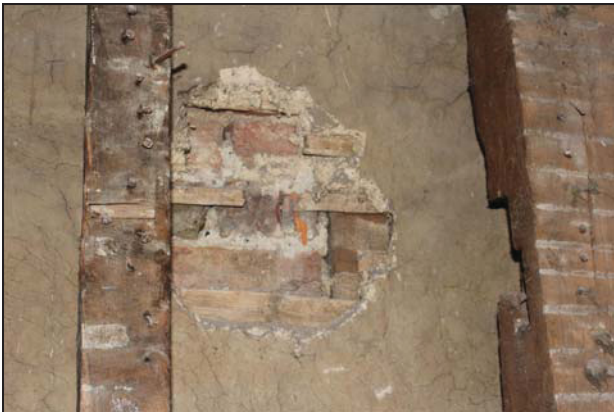
DP 97

Detail of the east wall of FF02 (west range) showing studwork constructed up against pre-existing fabric, taken from the north

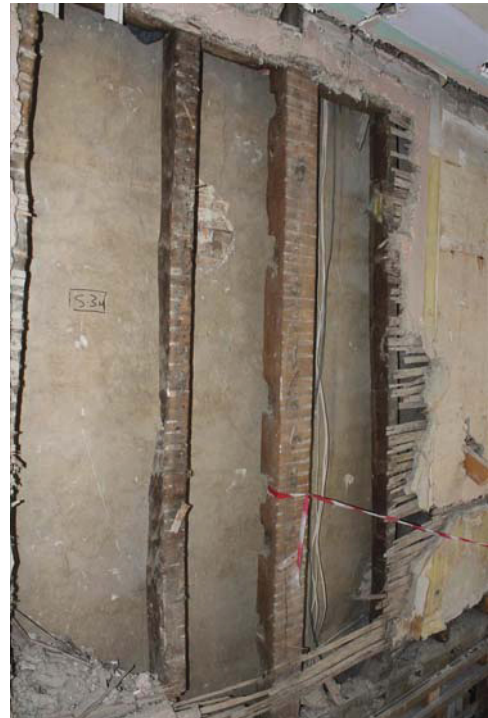
DP 98

East wall of FF02 (west range) showing studwork constructed up against pre-existing fabric, taken from the north-west

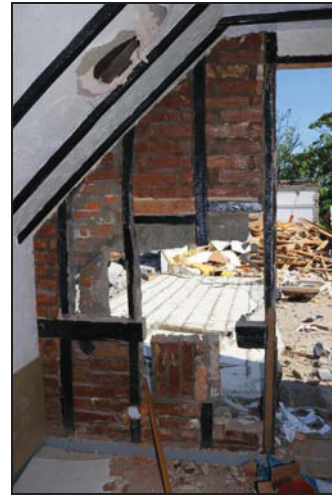
DP 100
North wall of Room SF03 (north-east range) showing surviving timber infilled with brickwork, taken from the south

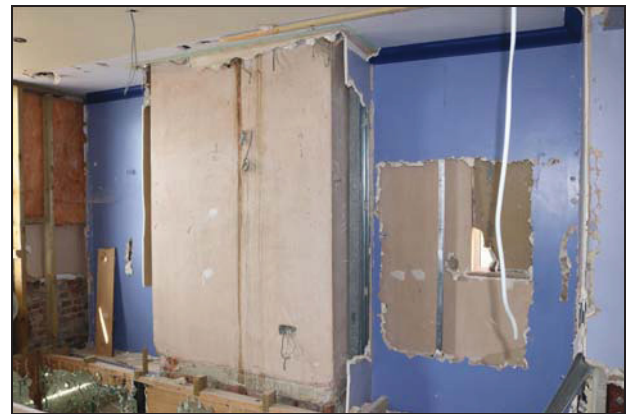
DP 102
West wall of FF02 (west range) showing some removal of dry-lining exposing a section of window, taken from the east

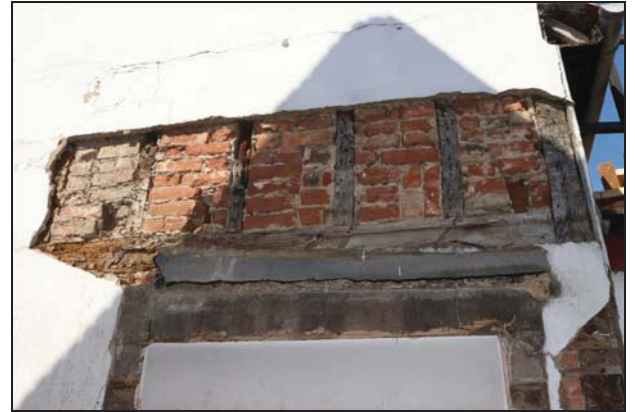
DP 106

East side of the main street front range following removal of the first floor linking corridor showing original studwork with brick infill, taken from the east

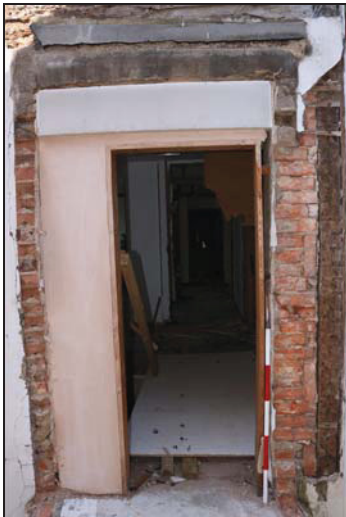
DP 107

East side of the main street front range following removal of the first floor linking corridor showing inserted doorway, taken from the east

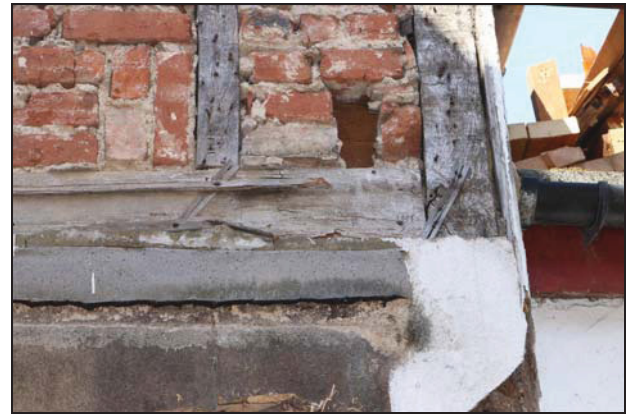
DP 108

East side of the main street front range following removal of plasterwork showing original studwork with chiselled assembly marks, taken from the east

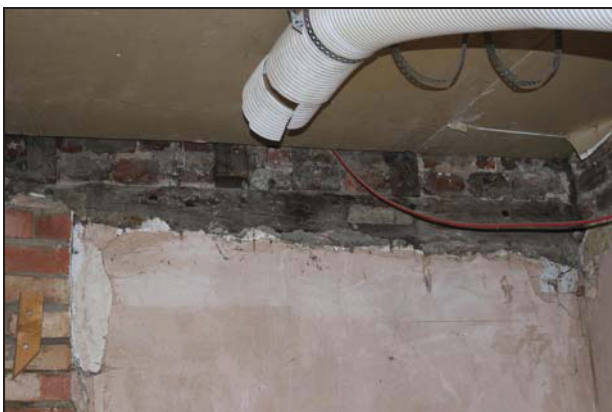
DP 109

Detail of the west wall of FF04 (north-west range) showing horizontal timber with upper studs and redundant mortices, taken from the east

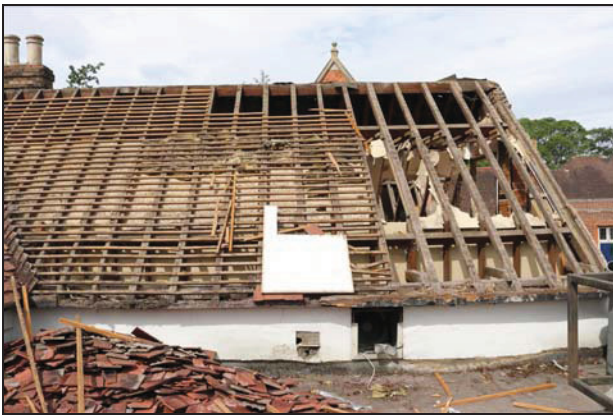
DP 112

View of the north-east range after removal of the roof cladding, taken from the north-east

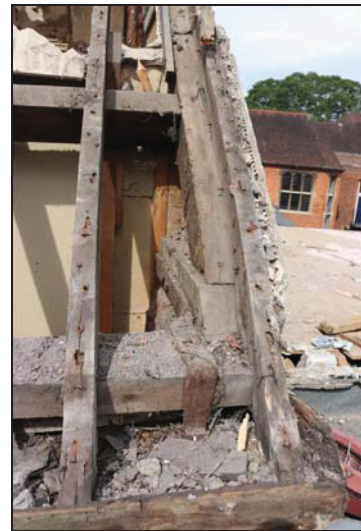
DP 113

View of the east pitch (north-east range) after removal of the roof cladding showing regular and even rafters, taken from the east

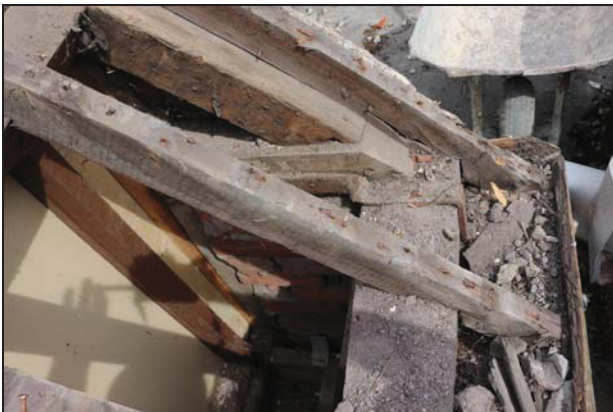
DP 114

Detail of the east pitch (north-east range) after removal of the roof cladding showing iron-strapped wall-plate and tie-beam, taken from the east

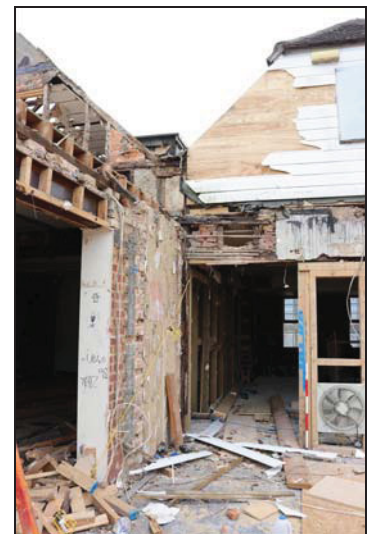
DP 121
North elevation of the north-west rear range following removal of the first floor extension showing modern elements with fragments of earlier studwork, taken from the north

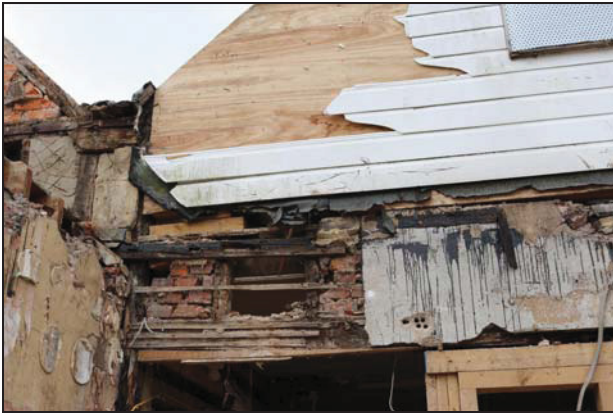
DP 122
North elevation of the north-west rear range following removal of the first floor extension, taken from the north

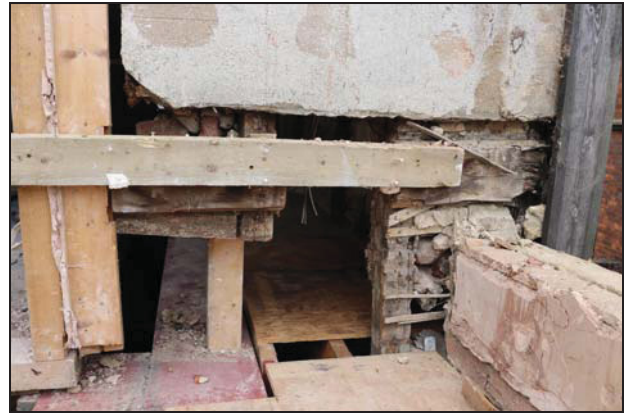
DP 123

North elevation of the north-west rear range following removal of the first floor extension showing fragmentary remains of timber-framing, taken from the north

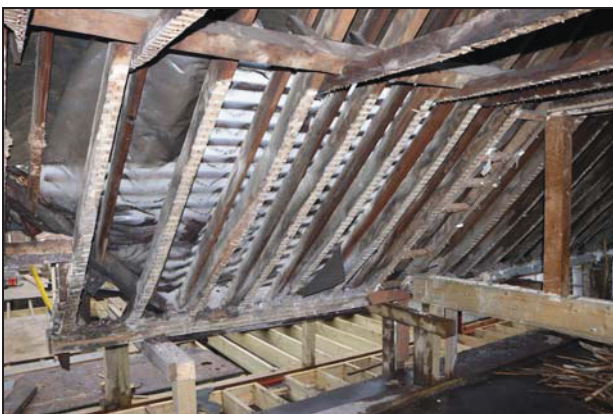
DP 126

View of the attic space (SF01) after the removal of lath and plasterwork, taken from the west

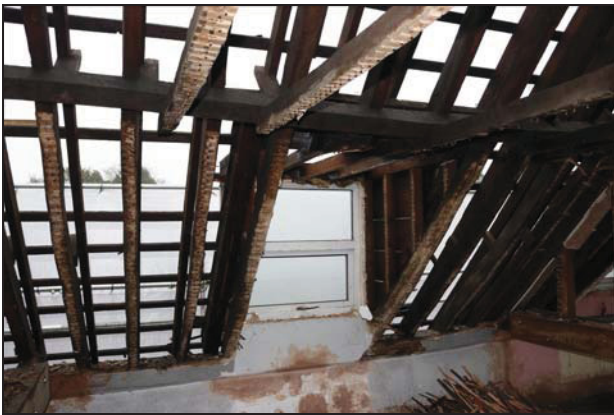
DP 130

South roof pitch of Bay 1 (SF01) showing inserted dormer window, taken from the north-west

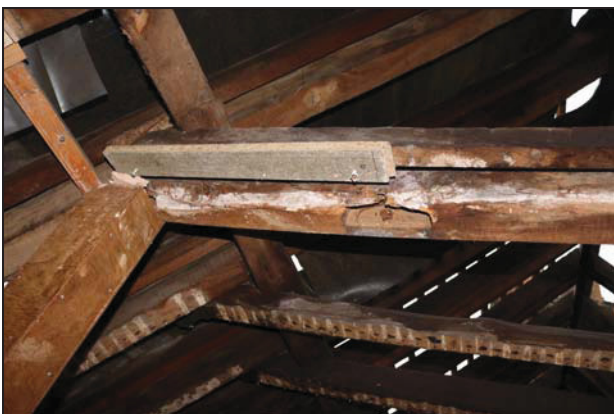
DP 132

North end of Truss 1 showing collar clasping the purlin which is splay-scarfed and nailed, taken from the west

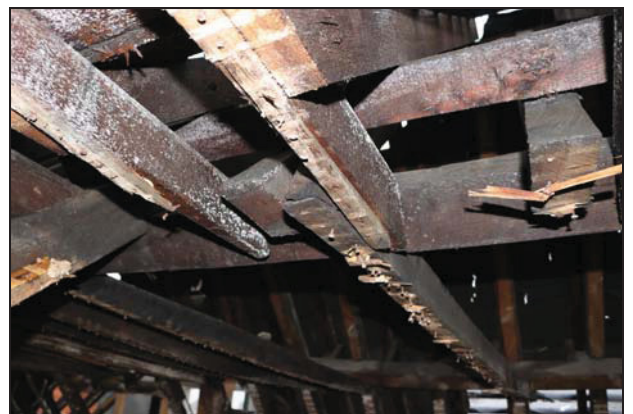
DP 133

North end of Truss 1 showing collar with mortice for a lower pegged stud, taken from the west

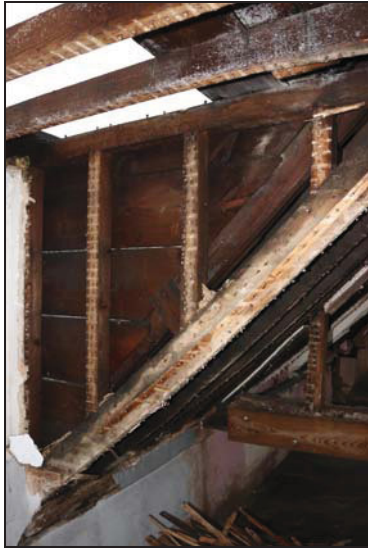
DP 134

Detail of the south side of Bay 2 (SF01) showing rafters truncated for the insertion of the dormer window, taken from the south

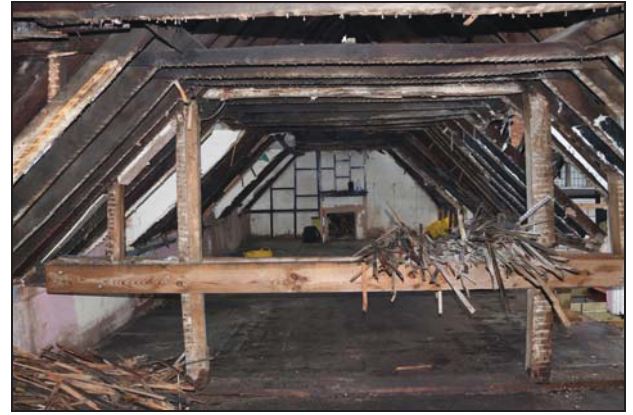
DP 135

Detail of the south side of Bay 2 (SF01) showing timberwork of the inserted dormer window, taken from the east
