ARCHAEOLOGICAL SOLUTIONS LTD

18-20 ST PETER'S STREET, BEDFORD,
BEDFORDSHIRE

HISTORIC BUILDING
MONITORING AND RECORDING

Author:	Tansy Collins MSt Kathren Henry	
NGR: TL 05141 50083	Report No: 5501	
District: Bedford	Site Code: AS1925	
Approved: Claire Halpin MCIfA	Project No: 6291	
	Date: 22 December 2017

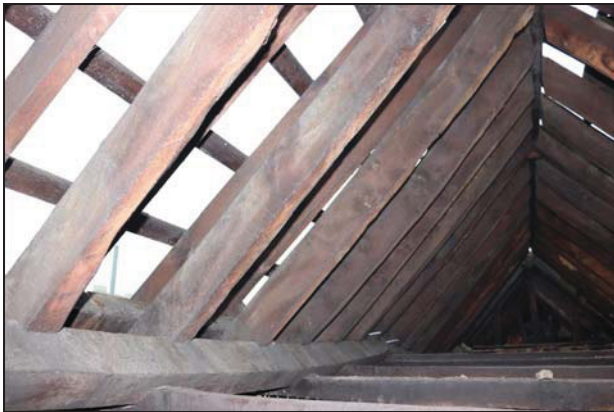
DP 136

View of the attic space (SF01) during the planned works after the removal of the chimney stack dividing the main and west ranges, taken from the east

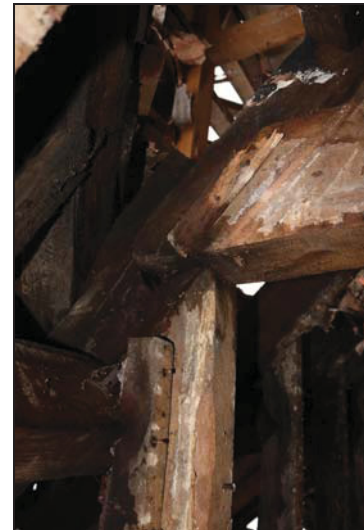
DP 137

View of the roof structure above collar level (SF01), taken from the east

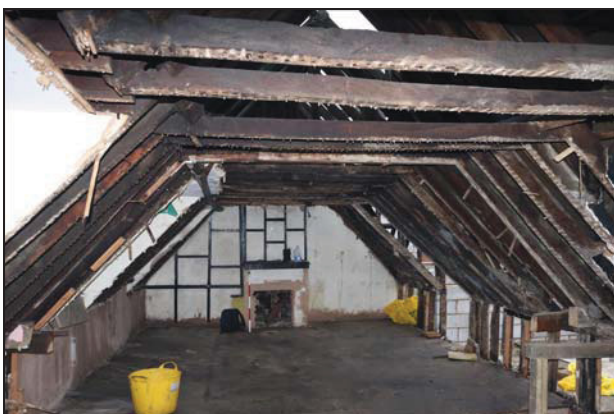
DP 138

North end of Truss 2 showing pegged collar and post nailed to the rafter, taken from the east

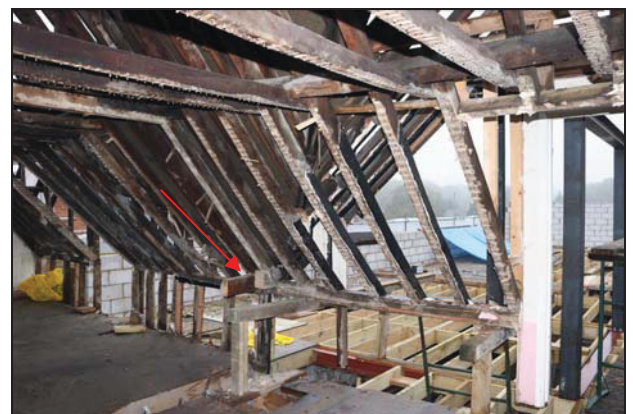
DP 139

View of the attic space (SF01) after the removal of the chimney stack dividing the main and west ranges, taken from the east

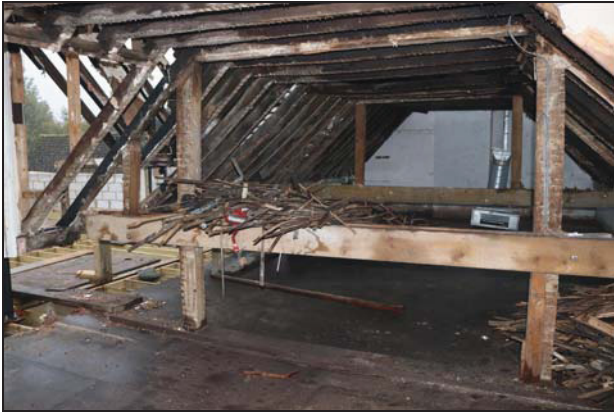
DP 140

North roof pitch of Bays 3 and 4 (SF01) showing junction between the two with truncated adjacent trusses (indicated), taken from the south-east

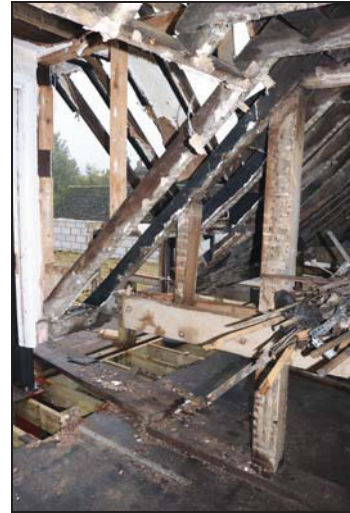
DP 141

View of the attic space (SF01) after the removal of lath and plasterwork and the north-west and north-east ranges, taken from the west

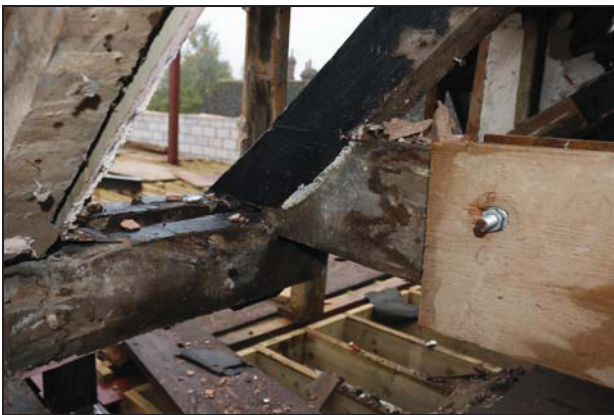
DP 142

North end of Truss 2 after the removal of timberwork and the north-east range, taken from the south-west

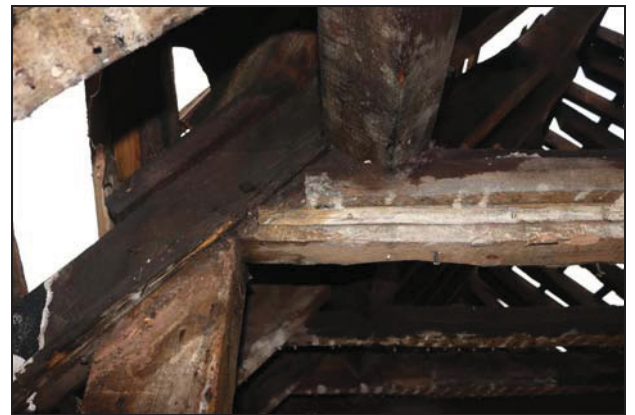
DP 143

North end of Truss 2 showing principal rafter pegged to the tie-beam, taken from the south-west

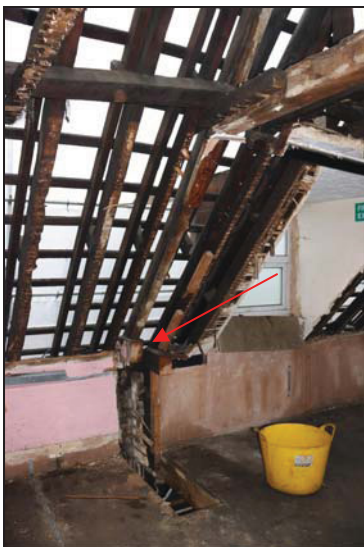
DP 144

North end of Truss 2 showing collar pegged to the principal rafter and clasping the purlin, taken from the west

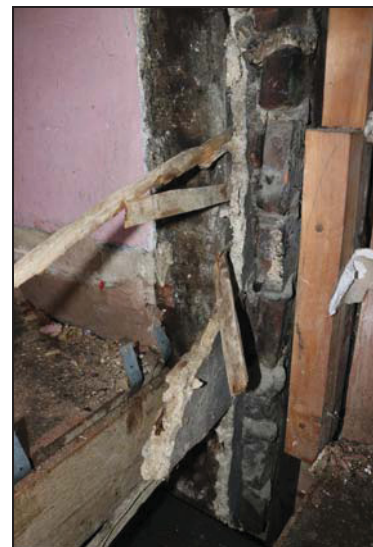
DP 145

South roof pitch between Bays 3 and 4 (SF01-02) showing truncated adjacent trusses (indicated), taken from the south-east

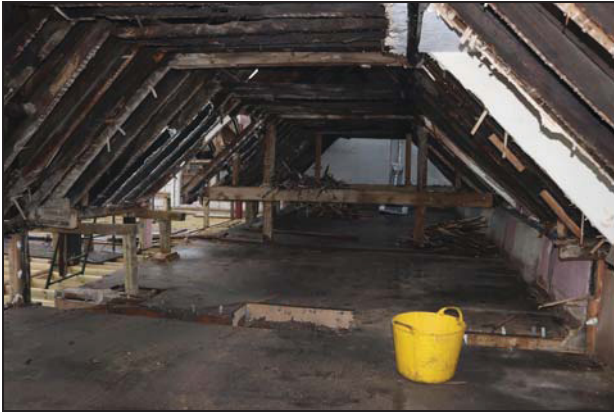
DP 146

South side between Bays 3 and 4 (SF01-02) showing formerly external plasterwork of the main range, taken from the north

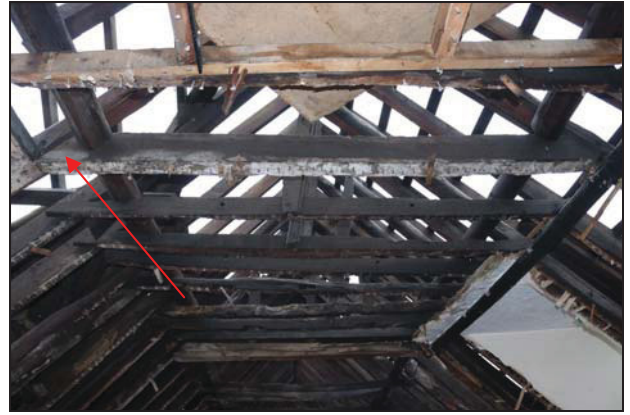
DP 147

View of the attic space after the removal of lath and plasterwork and the studwork on the north, taken from the west

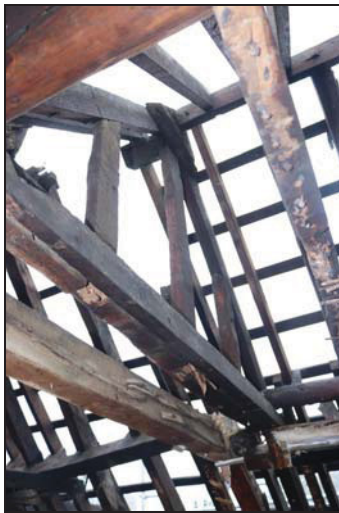
DP 148

Roof structure over Bay 4 (SF02) showing intermediate pegged collar (indicated) and additional nailed collars, taken from the west

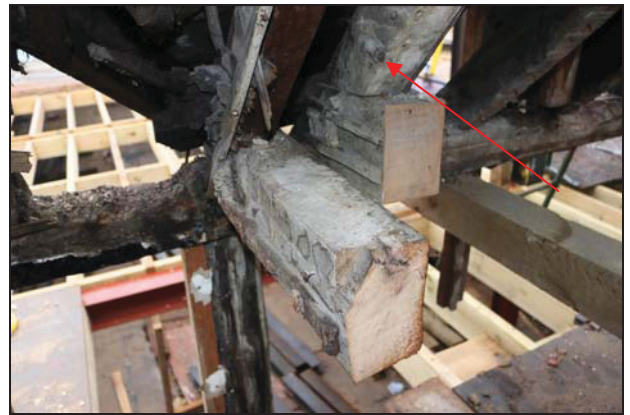
DP 149

Roof structure at the junction between the main range and west range (SF01 and SF02) showing studwork above the collar to the apex, taken from the north-west

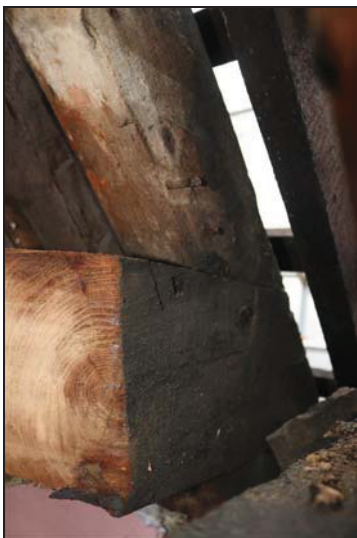
DP 150

Junction between bays 3 and 4 showing assembly mark (III, indicated) on the main range principal rafter and iron strapping on the adjacent tie-beam, taken from the south-west

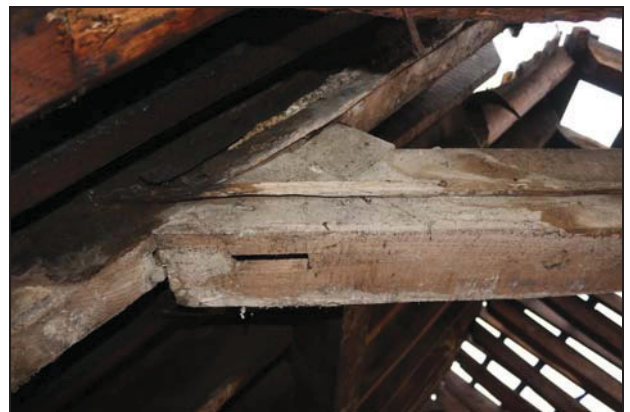
DP 151

South end of Truss 3 (main range) showing assembly marks (I) on the principal rafter and tie-beam, taken from the north-west
