**LOWER FARM, BURY GREEN, LITTLE HADHAM,
WARE, HERTFORDSHIRE SG11 2EY**

**HISTORIC BUILDING RECORDING AND
ARCHAEOLOGICAL MONITORING & RECORDING**

Authors: Tansy Collins MSt Lauren Wilson MA (Background Research) Kathren Henry	
NGR: TL 4522 2096	Report No: 5534
District: East Hertfordshire	Site Code: AS 1910
Approved: Claire Halpin MIfA	Project No: 7300
	Date: 7 February 2018

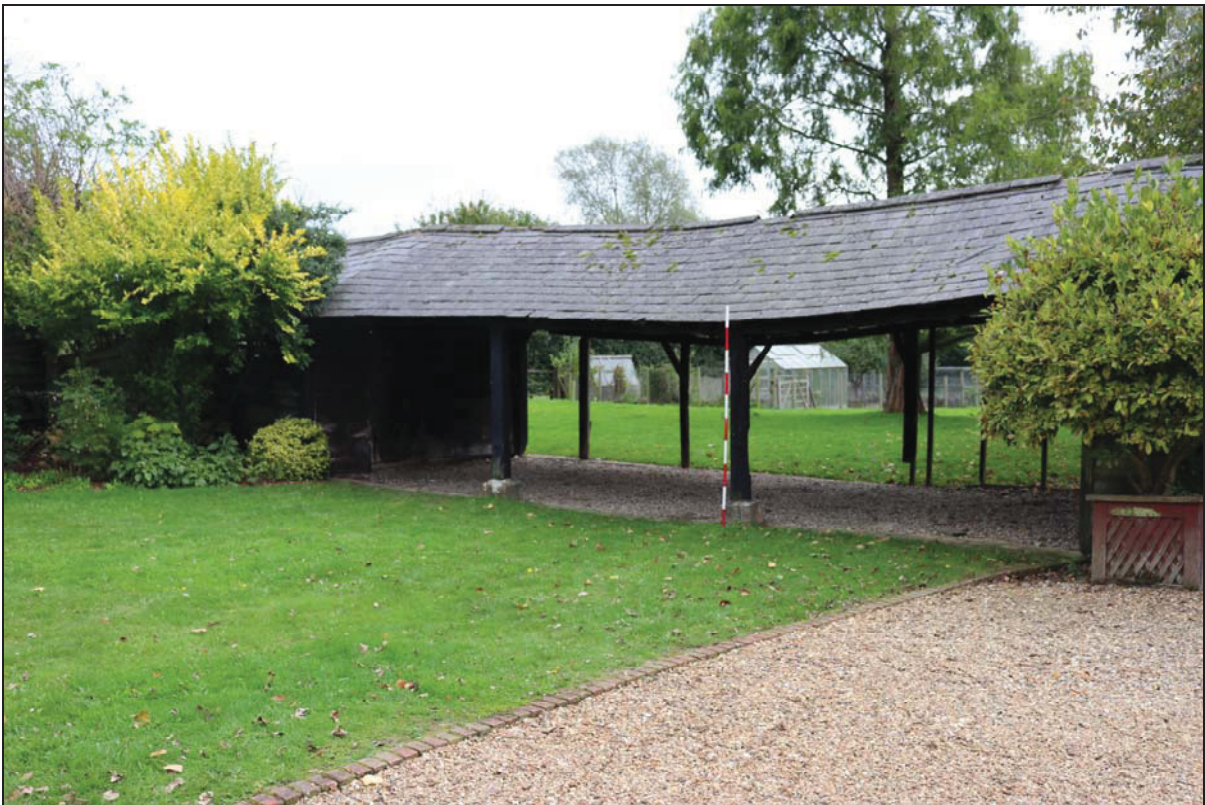
Plate 2 North-west elevation showing open-fronted section (Unit 2), taken from the west (DP03)

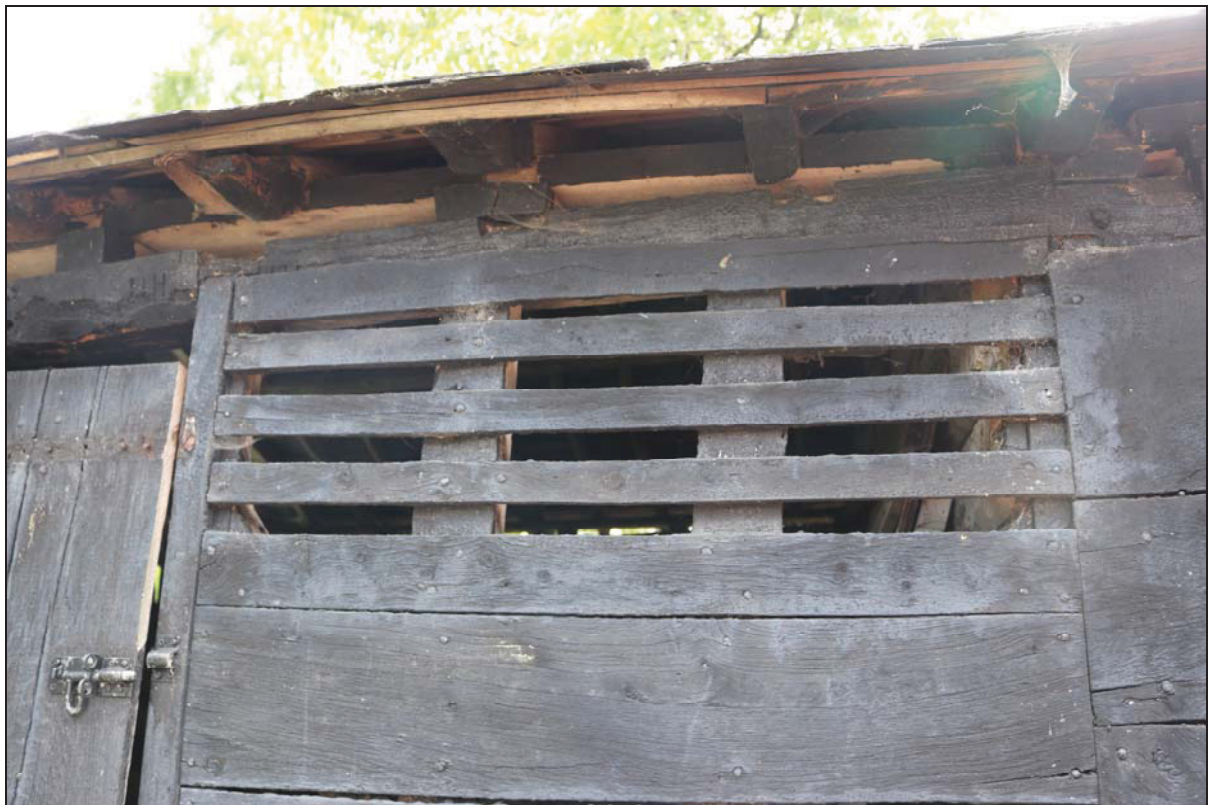
Plate 4 North-west elevation (Unit 3) showing ventilation aperture, taken from the north-west (DP 17)

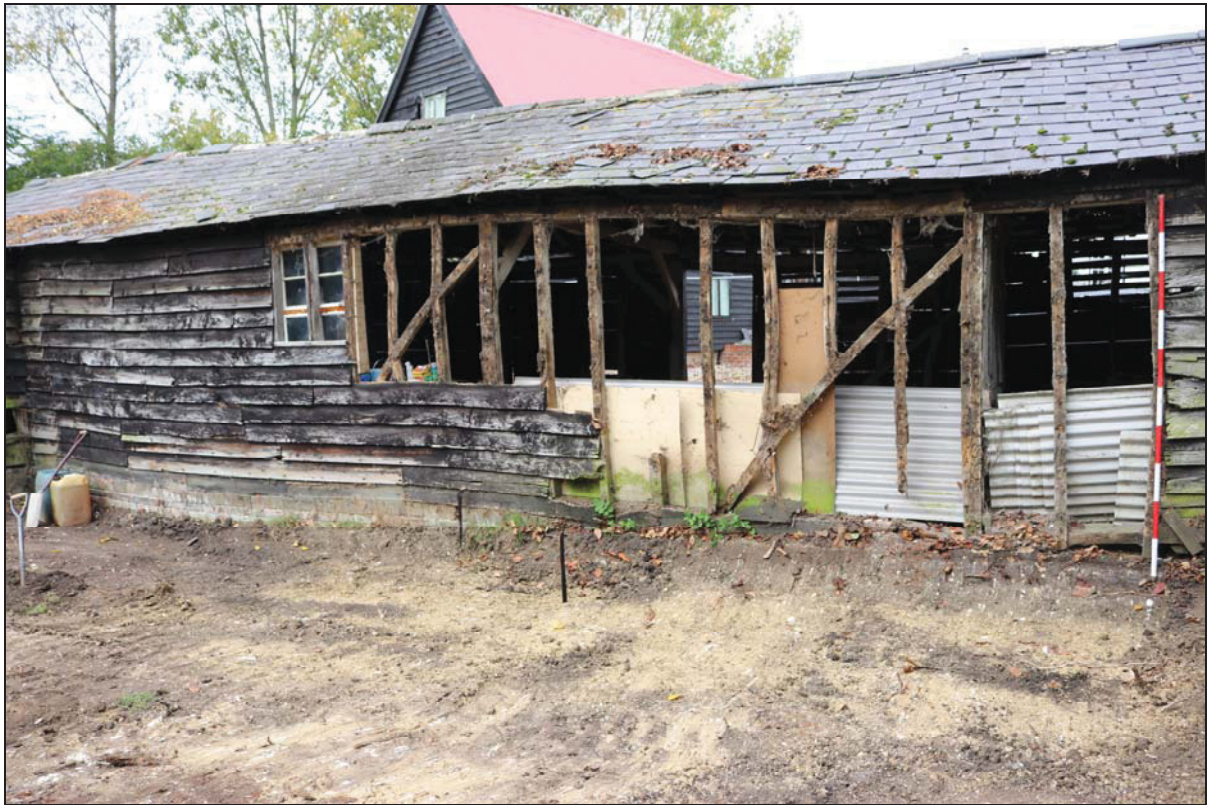
Plate 5 South-east elevation (Unit 5), taken from the south-east (DP 12)

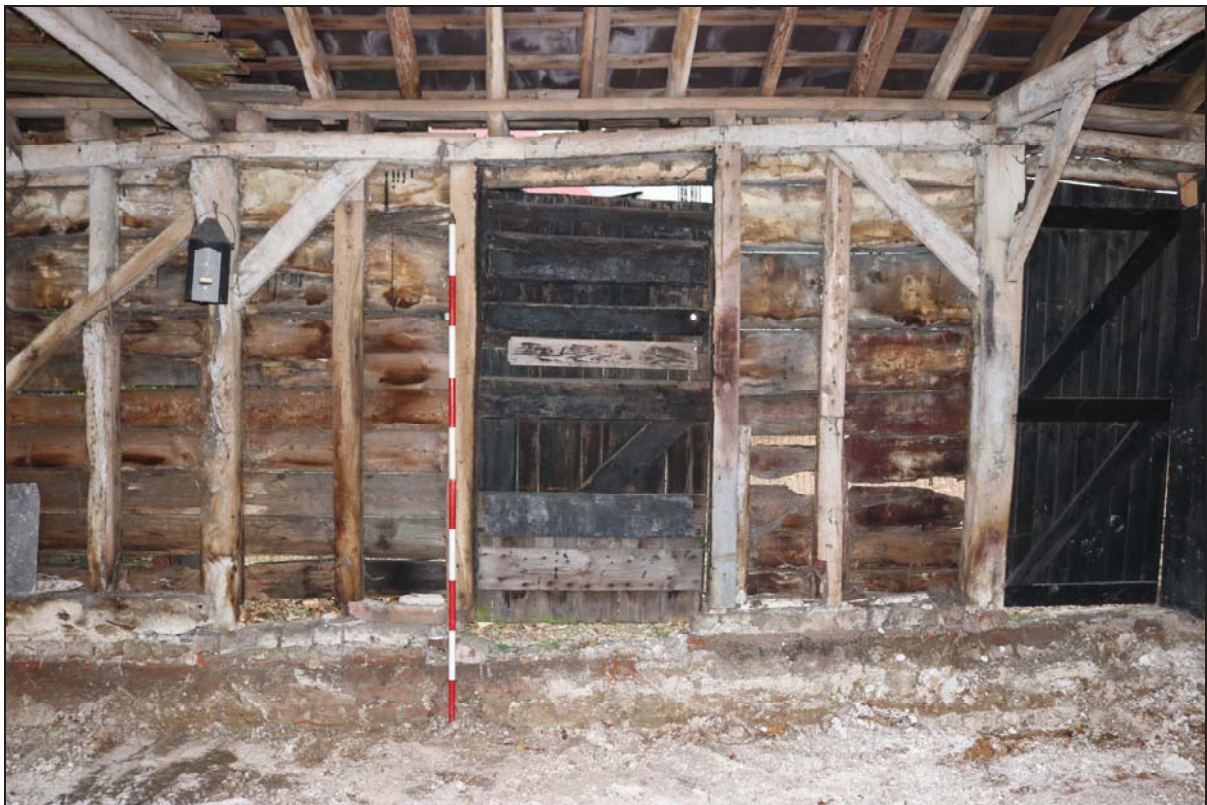
5.1.27 Inspection of the north-west side suggests an original pattern of open-fronted bays with lateral braces from bay post to wall-plates (Plate 6), while the absence of stud mortices in the soffit of the wall-plate suggests the existing studwork, complete with battened ventilation apertures and external horizontal boarding is secondary yet still historic and of value. The opposing south-east side of the building consisted of regular panels of slender primary-braced studwork, notable by the slightly curved nature of the primary-braces (Plate 7). This contrasts somewhat with the infill studwork of the north-west side which has displays occasional very straight primary braces (Plate 8).

Plate 6 North-west wall of Unit 5 (central bay) after the lowering of the floor level, taken from the south-east (DP 116)

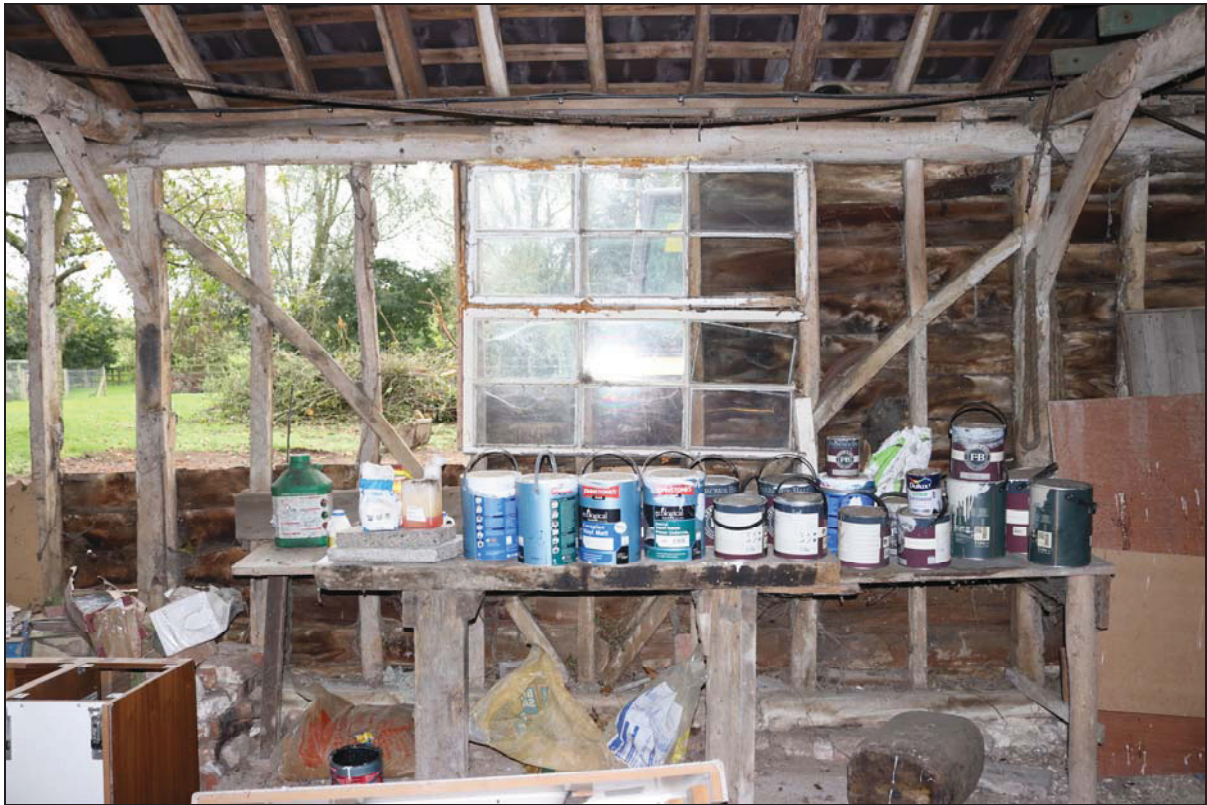
Plate 7 South-east wall of Unit 5 (central bay), taken from the north-west (DP 91)

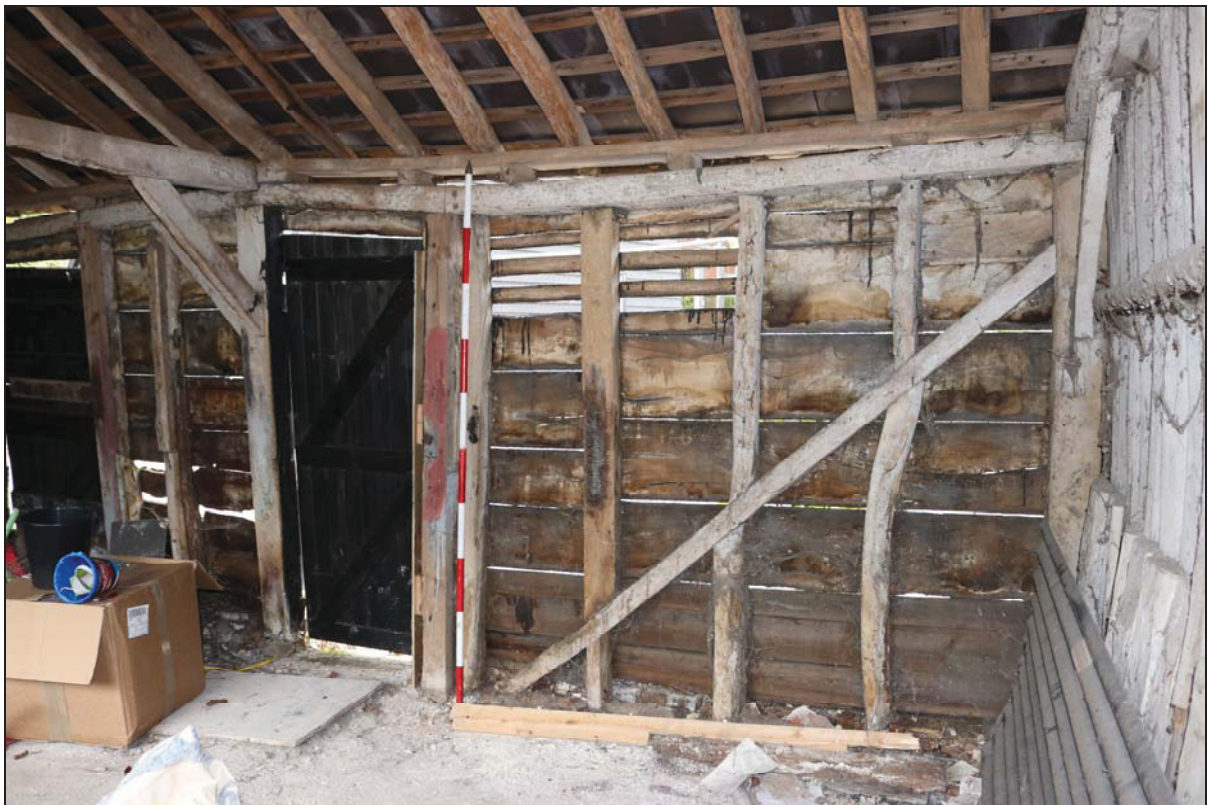
Plate 8 North-west wall of Unit 5 (north-east bay), taken from the south-east (DP 81)

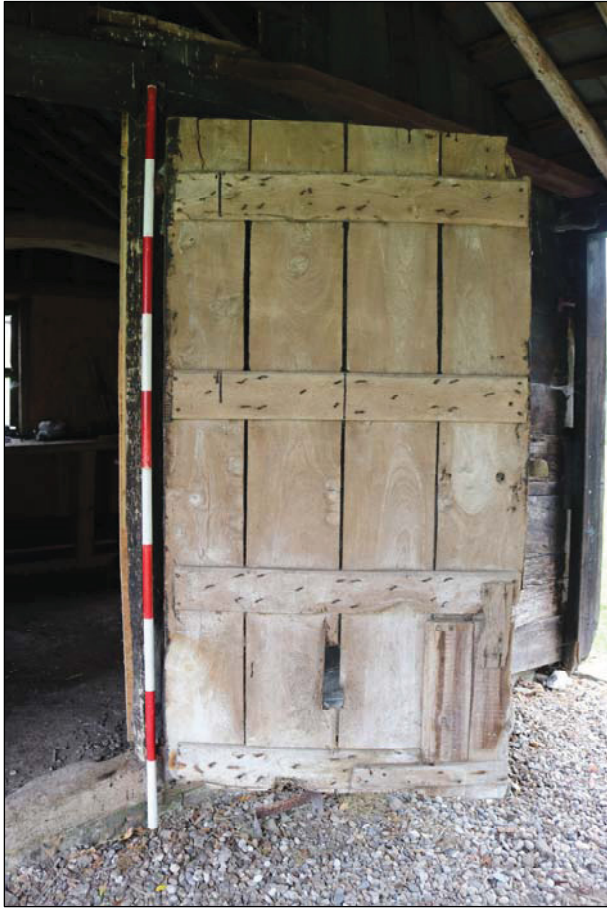
area of Unit 2 through a closed partition. The partition includes fairly wide horizontal boarding, possibly some elm with occasional softwood boards likely as replacements, and vertical boarding above tie-beam level. The doorway contains a good oak boarded and ledged door of 18th / 19th century date (Plate 9). There are four boards and four ledges to the rear, all secured with hand made nails and hung on strap hinges with round finials and pintles. Of interest is the timber latch and fastener which rarely survive (Plate 10). It is in good condition and worn through use.

Plate 9 Rear face of the historic boarded and ledged door to Unit 1, taken from the south-west (DP 32)

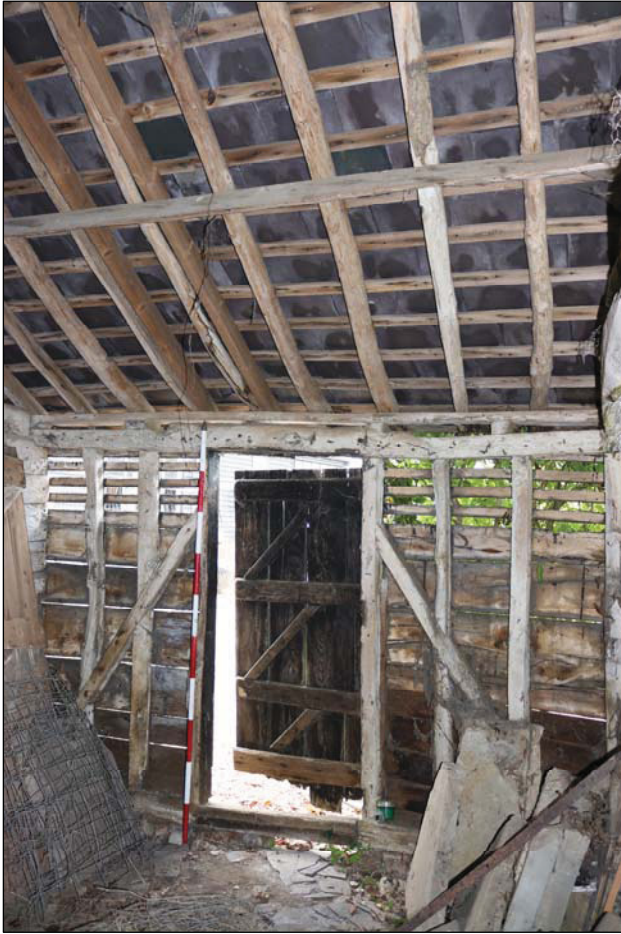
Plate 13 North-west wall of Unit 3 showing primary-braced framing with ledged and braced door and flanking ventilation apertures, taken from the south-east (DP 60)

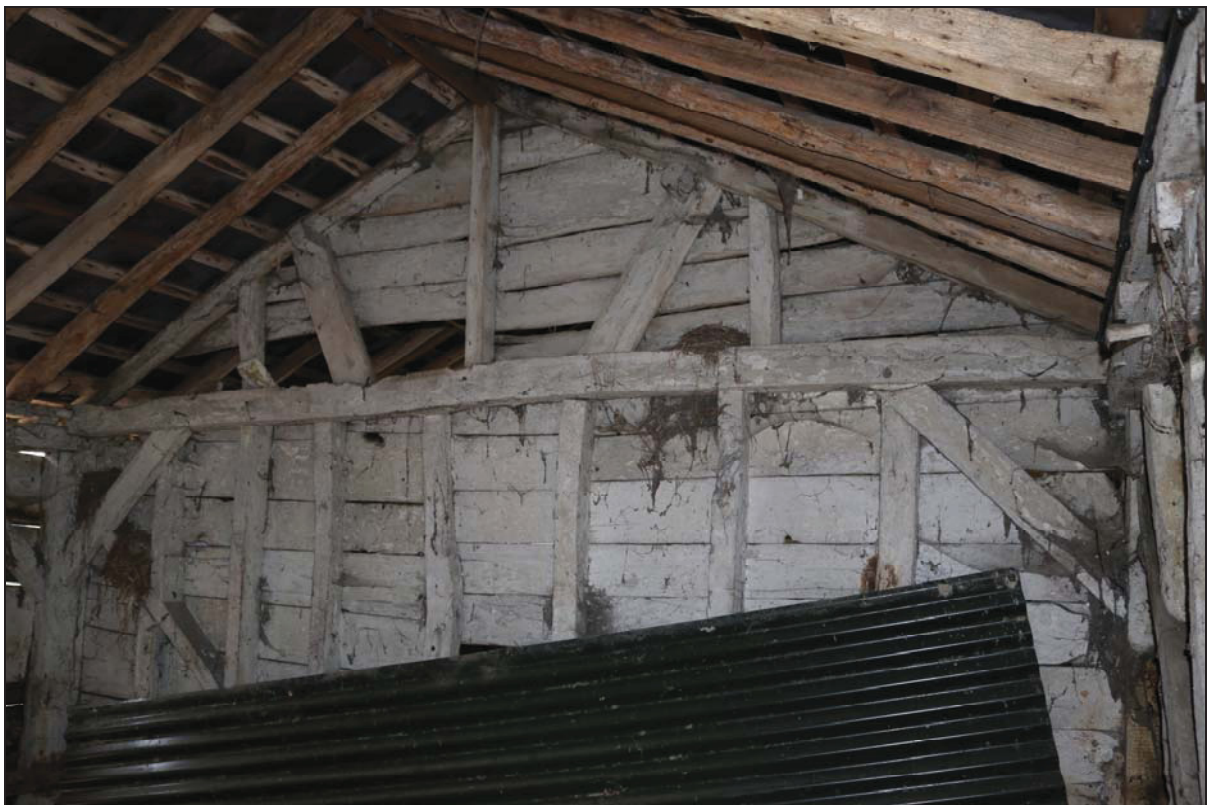
5.1.39 Unit 4 survives well though again the sole-plates are degraded. It spans a single bay, closed on both sides to the adjacent units. The north-east side is a closed studwork partition which appears secondary to the truss itself, but may be contemporary (Plate 14). The truss itself preserves the bay posts and tie-beam with inner braces, all single-pegged. The north-west bay post and brace has a III with a tag (Plate 15), while the south-east post and brace has a IIII (Plate 16). The tie-beam has raking struts which clasp the purlins which continue from Unit 2 but terminate here. The ends are flat-sawn and do not appear weathered which may suggest they were part of the original roof structure and truncated with the replacement of the roof.

Plate 14 North-east side of Unit 4 showing studwork with horizontal boarding to the rear, taken from the south (DP 71)

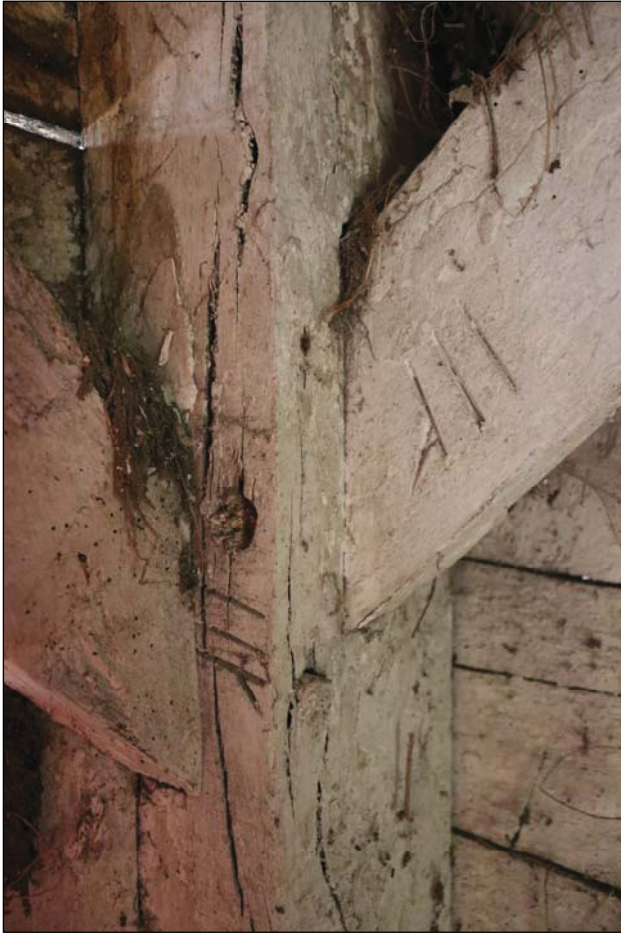
Plate 15 Detail of the north-west corner of Unit 4 showing assembly marks, taken from the south (DP 75)

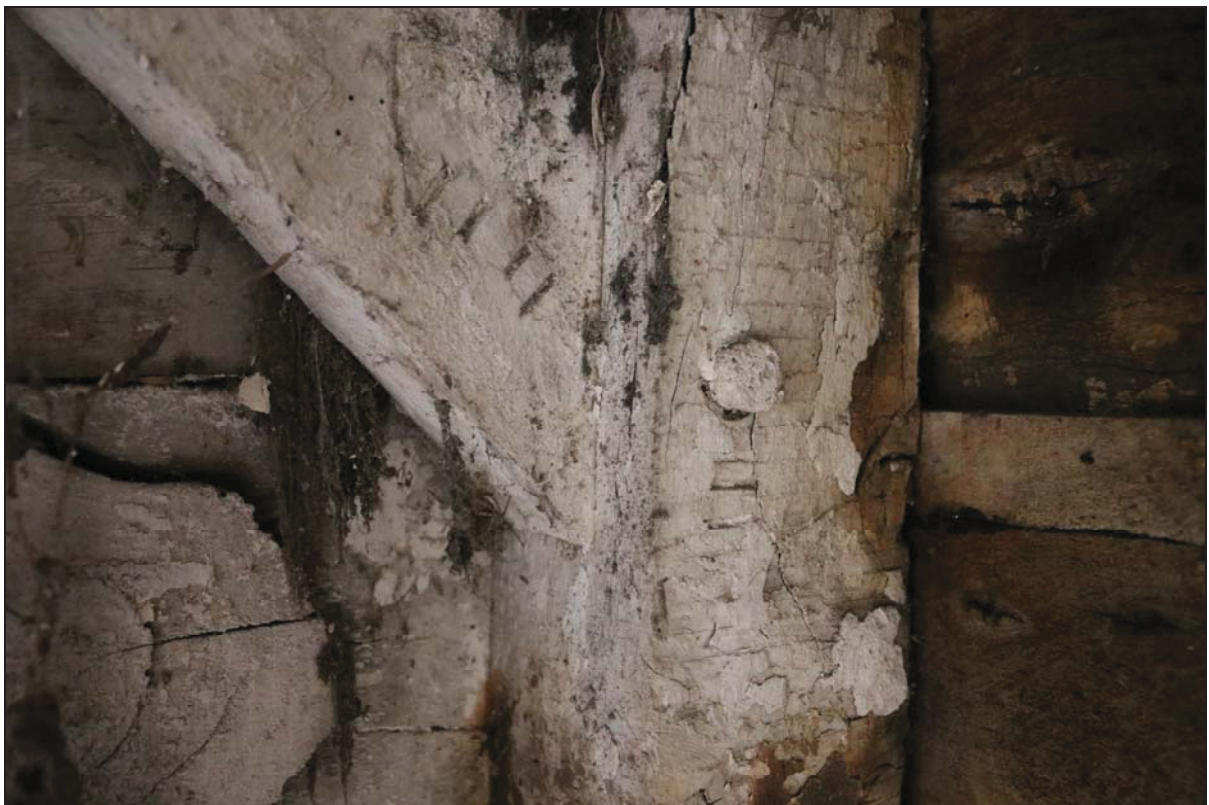
Plate 16 North-east corner of Unit 4 showing pegged inner brace with assembly marks, taken from the south (DP 77)

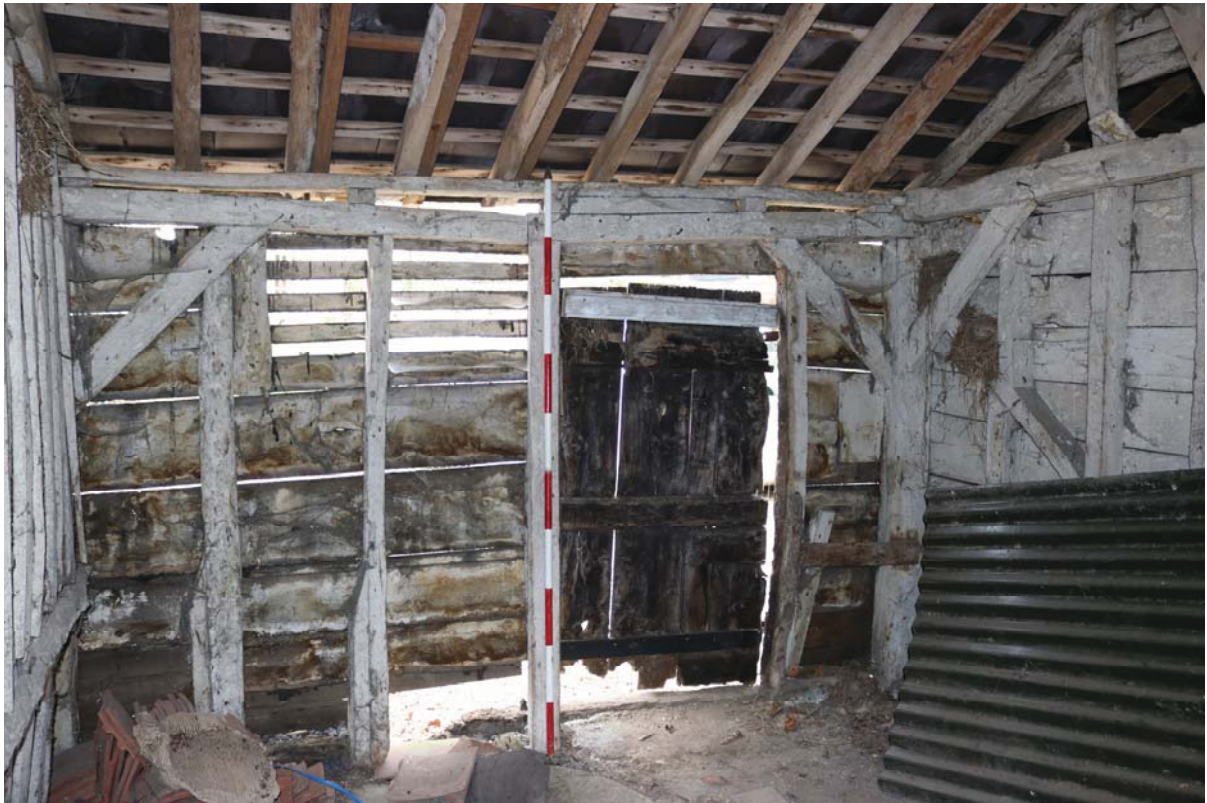
Plate 17 North-west side of Unit 4 showing lateral braces with infill studwork and door and ventilation aperture, taken from the south-east (DP 70)

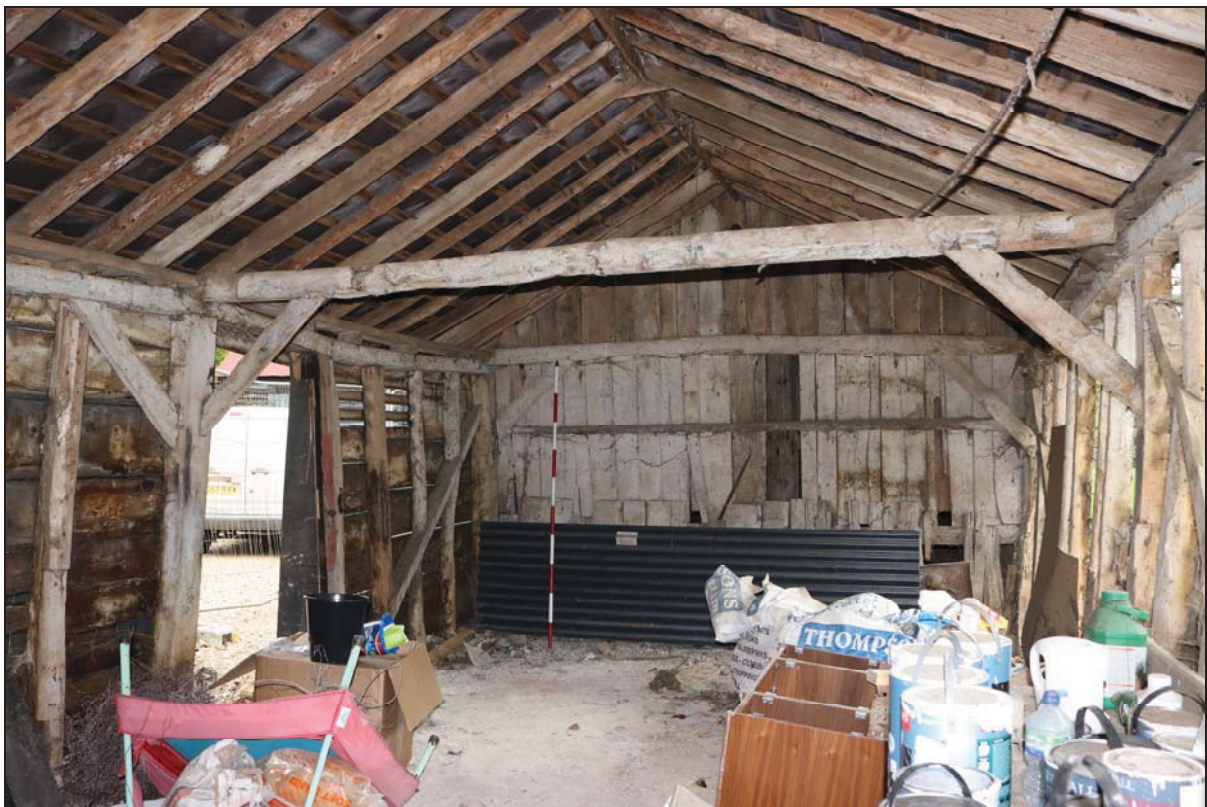
5.1.41 Unit 5 is an open space that spans three bays and continues the pattern of framing from the north, but here the variation in framing between the sides can be more easily appreciated (Plate 18 and 19). The two trusses dividing the bays are of the same form as elsewhere, with pegged inner braces from the bay posts to the tie-beam but no upper structure, while the wall-plates again display the same contracted scarf joints. This differs slightly at the south-west end, noted below.

Plate 18 Interior of Unit 5, taken from the south-west (DP 78)

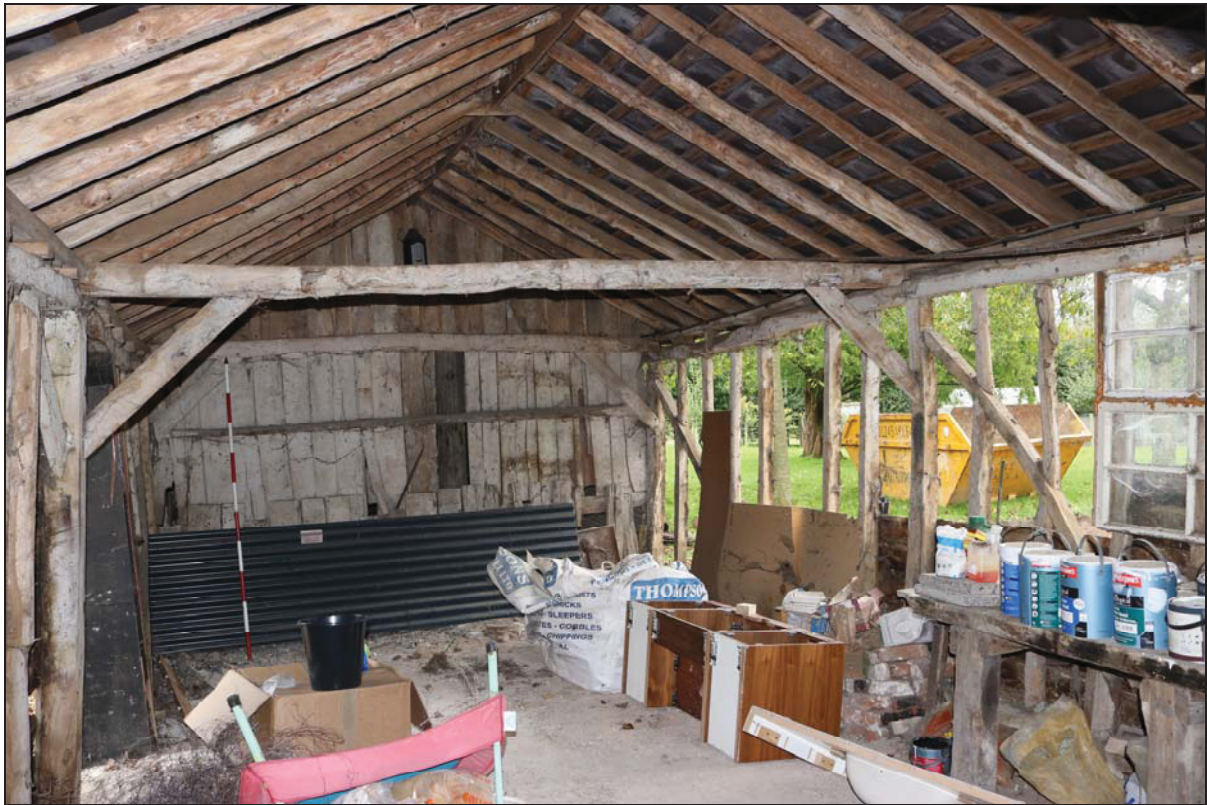
Plate 19 Interior of Unit 5 showing primary-braced framing on the right with the external weatherboarding removed, taken from the south-west (DP 79)

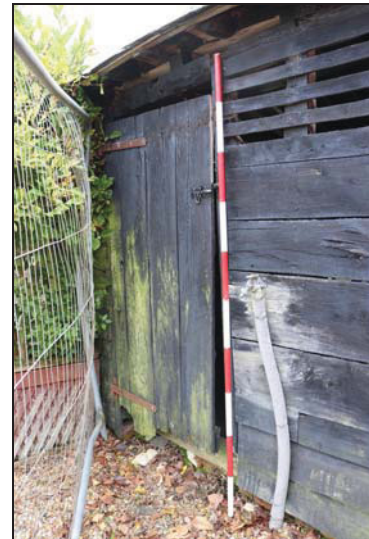
*DP 16
North-west elevation (Unit 3) showing boarded door with later hinges, taken from the south-west*

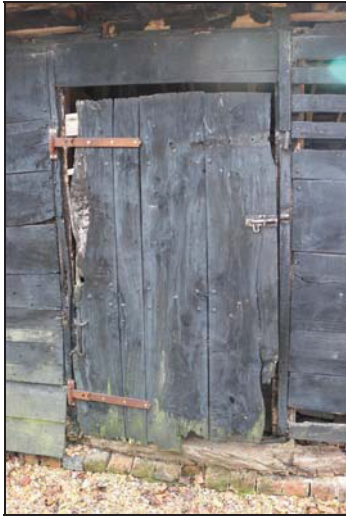
DP 19
North-west elevation (Unit 4) showing boarded door re-hung on the opposite side, taken from the north-west

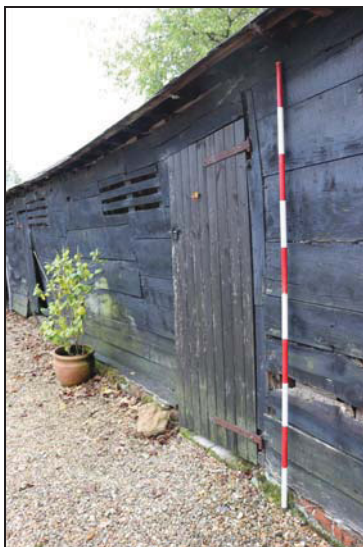
DP 23
North-west elevation of Units 4 and 5 showing fairly modern door set in the historic elevation, taken from the south-west

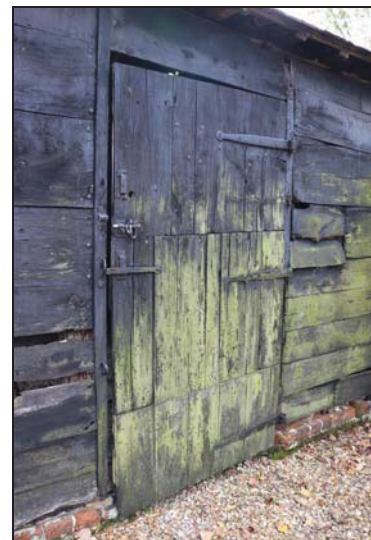
DP 25

Detail of the door on the north-west elevation of Unit 5 showing strap hinge hung on a pintle with impression below for lost example, taken from the north-west
