**BARNS AT DANE END HOUSE, CONDUIT LANE,
GREAT HORMEAD, BUNTINGFORD,
HERTFORDSHIRE**

HISTORIC BUILDING RECORDING

Level 3

Authors: Lauren Wilson MA PCIfA Kath Henry (Graphics)	
NGR: TL 40520 30120	Report No: 5372
District: East Herts	Site Code: AS 1883
Approved: Claire Halpin MCIfA	Project No: 6858
	Date: 5 May 2017

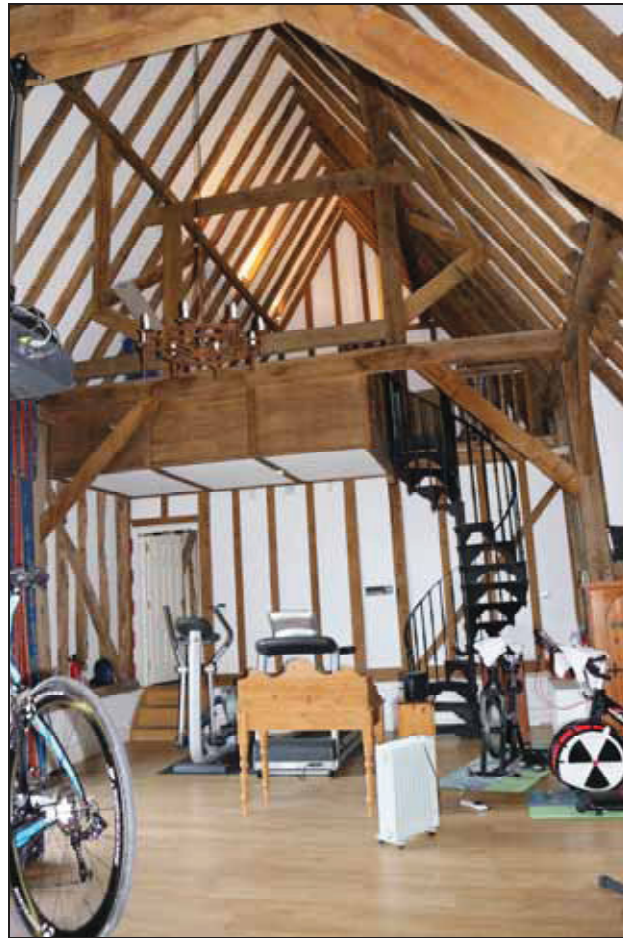
5.17 This bay has been subdivided and now gives access to the extensions to the north which houses an additional bedroom, bathroom and kitchen. Within the bay, half is shared with the main space and half provides a bedroom, above which a mezzanine provides access into two bathrooms pushed into the north extensions roof space (Plate 12).

Plate 12 Truss 2 in Barn 1, taken from the south (DP 27)

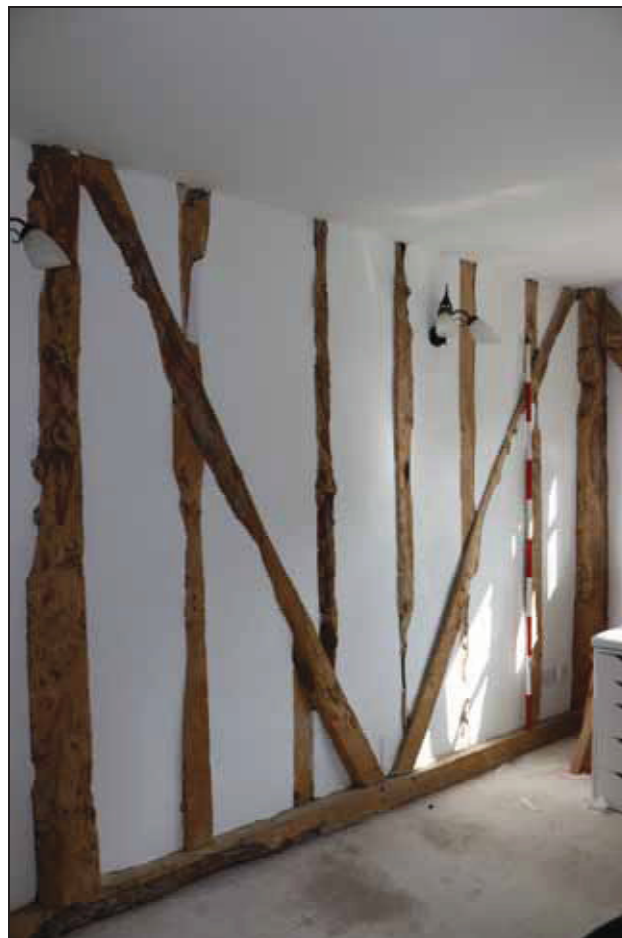
5.19 The sole-plate is intact here but the timber-framing has been cut for the introduction of the corridor to the west (Plate 13). Only eight studs survive with the sole-plate retaining empty mortises for a further two (Plate 14). There are three primary braces along this wall; the outer two descend from the principal posts and are pegged to the sole-plate, although the western one has been truncated by the corridor, and there is an additional third central primary brace which descends to the east. The west principal bay post has a notch for a horizontal timber and just below ceiling level the bottom part of an empty mortise is visible.

Plate 14 North-east end of bay 3 in Barn 1, taken from the south-west (DP 48)

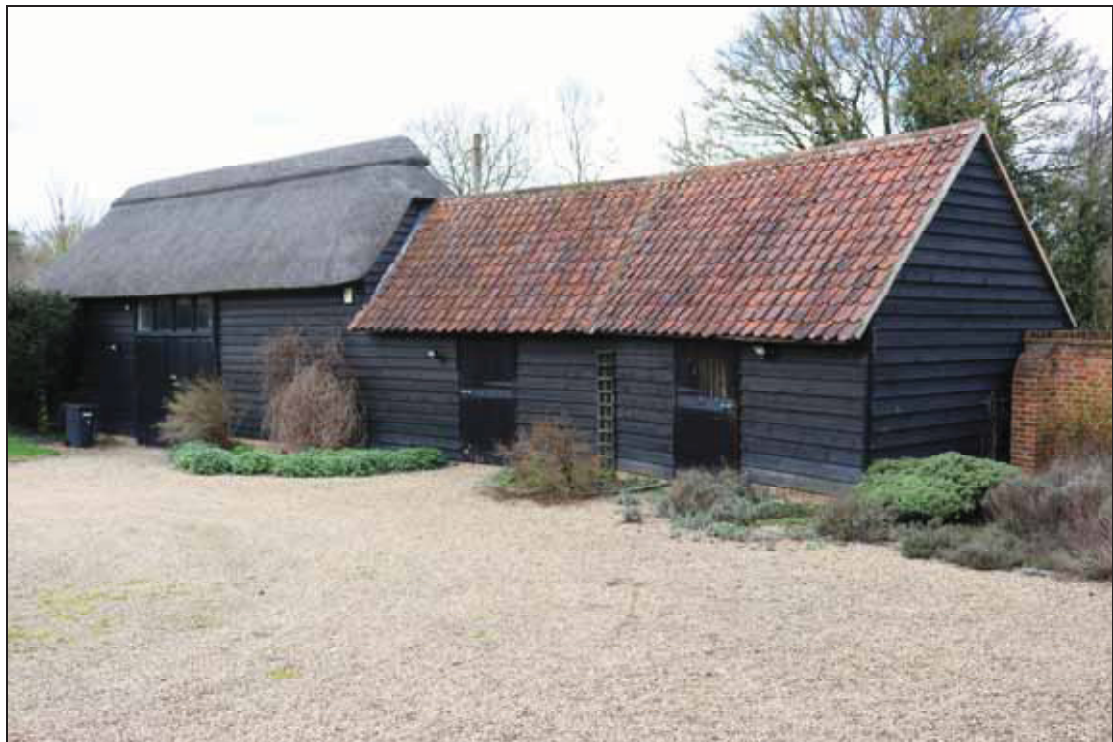
5.21 The principal south façade of Barn 2 faces into the yard (Plate 16). The barn comprises two main elements, the main barn to the west and the two storage rooms to the east which form this assessment. The entire building is weather-boarded above a brick dwarf wall though the external ground level has been raised meaning only one or two courses of brick are visible. Similar to its companion to the east the barn has a half-hipped thatch roof and a set of double doors to the yard.

Plate 16 Exterior of Barn 2, taken from the south-east (DP 07)

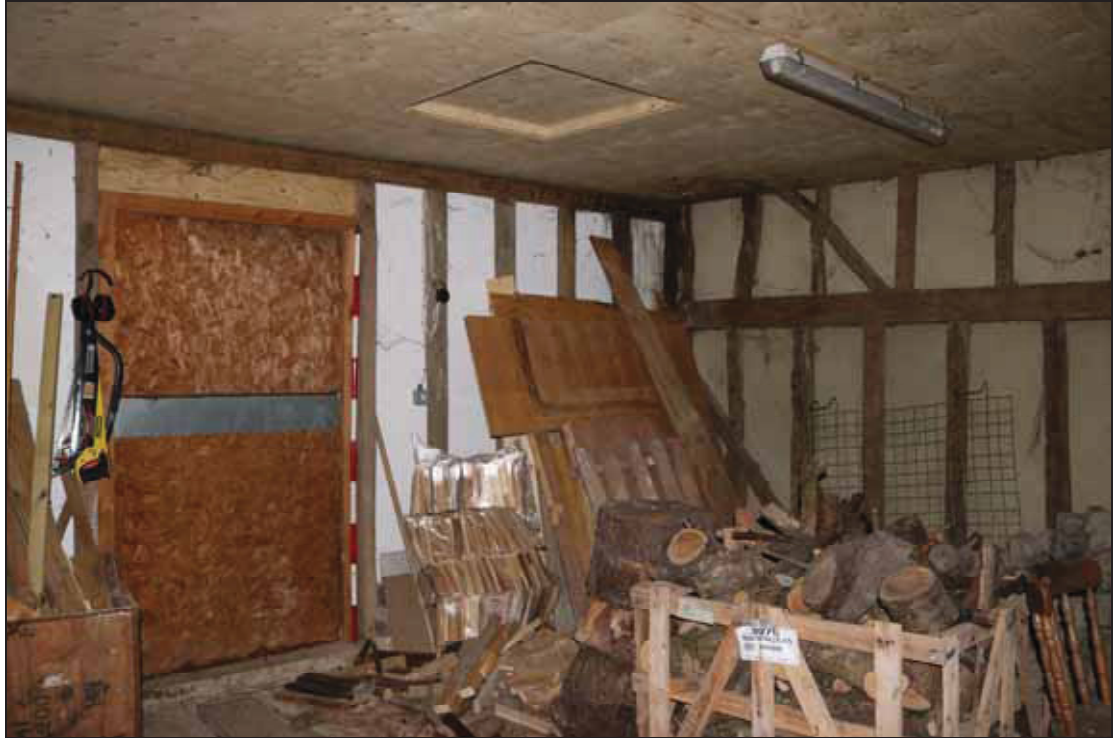
5.28 The south wall has a dwarf brick wall which supports slender studs with no primary bracing (Plate 19). A wide doorway provides access to the yard with modern materials.

Plate 19 Interior of the west room of Barn 2's outbuildings, taken from the north (DP 19)

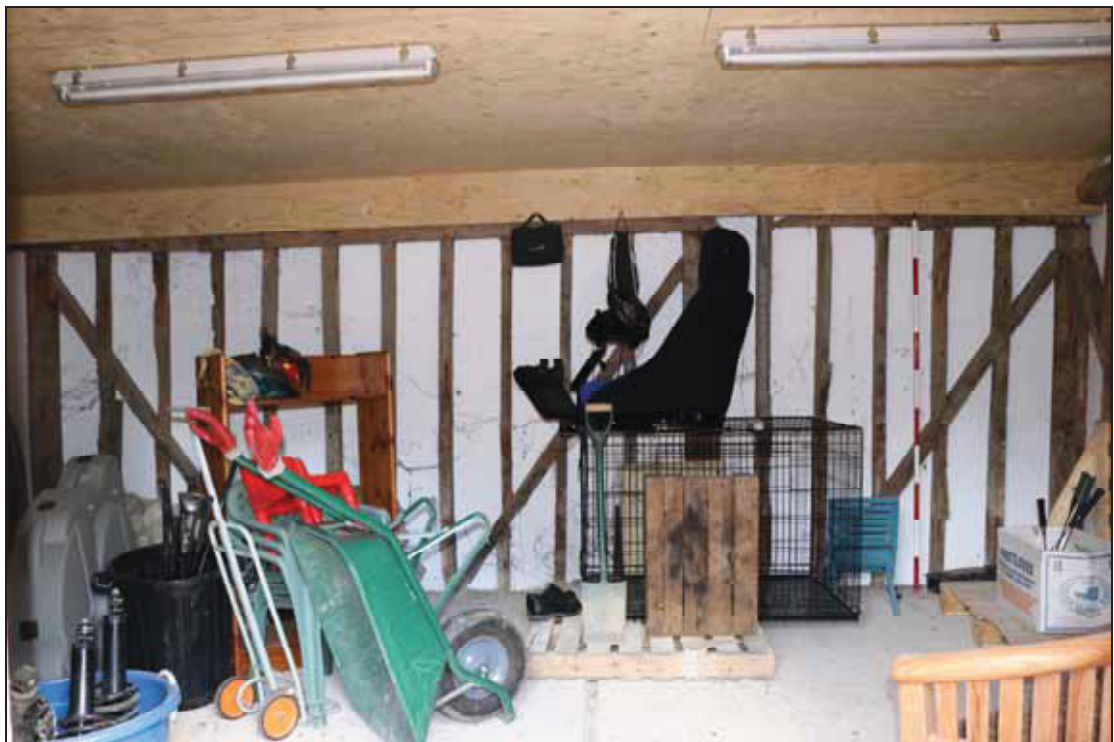
5.29 The east storage room is again, timber-framed on three sides with a breeze block west wall. The north wall reflects the original structural form and consists of two bays, one wide and one narrow, though the western post is set in from the end of the structure where it abuts the pre-existing barn (Plate 20). The west bay includes two principal posts with primary braces descending from the

Plate 20 North wall of the east room of Barn 2's outbuildings, taken from the south (DP 20)

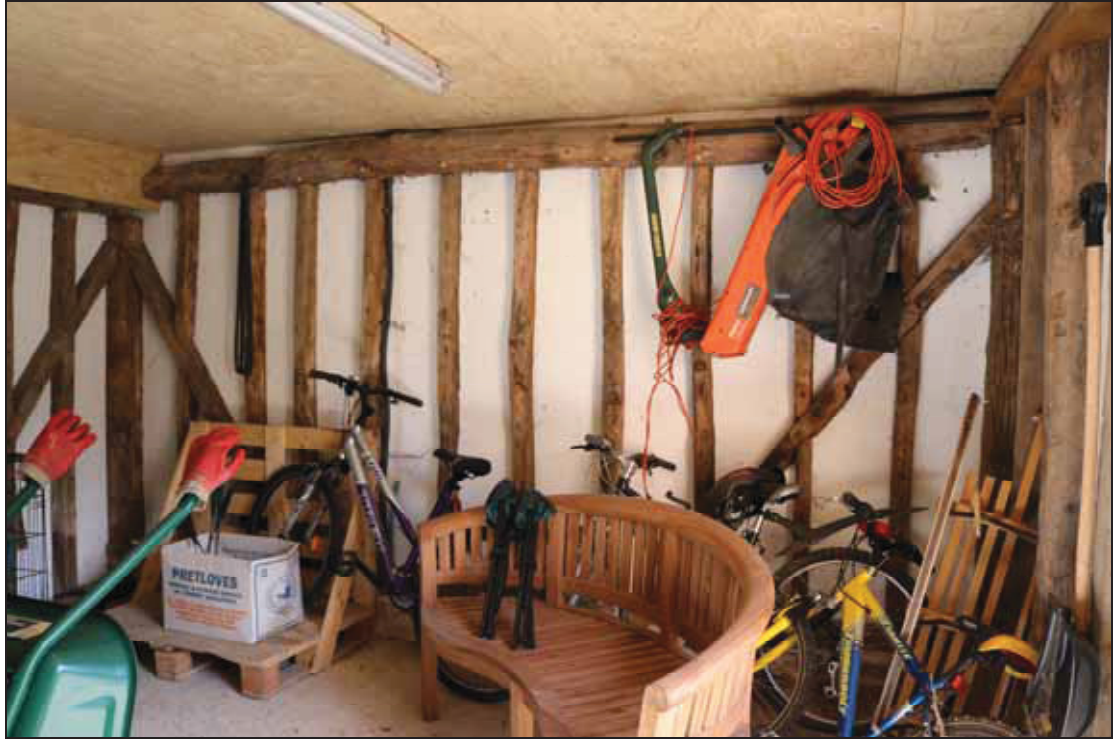
5.30 Along the east wall a rebuilt dwarf brick wall and renewed sole plate supports the studwork above (Plate 21). This is also primary-braced and utilising historic fabric though it has been reconstructed with modern pegging to the wall-plate. The pattern continues with outer wall posts and inner primary braces descending to the sole-plate, but the rebuilding has seen the pegging of every common stud instead of only the full-height examples and so does not exactly follow the historic form.

Plate 21 East wall of the east room of Barn 2's outbuildings, taken from the south (DP 24)

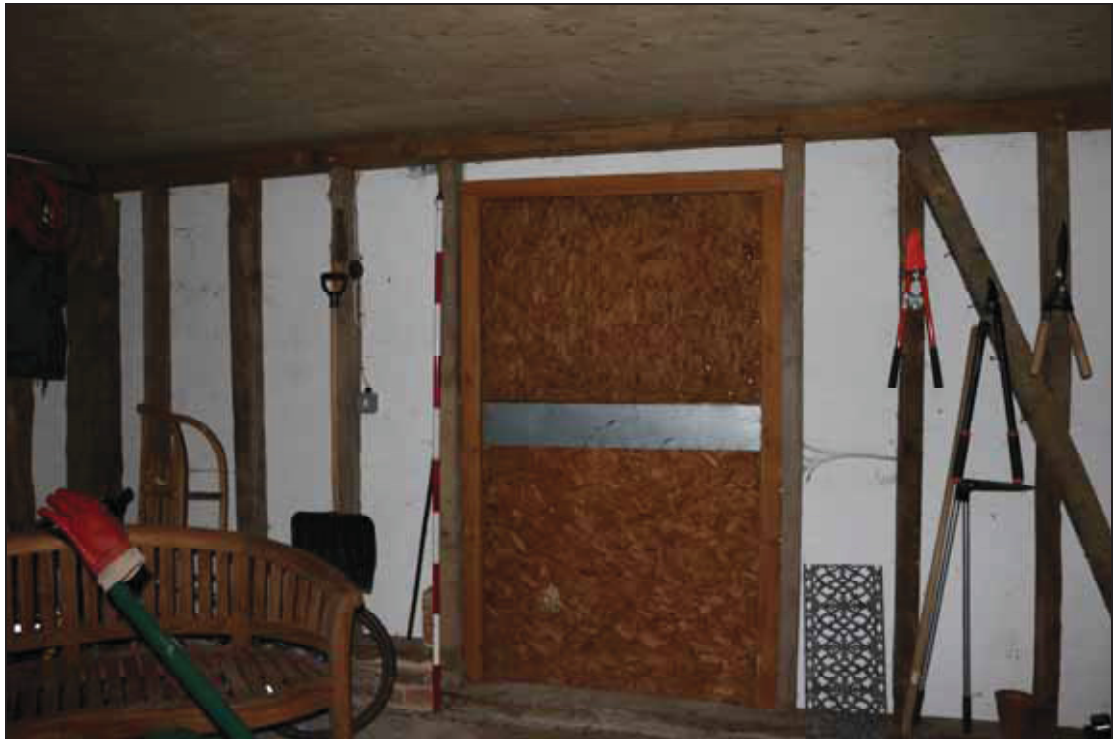
5.31 The south wall has part of a dwarf wall and sole plate to the east of the door, but other wise comprises just a sole plate, slender studs pegged to a wall-plate and a single primary-brace to the west, all of modern timber and machine sawn (Plate 22). To the west the end of the wall-plate of the adjoining room can be seen.

Plate 22 Interior of the east room of Barn 2's outbuildings, taken from the north-west (DP 25)
