AMWELL END, DOWN GREEN LANE,  
WHEATHAMPSTEAD, HERTFORDSHIRE  
HISTORIC BUILDING MONITORING AND RECORDING

Authors:	Tansy Collins BSc Kathren Henry	
NGR: TL 16762 13340	Report No. 4951	
District: St Albans	Site Code: n/a	
Approved: C. Halpin MCIFA	Project No. 5679	
Signed:	Date: 28 September 2015

## HISTORIC BUILDING MONITORING AND RECORDING

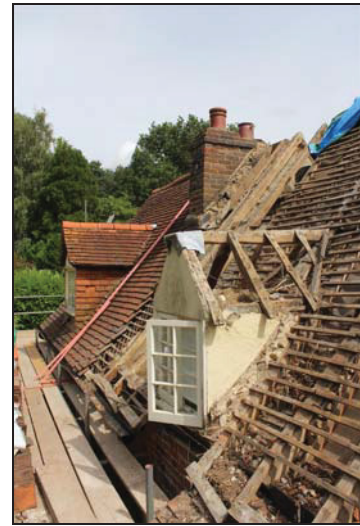
63  
West roof pitch of the historic core (Range 1: Bay 2, south end) showing rafters truncated by the insertion of the chimney stack, taken from the west
